## Construction Noise and Vibration Monthly Report – September 2023

Buckinghamshire

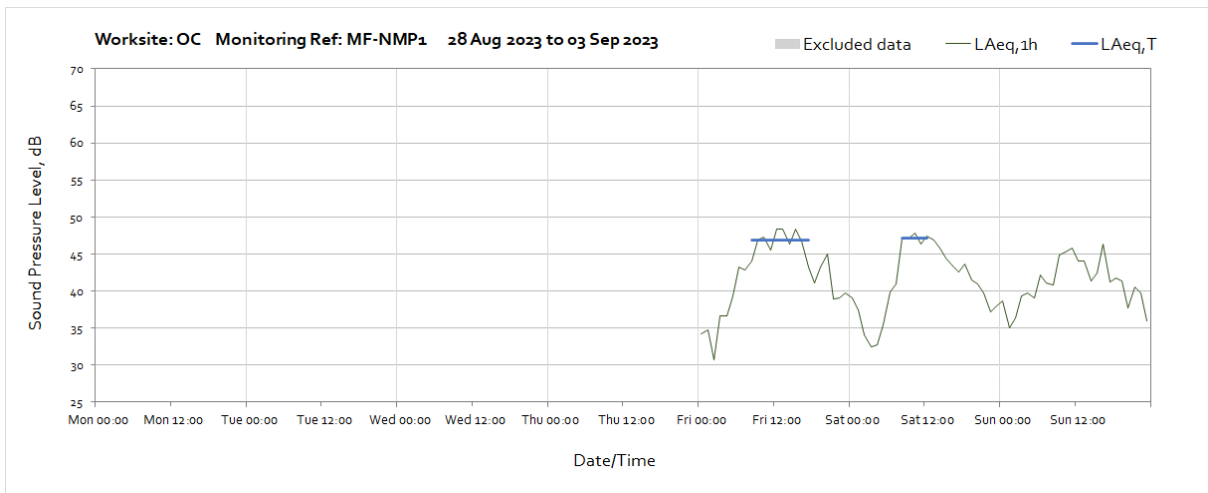
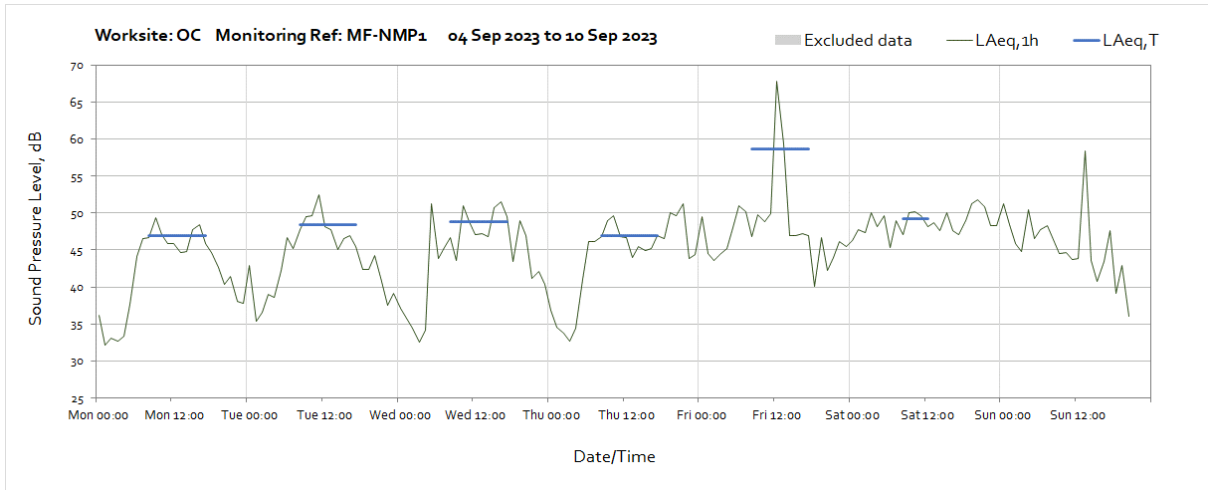
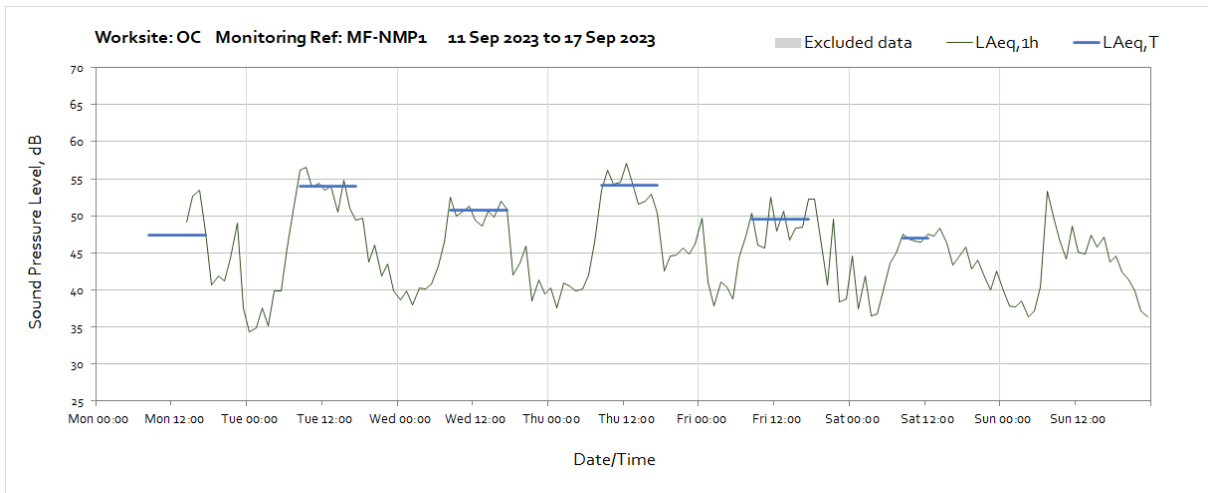
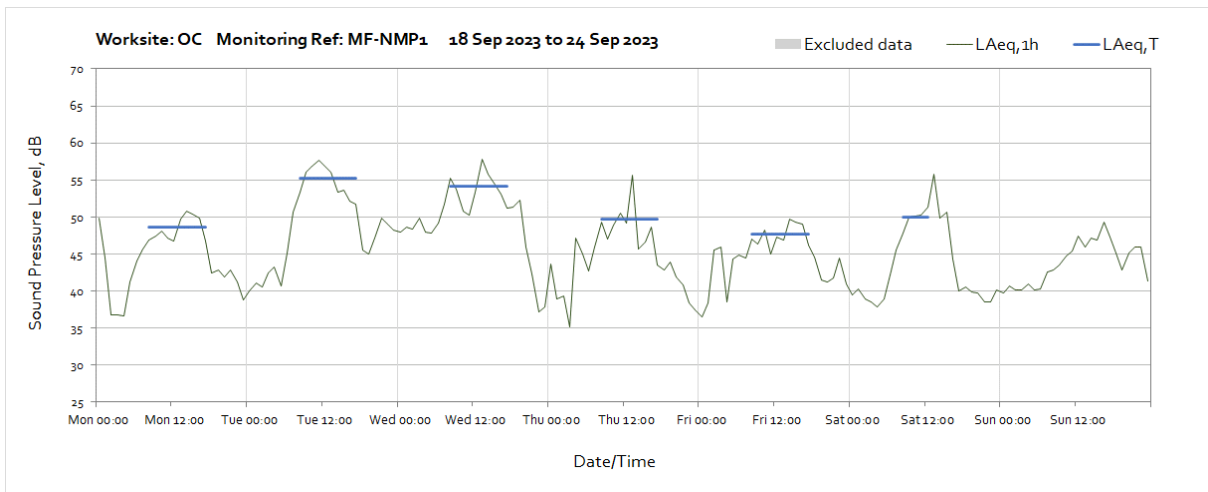
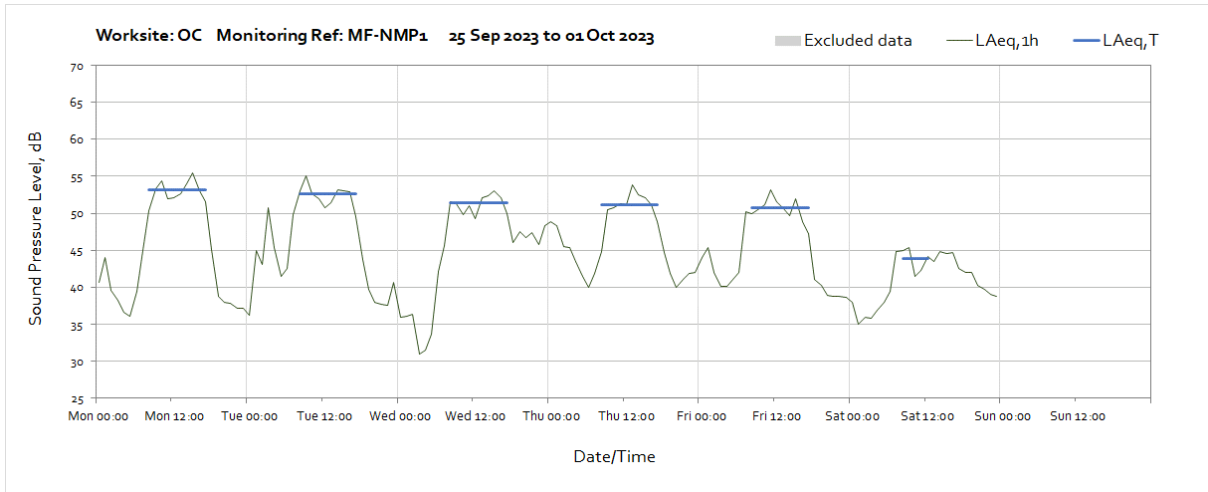
**Worksite: OC - Monitoring Ref: MF-NMP1**

Note: Missing data from 21:00 on Sunday 10<sup>th</sup> September until 14:00 on Monday 11<sup>th</sup> September was due to loss of monitor battery power.

Note: Missing data between 21:00 on Sunday 10<sup>th</sup> September and 14:00 on Monday 11<sup>th</sup> September was due to loss of monitor battery power.

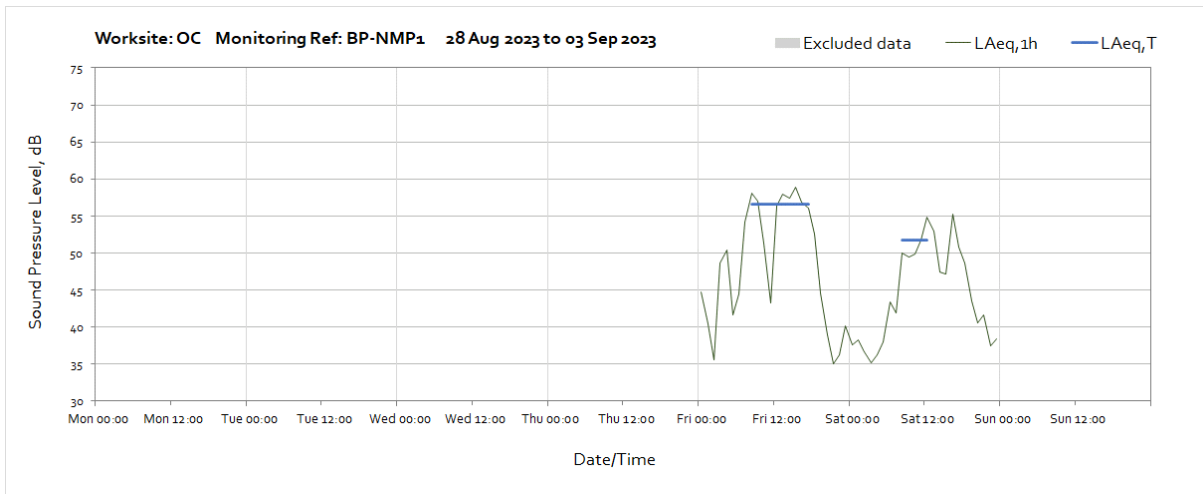
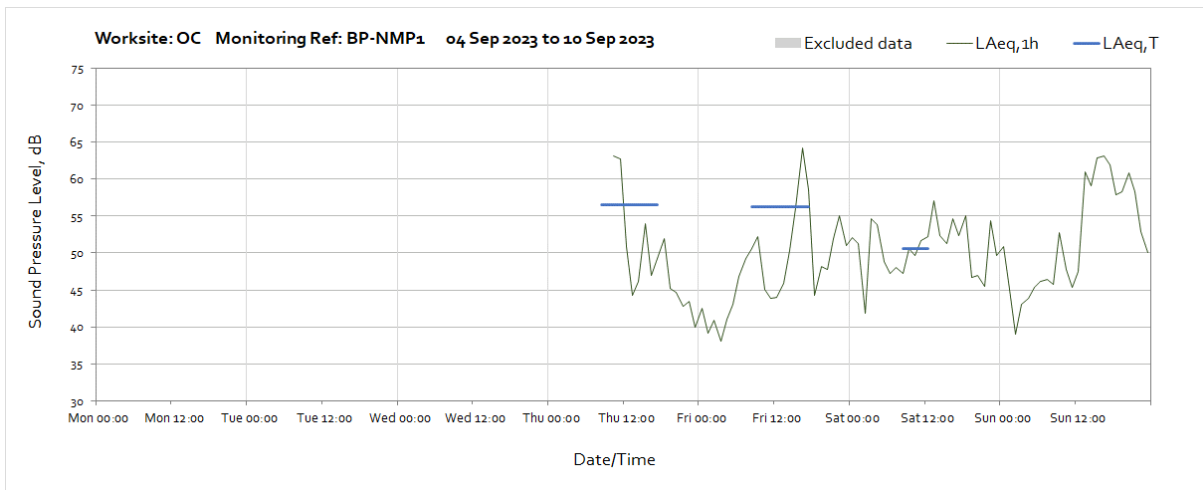
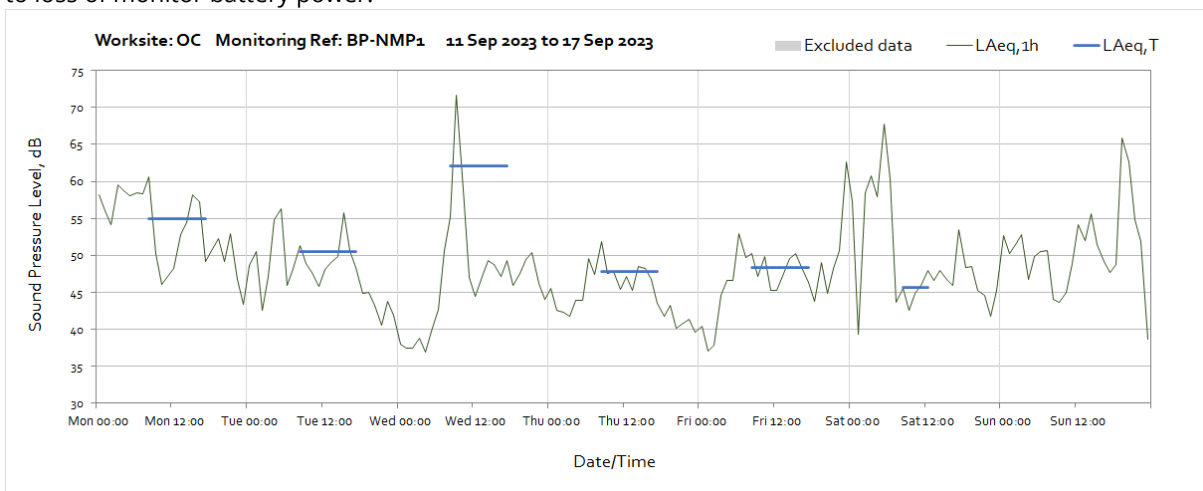
## Worksite: OC – Monitoring Ref: BP-NMP1

Note: Missing data between 00:00 on Sunday 3<sup>rd</sup> September and 10:00 on Thursday 7<sup>th</sup> September was due to loss of monitor battery power.

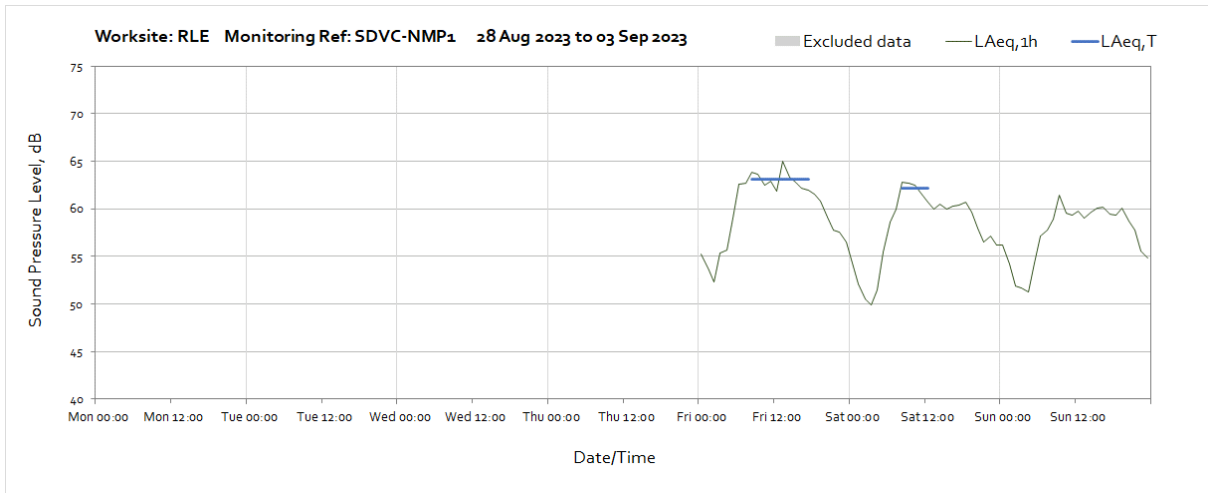
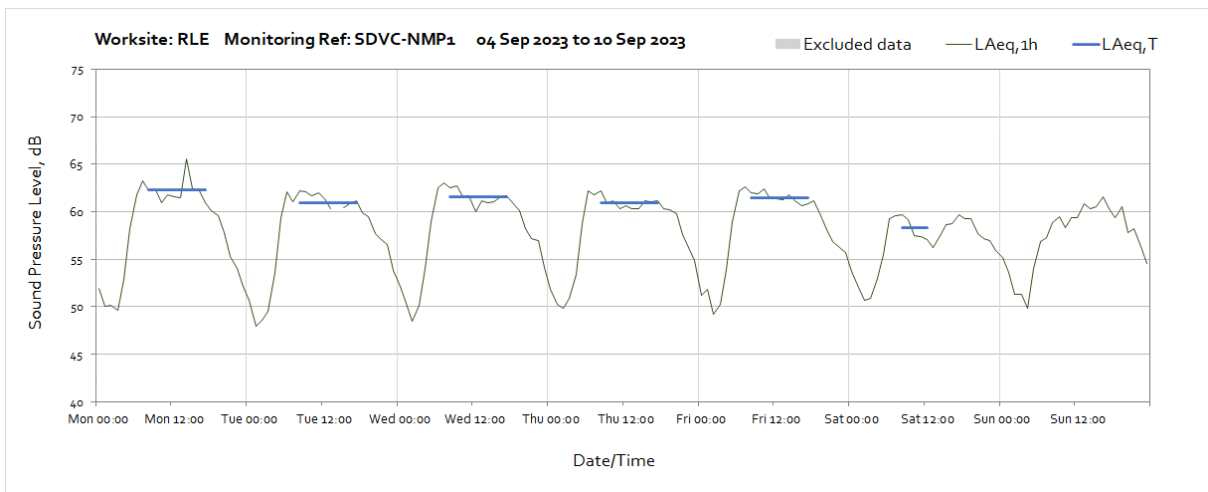
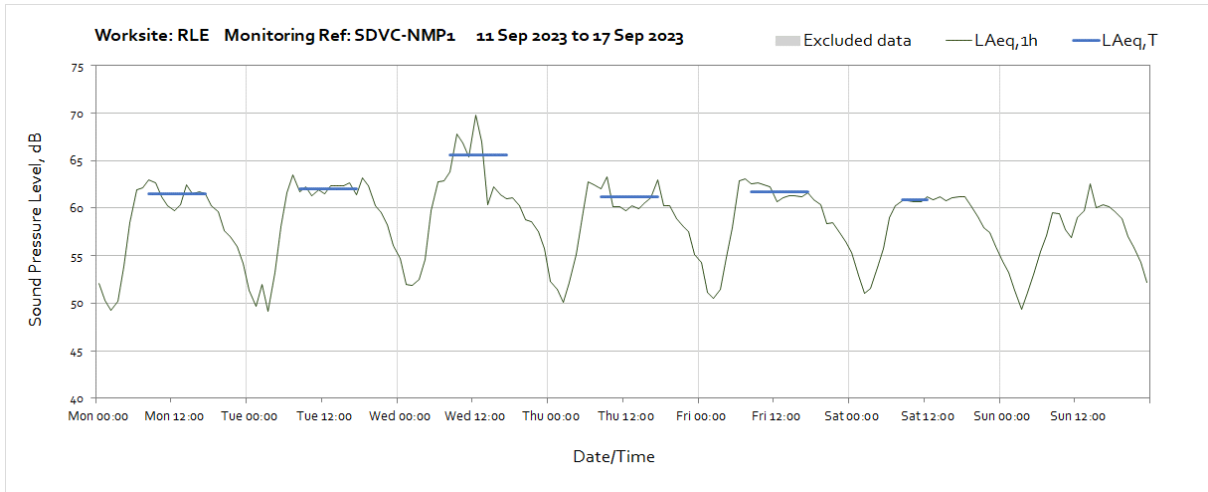
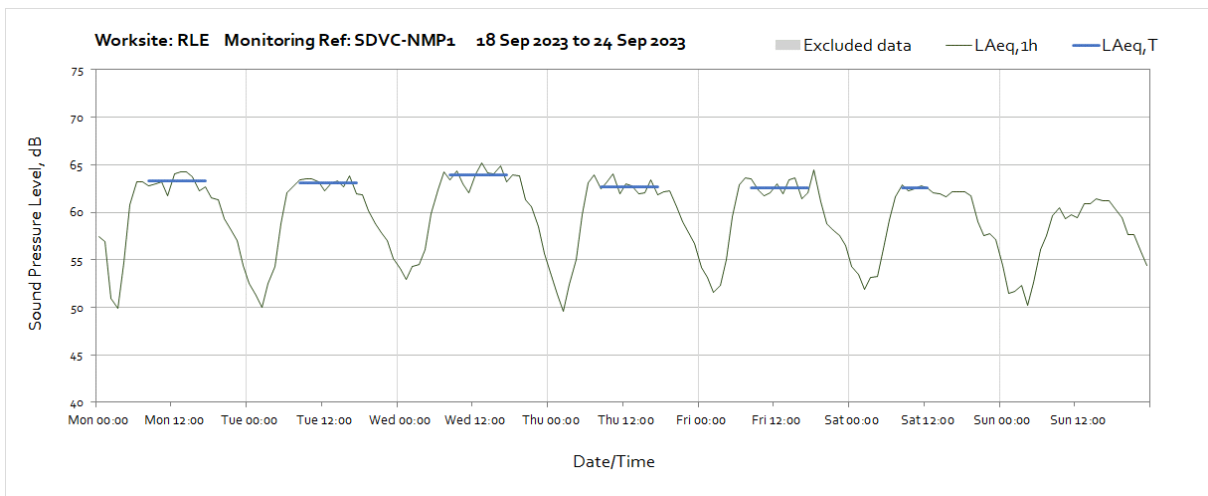
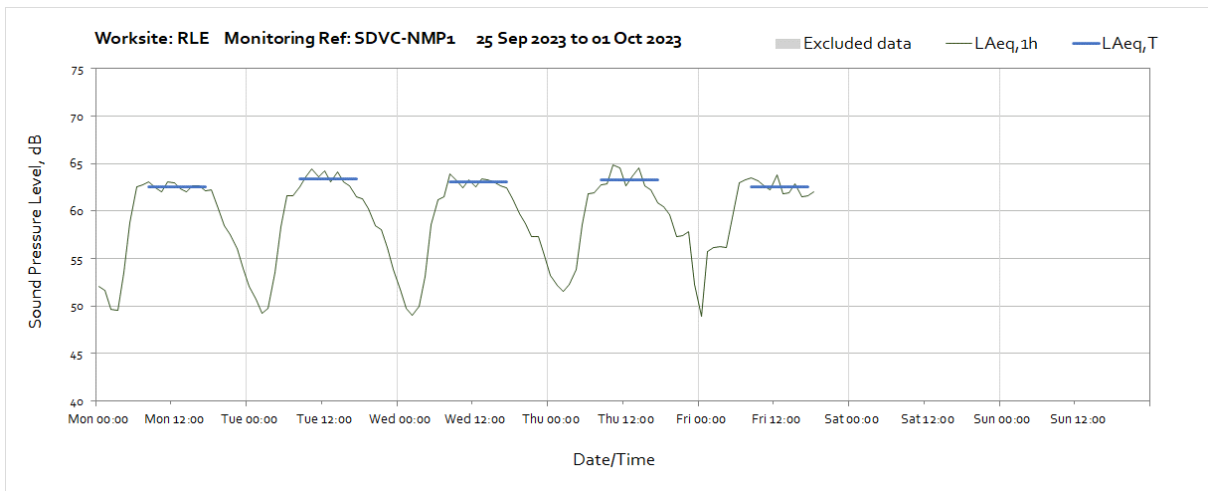
**Worksite: RLE – Monitoring Ref: SDVC-NMP1**

Note: Missing data between 14:00 and 15:00 on Tuesday 5<sup>th</sup> September was due to monitor maintenance.

Note: Missing data from 19:00 on Friday 29<sup>th</sup> September until month end was due to monitor error, monitor has now been replaced.

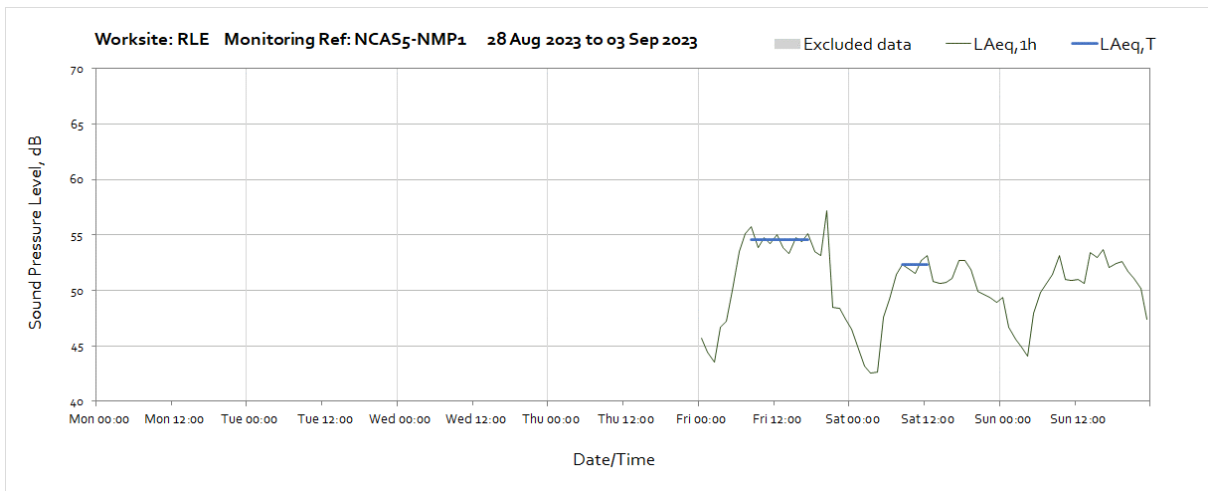
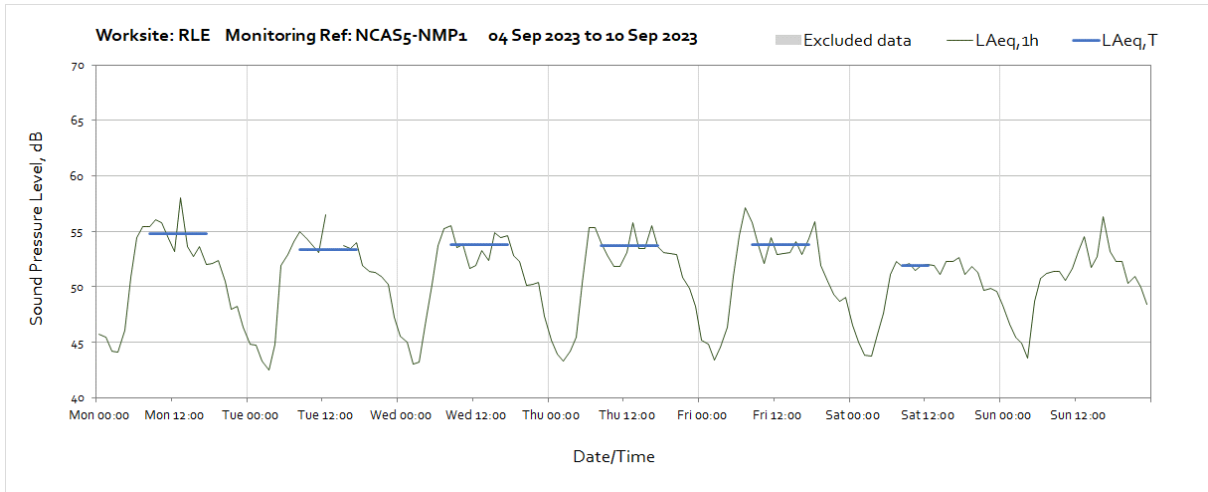
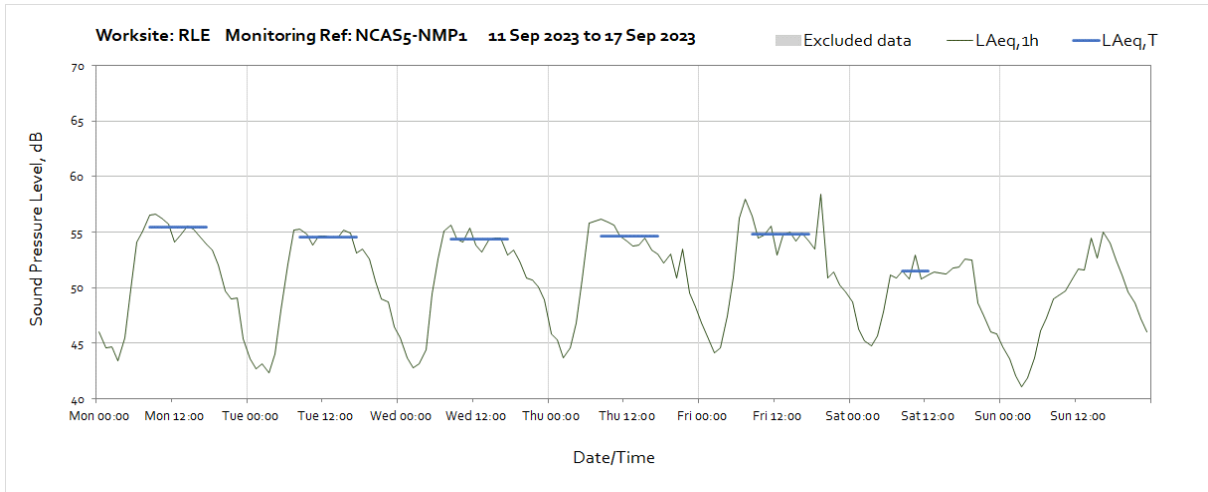
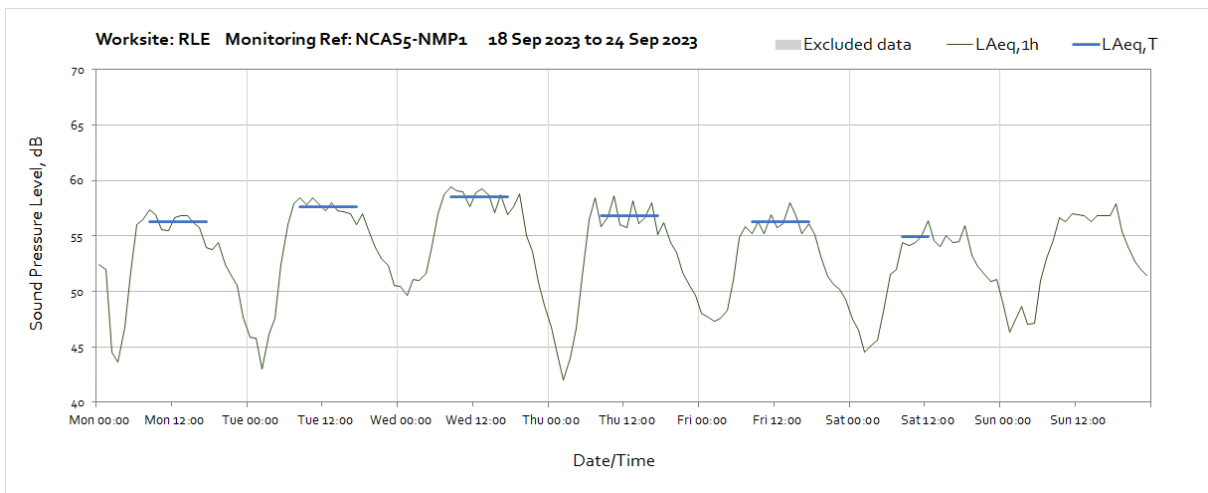
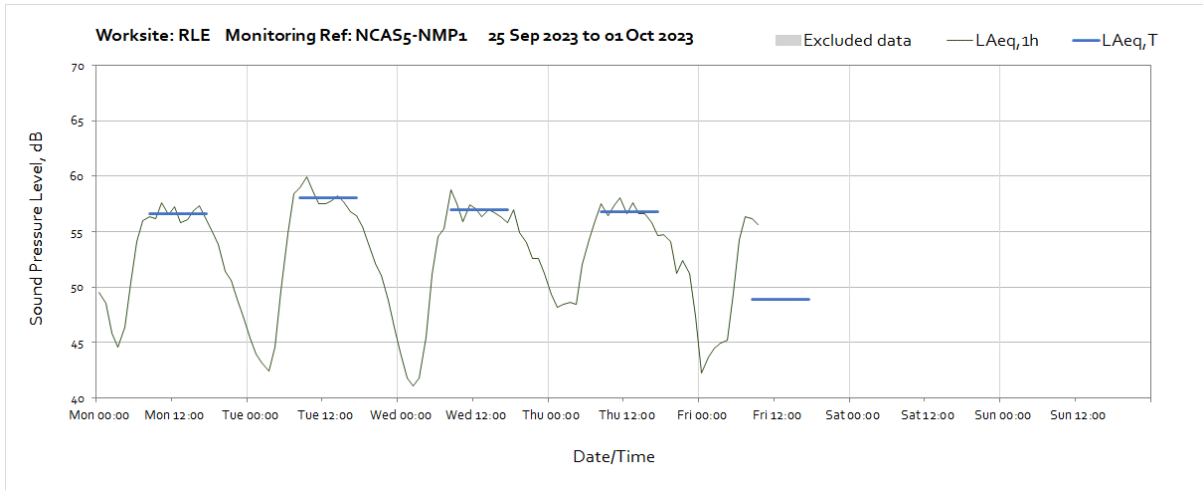
**Worksite: RLE - Monitoring Ref: NCAS5-NMP1**

Note: Missing data between 13:00 and 15:00 on Tuesday 5<sup>th</sup> September was due to monitor maintenance.

Note: Missing data from 10:00 on Friday 29<sup>th</sup> September until month end was due to monitor fault which is currently under investigation.

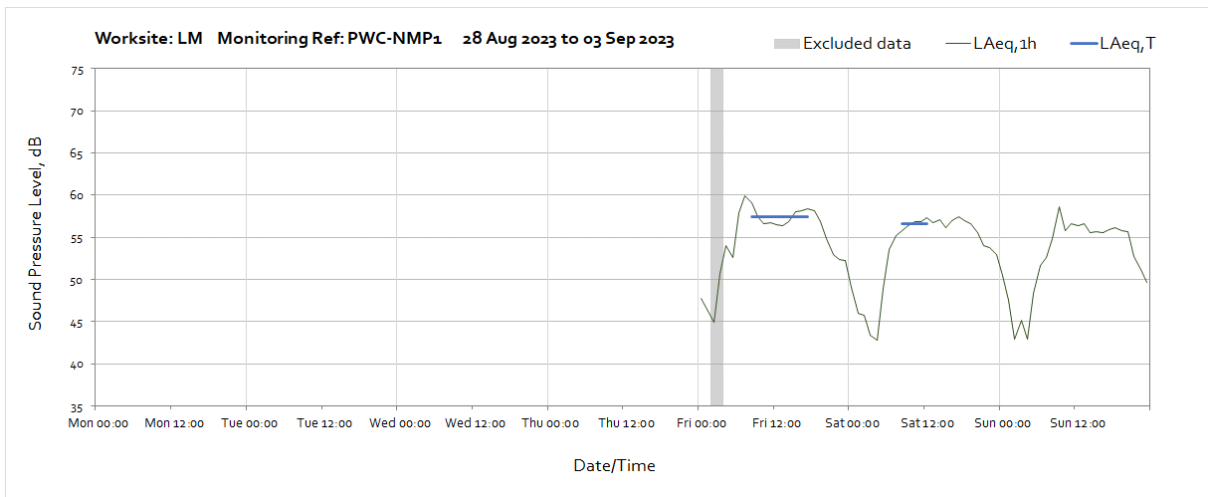
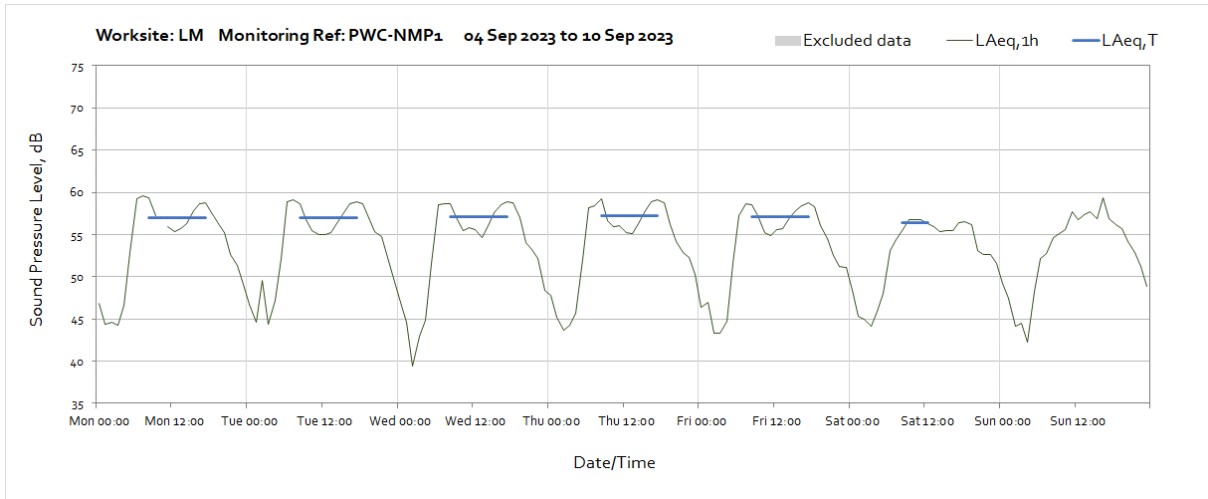
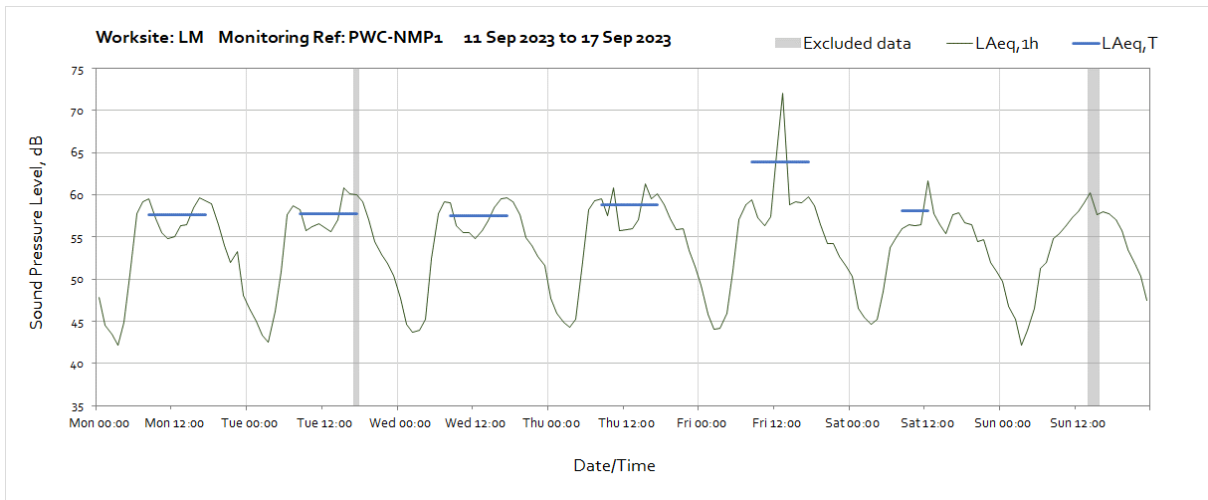
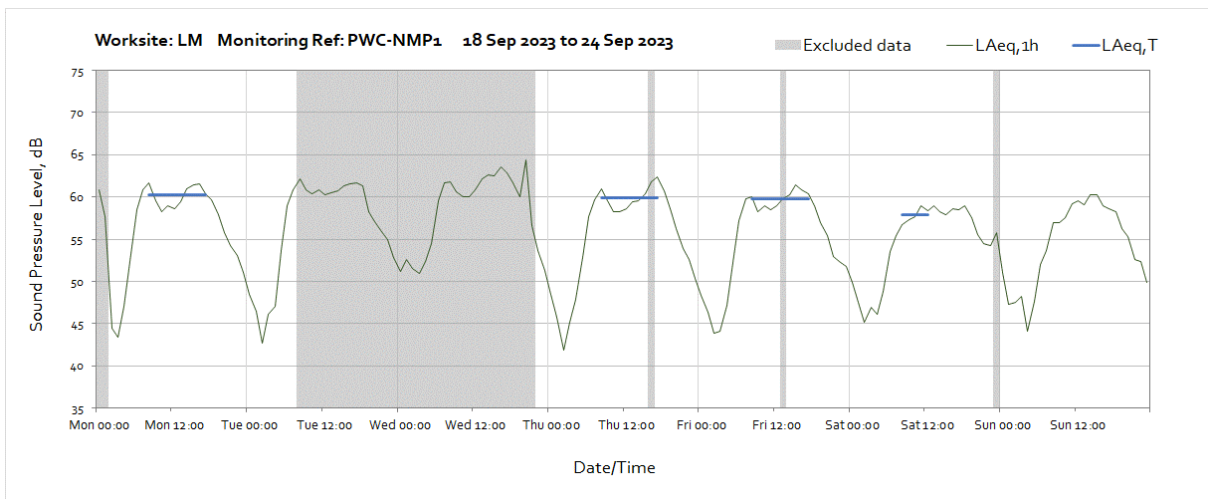
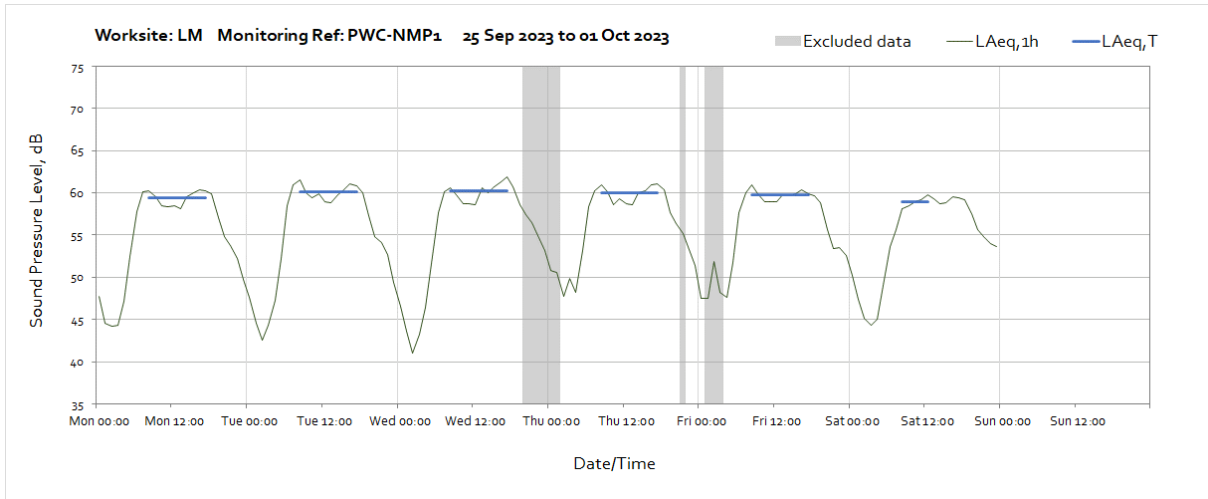
**Worksite: LM – Monitoring Ref: PWC-NMP1**

Note: Missing data between 10:00 and 11:00 on Monday 4<sup>th</sup> September was due to monitor maintenance.

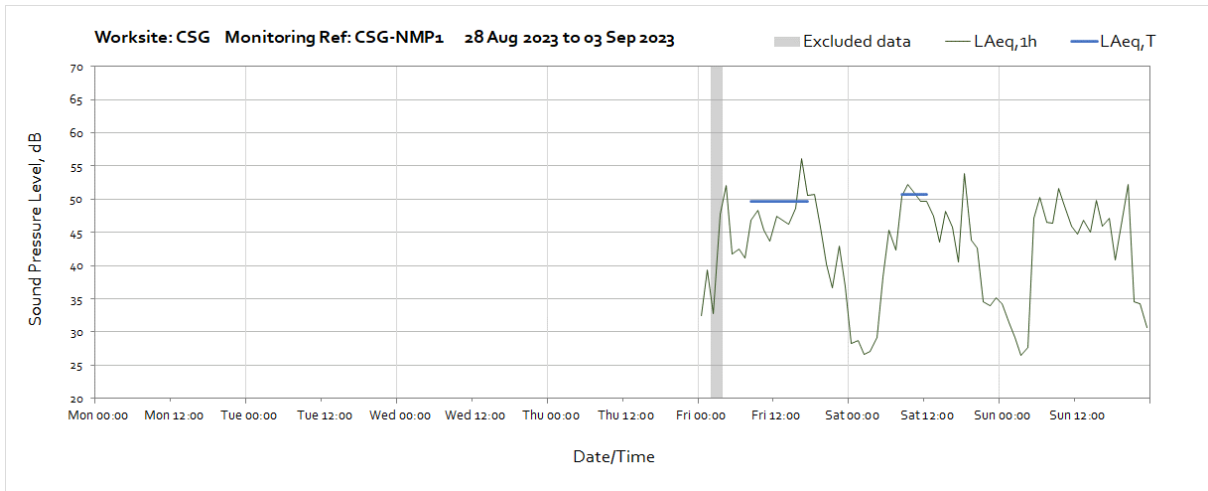
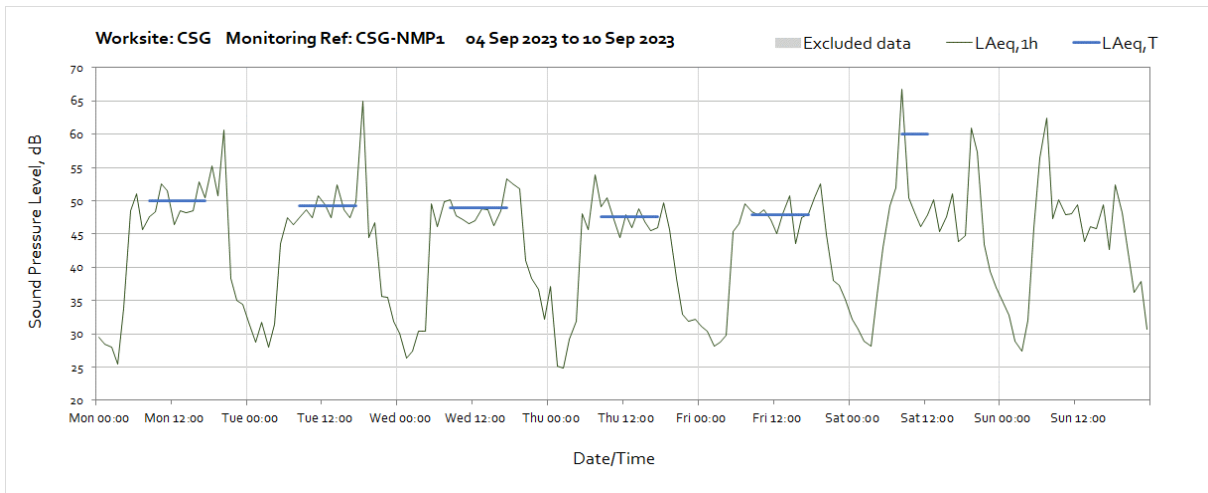
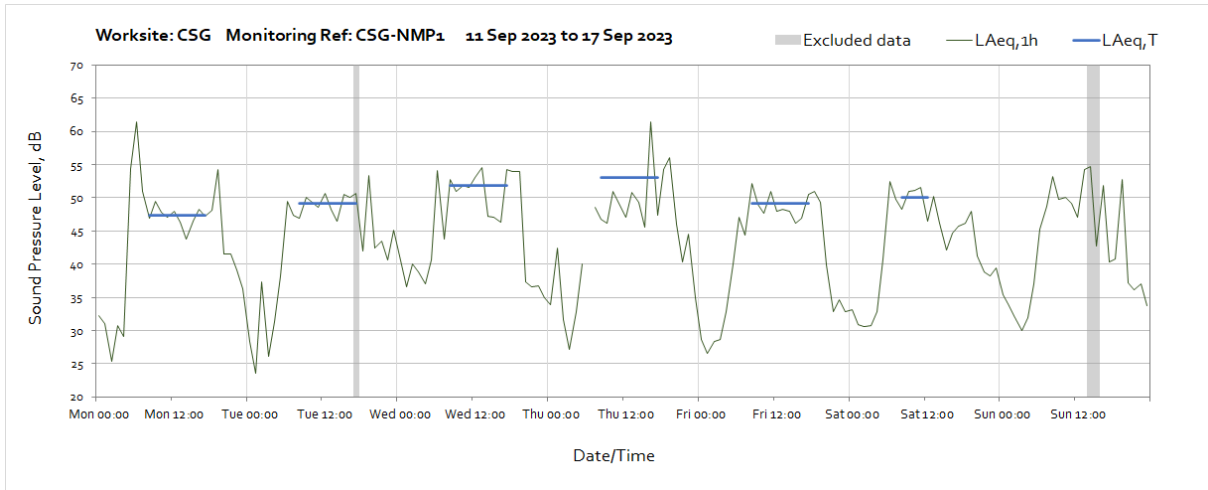
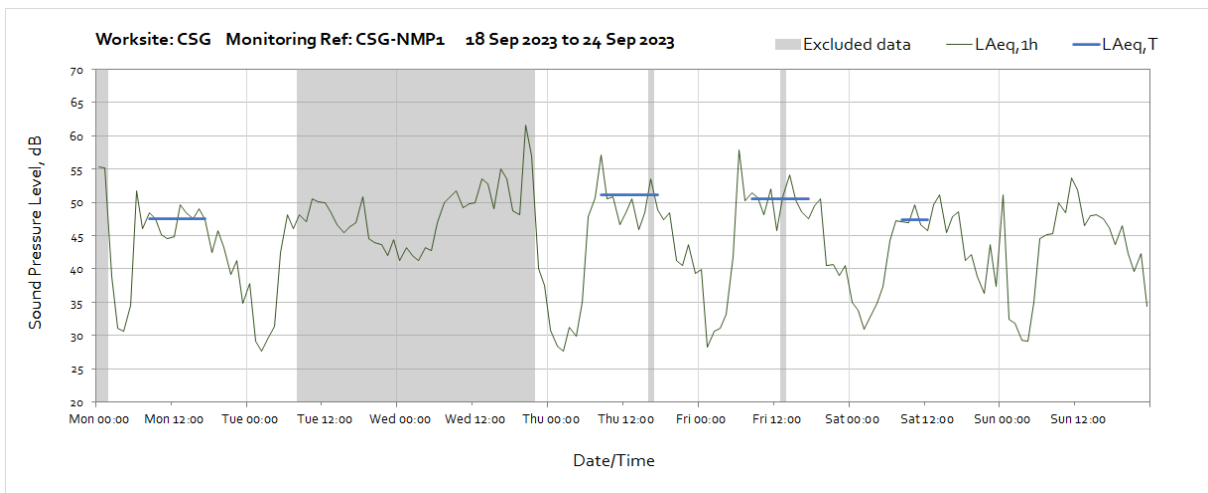
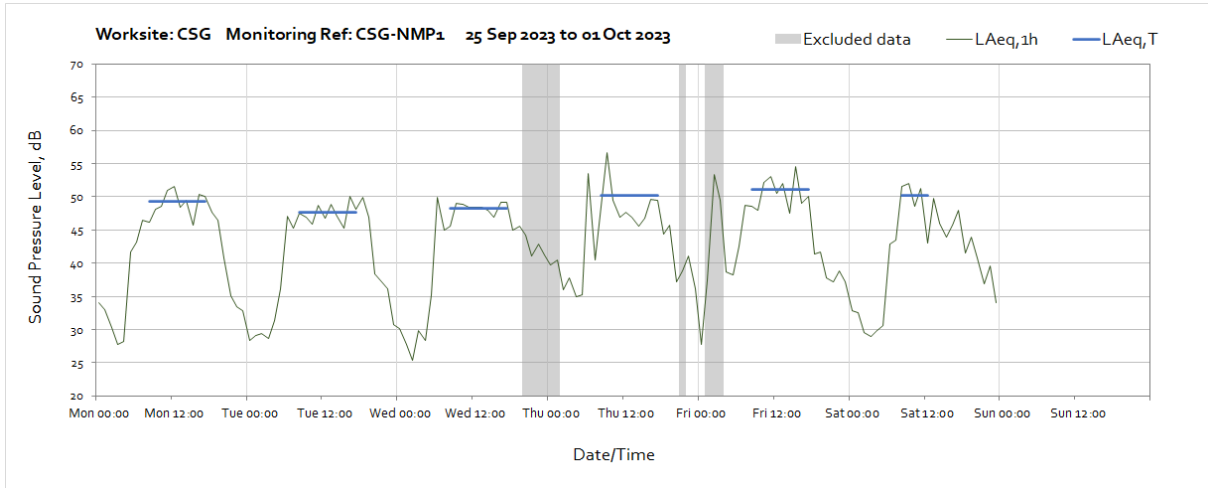
**Worksite: CSG – Monitoring Ref: CSG-NMP1**

Note: Missing data between 06:00 and 07:00 on Thursday 14<sup>th</sup> September was due to a monitor update.

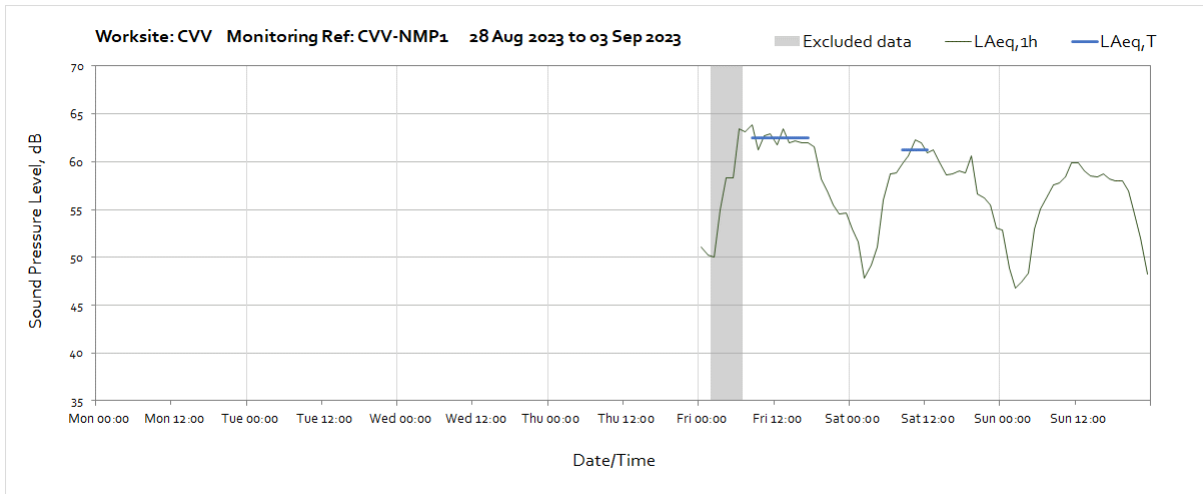
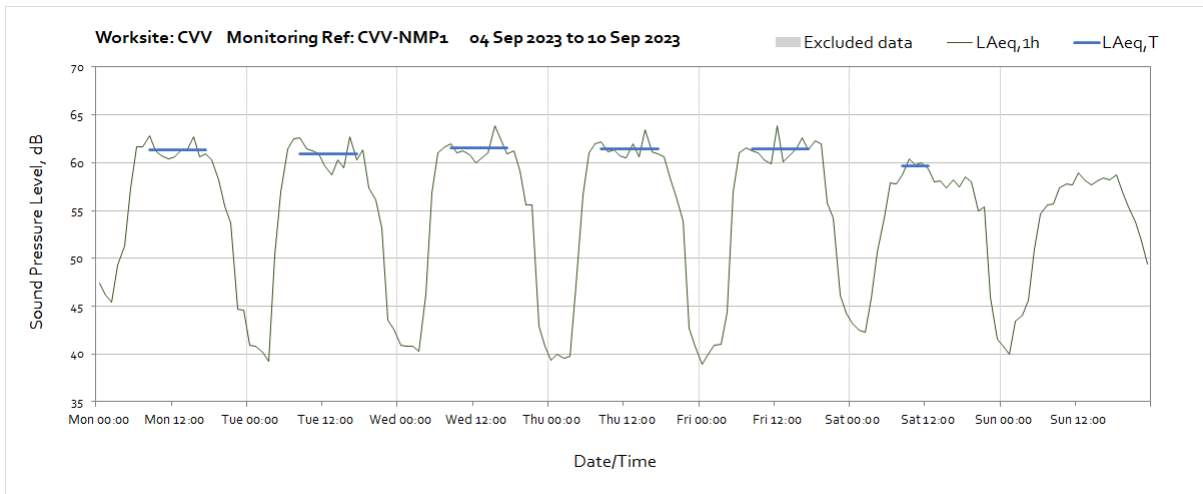
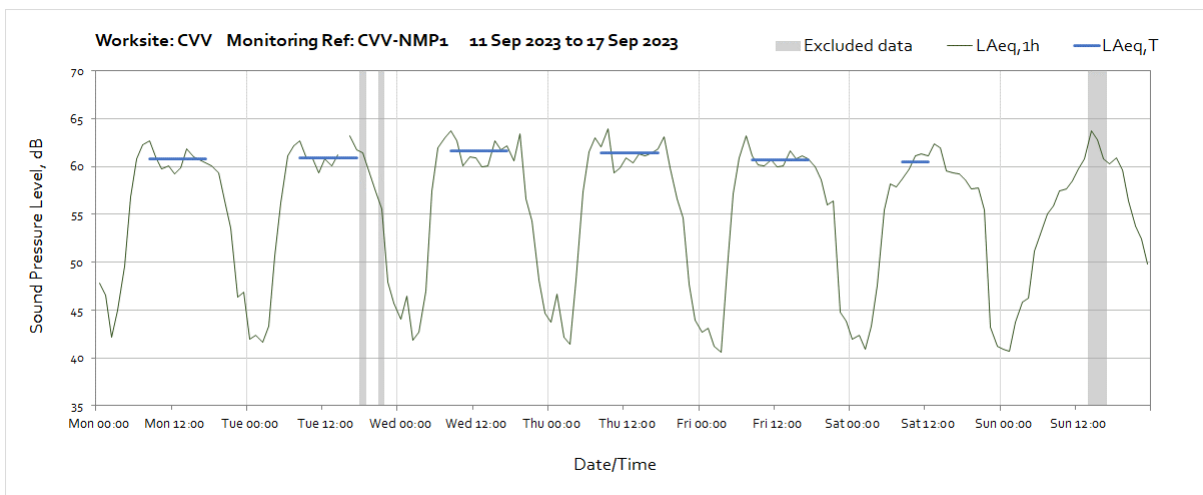
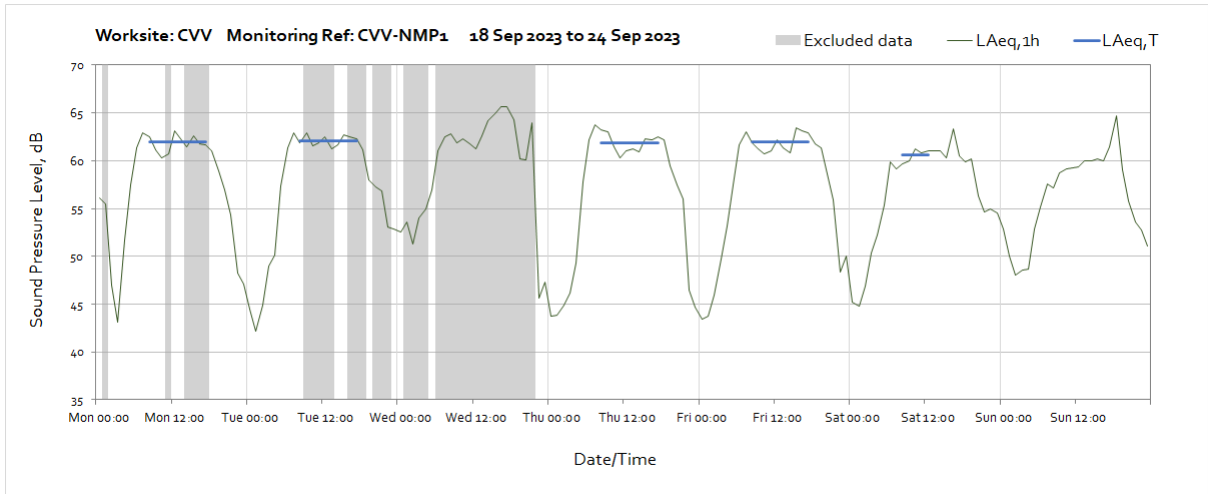
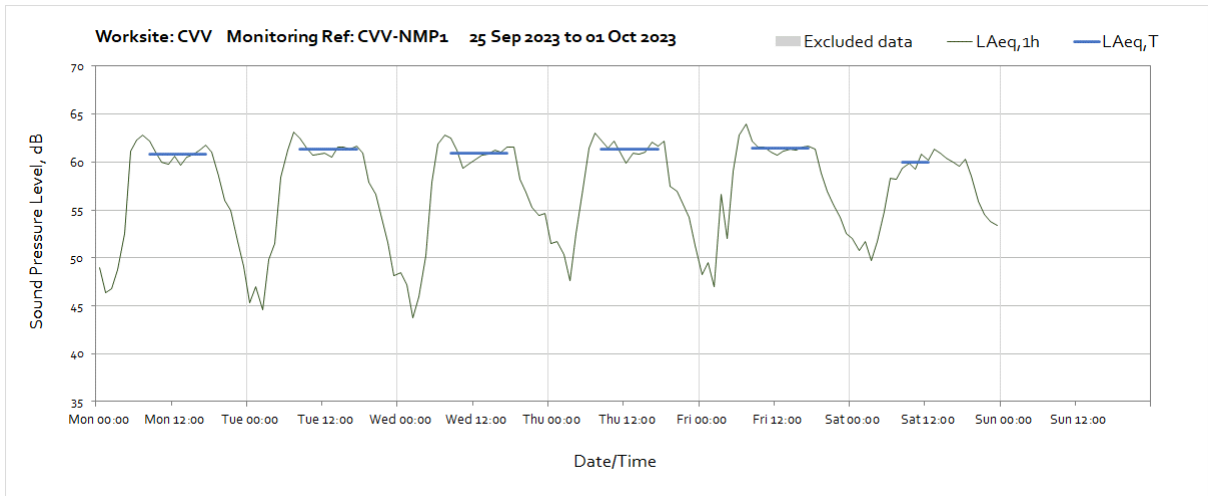
## Worksite: CVV- Monitoring Ref: CVV-NMP1

Note: Missing data between 15:00 and 16:00 on Tuesday 12<sup>th</sup> September was due to monitor maintenance.

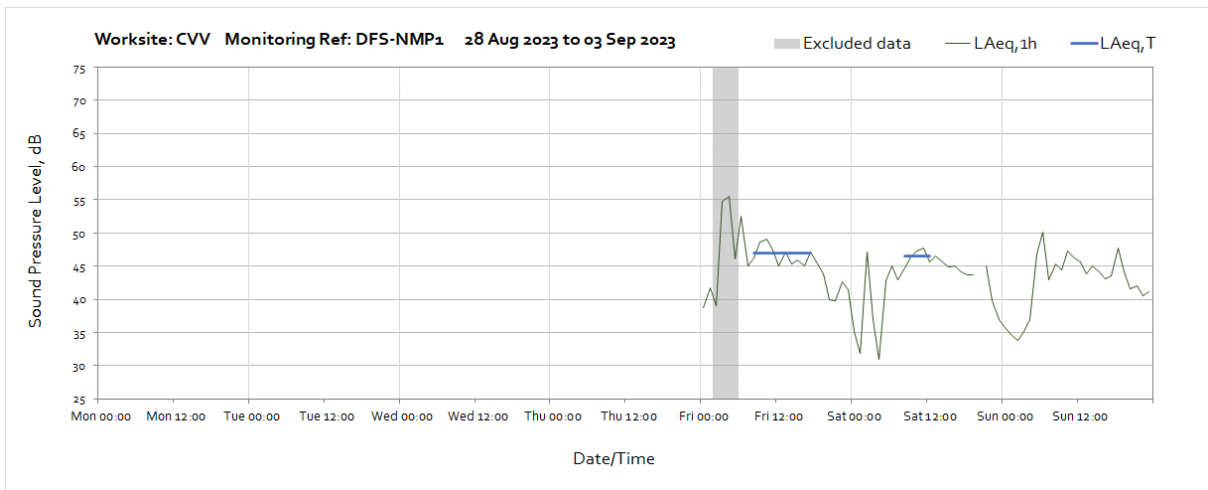
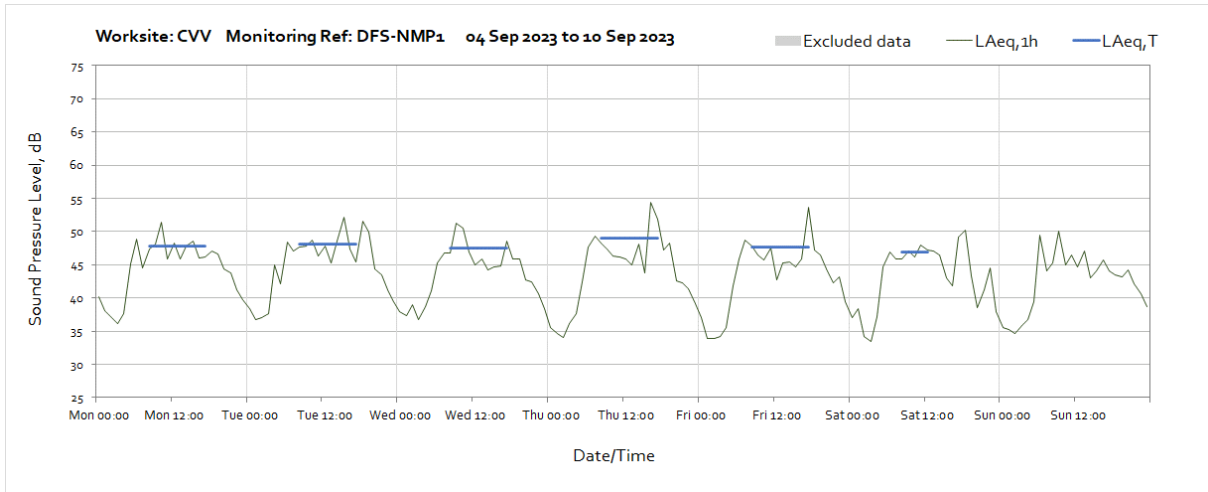
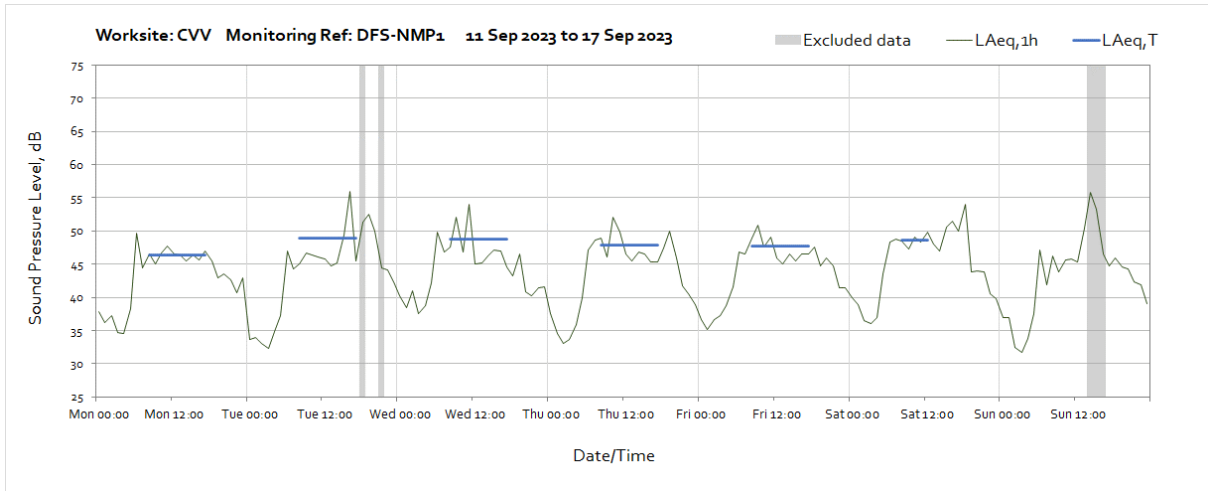
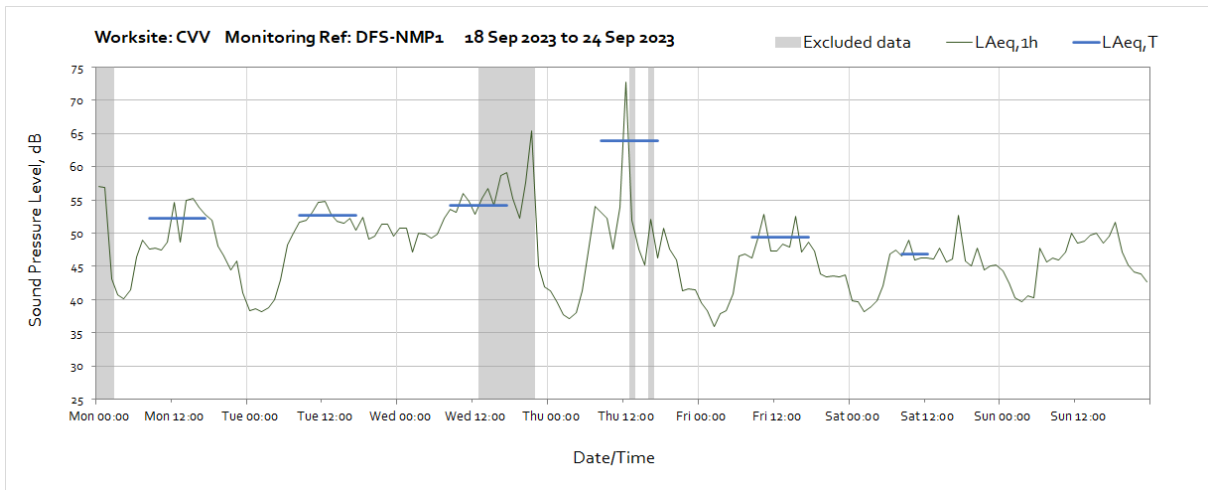
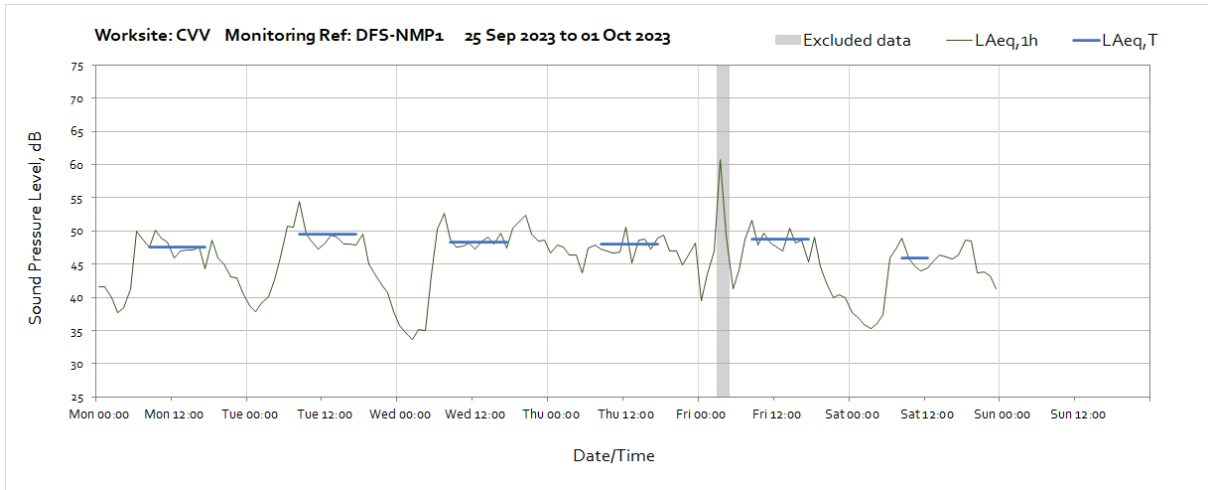
**Worksite: CVV - Monitoring Ref: DFS-NMP1**

Note: Missing data between 20:00 and 21:00 on Saturday 2<sup>nd</sup> September was due to a data transfer error.
