## Construction Noise and Vibration Monthly Report – September 2023

Buckinghamshire

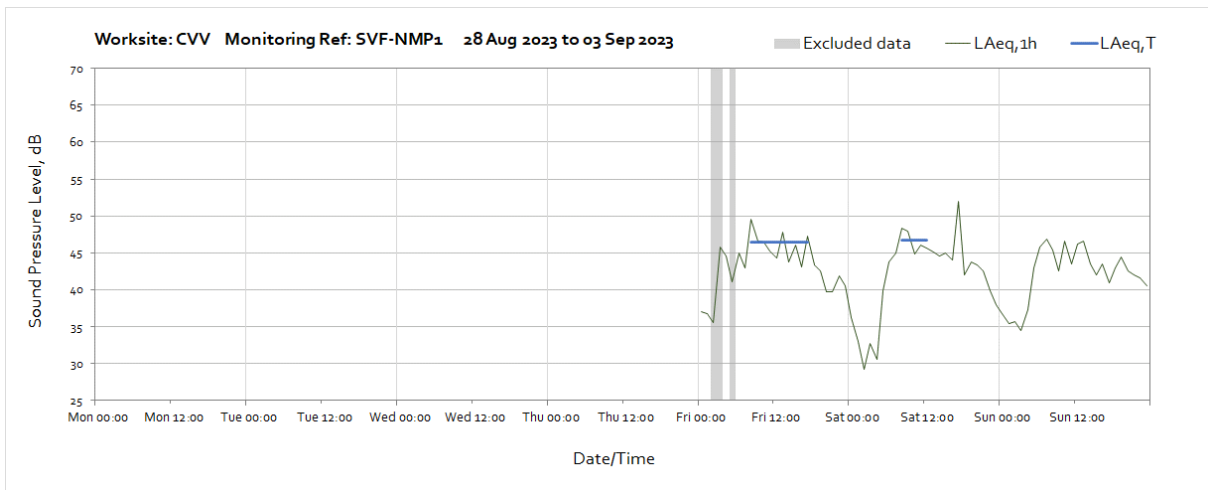
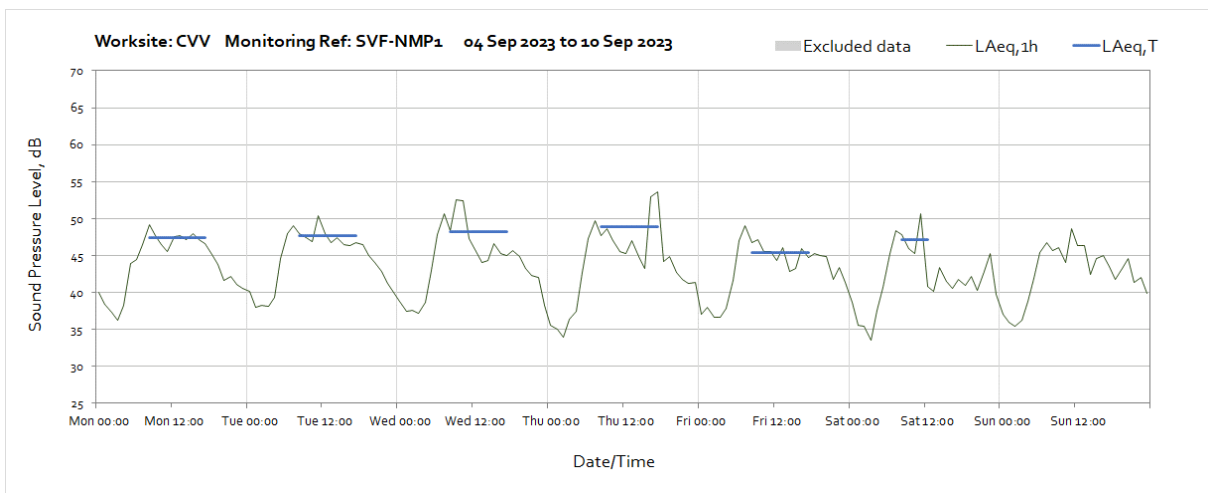
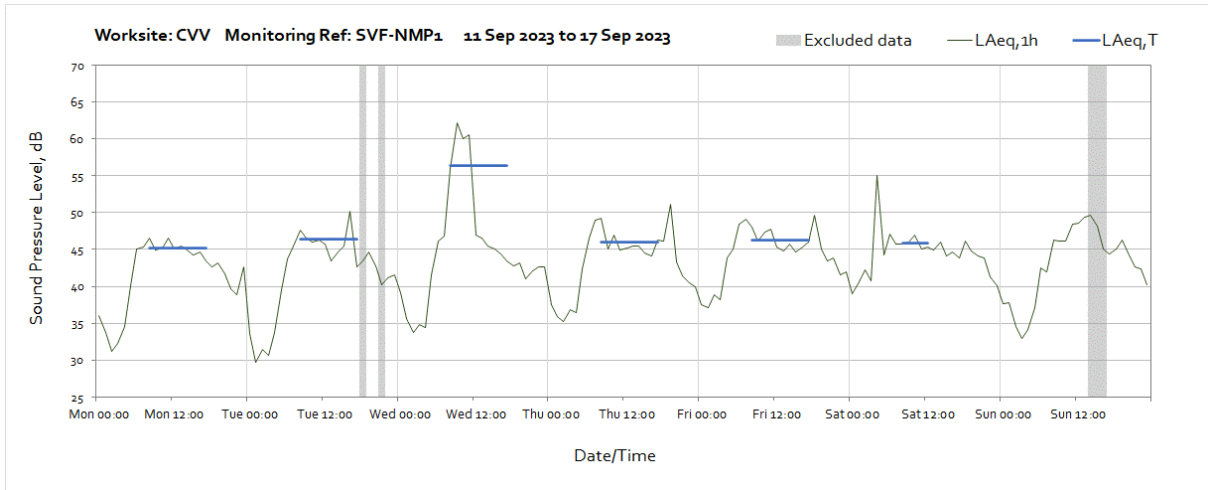
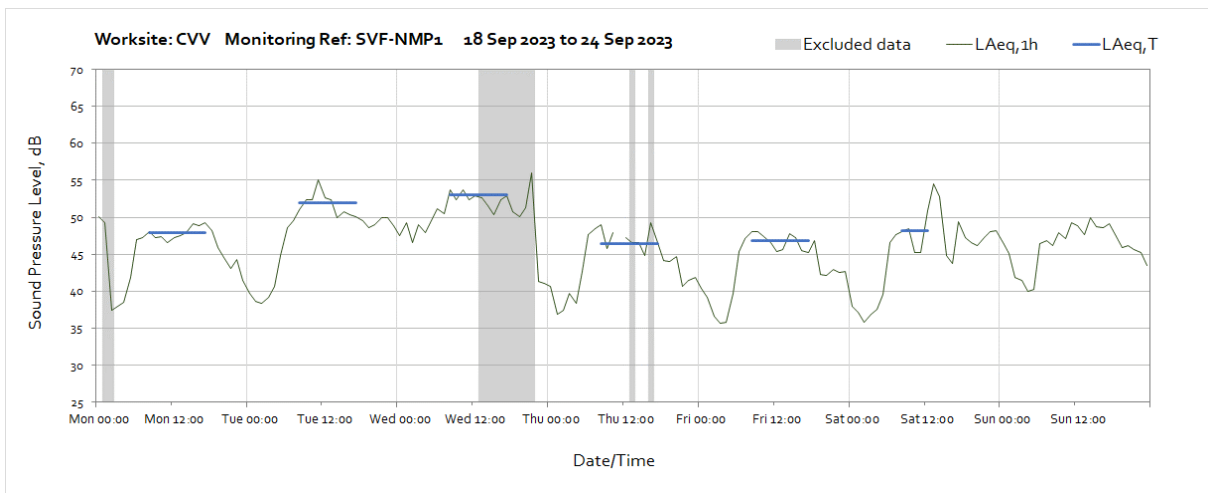
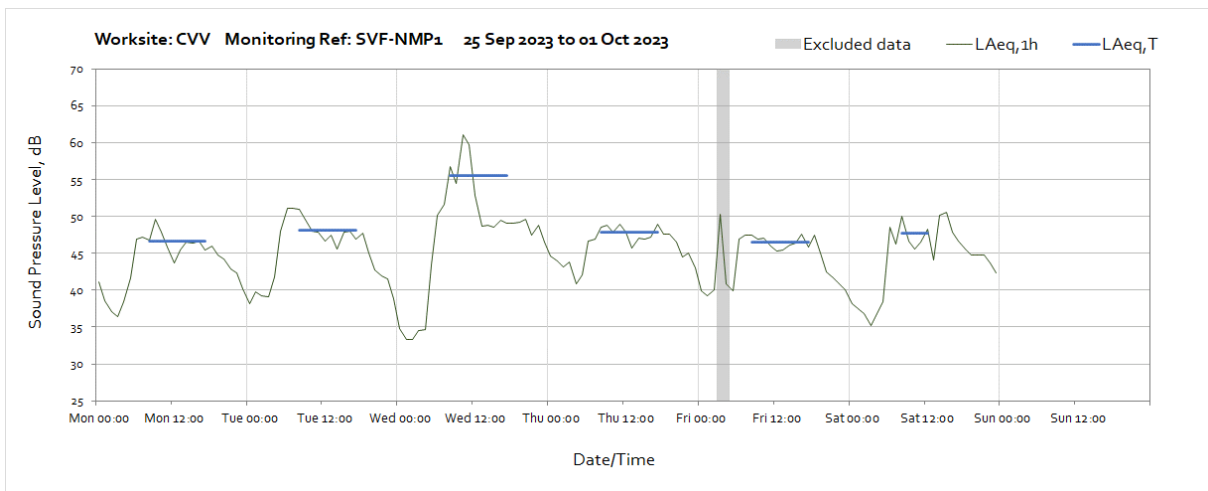
**Worksite: CVV – Monitoring Ref: SVF-NMP1**

Note: Missing data between 11:00 and 12:00 on Thursday 21<sup>st</sup> September was due to monitor field calibration.

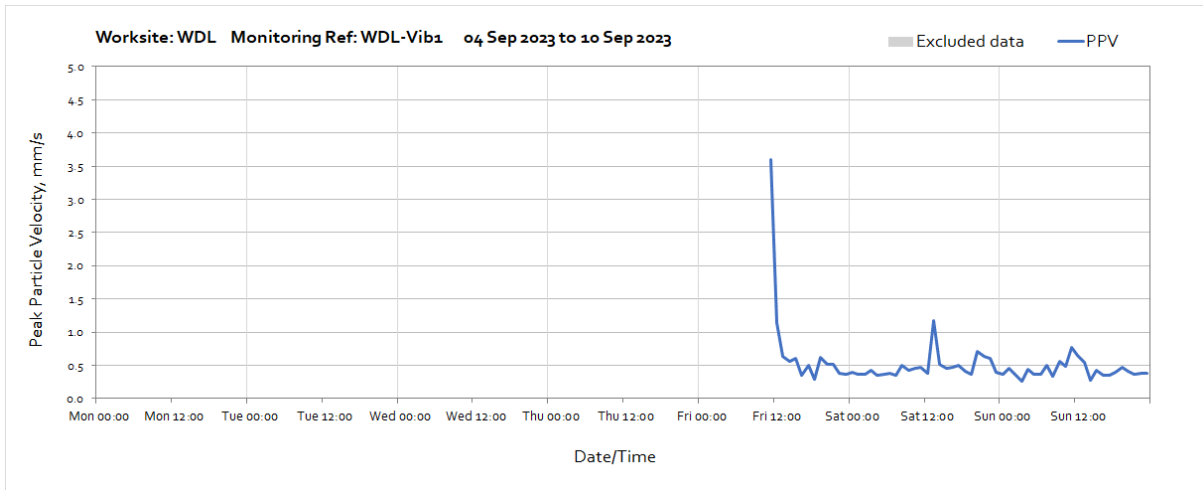
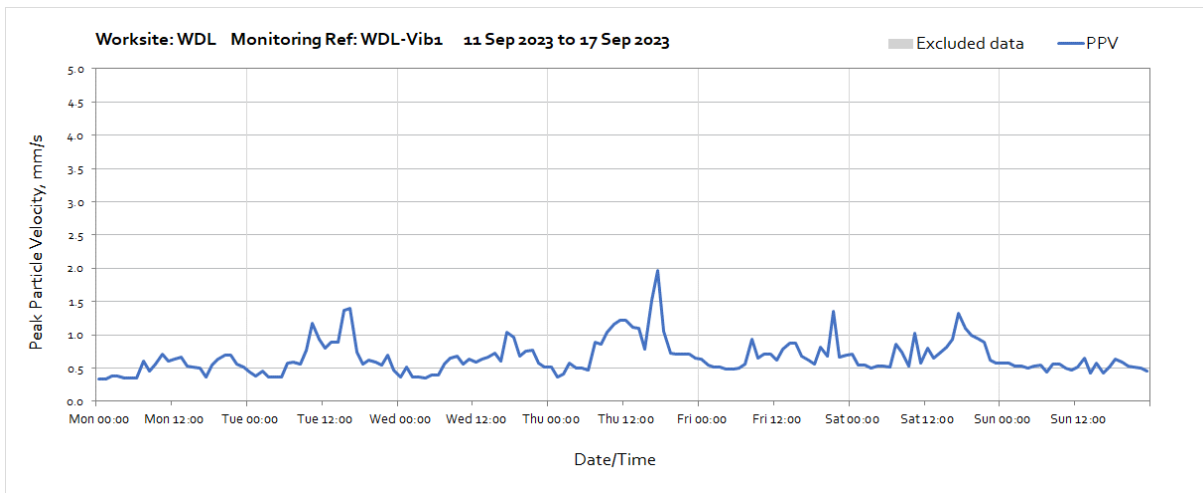
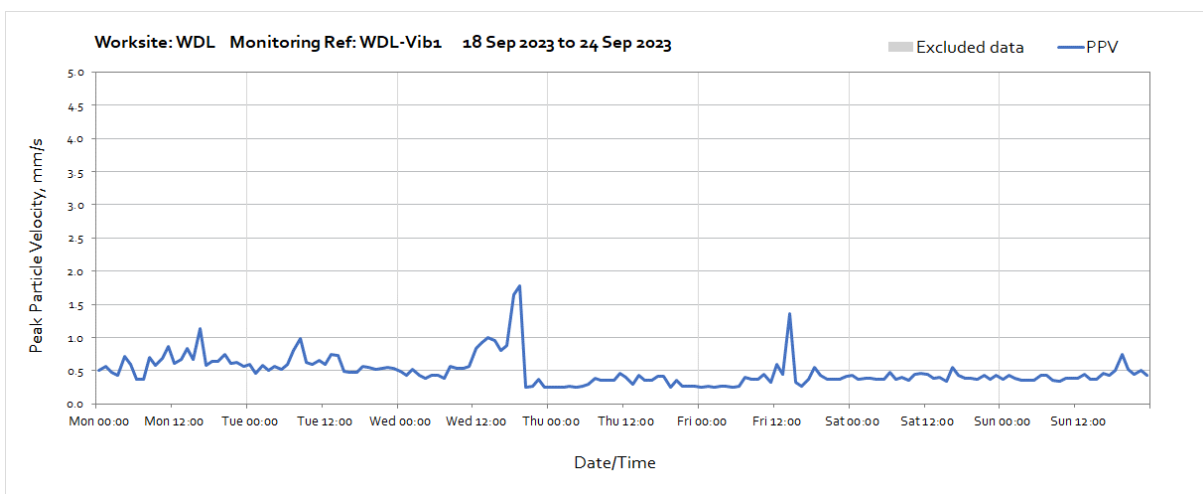
## Worksite: WDL – Monitoring Ref: WDL-Vib 1

The following graphs show the hourly measured peak particle velocity PPV recorded during the monitoring period. The graphs show the highest PPV of the three orthogonal axes x, y and z. Periods where PPV values have been affected by local interference with the vibration monitor or only measured for part of the period, which are not representative of HS2 construction works, have been greyed out and excluded when calculating values in Table 4 of the main report.

Note: Missing data from the start of the month until 11:00 on Friday 8<sup>th</sup> September was due to loss of battery power to monitor.

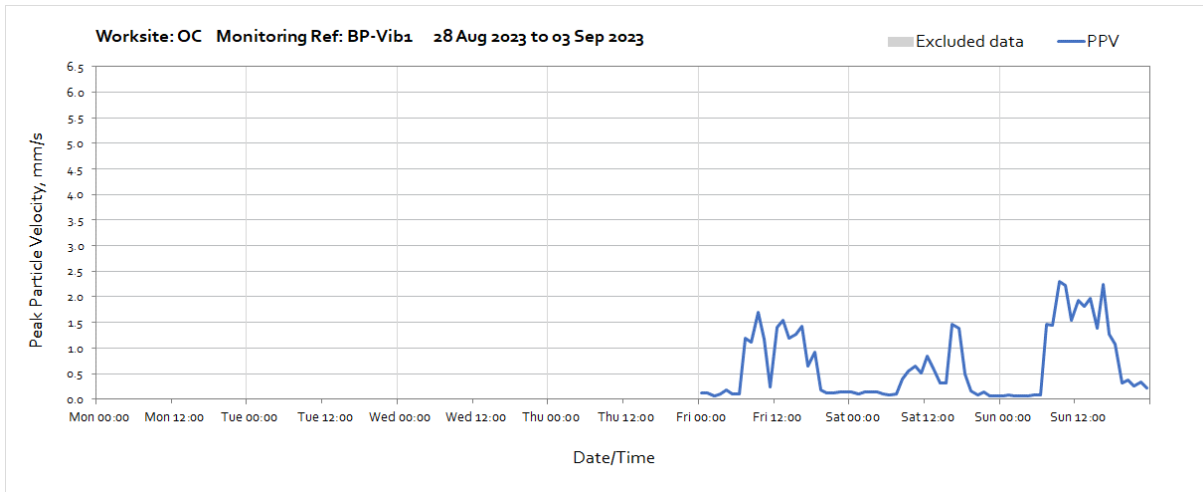
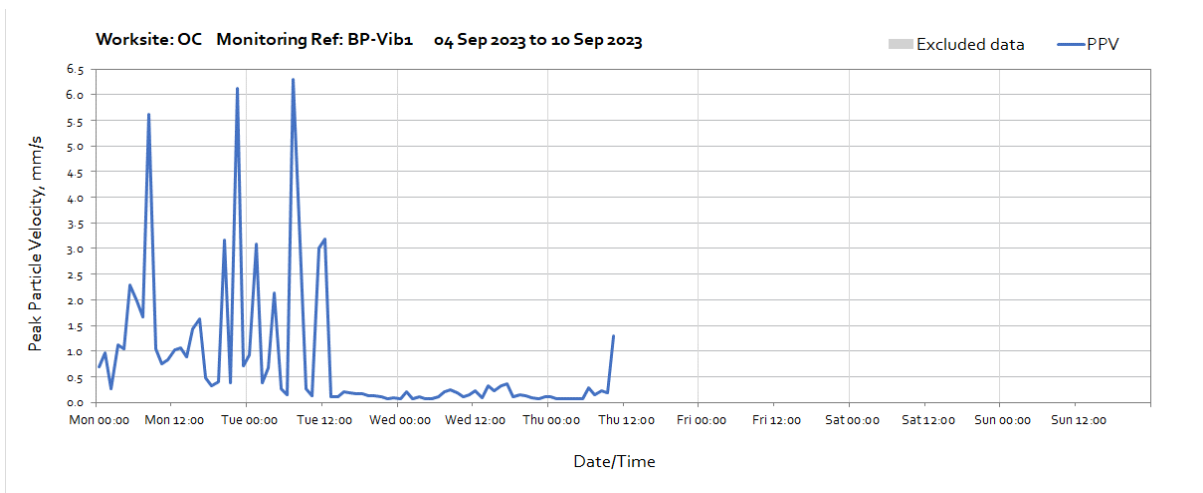
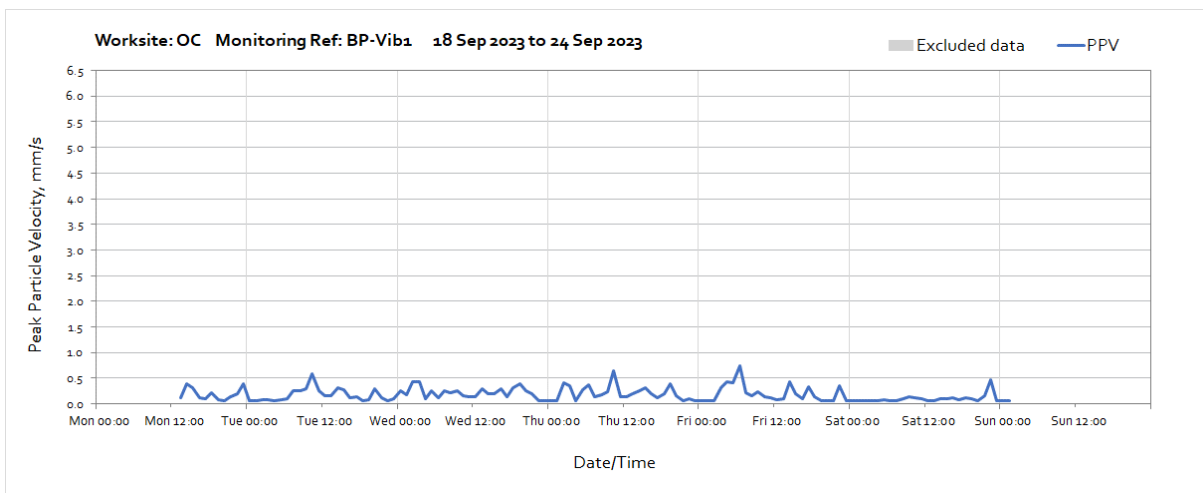
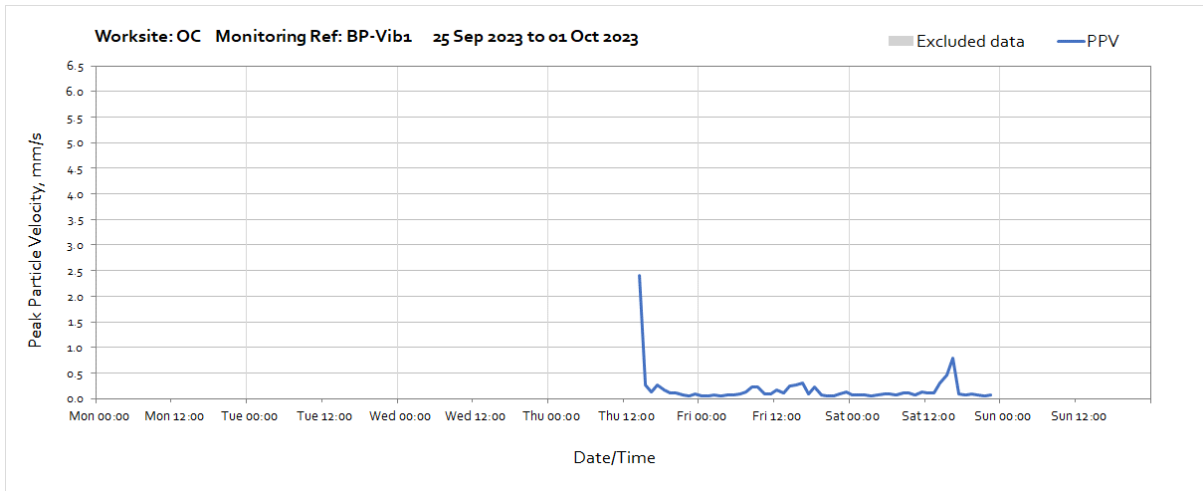
## Worksite: OC – Monitoring Ref: BP-Vib1

Note: Missing data from 11:00 on Thursday 7<sup>th</sup> September until 13:00 on Monday 18<sup>th</sup> September was due to a monitor fault.

to a monitor fault. Missing data from 02:00 on Sunday 24<sup>th</sup> September until 14:00 on Thursday 28<sup>th</sup> September was due to poor signal to monitoring station.

Note: Missing data from 02:00 on Sunday 24<sup>th</sup> September until 14:00 on Thursday 28<sup>th</sup> September was due to poor signal to monitoring station. Missing data between 23:00 and 00:00 on Saturday 30<sup>th</sup> September was due to signal loss.

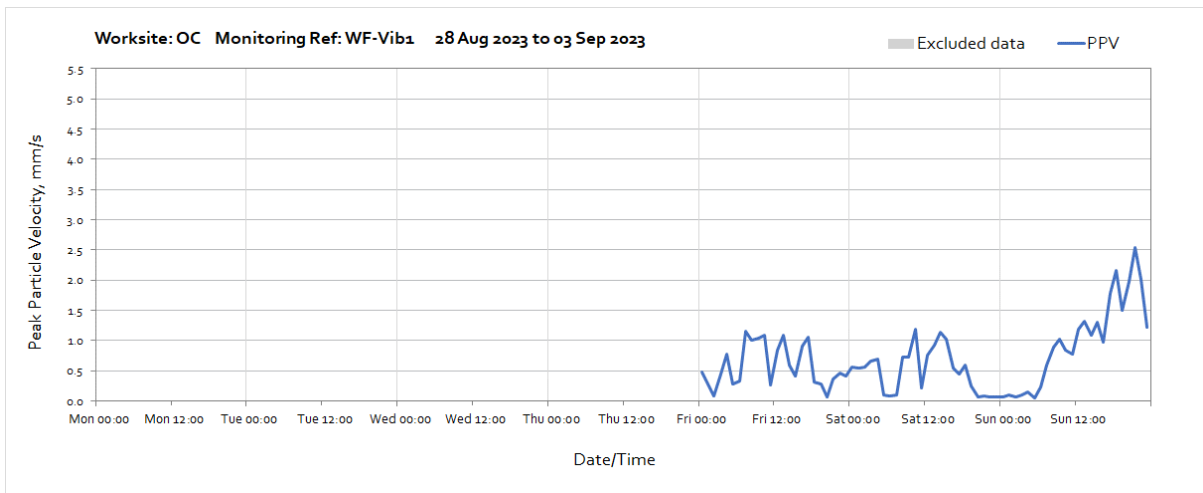
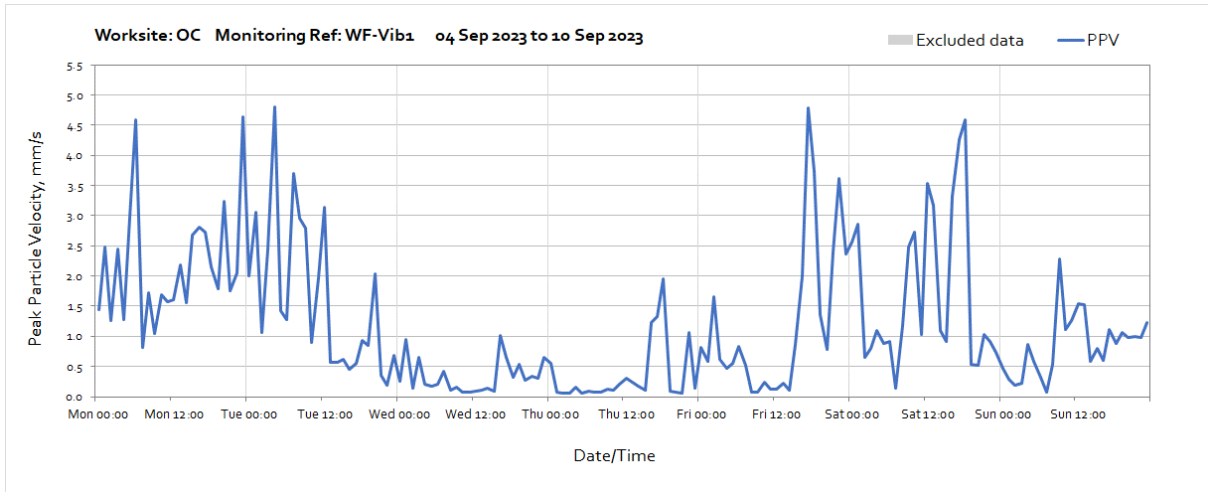
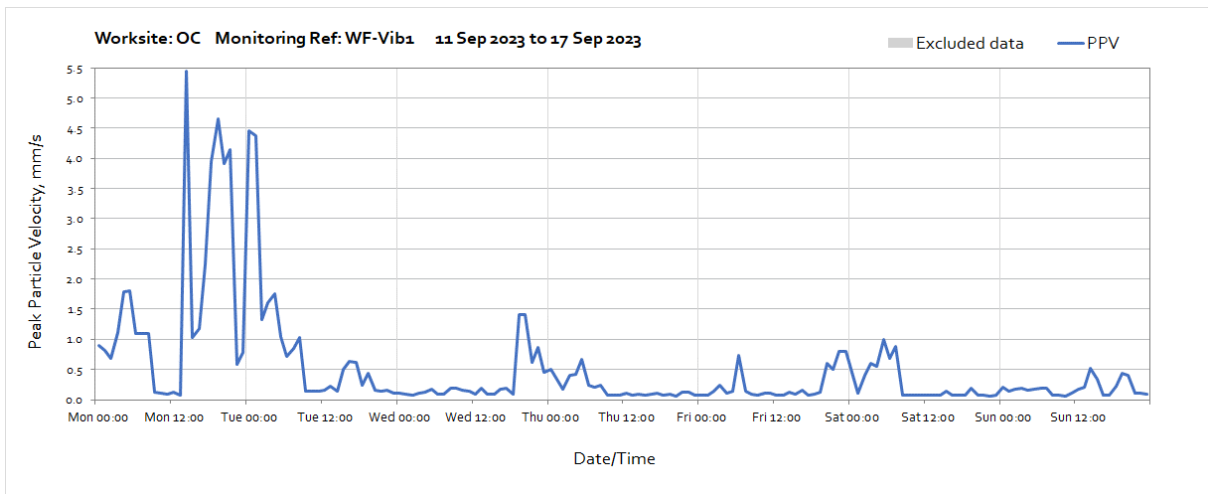
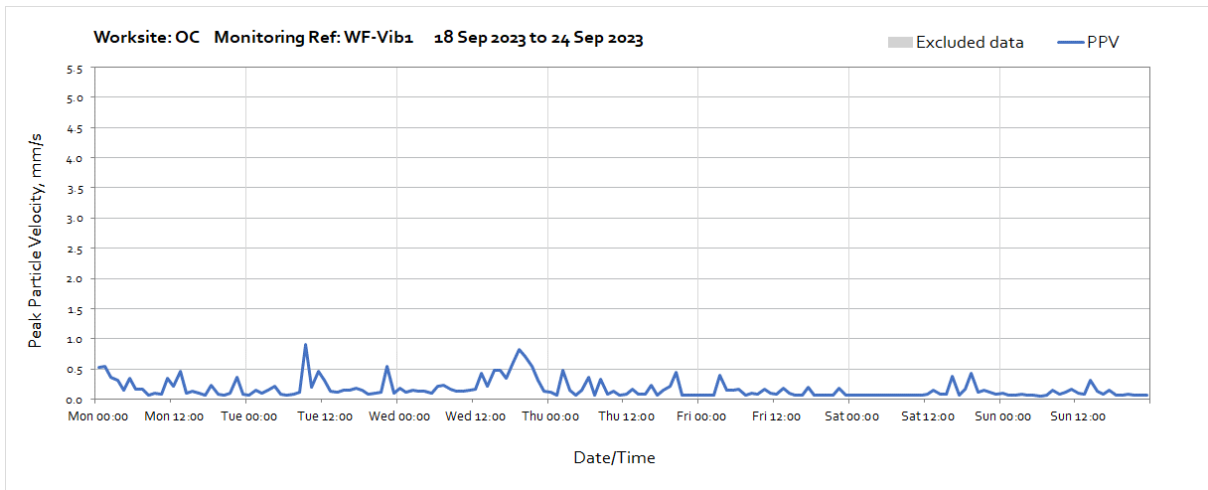
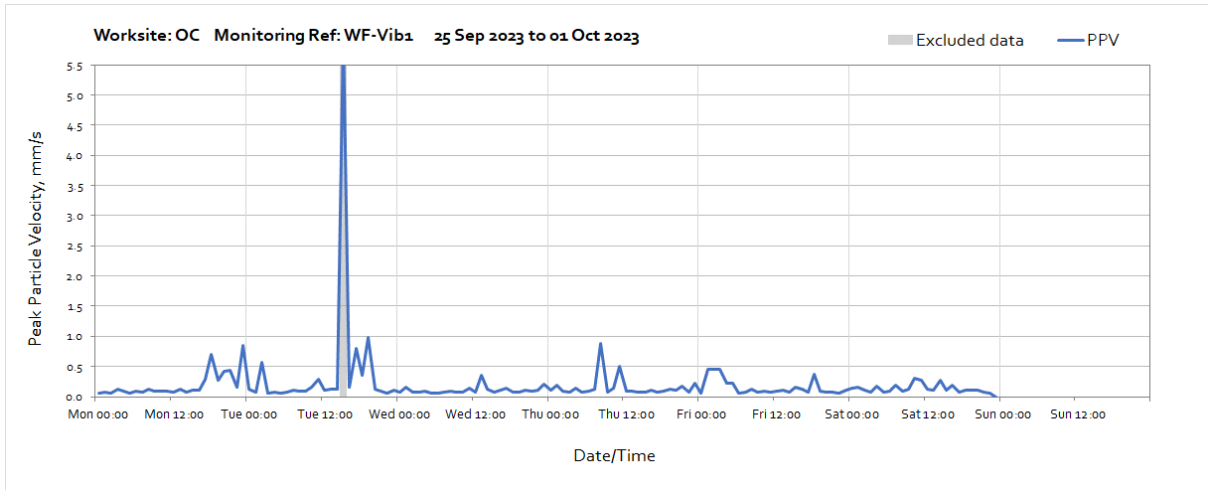
**Worksite: OC – Monitoring Ref: WF-Vib1**

Note: Missing data between 23:00 and 00:00 on Saturday 30<sup>th</sup> September was due to signal loss.

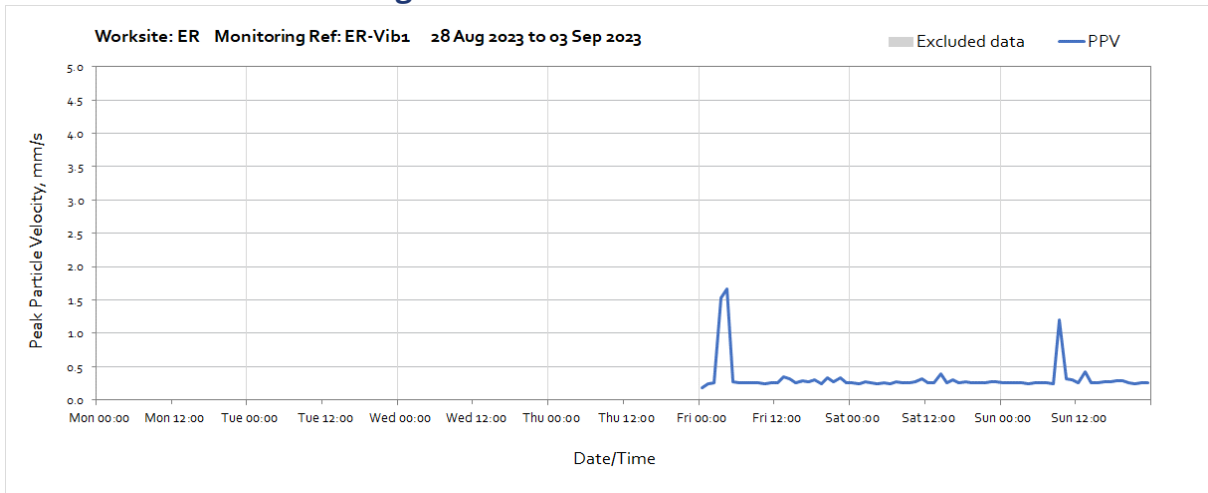
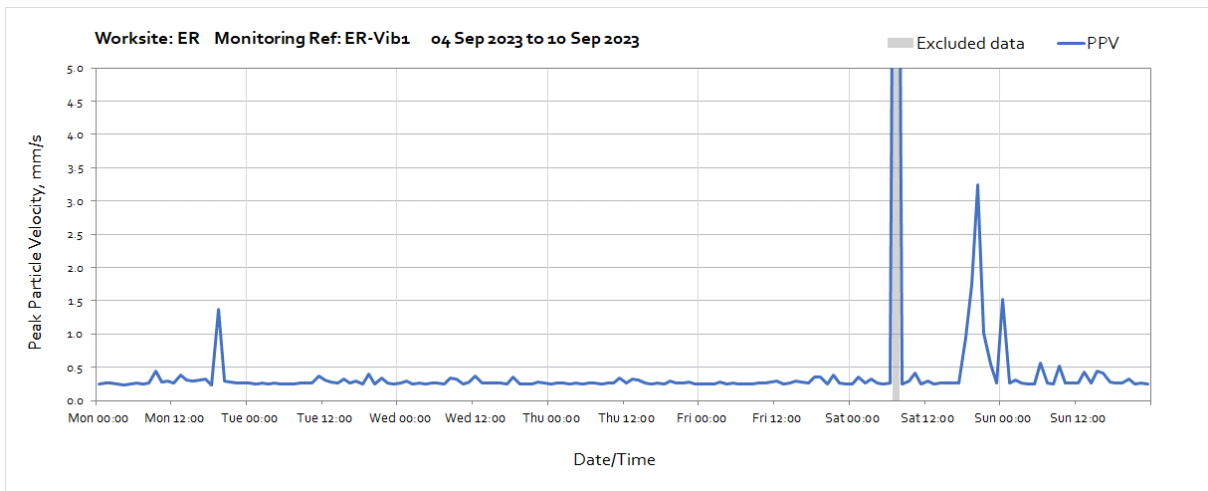
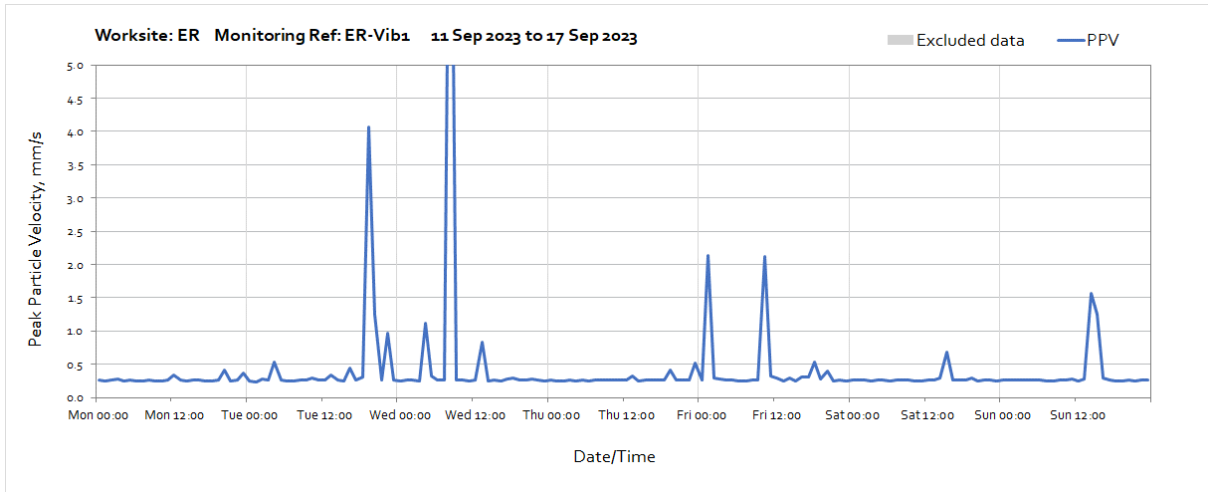
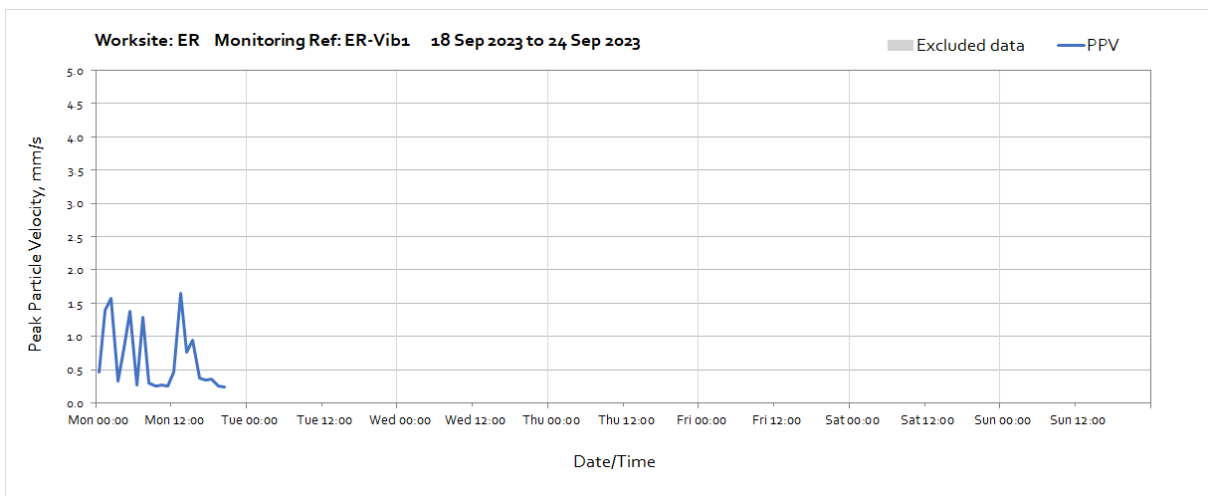
### Worksite: WGT - Monitoring Ref: ER-Vib 1

Note: Missing data from 21:00 on Monday 18<sup>th</sup> September until month end was due to depleted monitor battery.

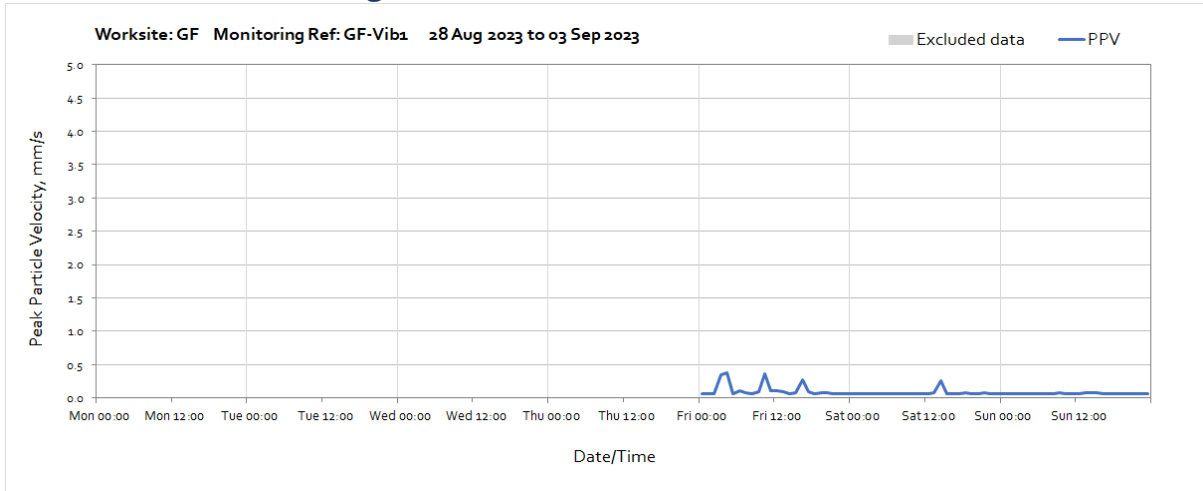
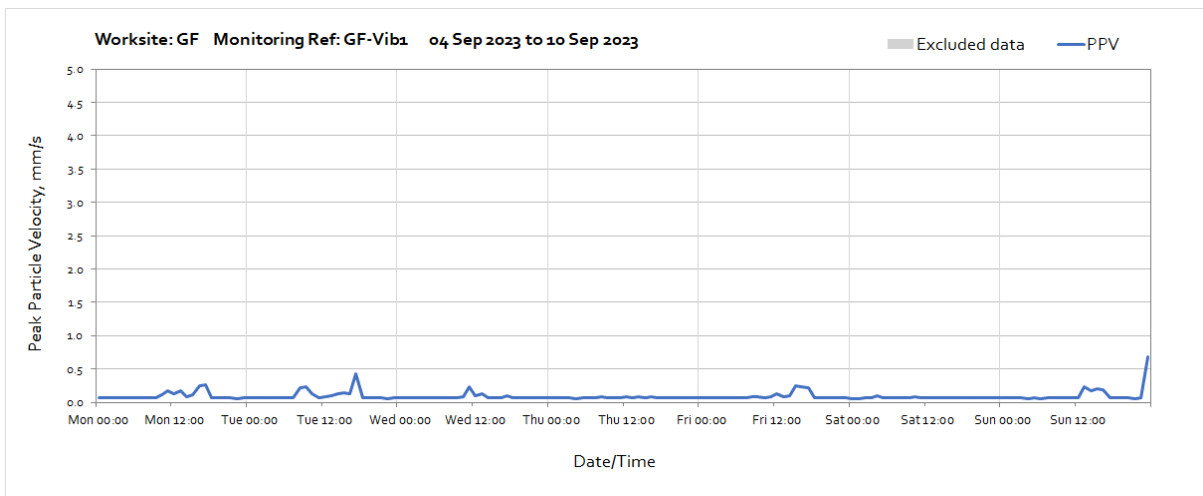
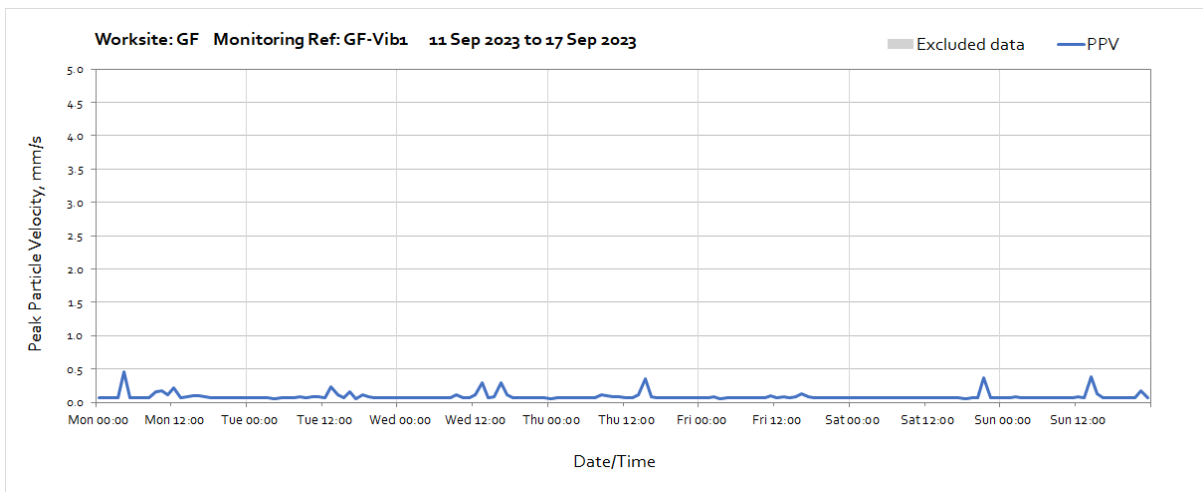
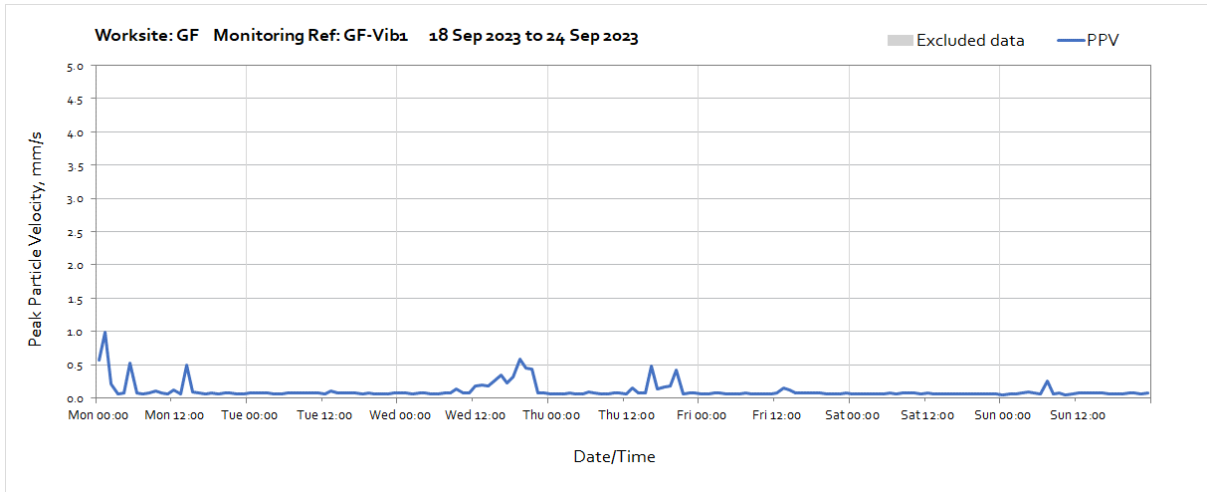
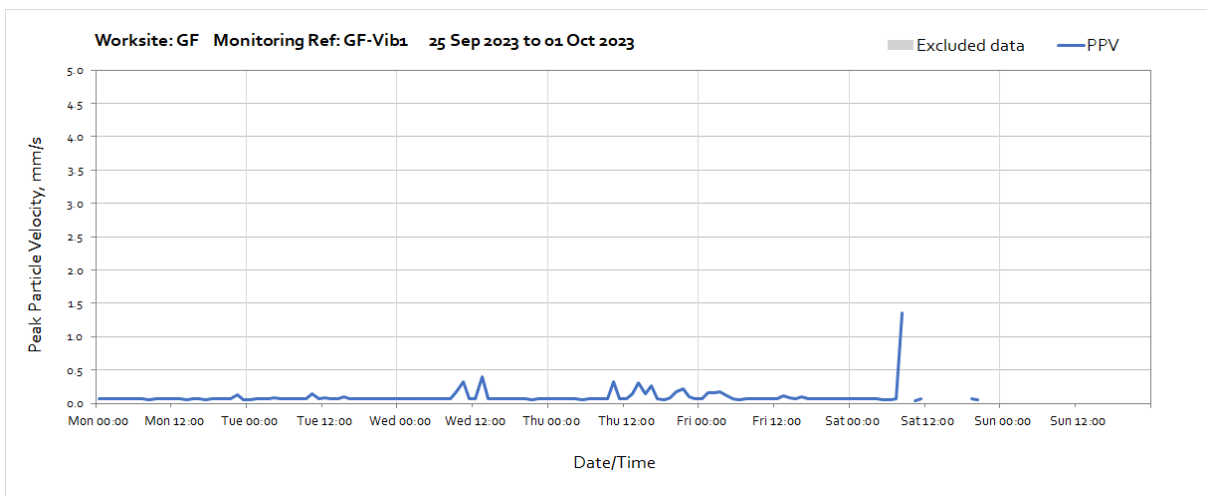
## Worksite: GF – Monitoring Ref: GF-Vib1

Note: Missing data on Saturday 30<sup>th</sup> September was due to a monitor network communication error.
