Construction Noise and Vibration Monthly Report – September 2023

London Borough of Camden

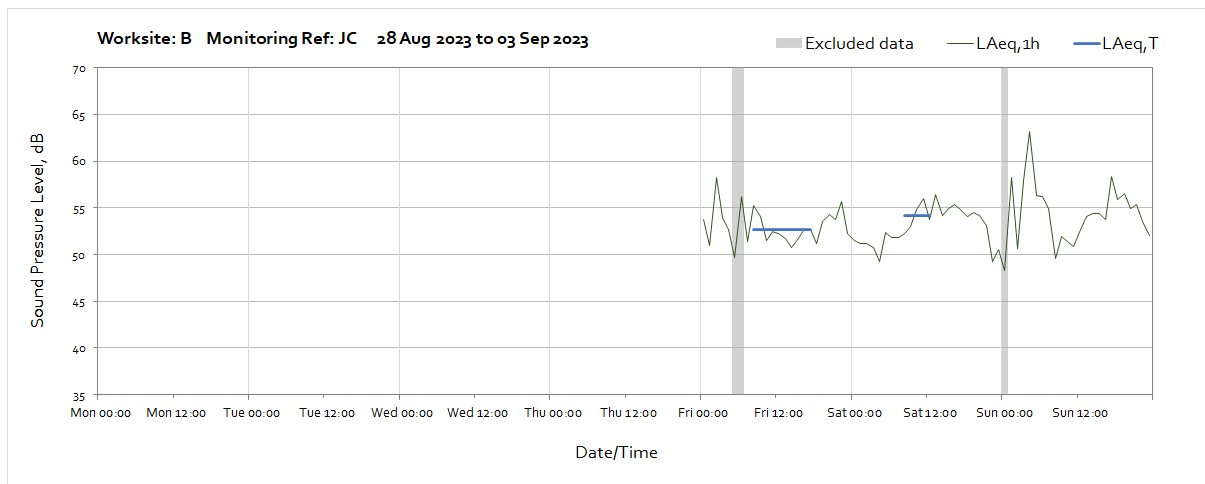
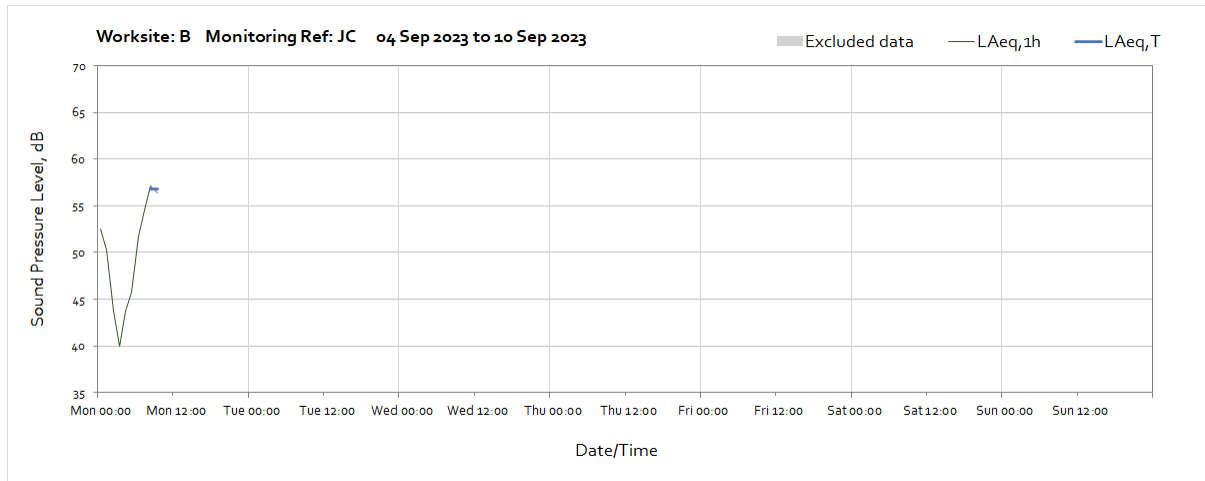
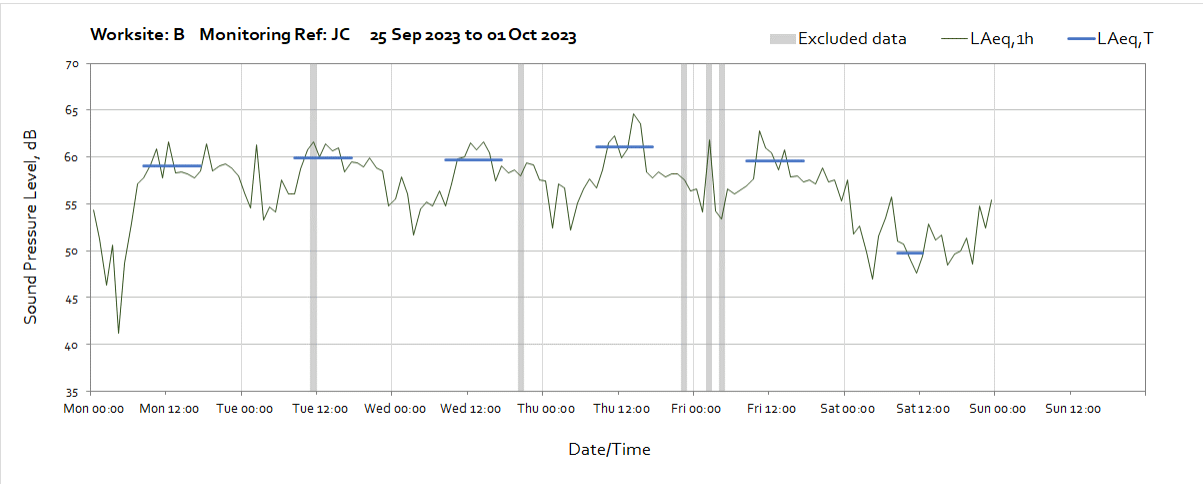
Worksite: B - Monitoring Ref: JC

Note: Missing data from 04th of August at 10:00 until 20th of August at 13:00 due to loss of power.
