## **Construction Noise and Vibration Monthly Report – September 2023**

**Stratford-on-Avon District Council**

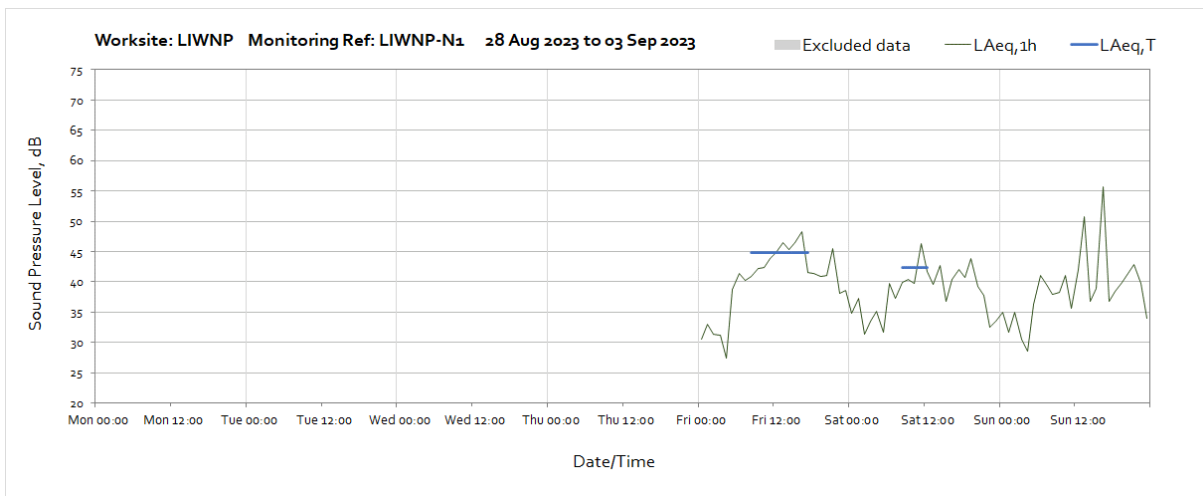
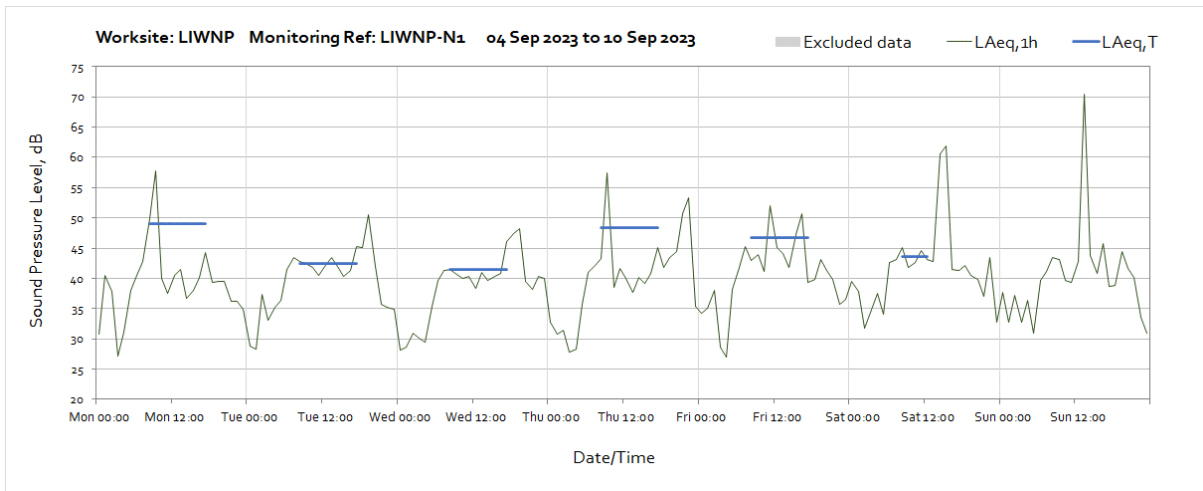
### Worksite: LIWNP Monitoring Ref: LIWNP-N1

The following graphs show the hourly measured ambient noise level  $L_{Aeq,1h}$  and, where relevant, the averaged noise level  $L_{Aeq,T}$  values, where the time period T is as specified in Table 1 of HS2 Information Paper E23. Periods where noise levels are adversely affected by weather or only measured for part of the period, which are not representative of HS2 construction works, have been greyed out and excluded from the calculation of the  $L_{Aeq,T}$  values in Table 3 of the main report.

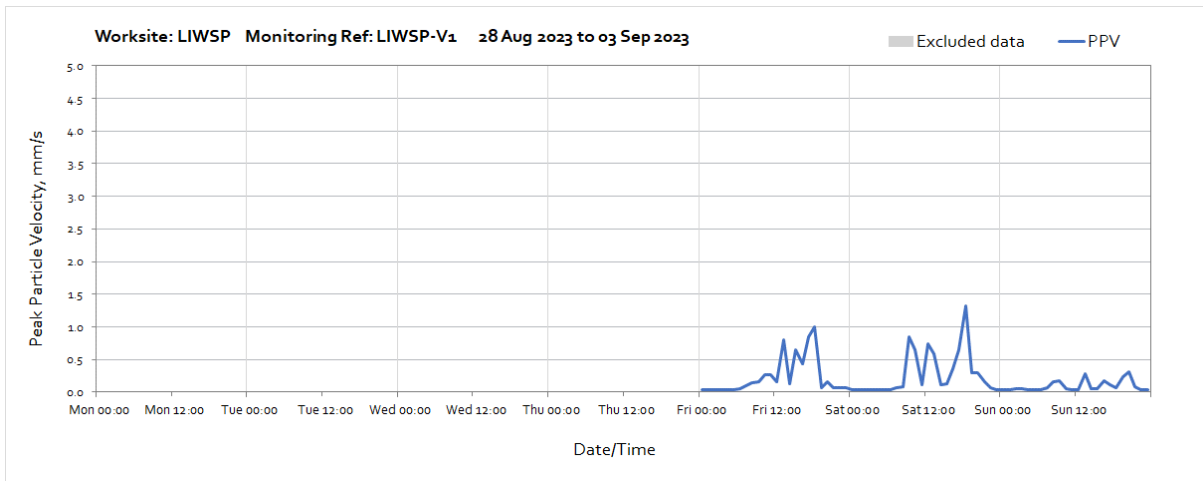
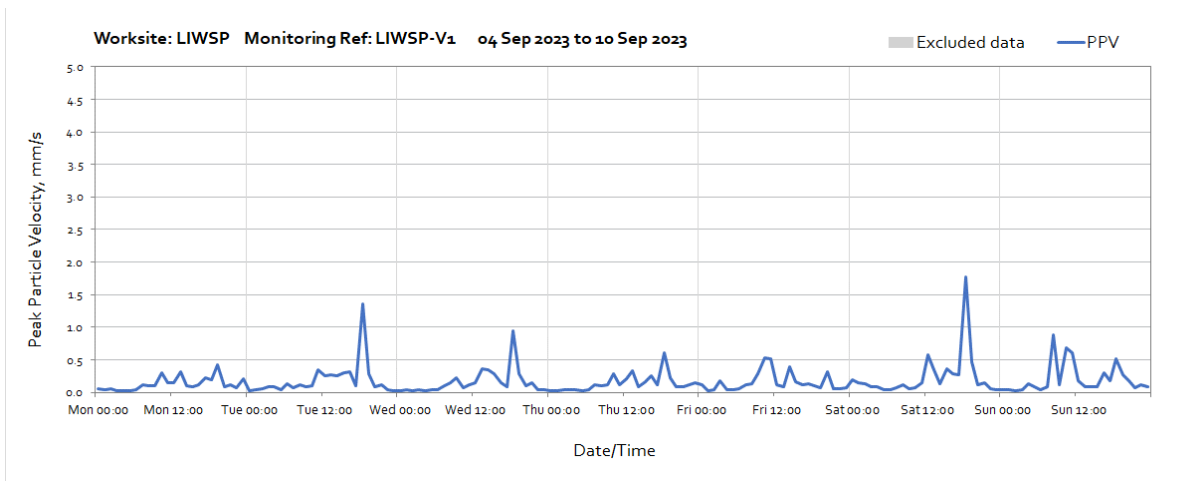
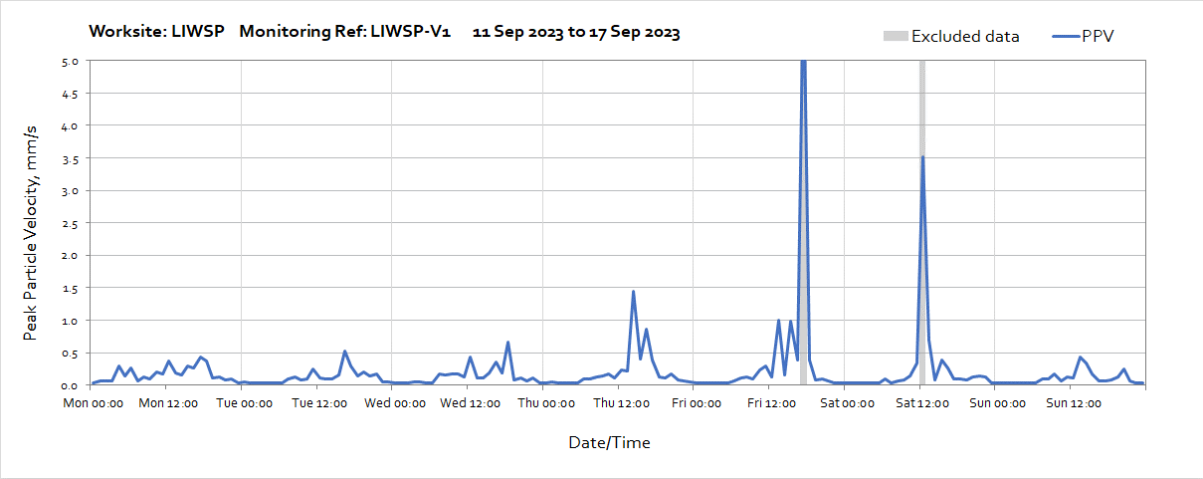
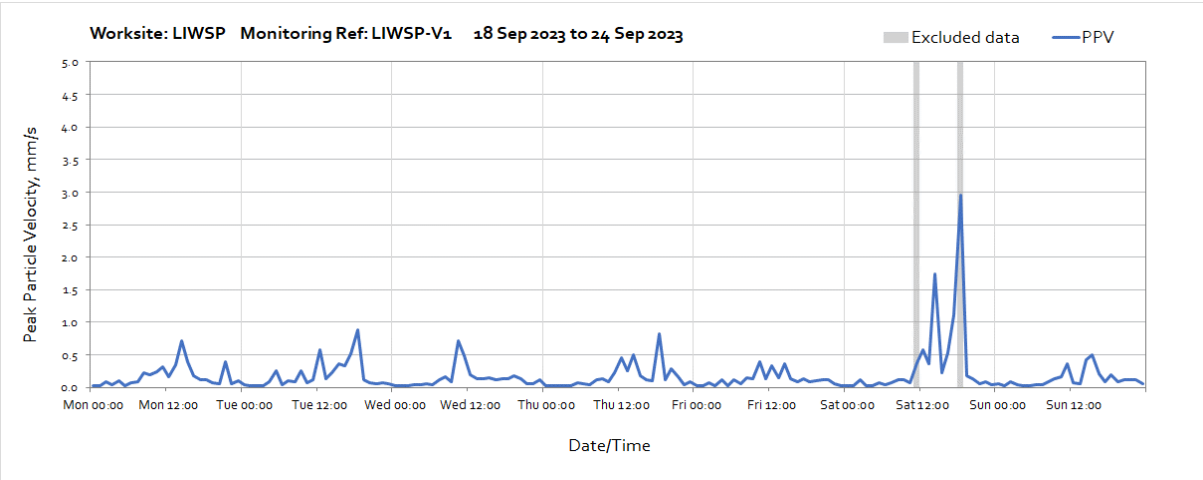
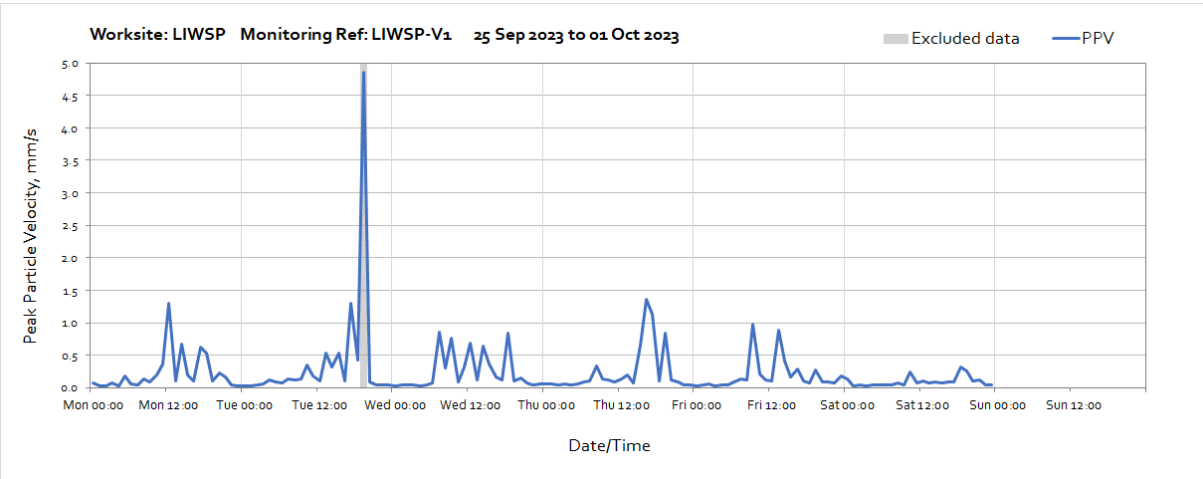
### Worksite: LIWSP Monitoring Ref: LIWSP-V1

The following graphs show the hourly measured peak particle velocity PPV recorded during the monitoring period. The graphs show the highest PPV of the three orthogonal axes x, y and z. Periods where PPV values have been affected by local interference with the vibration monitor or only measured for part of the period, which are not representative of HS2 construction works, have been greyed out and excluded when calculating values in Table 4 of the main report.

Worksite Reference	Measurement Reference	Monitor Address	Highest PPV measured in any axis, mm/s
LIWSP	LIWSP-V1	Woodside House, Bascote Heath, Southam	1.67 (Z-axis)
