Rail Accident Investigation Branch

Rail Accident Report

Freight train derailment at London Gateway, Essex 24 December 2021

Report 14/2023
December 2023

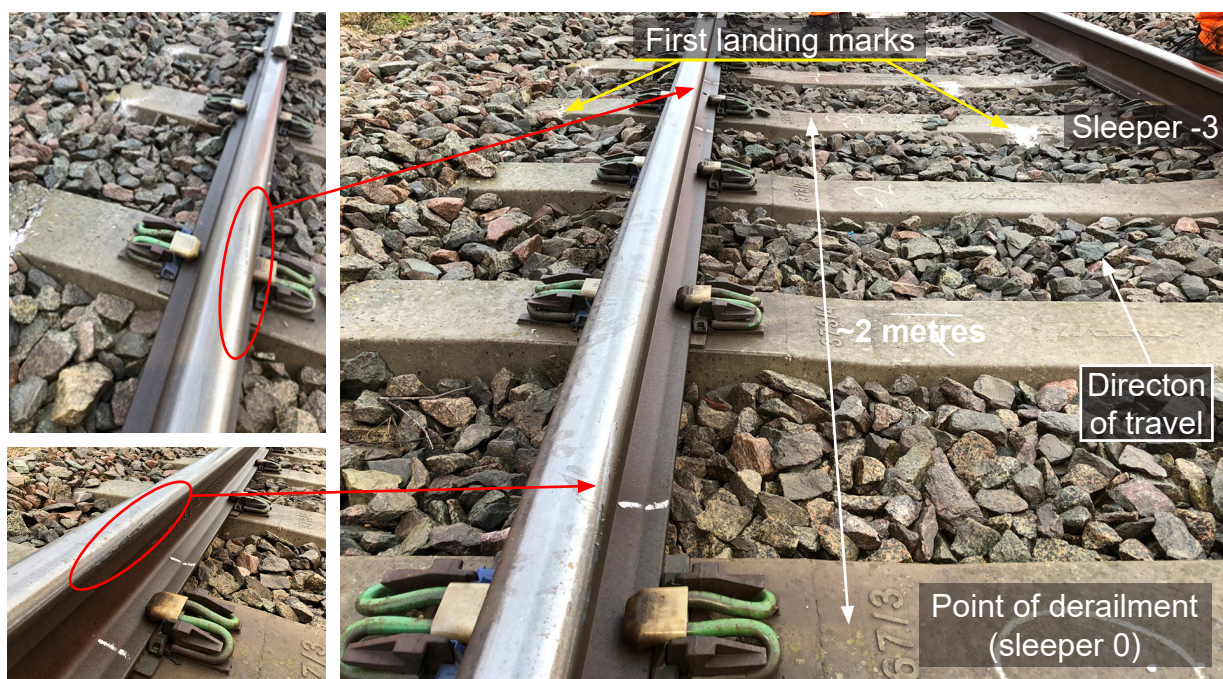
Figure 6: Derailment marks and track damage in the vicinity of the designated point of derailment (photographs courtesy of Network Rail).

- 43 The first identified derailment mark was on the left-hand rail, approximately 11 metres on the approach to LG11 signal. This was designated the point of derailment and numbered as sleeper 0.⁸ The second derailment mark was identified at sleeper -3, around 2 metres beyond the point of derailment (figure 6). The separation of the marks was consistent with the 1.8 metre wheelbase of the TF20 bogies fitted to wagon 12 (see paragraphs 49 and 58). This, and the form of the marks (short, and at an angle to the rail), shows that both wheelsets on the same bogie had lifted suddenly, and simultaneously left the track on a trajectory towards the left.

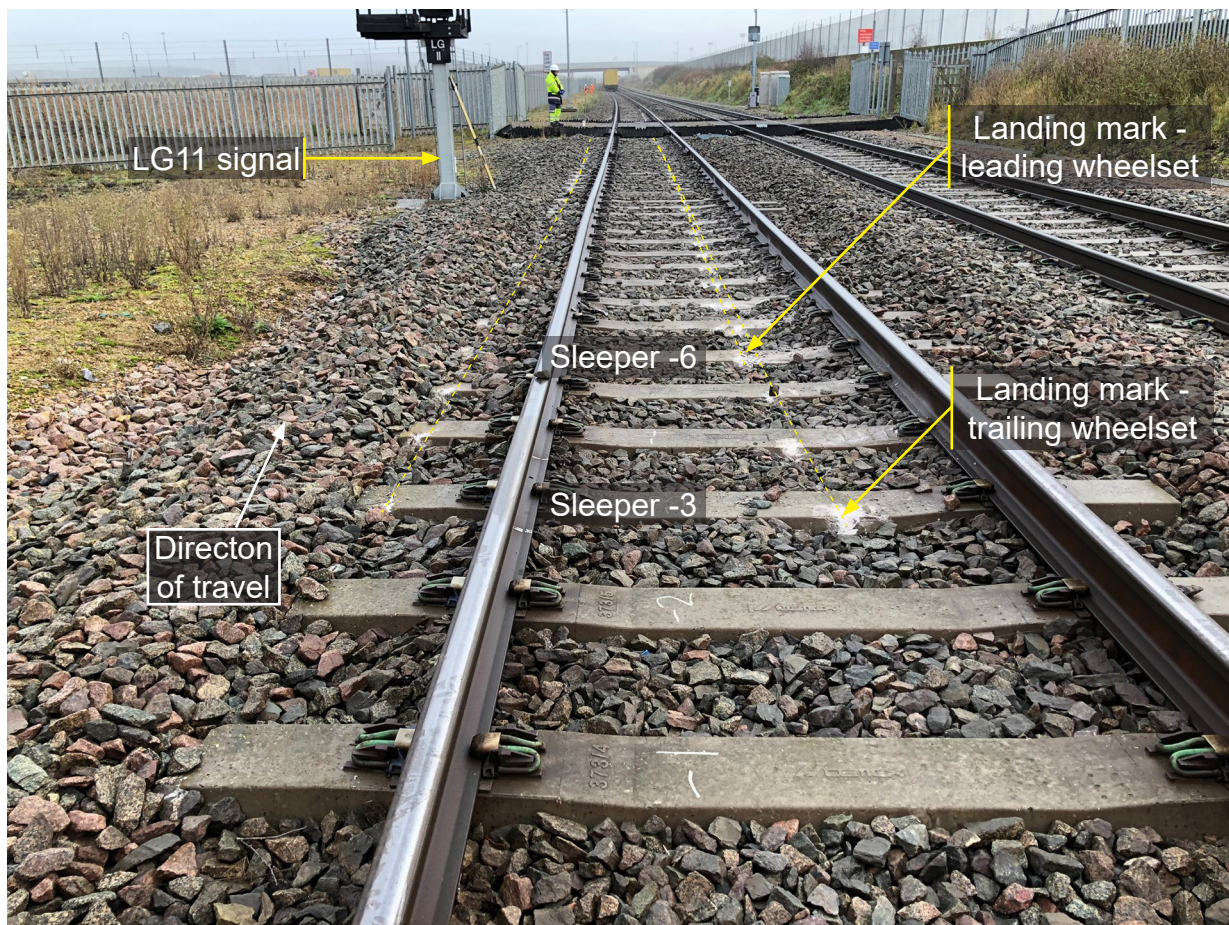
Figure 7: Derailment marks and track damage on the approach to LG11 signal and The Bridleway level crossing beyond (photograph courtesy of Network Rail).

44 Other marks were found further along the track. These took the form of damage to sleepers in the four-foot and cess. There was an absence of marks between sleeper 0 and sleeper -3, evidence of one wheelset running derailed between sleeper -3 and sleeper -6 and, after this, evidence of two wheelsets running derailed. This indicates that the two wheelsets on the bogie landed more or less at the same time, the leading wheelset close to sleeper -6 and the trailing wheelset close to sleeper -3. They had remained airborne in the meantime (figure 7). There were no marks to suggest that more than one bogie ran derailed on the Down Thames Haven line. RAIB has concluded, from other evidence, that the wheelsets which derailed at this point were on the leading bogie of wagon 12 (see paragraph 66).

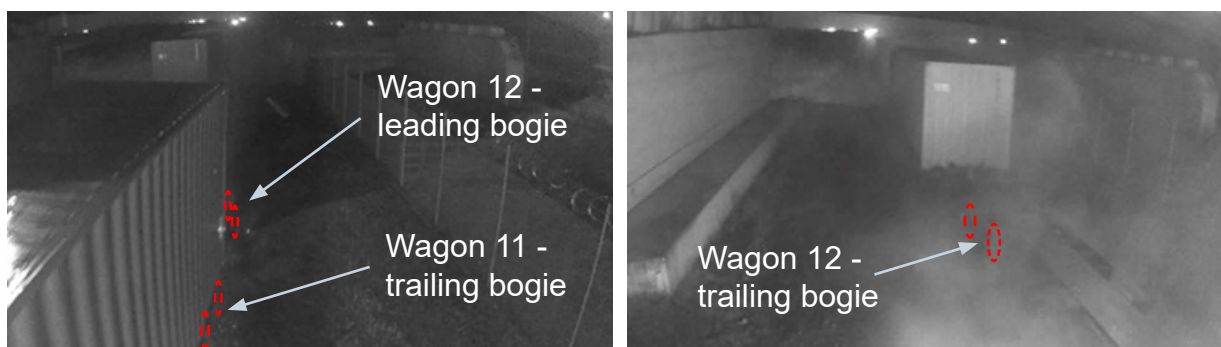
Figure 8: CCTV images of train 4L47 passing the London Gateway port cameras and OCR scanners (images courtesy of DP World).

45 Closed-circuit television (CCTV) images from the lineside cameras (paragraph 30) showed that three bogies in total had derailed by the time wagon 12 was running on the Thames Haven Single line (figure 8). These were the trailing bogie on wagon 11 and both bogies on wagon 12. All three of these bogies were shown running derailed to the left. RAIB concluded that the trailing bogie on wagon 12 and the trailing bogie on wagon 11 had been drawn into derailment due to the path that the already derailed leading bogie of wagon 12 was forced to take as it ran through LG1 points, where the Up Thames Haven and Down Thames Haven lines join to form the single line (paragraph 13). Marks and damage on the track at LG1 points support this.

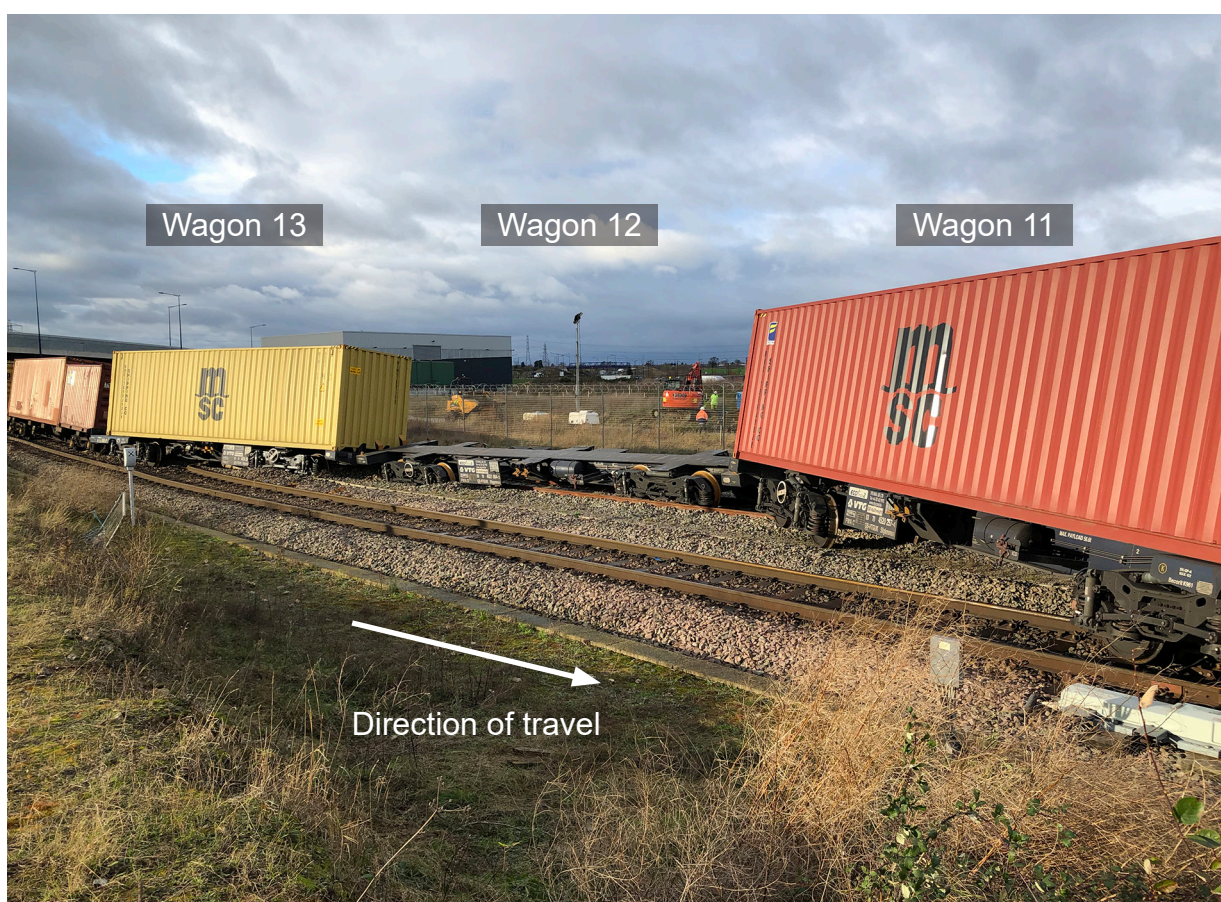
Figure 9: Final position of Wagons 11, 12 and 13 (photograph courtesy of VTG Rail).

- 46 When the derailed train reached LG2 points, the leading bogie on wagon 11 and both bogies of wagon 13 also derailed (figure 9).

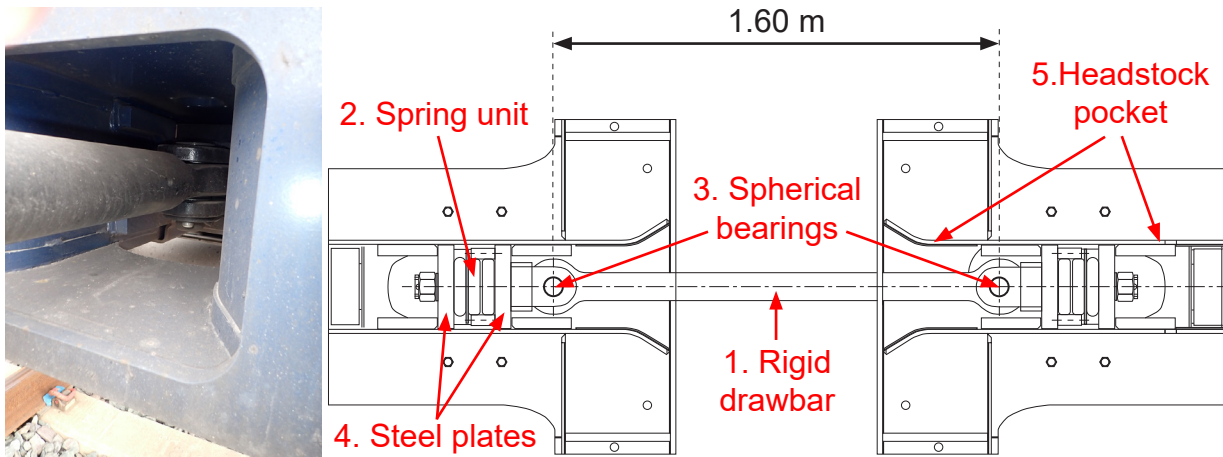
Figure 11: Bar coupler arrangement at the inner headstock locations. Photograph shows the general arrangement and the space available for pitch and yaw rotation within the headstock pocket.

- 53 The bar couplers that connect Ecofret 2 triple-wagons together (paragraph 26) are anchored within a central pocket on the inner headstocks (the ‘headstock pocket’). With reference to figure 11, the bar coupler arrangement comprises a rigid drawbar¹¹ (1) that connects to spring units (2), one on each wagon, via spherical bearings (3). Each spring unit is made up of three elastomeric ring elements. These are preloaded by being clamped between two steel plates (4), which locate and secure each spring unit within the headstock pocket (5). The spring units enable the drawbar couplings to compress (or extend) when the externally applied longitudinal force exceeds the preload amount in either compression (causing the coupled wagons to draw closer together) or tension (causing the coupled wagons to separate). The material used in the spring components enables the bar coupler arrangement to absorb energy when alternating forces apply.

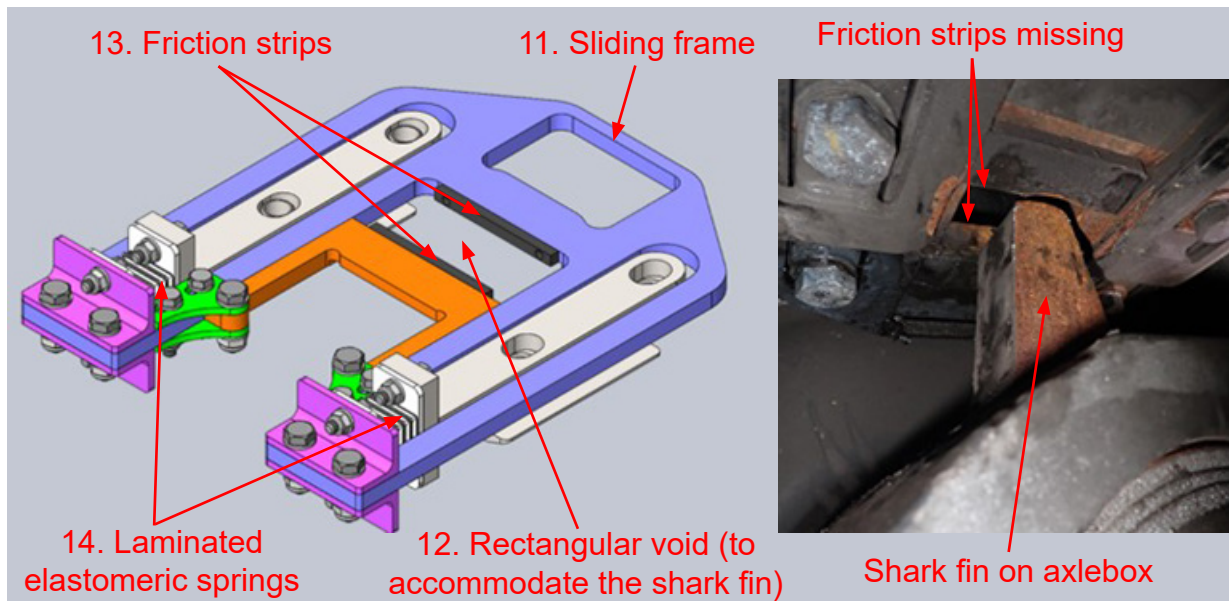
Figure 15: Primary lateral buffer device (diagram courtesy of VTG Rail). Photograph shows the condition of a PLB device as found on wagon 12.

- 67 Special suspension movement control devices were added to the TF20 bogie as a late modification (paragraph 62). Referred to as 'primary lateral buffers' (PLBs), they comprise a sliding frame designed to capture and restrain a vertical metal lug on top of each axlebox. The lug is informally known as the 'shark fin'. With reference to figure 15, the sliding frame (11) is secured to the underside of the bogie frame, the shark fin passing through a rectangular void (12). Two friction strips (13) attached to the sliding frame are designed to bear against the sides of the shark fin. These allow the shark fin (and axlebox) to slide up and down. The side-to-side (lateral) movement of the axlebox is restrained by two laminated elastomeric springs (14).

- 68 RAIB identified signs of significant damage and degradation on several PLBs. On wagon 12, nearly all the friction strips had detached and there was evidence that some of the laminated elastomeric springs had split. Degradation of the PLBs on Ecofret 2 wagons was a problem that existed before the derailment, and work was being carried out to investigate it when the derailment occurred.

- 119 RAIB identified signs of significant damage and degradation on several PLB devices on wagon 12 (paragraph 68). The PLBs were fitted to remedy a running behaviour issue that was unrelated to the concerns about the risk of derailment due to longitudinal compressive forces (paragraph 62). In the baseline derailment simulation case, they were modelled with additional clearance to account for the degradation resulting from the detachment of the friction strips, with a longitudinal compressive force of 460 kN predicted as being needed for the wheel flanges to contact opposite rails (stage C in the derailment sequence (paragraph 90)) and 650 kN for full derailment (stage E in the derailment sequence). Sensitivity studies predicted that when the PLBs were modelled as being intact, the forces predicted as being needed increased to 500 kN and 680 kN respectively. This supports the degradation of the PLBs reducing the amount of longitudinal compressive force required for the wheel flanges to contact the opposite rails, and for a bogie to ultimately derail.

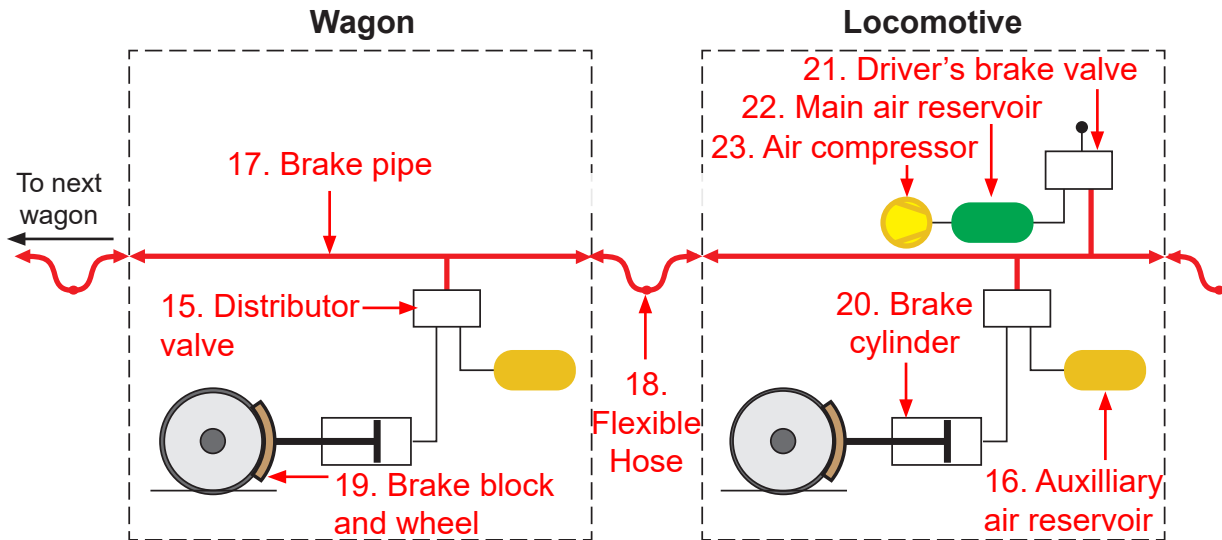
Figure 17: Single pipe automatic air brake system (simplified).

86 Brake distributor valves have a set of chokes that can be set to either ‘passenger’ or ‘goods’ settings. In the passenger setting, the train can stop in a shorter distance because the wagon brakes apply more quickly. In the goods setting a slightly delayed brake application is made. This helps ensure that the brakes on the wagons throughout a long freight train apply in a more consistent manner. The brake distributor valves on train 4L47 were all in the passenger setting. This was so the train was able to achieve the braking performance needed to be compatible with its maximum operating speed, which was 75 mph (121 km/h), and the signal spacing on the route.

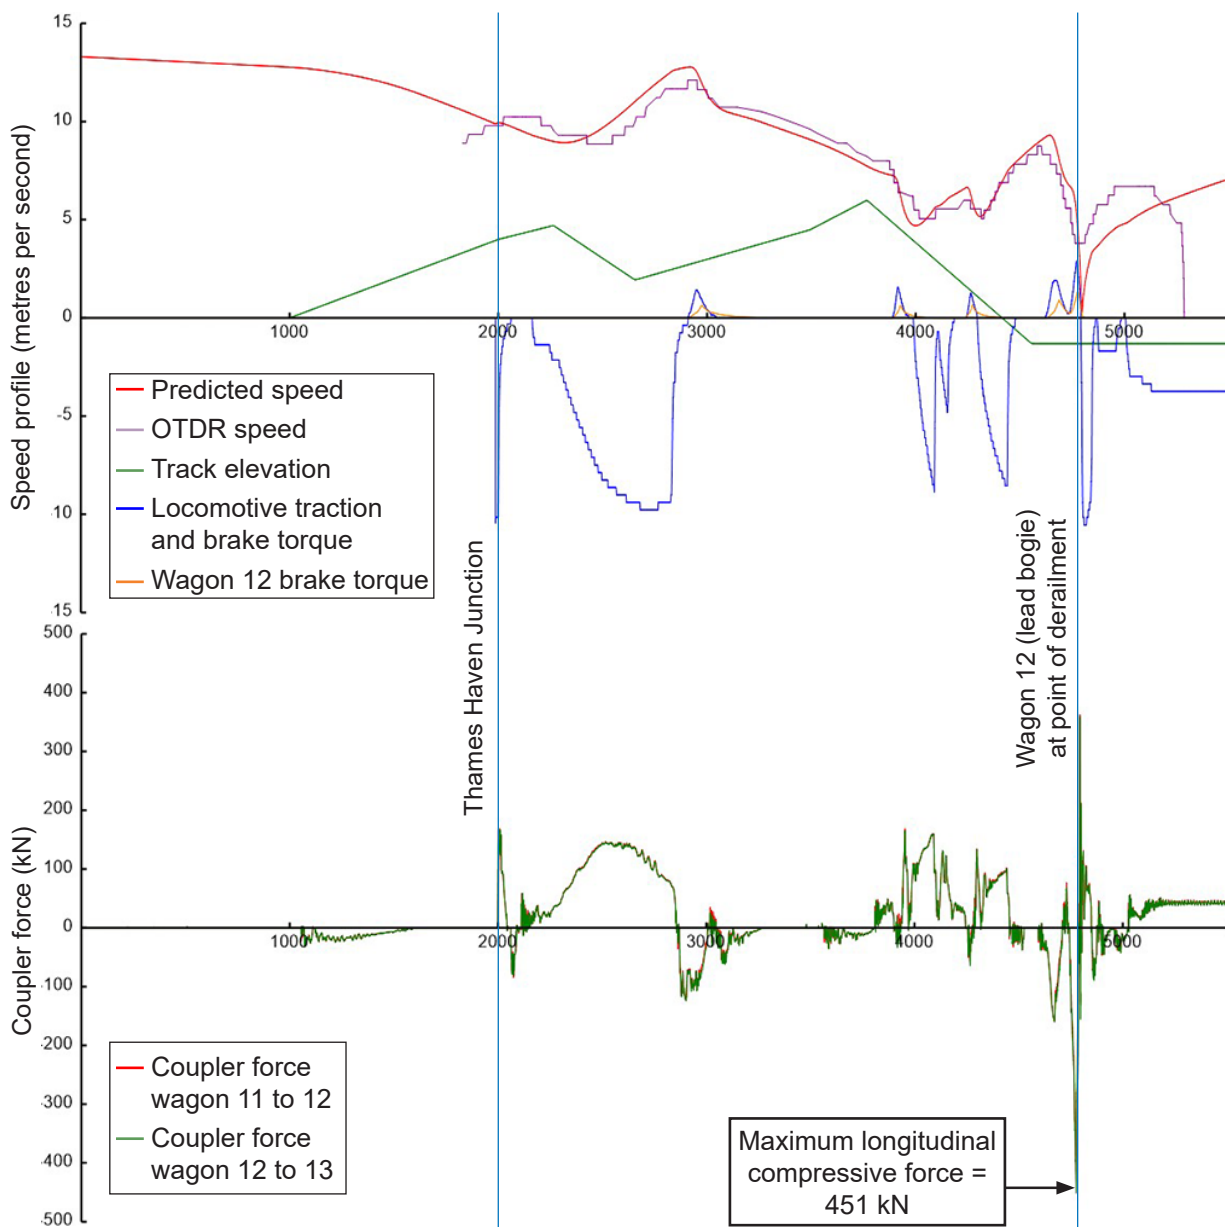
Figure 19: Predicted speed profile and coupler force – sensitivity study C4.

- 93 The upper graph plot shows the predicted speed profile and that recorded by the locomotive OTDR. The track gradient profile and applied traction and brake torques (at the locomotive and wagon 12) are shown for pictorial reference. The lower graph plot shows the predicted variation of the force in the couplers at either end of wagon 12. OTDR analysis shows how the double brake application made by the driver of train 4L47 coincided with wagon 12 approaching the point of derailment location (paragraph 37). Figure 19 shows that the maximum longitudinal compressive force was predicted to occur at the same time. Other sensitivity studies show how replacing the double brake application with a brake application of different form and size could significantly affect both the magnitude and location of the maximum longitudinal compressive force (appendix C). Together these show that the high longitudinal compressive force that occurred was because of the double brake application and that it is evident that the force generated was sufficient to result in the derailment of the leading bogie of wagon 12.

92 The longitudinal train dynamics simulation studies showed that a high longitudinal compressive force would have been rapidly generated within the train at the time of the derailment (paragraph 82b and appendix C). Baseline simulations predicted that the maximum longitudinal compressive force occurred as the leading bogie of wagon 12 was approaching the point of derailment. Sensitivity studies showed that refining the traction and brake torque time histories, so that the calculated speed profile better matched that recorded by the locomotive OTDR, significantly increased the magnitude of the maximum longitudinal compressive force but did not alter its location. Altering the characteristics of the couplers, for instance, by introducing the effect of slack (at side buffer and screw coupling arrangements) and reducing their capacity to absorb energy was also found to increase the magnitude of the maximum longitudinal compressive force, again without altering its location. Figure 19 shows the calculated forces in the couplers on wagon 12 and speed profile for sensitivity study C4. Of the sensitivity studies undertaken, this study calculated the greatest maximum longitudinal compressive force (451 kN).

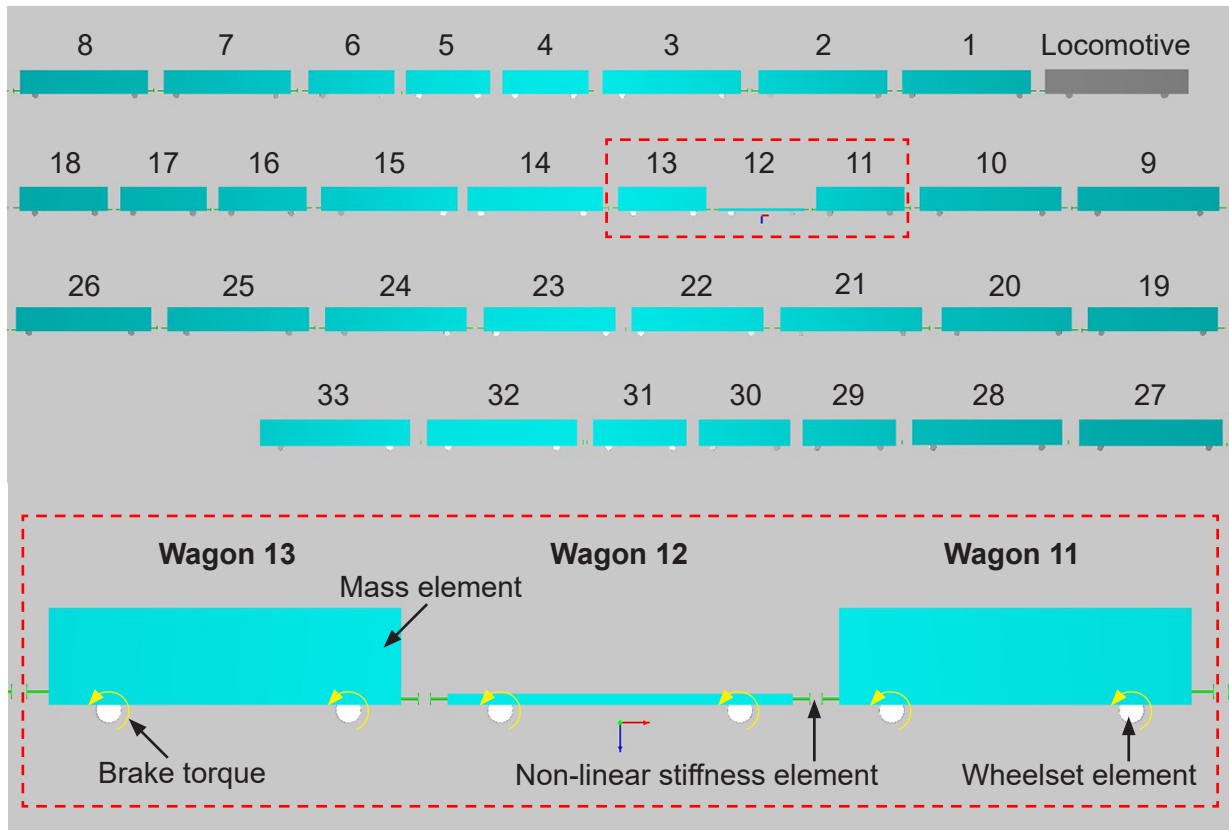
Figure C1: Longitudinal train dynamics simulation – model of train 4L47.

C2 A simulation model was developed using the longitudinal analysis capabilities of an industry-standard railway vehicle dynamics analysis package. The train was modelled as a string of 34 mass elements connected using pairs of special spring elements ('bumpstop' elements) to represent the coupler non-linear stiffness, with friction elements added in parallel to represent the energy absorbing characteristics. The mass elements represented the inertia properties of the non-rotating parts of each of the vehicles. Separate 'wheelset' elements, two per vehicle for simplicity, were used to represent the rotating parts (figure C1).

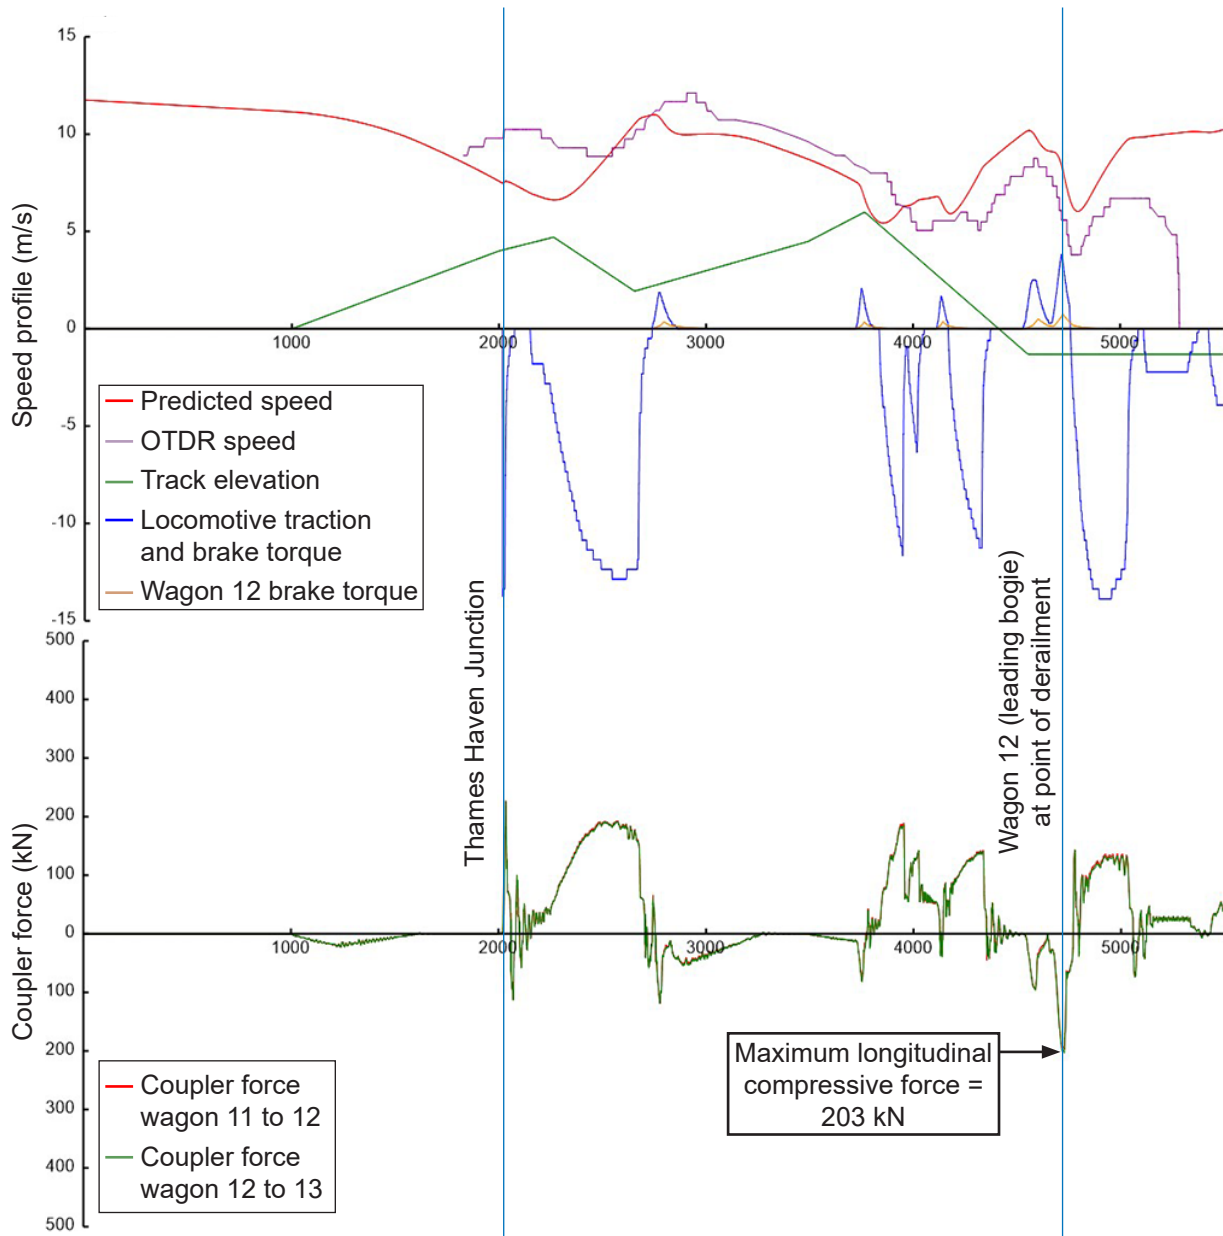
Figure C2: Predicted speed profile and coupler force – baseline simulation. The upper graph plot shows the predicted speed profile and that recorded by the locomotive OTDR. The track gradient profile and applied traction and brake torques (at the locomotive and wagon 12) are shown for pictorial reference only. The lower graph plot shows the predicted variation of the force in the couplers at either end of wagon 12.

C6 Several steps and assumptions were involved in estimating the traction and brake torque time histories and, because of this, a degree of uncertainty must be recognised in the results. RAIB found that an improved speed match could be obtained by factoring the traction and brake torque values (referred to as the 'refined traction and brake torque time histories'). No change was made to the time at which the torques applied. Simulations using the refined traction and brake time histories are referred to as sensitivity study C1. They predicted the maximum longitudinal compressive force occurred at the same location, but its magnitude was greatly increased.
