Construction Noise and Vibration Monthly Report – October 2023

London Borough of Camden

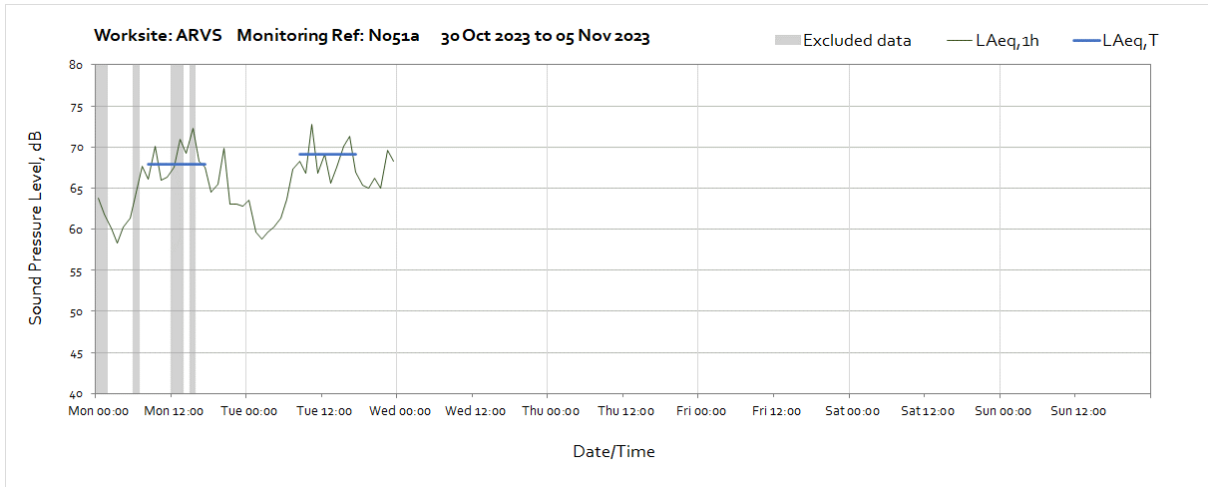
Adelaide Road Ventilation Shaft (ARVS) – Monitoring Ref: N051a

Note: Missing data from the start of the month until 02nd of October at 09:00 due to a monitoring station configuration error.

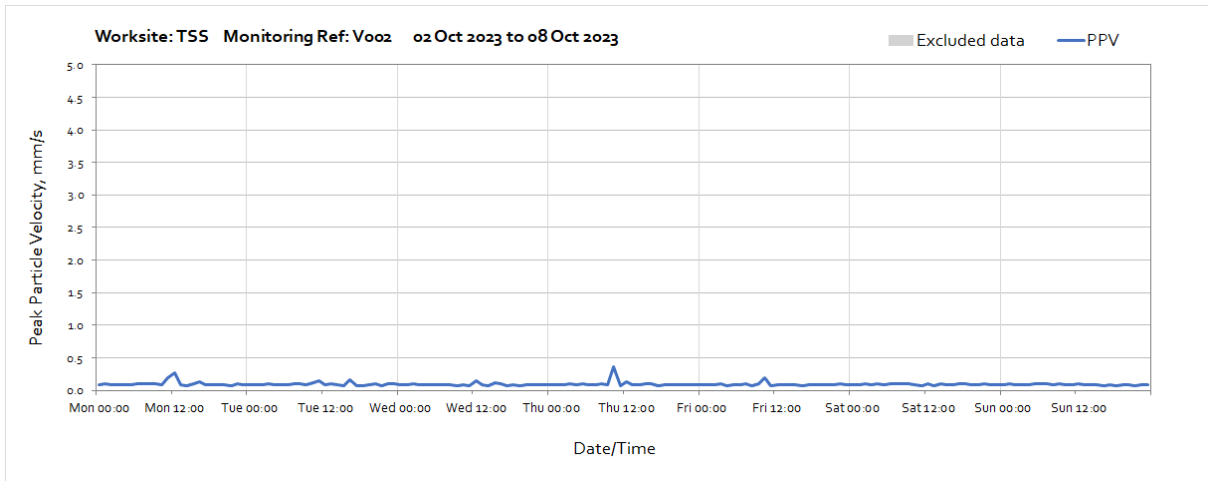
Worksite: TSS - Monitoring Ref: V002

Note: Missing data between 01:00 and 02:00 on Sunday 29th October was due to a monitor time adjustment at the end of British Summertime.
