Construction noise and vibration Monthly Report – October 2023

London Borough of Hillingdon

Non-Technical Summary

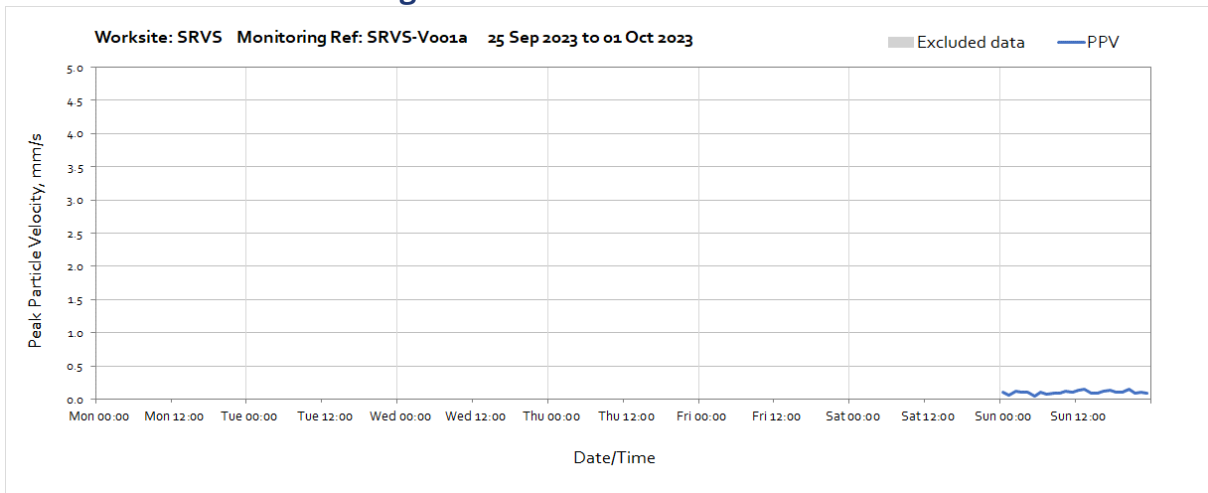
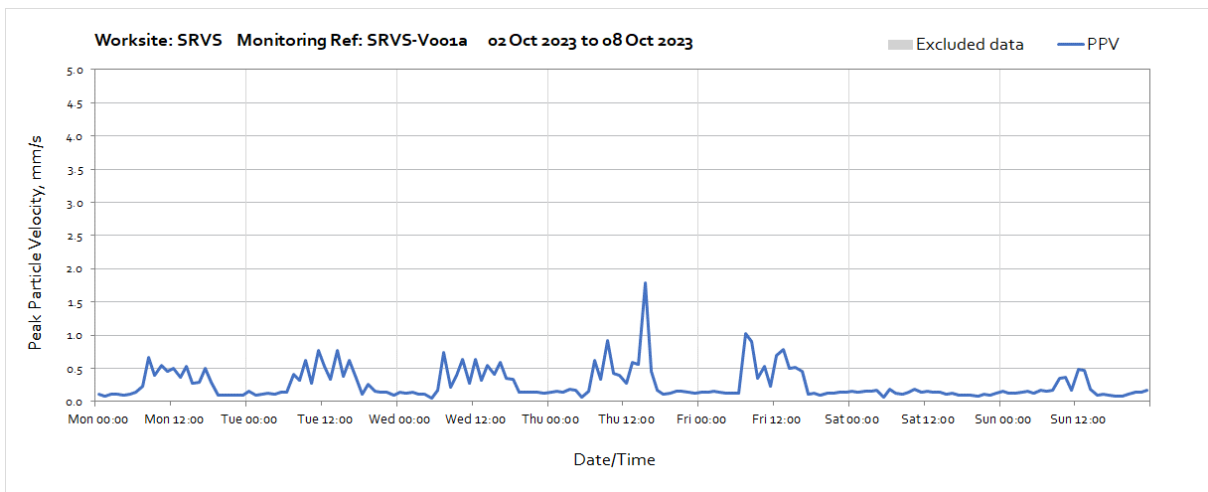
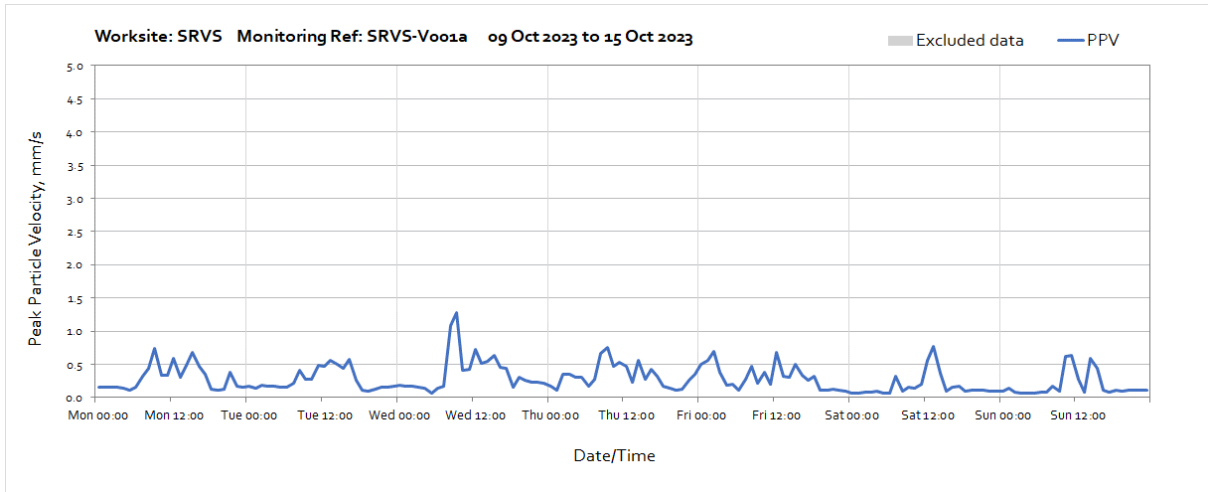
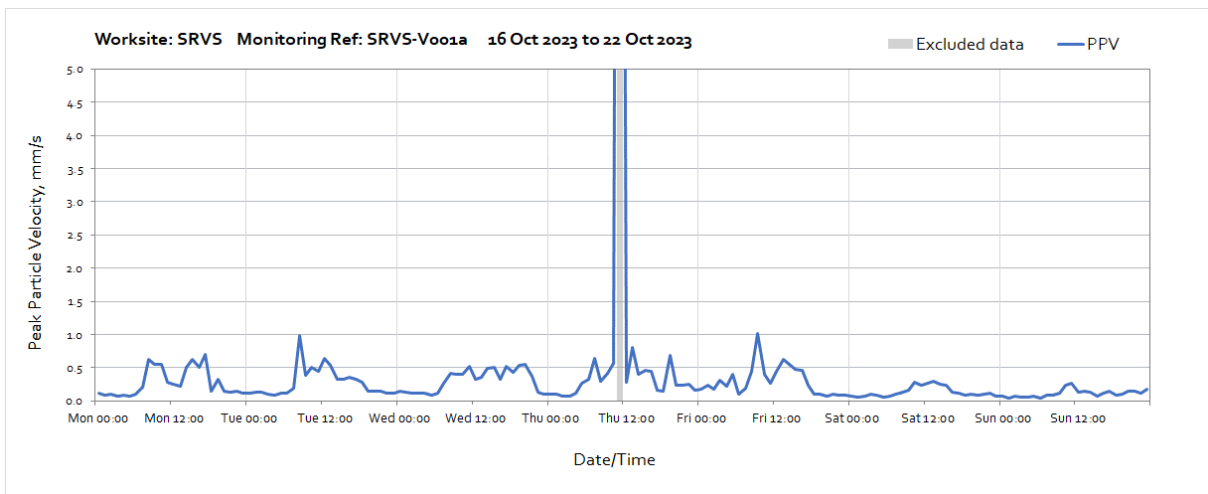
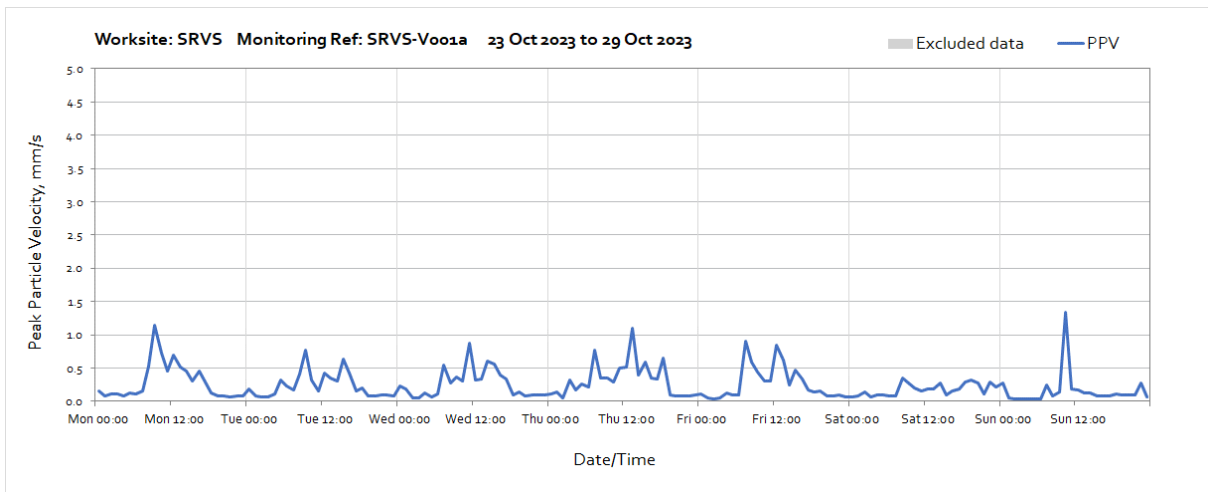
Worksite: SRVS – Monitoring Ref: SRVS-V001a

Worksite Reference	Measurement Reference	Monitor Address	Highest PPV measured in any axis, mm/s
WRP	GW-V001	95 The Greenway, Ickenham, Uxbridge	0.49 (Y-axis)
SRVS	SRVS-V001a	Braintree Road, Ruislip	1.79 (Z-axis)

The following graphs show the hourly measured peak particle velocity PPV recorded during the monitoring period. The graphs show the highest PPV of the three orthogonal axis x, y, and z. Periods where PPV values have been affected by local interference with the vibration monitor or only measured for part of the period, which are not representative of HS2 construction works, have been greyed out and excluded when calculating values in Table 4 of the main report.
