Construction Noise and Vibration Monthly Report – October 2023

Stratford-on-Avon District Council

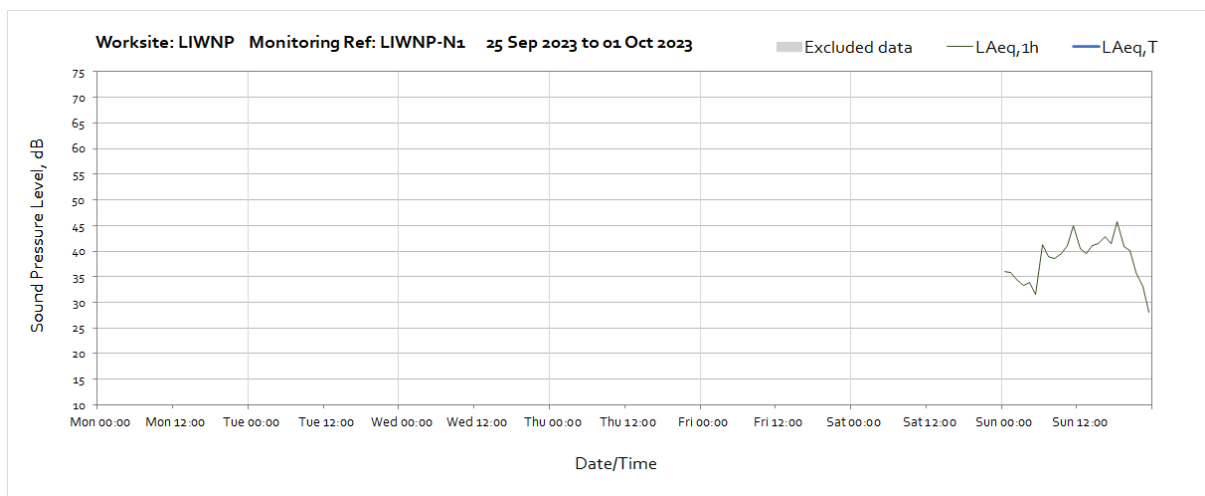
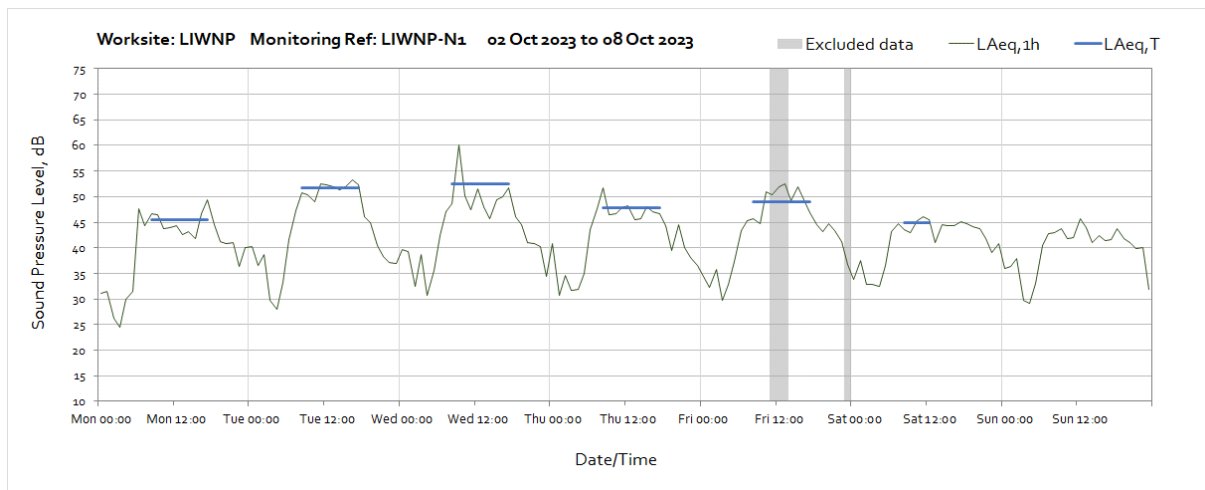
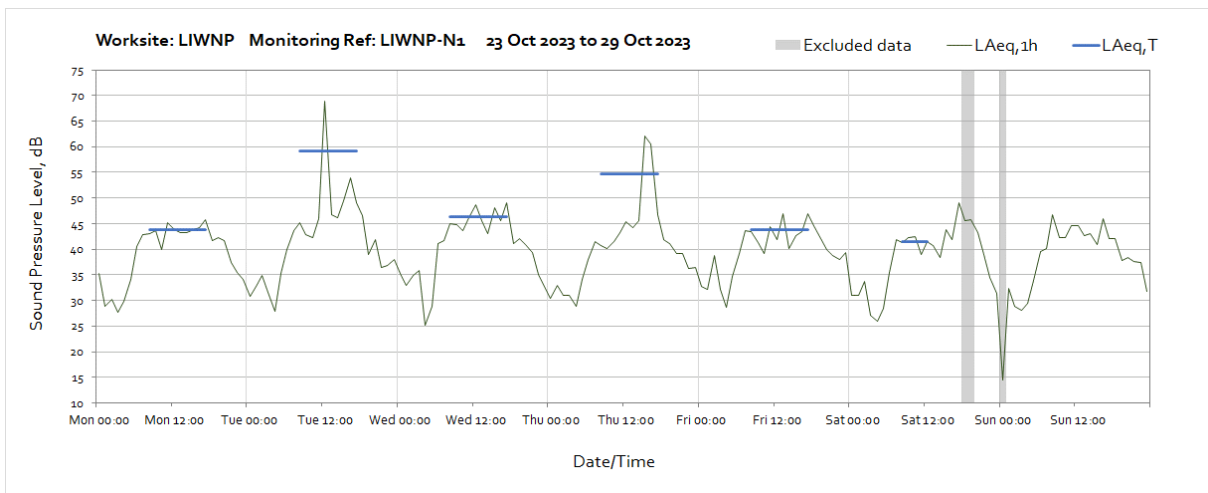
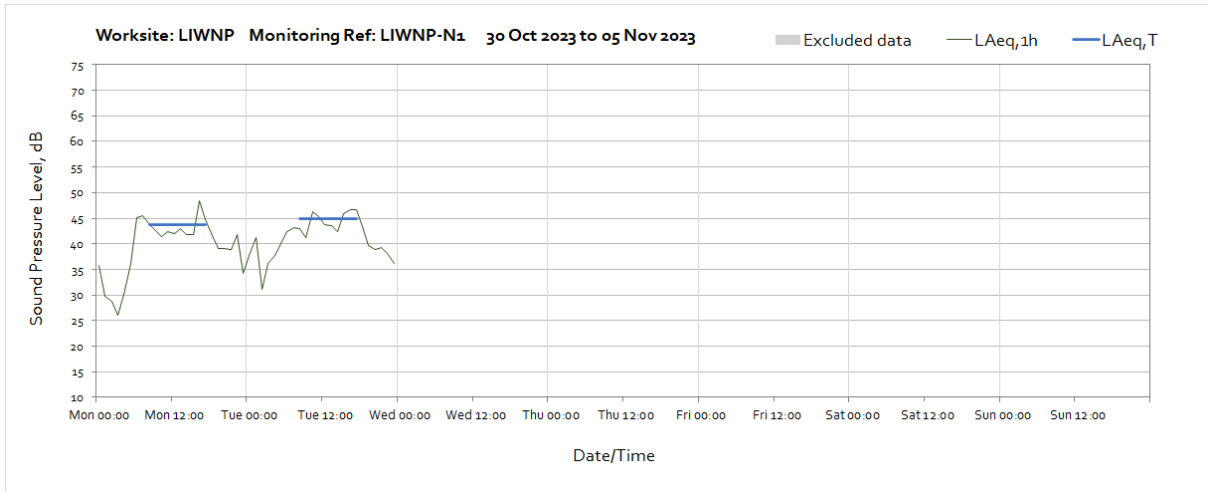
Worksite: LIWNP Monitoring Ref: LIWNP-N1

The following graphs show the hourly measured ambient noise level $L_{Aeq,1h}$ and, where relevant, the averaged noise level $L_{Aeq,T}$ values, where the time period T is as specified in Table 1 of HS2 Information Paper E23. Periods where noise levels are adversely affected by weather or only measured for part of the period, which are not representative of HS2 construction works, have been greyed out and excluded from the calculation of the $L_{Aeq,T}$ values in Table 3 of the main report.

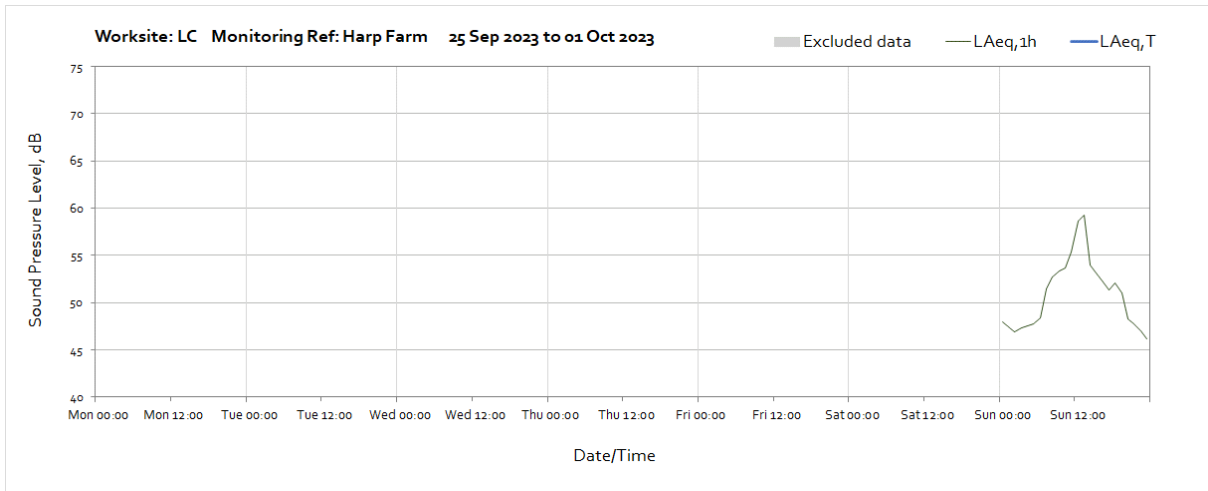
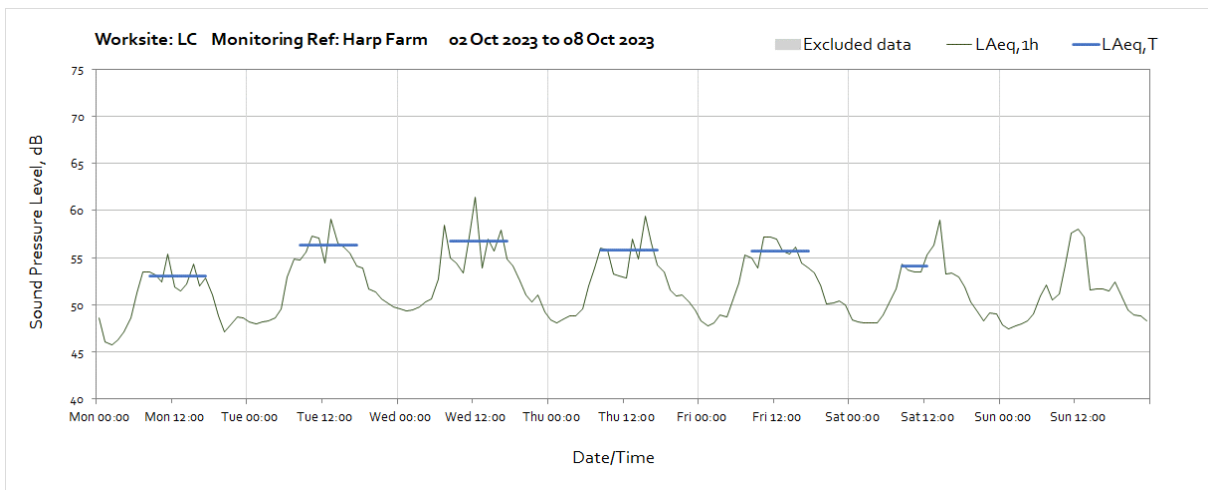
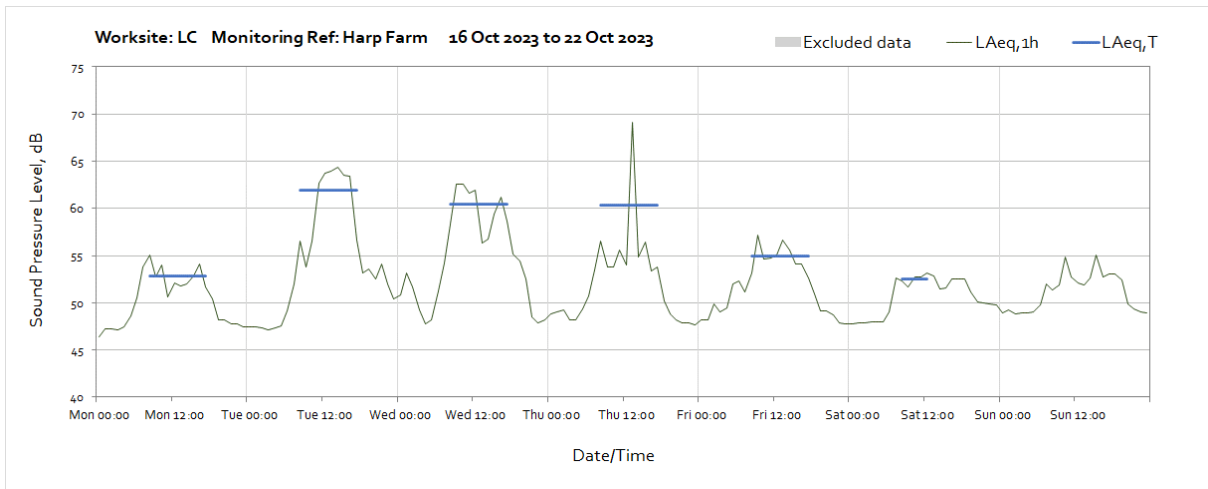
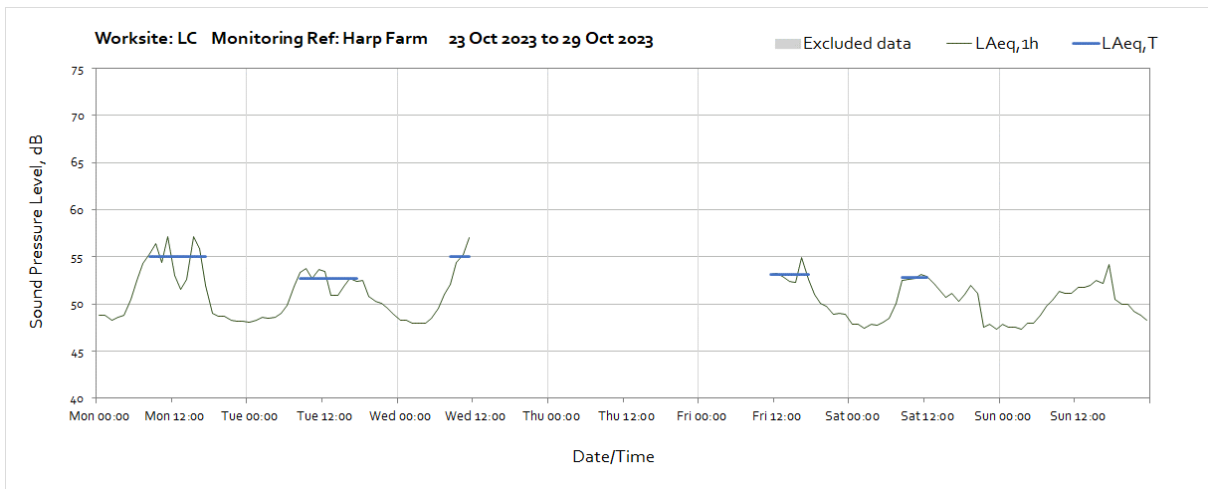
Worksite: LC Monitoring Ref: HF-N1

Note: Missing data between 12:00 on 25th October until 10:00 on 26th October was due to monitor laboratory calibration.

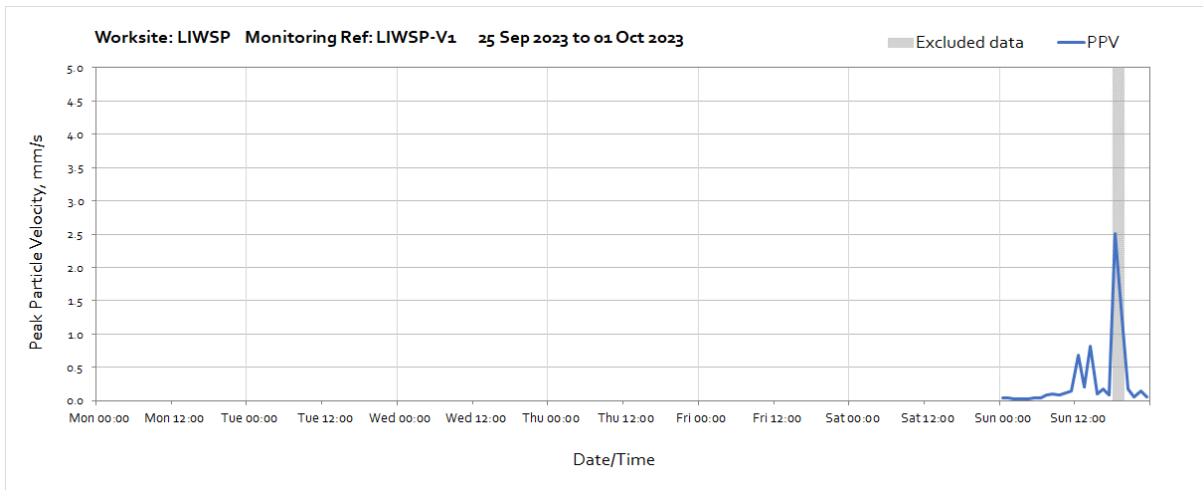
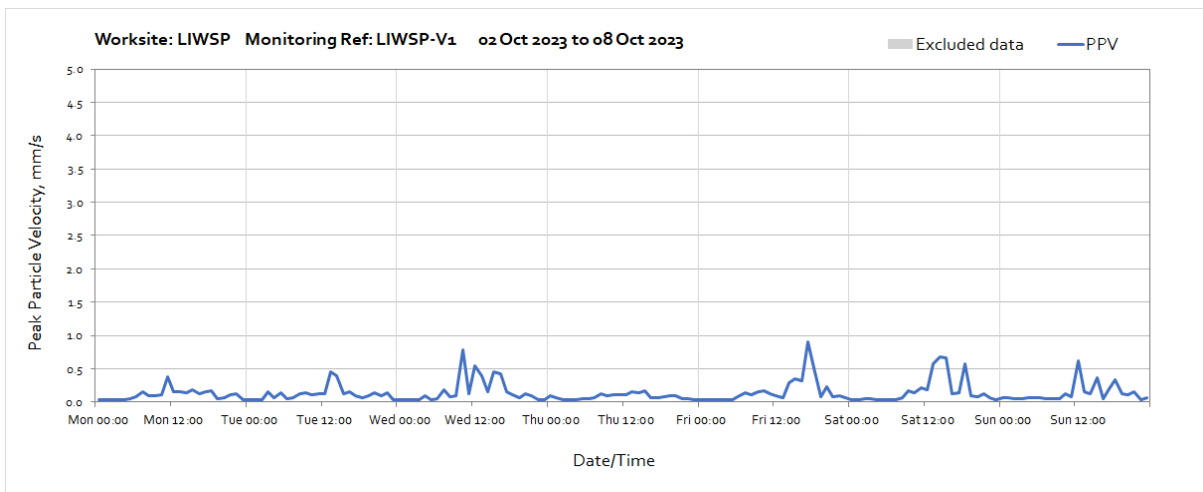
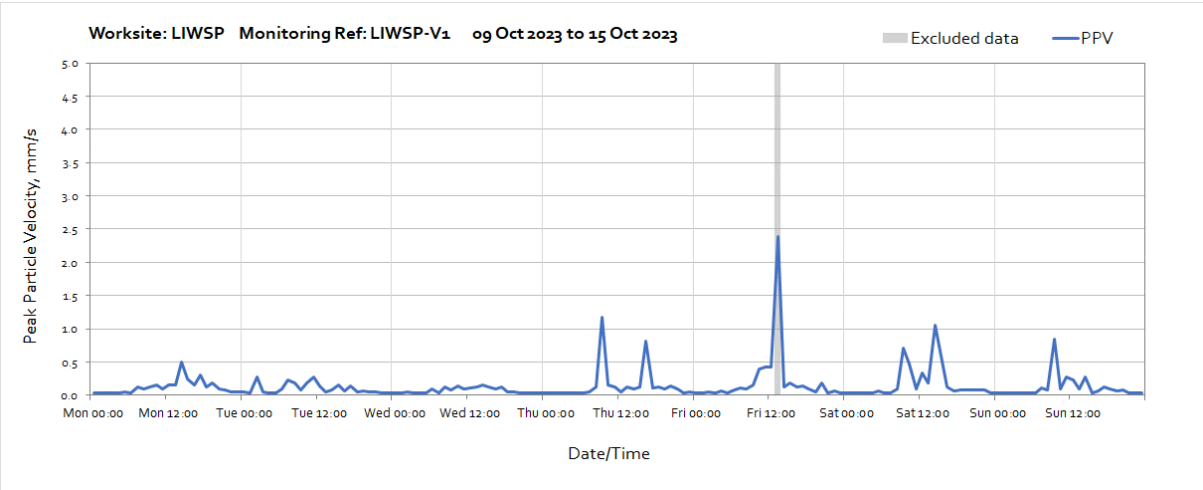
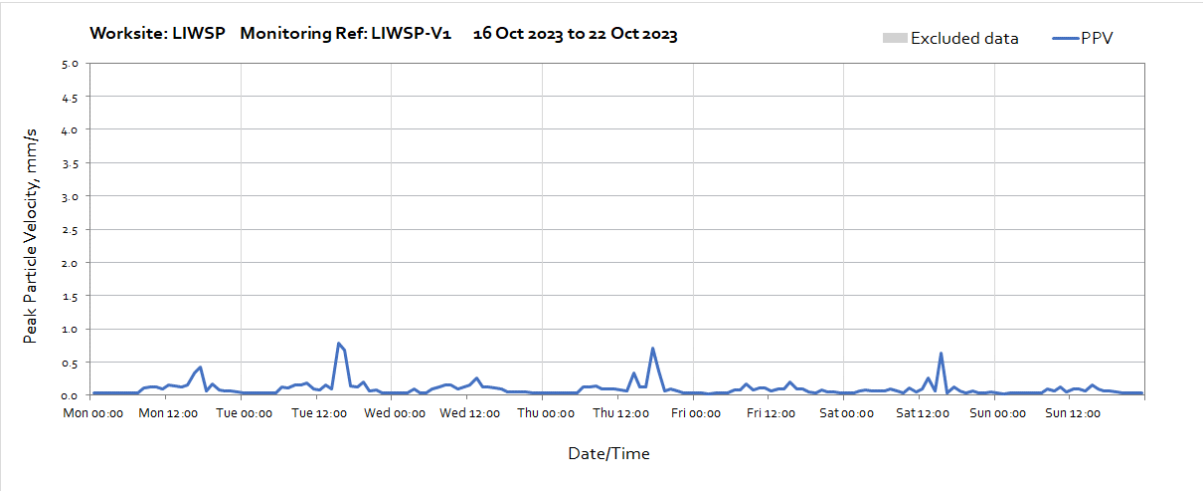
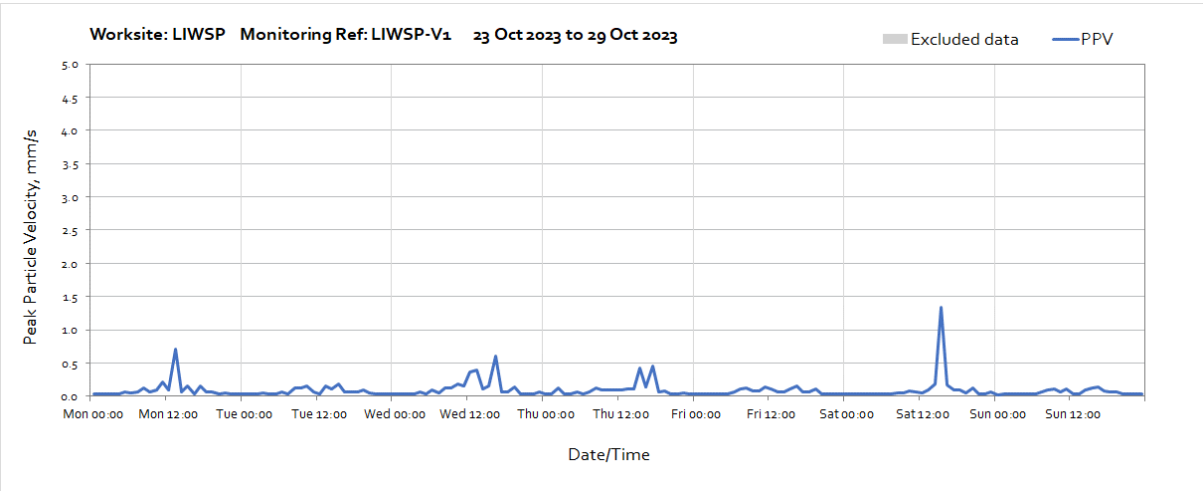
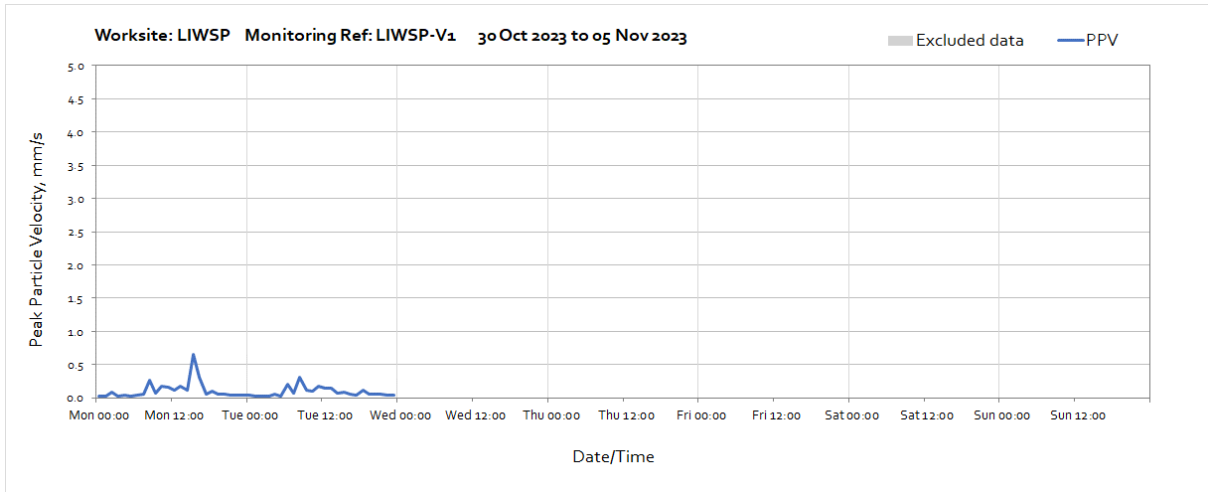
Worksite: LIWSP Monitoring Ref: LIWSP-V1

Worksite Reference	Measurement Reference	Monitor Address	Highest PPV measured in any axis, mm/s
LIWSP	LIWSP-V1	Woodside House, Bascote Heath, Southam	1.27 (Z-axis)

The following graphs show the hourly measured peak particle velocity PPV recorded during the monitoring period. The graphs show the highest PPV of the three orthogonal axes x, y and z. Periods where PPV values have been affected by local interference with the vibration monitor or only measured for part of the period, which are not representative of HS2 construction works, have been greyed out and excluded when calculating values in Table 4 of the main report.
