# DESK TOP STUDY REPORT

Site Address:	Land to the west of Clatterbury Lane, Clavering, Essex
Report Date:	October 2023
Project No.:	18256
Prepared for:	BAYA Group
Planning Application	Uttlesford District Council

## **PRELIMINARY RISK ASSESSMENT – DESK TOP STUDY - PHASE 1 REPORT**

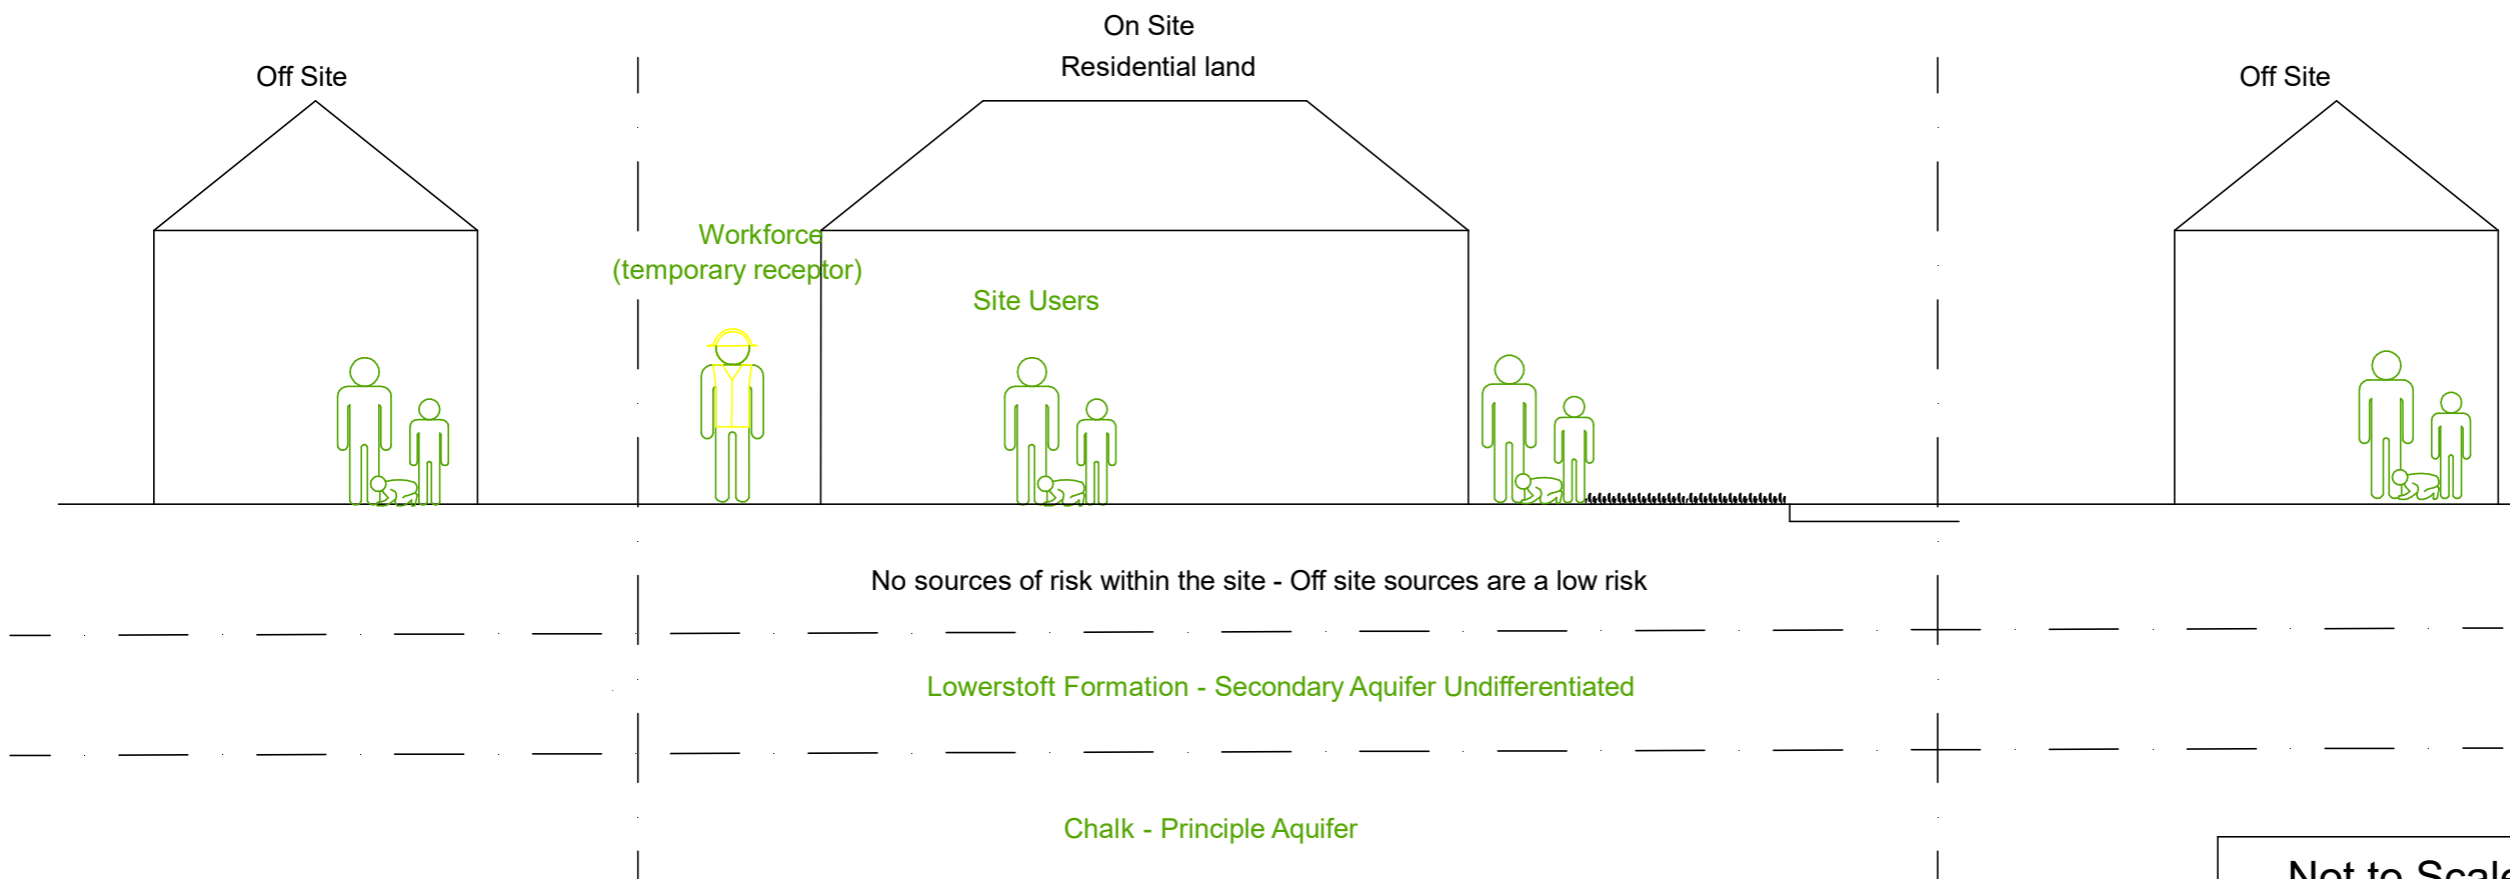
Not to Scale  
Sketch No. : DTS / 18595 / 01 / 01

Red =Possible

sources

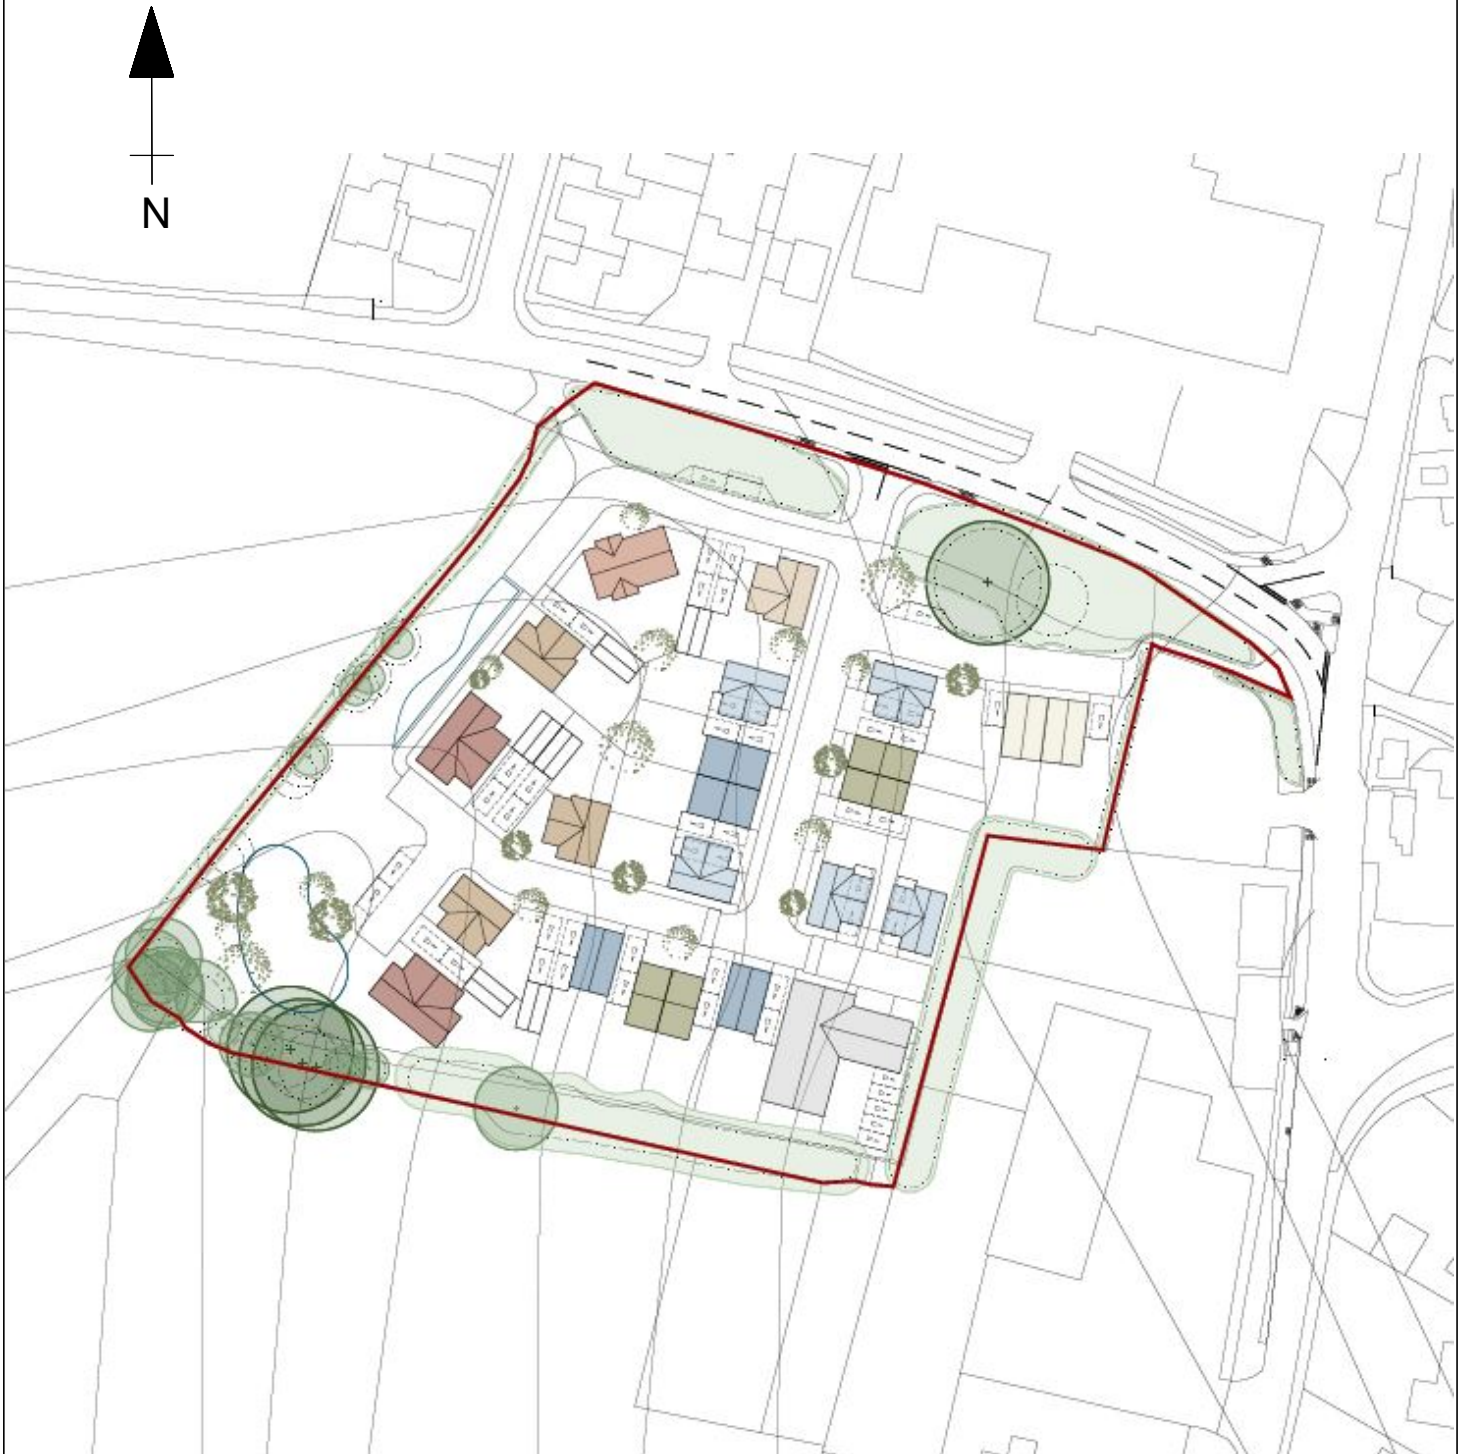
### Proposed Site Plan

Outline application with all matters reserved except access for up to 28 dwellings (Class C3) including public open space, sustainable drainage systems, landscaping and associated infrastructure and development.
