# **CORMORANT ALPHA DERRICK STRUCTURE REMOVAL AND MDR INSTALLATION**

**Decommissioning Close Out Report**

October 2023 – Revision 03

TB-COADEC01-X-CO-0001-000

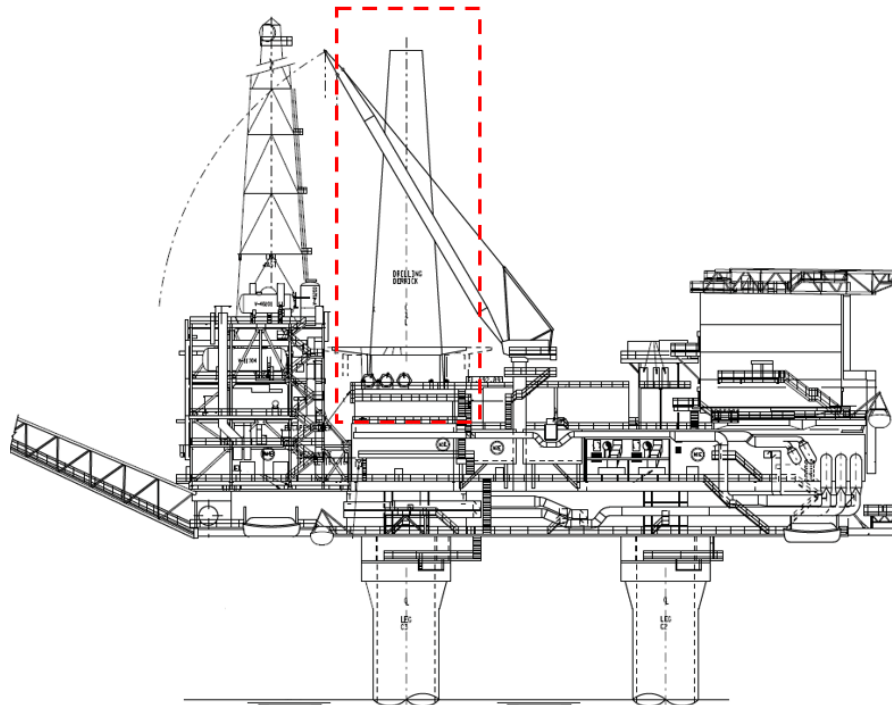
**Figure 1-1: Cormorant Alpha East Elevation, Drilling Derrick Structure Highlighted**

The scope of the facilities covered by this close out report is shown in [Figure 1-1](#) and [Figure 1-2](#). The location of Cormorant Alpha in relation to the other installations in the Northern North Sea is shown in [Figure 1-3](#).

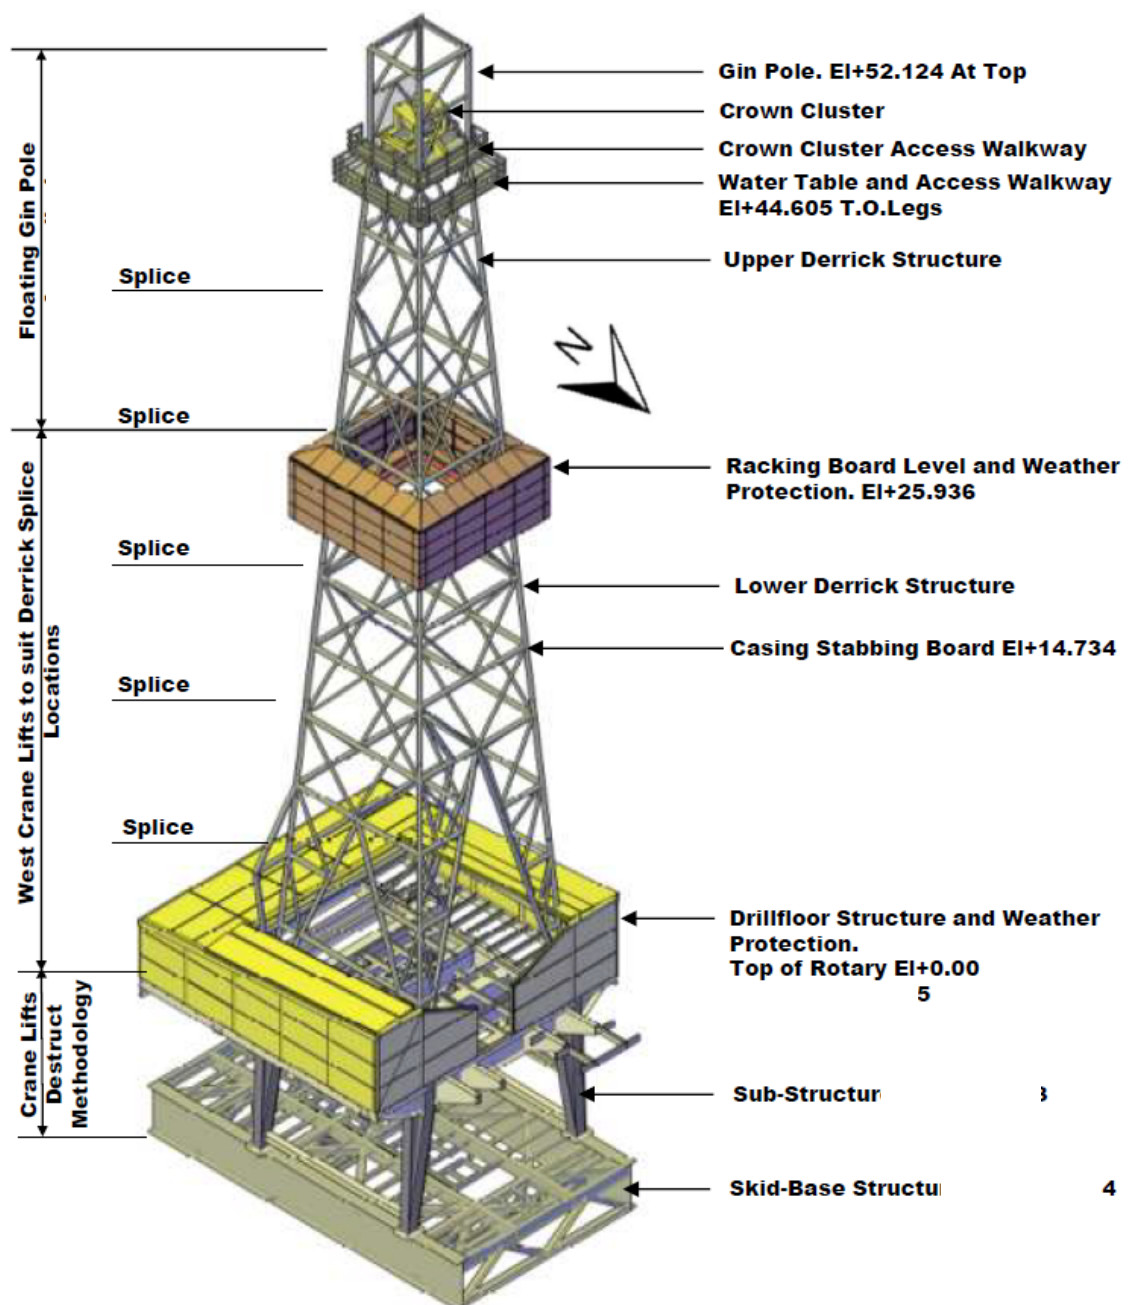
Figure 1-2: Cormorant Alpha Drilling Derrick Structure

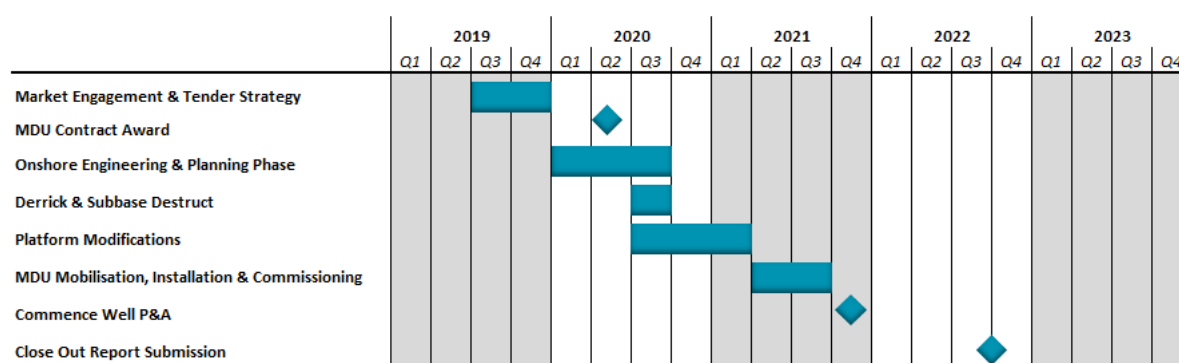
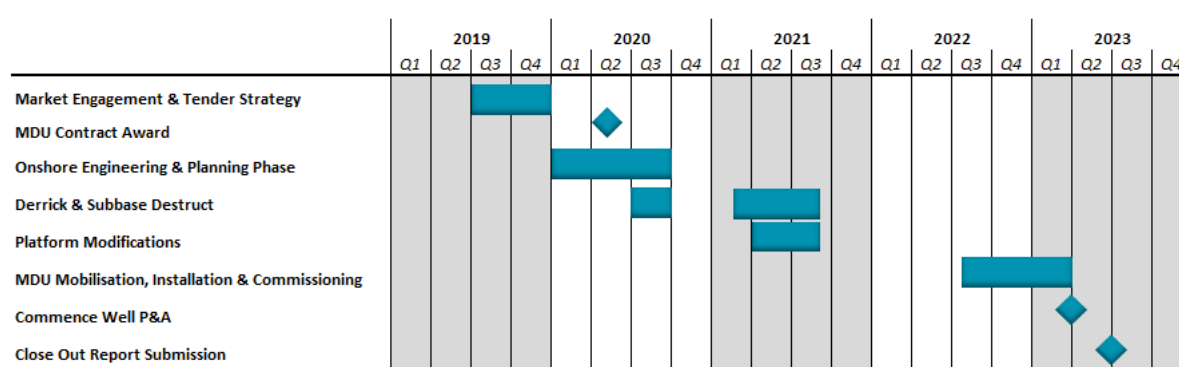
Figure 1-4: Comparison of Planned vs Actual Decommissioning Schedules

Figure 1.4, shows the originally intended schedule for decommissioning of the existing drilling equipment (above) compared to the actual schedule (below). The difference is due to a number of factors including the impact of the COVID-19 pandemic on offshore Personnel on Board (PoB) levels, MDU readiness to ship offshore, and poor weather offshore. Additional time was also required as the system integration and commissioning effort required to bring the system to a state where it was fit to safely carry out well Plug and Abandonment (P&A) operations was greatly in excess of that originally envisaged. Given that the work took place on an operational installation, this had limited impact, beyond the additional time taken.

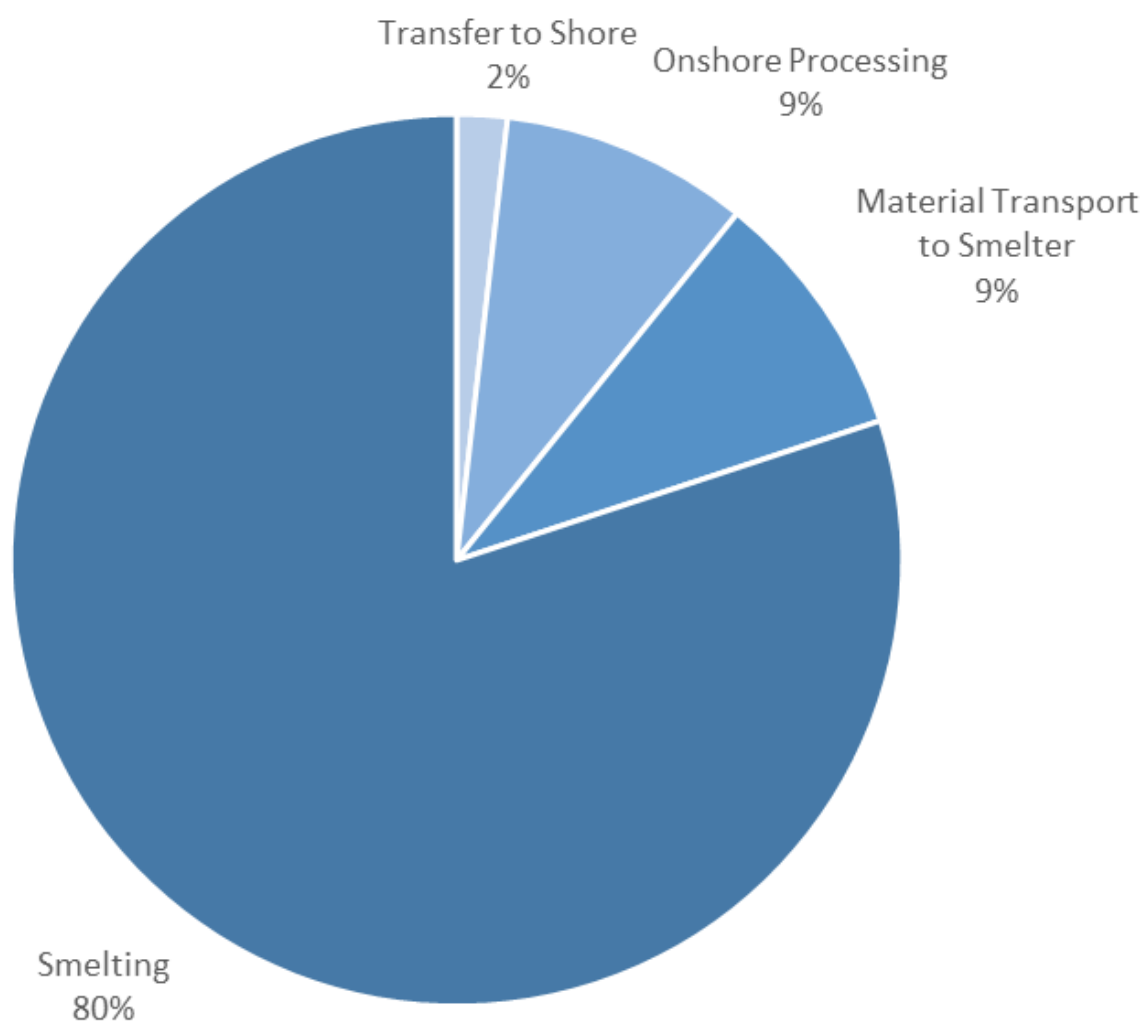
Figure 3-1: Contributing Sources of CO<sub>2</sub>

The results from the assessment show a total of approximately 325 tonnes of CO<sub>2</sub> (Carbon Dioxide) can be attributed to the Cormorant Alpha derrick removal project. This figure is below the estimate presented in the DP. The figure reported here is derived from detailed consideration of the fate of the materials removed from the platform and informed by TAQA's experience of other, completed, decommissioning projects. [Figure 3-1](#) below shows the contributing sources to the overall total of CO<sub>2</sub>.

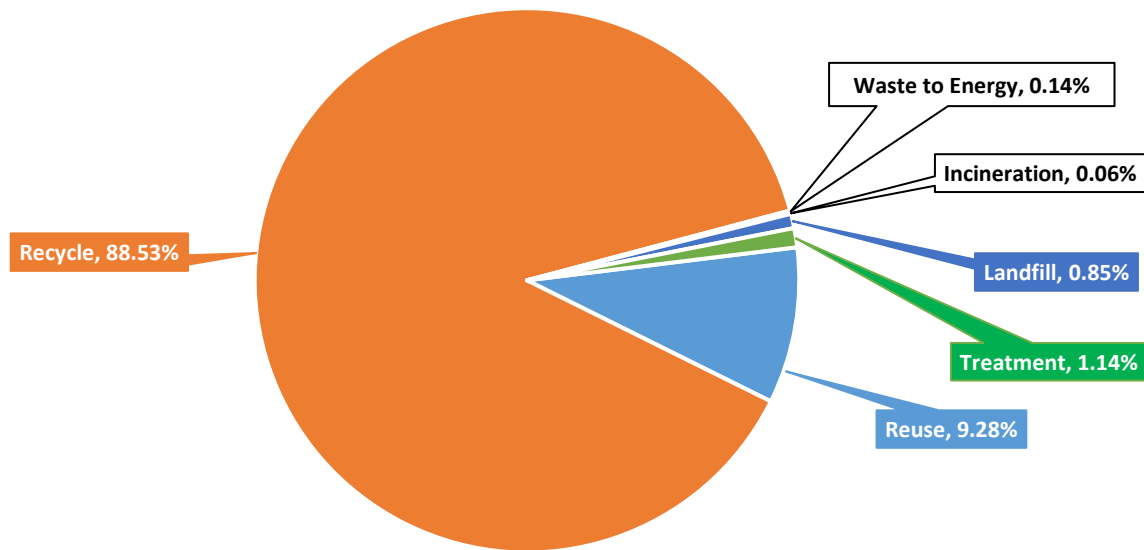
**Figure 5-1: Waste Destinations**

Figure 5-1 below shows the percentages of material for each waste stream. In total, the combined reuse and recycle percentage was 97.81% which exceeds the project aim of 97%.

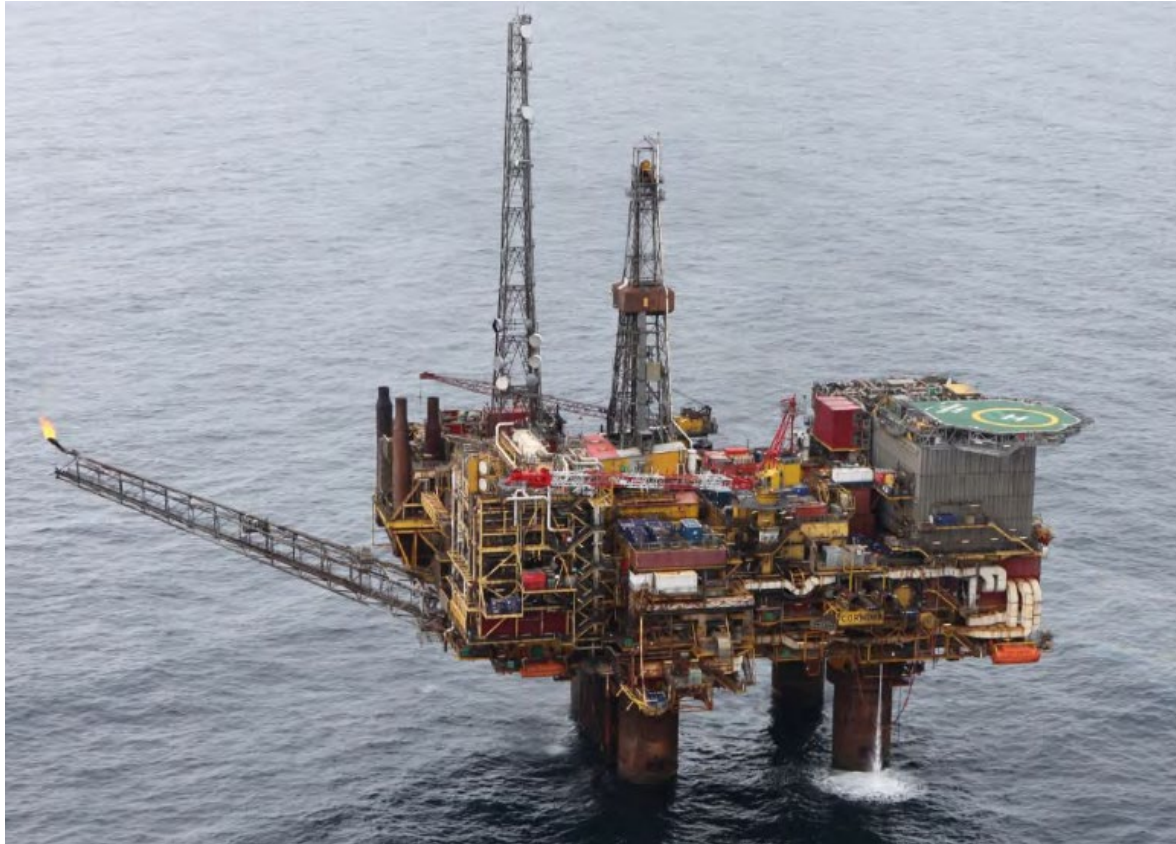
Figure 8-1: Cormorant Alpha with original Drilling Derrick Structure in situ

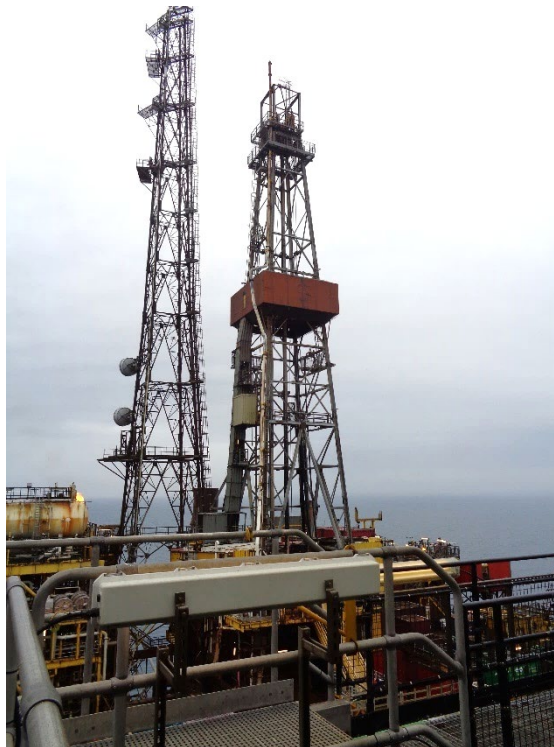
Figure 8-2: Close up of original Drilling Derrick Structure, adjacent to Telecoms Tower

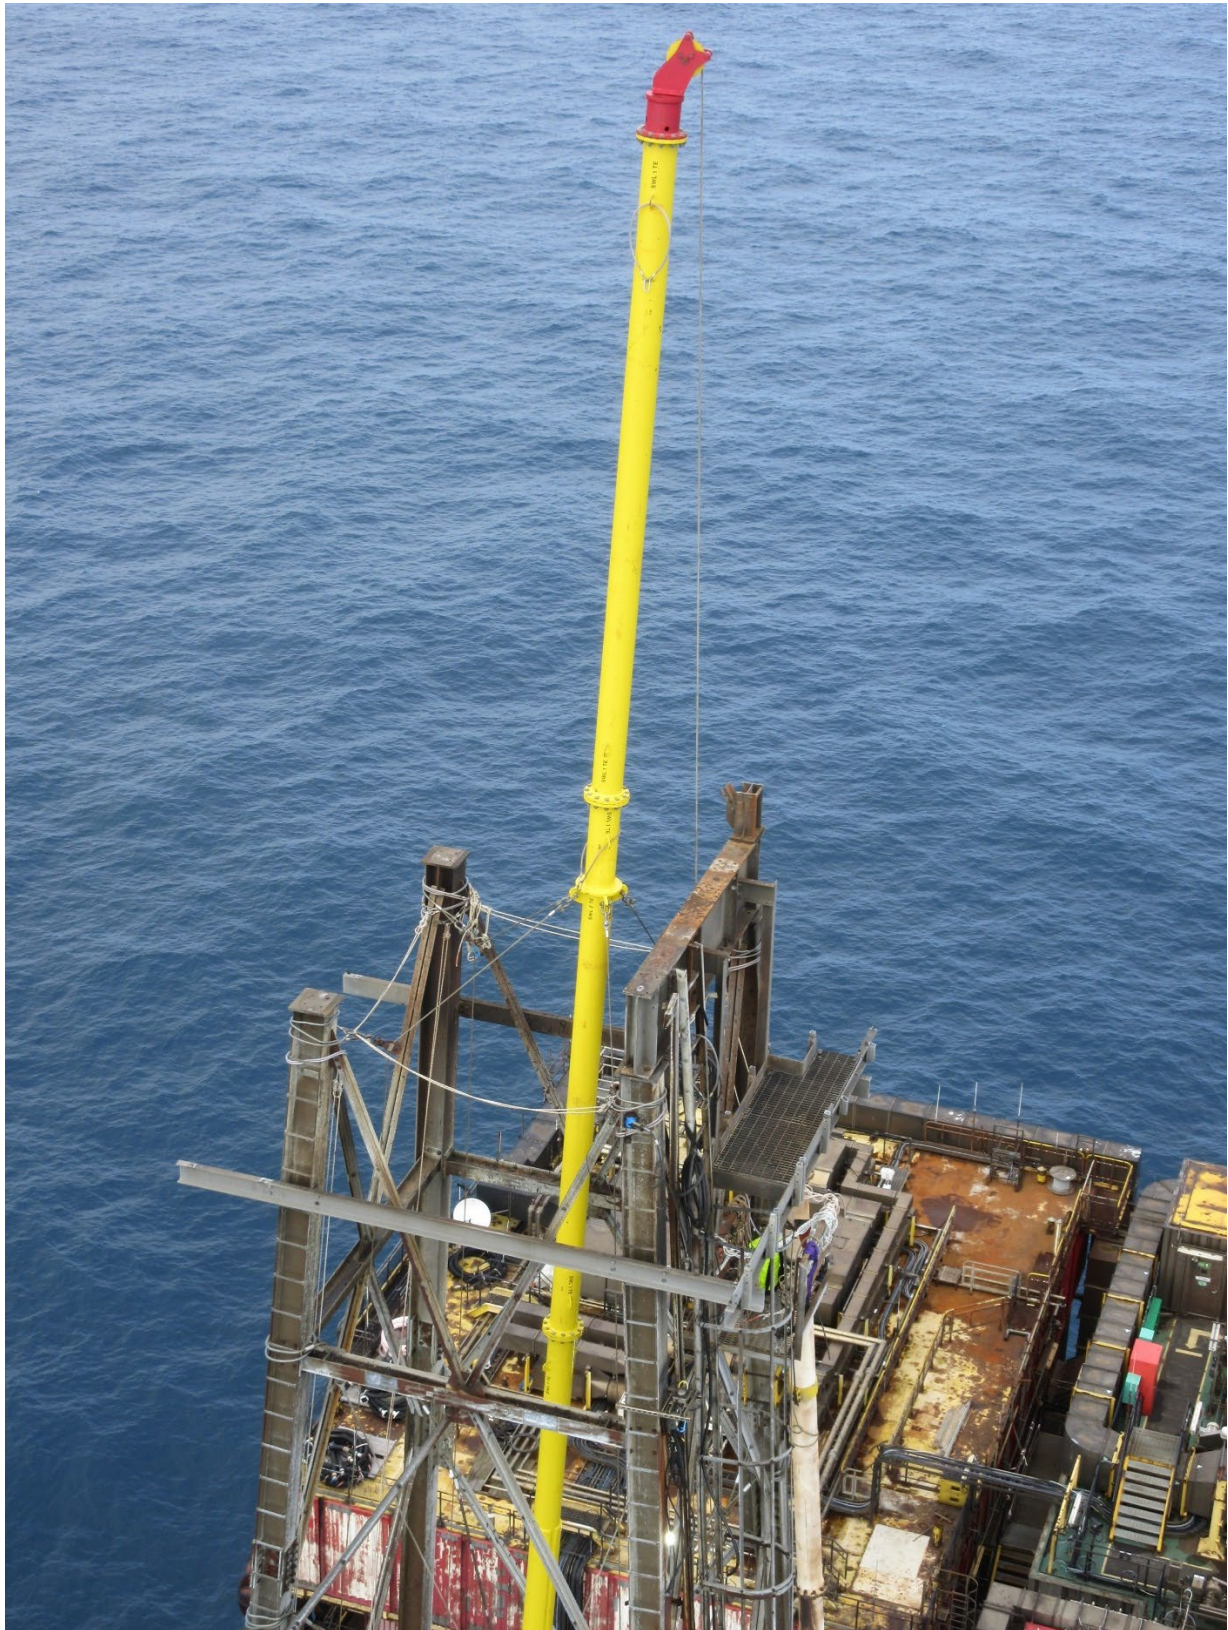
Figure 8-3: Commencement of Derrick Destruct using floating gin pole

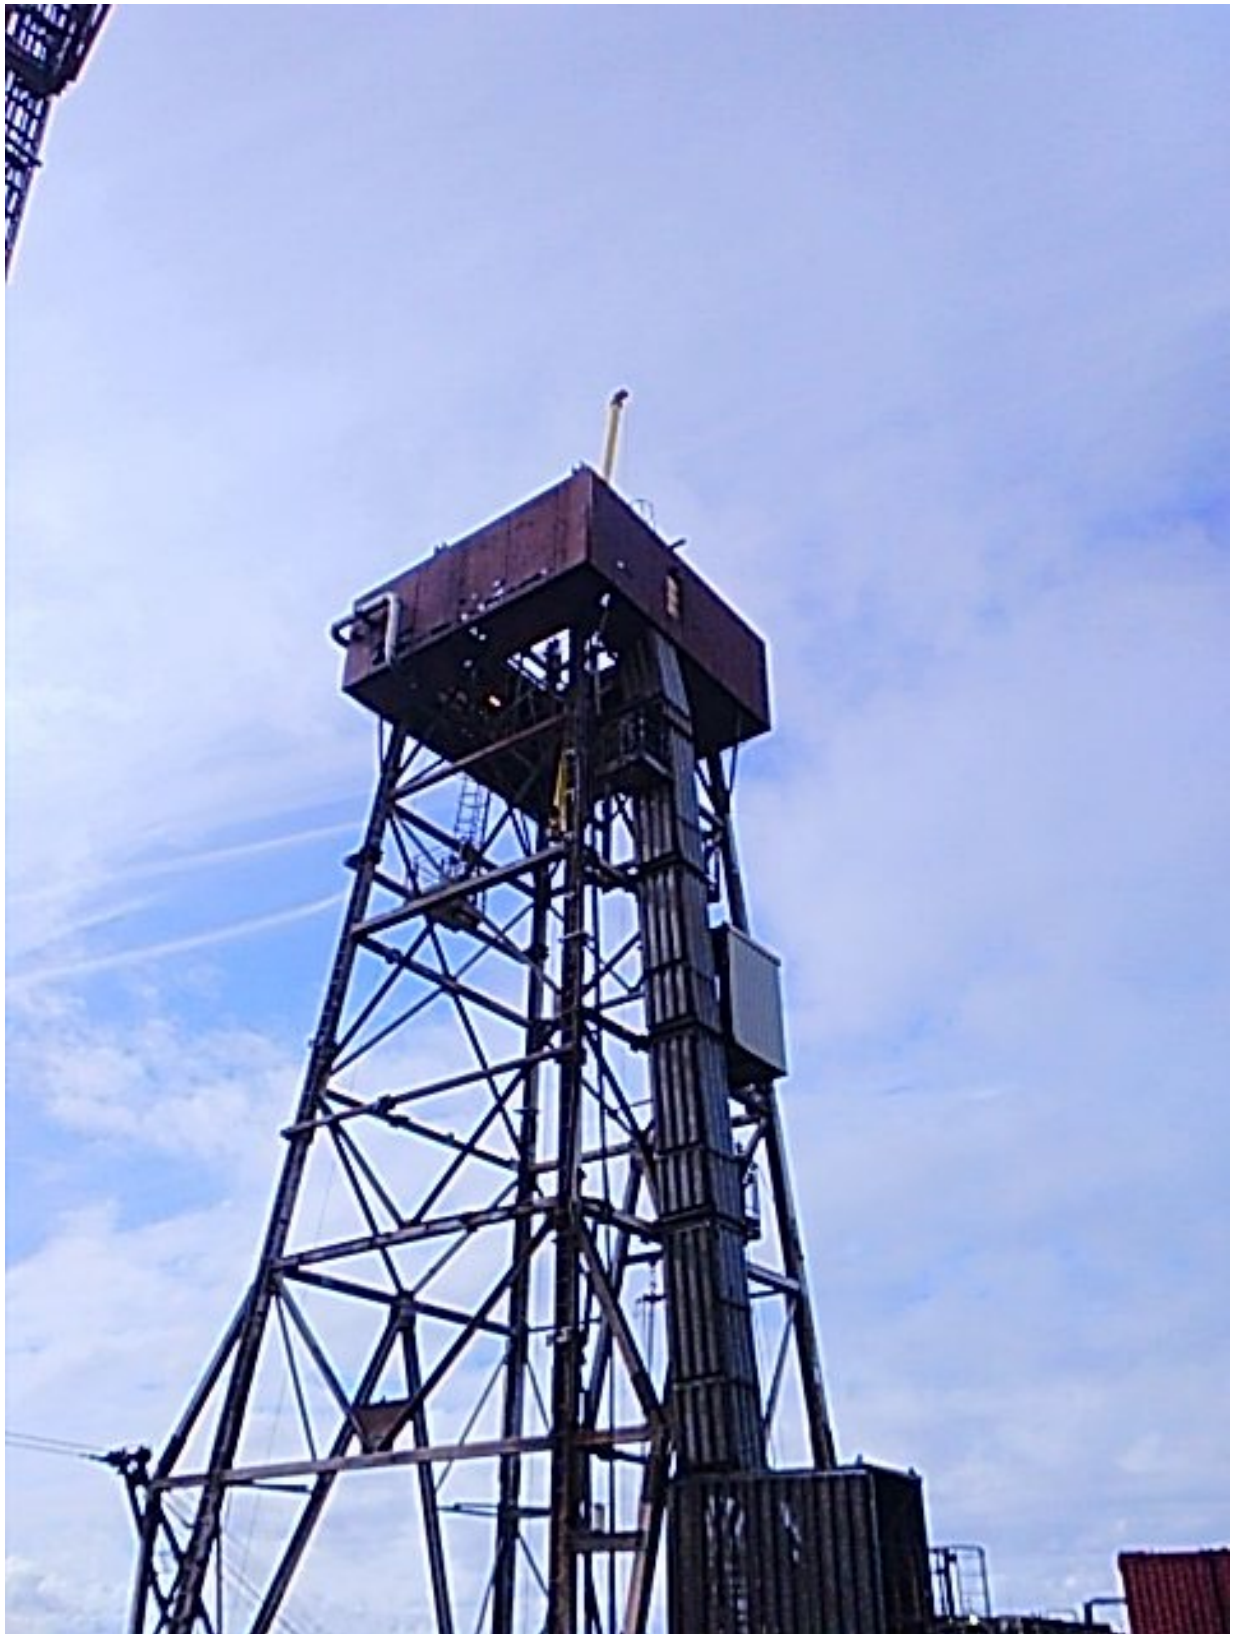
Figure 8-4: Ongoing Derrick Destruct

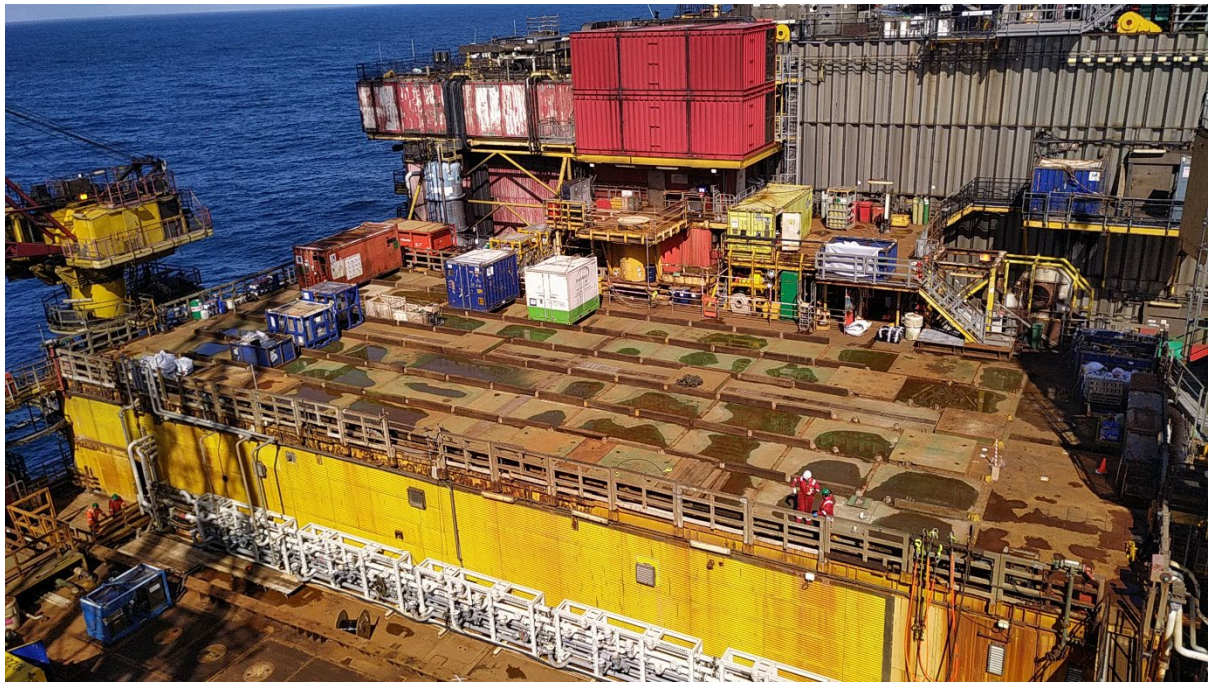
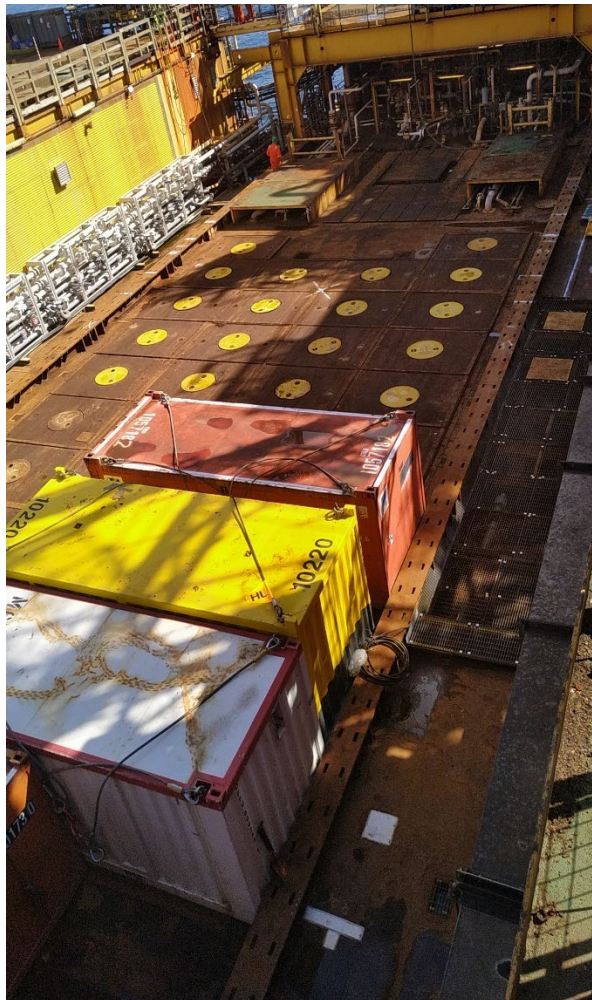
Figure 8-5: Clear pipe deck (above) and skid deck (below) ahead of MDU Construction

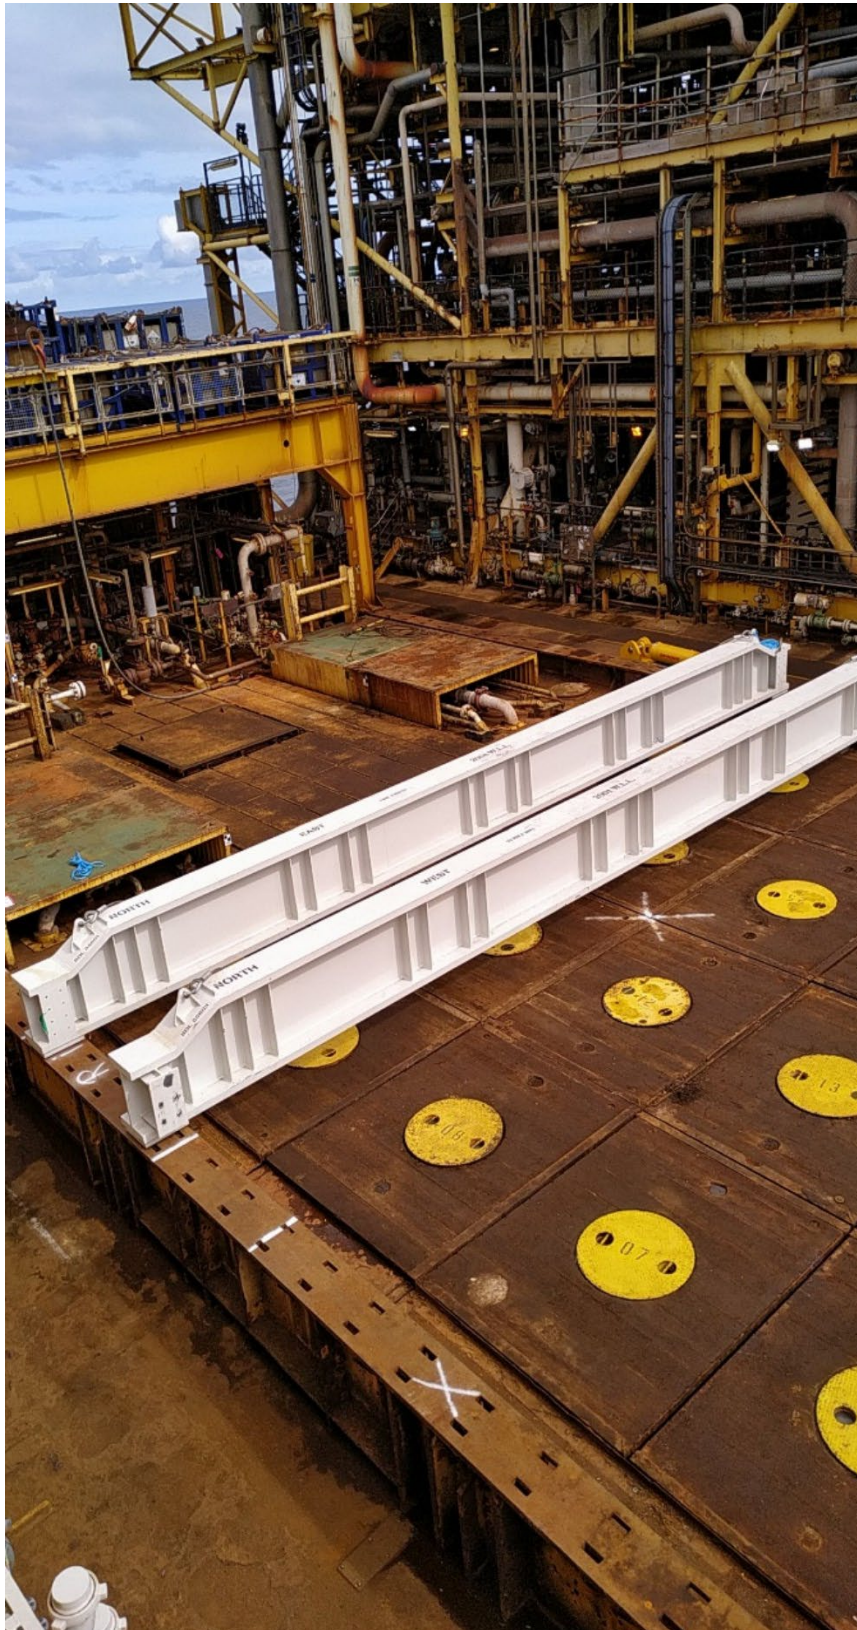
Figure 8-6: Commencement of Construction

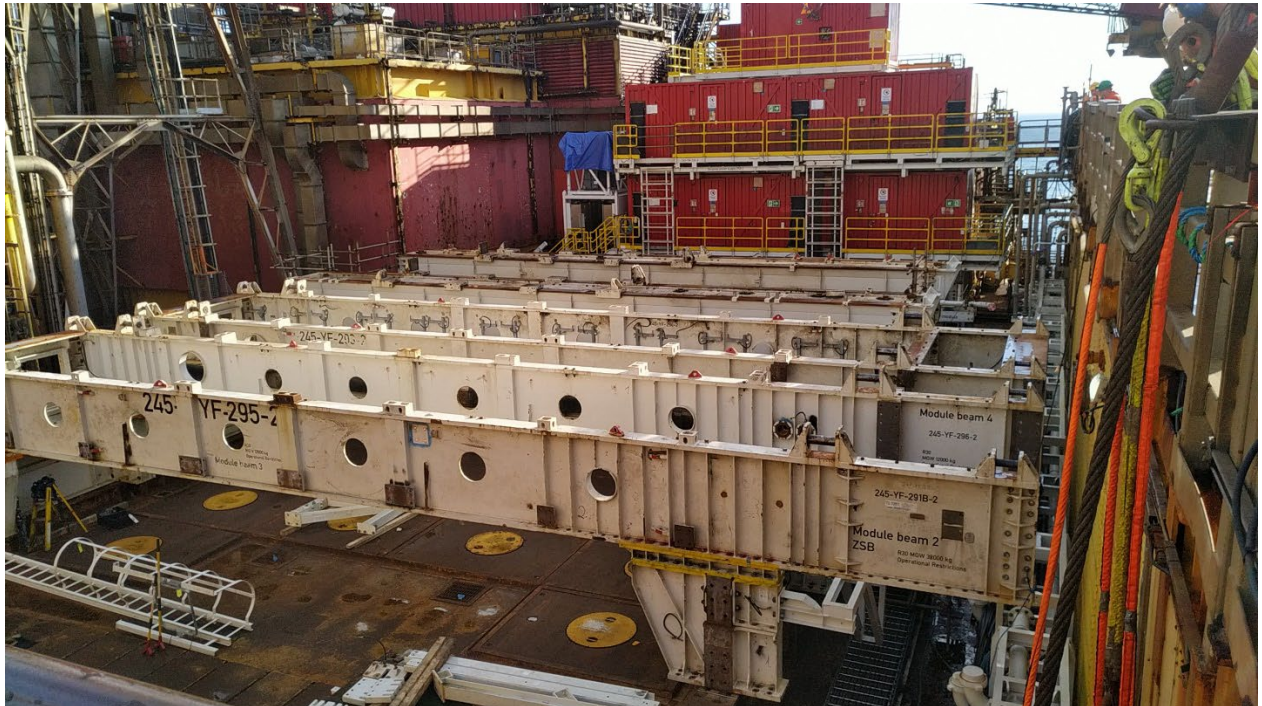
Figure 8-7: Ongoing MDU Construction

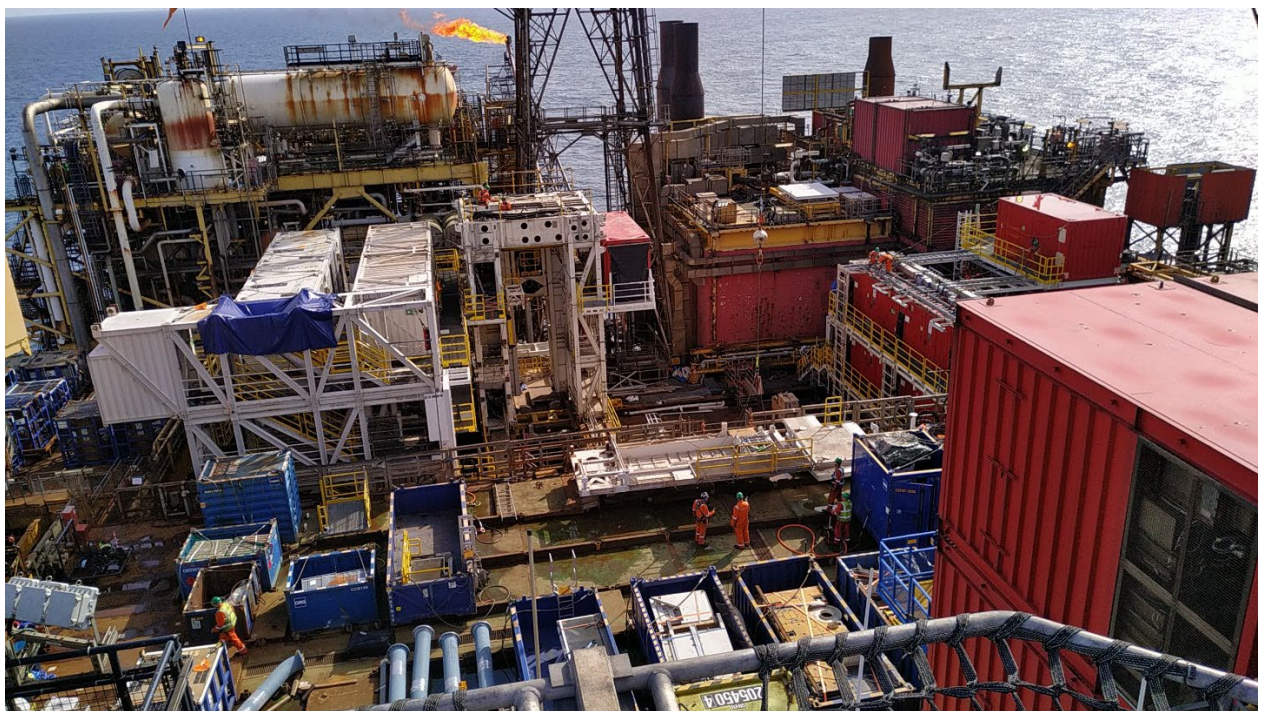
Figure 8-8: Ongoing MDU Construction

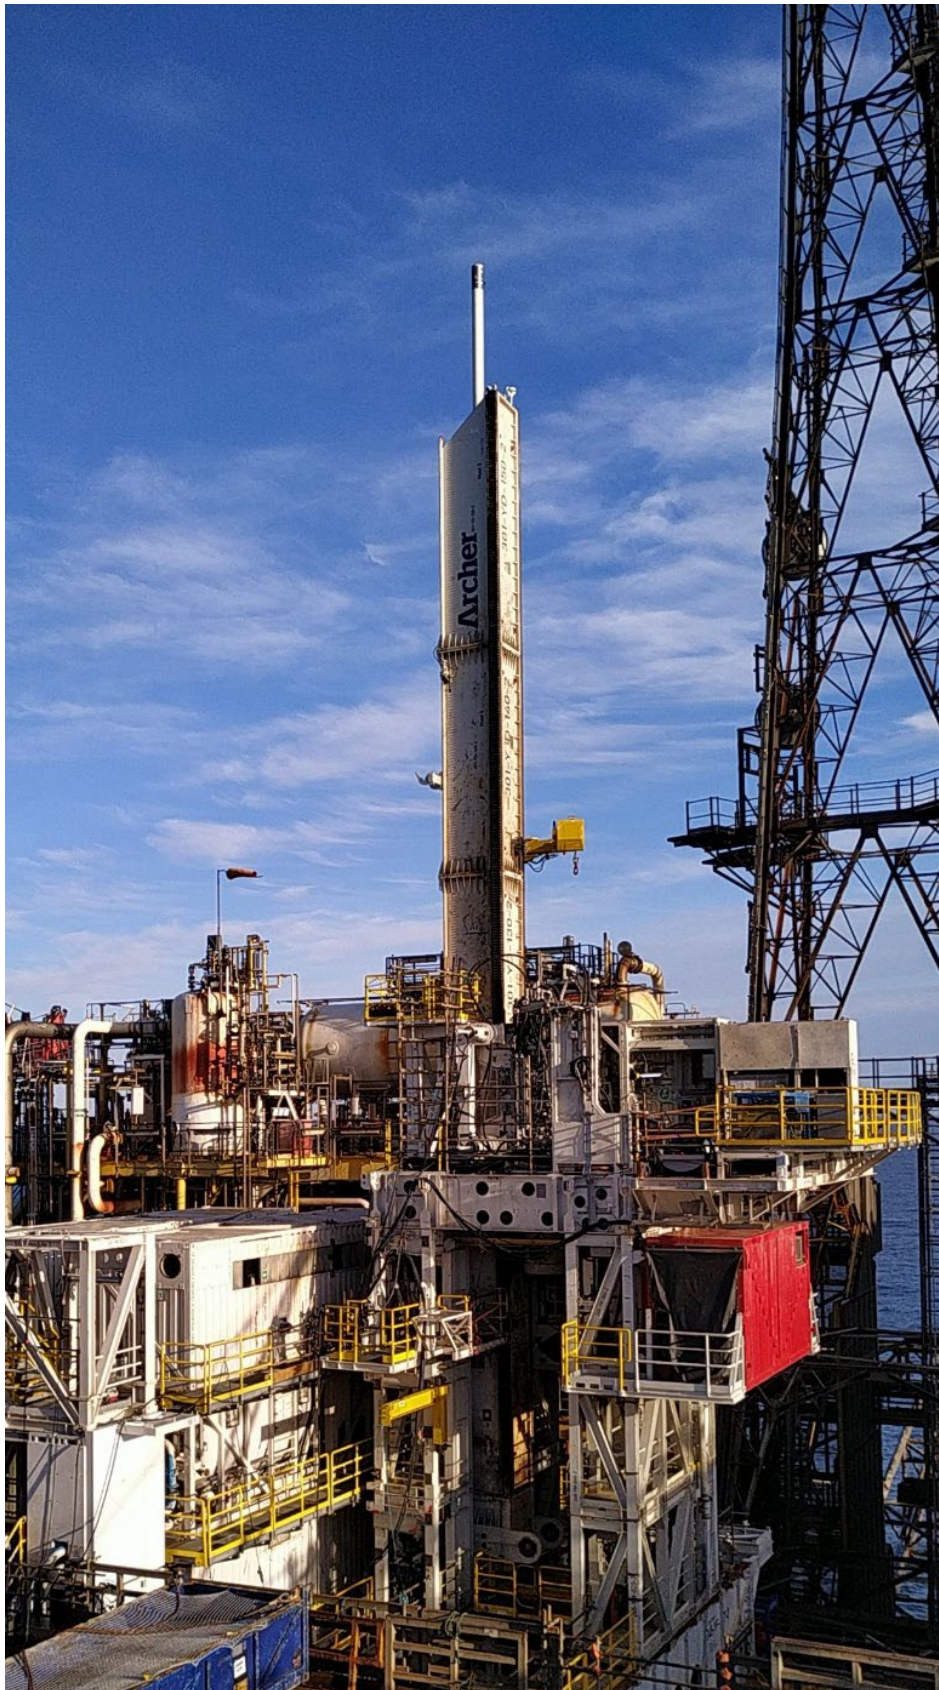
Figure 8-9: Mast Installation

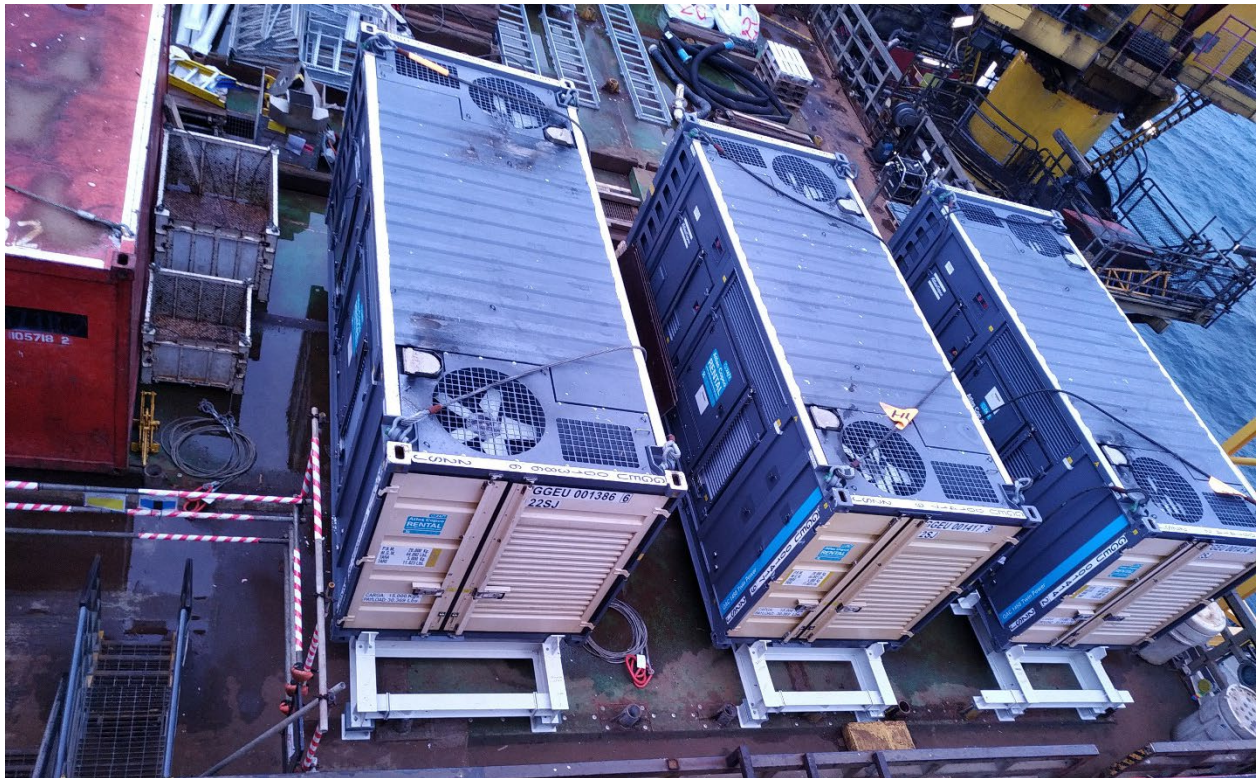
Figure 8-10: Power Generation Units Installed

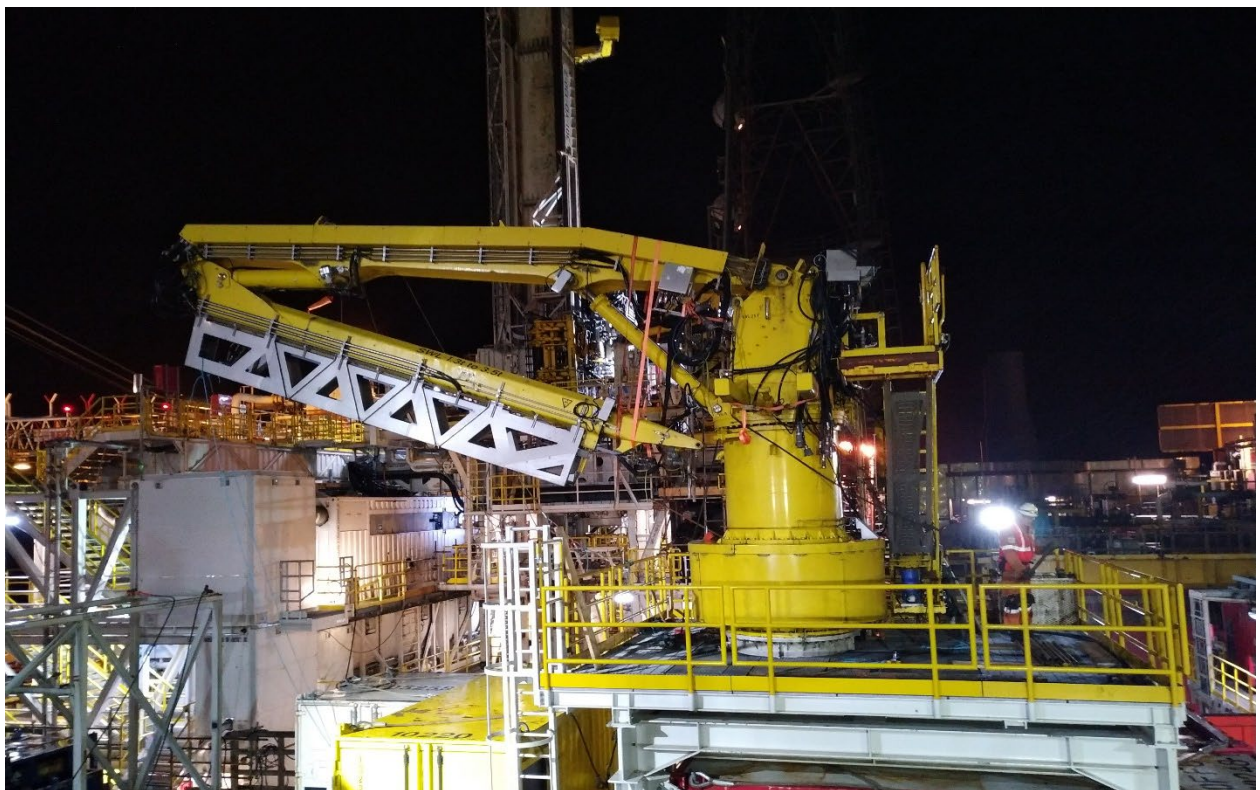
Figure 8-11: Palfinger Crane Boom Installed

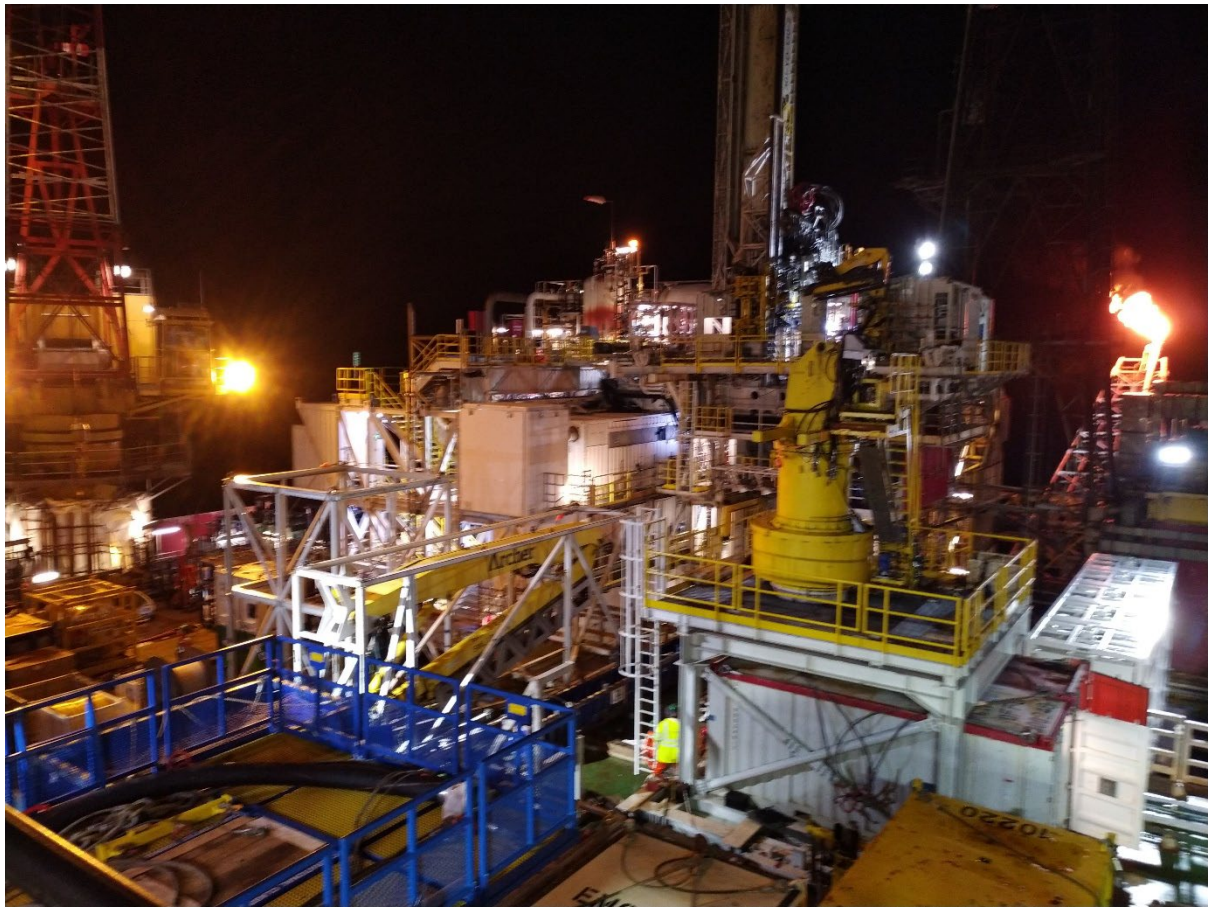
Figure 8-12: MDU Emergency Lighting Energised

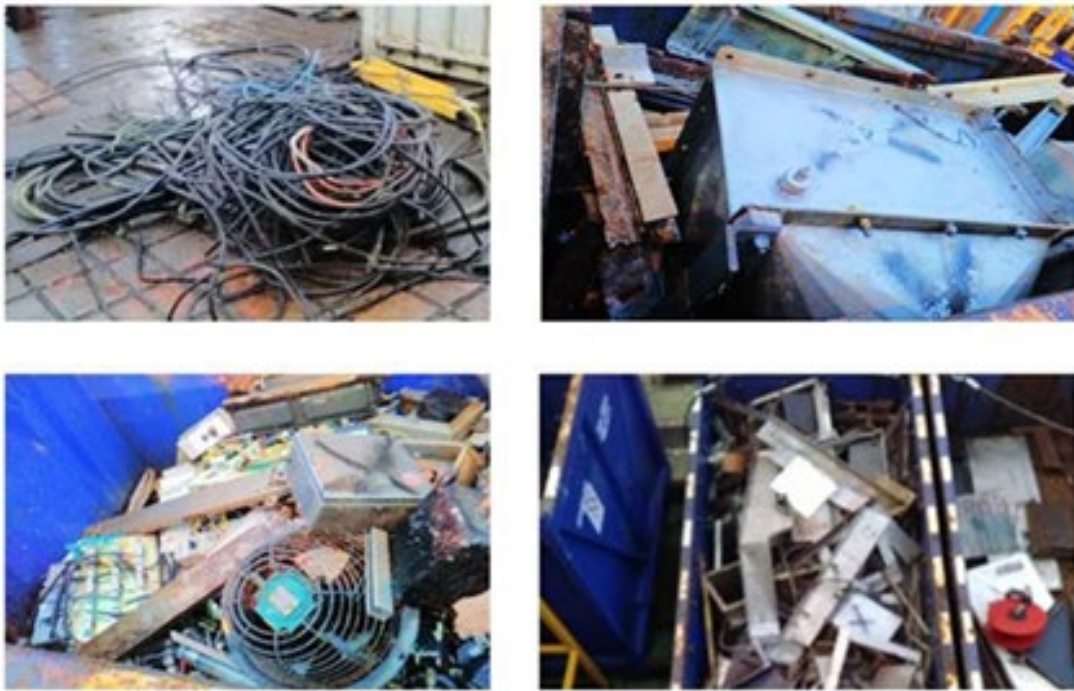
Figure 8-13: Derrick Destruct Waste Segregation (Cable, Steel & Electrical Equipment)

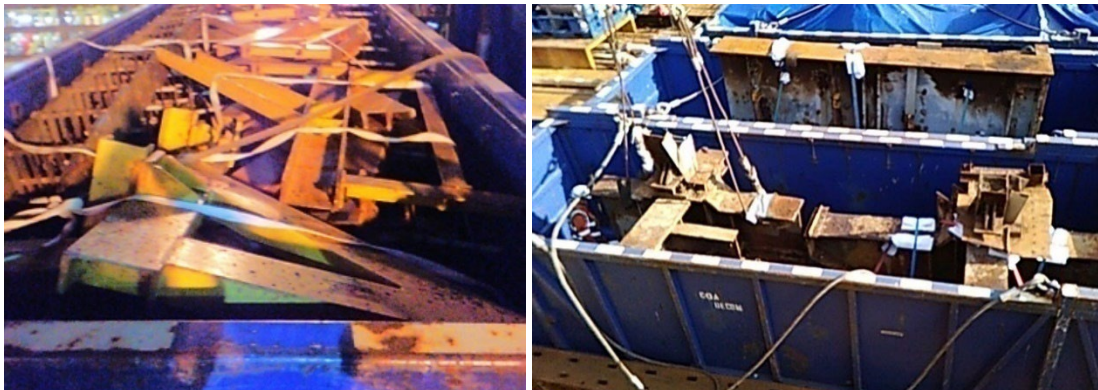
Figure 8-14: Derrick Destruct Waste Segregation (Scrap Metal)

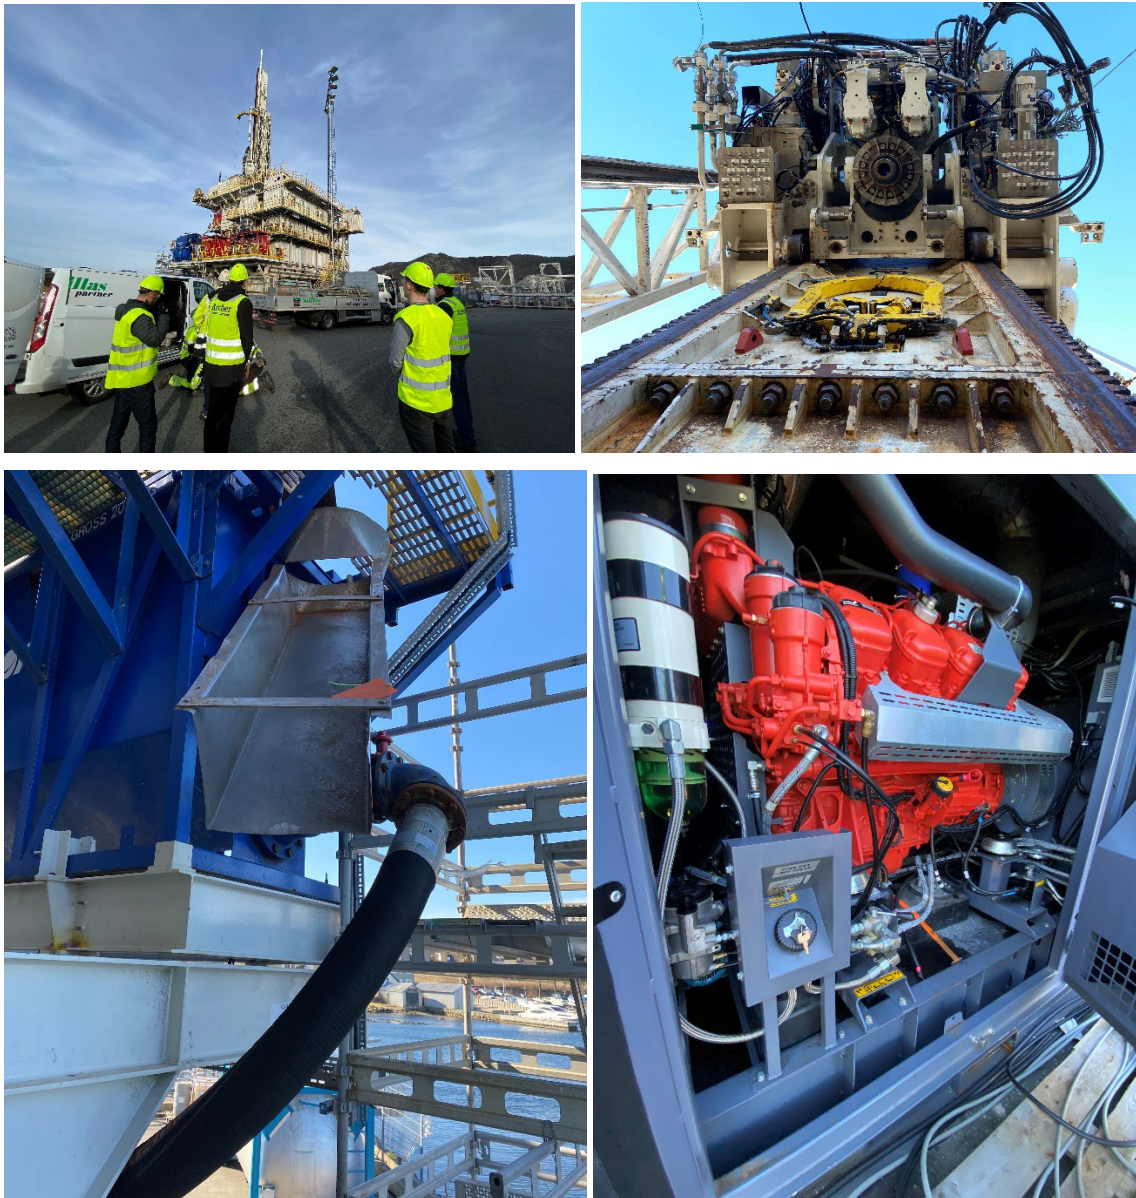
Figure 8-15: Environmental Audit of MDU at Sandnes, Norway (March 2022)

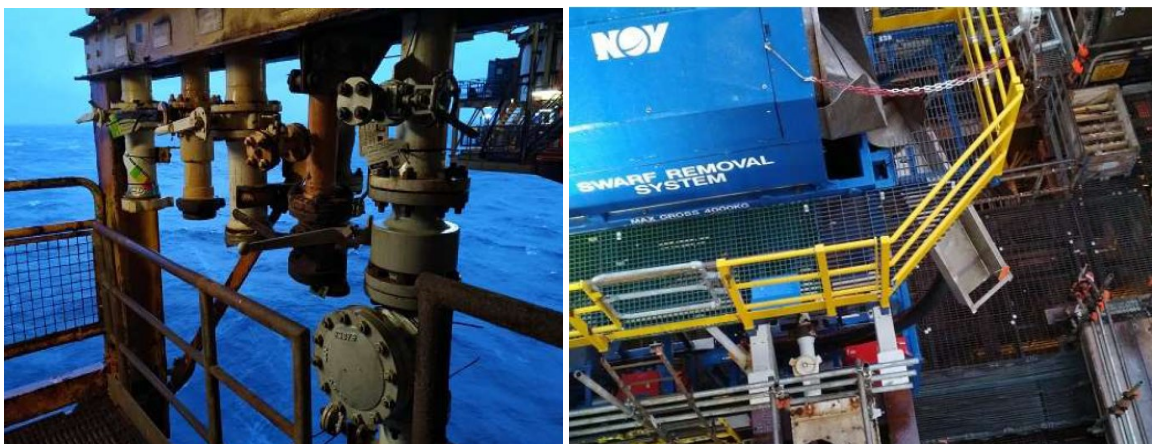
Figure 8-16: MDU Commissioning Environmental Audit (January 2023)
