# BRAE AREA

## BRAE BRAVO TOPSIDES, FLARE BRIDGE, FLARE TOWER & FLARE JACKET

### Decommissioning Close Out Report

9010-TAQ-99-PM-RP-00005-000

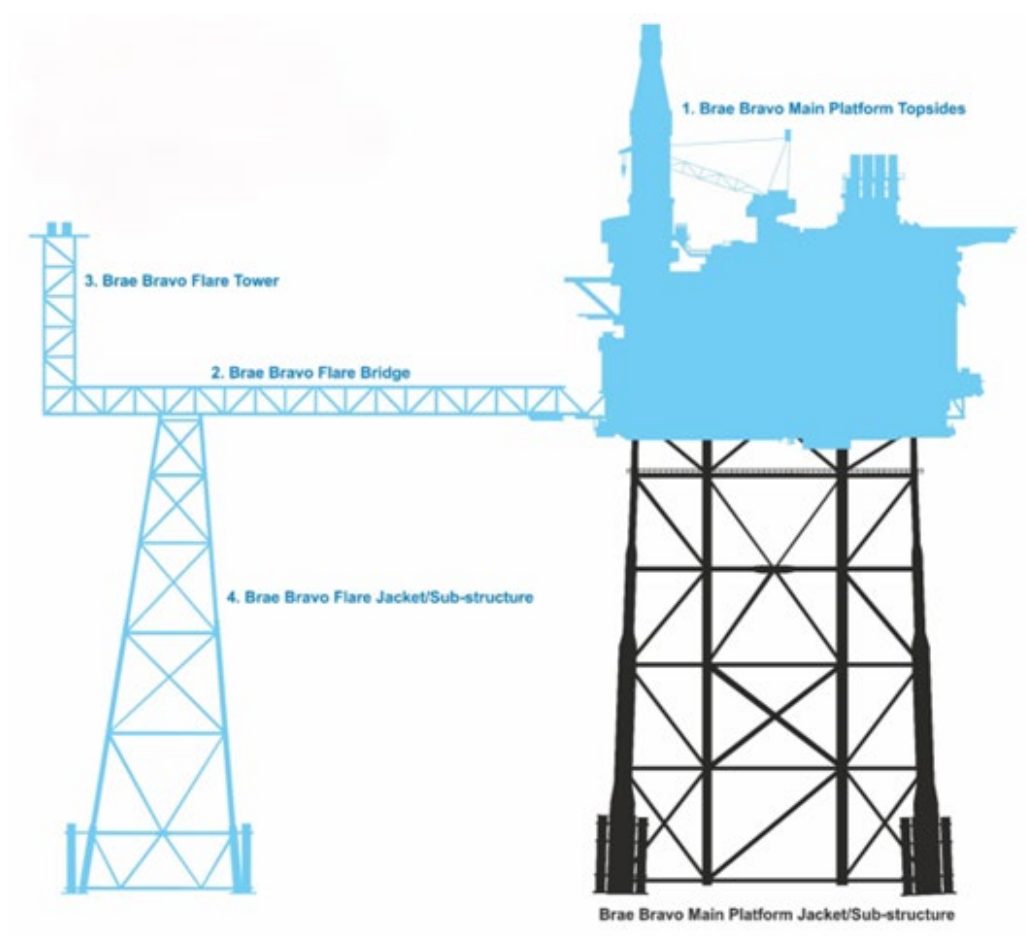
Figure 1-1: Brae Bravo Facilities

The Brae Bravo platform facilities included modular topsides and a steel jacket/sub-structure. The platform flare consisted of a second steel jacket/sub-structure, the flare tower and a steel connecting bridge to the Brae Bravo platform.

The scope of the facilities covered by this close out report is shown in blue in [Figure 1.1](#). The location of Brae Bravo in relation to the other installations in the Brae Area is shown in [Figure 1-2](#).

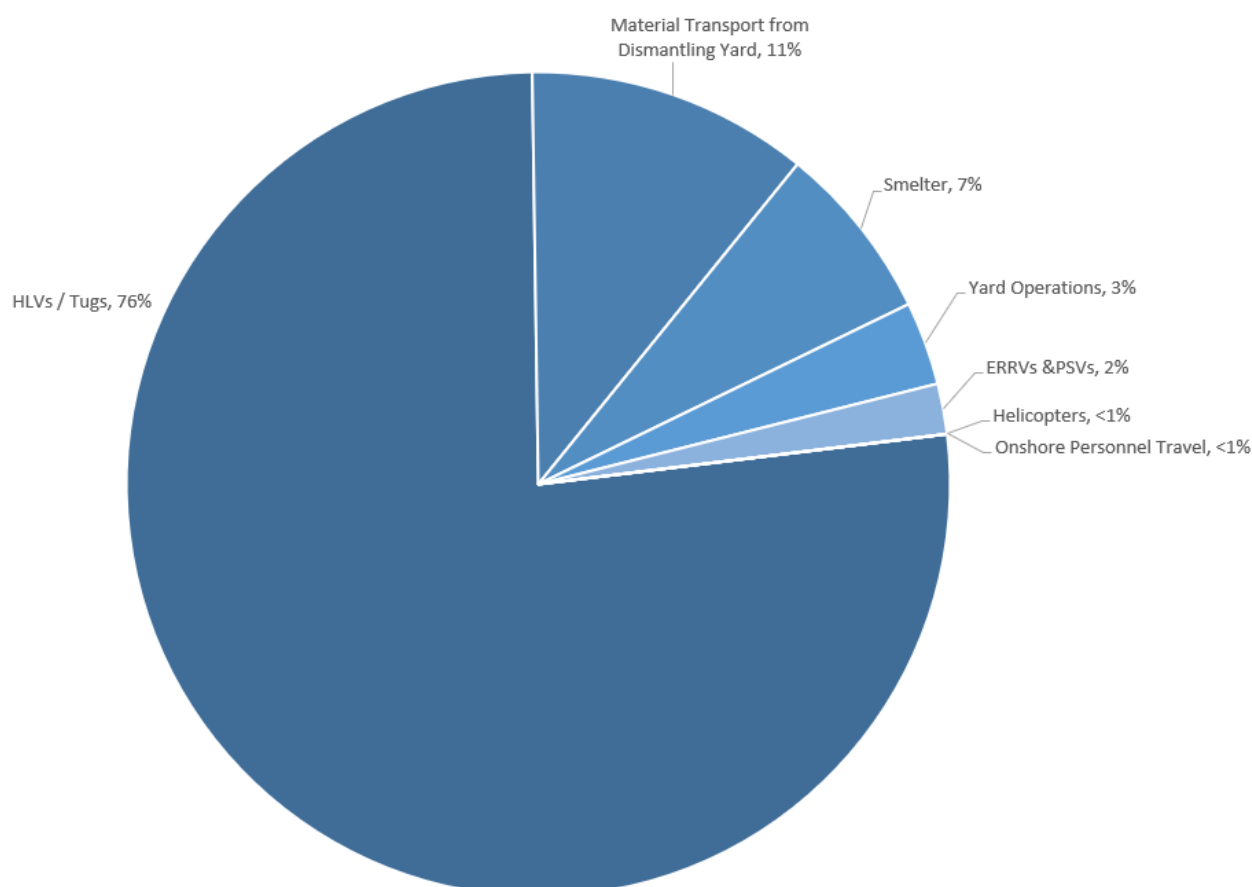
**Figure 3-1: Sources of CO<sub>2</sub>**

The results from the assessment show a total of approximately 17,000 tonnes of CO<sub>2</sub> (Carbon Dioxide) can be attributed to the Brae Bravo topsides, flare bridge, flare tower and flare jacket decommissioning project.<sup>1</sup> This equates to approximately 6% of the average annual platform CO<sub>2</sub> emissions during previous normal platform operating mode.

Figure 3.1 below shows the contributing sources to the overall total of CO<sub>2</sub>.

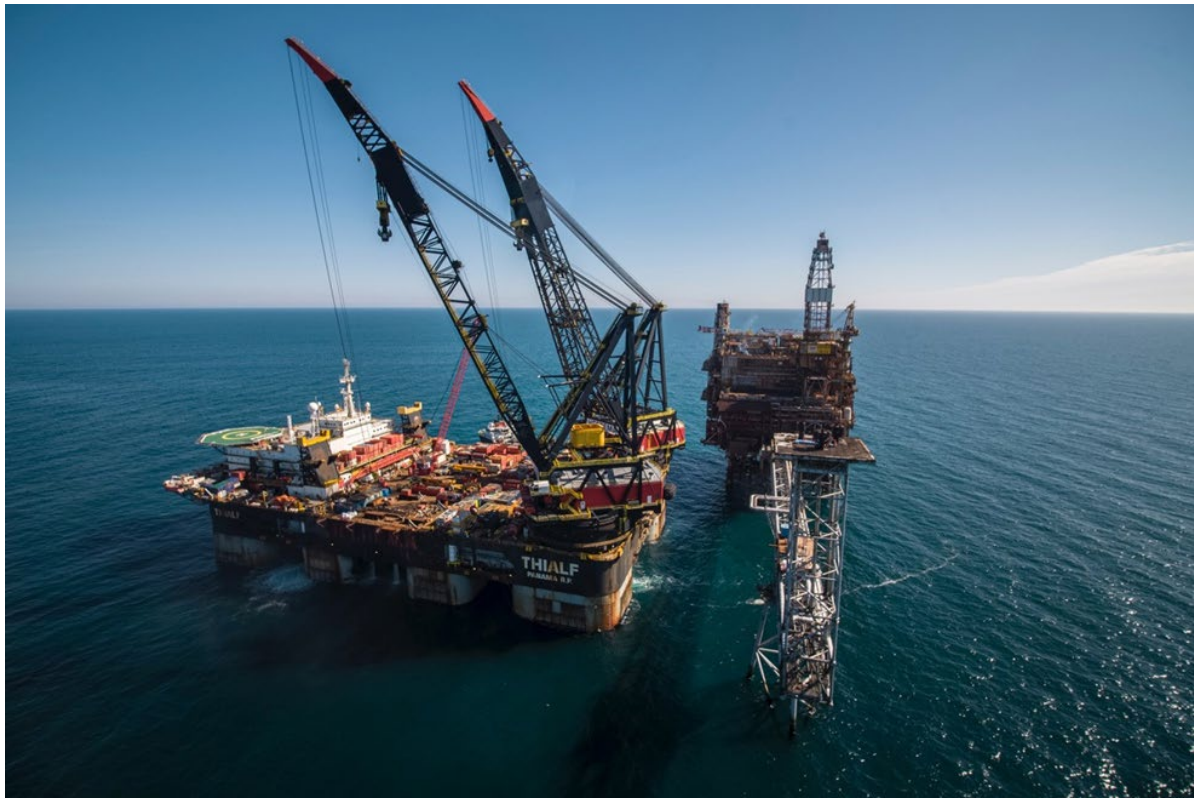
Figure 8-3: Transferring rigging platforms to the flare

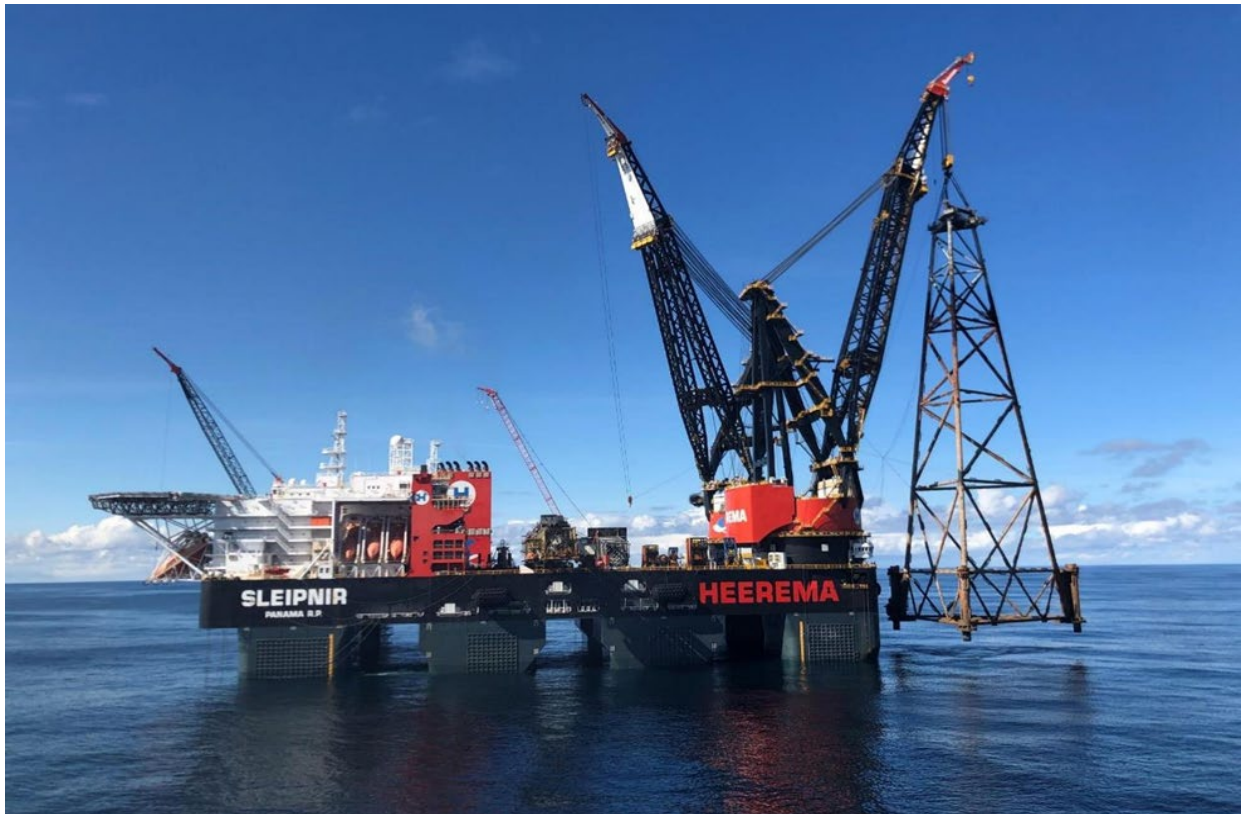
Figure 8-5: Sleipnir removing the entire flare jacket in a single lift

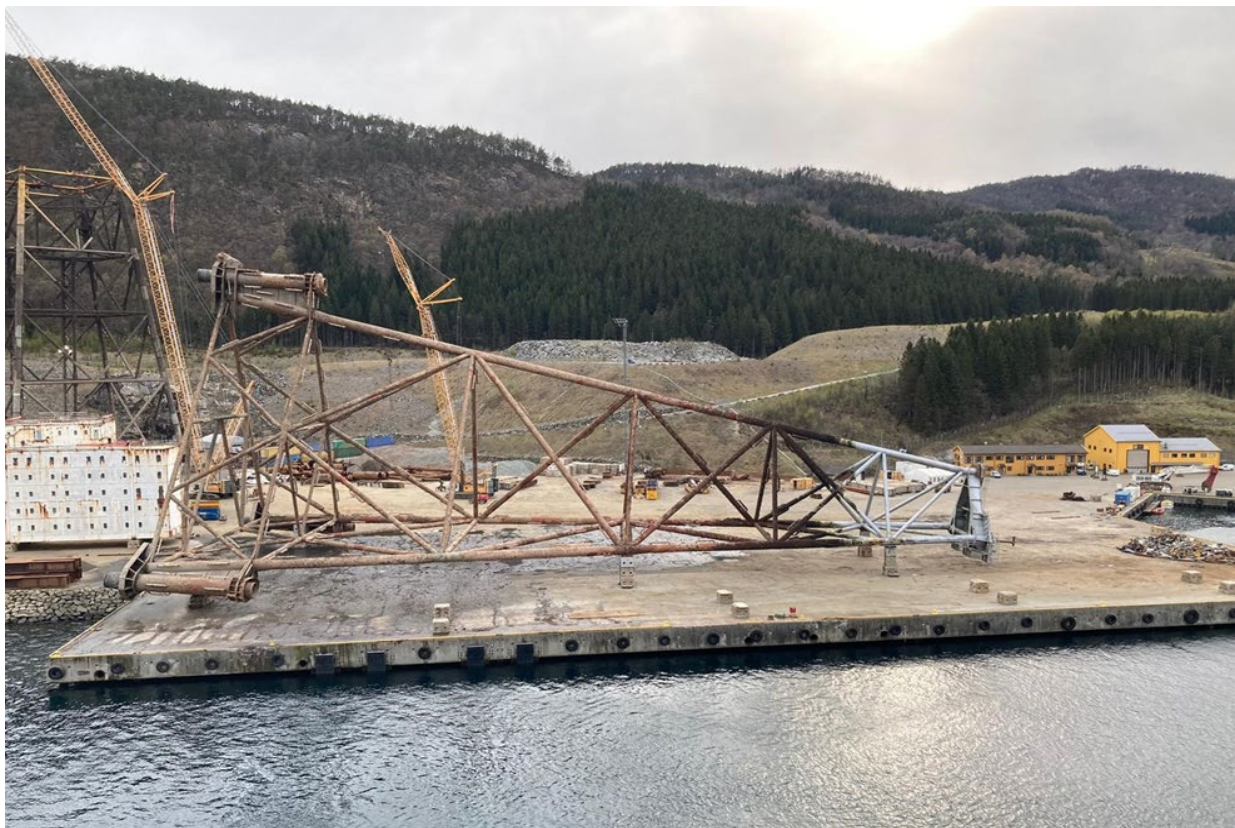
Figure 8-6: Flare jacket as it was landed on the quayside

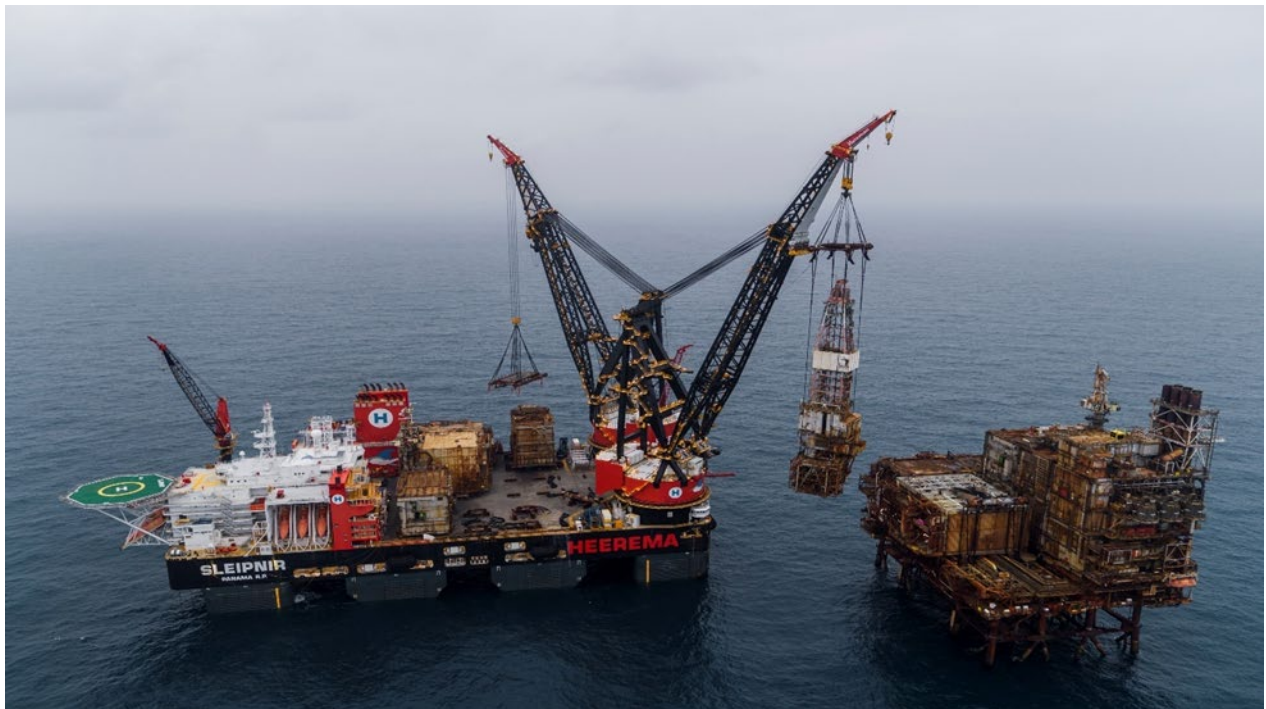
Figure 8-8: Brae Bravo Drilling Rig removal

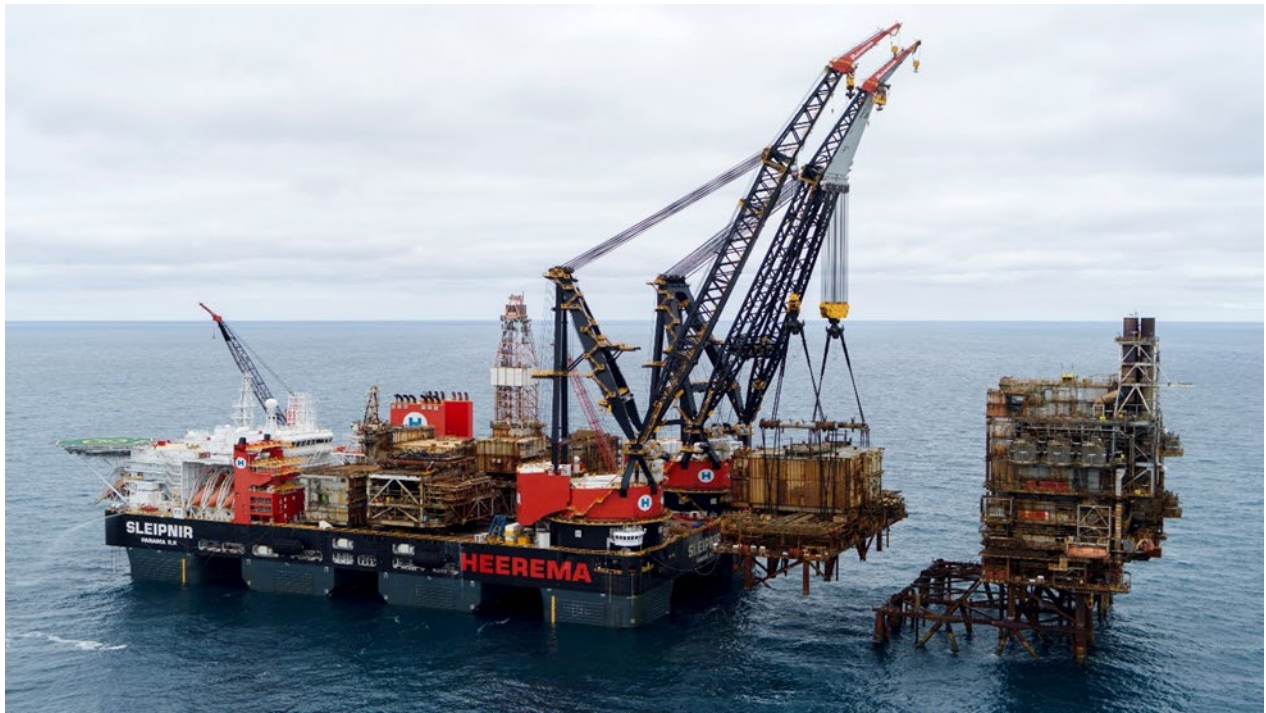
Figure 8-9: West Module Support Frame (MSF) removal

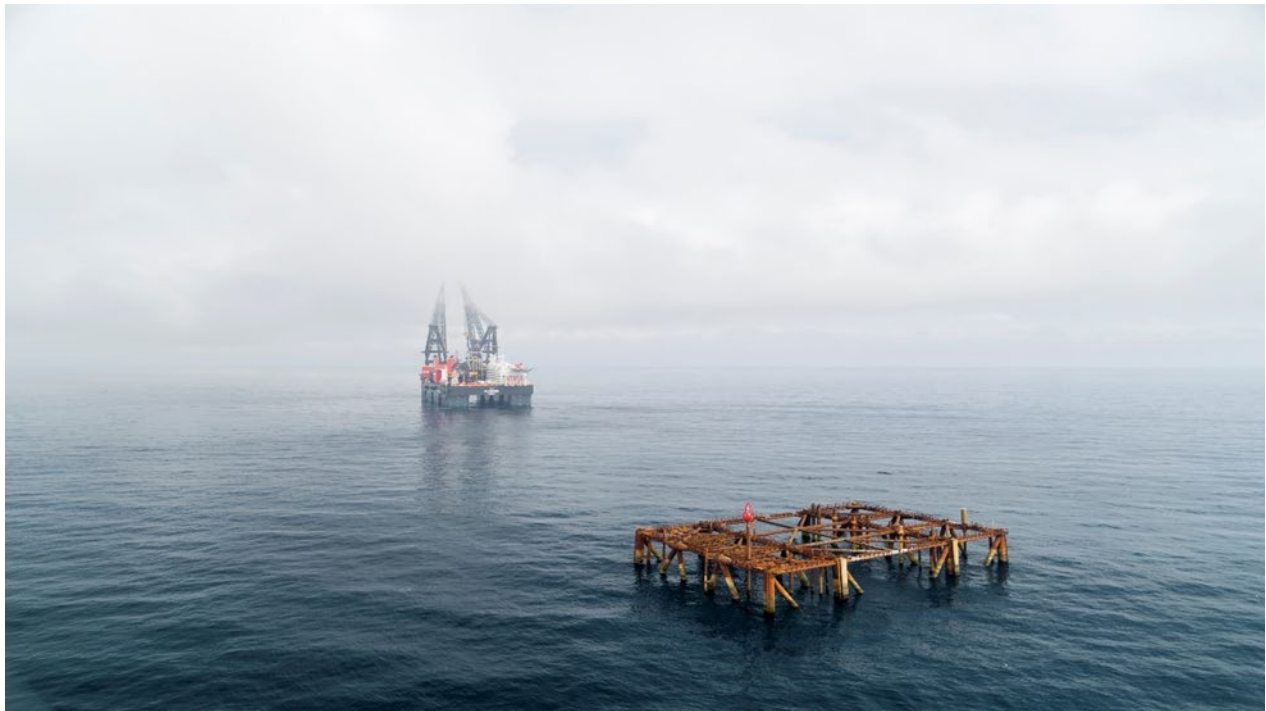
Figure 8-10: Topsides removal complete offshore

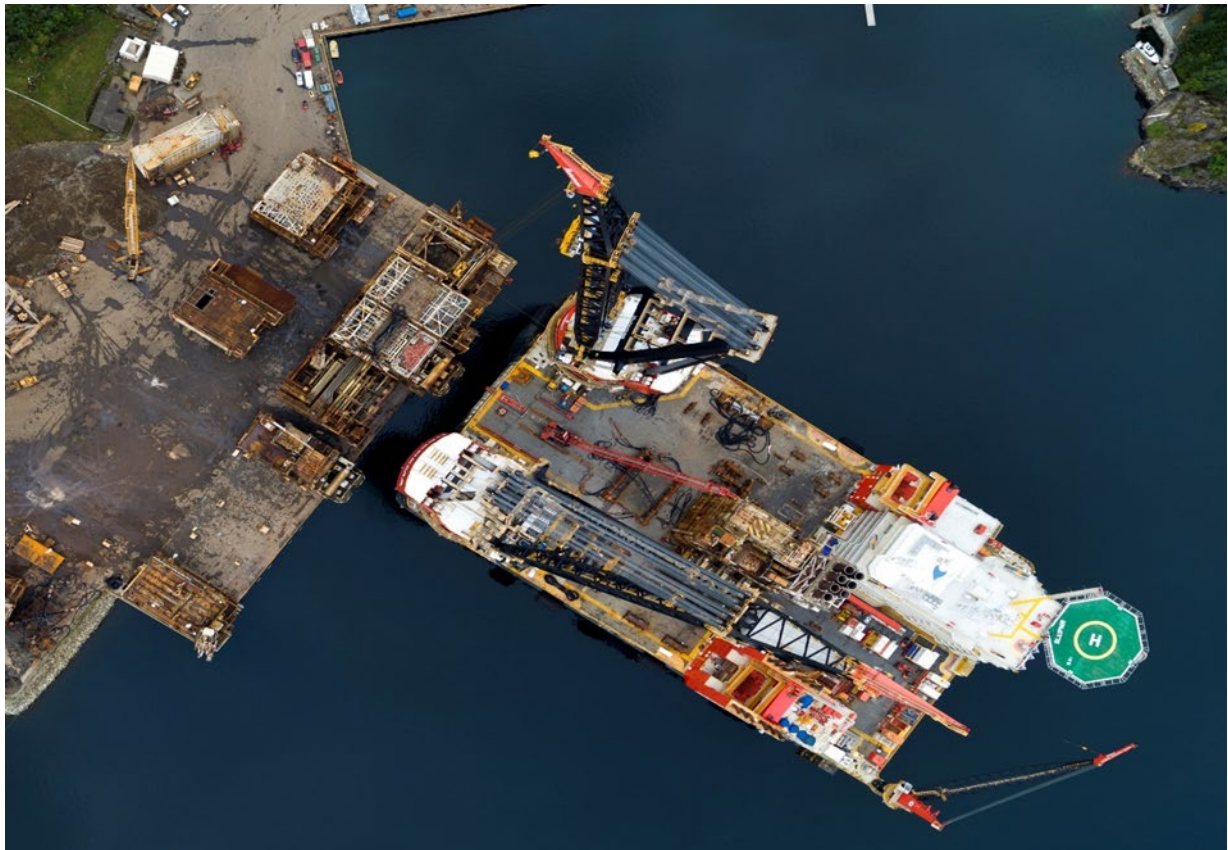
Figure 8-11: Module offload at the Vats yard quayside

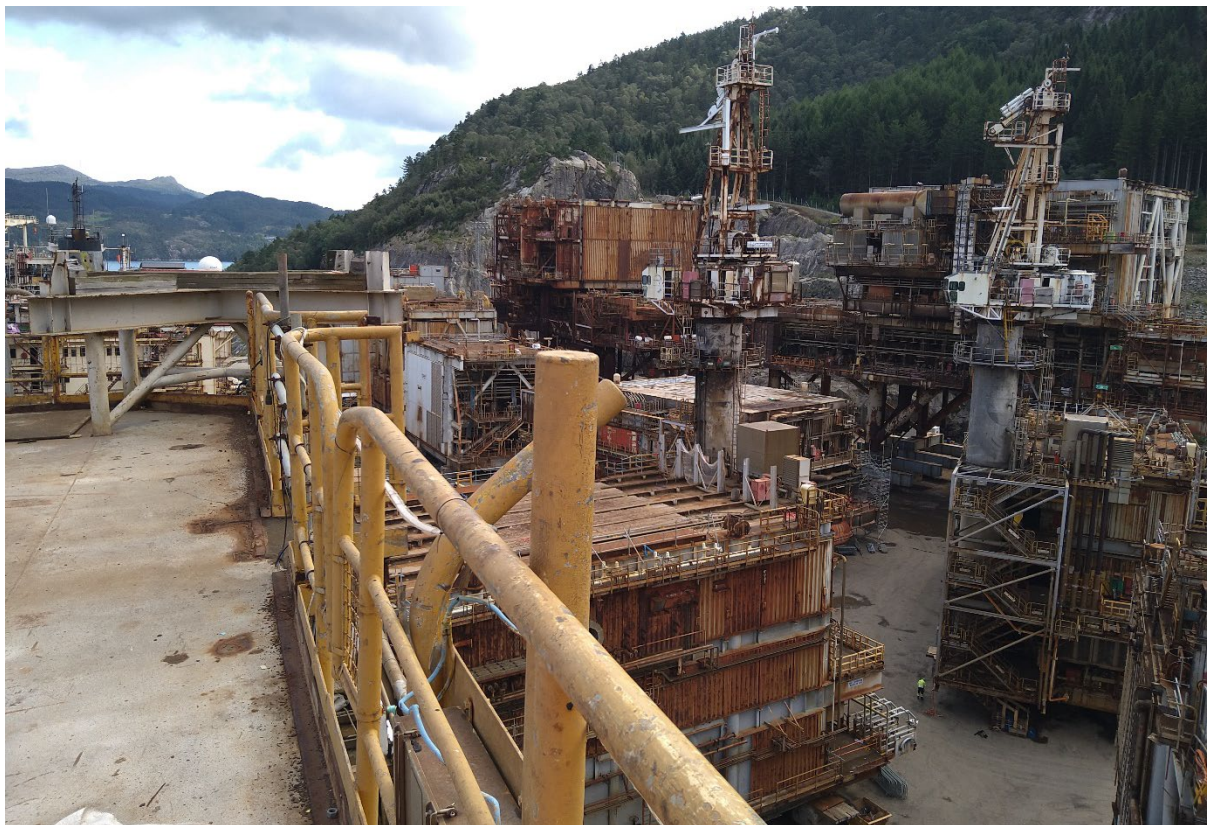
Figure 8-12: Bravo modules relocated on the quayside ready for demolition

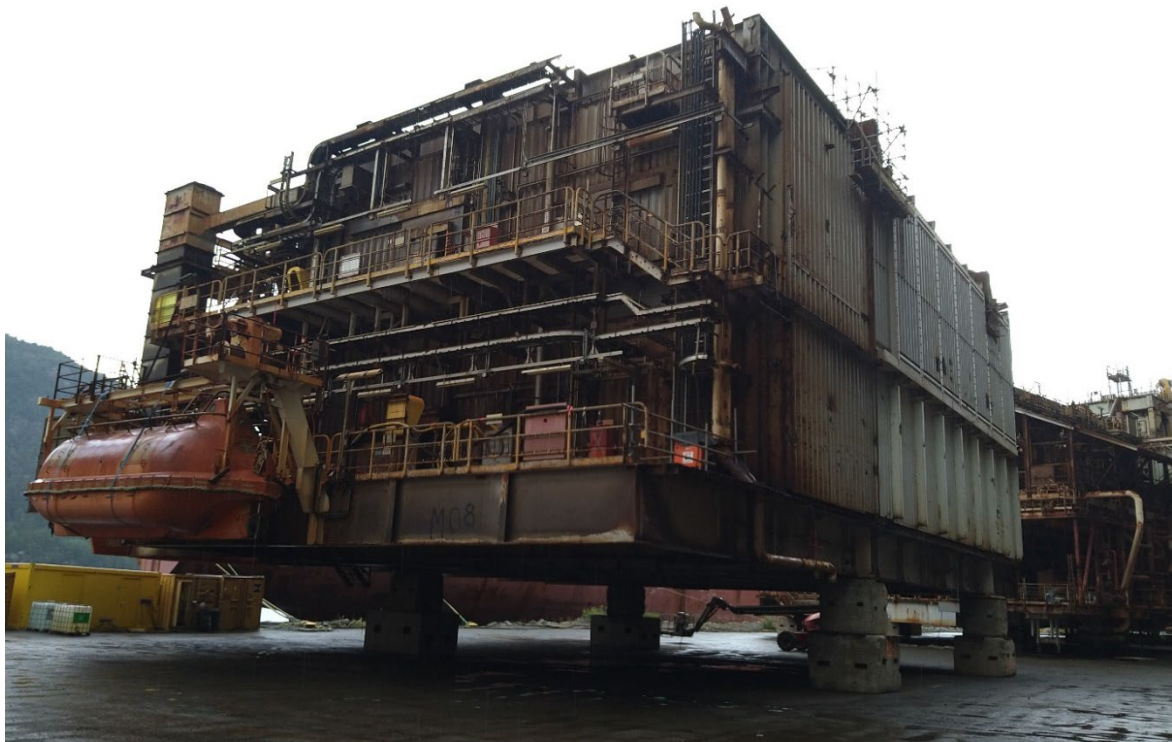
Figure 8-13: Module 8 ready to commence demolition

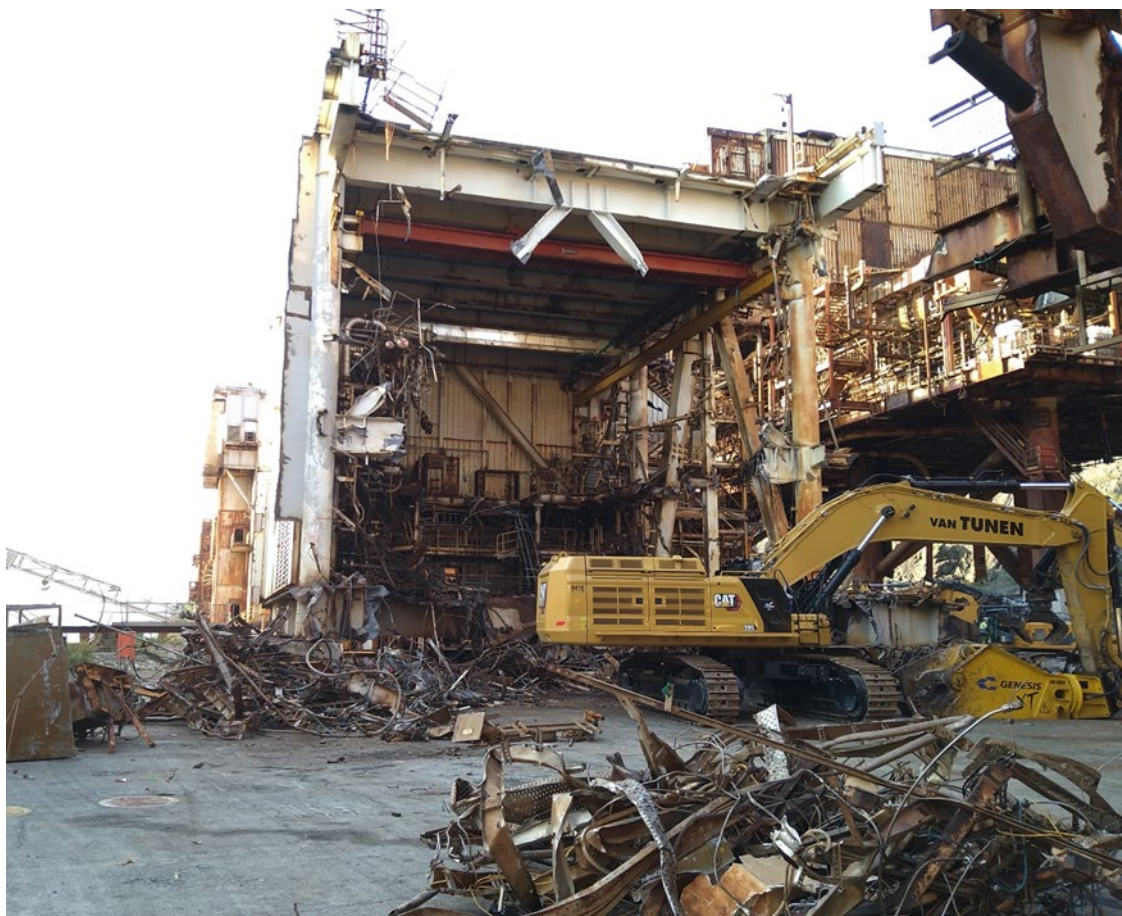
Figure 8-14: Module demolition underway

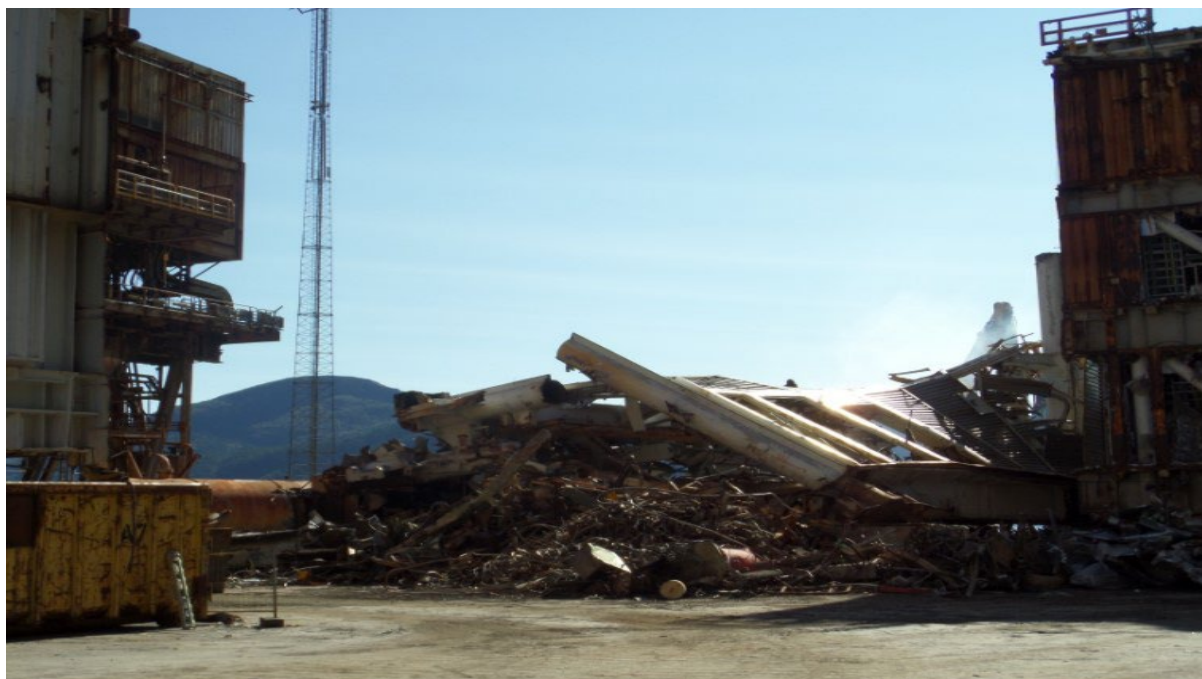
Figure 8-15: Demolition ongoing

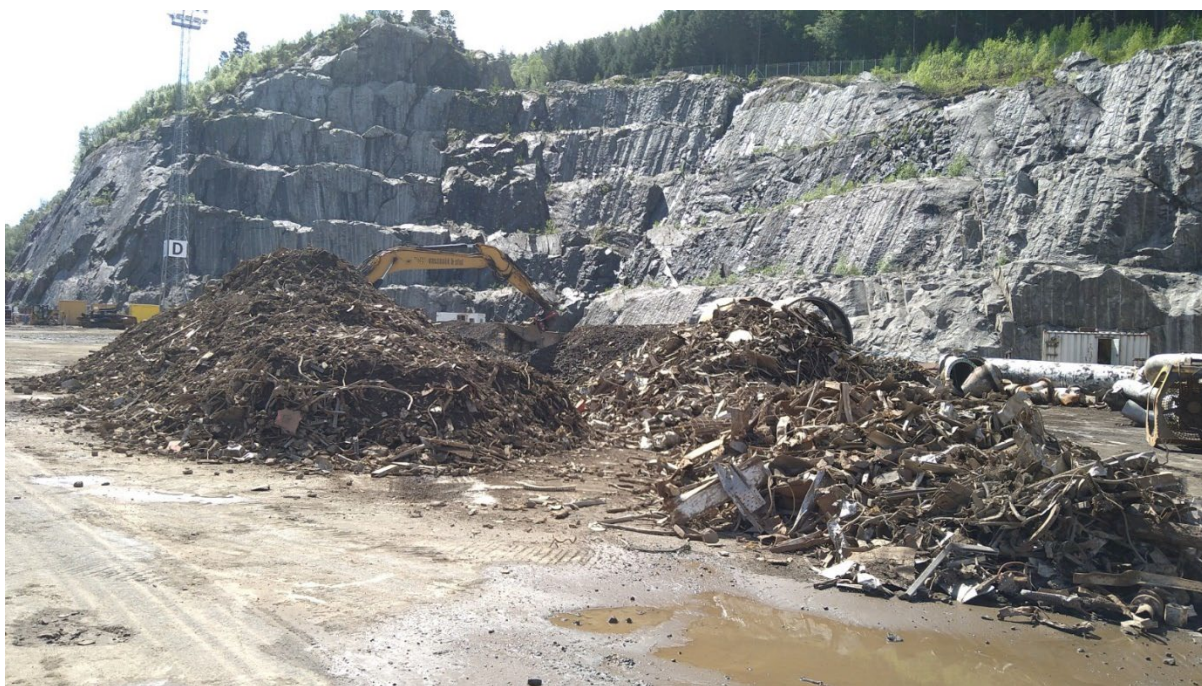
Figure 8-16: Material sorting

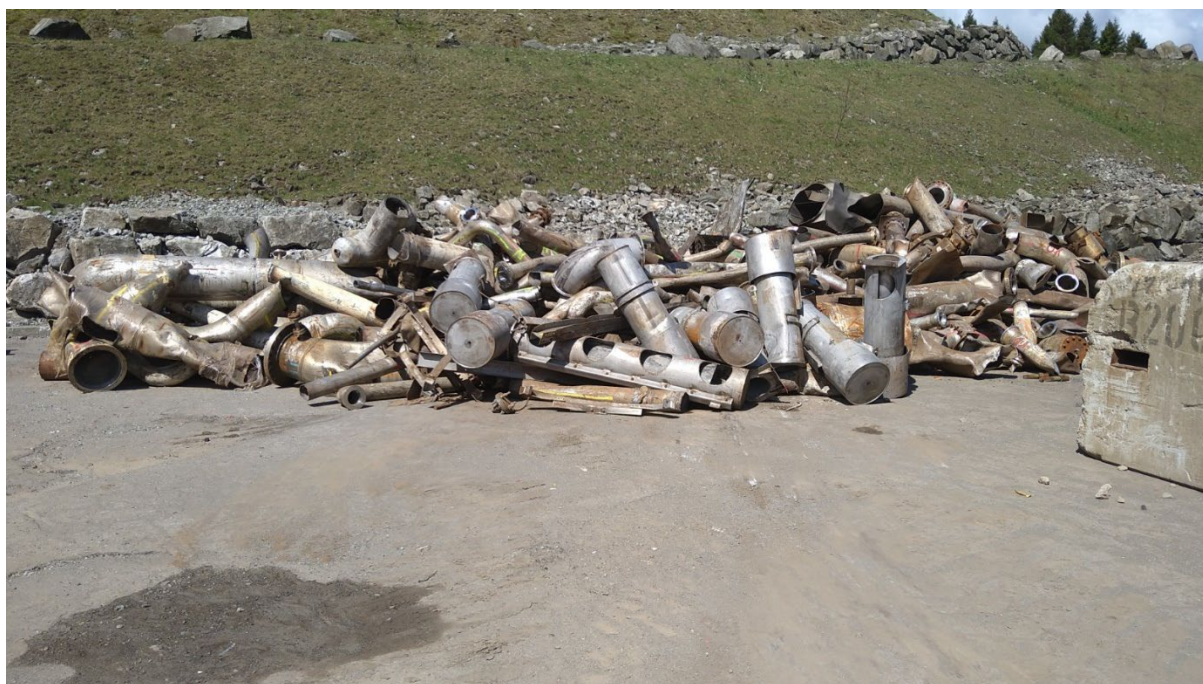
Figure 8-17: The final pile of steel

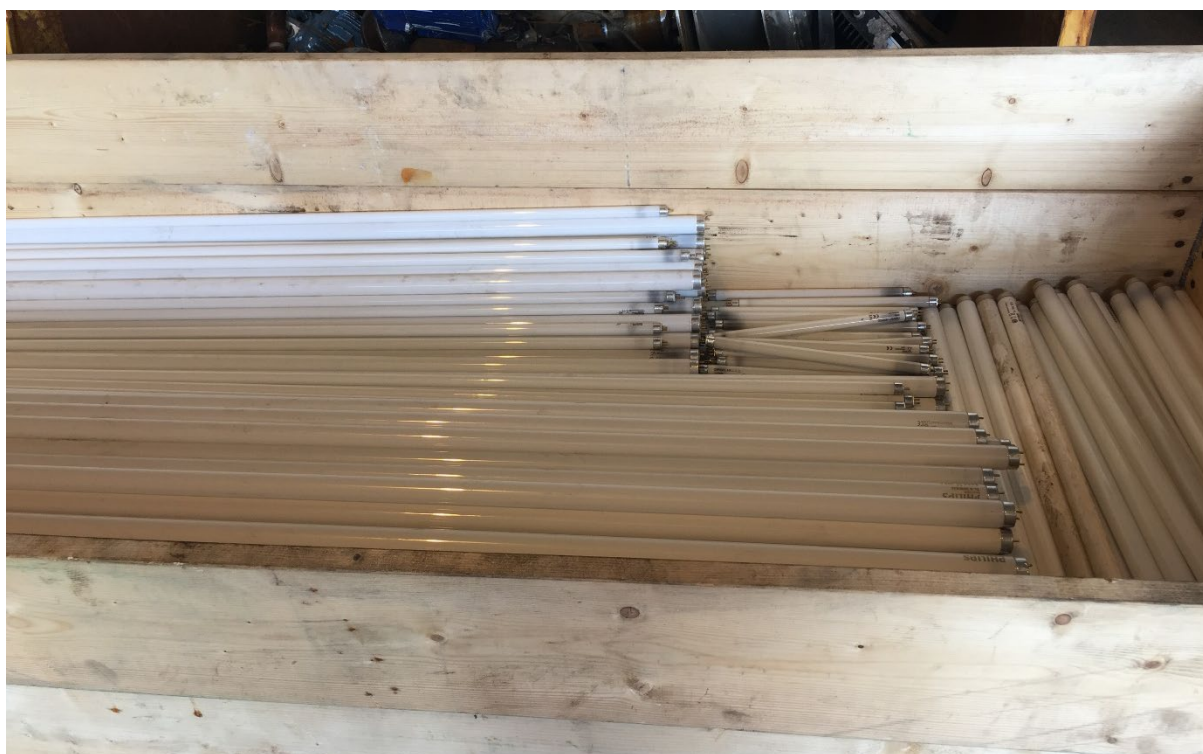
Figure 8-18: Hazardous waste sorting
