Construction Noise and Vibration Monthly Report – November 2023

Buckinghamshire

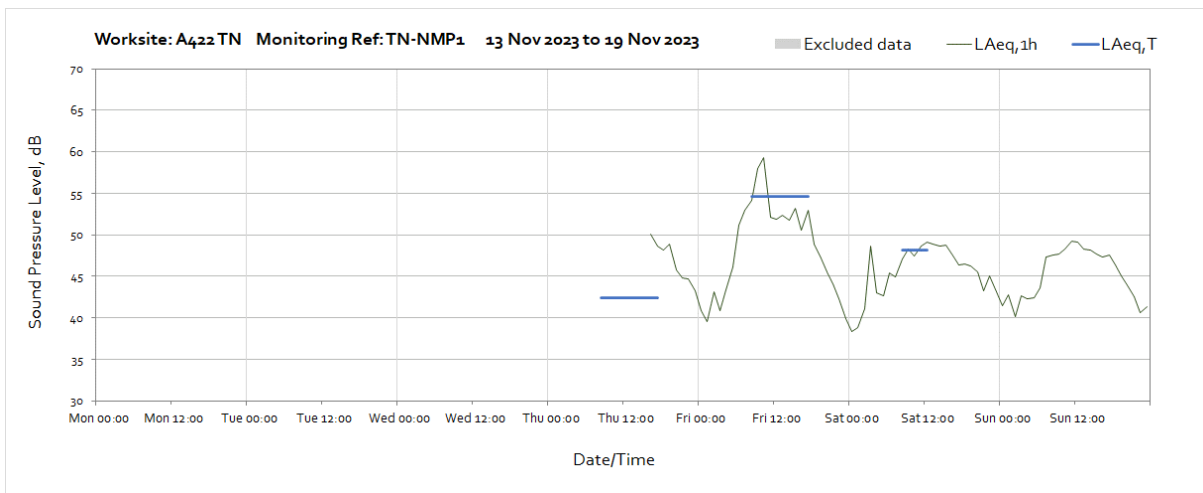
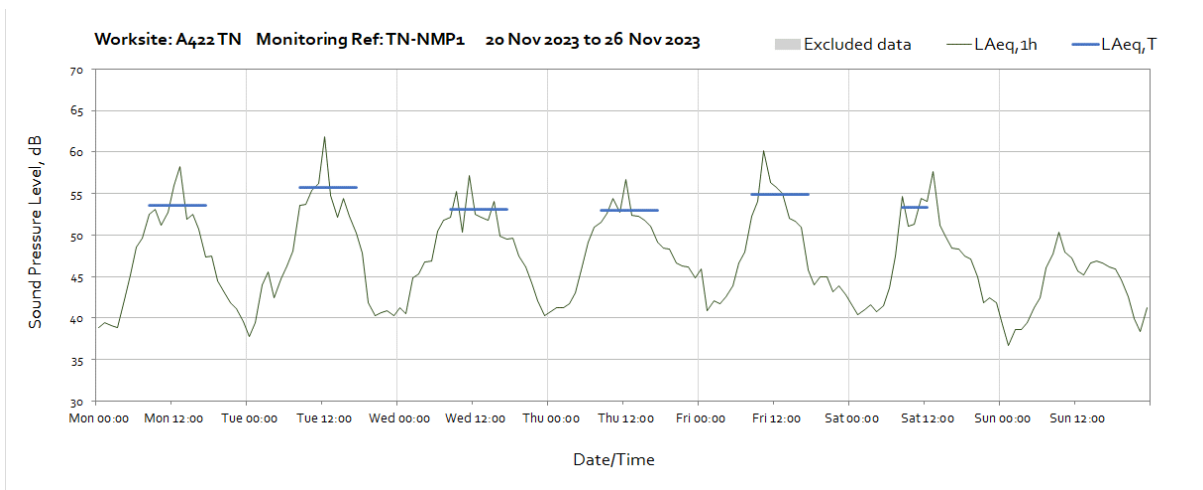
Worksite: A422 TN – Monitoring Ref: TN-NMP1

Note: Missing data until 16:00 on Thursday 16th December was due to monitor retrieval for laboratory calibration.

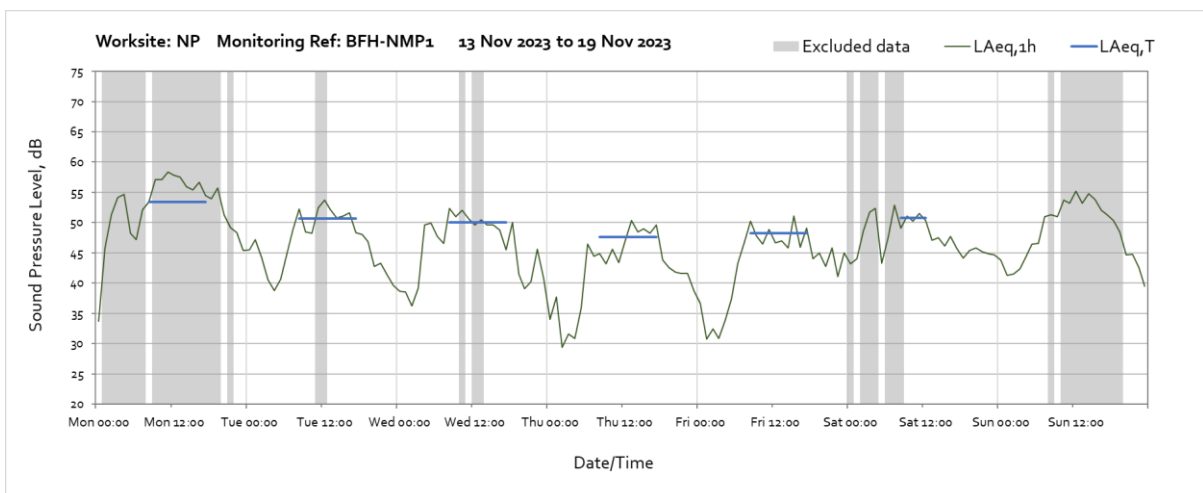
Worksite: NP – Monitoring Ref: BFH-NMP1

Note: Missing data between 14:00 and 15:00 on Thursday 2nd November was due to monitor field calibration.

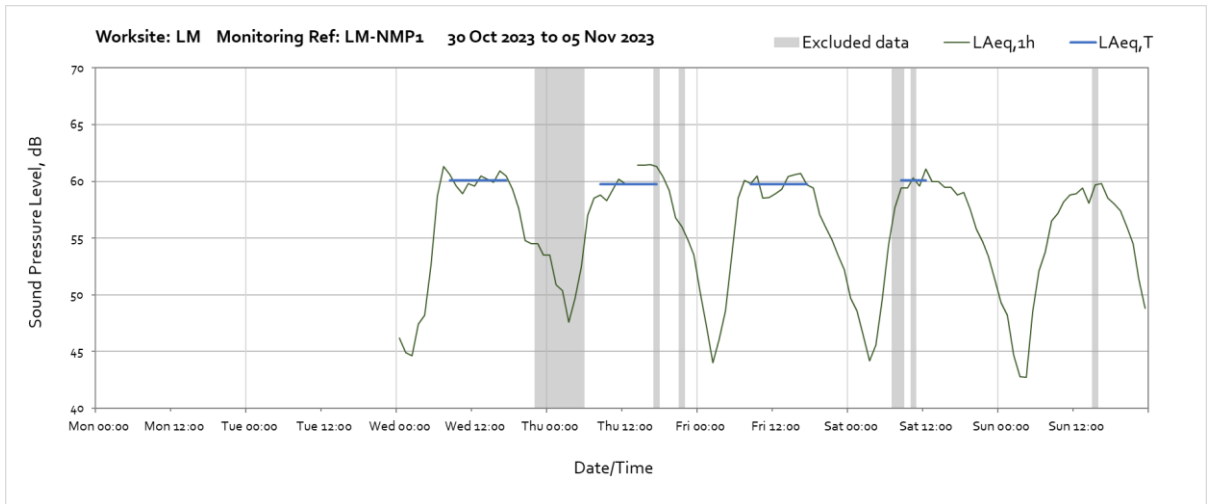
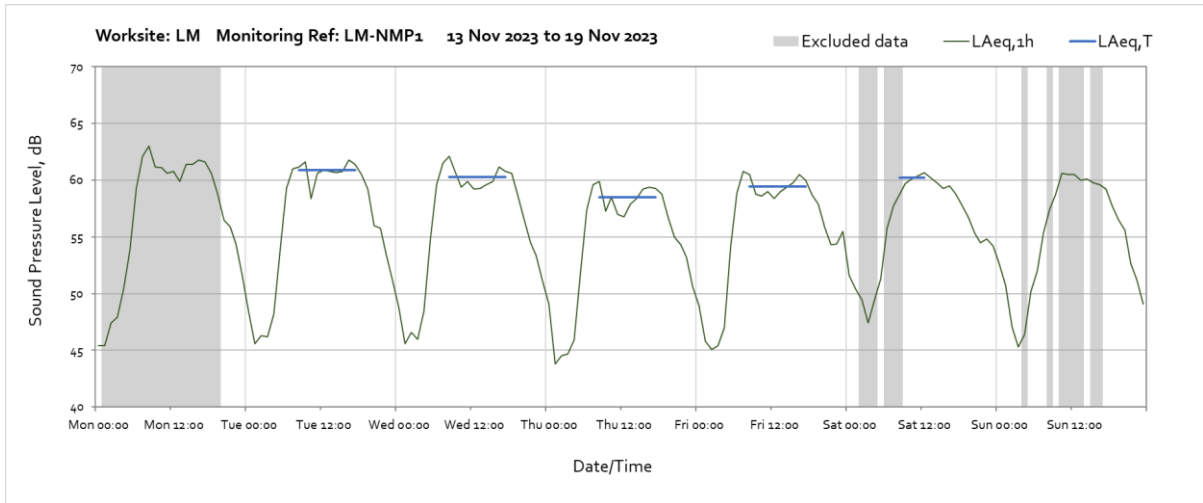
Worksite: LM – Monitoring Ref: LM-NMP1

Note: Missing data between 13:00 and 14:00 on Thursday 2nd November was due to monitor field calibration.

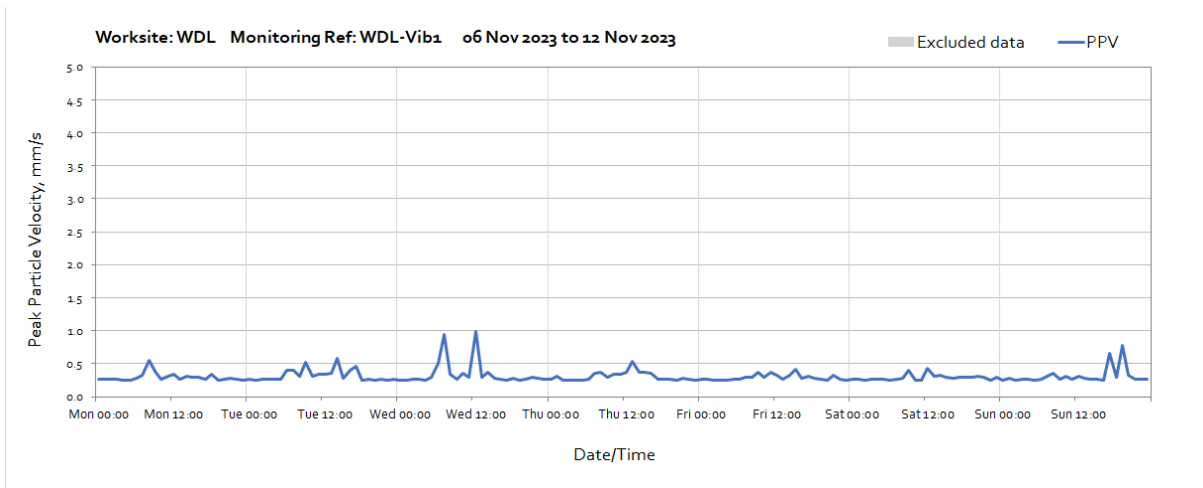
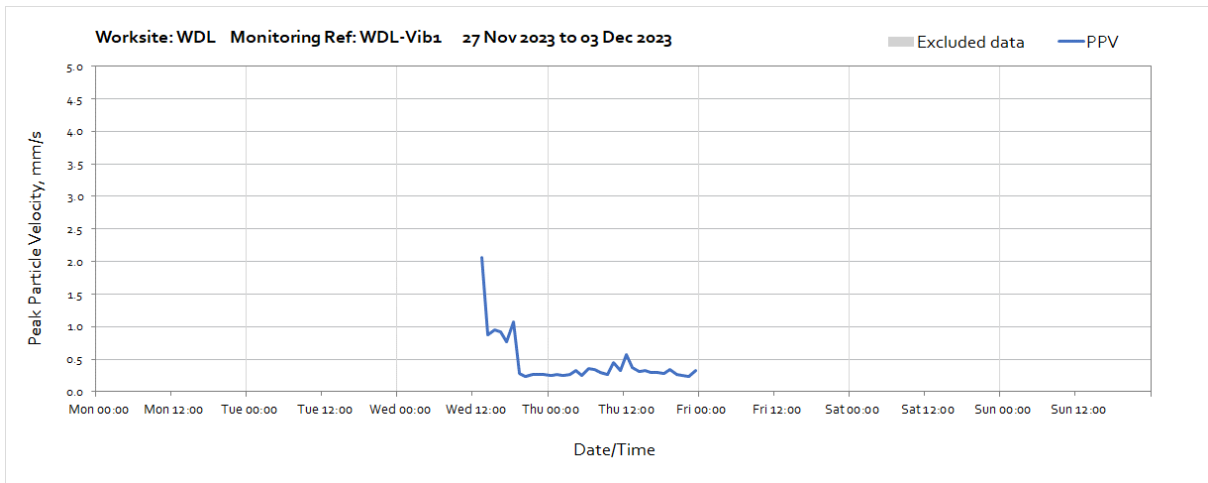
Worksite: WDL – Monitoring Ref: WDL-Vib 1

Note: Missing data between 16:00 on Tuesday 21st November until 13:00 on Wednesday 29th November was due to depleted monitor battery, the battery has now been replaced.

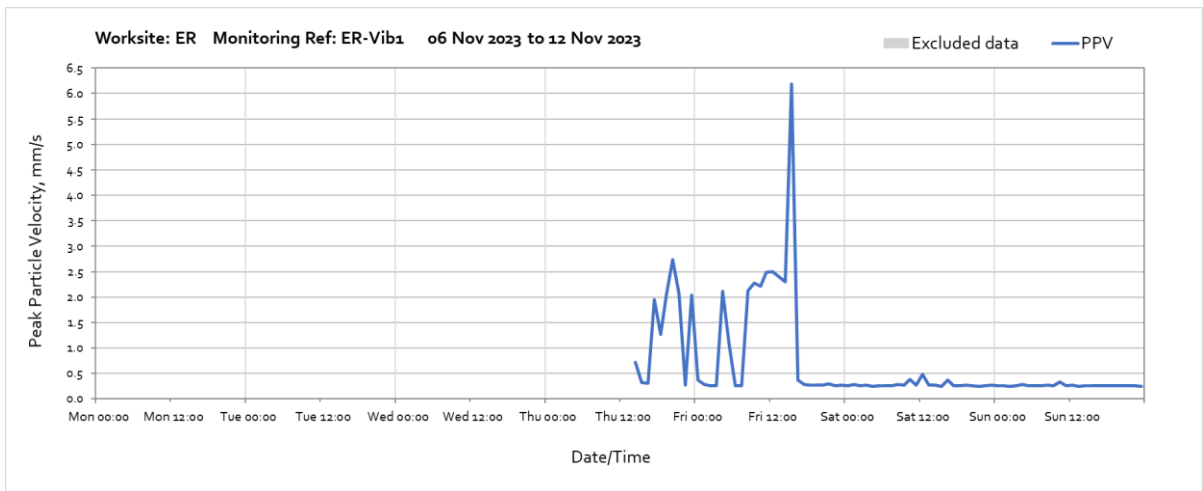
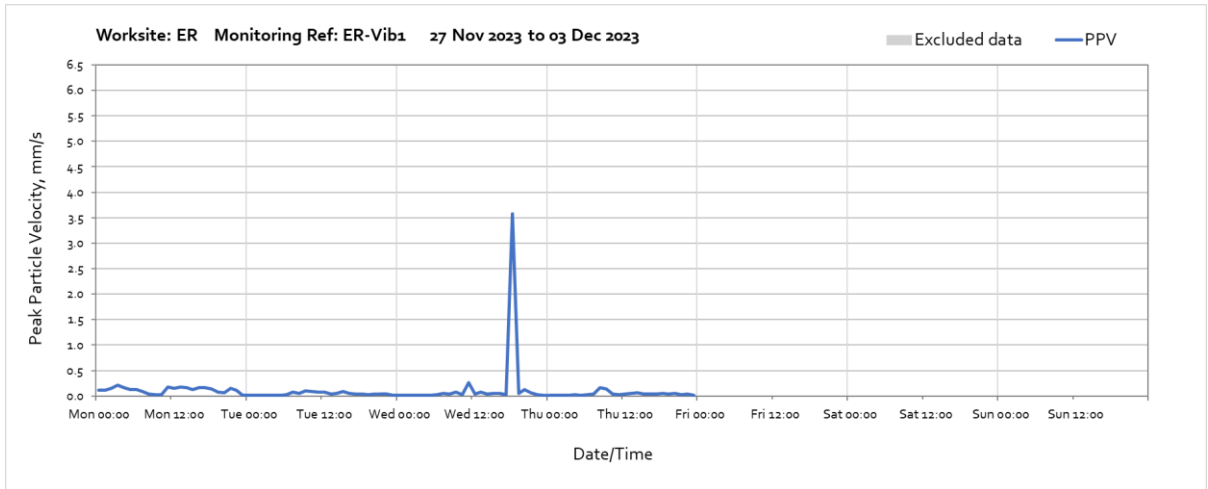
Worksite: WGT – Monitoring Ref: ER-Vib 1

Note: Missing data between 21:00 on Sunday 5th November until 14:00 on Thursday 10th November was due to depleted monitor battery which has now been replaced.
