Construction Noise and Vibration Monthly Report – November 2023

London Borough of Ealing

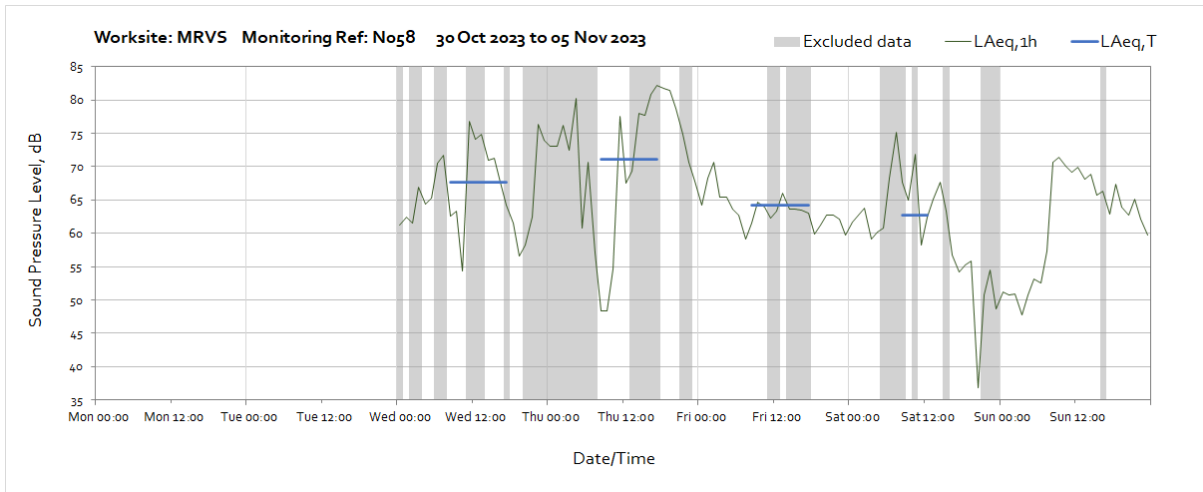
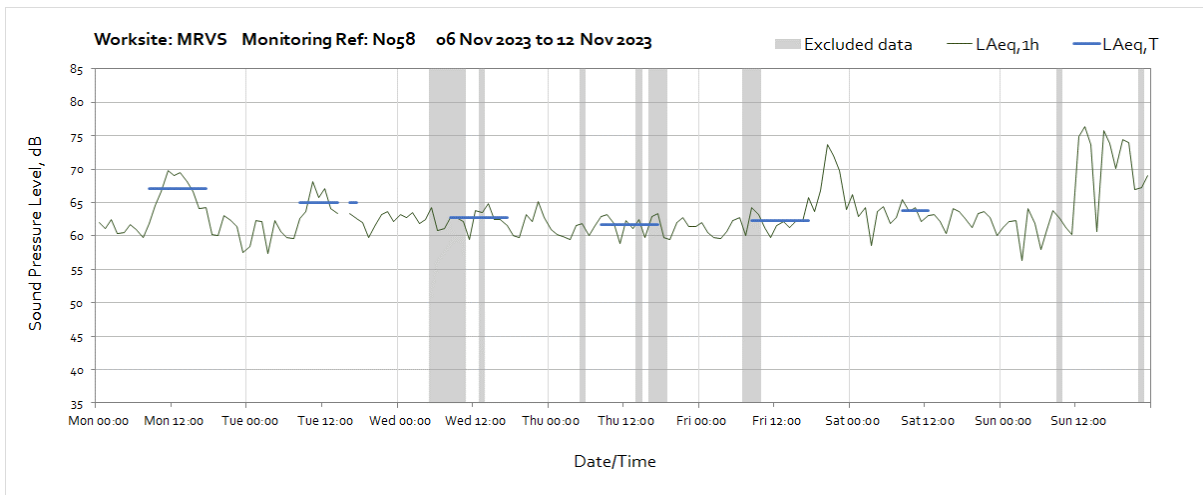
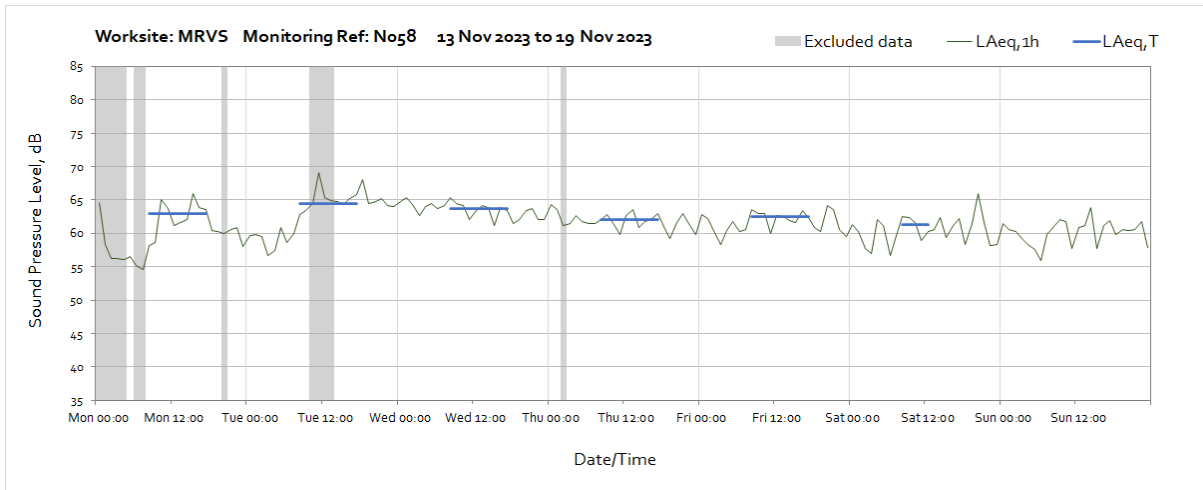
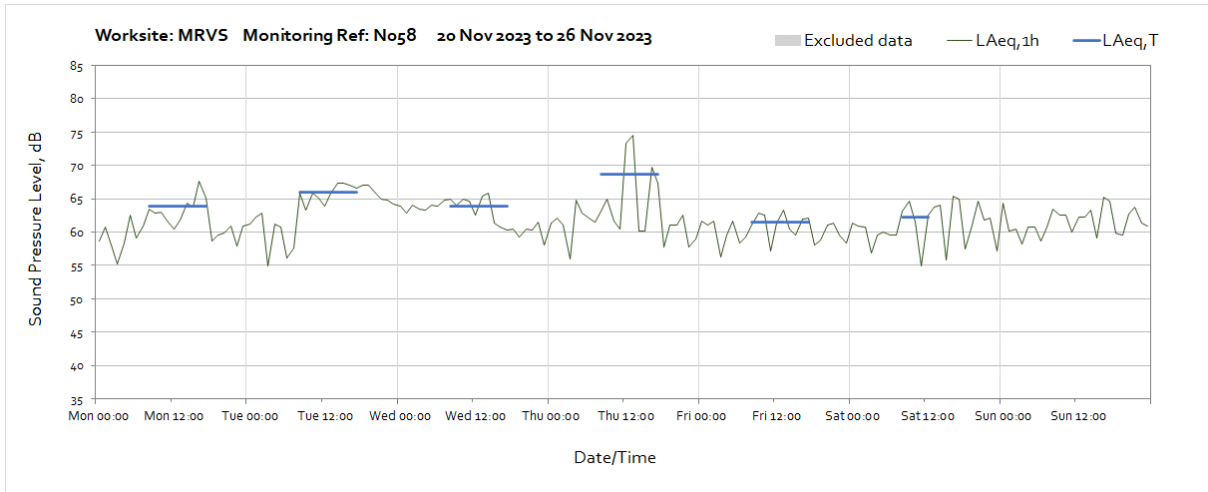
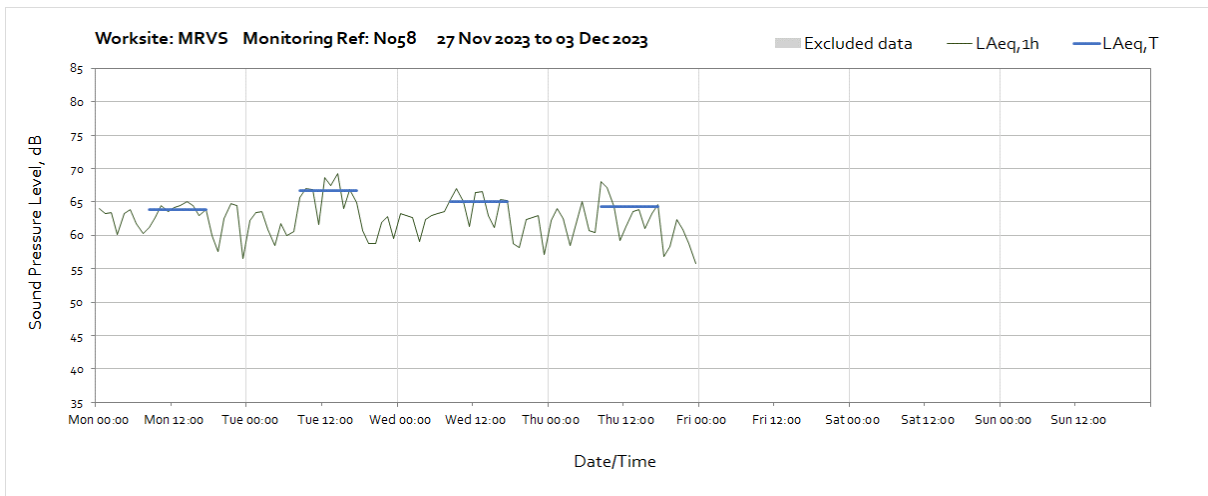
Worksite: MRVS – Monitoring Ref: N058

Note: Missing data between 15:00 and 16:00 on Tuesday 7th November was due to maintenance works on the monitor.

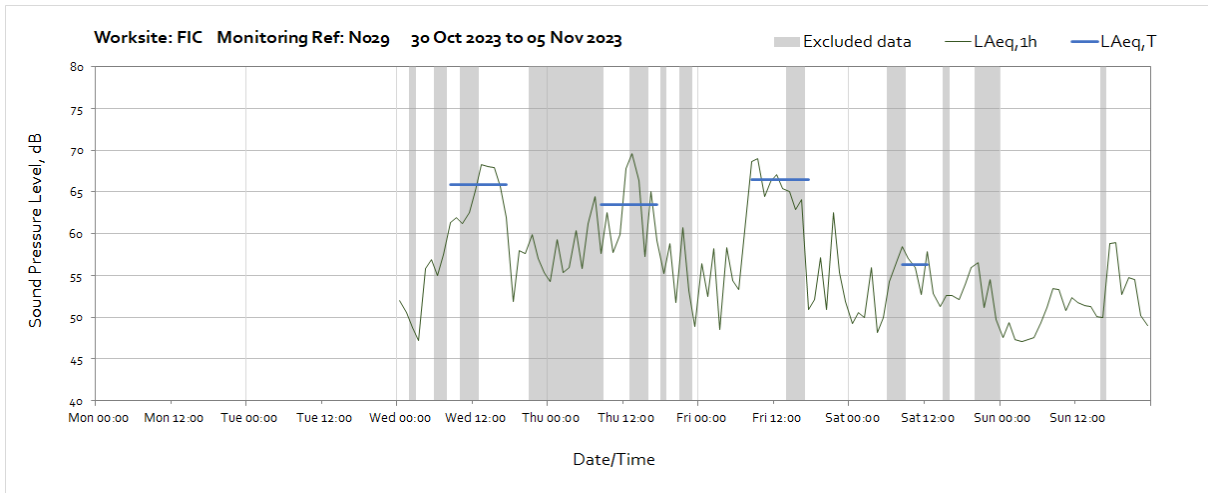
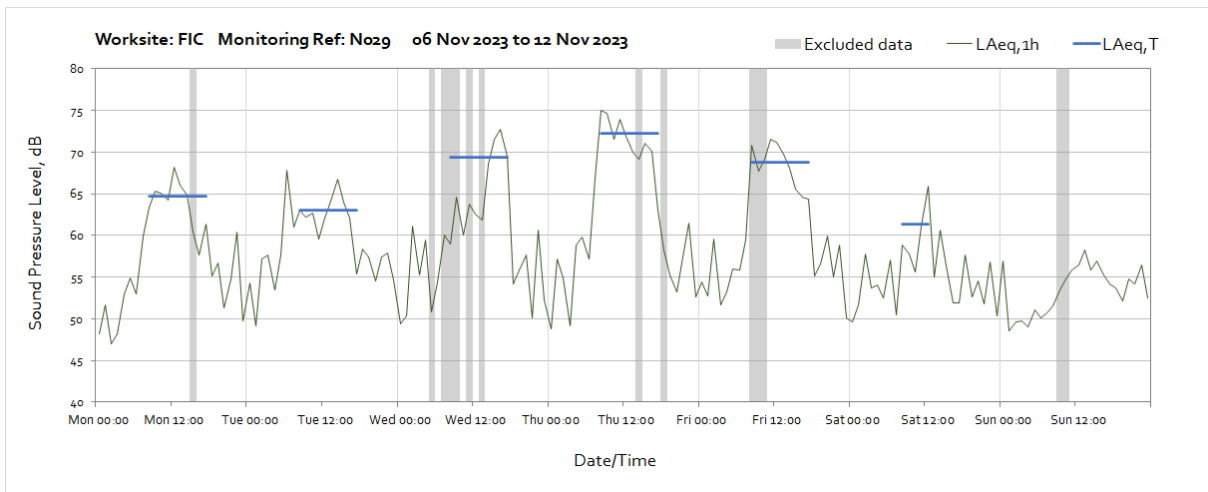
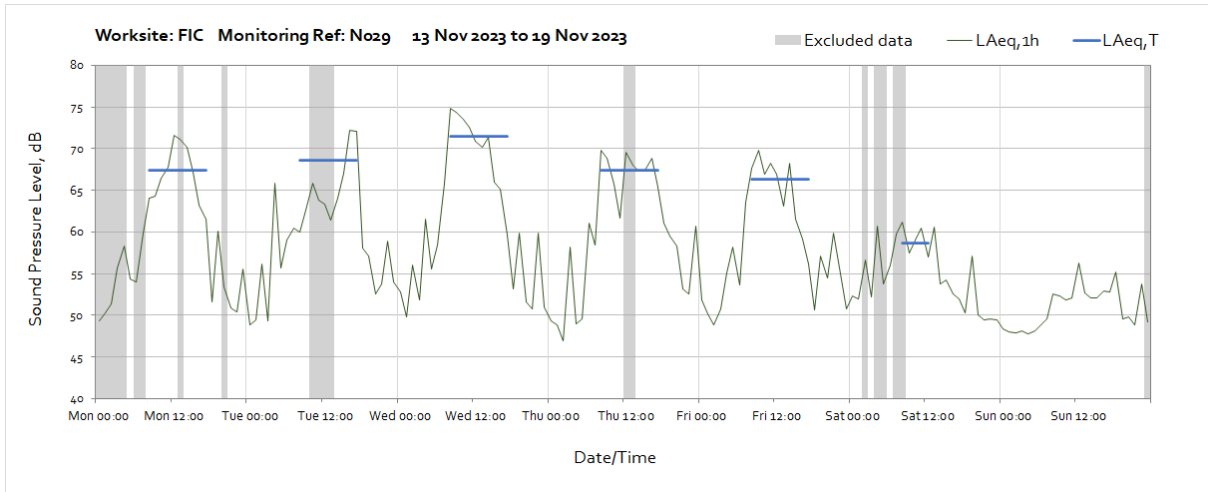
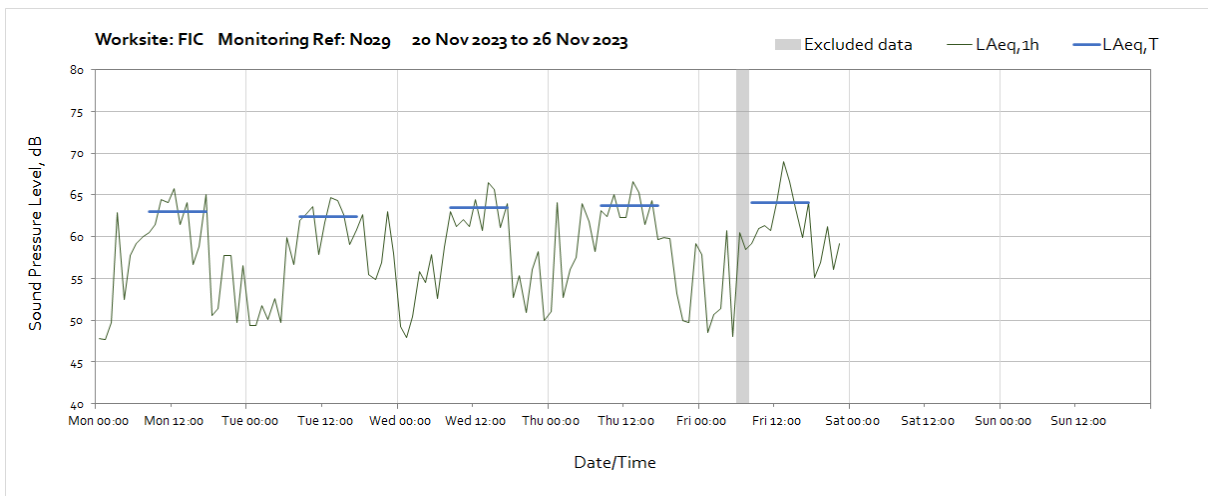
Worksite: FIC – Monitoring Ref: N029

Note: Missing data from 23:00 on Friday 24th November until the end of the month was due to loss of continuous power at the monitoring station.
