Serious Incident

Aircraft Type and Registration:	Leonardo AW189, G-MCGT
No & Type of Engines:	2 General Electric Co CT7-2E1 turboshaft engines
Year of Manufacture:	2014 (Serial no: 92006)
Date & Time (UTC):	26 July 2021 at 1950 hrs
Location:	Ballintoy Harbour, County Antrim
Type of Flight:	Emergency Services Operations
Persons on Board:	Crew – 4 Passengers – None
Injuries:	Crew – None Passengers – N/A
Nature of Damage:	None
Commander's Licence:	Airline Transport Pilot's Licence
Commander's Age:	46 years
Commander's Flying Experience:	5,100 hours (of which 1,100 were on type) Last 90 days – 101 hours Last 28 days – 30 hours
Information Source:	AAIB Field Investigation

Synopsis

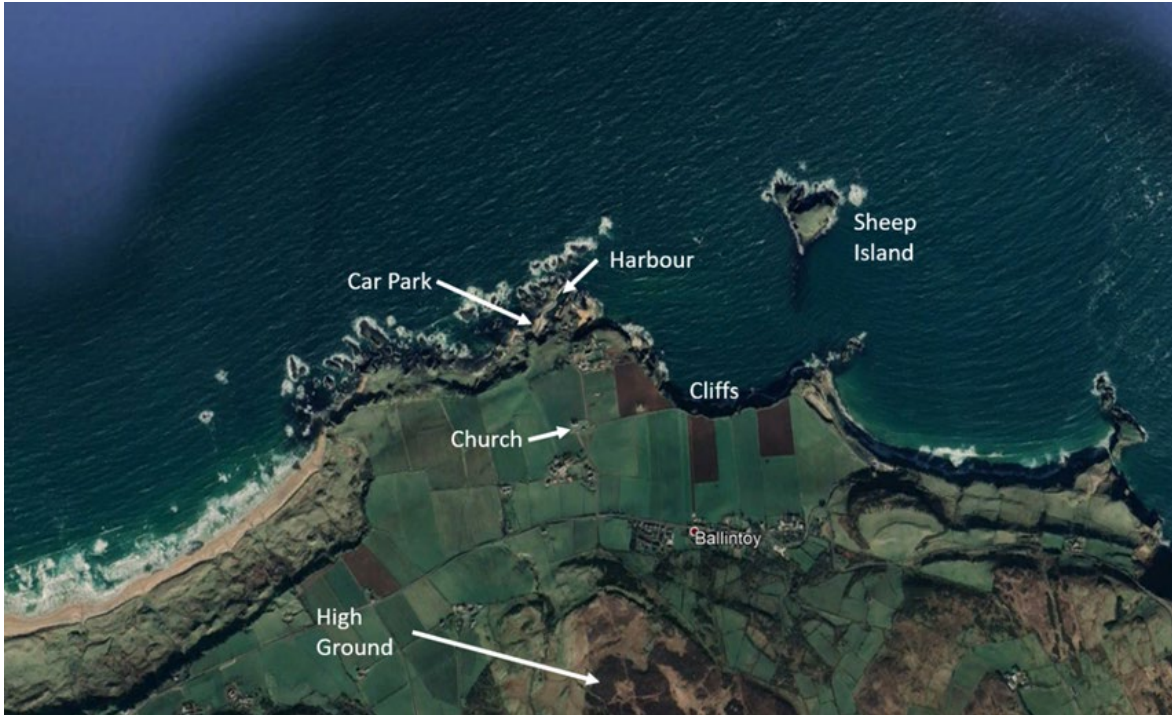
Figure 3

The ground rises to 700 ft amsl about 1 km inland. A church is approximately 450 m south of the landing site at an elevation of 165 ft amsl (Figure 3). There are 100 ft high cliffs either side of the harbour, which to the east rise to 160 ft (Figure 4). The casualty was being treated on the beach to the west of the car park. Coast guard vehicles with flashing blue lights were parked on the road near the casualty and at the church.

Ballintoy Harbour local area © 2021 Google, Image © TerraMetrics

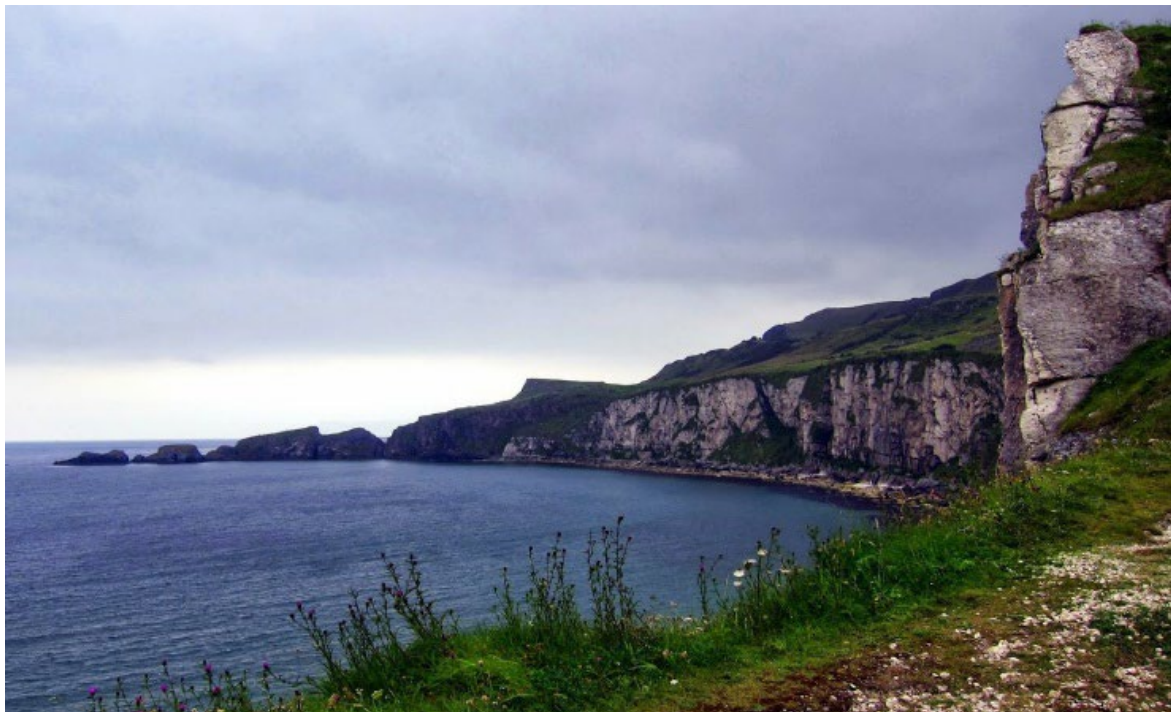
Figure 4

Cliffs at Ballintoy Harbour
© 2021 Google, Image © TerraMetrics

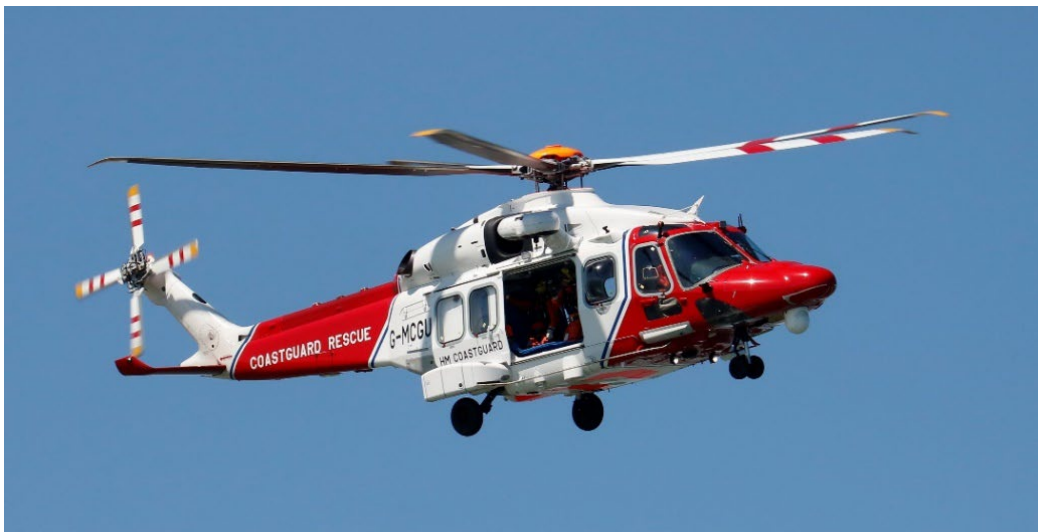
Figure 5

The AgustaWestland AW189 SAR helicopter (Figure 5) is a derivative of the commercial air transport version, which is equipped with specialist role equipment and a modified AFCS providing additional functionality for the SAR role.

An AgustaWestland AW189 (Used with permission)

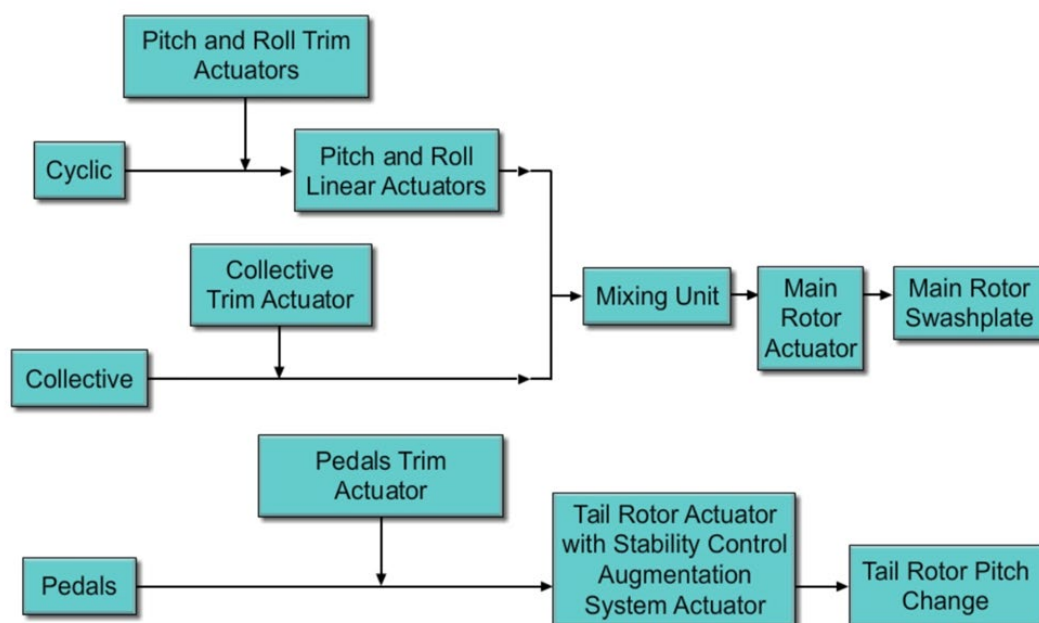
Figure 6

The flight controls allow the crew to control the flight attitude, altitude, and direction of the helicopter. Control is transmitted to the main rotor swash plate and tail rotor pitch change mechanism through mechanical linkages connected to the cyclic stick, collective lever, and yaw pedals. The mechanical control is augmented by electric actuators mounted in series (linear) and parallel (trim) in each of the control systems (Figure 6).

Flight control system (©Leonardo Helicopters)

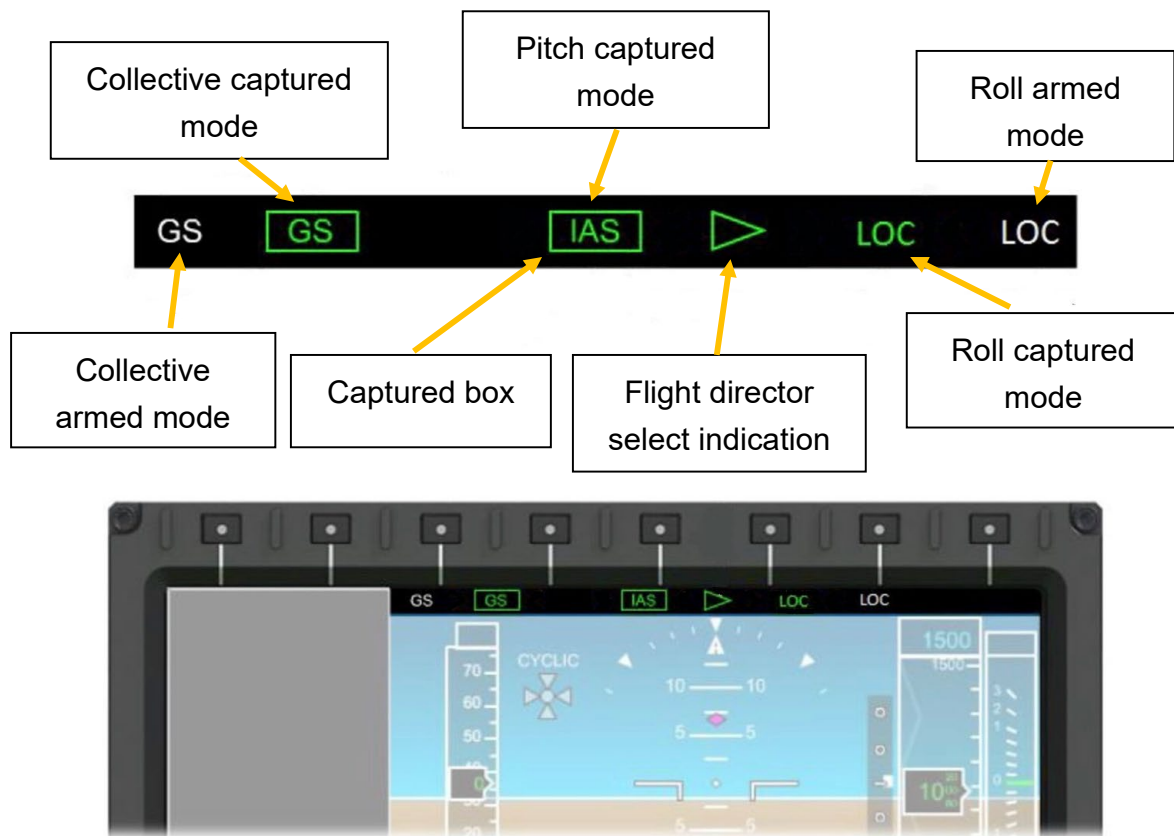
Figure 7

The flight director select indication is a green triangle (Figure 7), which is displayed on the FMA on both PFDs and indicates the 'in-command' Flight Director (FD). It is selected by pressing the FD SEL button on the Display Control Panel. The PFD/multi-function display on the side with the 'in-command' FD supplies reference data to the AFCS. When power is first provided to the AFCS, the in-command FD defaults to the right. The operator's SOPs required that the in-command FD corresponded to the pilot acting as PF.

FMA located at the top of the PFD (©Leonardo Helicopters)

The Flight Mode Annunciator (FMA) located at the top of the Primary Flight Display (PFD) provides a visual display to the pilots of the modes which have been armed, captured, or are degraded (Figure 7). Captured modes are green, indicating the mode is in use, and is outlined by a green box which flashes for five seconds when first captured. Armed modes, which indicate that the mode has been selected but the parameters are not within range, are white and displayed next to the captured modes. A single aural tone sounds when a mode is engaged or disengaged.

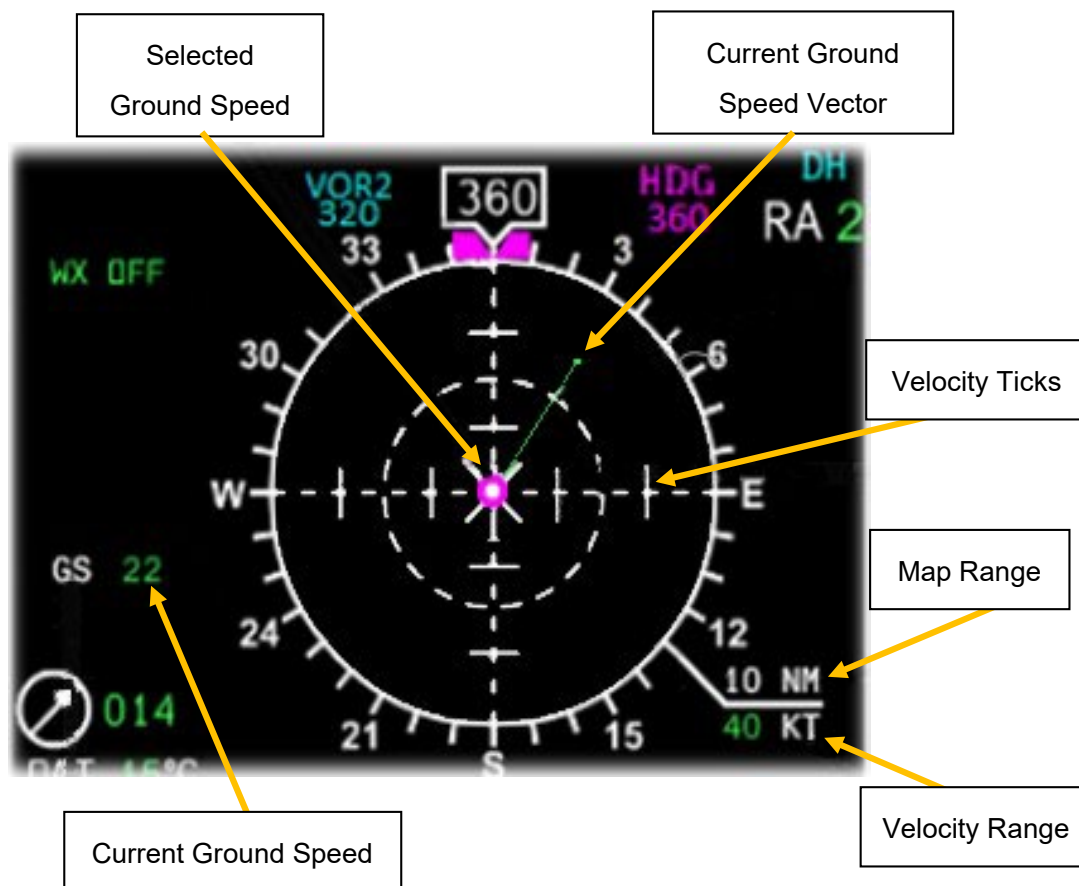
Figure 9

On selection of HOV mode, the HSI display changes to the hover mode symbology format (Figure 9). This symbology is overlaid on the compass rose and shows the current groundspeed and a velocity vector in green; the target groundspeed is indicated by the selected ground speed bug in magenta.

HSI Hover Speed mode symbology² (©Leonardo Helicopters)

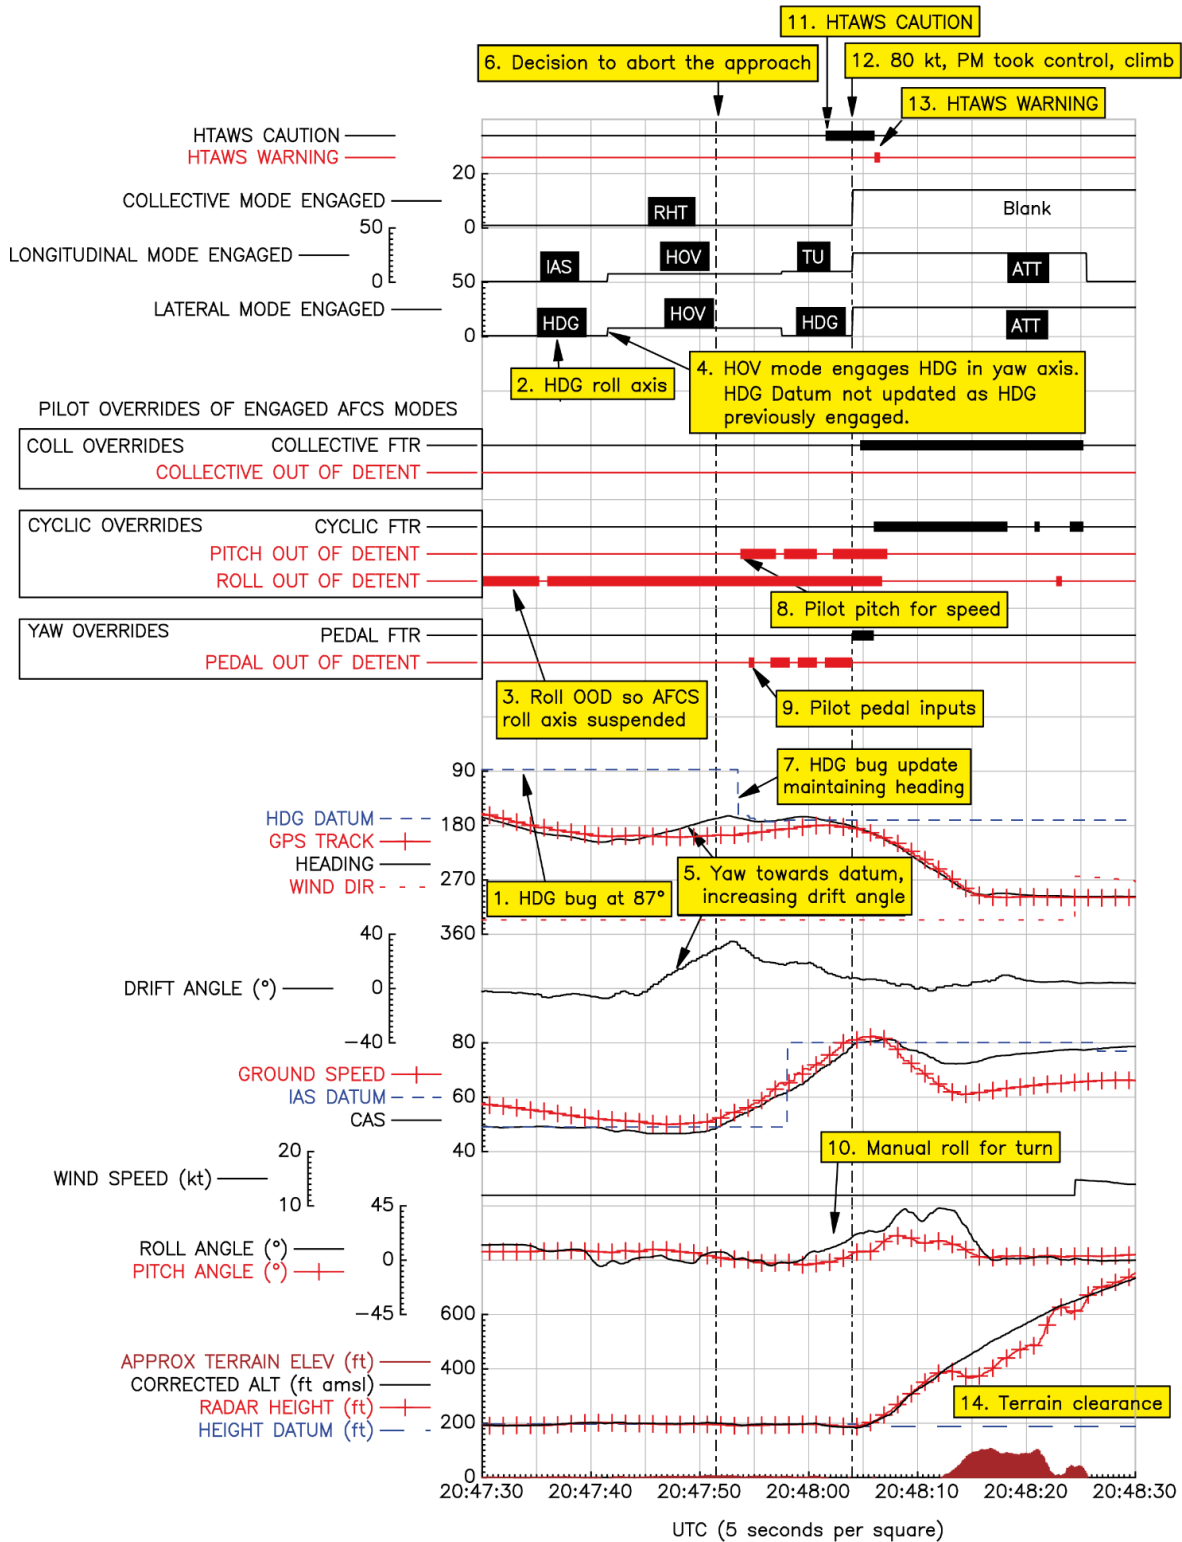
Figure 11

- Two seconds later, just after the helicopter started to climb, a HTAWS WARNING TERRAIN (13) briefly triggered. The climb rate reached a peak of 2,000 ft/min and the bank angle peaked at approximately 43° to the right.

- The lowest recorded radio height over terrain was 380 ft (14).
- The helicopter headed out to sea climbing, and returned to Prestwick.

Recorded data for the later stage of the third approach and HTAWS alert

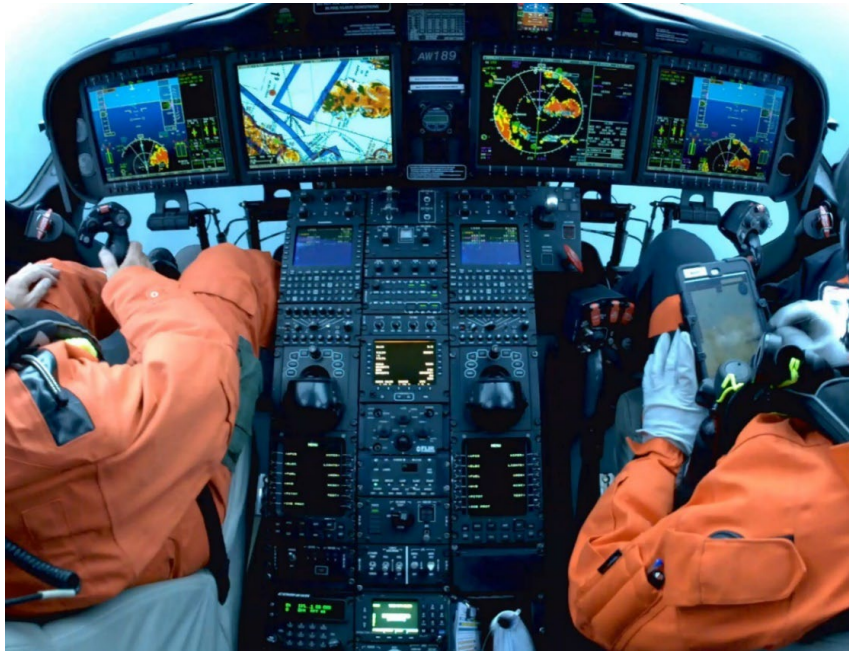
**Figure A-1**

Image from the cockpit camera.

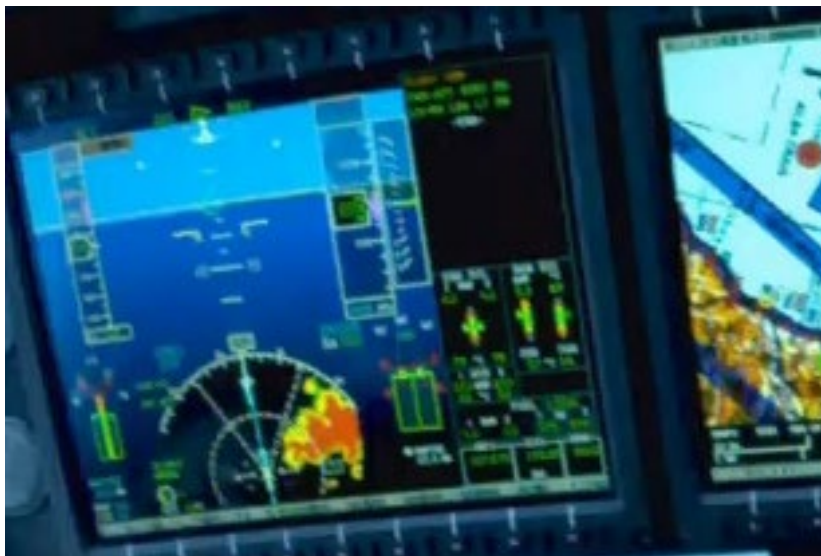
**Figure A-2**

Figure A-2 shows a zoomed-in view of the PFD. A combination of the AIR resolution and the use of a wide-angle lens meant that the displays were not readable, but there was no requirement for this. It is not known to what extent, if any, image compression affected the readability of the display images; however, there was still sufficient resolution to identify key features and the type of information displayed to the crew.

Cropped image of the left PFD showing the benefits and limitations of the camera's resolution.

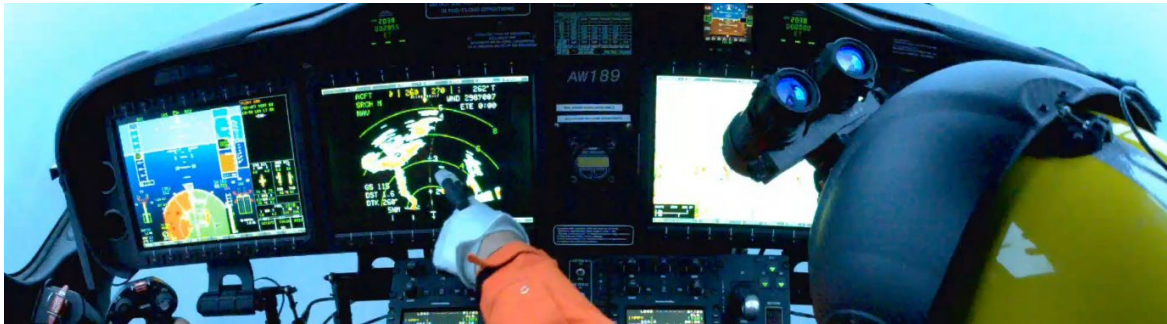
While the general light levels across most of the image were relatively dark, the map display had a light background which meant that it appeared mostly white on the recordings, thereby losing the information that was displayed. This can be seen in Figure A-3 where the detail on the map displayed on the Multi Functional Display (MFD) on the right side of the cockpit is 'washed out' compared with the MFD on the left side of the cockpit.

Image showing crew communication and focus (pointing), NVG's fitted to the helmet, detail displayed on the MFDs and the effect of the limitation of the dynamic range of the video recording system.

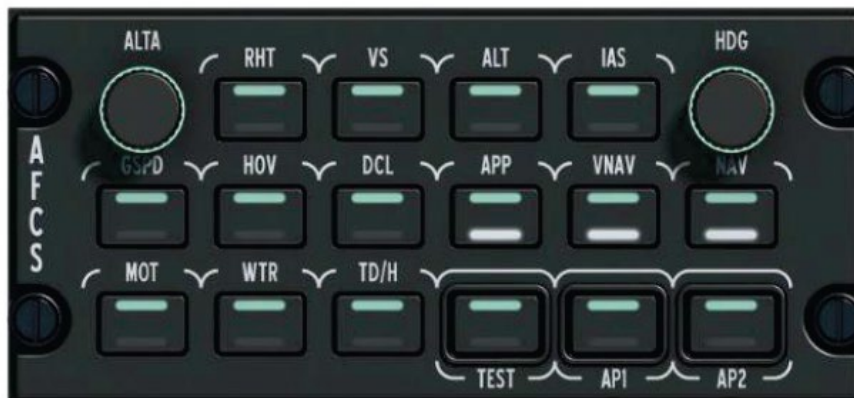
Figure B-1

The control panel for the AFCS, referred to as the APCP, provides controls for the arming or engagement of a mode and display of its associated status. It is also used for pre-flight testing. The APCP is in the centre of the inter-seat console between the pilots. It has 16 push buttons and two rotary/push knobs. Each button or rotary knob has its function annotated above it (Figure B-1).

Autopilot Control Panel

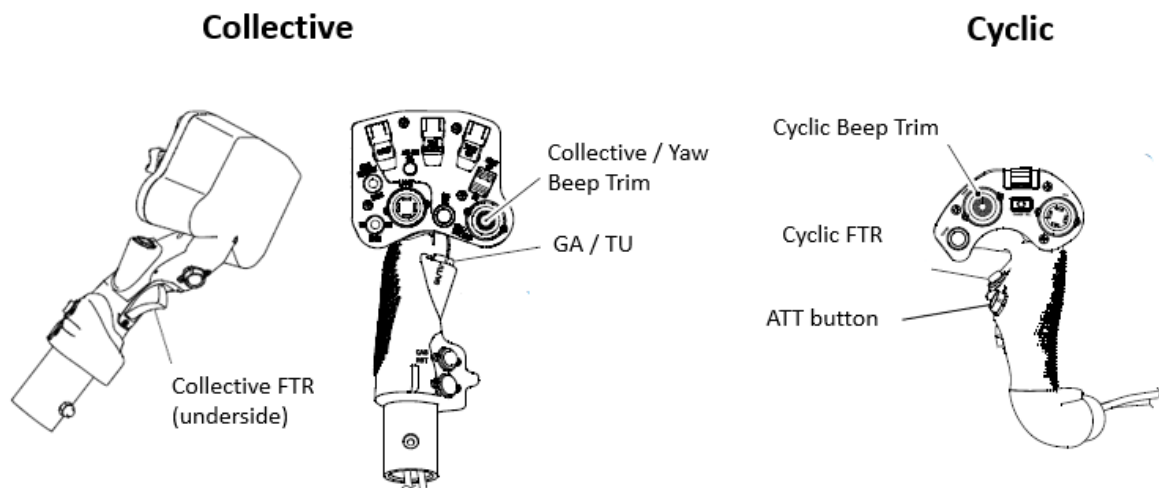
**Figure B-2**

Collective and Cyclic AFCS Controls
