Construction Noise and Vibration Monthly Report – December 2023

London Borough of Camden

Non-Technical Summary

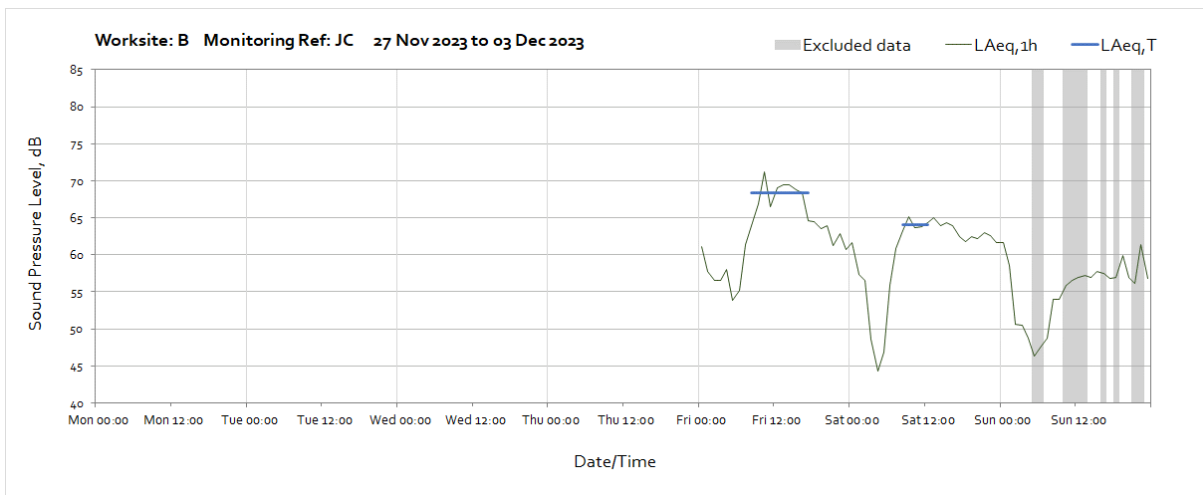
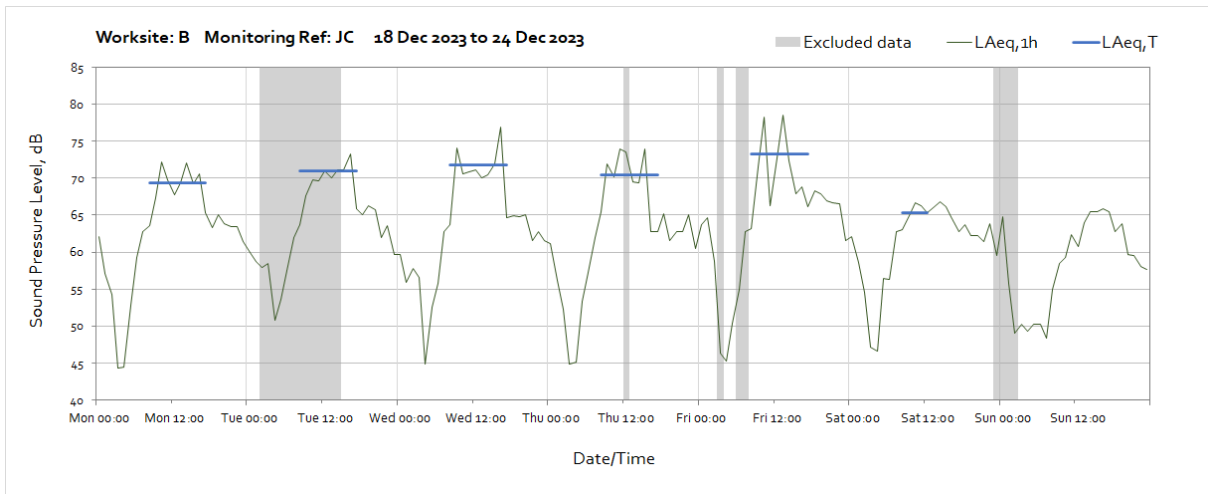
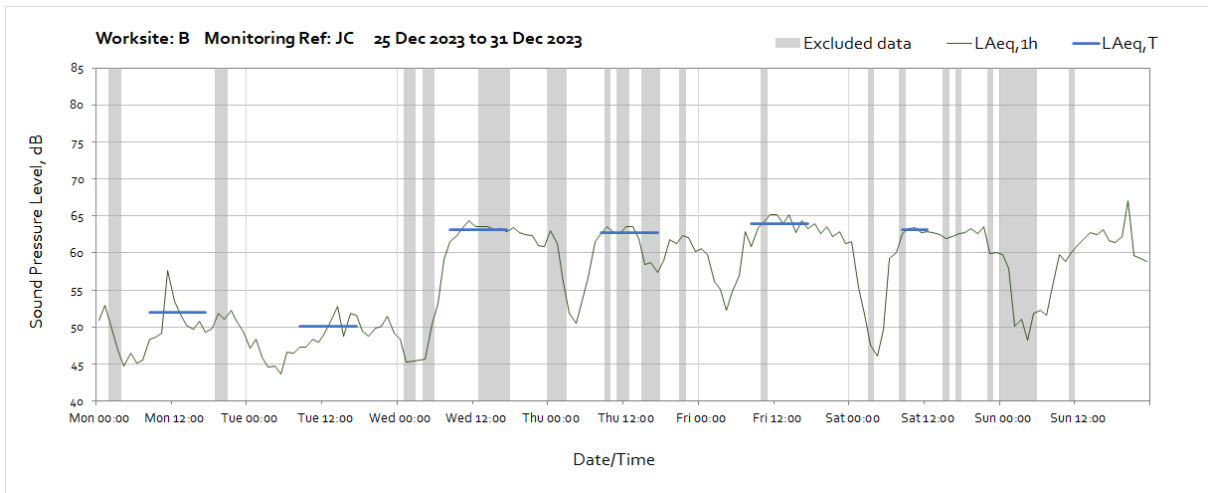
Worksite: B – Monitoring Ref: JC

The following graphs show the hourly measured ambient noise level $L_{Aeq,1h}$ and, where relevant, the averaged noise level $L_{Aeq,T}$ values, where the time period T is as specified in Table 1 of HS2 Information Paper E23. Periods where noise levels are adversely affected by weather or only measured for part of the period, which are not representative of HS2 construction works, have been greyed out and excluded from the calculation of the $L_{Aeq,T}$ values in in Table 3 of the main report.

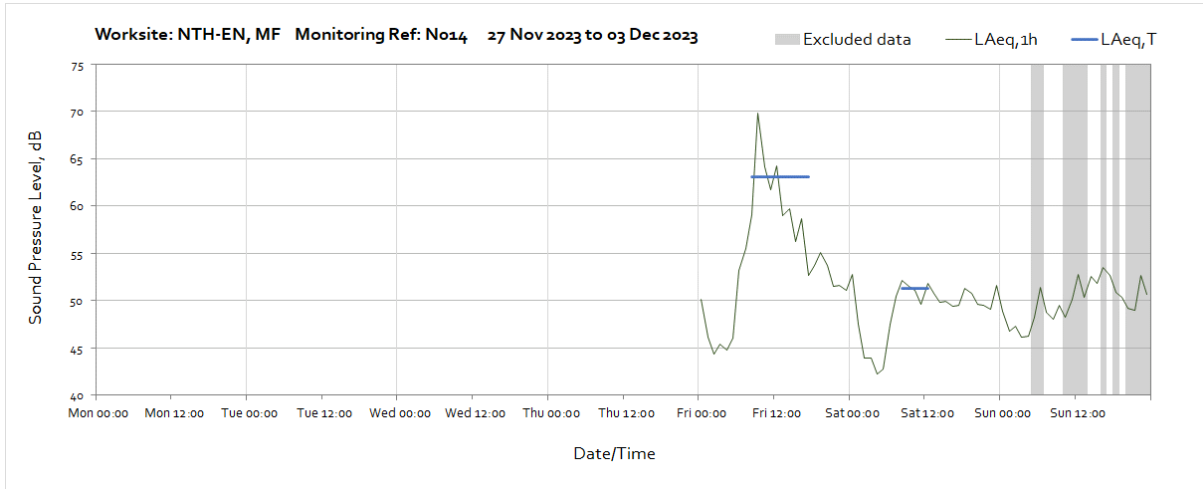
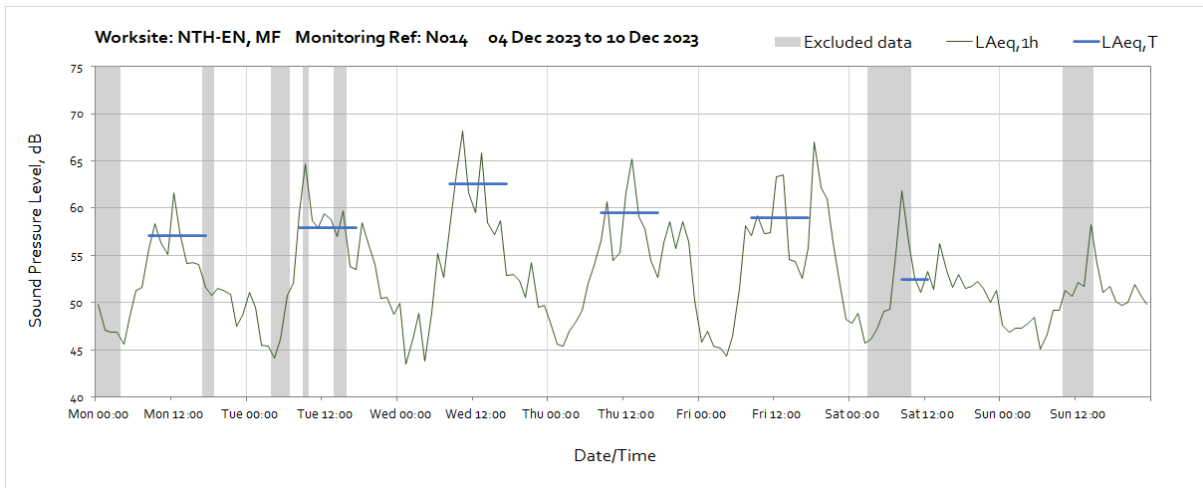
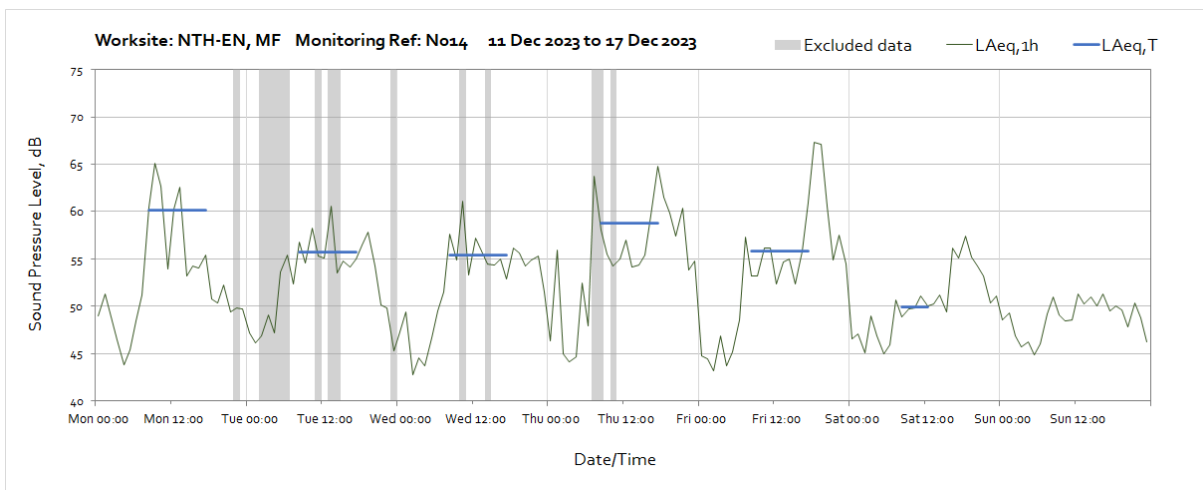
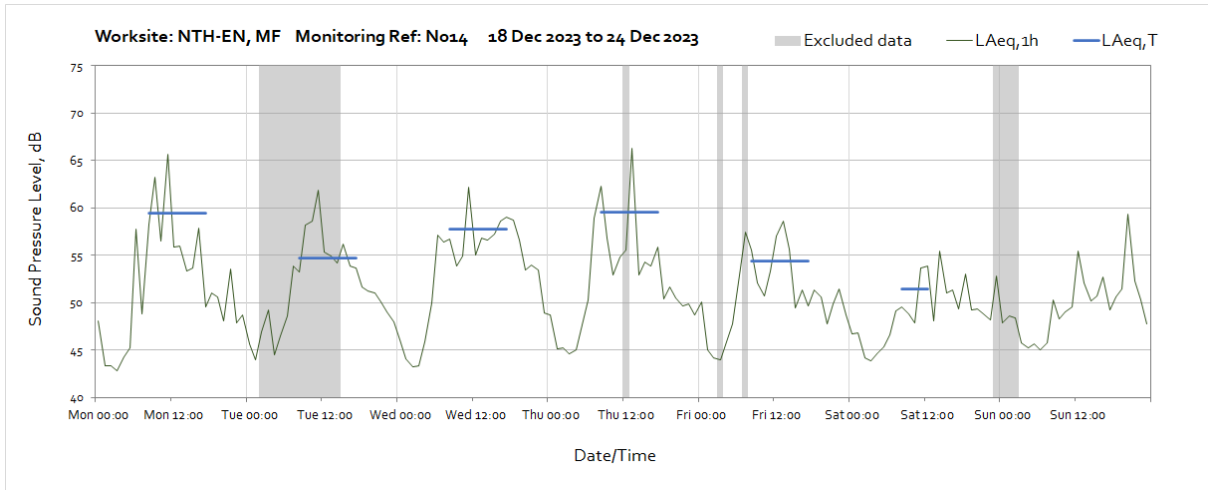
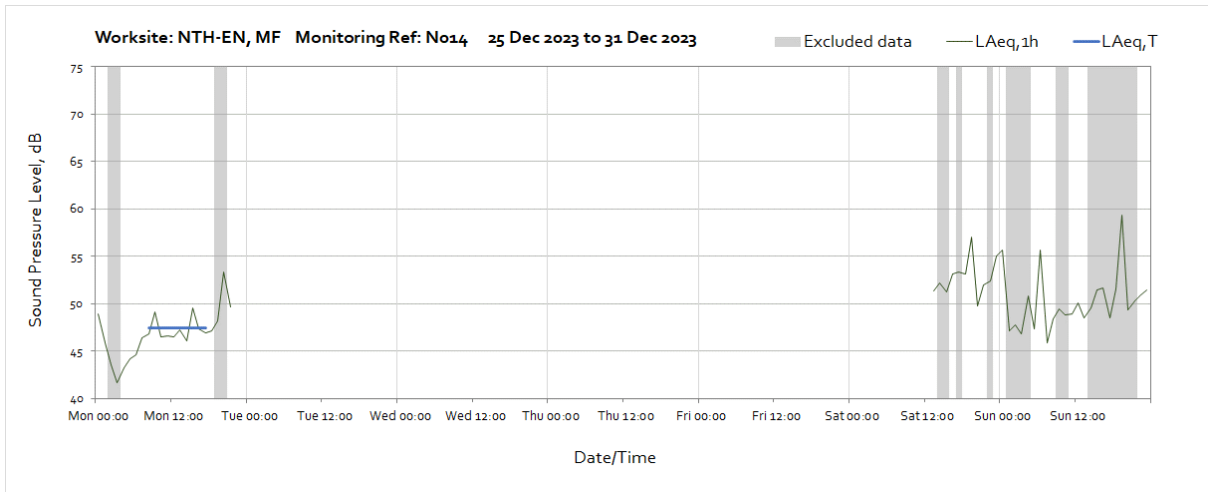
Worksite: NTH-EN, MF – Monitoring Ref: N014

Note: Missing data from 22:00 on 25th December until 12:00 on 30th December was due to a monitoring station error.
