February 2024

Construction noise and vibration Monthly Report – December 2023

London Borough of Hillingdon

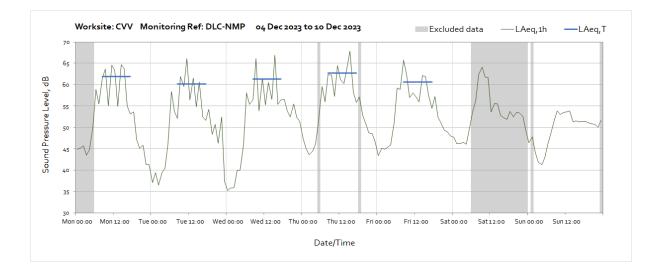
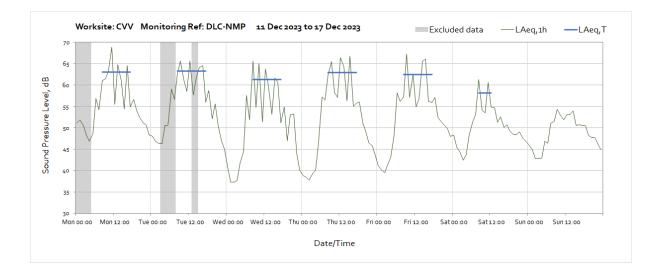
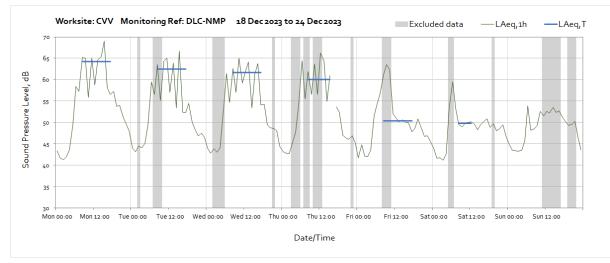
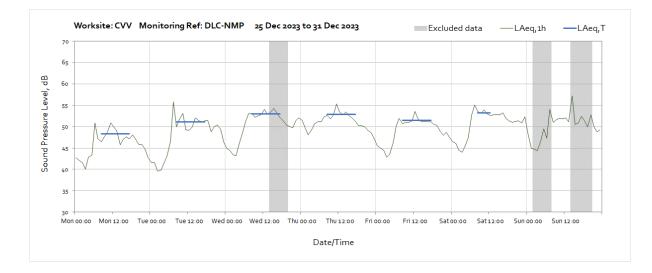
Worksite: CVV – Monitoring Ref: DLC-NMP

Note: Missing data between 16:00 and 17:00 on Thursday 21st December was due to a communication error between the monitoring station and the server.

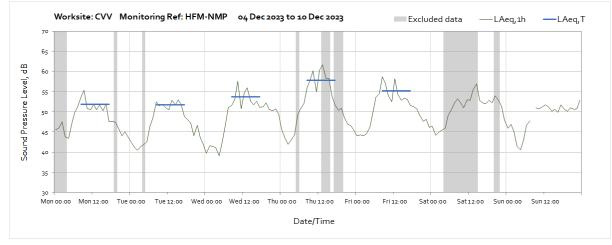
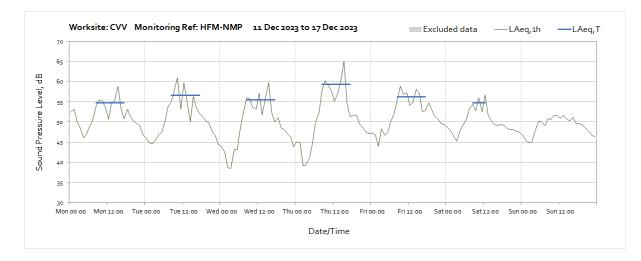
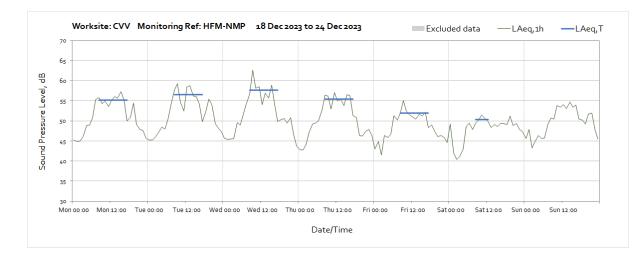
Worksite: CVV - Monitoring Ref: HFM-NMP

Note: Missing data between 08:00 and 09:00 on Sunday 10th December was due to a communication error between the monitoring station and the server.

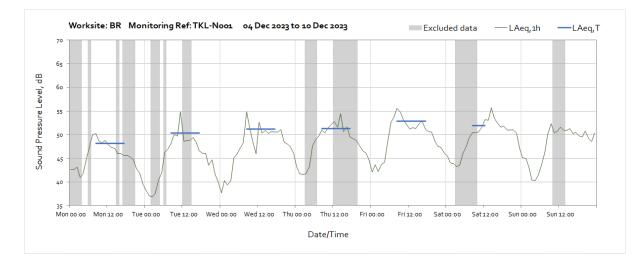
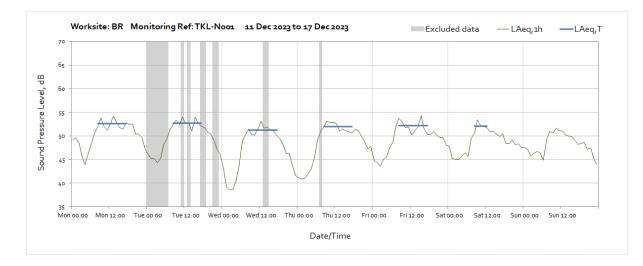
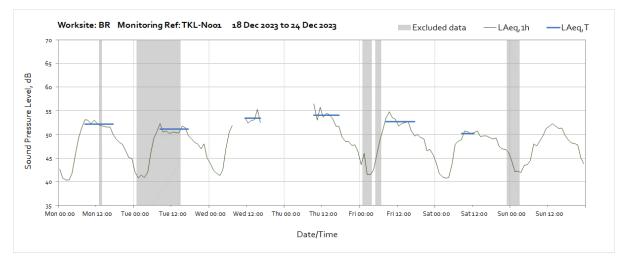
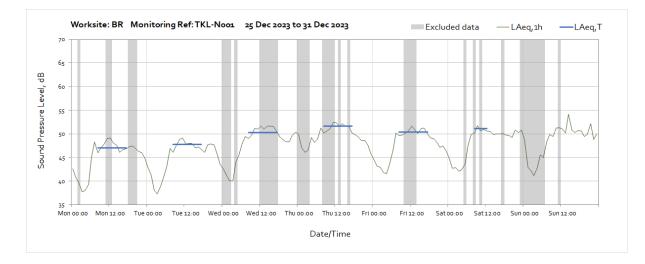
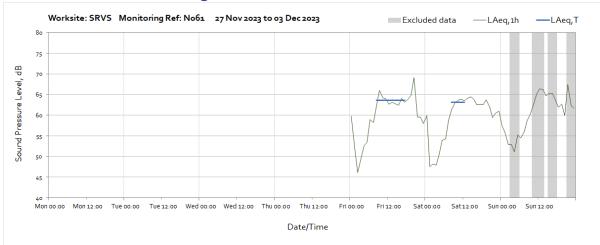
Worksite: BR – Monitoring Ref: TKL-N001

Note: Missing data on Wednesday and Thursday was due to depleted battery.

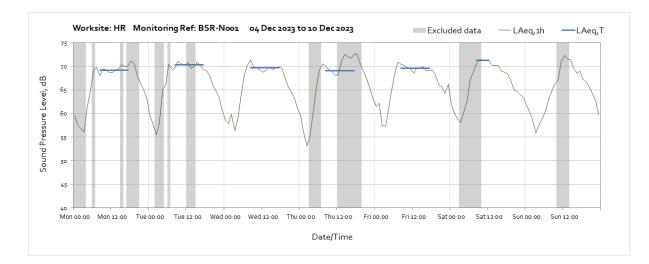
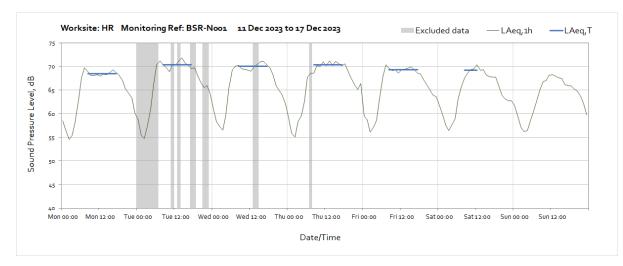
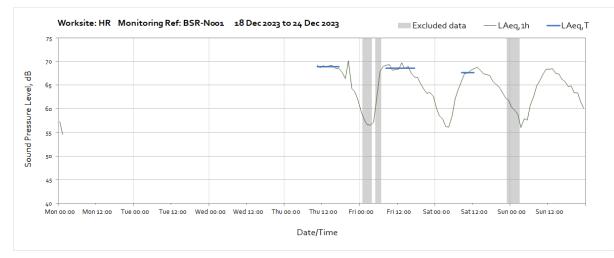
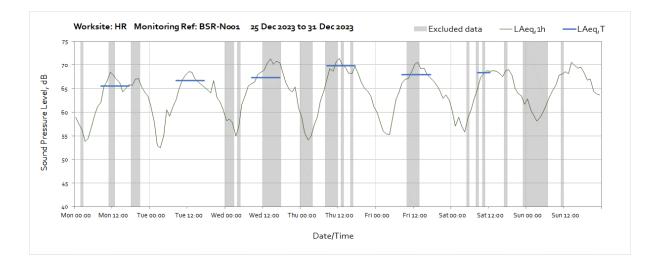
Worksite: HR - Monitoring Ref: BSR-N001

Note: Missing data between 02:00 on Monday 18th December and10:00 on Thursday 21st December was due to depleted battery.

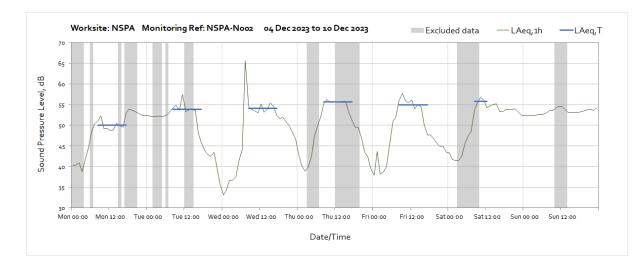
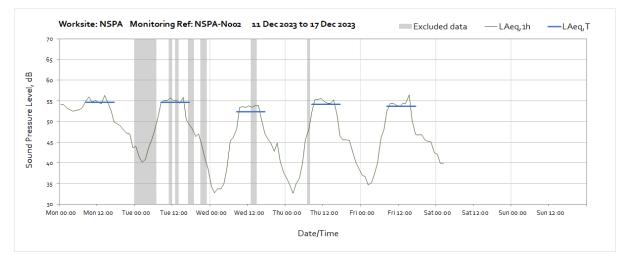
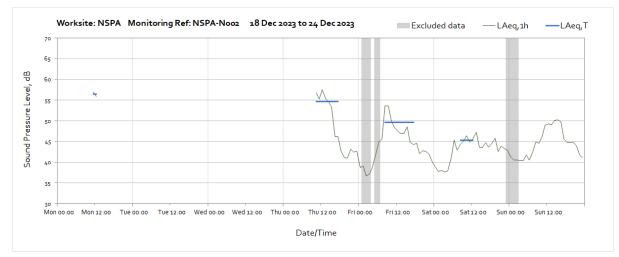
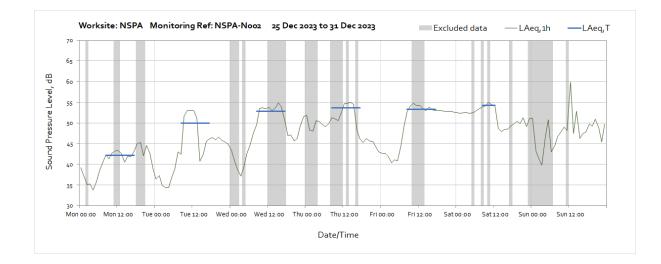
Worksite: NSPA – Monitoring Ref: NSPA-N002

Note: Missing data between 02:00 on Saturday 16th December and 11:00 on Monday 18th December was due to depleted battery.

Note: Missing data between 13:00 on Monday 18th December and 10:00 on Thursday 21st December was due to depleted battery.

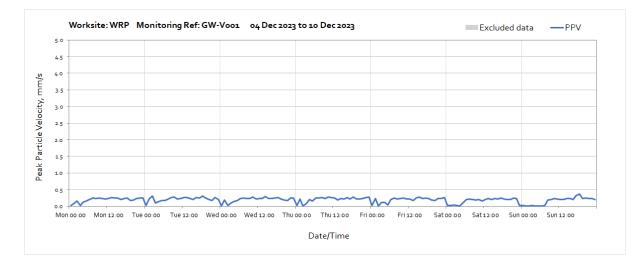
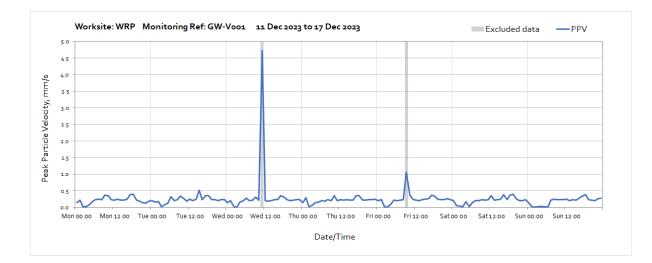
Worksite: WRP - Monitoring Ref: GW-V001

The following graphs show the hourly measured peak particle velocity PPV recorded during the monitoring period. The graphs show the highest PPV of the three orthogonal axis x, y, and z. Periods where PPV values have been affected by local interference with the vibration monitor or only measured for part of the period, which are not representative of HS2 construction works, have been greyed out and excluded when calculating values in Table 4 of the main report.
