Construction Noise and Vibration Monthly Report – December 2023

Lichfield District Council

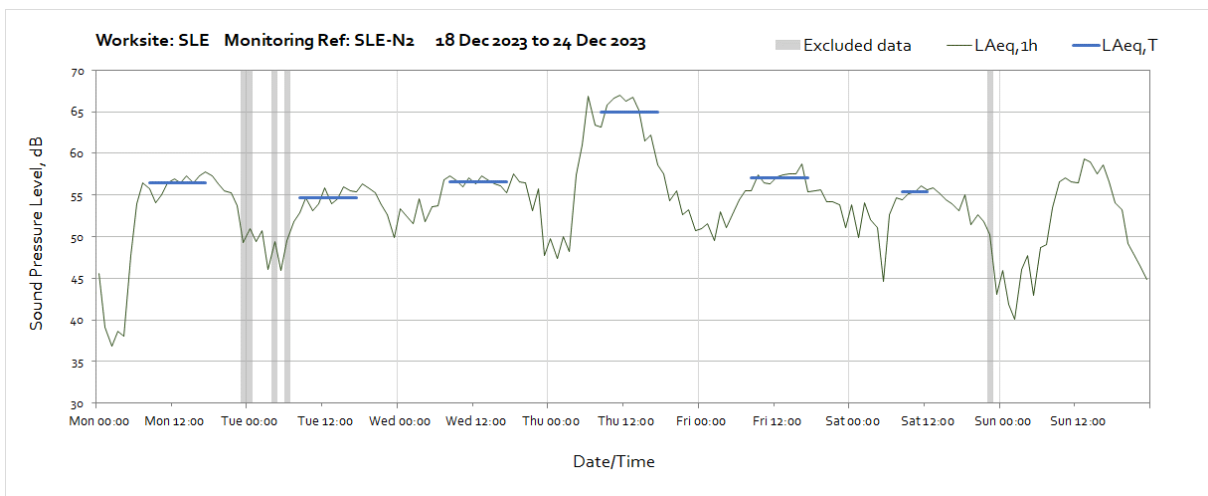
Worksite:SLE - Monitoring Ref: SLE-N2

The following graphs show the hourly measured ambient noise level LAeq,1h and, where relevant, the averaged noise level LAeq,T values, where the time period T is as specified in Table 1 of HS2 Information Paper E23. Periods where noise levels are adversely affected by weather or only measured for part of the period, which are not representative of HS2 construction works, have been greyed out and excluded from the calculation of the LAeq,T values in Table 3 of the main report.

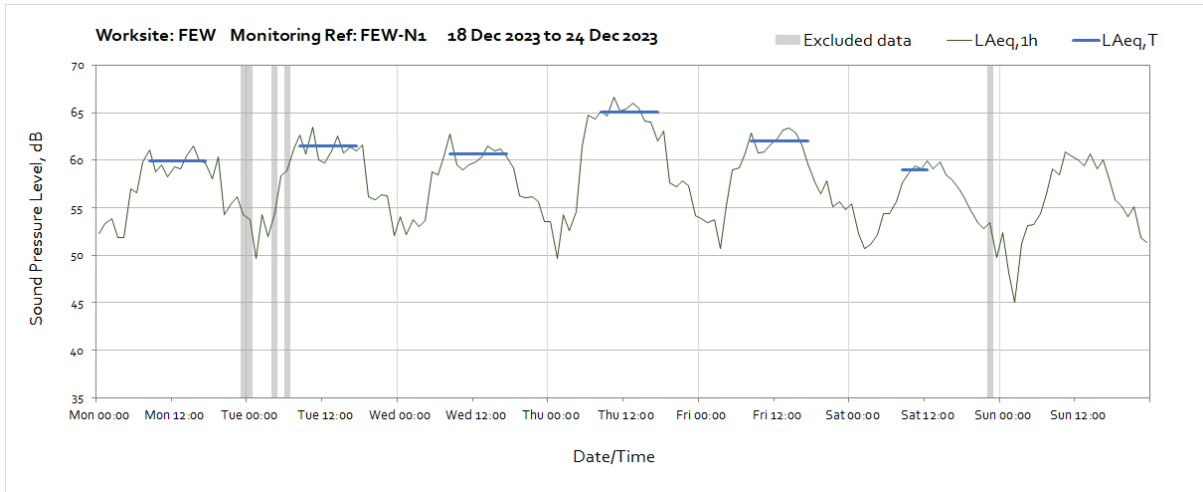
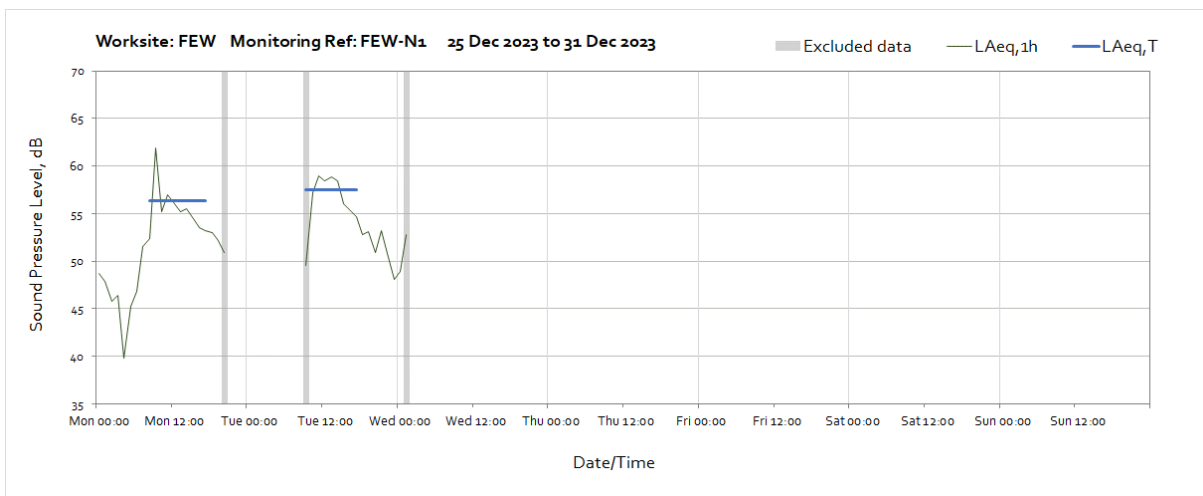
Worksite:FEW – Monitoring Ref: FEW-N1

Note: Missing data from 25th of December at 21:00 until 26th of December at 08:00 and from 27th of December at 02:00 until the end of the month was due to a loss of power at the monitoring station caused by insufficient sunlight for the solar panels.

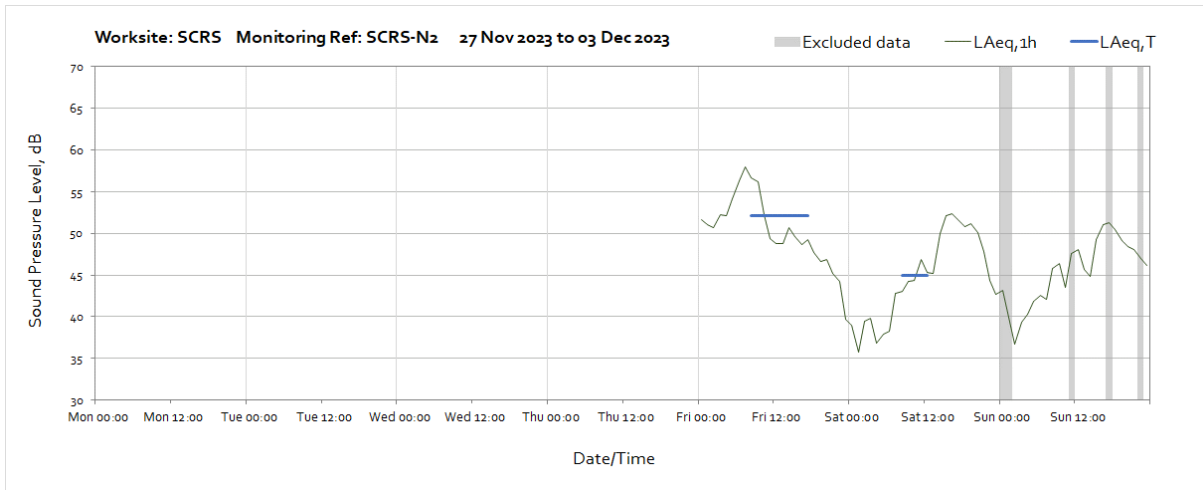
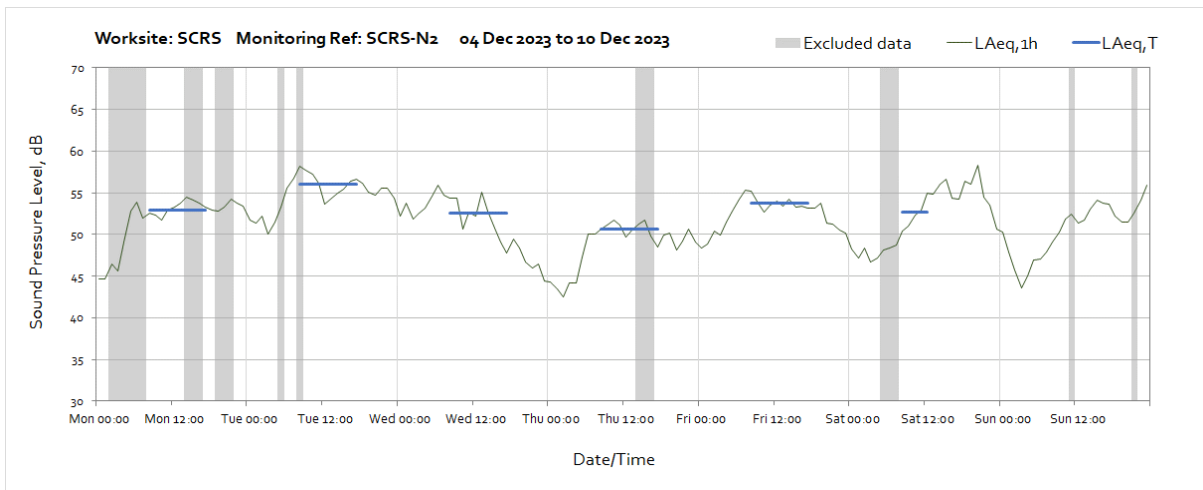
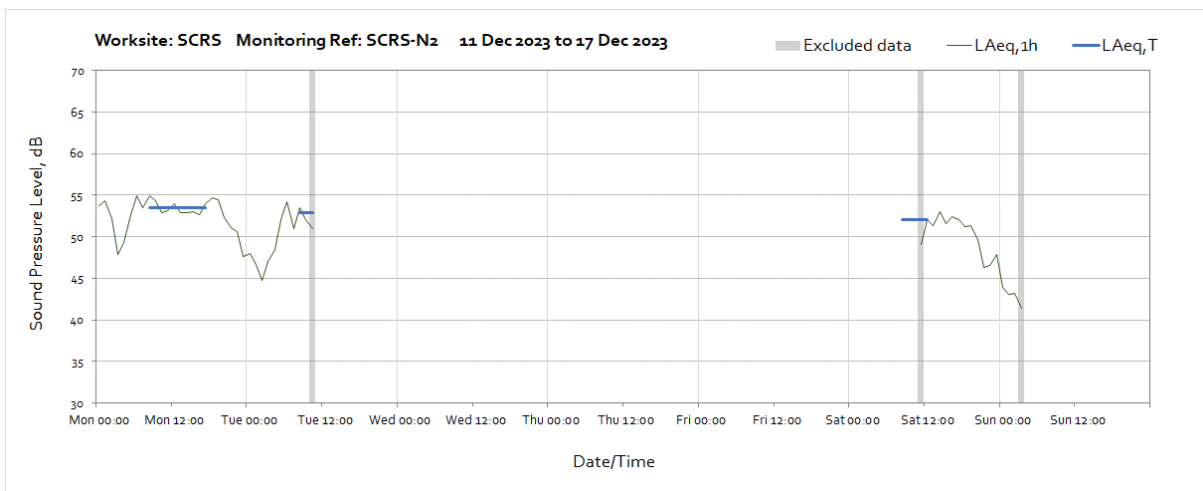
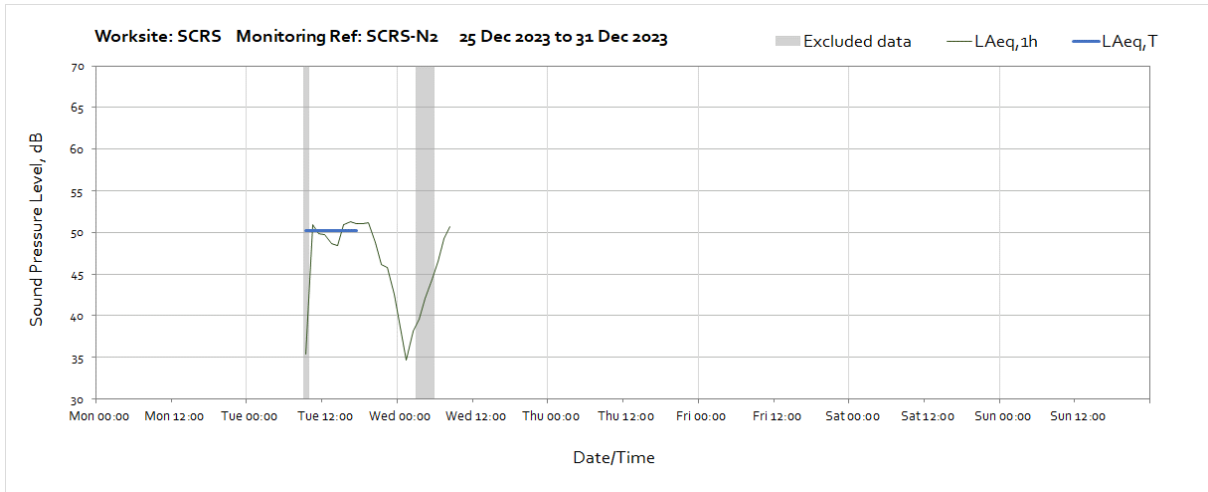
Worksite: SCRS – Monitoring Ref: SCRS-N2

Note: Missing data from 12th of December at 11:00 until 16th of December at 10:00 and from 17th of December at 04:00 until 26th of December at 08:00 was due to a loss of power at the monitoring station caused by insufficient sunlight for the solar panels.

Note: Missing data throughout the week until the end of the month was due to a loss of power at the monitoring station caused by insufficient sunlight for the solar panels.

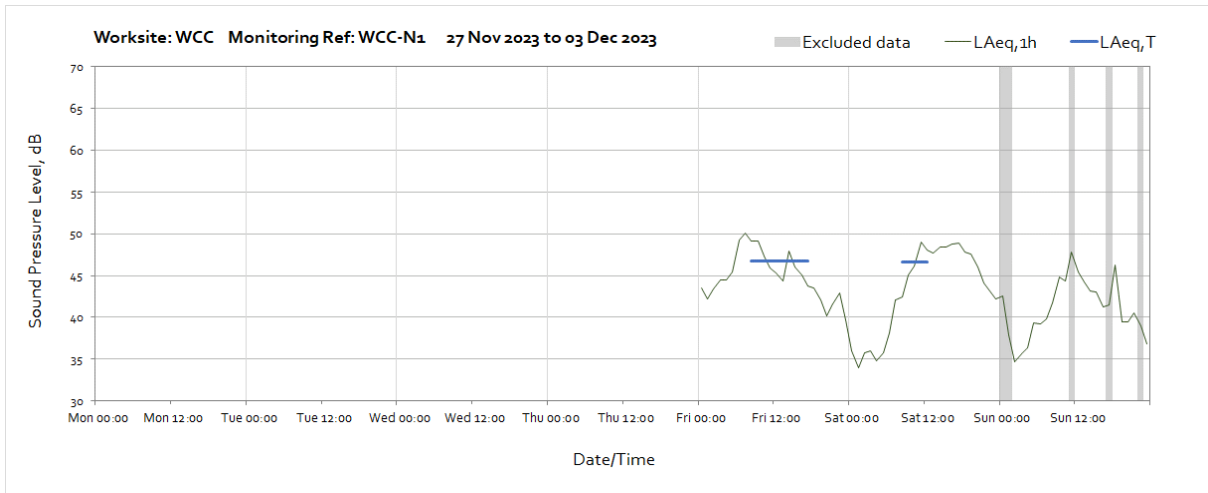
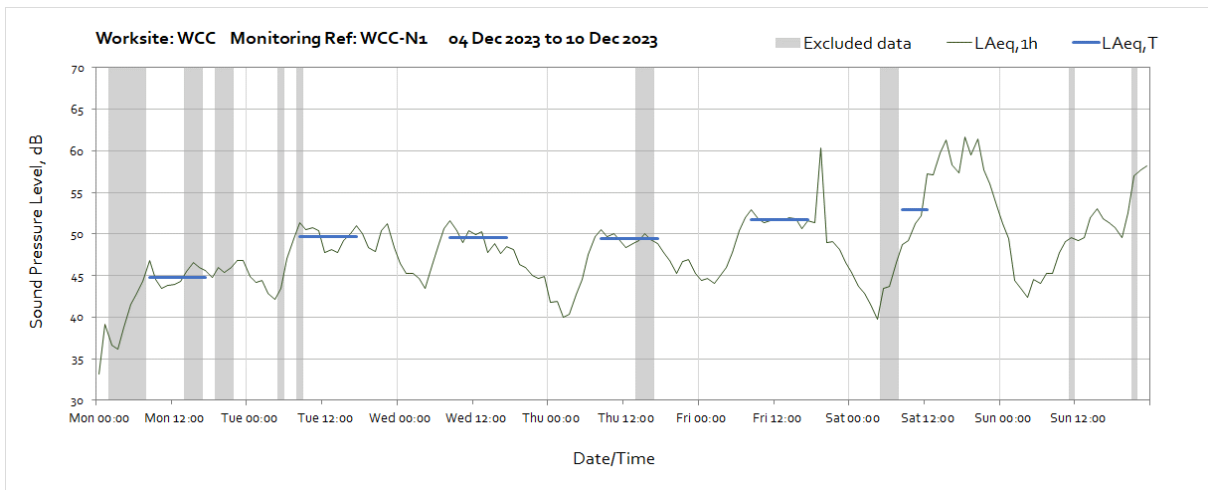
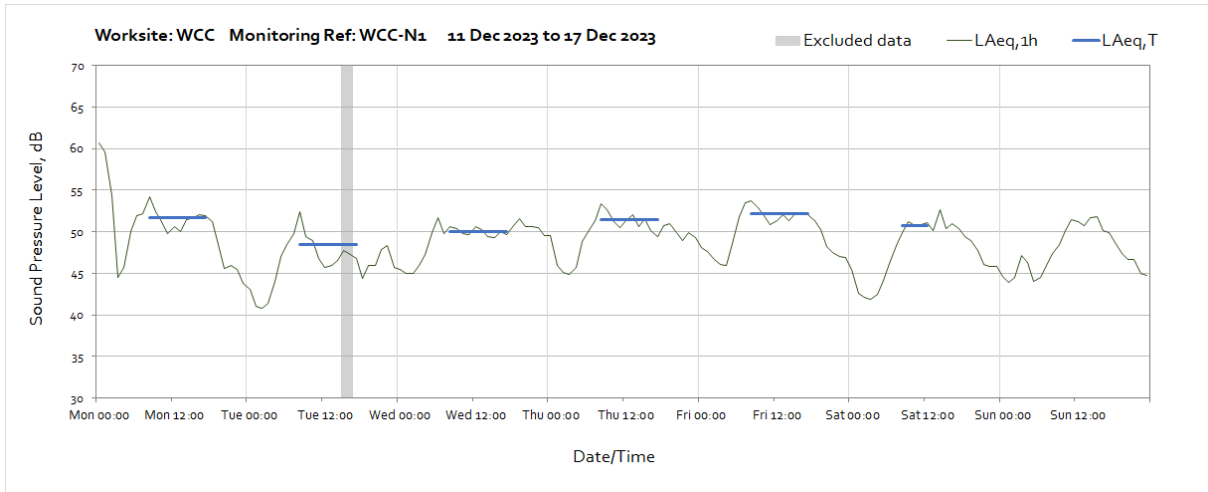
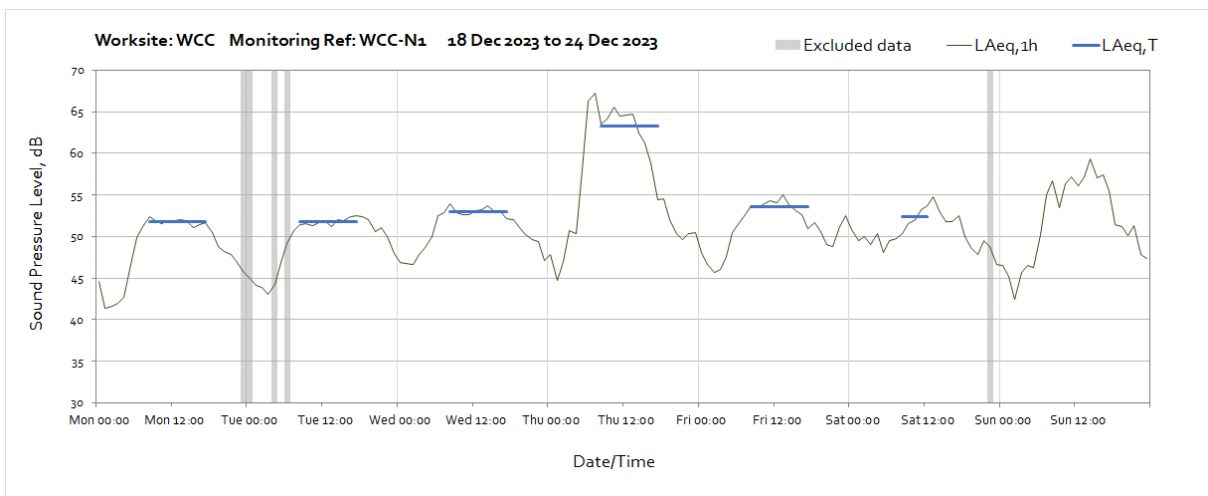
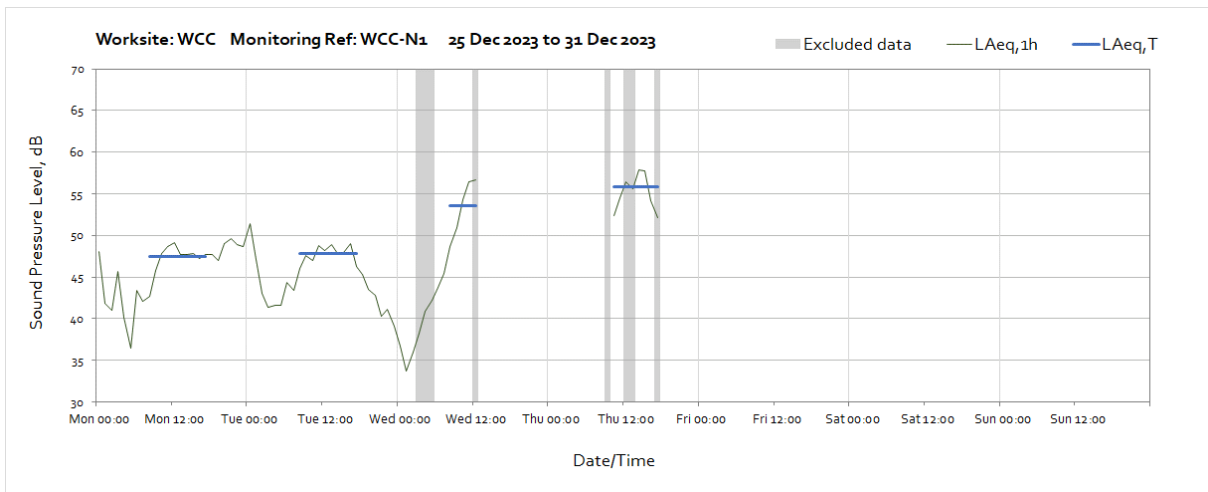
Worksite:WCC – Monitoring Ref: WCC-N1

Note: Missing data from 27th of December at 13:00 until 28th of December at 09:00 and from 28th of December at 04:00 the end of the month was due to a loss of power at the monitoring station caused by insufficient sunlight for the solar panels.

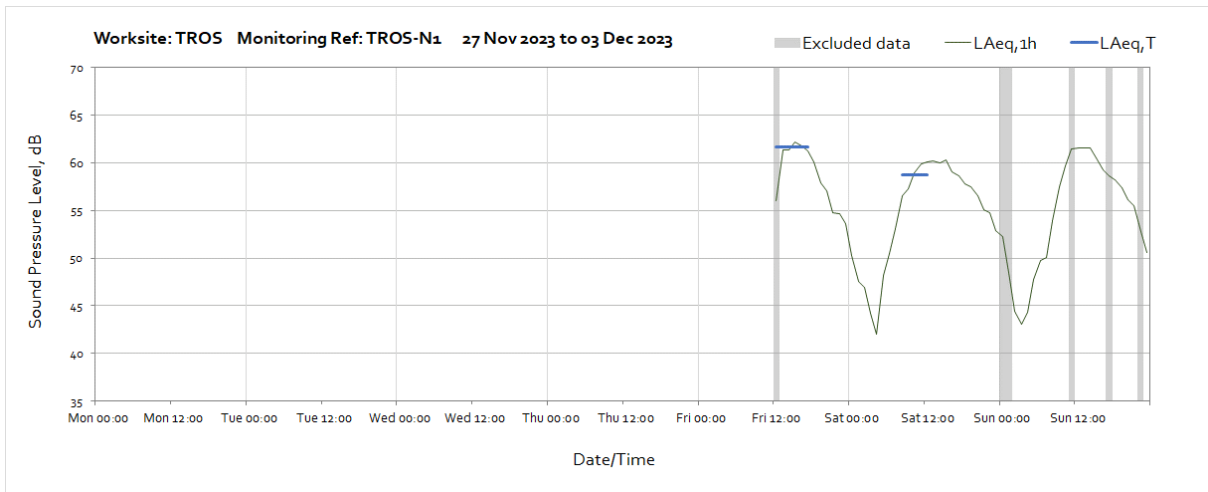
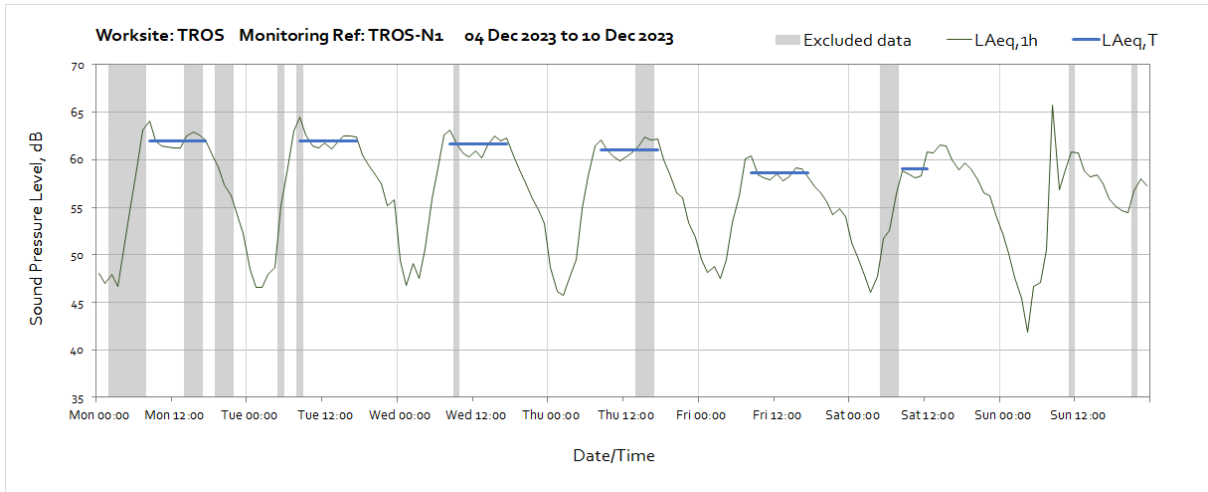
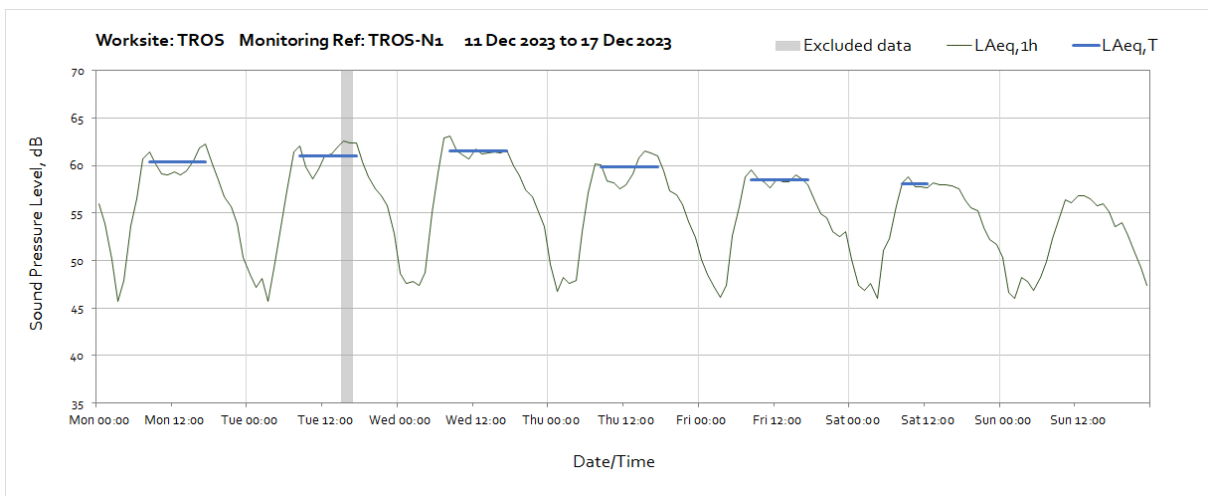
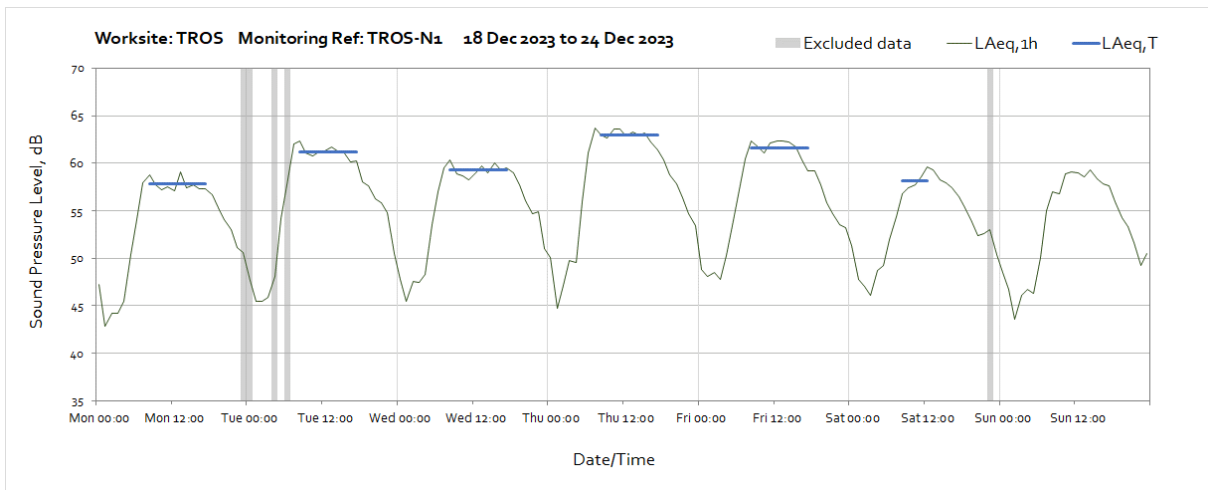
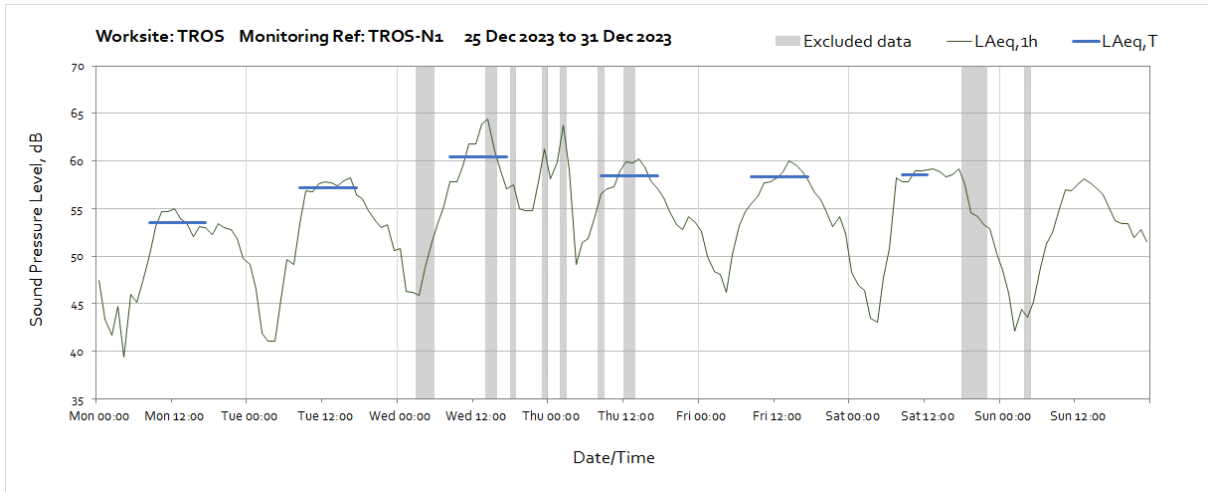
Worksite:TROS – Monitoring Ref: TROS-N1

Note: Missing data from the start of the month until 1st of December at 11:00 was due to a loss of power at the monitoring station caused by insufficient sunlight for the solar panels.

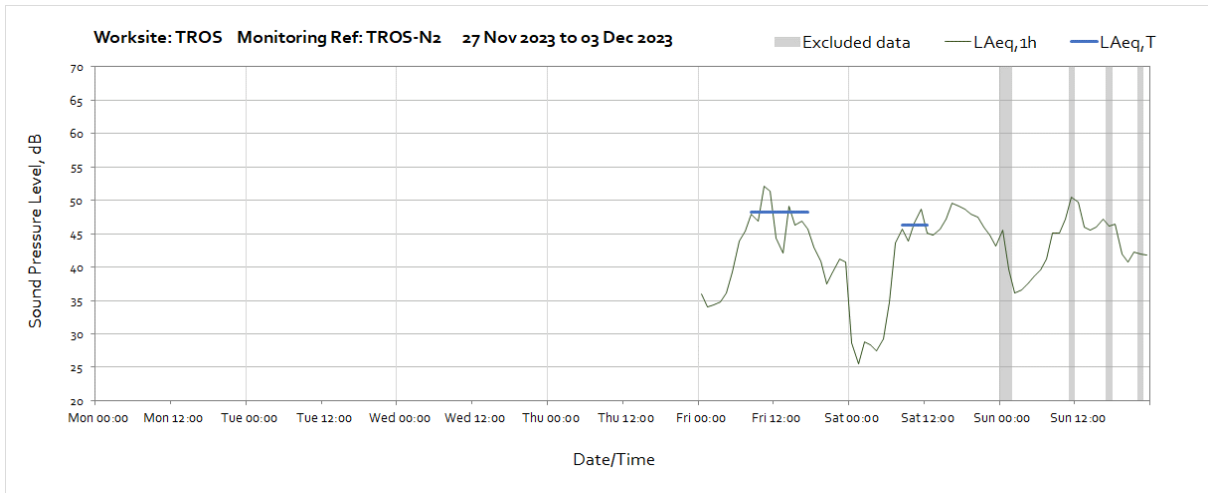
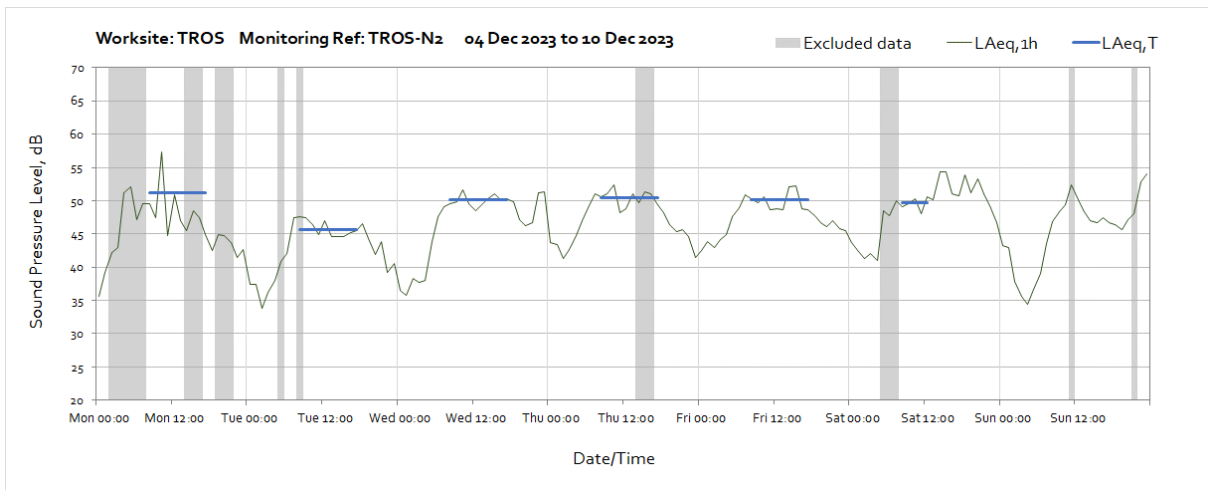
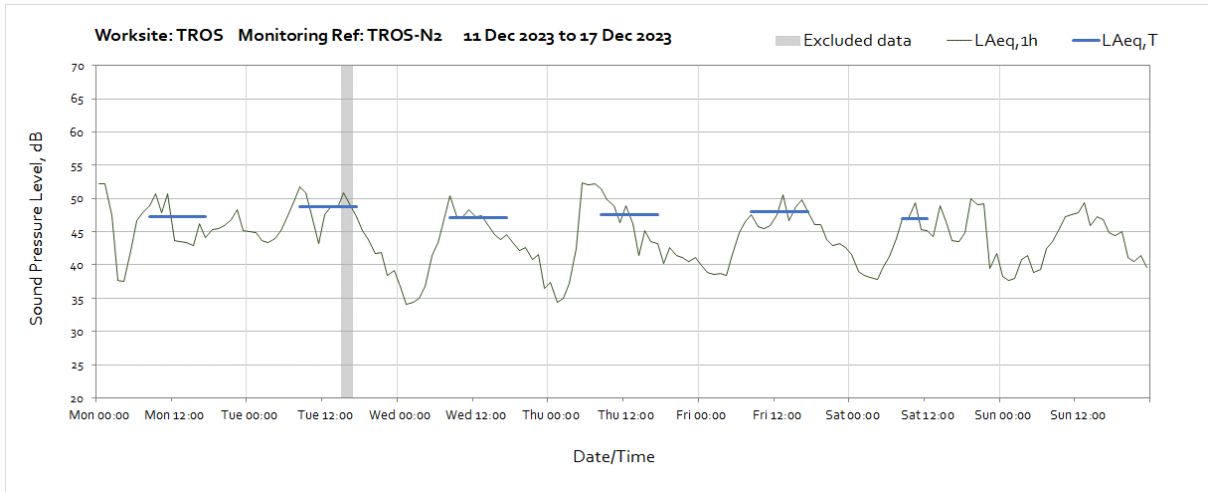
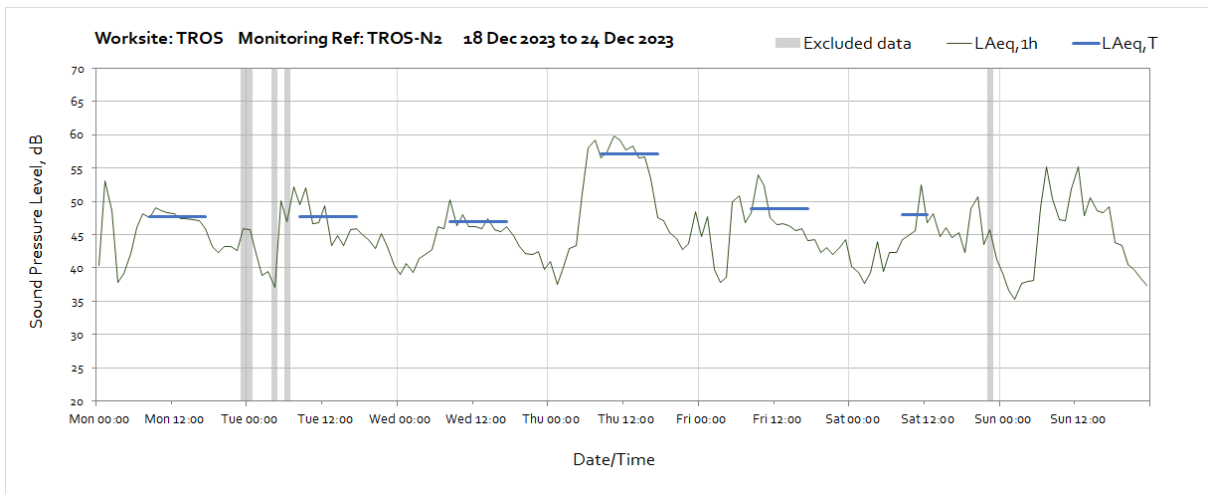
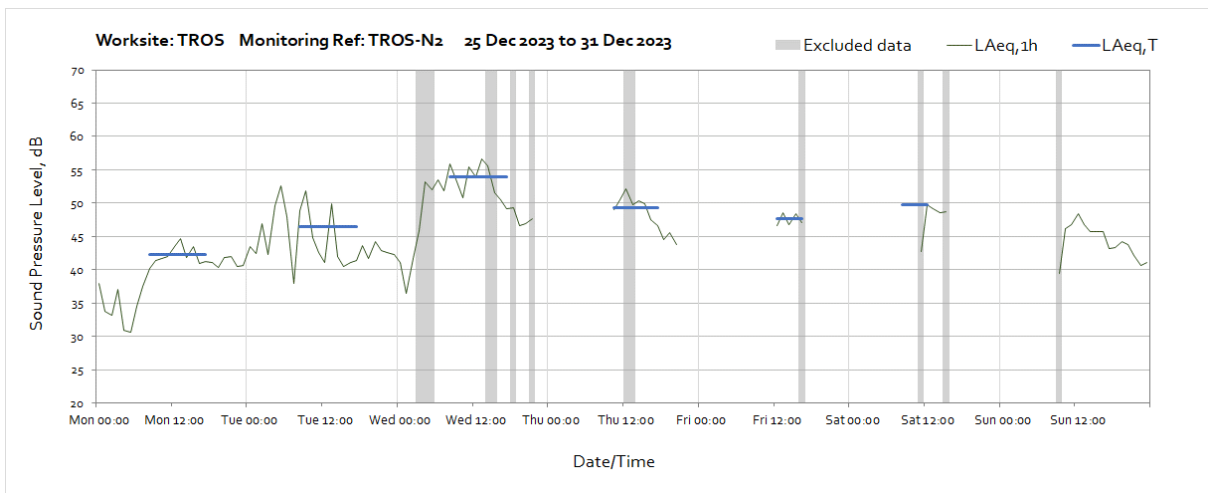
Worksite:TROS – Monitoring Ref: TROS-N2

Note: Missing data throughout the week was due to a loss of power at the monitoring station caused by insufficient sunlight for the solar panels.

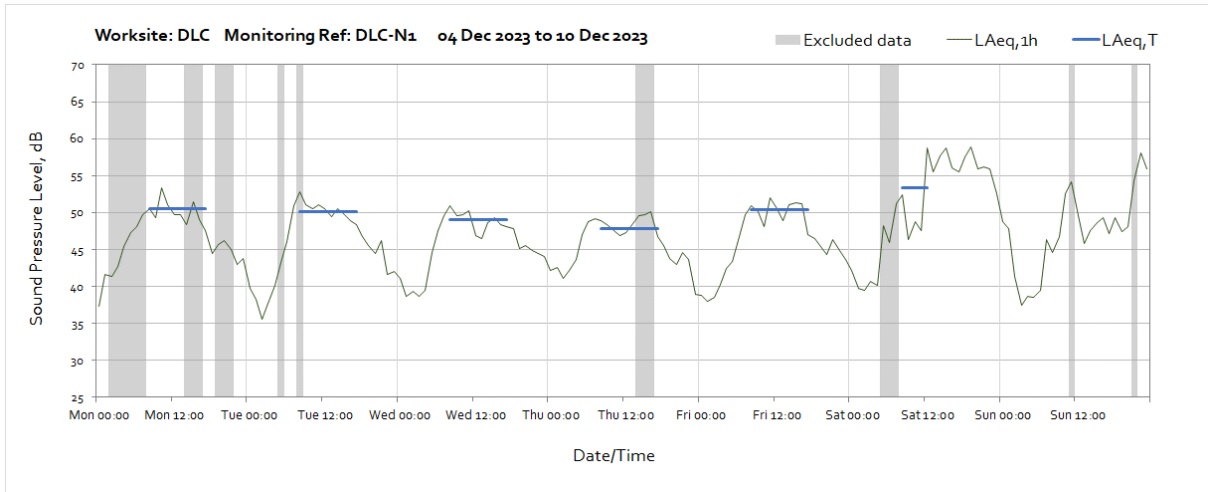
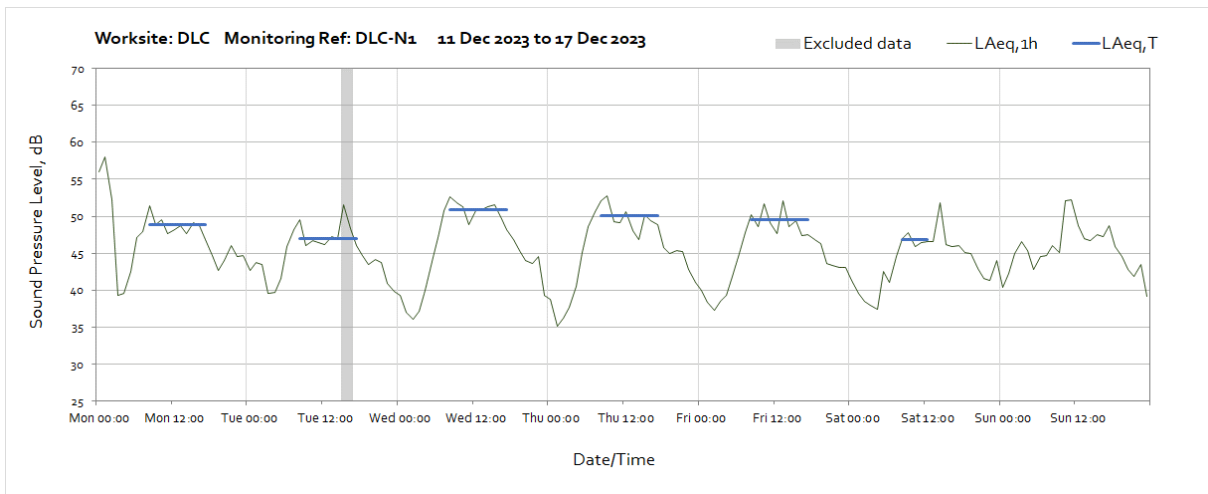
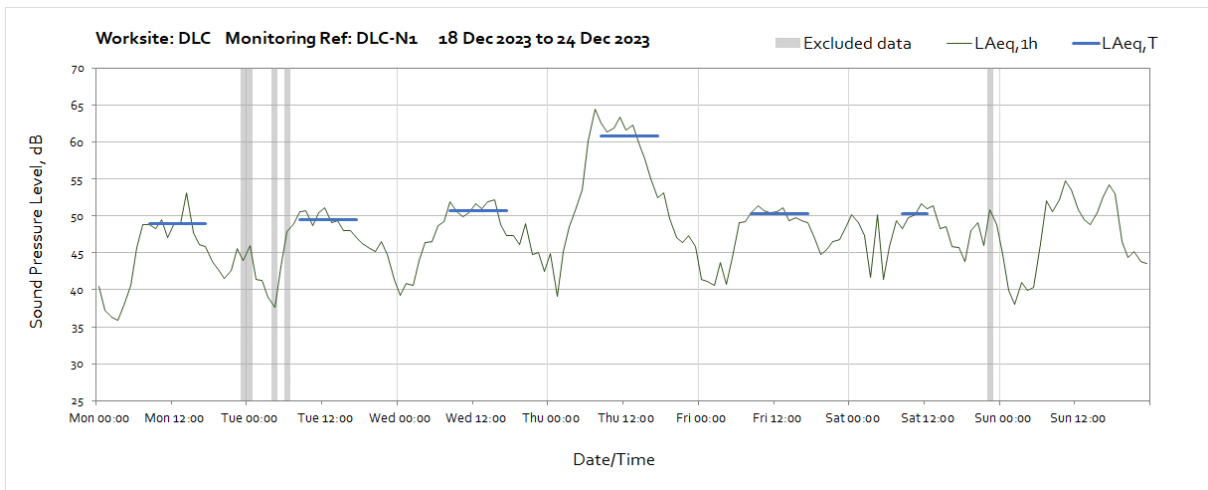
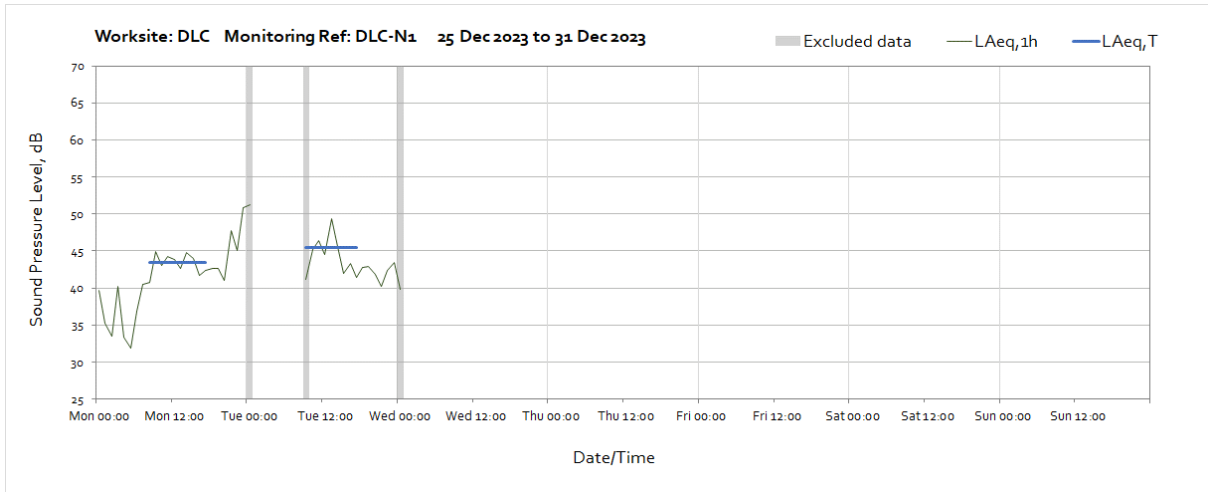
Worksite: DLC - Monitoring Ref: DLC-N1

Note: Missing data from the 06th of December at 01:00 until 08:00 and from 27th of December at 01:00 until the end of the month was due to a loss of power at the monitoring station caused by insufficient sunlight for the solar panels.

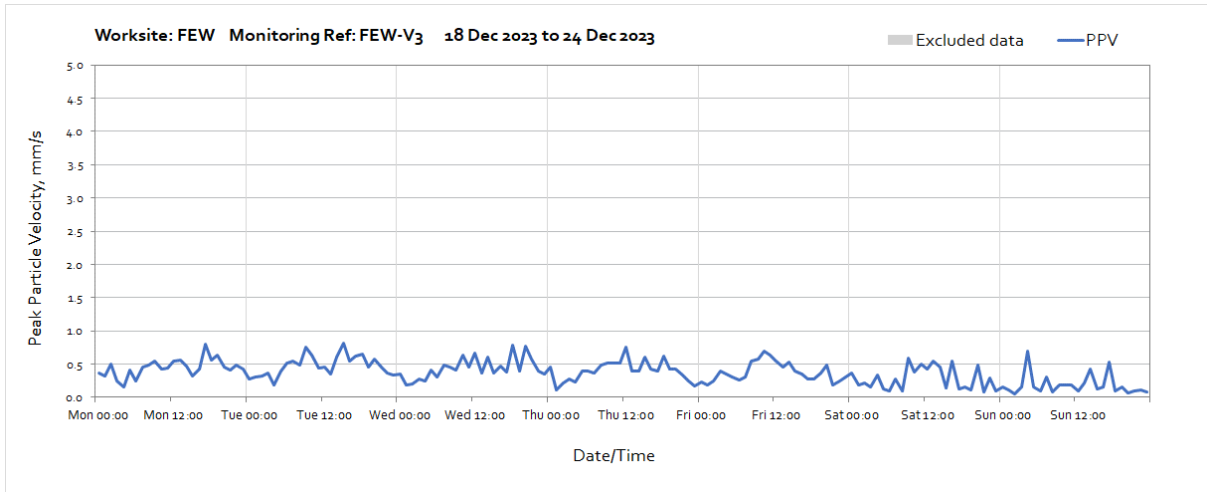
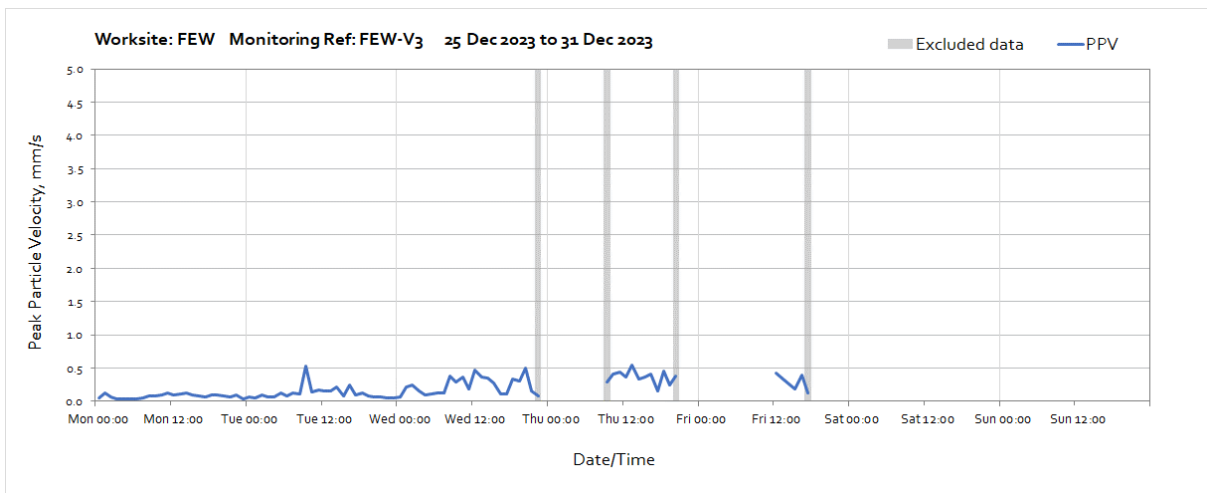
Worksite: FEW – Monitoring Ref: FEW-V3

The following graphs show the hourly measured peak particle velocity PPV recorded during the monitoring period. The graphs show the highest PPV of the three orthogonal axes x, y and z. Periods where PPV values have been affected by local interference with the vibration monitor or only measured for part of the period, which are not representative of HS2 construction works, have been greyed out and excluded when calculating values in Table 4 of the main report.

Note: Missing data throughout the week and until the end of the month was due to a loss of power at the monitoring station caused by insufficient sunlight for the solar panels.

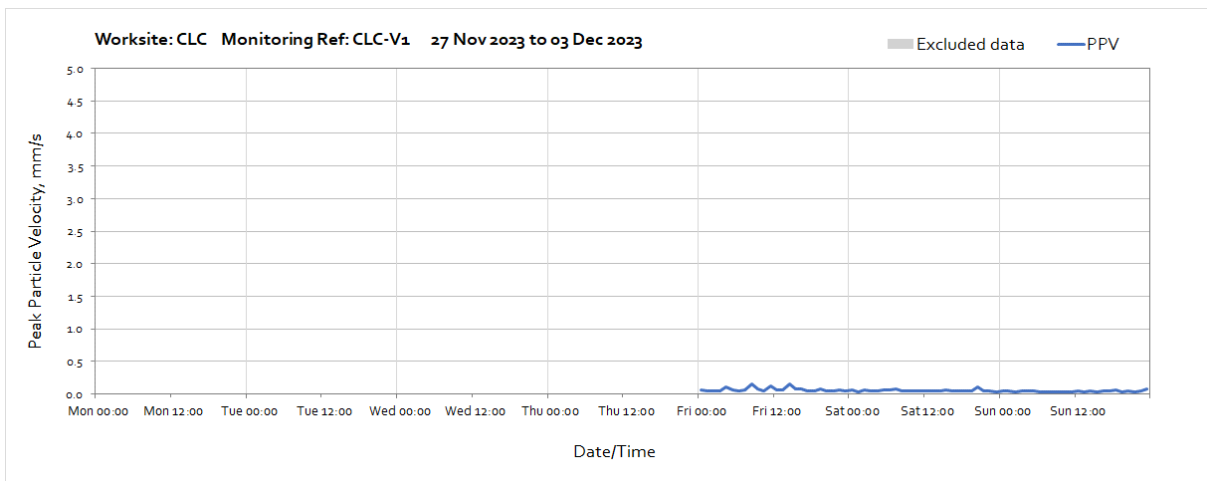
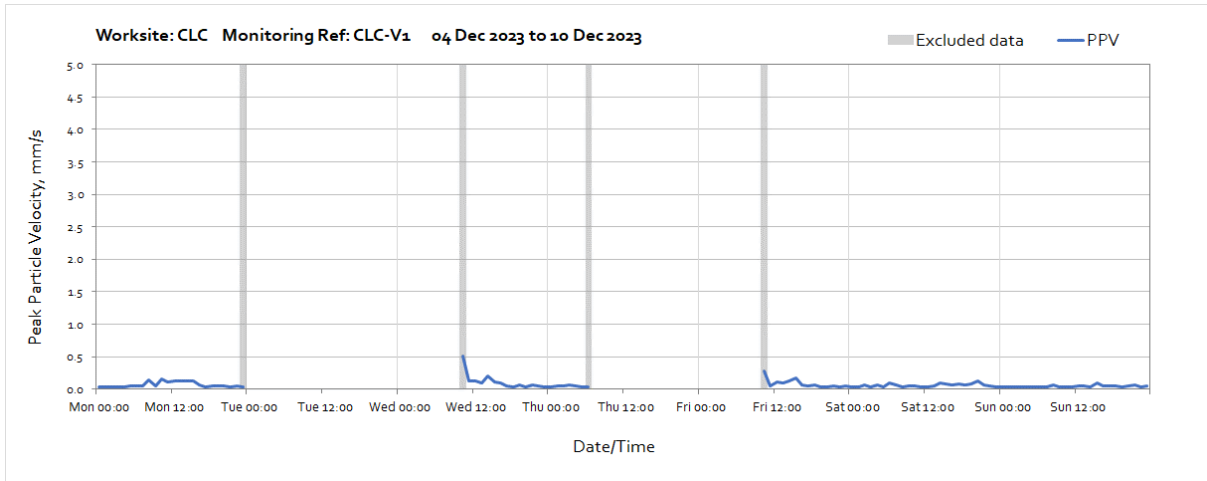
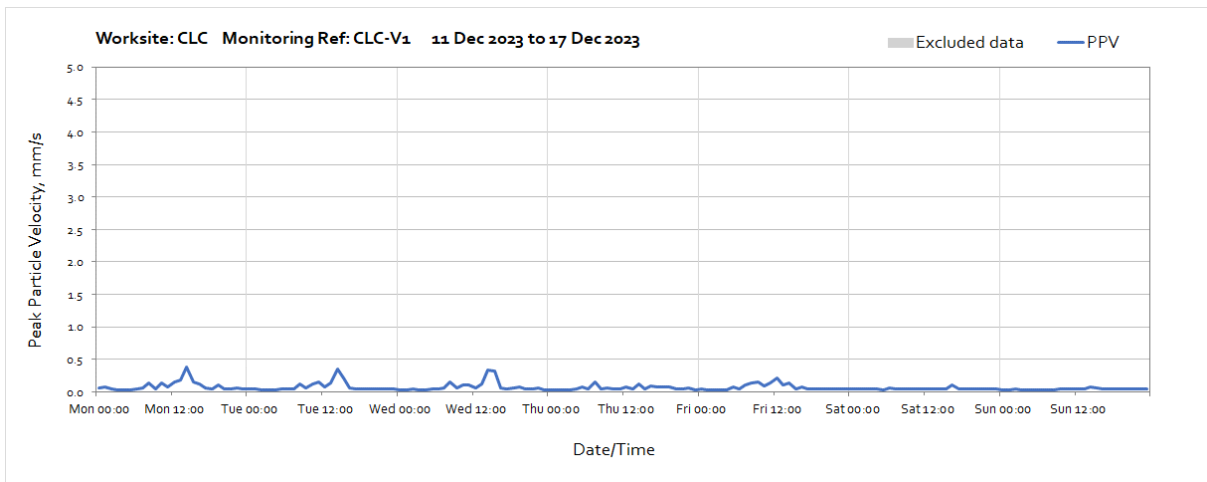
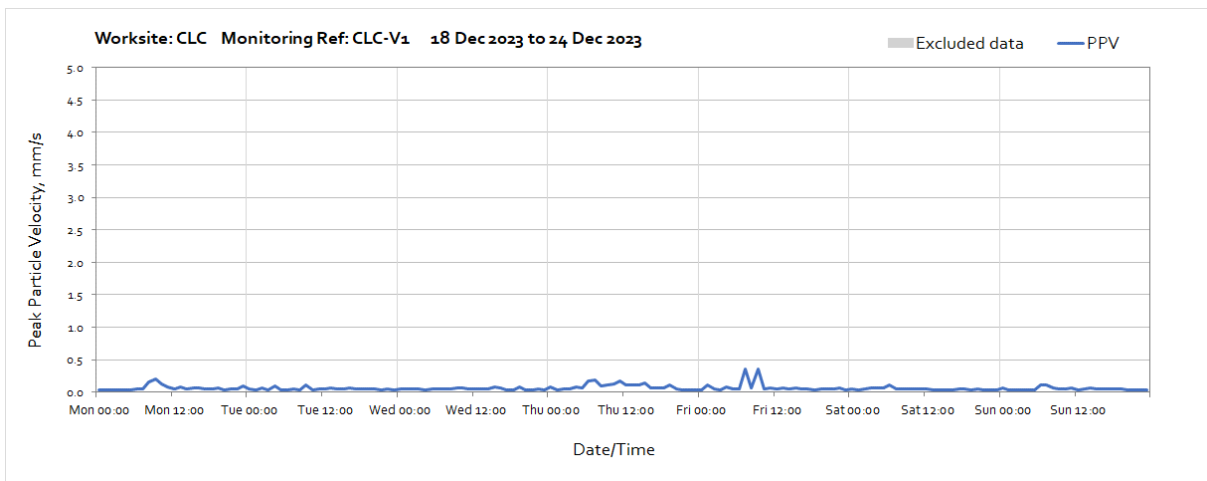
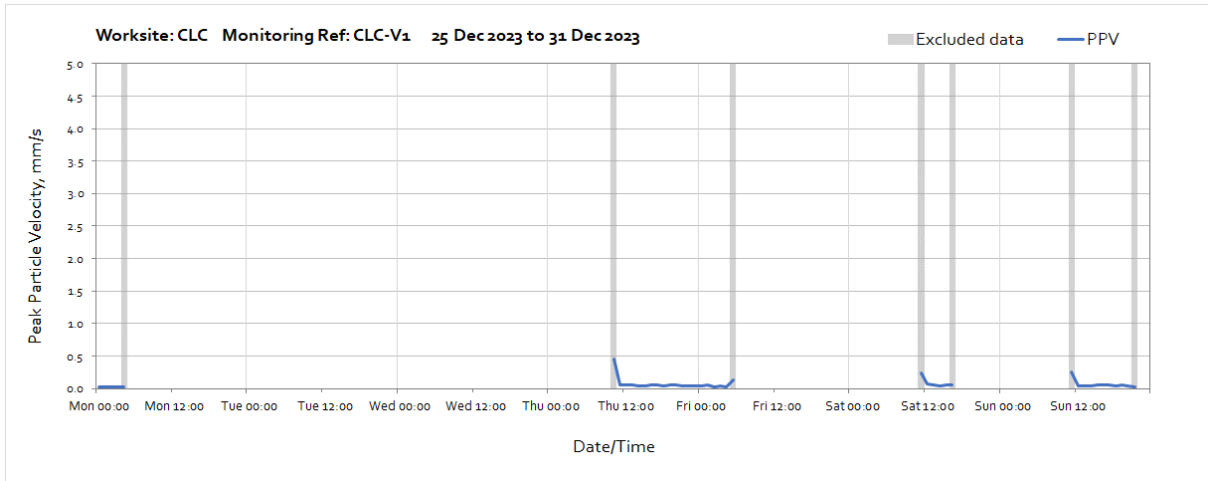
Worksite: CLC – Monitoring Ref: CLC-V1

Note: Missing data from the 05th of December at 00:00 until the 6th of December at 09:00 and from 07th of December at 07:00 until 08th of December at 09:00 was due to blocked solar panel resulting in power issues at the monitoring station.

Note: Missing data throughout the week was due to blocked solar panel resulting in power issues at the monitoring station.

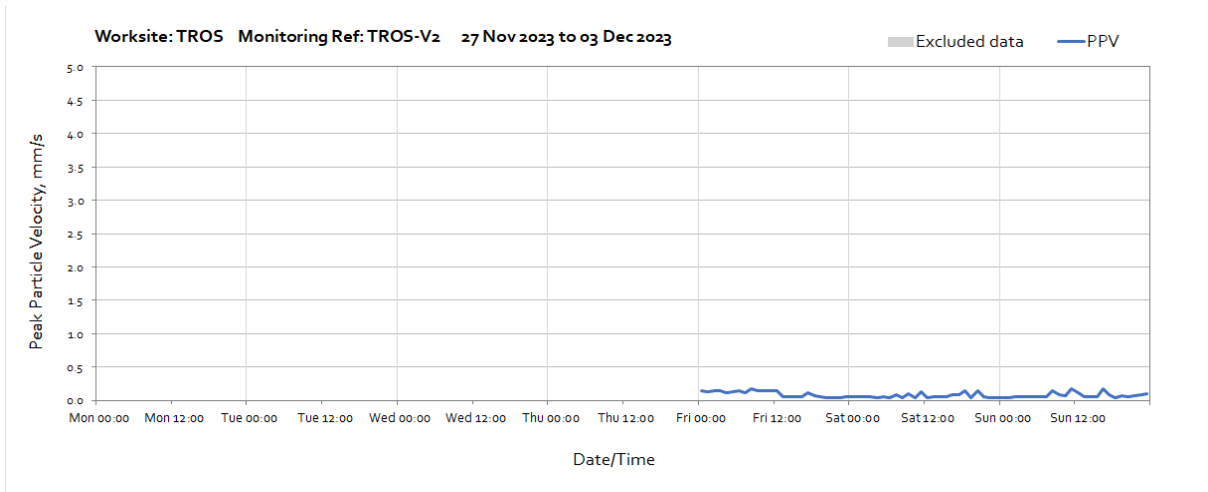
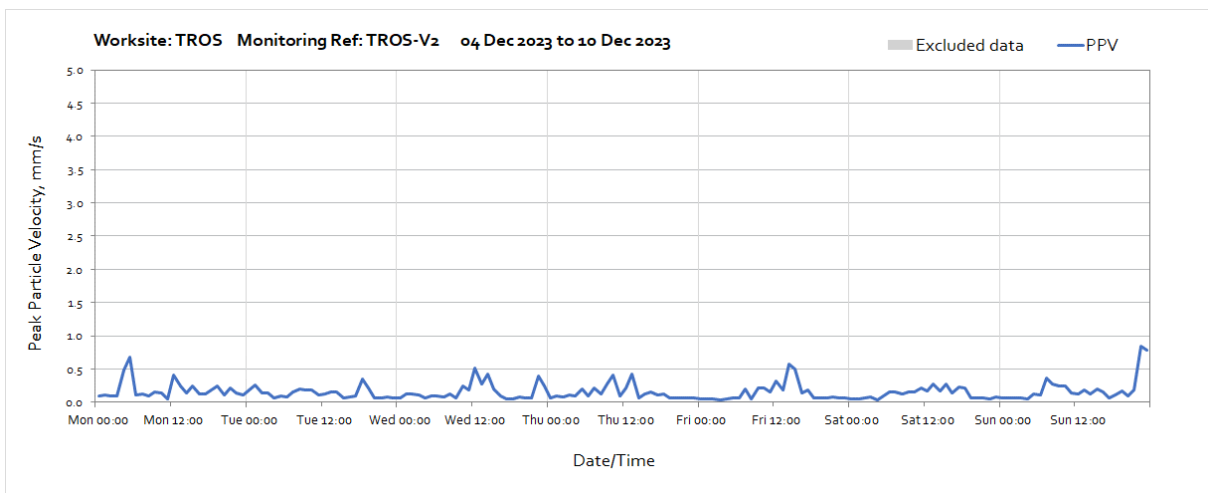
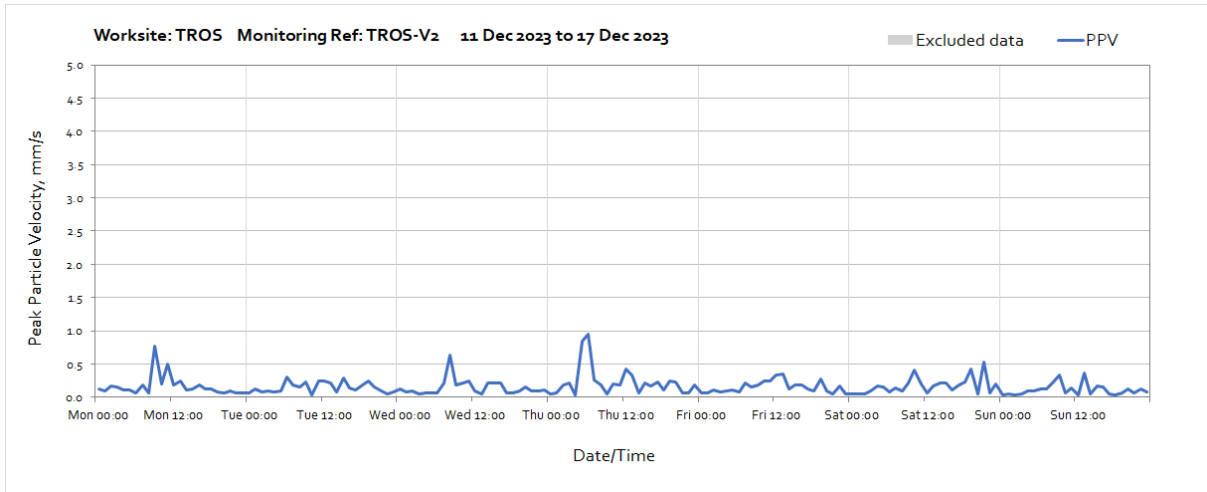
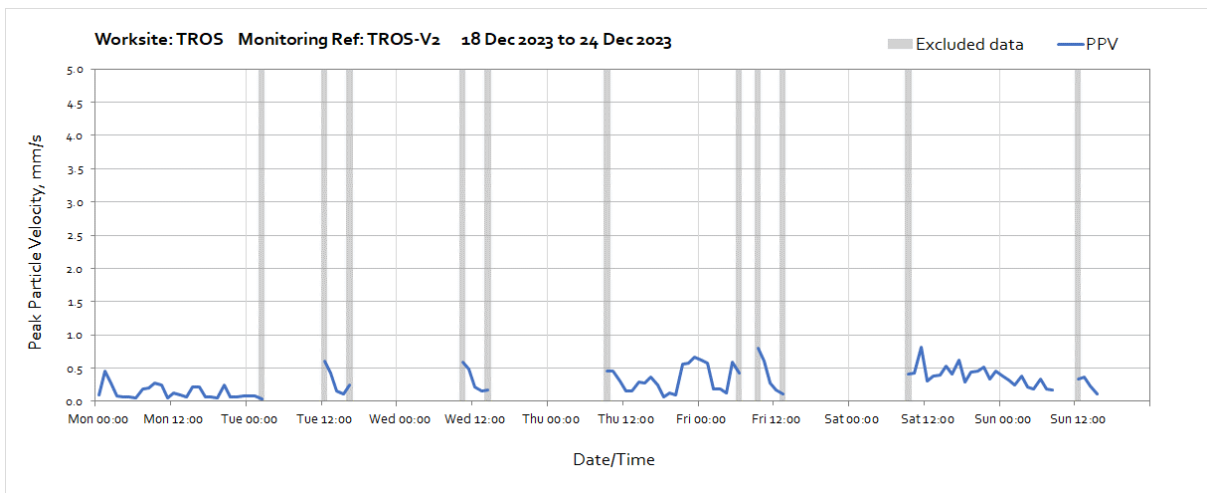
Worksite: TROS – Monitoring Ref: TROS-V2

Note: Missing data throughout the week until the end of the month was due to a loss of power at the monitoring station caused by insufficient sunlight for the solar panels.
