Construction Noise and Vibration Monthly Report – December 2023

Lichfield District Council

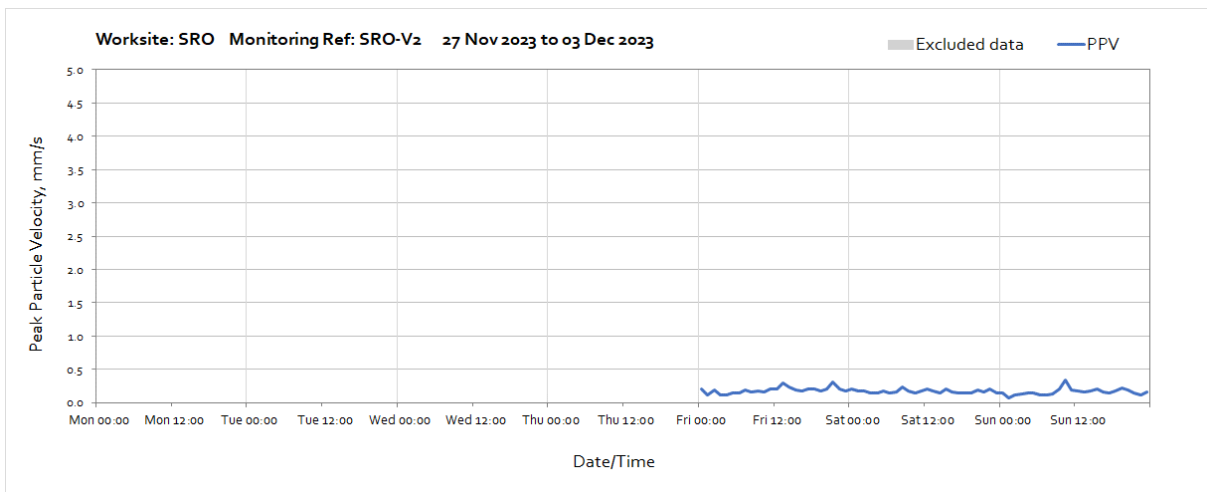
Worksite: SRO - Monitoring Ref: SRO-V2

The following graphs show the hourly measured peak particle velocity PPV recorded during the monitoring period. The graphs show the highest PPV of the three orthogonal axes x, y and z. Periods where PPV values have been affected by local interference with the vibration monitor or only measured for part of the period, which are not representative of HS2 construction works, have been greyed out and excluded when calculating values in Table 4 of the main report.
