## **Construction Noise and Vibration Monthly Report – December 2023**

### **Solihull Metropolitan Borough Council**

# Non-Technical Summary

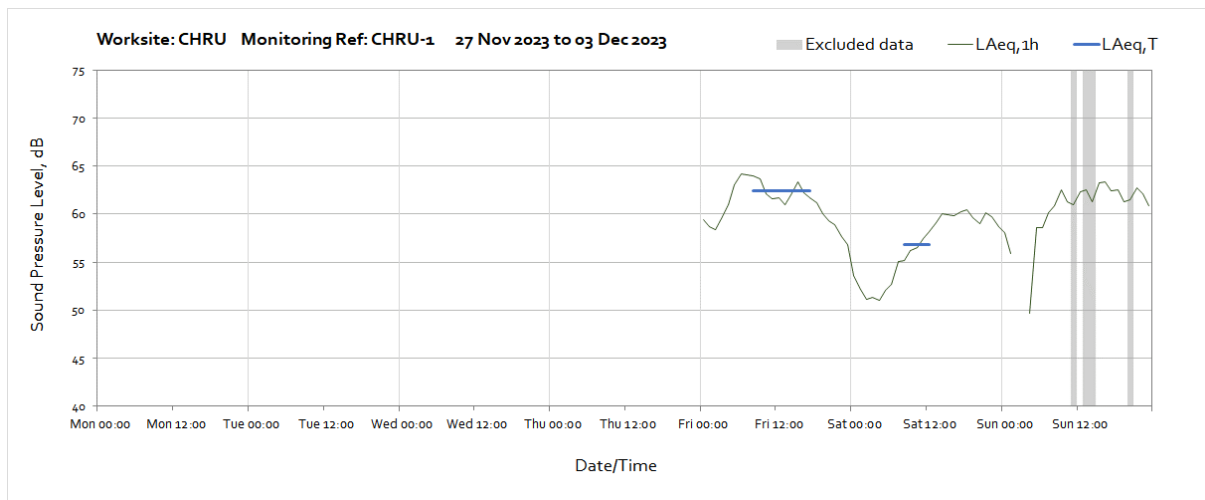
### Worksite: CHR - Monitoring Ref: CHRU-1

Note: Missing data between 02:00 and 04:00 on Sunday 3<sup>rd</sup> of December was due to a clock alignment issue at the monitoring station.

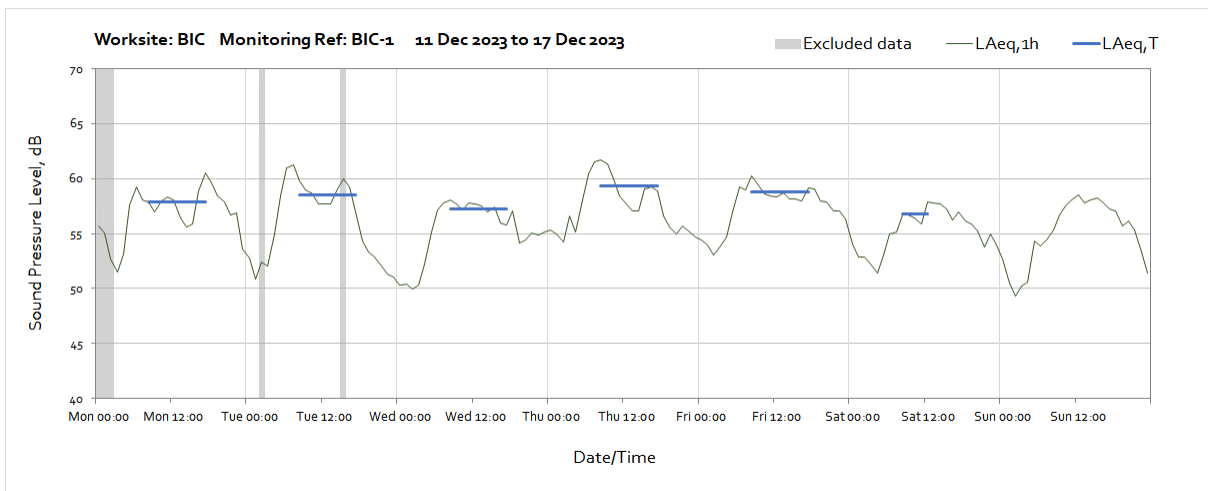
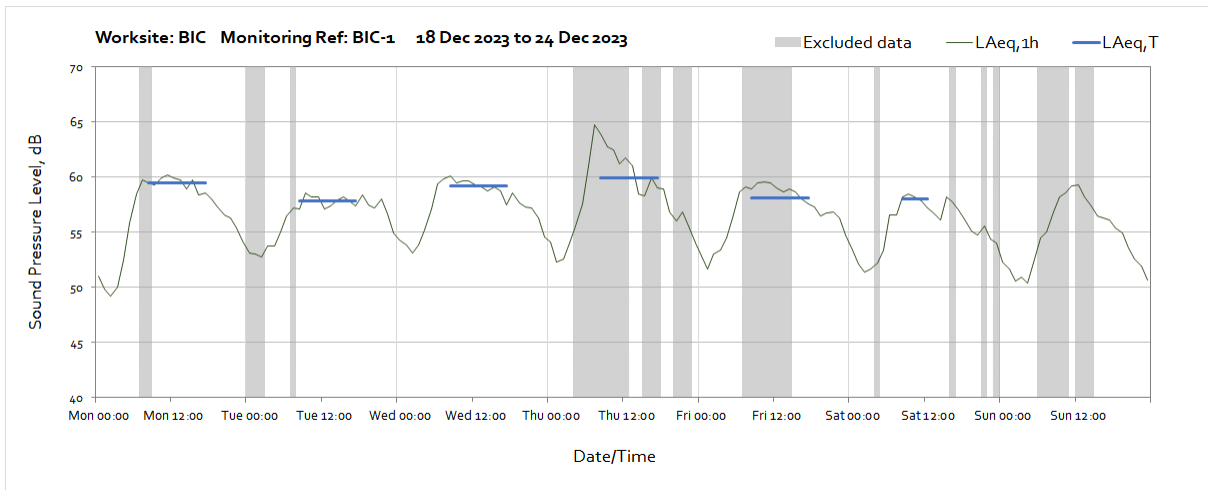
**Worksite: BIC - Monitoring Ref: BIC-1**

Note: Intermittent missing data throughout the week until the end of the month was due to poor weather conditions effecting the solar power source to the monitoring station.

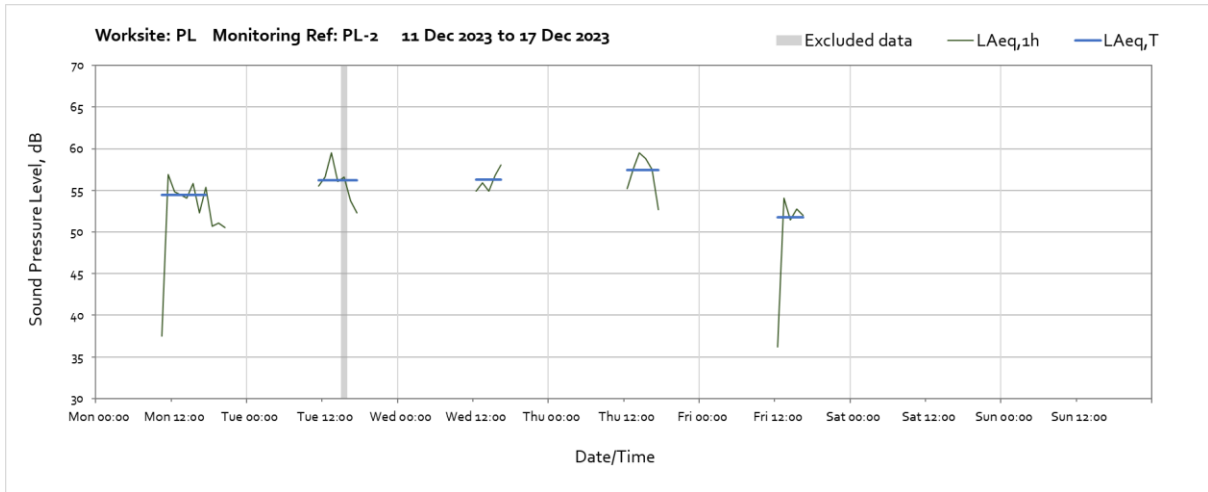
## Worksite: PL - Monitoring Ref: PL-2

Note: Intermittent missing data throughout the month was due to poor weather conditions and vegetation growth effecting the solar power source to the monitoring station.

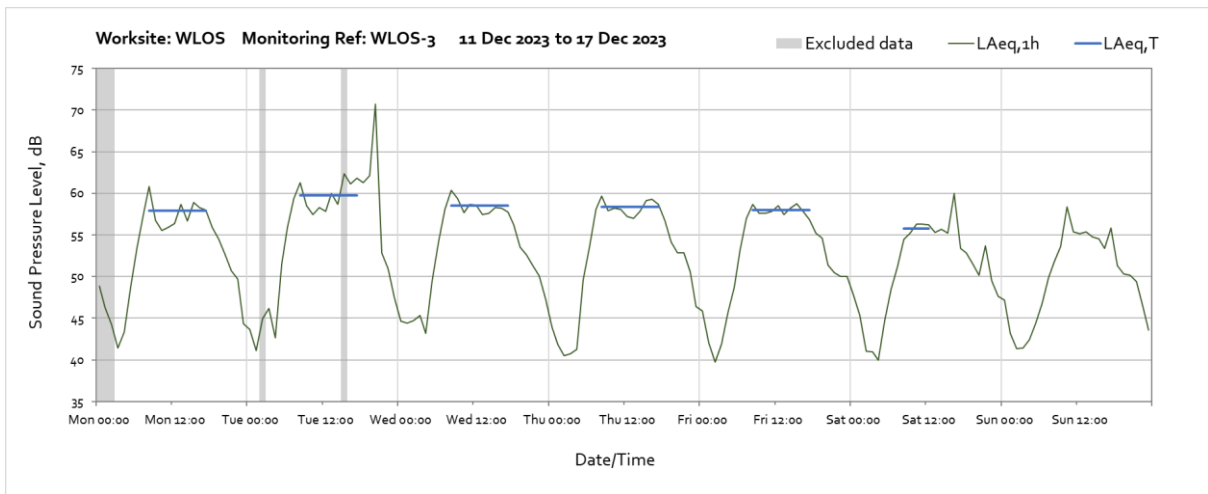
**Worksite: WLOS - Monitoring Ref: WLOS-3**

Note: Missing data throughout the week until the end of the month was due to poor weather conditions and vegetation growth effecting the solar power source to the monitoring station.

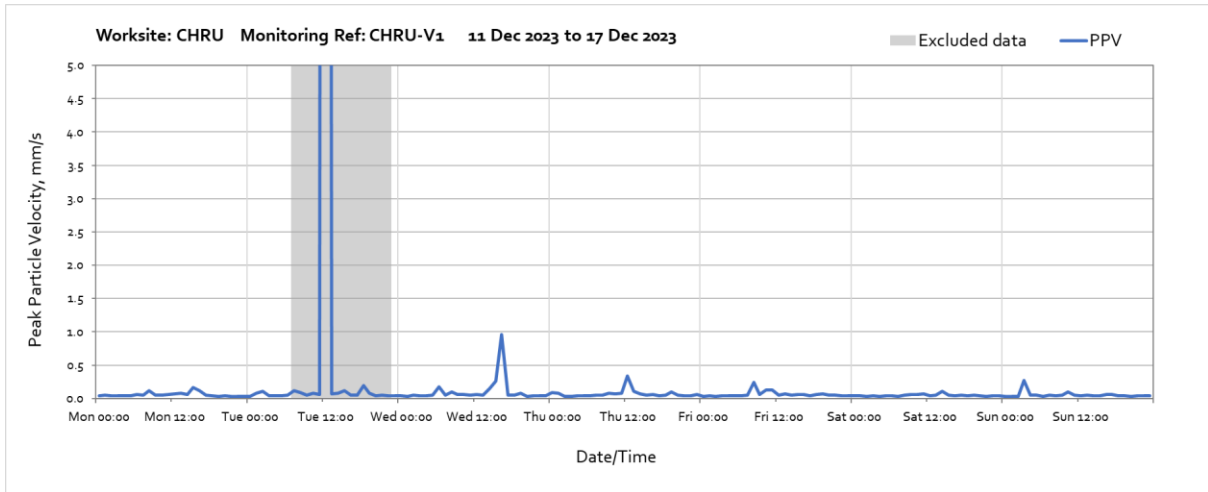
## Worksite: CHR – Monitoring Ref: CHRU-V1

Note: Missing data between 07:00 and 08:00 on Sunday 31st January was due to poor weather conditions and vegetation growth effecting the solar power source to the monitoring station.

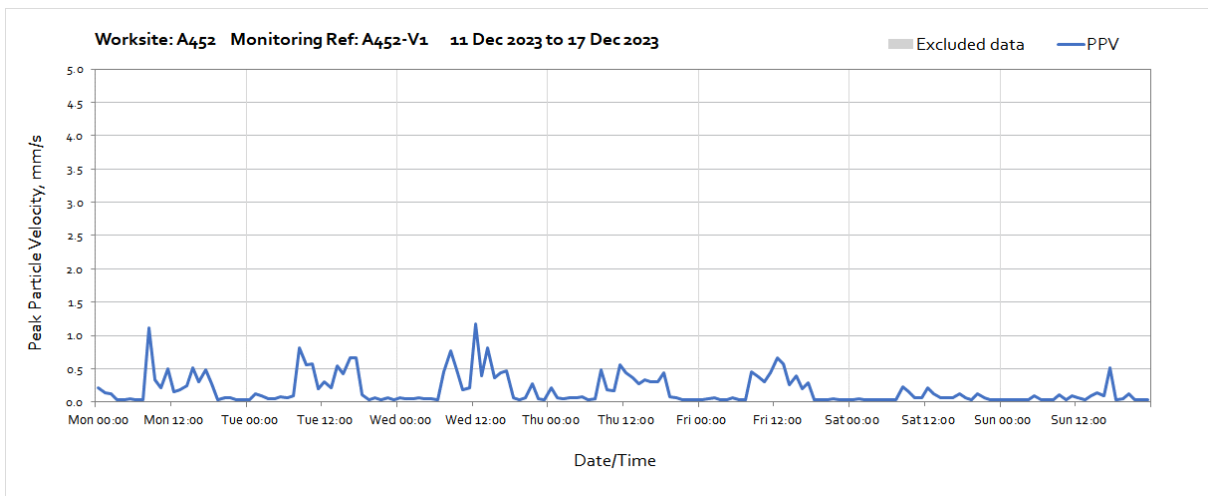
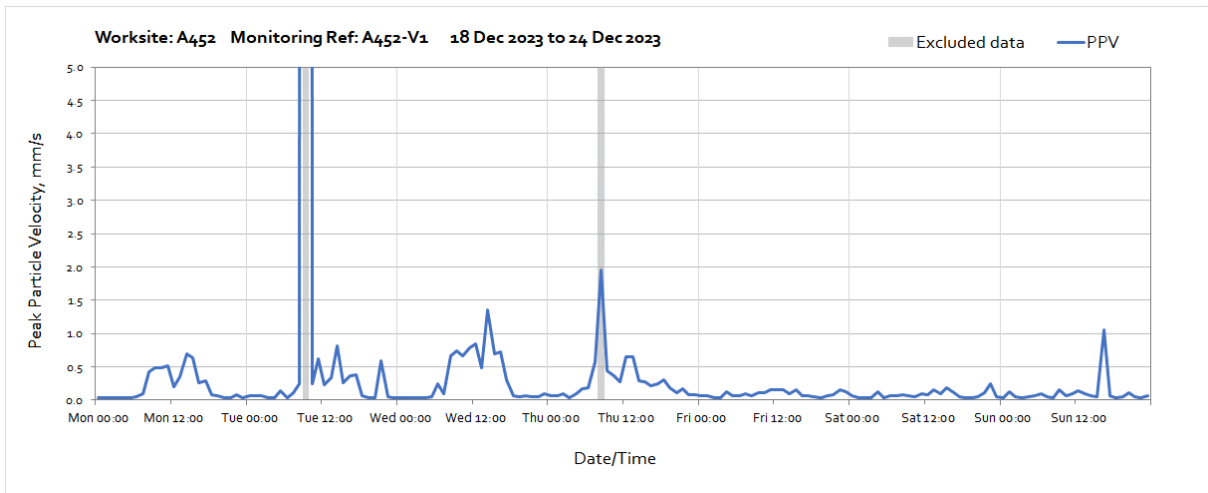
**Worksite: A452 – Monitoring Ref: A452-V1**

Note: Intermittent missing data Throughout the week until the end of the month was due to poor weather conditions and vegetation growth effecting the solar power source to the monitoring station.

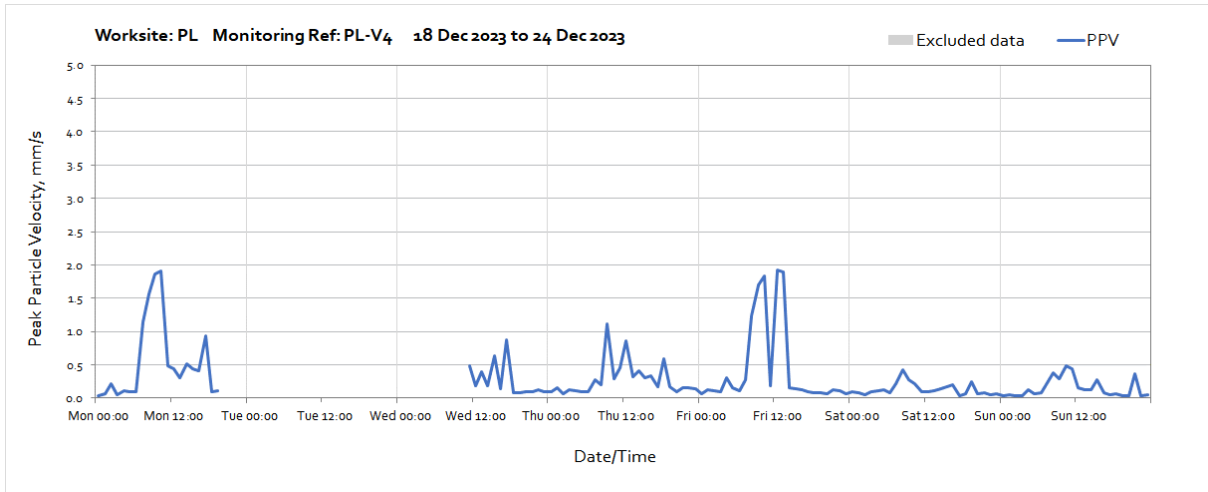
## Worksite: PL – Monitoring Ref: PL-V4

Note: Missing data between 20:00 on Monday 18<sup>th</sup> December until 11:00 on Wednesday 20<sup>th</sup> December was due to battery replacement at the monitoring station.
