## **Construction Noise and Vibration Monthly Report – January 2024**

**Lichfield District Council**

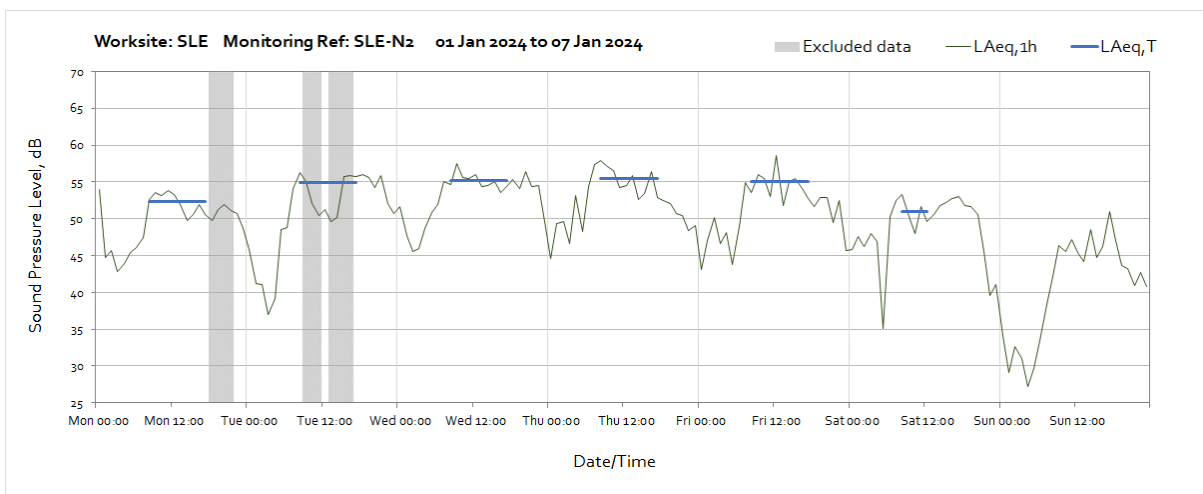
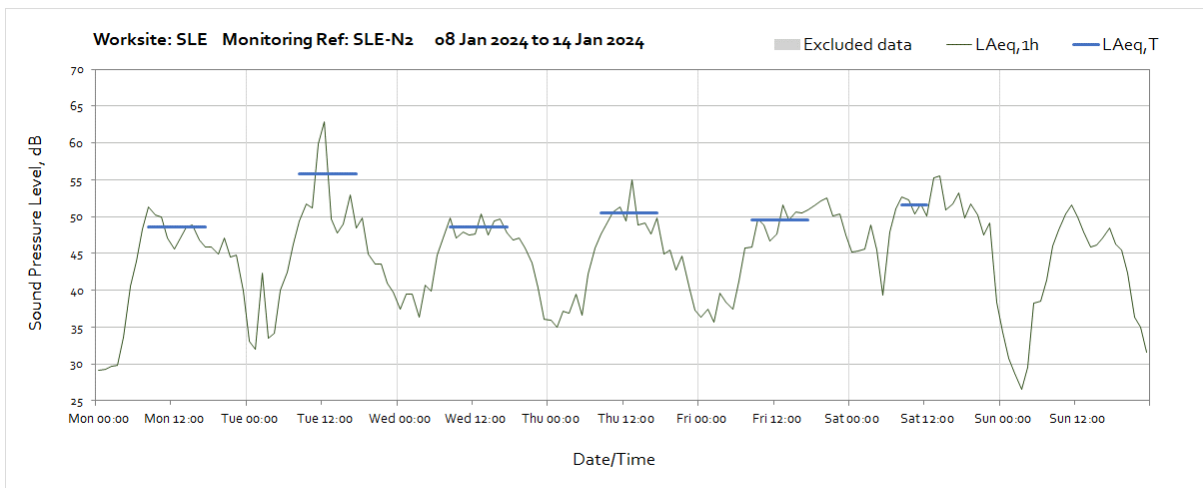
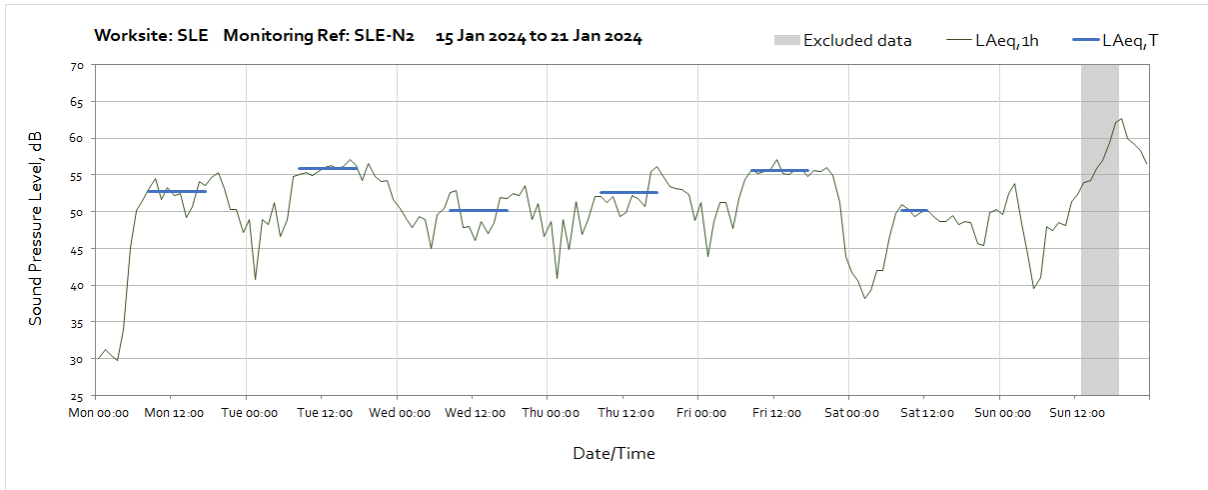
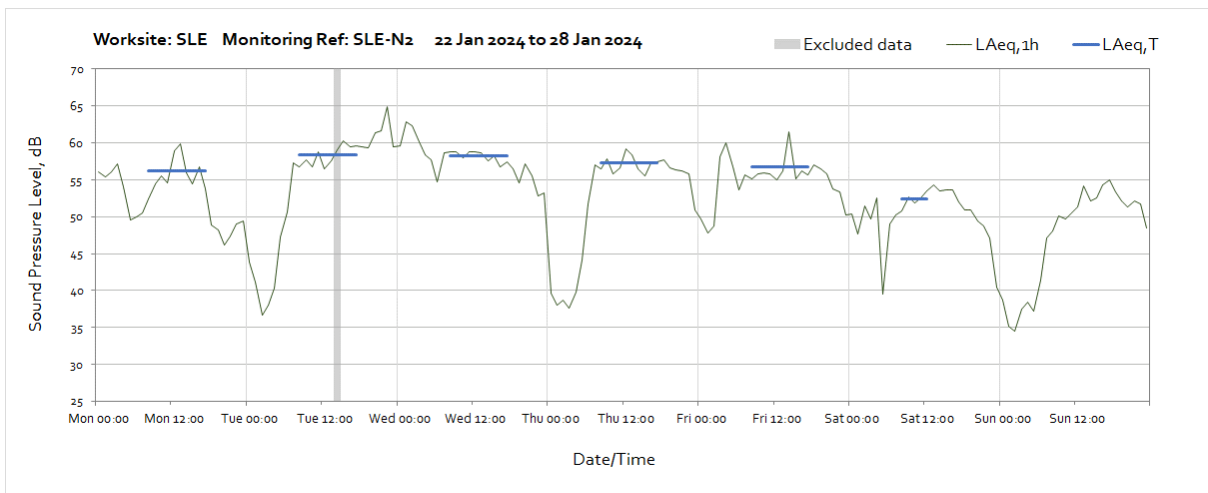
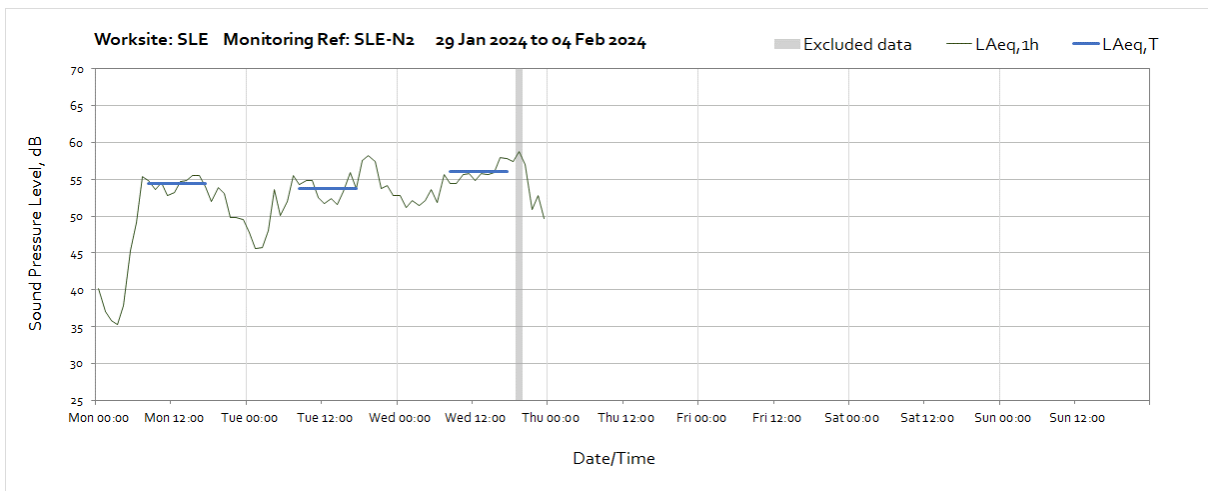
### Worksite:SLE - Monitoring Ref: SLE-N2

The following graphs show the hourly measured ambient noise level  $L_{Aeq,1h}$  and, where relevant, the averaged noise level  $L_{Aeq,T}$  values, where the time period T is as specified in Table 1 of HS2 Information Paper E23. Periods where noise levels are adversely affected by weather or only measured for part of the period, which are not representative of HS2 construction works, have been greyed out and excluded from the calculation of the  $L_{Aeq,T}$  values in Table 3 of the main report.

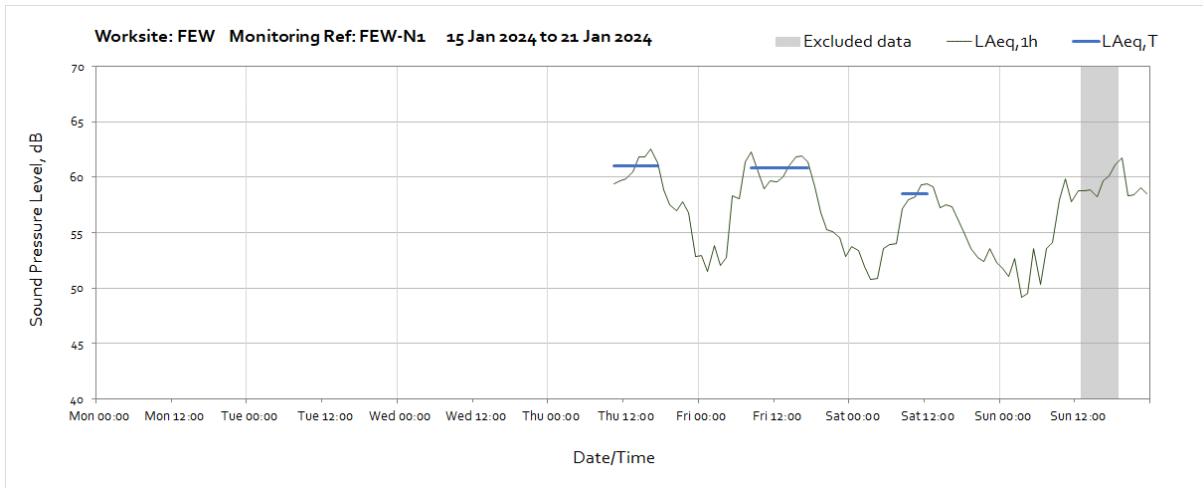
## Worksite:FEW – Monitoring Ref: FEW-N1

Note: Missing data from the start of the month until 09:00 on Thursday 18<sup>th</sup> January was due to loss of power to the monitoring station caused by poor weather conditions preventing sufficient light to reach the solar panel followed by monitoring station maintenance.

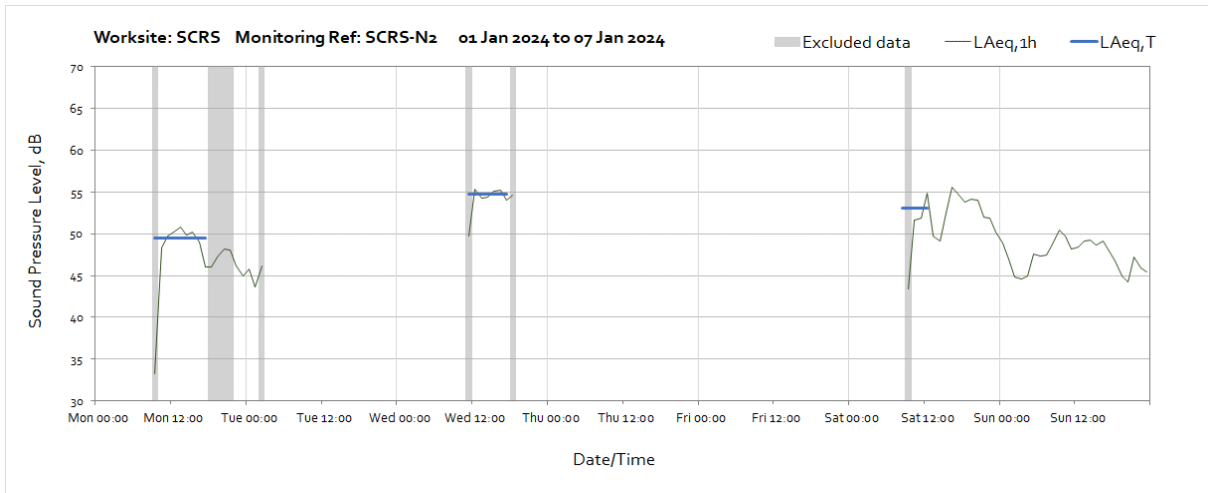
### Worksite:SCRS – Monitoring Ref: SCRS-N2

Note: Missing data throughout the week was due to poor weather conditions preventing sufficient light from reaching the solar panel.

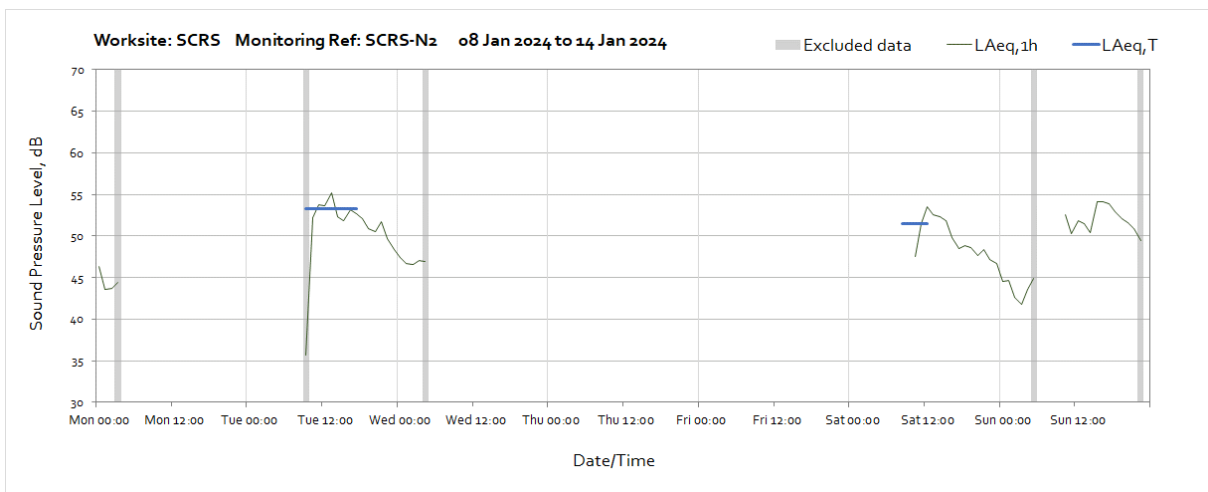
Note: Missing data throughout the week was due to poor weather conditions preventing sufficient light from reaching the solar panel.

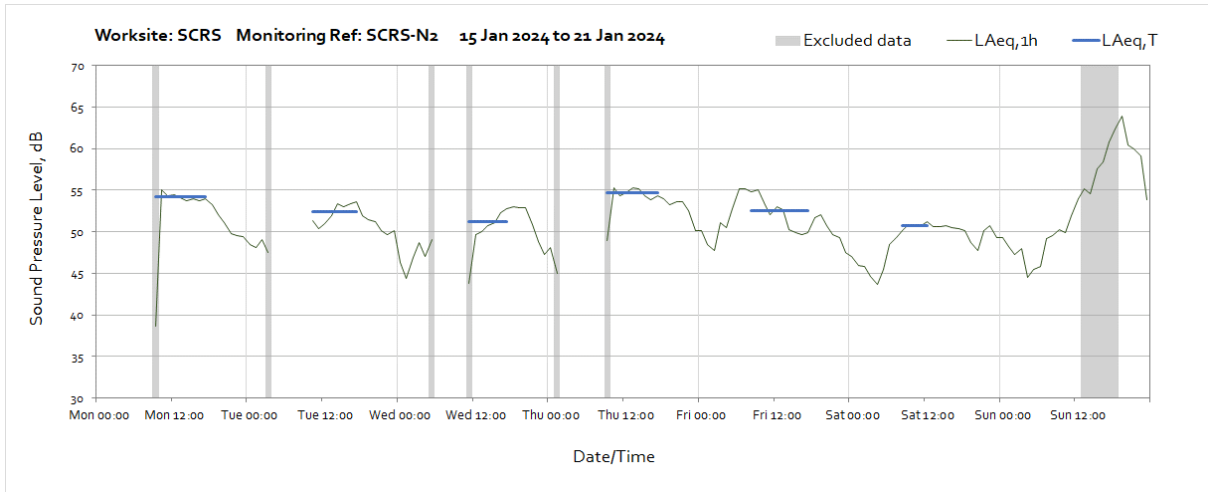
Note: Missing data throughout the week was due to poor weather conditions preventing sufficient light from reaching the solar panel.

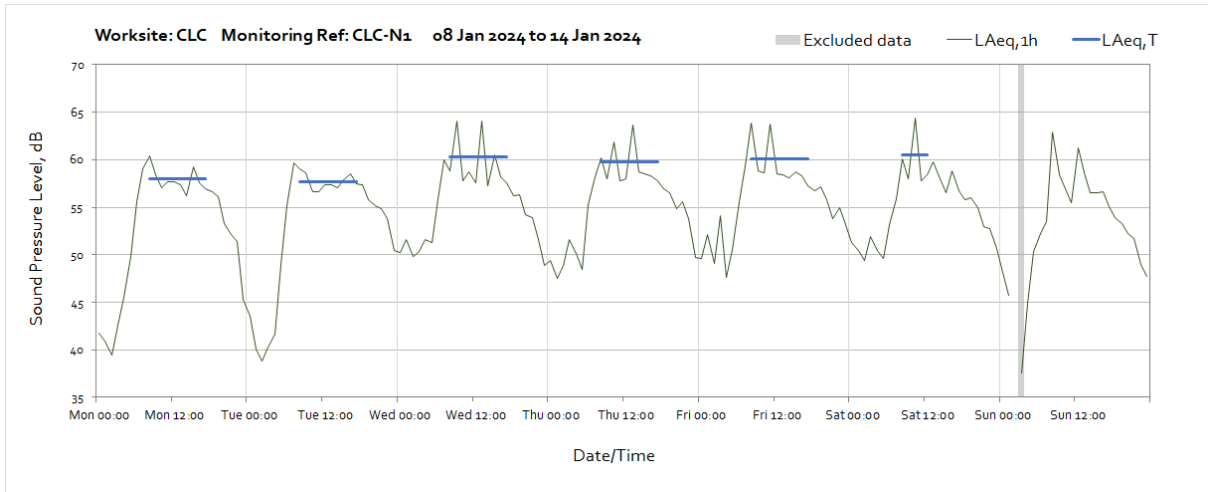
### Worksite: CLC - Monitoring Ref: CLC-N1

Note: Missing data between 01:00 and 03:00 on Sunday 14<sup>th</sup> of January was due to a clock synchronization error at monitoring station.

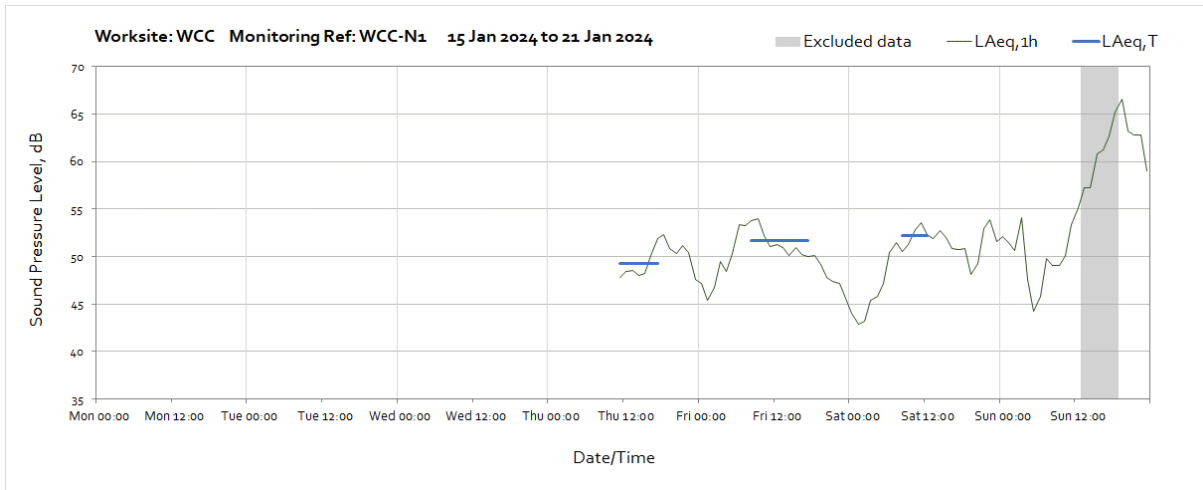
## Worksite:WCC – Monitoring Ref: WCC-N1

Note: Missing data from the start of the month until 10:00 on Thursday 18<sup>th</sup> January was due to poor weather conditions preventing sufficient light from reaching the solar panel.

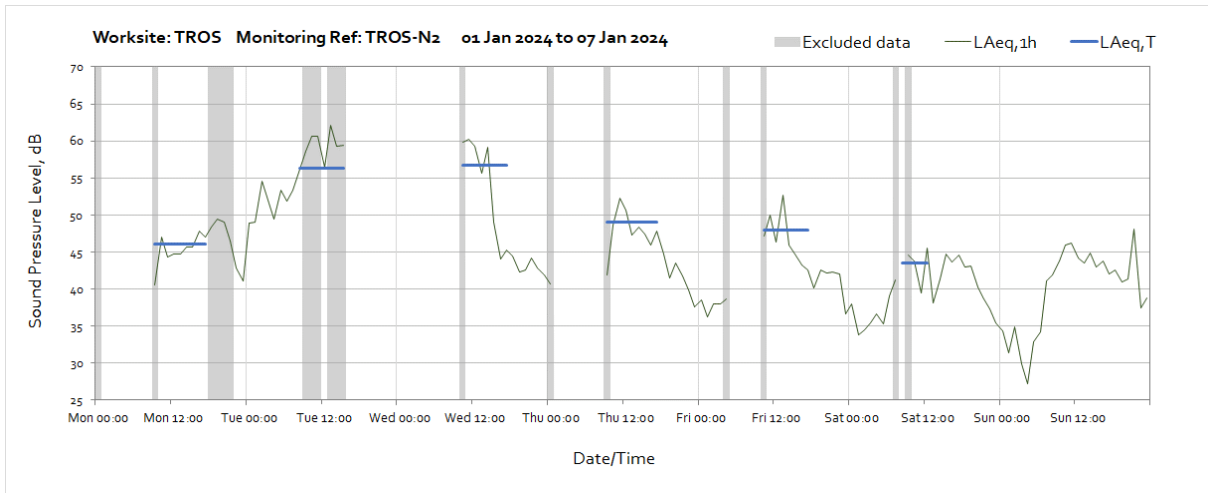
**Worksite:TROS – Monitoring Ref: TROS-N2**

Note: Missing data throughout the week was due to poor weather conditions preventing sufficient light from reaching the solar panel.

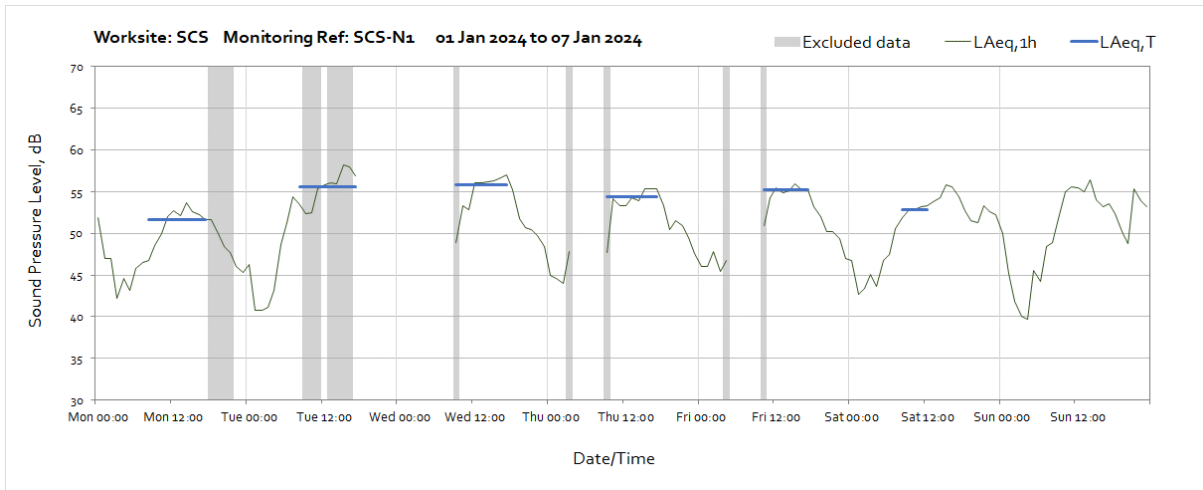
## Worksite: SCS – Monitoring Ref: SCS-N1

Note: Missing data throughout the week was due to poor weather conditions preventing sufficient light from reaching the solar panel.

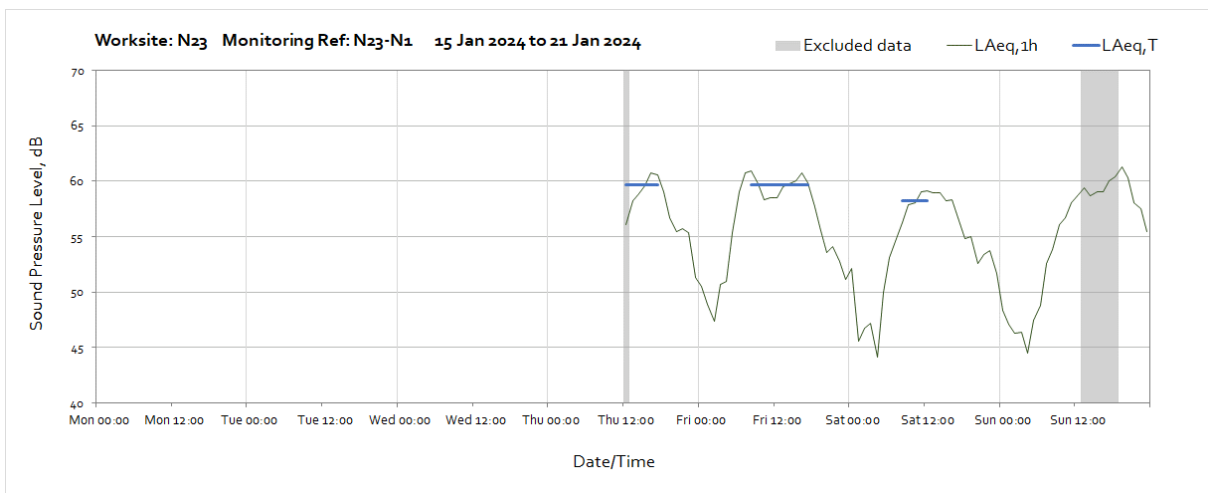
**Worksite: N23 - Monitoring Ref: N23-N1**

Note: Missing data from the start of the month until 11:00 on Thursday 18<sup>th</sup> January was due to poor weather conditions preventing sufficient light from reaching the solar panel.

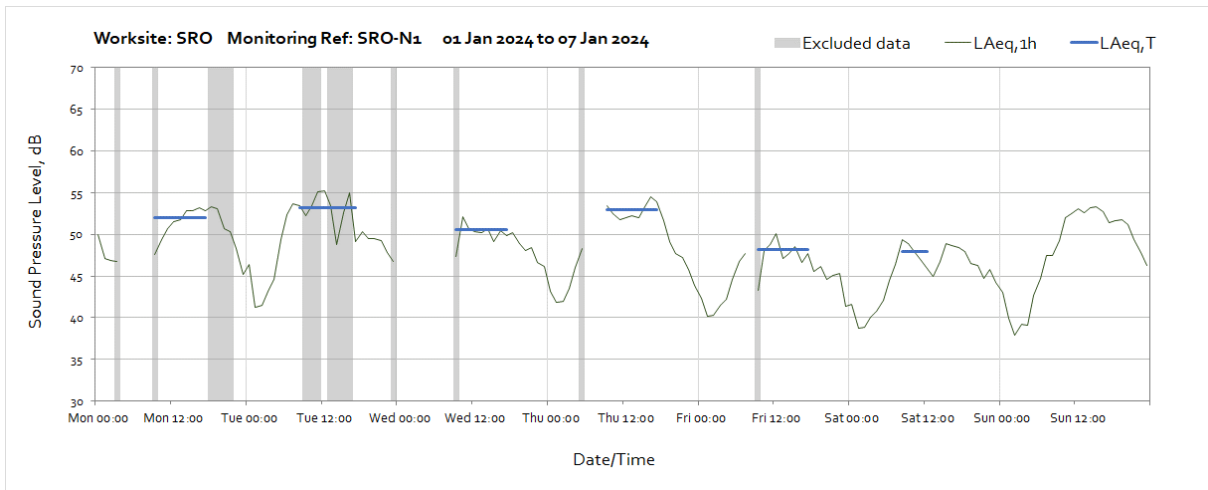
**Worksite: SRO – Monitoring Ref: SRO-N1**

Note: Missing data throughout the week was due to poor weather conditions preventing sufficient light from reaching the solar panel.

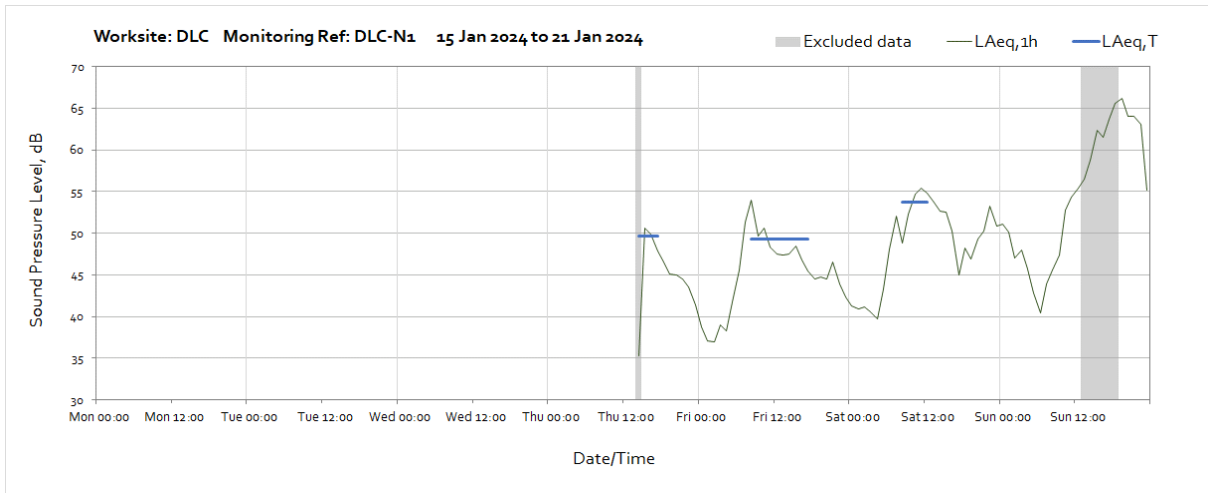
### Worksite: DLC - Monitoring Ref: DLC-N1

Note: Missing data from the start of the month until 13:00 on Thursday 18<sup>th</sup> of January was due to poor weather conditions preventing sufficient light from reaching the solar panel.

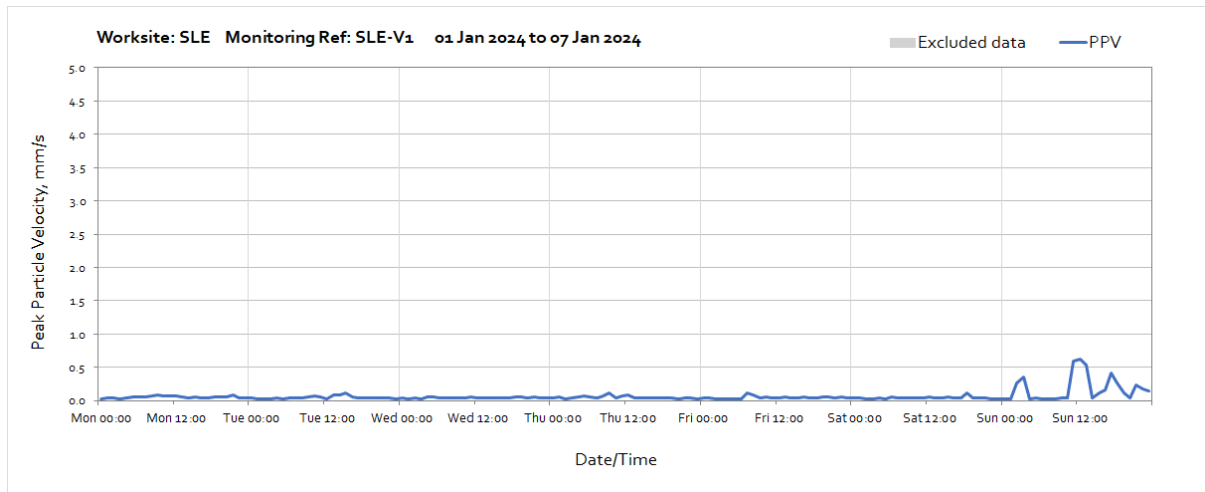
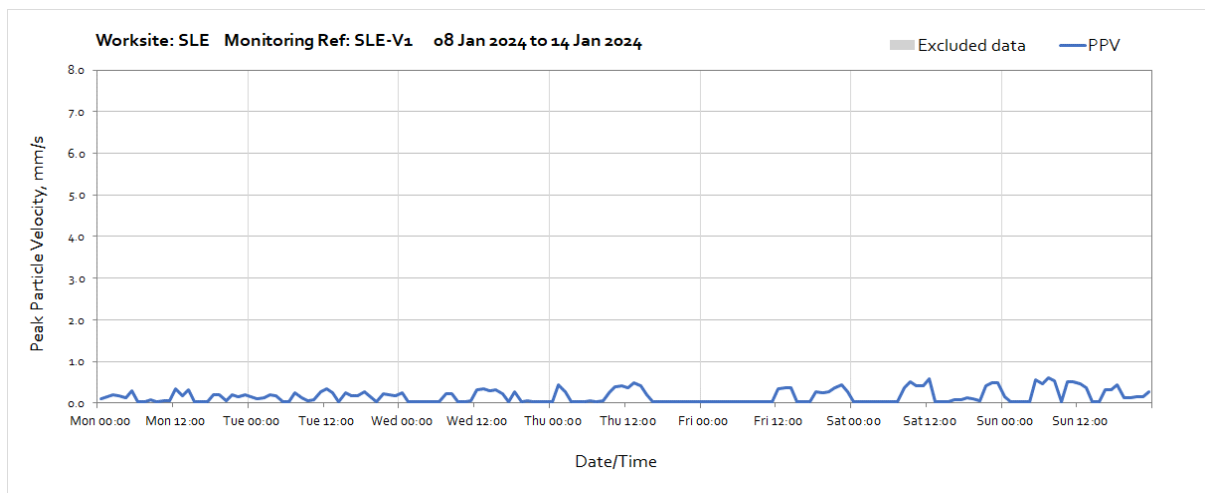
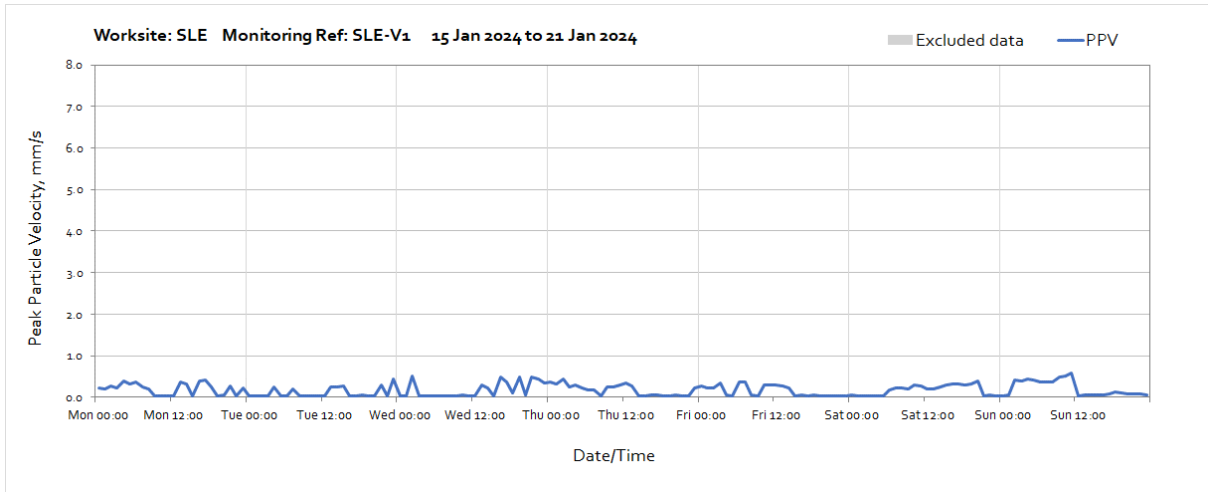
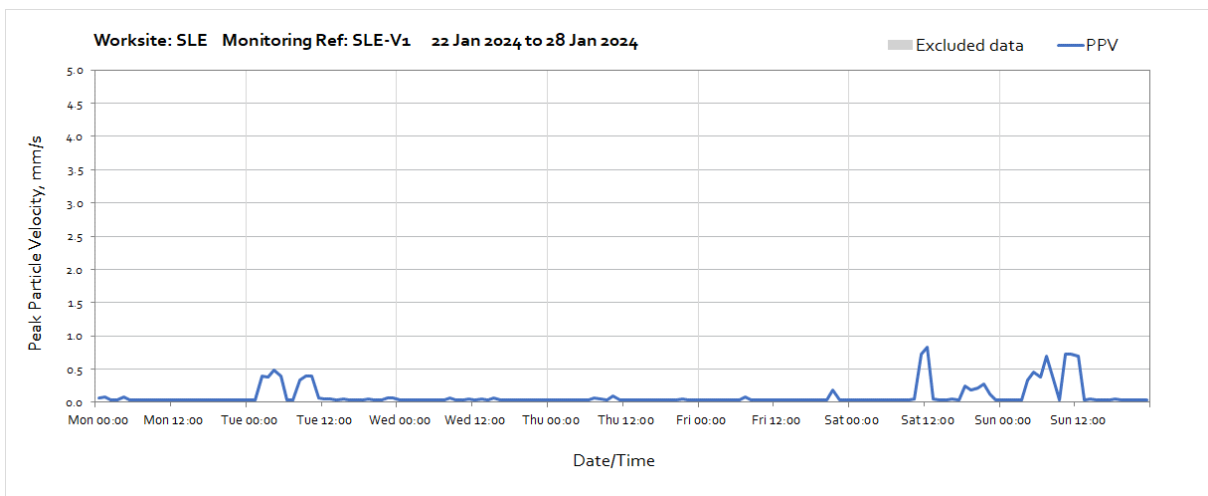
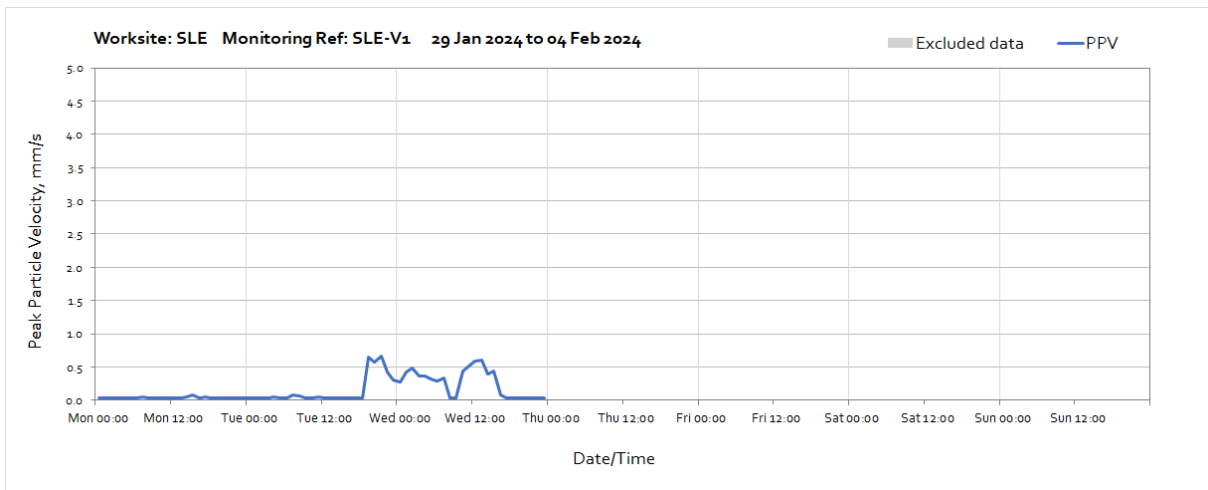
### Worksite: SLE – Monitoring Ref: SLE-V1

The following graphs show the hourly measured peak particle velocity PPV recorded during the monitoring period. The graphs show the highest PPV of the three orthogonal axes x, y and z. Periods where PPV values have been affected by local interference with the vibration monitor or only measured for part of the period, which are not representative of HS2 construction works, have been greyed out and excluded when calculating values in Table 4 of the main report.

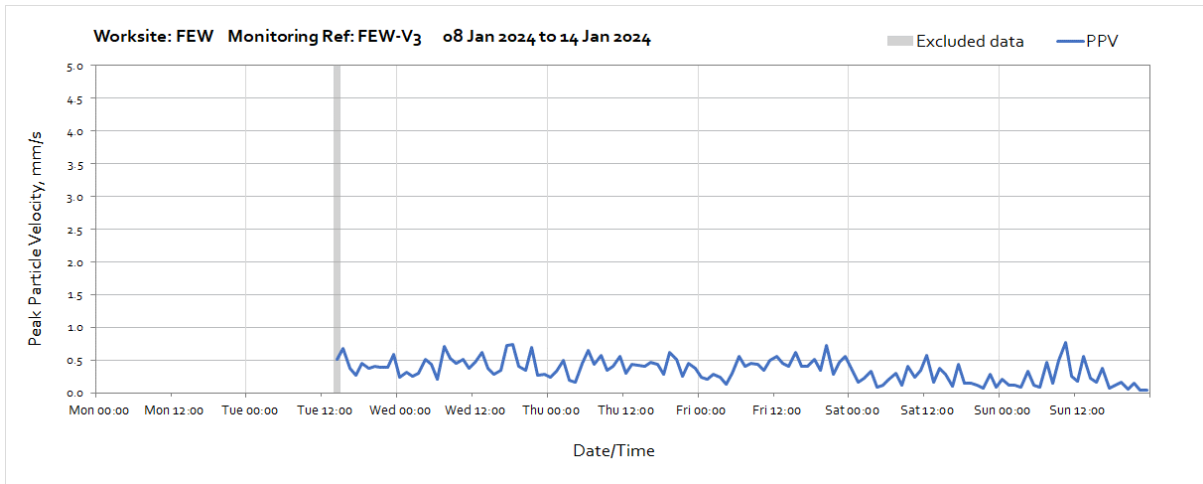
## Worksite: FEW – Monitoring Ref: FEW-V3

Note: Missing data from the start of the month until 13:00 on Tuesday 09<sup>th</sup> January was due to poor weather conditions preventing sufficient light from reaching the solar panels.

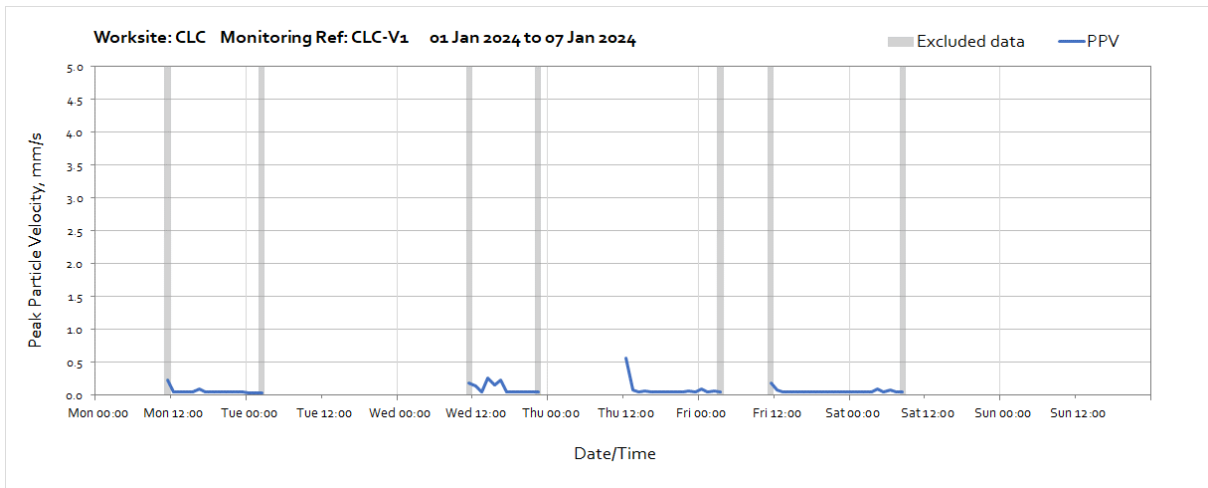
**Worksite: CLC – Monitoring Ref: CLC-V1**

Note: Missing data throughout the week was due to poor weather conditions preventing sufficient light from reaching the solar panels.

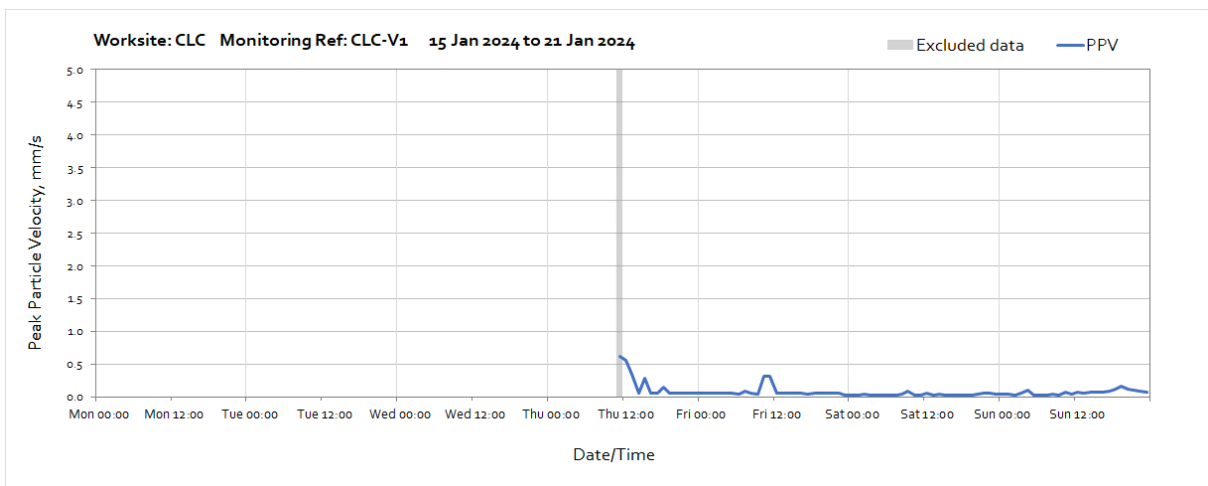
Note: Missing data from 09:00 on Saturday 6<sup>th</sup> January until 10:00 on Thursday 18<sup>th</sup> January was due to poor weather conditions preventing sufficient light from reaching the solar panels.

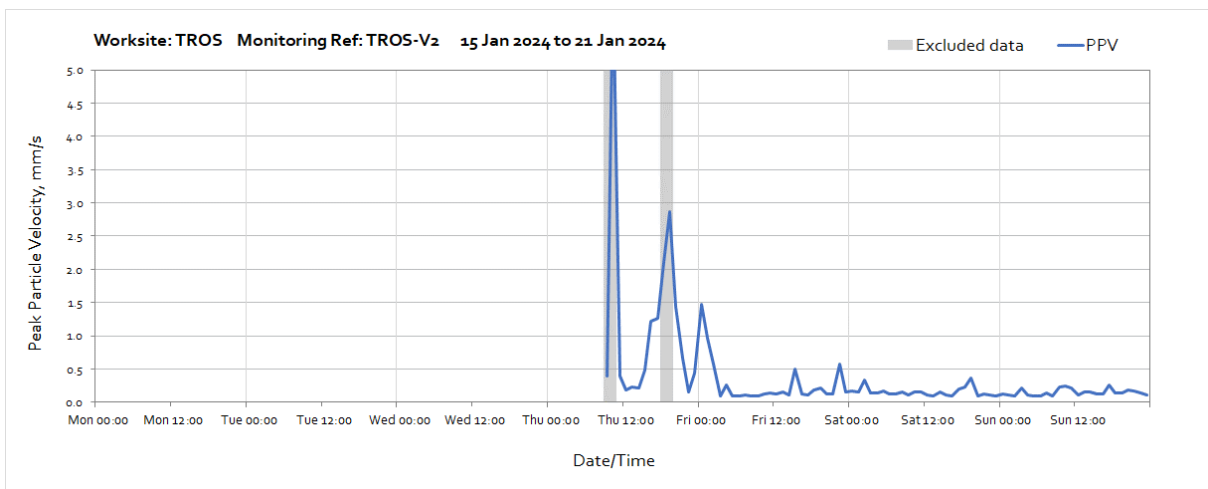
### Worksite: TROS – Monitoring Ref: TROS-V2

Note: Missing data from the start of the month until 08:00 on Thursday 18th January was due poor weather conditions preventing sufficient light from reaching the solar panel.
