## **Construction Noise and Vibration Monthly Report – January 2024**

### **North Warwickshire Borough Council**

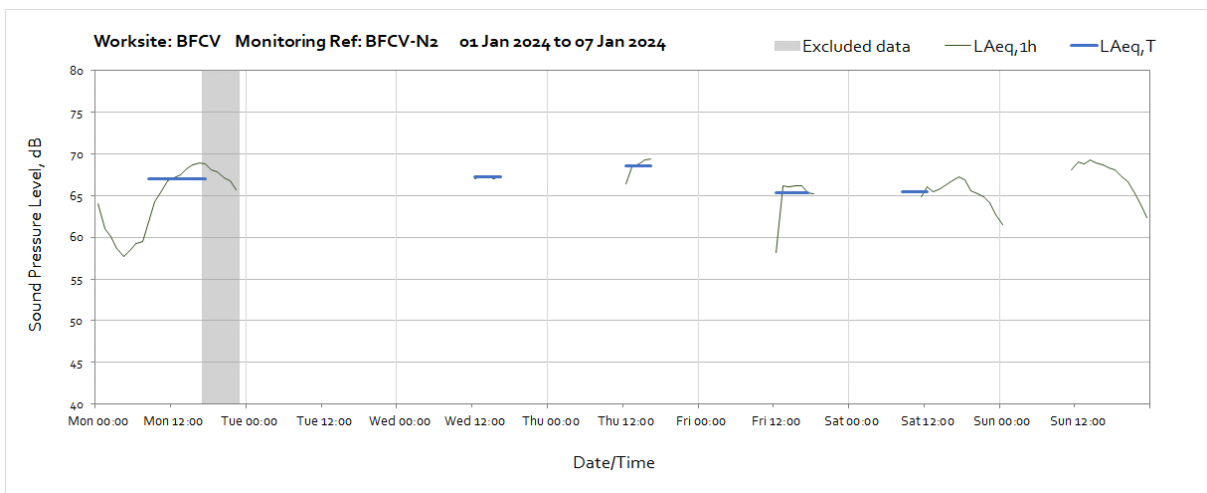
### Worksite: BFCV – Monitoring Ref: BFCV-N2

Note: Missing data throughout the week was due to the loss of power at the monitoring station caused by poor weather conditions preventing sufficient light to reach the solar panel.

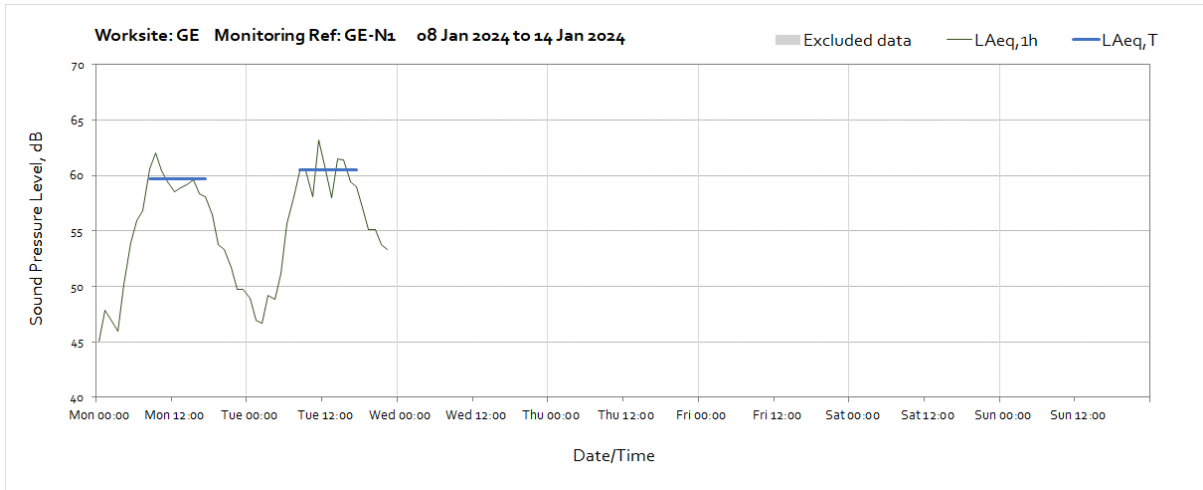
Note: Missing data from 22:00 on Tuesday 9<sup>th</sup> January until the end of the month was due to the loss of power at the monitoring station caused by the disconnection of mains power.

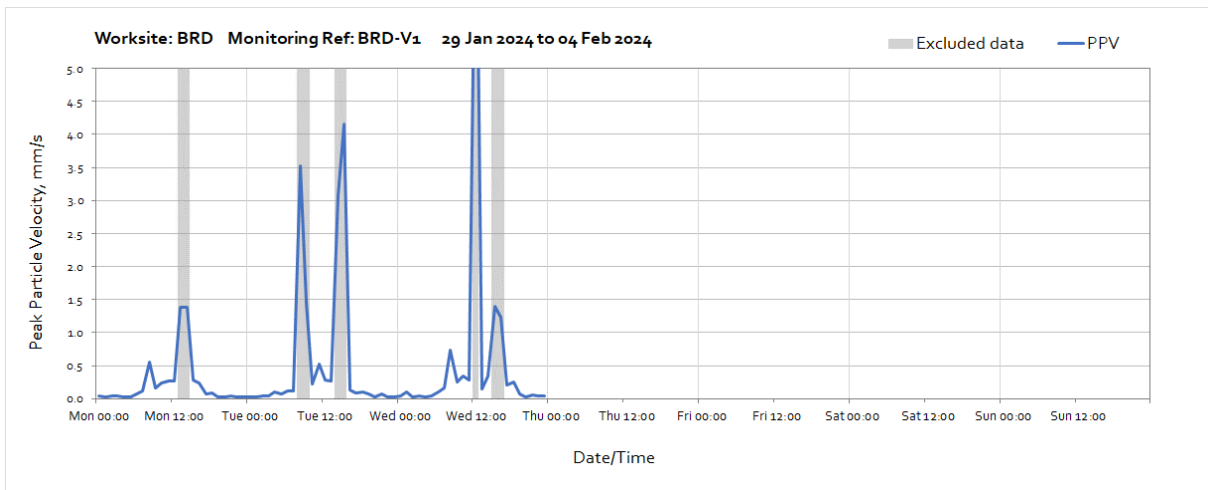
Note: Missing data between 04:00 on Tuesday 9<sup>th</sup> and 14:00 on Thursday 25<sup>th</sup> January was due to the loss of power at the monitoring station caused by connection issues between the power source and the monitoring station.
