Construction Noise and Vibration Monthly Report – January 2024

Warwick District Council

This Noise and Vibration Monitoring Report fulfils HS2 Limited's commitment detailed in the Environmental Minimum Requirements (EMRs), Annex 1, Code of Construction Practice, to present the results of noise and vibration monitoring carried out within Warwick District Council (WDC) area during the month of January 2024.

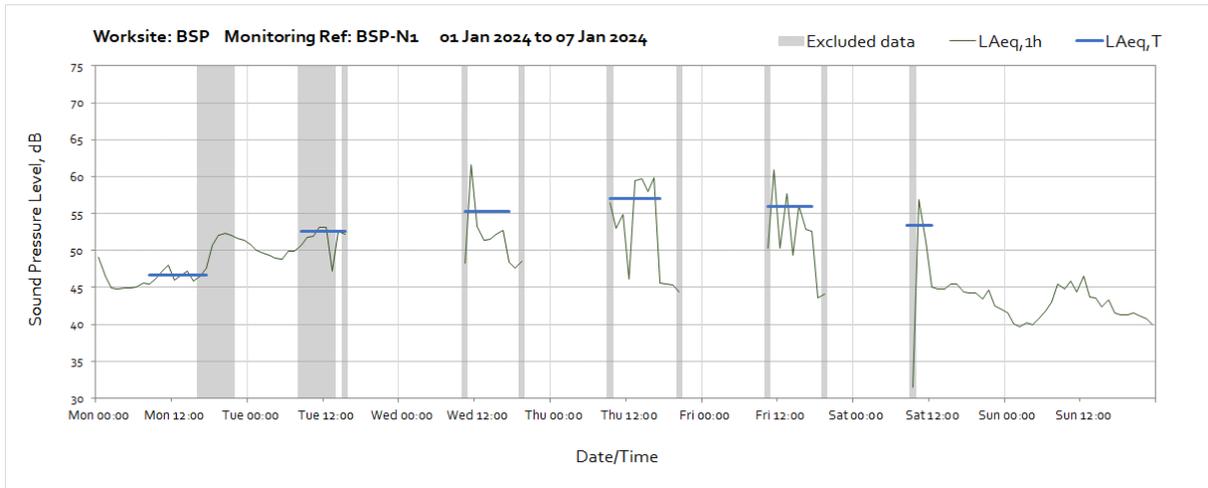
Worksite: BSP – Monitoring Ref: BSP-N1

Note: Missing data throughout the week was due to a loss of power at the monitoring station caused by insufficient sunlight for the solar panels.

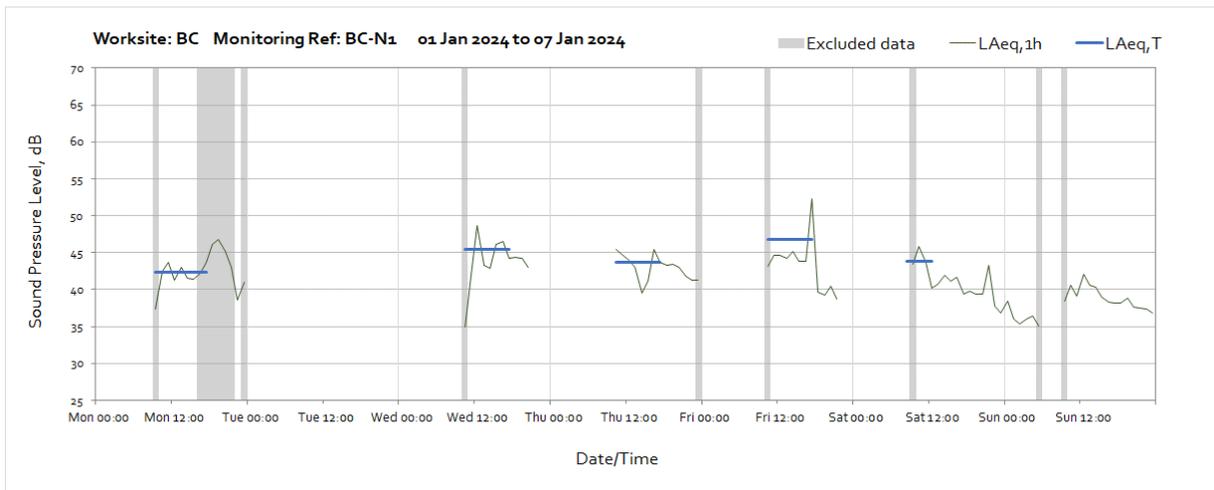
Worksite: BC - Monitoring Ref: BC-N1

Note: Missing data throughout the week was due to a loss of power at the monitoring station caused by insufficient sunlight for the solar panels.

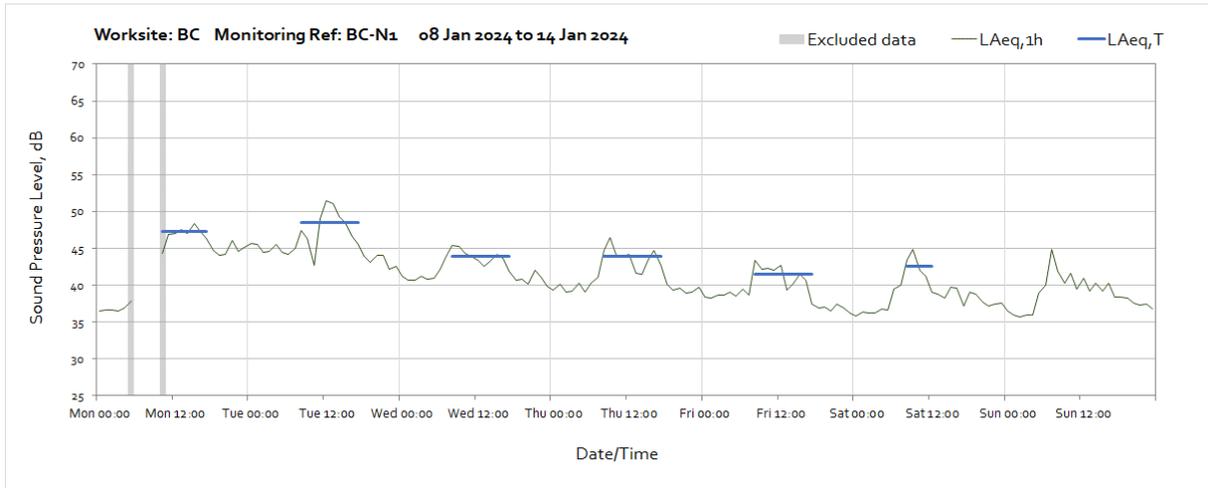
Note: Missing data from 08th of January at 06:00 until 09:00 was due to a loss of power at the monitoring station caused by insufficient sunlight for the solar panels.

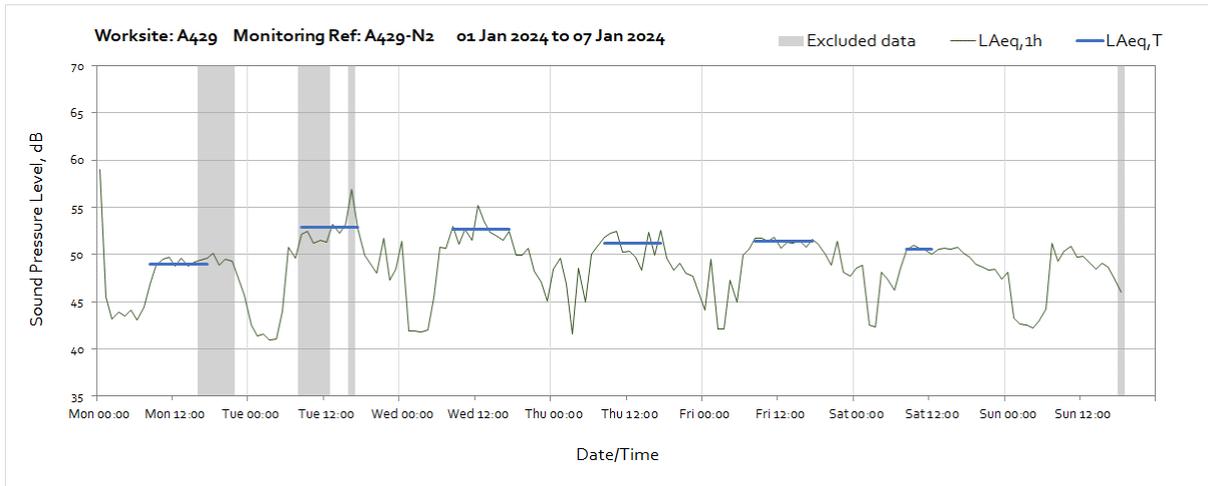
Worksite: A429 – Monitoring Ref: A429-N2

Note: Missing data from 07th of January at 19:00 until 25th of January at 15:00 was due to a loss of power at the monitoring station caused by insufficient sunlight for the solar panels.

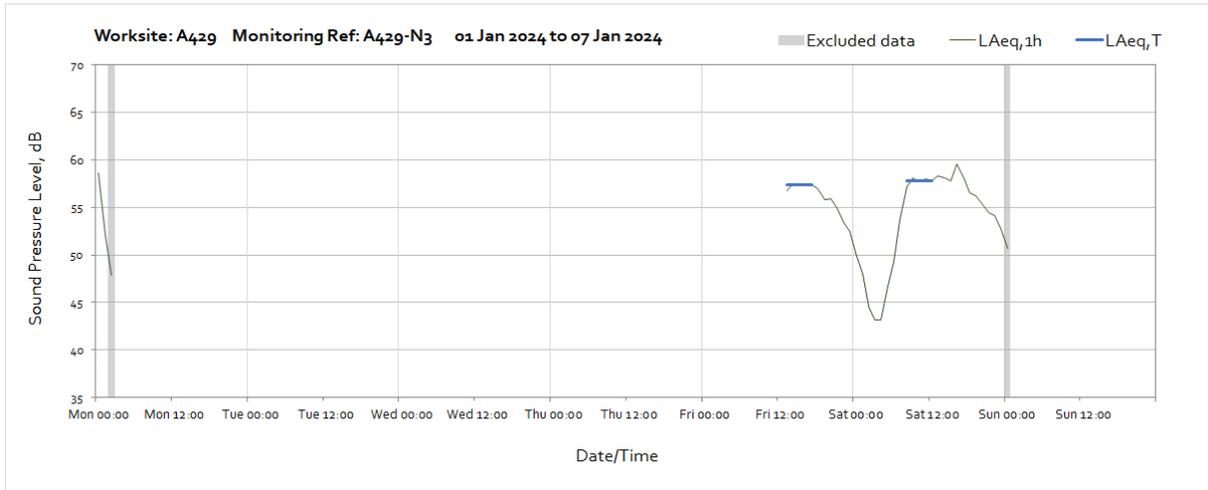
Worksite: A429 – Monitoring Ref: A429-N3

Note: Missing data throughout the week was due to a loss of power at the monitoring station caused by insufficient sunlight for the solar panels.

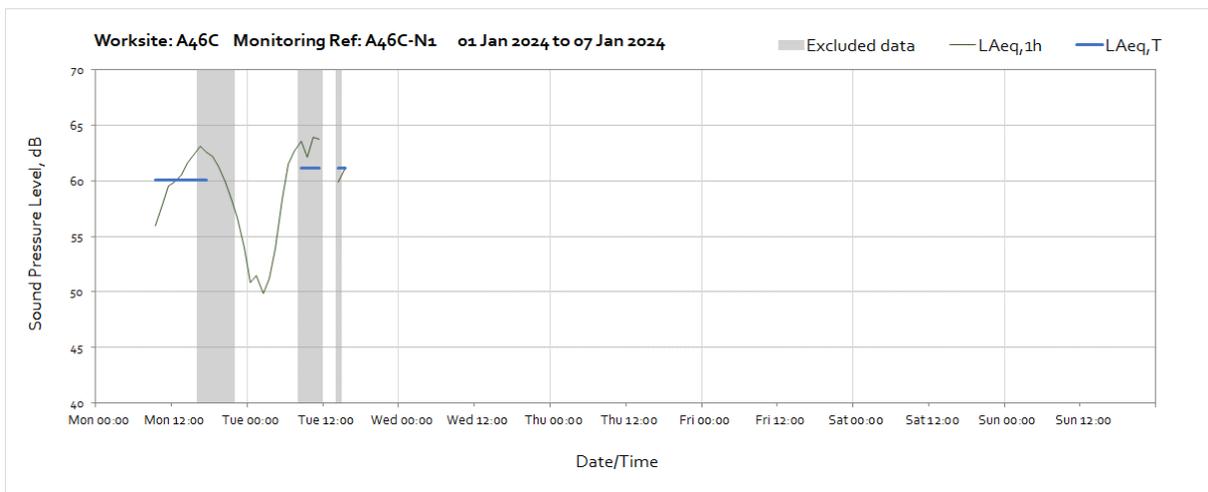
Worksite: A46C - Monitoring Ref: A46C-N1

Note: Missing data throughout the week was due to a loss of power at the monitoring station caused by insufficient sunlight for the solar panels.

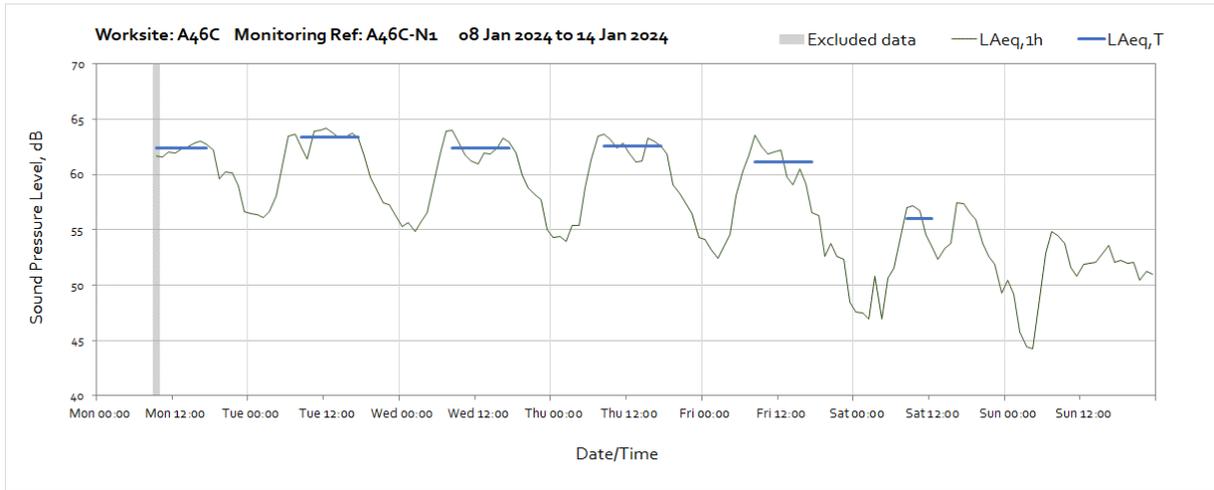
Note: Missing data from 08th of January at 00:00 until 08:00 was due to a loss of power at the monitoring station caused by insufficient sunlight for the solar panels.

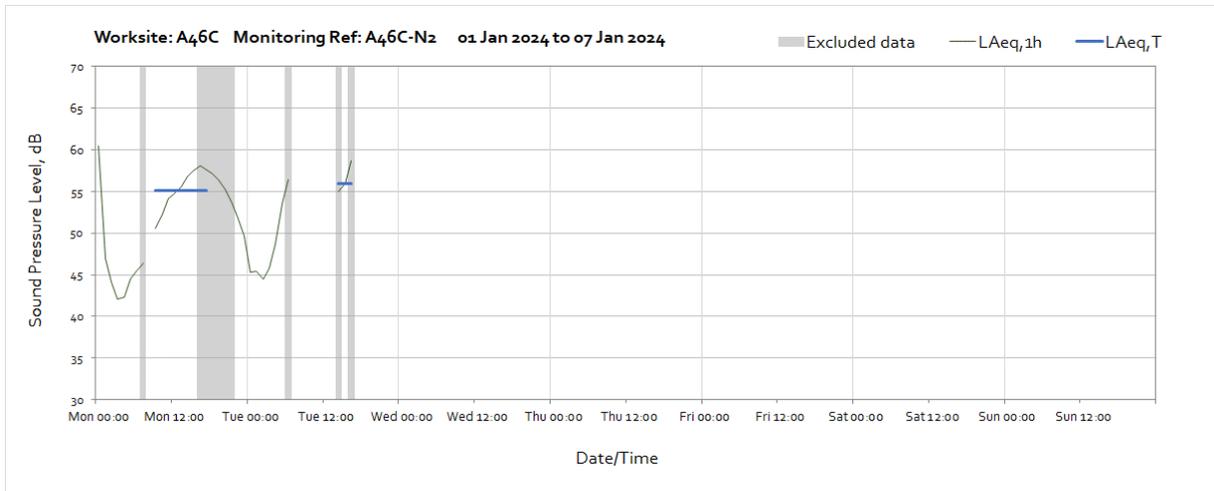
Worksite: A46C – Monitoring Ref: A46C-N2

Note: Missing data throughout the week was due to a loss of power at the monitoring station caused by insufficient sunlight for the solar panels.

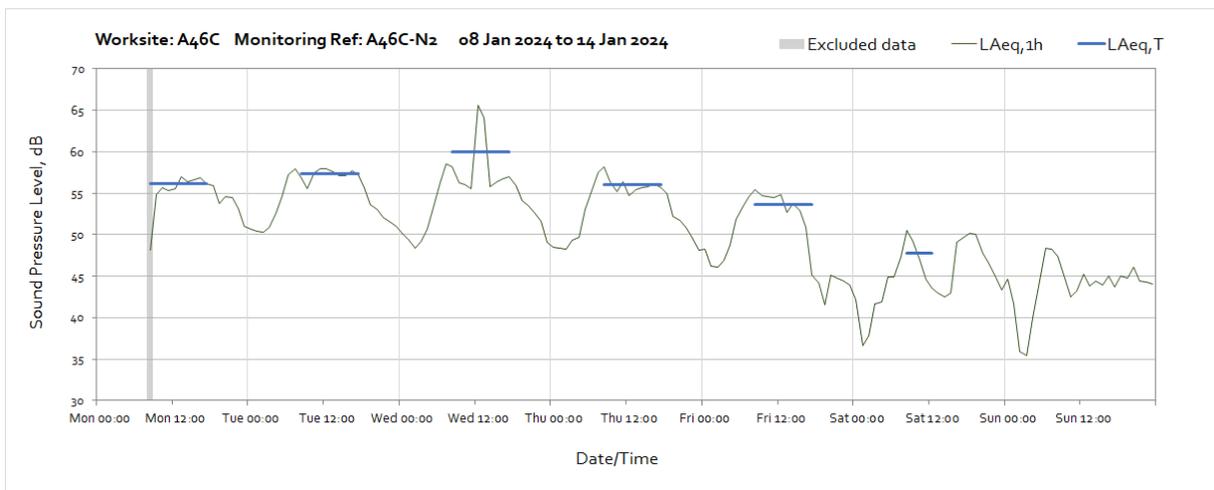
Note: Missing data from 08th of January at 00:00 until 08:00 was due to a loss of power at the monitoring station caused by insufficient sunlight for the solar panels.

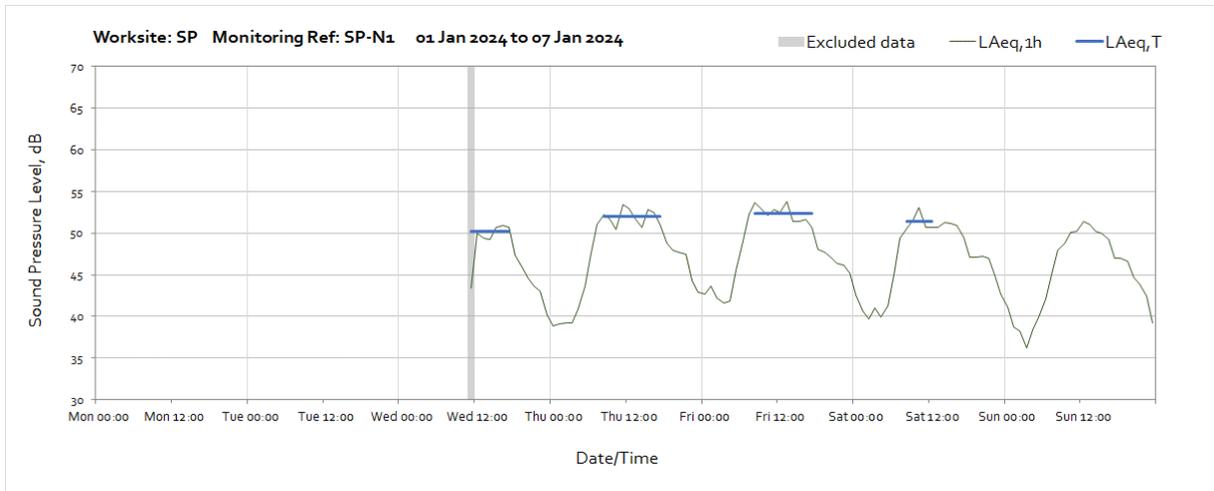
Worksite: SP – Monitoring Ref: SP-N1

Note: Missing data from the start of the month until 03rd of January at 11:00 was due to a loss of power at the monitoring station caused by insufficient sunlight for the solar panels.

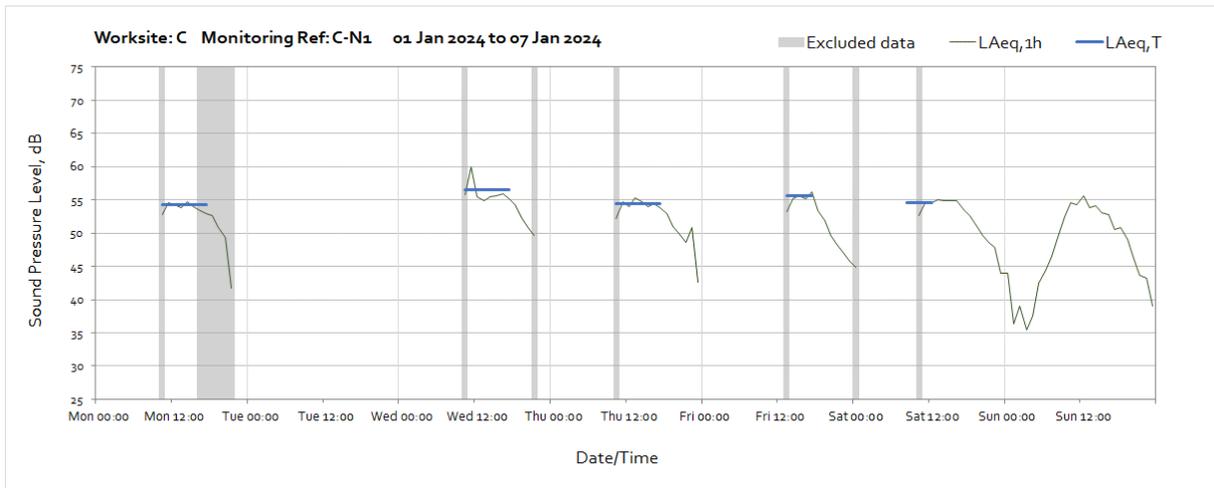
Worksite: C – Monitoring Ref: C-N1

Note: Missing data throughout the week was due to a loss of power at the monitoring station caused by insufficient sunlight for the solar panels.

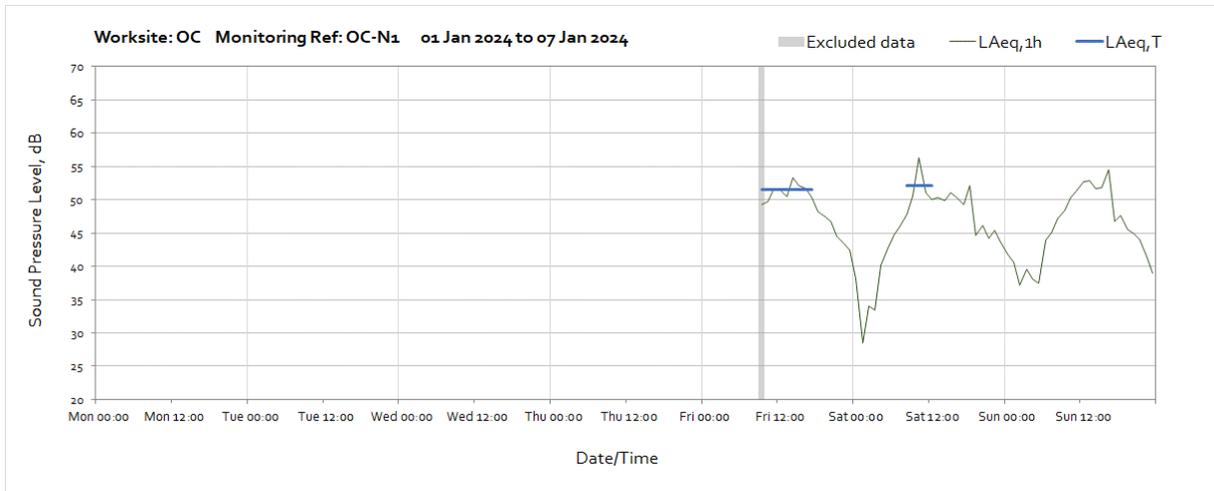
Worksite: OC - Monitoring Ref: OC-N1

Note: Missing data from the start of the month until 05th of January at 09:00 was due to a loss of power at the monitoring station caused by insufficient sunlight for the solar panels.

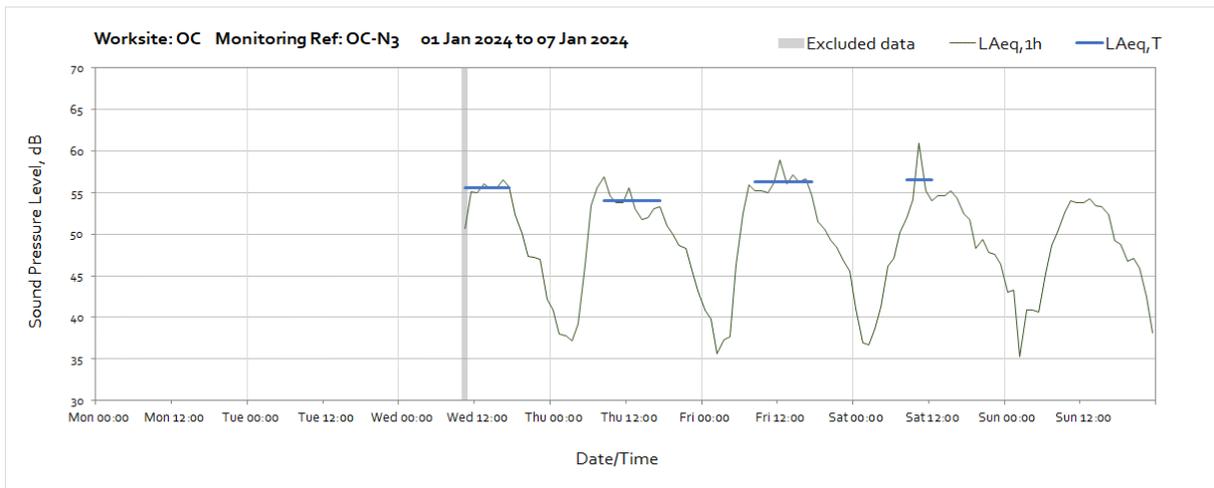
Worksite: OC - Monitoring Ref: OC-N3

Note: Missing data from the start of the month until 03rd of January at 10:00 was due to a loss of power at the monitoring station caused by insufficient sunlight for the solar panels.

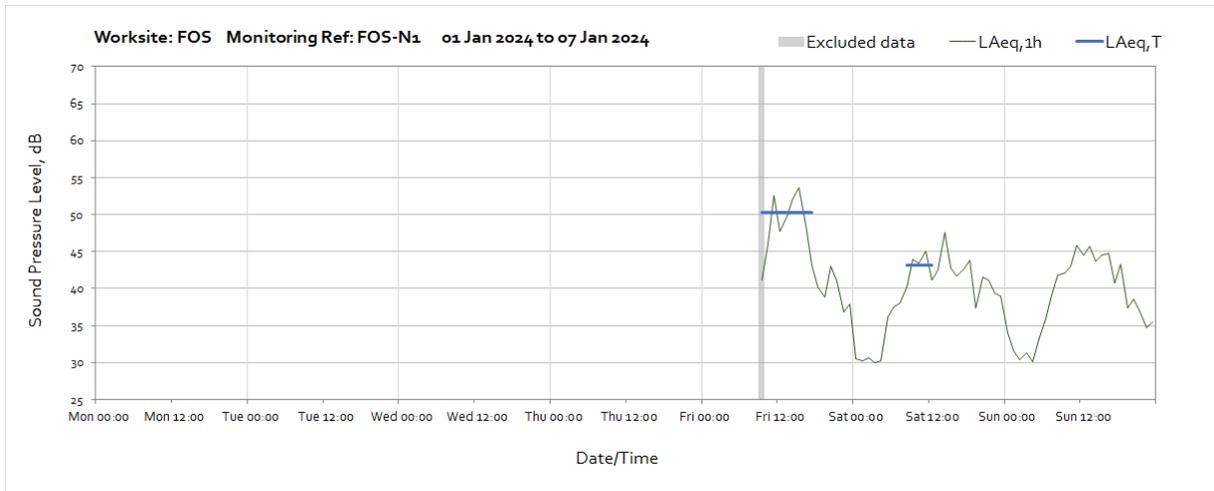
Worksite: OC - Monitoring Ref: FOS-N1

Note: Missing data from the start of the month until 05th of January at 09:00 was due to a loss of power at the monitoring station caused by insufficient sunlight for the solar panels.

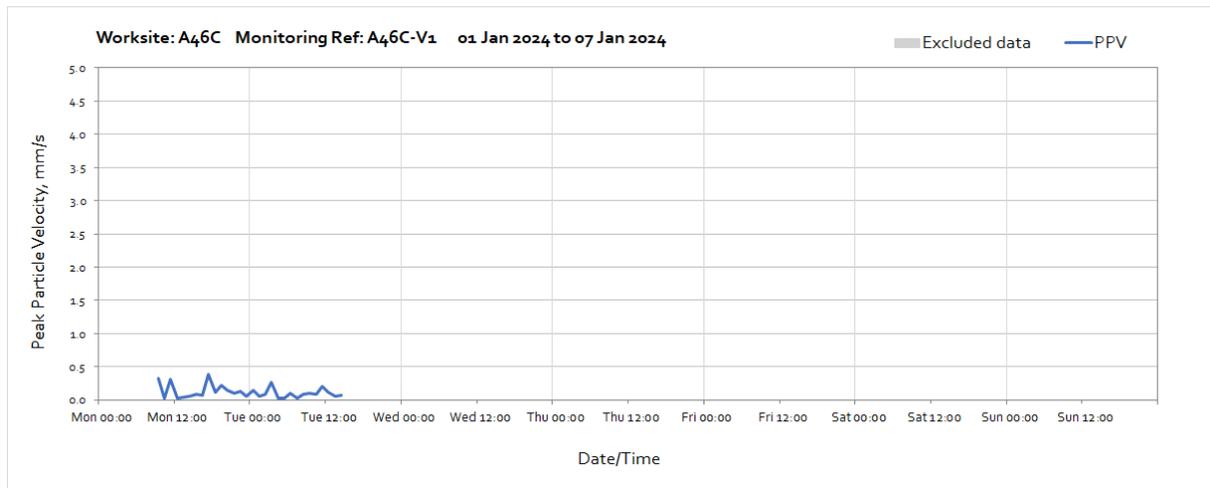
Worksite: A46C – Monitoring Ref: A46C-V1

Note: Missing data throughout the week was due to a loss of power at the monitoring station caused by insufficient sunlight for the solar panels.

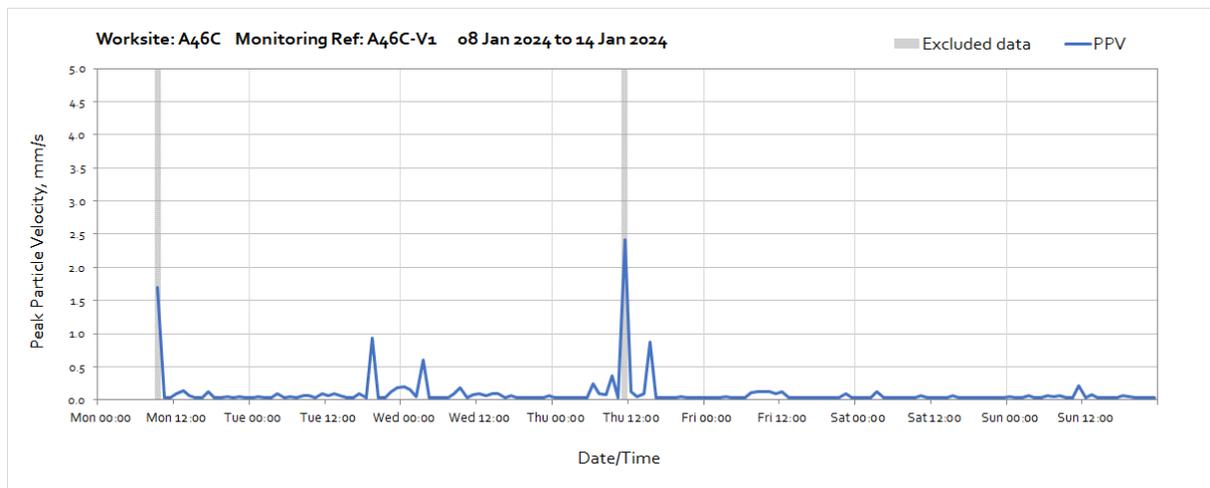
Note: Missing data from the 08th of January from 00:00 until 09:00 was due to a loss of power at the monitoring station caused by insufficient sunlight for the solar panels.

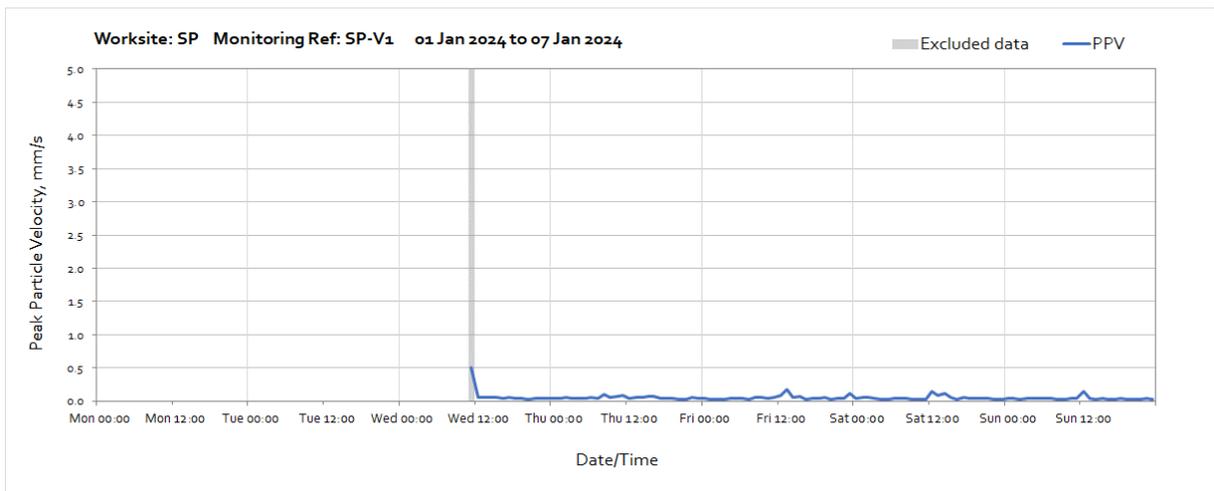
Worksite: SP – Monitoring Ref: SP-V1

Note: Missing data from the start of the month until the 03rd of January at 11:00 was due to a loss of power at the monitoring station caused by insufficient sunlight for the solar panels.

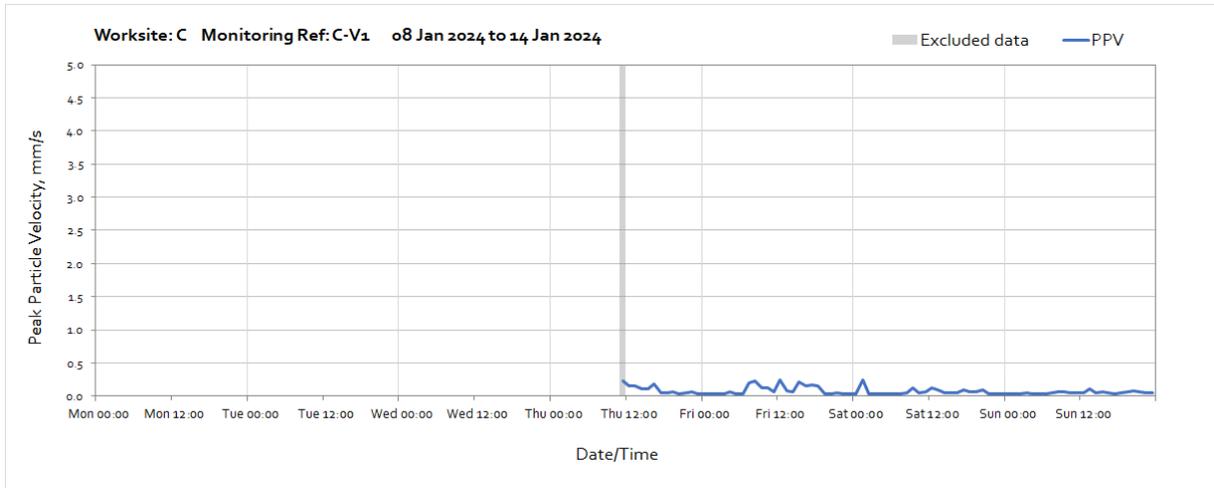
Worksite: C – Monitoring Ref: C-V1

Note: Missing data from the start of the month until the 11th of January at 11:00 was due to a loss of power at the monitoring station caused by insufficient sunlight for the solar panels.

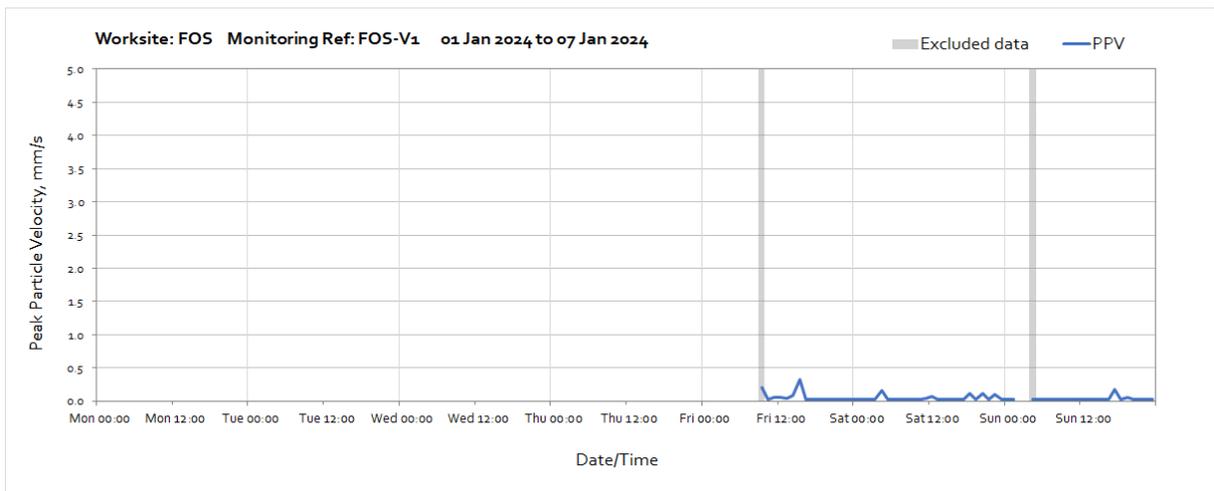
Worksite: OC - Monitoring Ref: FOS-V1

Note: Missing data throughout the week was due to a loss of power at the monitoring station caused by insufficient sunlight for the solar panels.
