# Clifton & Hotwells

Character Appraisal & Management Proposals

June 2010

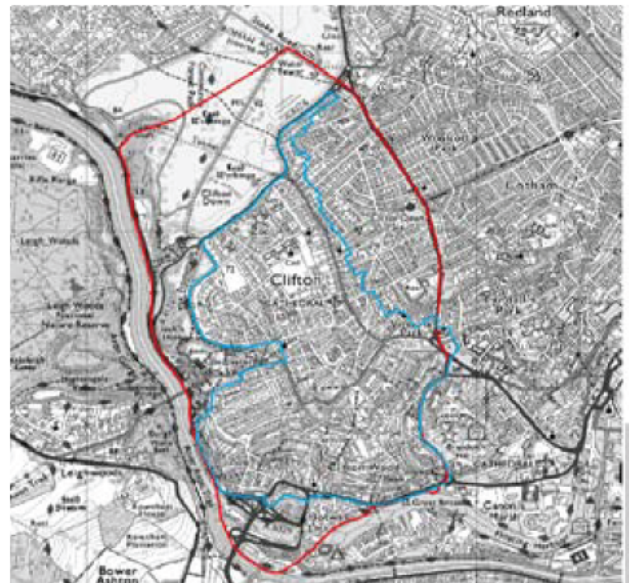
Figure 4: The original Manor of Clifton as surveyed in 1627, on modern OS map base, (© Crown Copyright & Landmark Information Group Ltd)

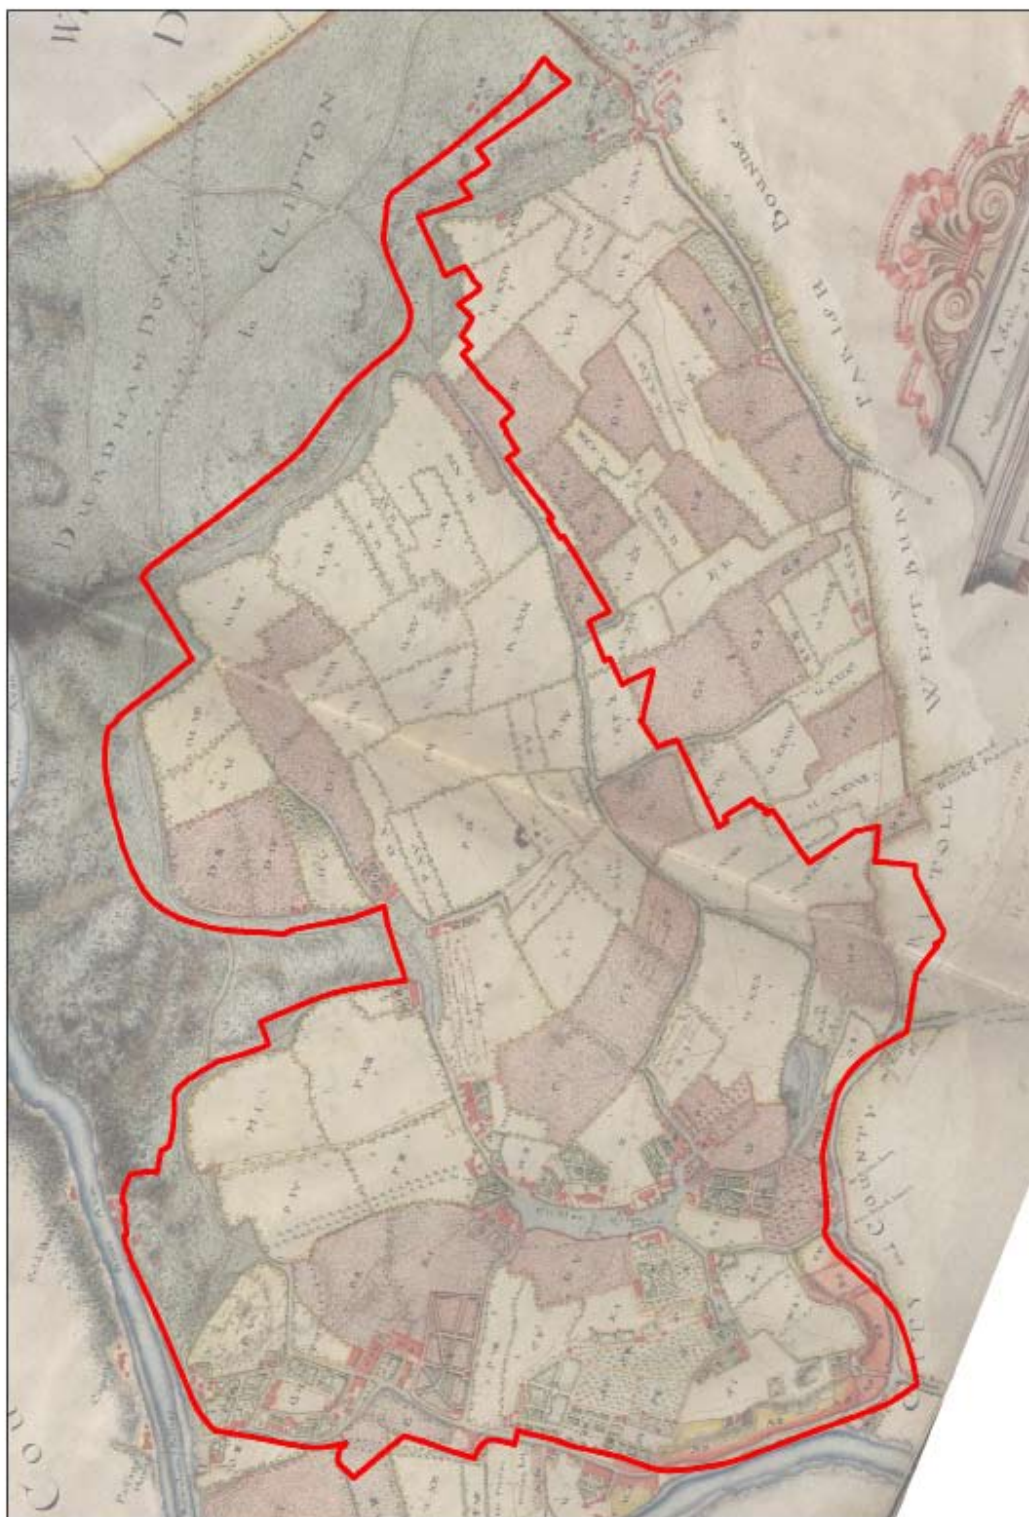
Figure 6: De Wilstar's Map, 1746 - produced for the Society of Merchant Venturers and provides the first pictorial representation of Clifton (© BCC Historic Environment Record).

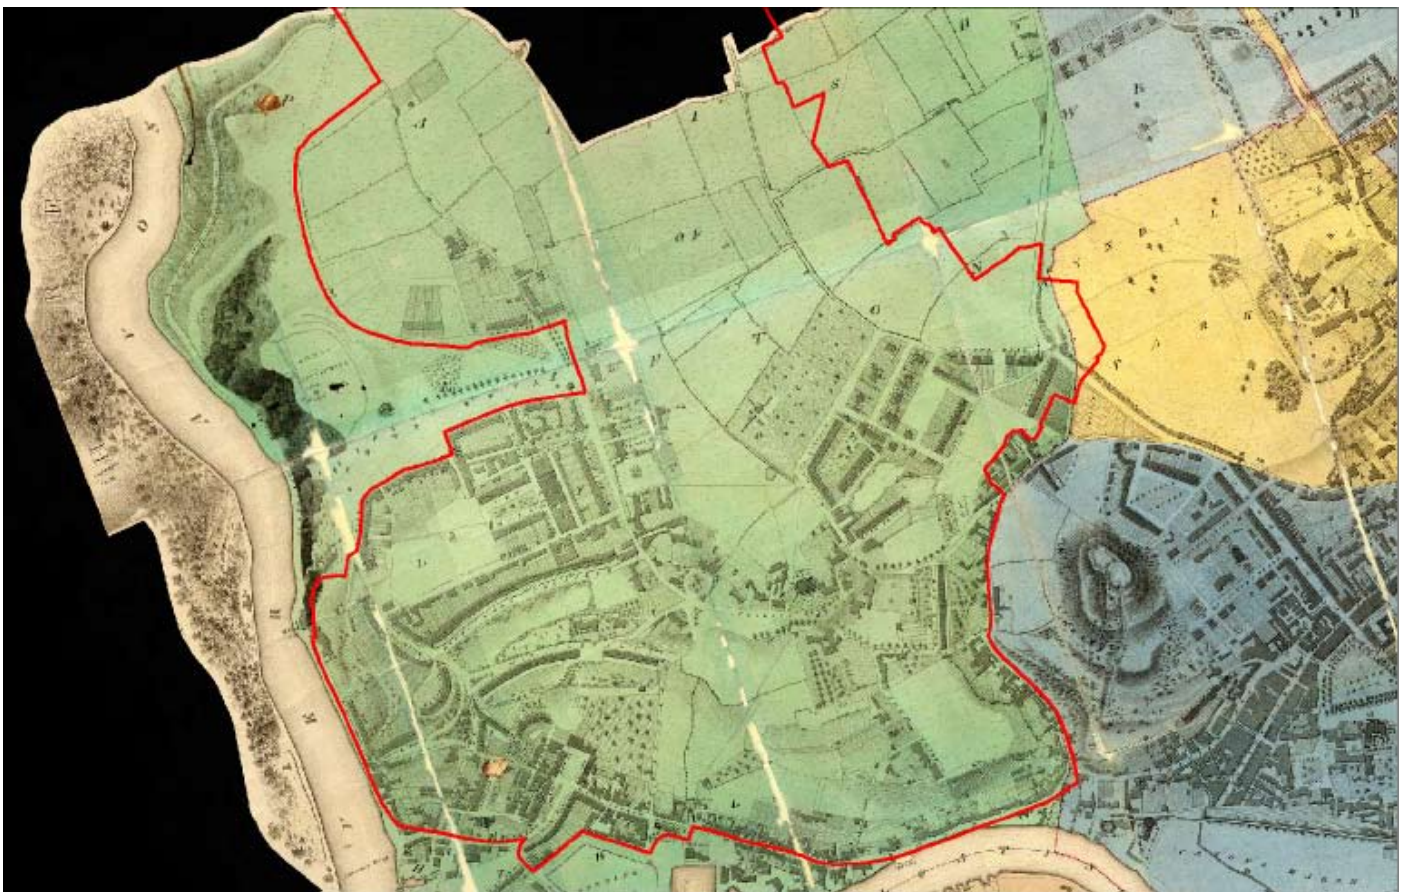
Figure 7: Plumley & Ashmead's Plan, 1828 (© BCC Historic Environment Record)

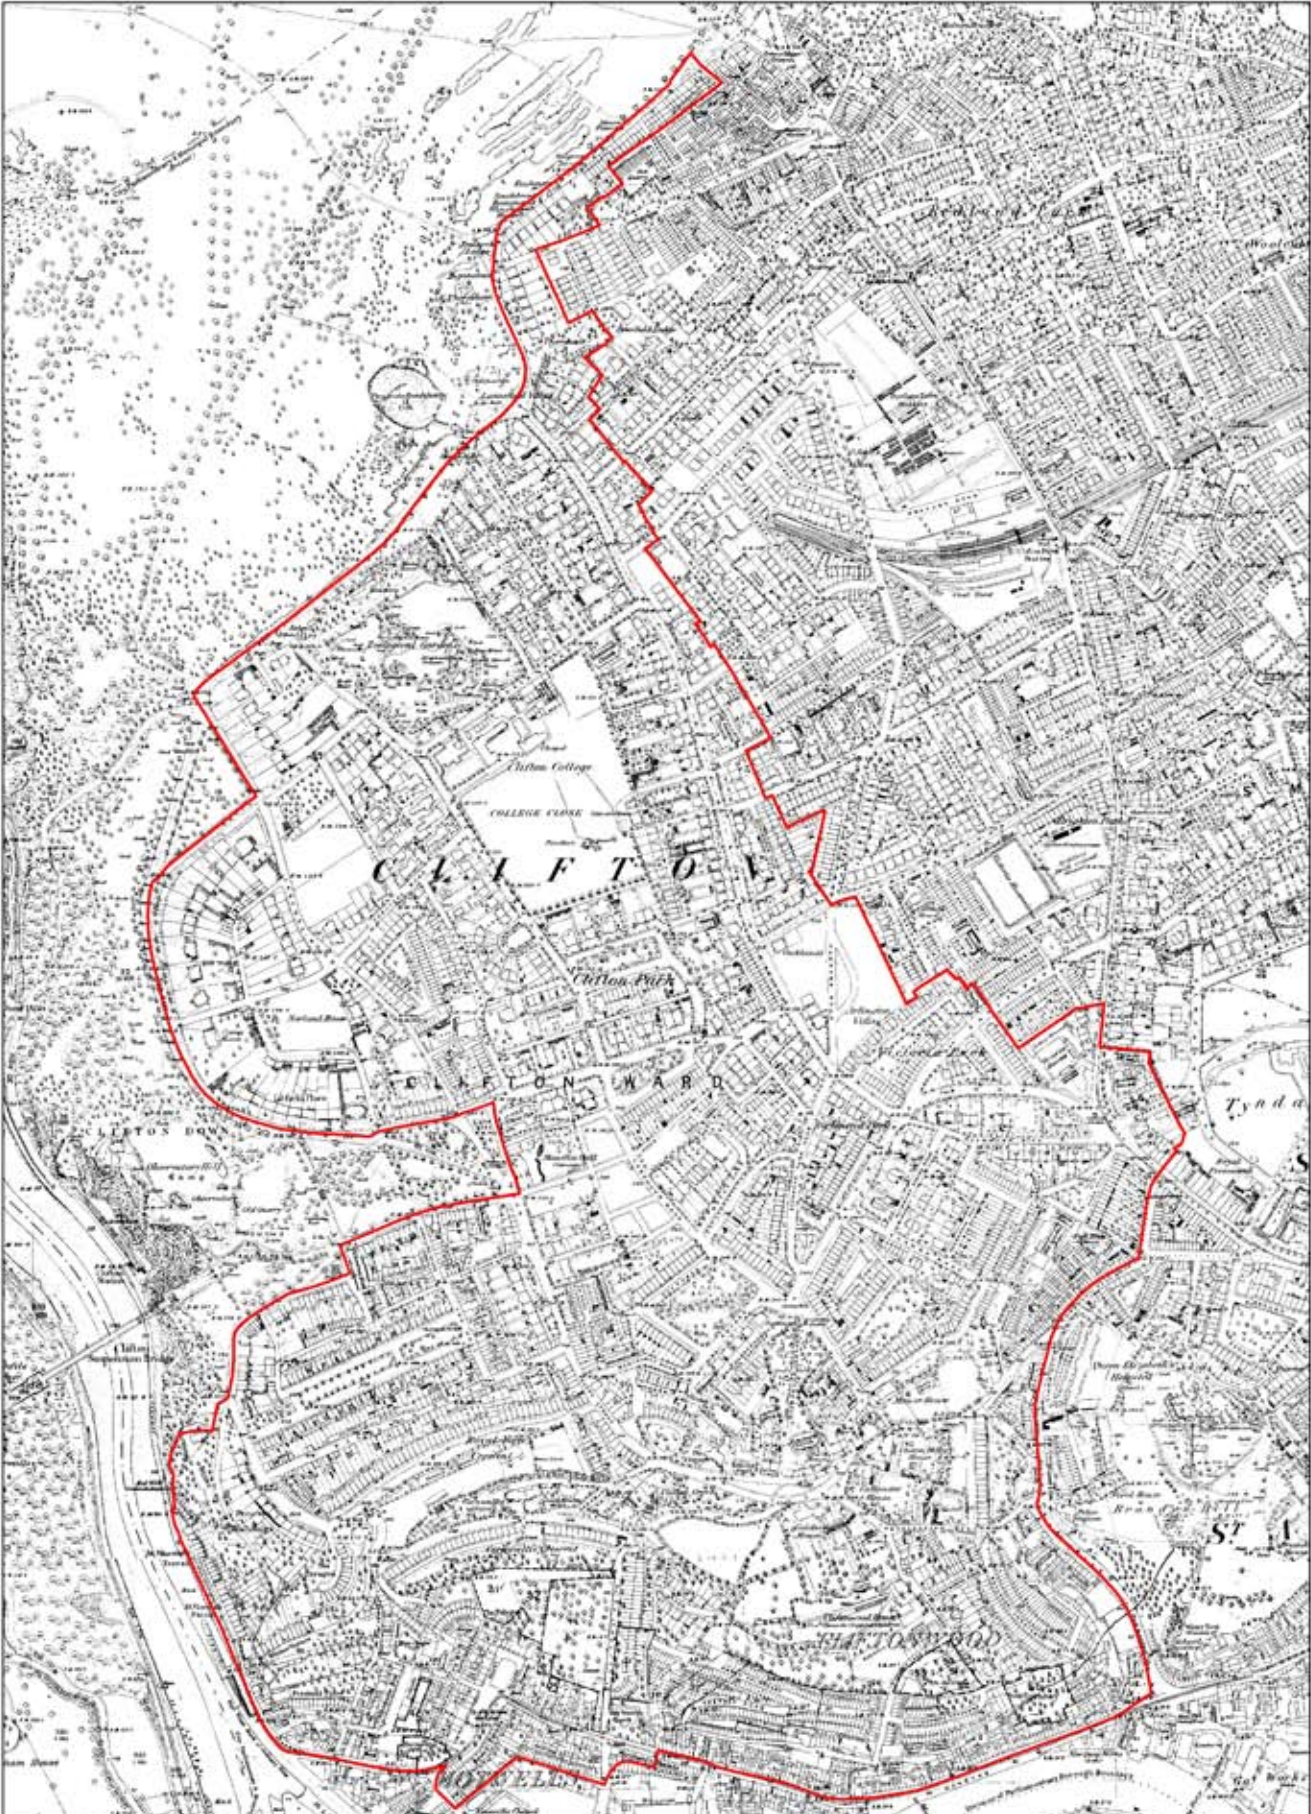
Figure 8: First Edition Ordnance Survey Map of Clifton, 1885.  
(© Crown Copyright & Landmark Information Group Ltd)

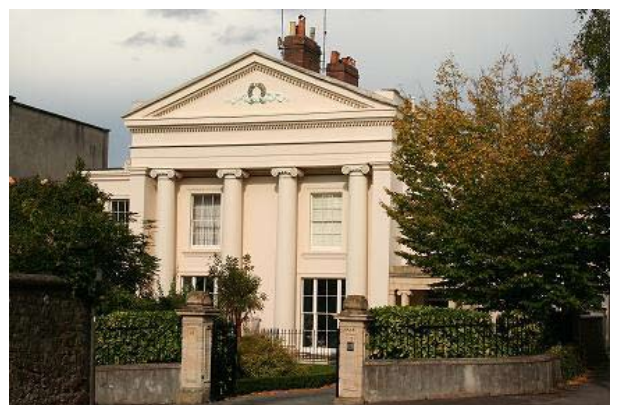
Figure 19: Two houses are reconciled into an Ionic temple, Buckingham Vale

7.1.1f **Buckingham Vale** (1847-50) has an extremely verdant and intimate character. With substantial semi-detached villas set behind low stone walls and gateposts with laurel hedges.

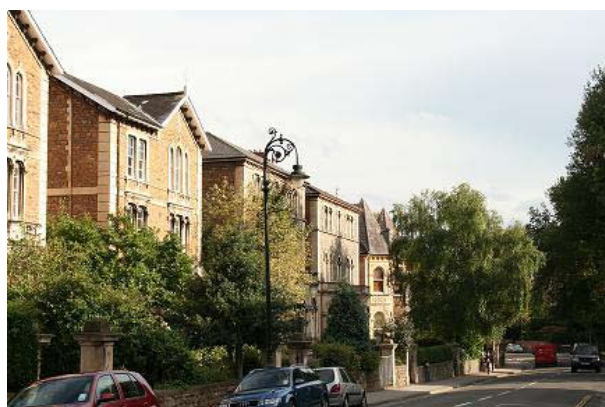
Figure 20: Pembroke Road. These substantial Italianate villas are set in generous landscaped gardens and largely retain much of their original character and appearance. These massive blocks of limestone rubble march confidently up the slope to meet The Downs above. Many have finely detailed Bathstone quoins and window surrounds

7.1.1h Further northwards, Pembroke Road characterises the shift in Victorian architecture towards an Italianate style from the mid 19<sup>th</sup> century onwards. Here is one the most impressive streets of late Victorian villa development linking the terraces of lower Clifton with The Downs. Buildings are of local rubble stone with Bathstone dressings, all with a green setting and red rubble boundary walls.

7.1.1i Pembroke Road was completed in 1870. Eight wonderful 'arc' cast iron lamp posts survive from late 19<sup>th</sup> century. The street is notably more leafy and houses, larger than towards the south. The verdant character of private gardens gives impression of wide green, tree-lined route, although there are no street trees.

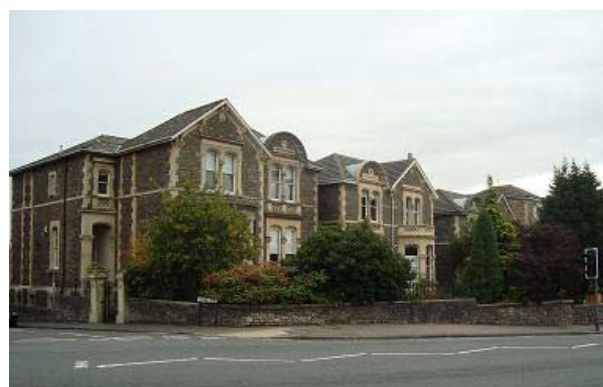
Figure 21: Upper Belgrave Road villas with front gardens and rubble walls

7.1.1j **Upper Belgrave Road (1860)** faces onto The Downs and continues the trend of substantial Italianate villas of rubble stone with Bathstone details. Nos. 1-18 are detached villa with extensive gardens.

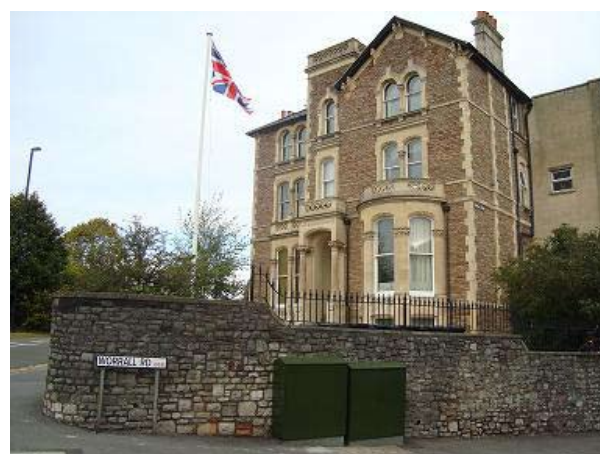
Figure 22: Corner of Upper Belgrave Road and Worrall Road, with ornate stone carving

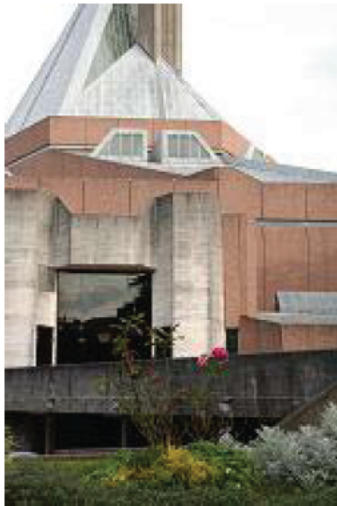
Figure 23:  
Clifton RC  
Cathedral

7.1.1m **Clifton RC Cathedral.** In 1965 architects Percy Thomas Partnership were commissioned to design and construct a new cathedral that would provide congregational space for up to 1000 around the high altar; the building was consecrated in 1973. Reinforced concrete clad, with panels of Aberdeen Granite and a concrete spire, which is one of Clifton's most recognisable landmarks. The concrete boundary wall and approach means the boldly modern structure sits uncomfortably within its surroundings.

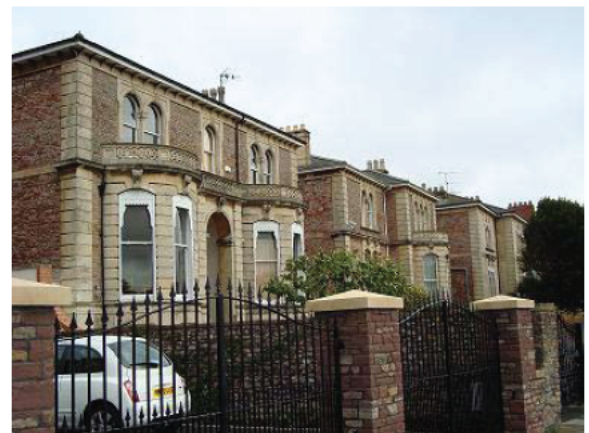
Figure 24: College Fields

7.1.2c **College Fields** (1870) faces the College sports field and consists of two storey, semi-detached or double-fronted properties in Pennant sandstone with Bathstone details, all Italianate style. Rubble boundary walls capped with railings, with stone gateposts, some original, are a particular feature.

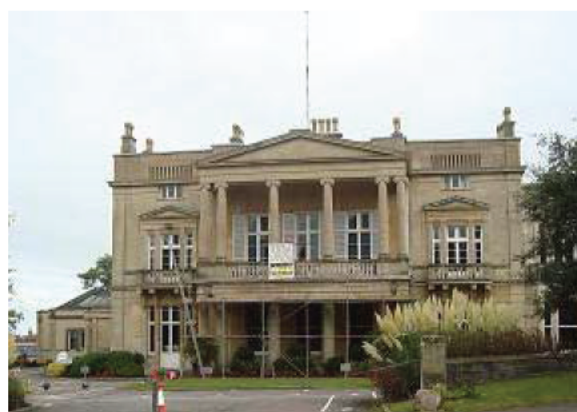
Figure 28: The Engineers House

7.1.3f **The Engineers House** (1831) is Grade II\* pedimented and double-fronted villa, by Charles Dyer, in limestone ashlar. Now in office use, there are unsympathetic alterations to gateway, hedge and railings; the very poorly maintained garden provides a poor setting for this heritage asset.

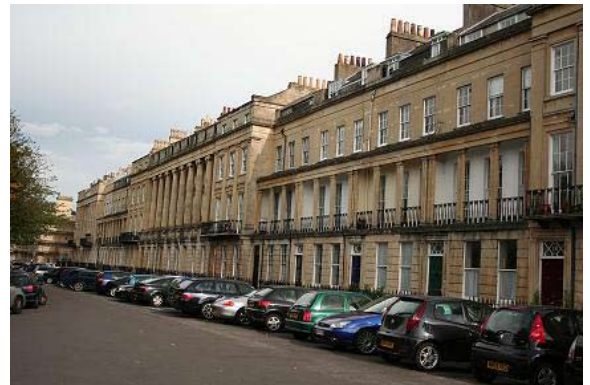
Figure 29: Vyvyan Terrace

7.1.4d Vyvyan Terrace (1832-1846) by Richard Shackleton Pope, was named after the Tory MP Sir Richard Vyvyan, who won the 1832 parliamentary election by defying the Reform Bill & bribing 1200 voters. Nos. 14-17 were the first to be built and stood alone for many years before the rest of the terrace was completed. The group sits on a privately owned raised pavement and railings were replaced as a community project in the late 1970s.

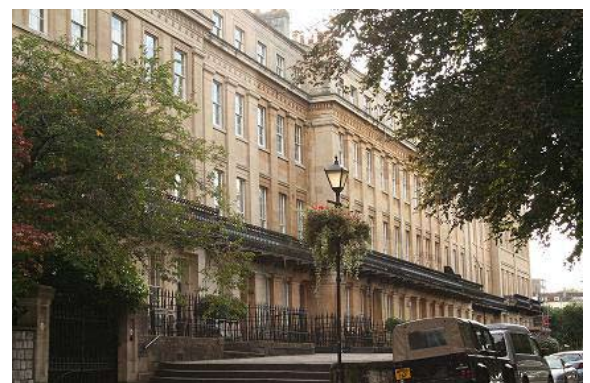
Figure 30: Worcester Terrace

7.1.4e Worcester Terrace (1848-1853) by Charles Underwood, Grade II\*, is a beautiful and well-maintained symmetrical terrace, with fine architectural details including stone carving, ornate balconies and stone gateposts. This group also has a raised pavement.

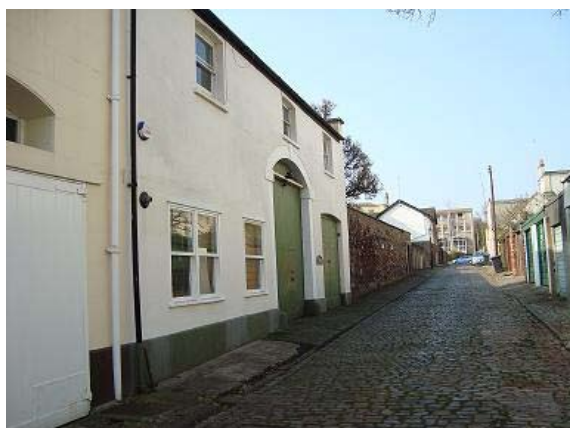
Figure 31: Cobblestone Mews

7.1.4f Cobblestone Mews is a fine back lane, which originally serviced Worcester Terrace. The intimate street retains its traditional mews character and cobbled street surface. Many coach houses retain their original character and arched openings.

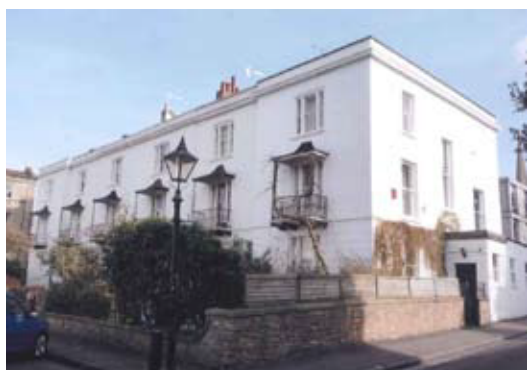
Figure 32: Rear of Canynge Square villas, formerly Somerset Place

7.1.4g Canynge Square (1841) is a distinctive area developed in the first half of the 19<sup>th</sup> century, starting with the terrace of the south end. The ashlar faced or rendered houses contrast with the limestone rubble on the north side of Percival Road. Upper Canynge Road, formerly Somerset Place, is earlier.

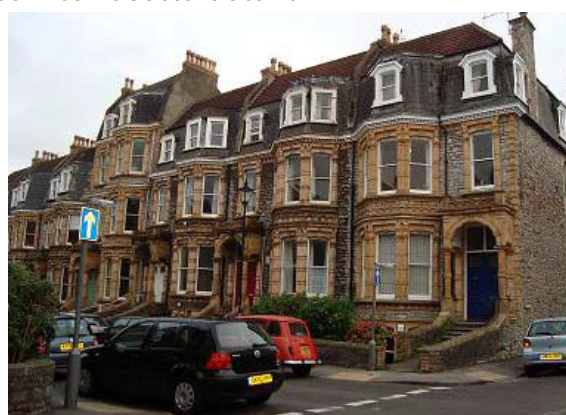
Figure 34: Manilla Road

7.1.4l Manilla Road (1890) is distinctive for its tall mansard roofs, porches and bays with buff terracotta details.

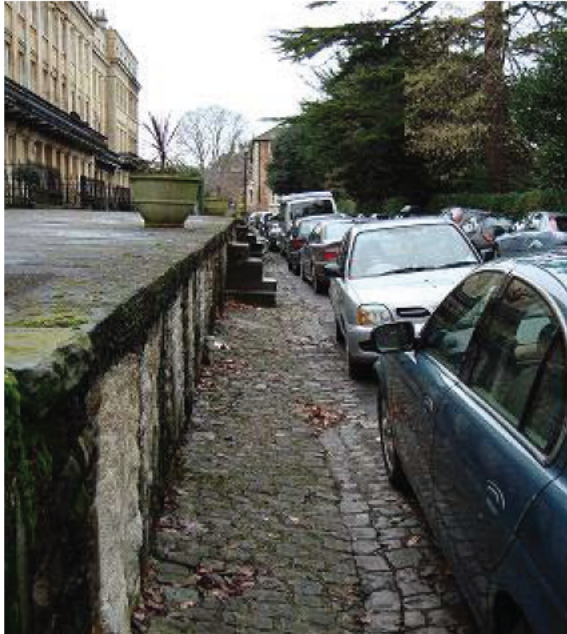
7.1.4m Historic street surfaces include the raised pavements to Vyvyan Terrace and Worcester Terrace and the original setted Cobblestone Mews. Vyvyan Terrace also has fine wrought iron and stone balconies, and stone Juliet balconies at nos. 3 & 19.

Figure 35: Worcester Terrace raised pavement

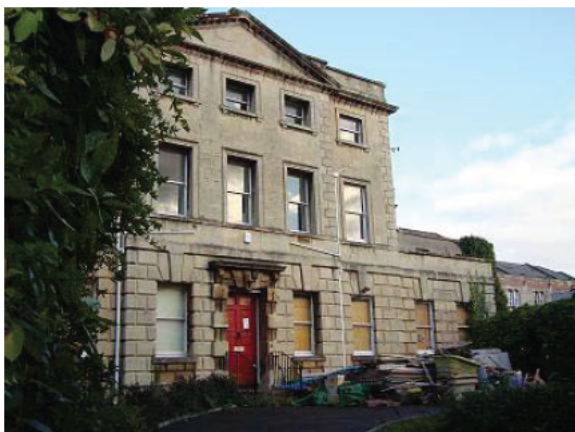
Figure 36: Mortimer House, Clifton Down Road

7.1.4o The special interest of this area is undermined by the volume of rush-hour traffic that uses it as a rat run turning left into Clifton Down. The Grade II\* listed Mortimer House, Clifton Down Road, stands empty and in a poor state of repair.

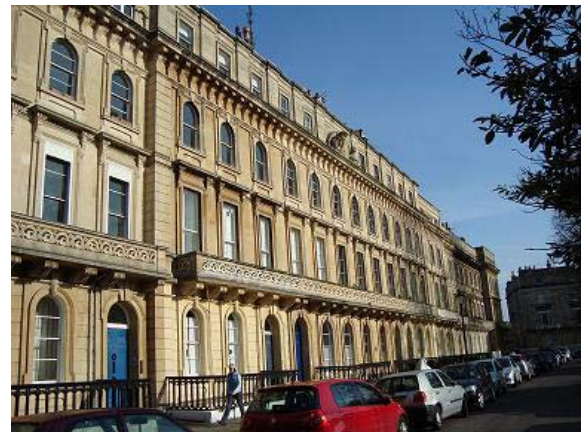
Figure 37: Victoria Square

7.1.5c **Victoria Square** (1840) is the largest of the formal spaces in Clifton and is contained by grand terraces on three sides in monumental style. Each terrace of the three-sided square was completed separately, though the group achieves harmony by the quality of architectural details, including stone balconies and cast iron, original foot scrapers, fanlights railings and the raised Pennant pavements. The Community Garden, is a formal green space, well used and loved by local residents.

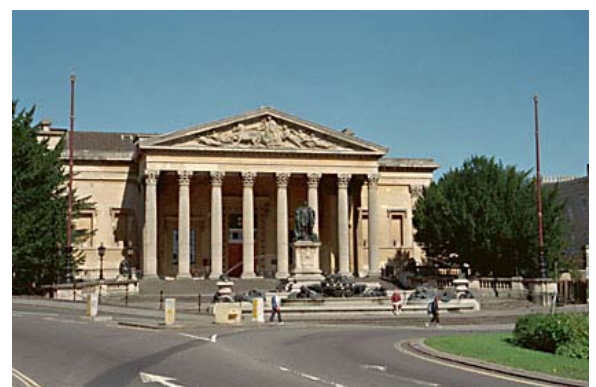
Figure 38: The Victoria Rooms

7.1.5d **The Victoria Rooms** (1839-41) by Charles Dyer, sits on the axis of the prominent intersection of Queens Road. The Grade II\* former assembly and concert hall is now the property of the University of Bristol. Originally sphinxes stood on the forecourt but were removed at the beginning of the 20<sup>th</sup> century and replaced by the Baroque fountain and the statue of King Edward VII.

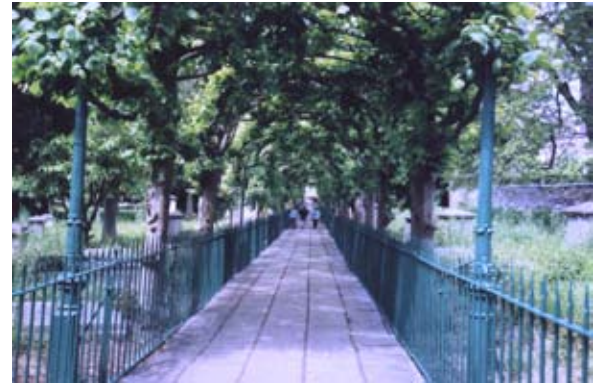
7.1.6b On the north side of Clifton Hill is St Andrew's Churchyard. The parish church of St Andrew's, stood on the summit of Clifton Hill, is first mentioned in 1154, and was partially rebuilt in 1654. The Regency Gothic church, by James Foster, 1819-22, was bombed and its tower pulled down in 1954 - only the foundations remain.

Figure 40: St Andrew's Churchyard 1820. Gothic wrought iron gate 1822 in Clifton Hill. Stone gatepost; early cast iron posts with lanterns above avenue of pleached limes

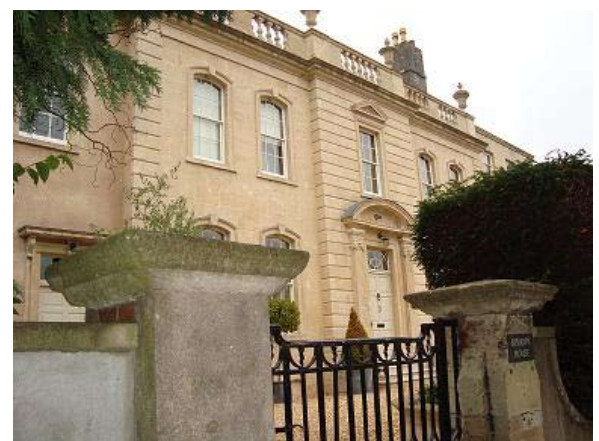
Figure 41: Bishop's House

7.1.6d **Bishop's House**, Clifton Hill (1711) is Grade II\*, limestone ashlar in early Georgian style. Originally known as the Church House, the mansion later became the official residence of the Bishop of Bristol (now in private ownership).

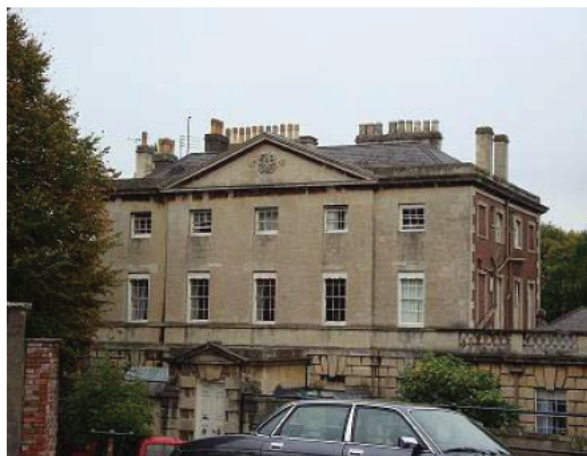
Figure 42: Clifton Hill House 1747

7.1.6e **Clifton Hill House** (1747), Clifton Hill, is Grade I listed and Clifton's most impressive Georgian mansion. Built by Isaac Ware for Paul Fisher, a wealthy merchant, whose monogram appears in the pediment. The main front faces south, away from the road.

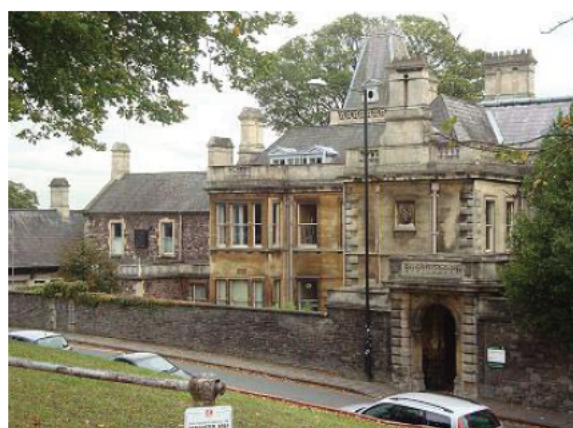
Figure 43: Goldney House 1714

7.1.6f **Goldney House**, Clifton Hill (Grade II) Built in 1720, possibly by John Wood of Bath, for Thomas Goldney, a Quaker merchant, and later remodelled in the mid 19<sup>th</sup> century. The 18<sup>th</sup> century gardens are the most famous feature of Goldney House with an orangery, canal, Gothic garden house and a bastion. The Grotto, a man-made cavern lined with minerals and shells, dates from 1739. The house is now a hall of residence of the University of Bristol.

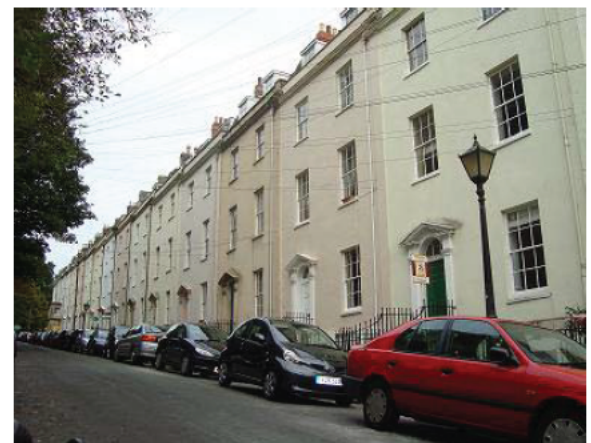
Figure 46: Bellevue Terrace

7.1.7d **Bellevue** (1792 - 1815) is an impressive Grade II listed terrace of 19 houses in a late Georgian style, by William Paty. There are steps up from the pavement to a raised ground floor. Many original railings and two original gas lamp fittings still exist. Notably, all doors are original with many fanlights.

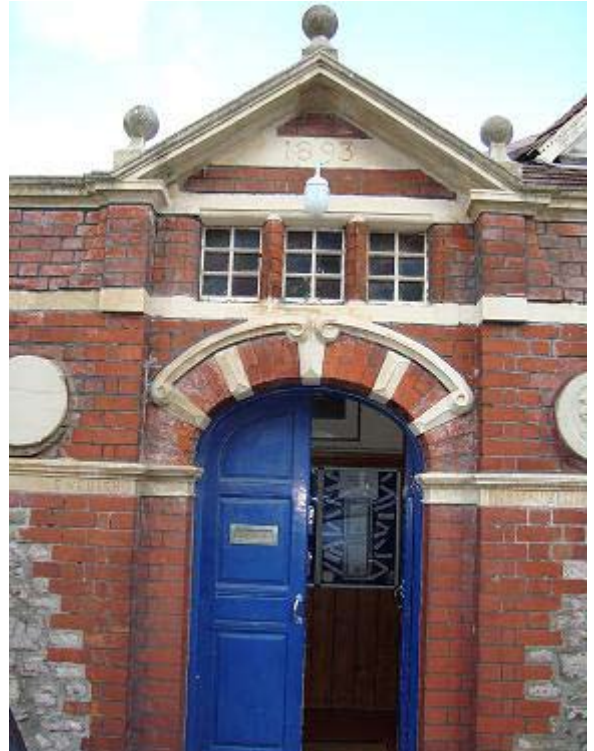
Figure 49: Entrance to Jacob's Wells Bathhouse

7.1.7g Jacob's Wells Road Bathhouse (now Dance Centre) Grade II by Josiah Thomas and opened in 1887 as a public baths. The water for the pool came from Jacob's Well on Brandon Hill. The building is red Cattybrook brick with buff terracotta dressings, gable stacks and slate roof.

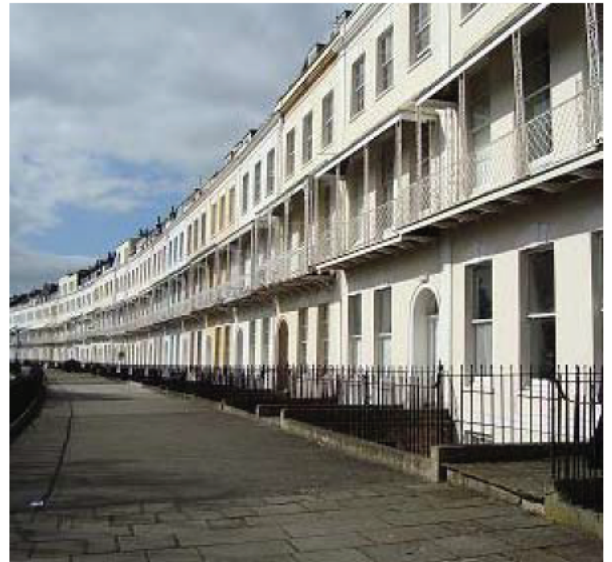
Figure 50: Royal York Crescent

7.1.8c **Royal York Crescent.** This Grade II\* terrace is claimed to be the longest in Europe. Building began in 1791 but the original developer went bankrupt in 1793 and the Crescent remained unfinished until completed in 1820.

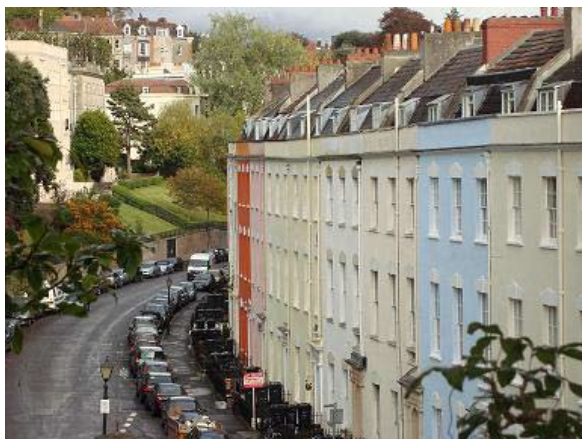
Figure 51: Cornwallis Crescent

7.1.8g **Cornwallis Crescent (1791-1827)** was originally called the Lower Crescent. This Grade II\* group and Royal York Crescent were planned to rival the Bath crescents. Affected by the building crisis of the late 18<sup>th</sup> century, building ceased until the 19<sup>th</sup> century; the establishment of a right of way during the interval meant that the original design was never completed.

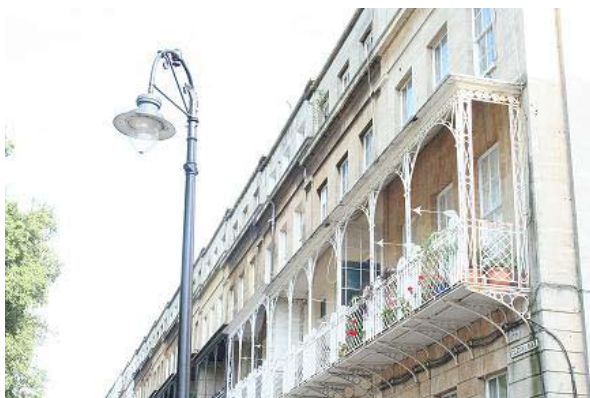
Figure 52: Balconies nos. 1-2 Caledonia Place

7.1.8h Caledonia Place (1833-40) is a Grade II\* stepped terrace which, with nos. 14-34 West Mall opposite, form a uniquely formal planned square for Clifton; which overlook the publicly accessible railed central gardens. Nos. 1-31 differ from nos. 32 onwards. The stone first floor balconies on cast-iron brackets, with wrought iron lattice sections and arched tops, are a particular feature. There is also a plaque to Lord Macauley, interesting Egyptian-style doors and Pennant mounting blocks.

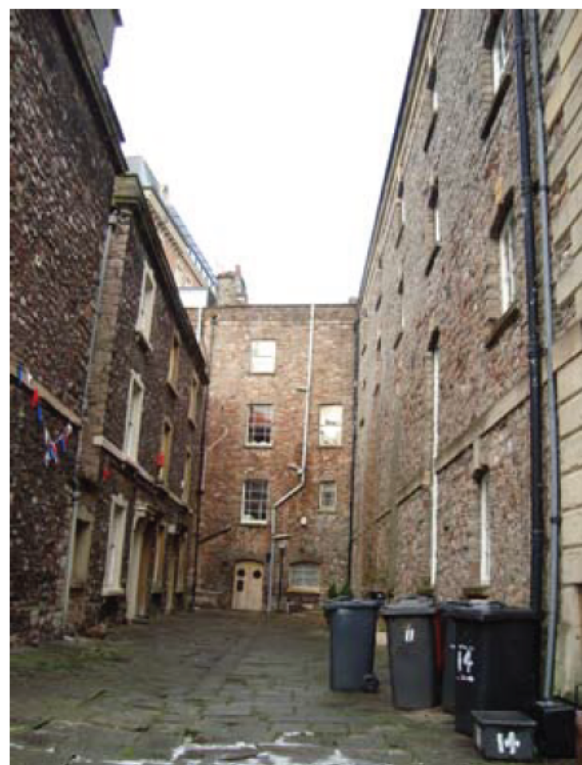
Figure 54a: Carters Buildings, off Portland Street West

7.1.8p **Carters Buildings** (1790s altered 1850) is a complex of listed warehouse and workers courtyard housing off Portland Street West. This intimate space is unique and in Clifton, with an intimate character that is relatively unaltered. The original Pennant flagged street surface and Windsor lantern remain.

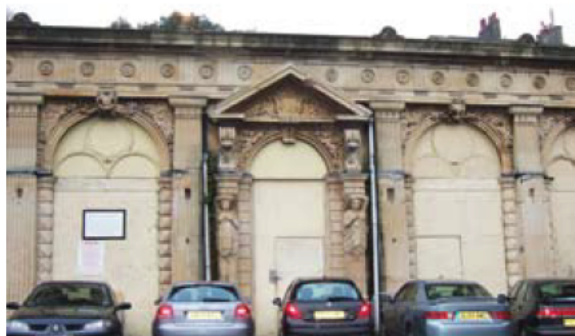
Figure 55: Clifton Spa Pump Room

7.1.8q **Clifton Spa Pump Room**, Princess Lane, was built in 1894 for Sir George Newnes. The Bathstone ashlar single-storey building has an ornate carved Classical front. The Spa, which was fed by a deep bore hole to the Hotwells 70m below, functioned until 1922. The room was then used as a cinema until 1928, then a ballroom until the 1974. Sadly this Grade II listed asset is in a perilous state and is Risk Grade 2 on the Buildings at Risk Register.

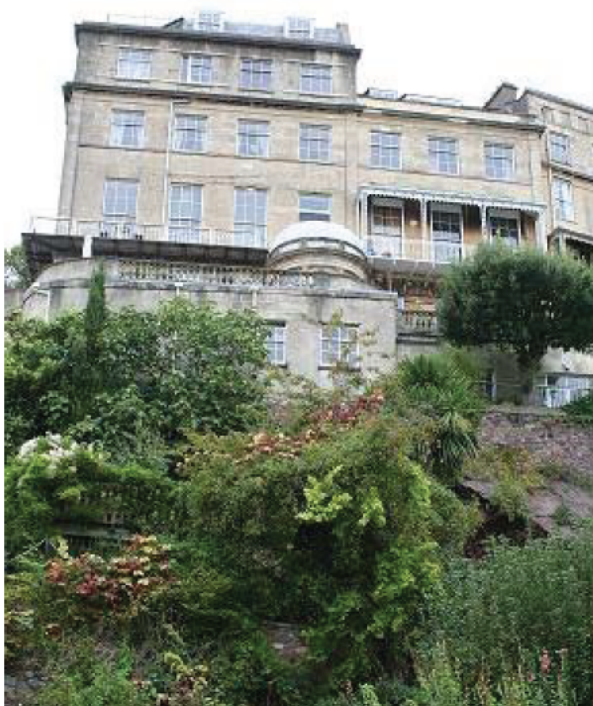
Figure 56: The Paragon

7.1.8f **The Paragon (1809-14)** forms a sharp convex crescent of 14 Grade II\* listed houses by John Drew. The buildings have their entrances, bowed single-storey porches, with unusual carved stone guttering, to the rear to allow the main frontage the spectacular views to the south.

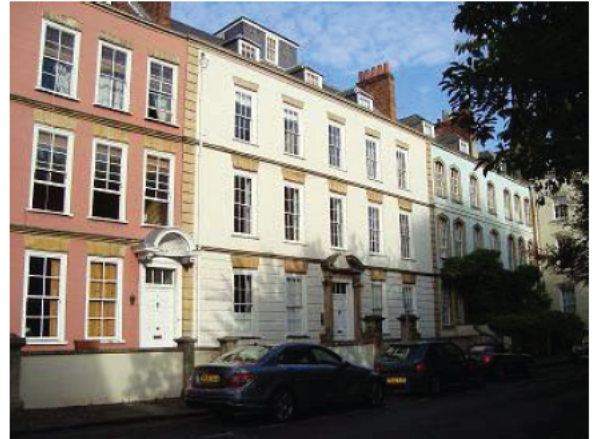
7.1.9b Dowry Square (1721), by Thomas Oldfield and George Tully, was the first significant development associated with the Spa. Dowry Square and its western extension, Chapel Row were begun about 1720, intended as visitor's lodgings to serve

the popular Hotwell Spa. The Grade II\* Square has an intimate character, three-sided around a garden with mature trees, which is a vital component of its composition. The central gardens have spear-headed railings, mounted in copper slag block coping.

Figure 57: Dowry Square 1721, with distinctive Queen Anne style 'shell' door hoods

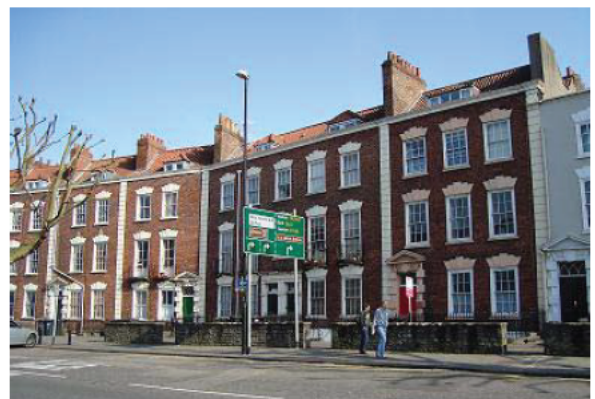
Figure 58: Dowry Parade 1763

7.1.9c **Dowry Parade** is a modest 1763 development of pleasant Grade II, red brick terrace houses. The group is ordered with alternating 5 and 3 bay houses. The larger 5 bayed properties were sub-divided in the late 18<sup>th</sup> century, resulting in the crowded pairs of front doors and blocked central windows. The original doors have heavy Gibbs surrounds.

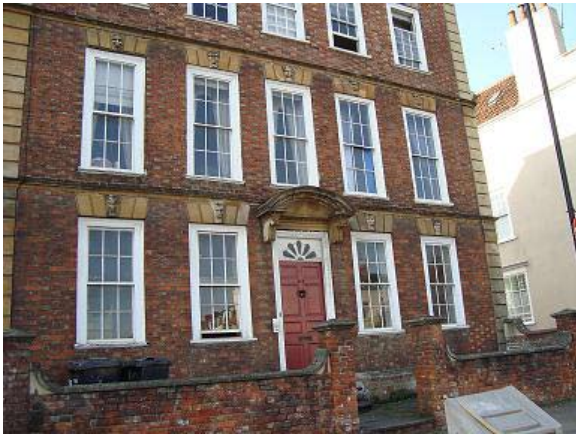
Figure 59: Chapel Row 1725

7.1.9d **Chapel Row** (1725-27) is the continuation of the west side of Dowry Square, also Grade II\* listed. No. 262 is a double fronted house with grotesque window keystones.

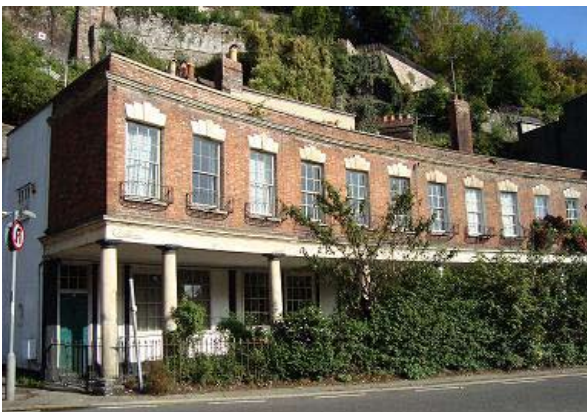
Figure 60: The Colonnade

7.1.9f **The Colonnade, Hotwell Road,** is all that remains of the once fashionable Spa. Built in 1786, by Samuel Powell, to meet the need for a sheltered walk. It was designed with shops below and living quarters above; the north end originally joined the Pump Room. The Grade II\* group has a gently curving brick front of 13 bays with shopfronts beneath a deep Tuscan colonnade supported by pillars. Built into rock at back with caves for storage.

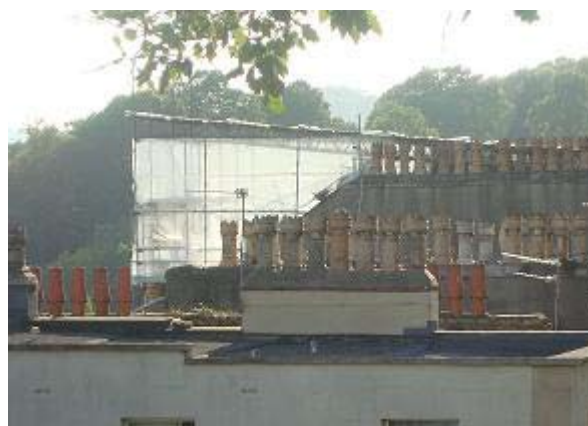
7.2.4 Chimney stacks and pots form striking features when seen against the skyline. Replacement or removal of chimney pots and stacks is discouraged, even when redundant.

Figure 61: Chimney stacks and pots along the skyline

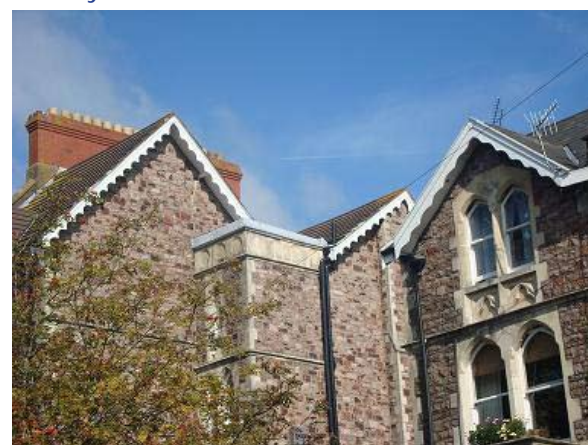
Figure 62: A variety of white painted barge boards appear on later Victorian buildings

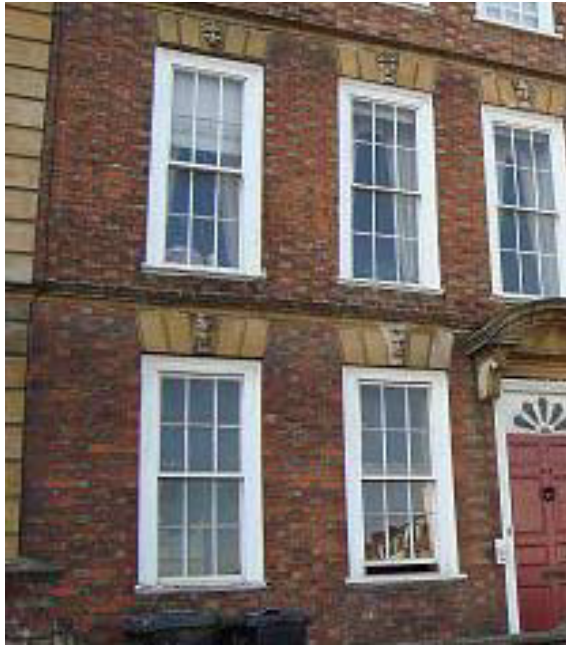
Figure 63: Early 6-over-6 timber sashes, Dowry Parade, flush with the brick facade

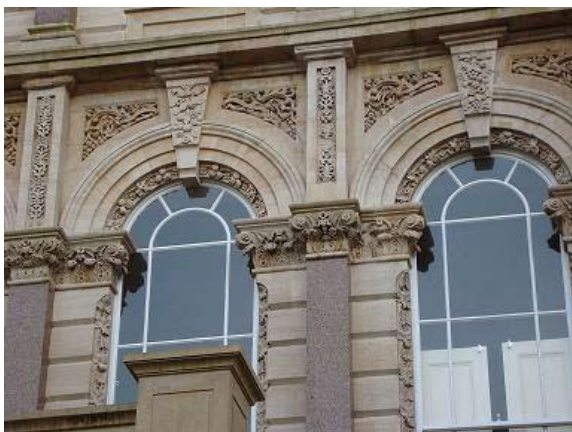
Figure 64: Victorian round-headed sashes with unusual glazing bar pattern

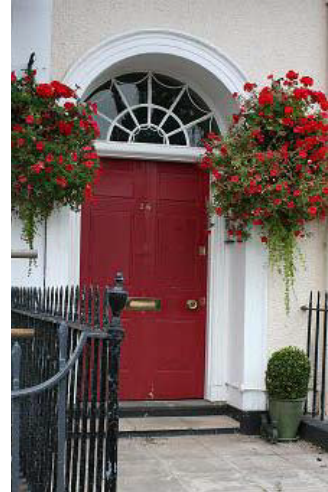
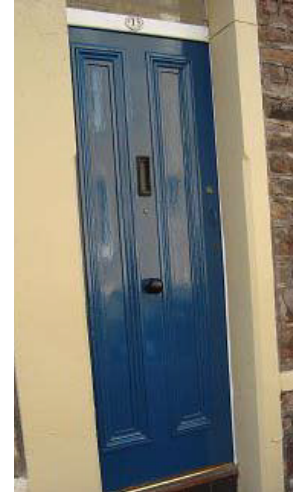
Figure 65 & 66: 6 panel door with ornate fanlight, Royal York Crescent; Simple 2 panel door in Clifton Wood

7.2.7 Doors and Bathstone surrounds are the most elaborately detailed element of the facades. In Clifton & Hotwells there are a variety of original 6-panel doors with traditional door furniture. These have a variety of limestone Classical surrounds and porches.

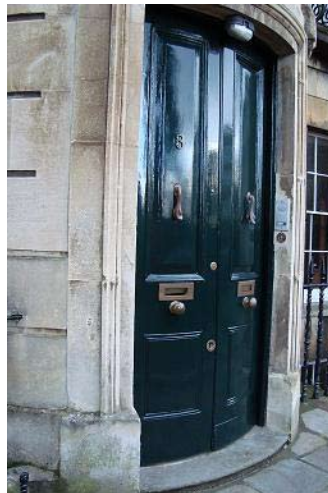
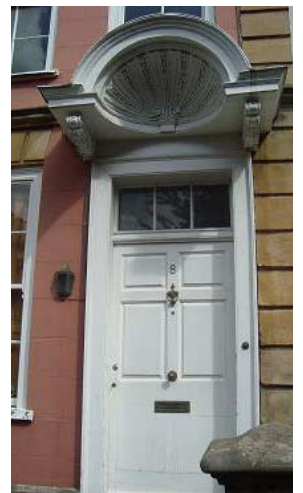
Figure 67 & 68: Unusual double bowed door, The Paragon; Elaborate carved timber 'shell' canopy, no. 8 Dowry Square

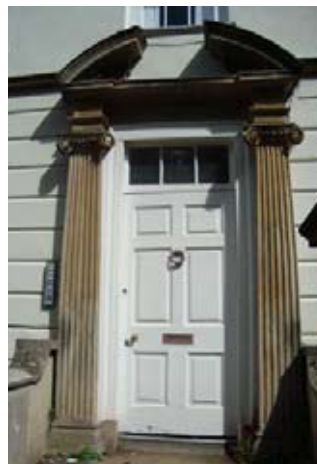
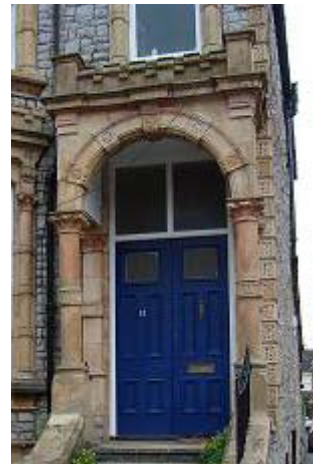
Figure 69 & 70: Broken pediment and Ionic stone surround, Dowry Square; late Victorian terracotta and stone porch with double door, Manilla Road

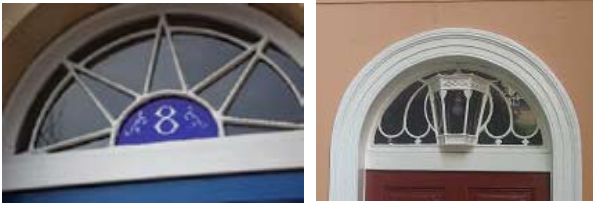
Figure 71: & 72 Wrought iron 'star' fanlight, West Mall; delicate 'Bats wing' fanlight with lantern

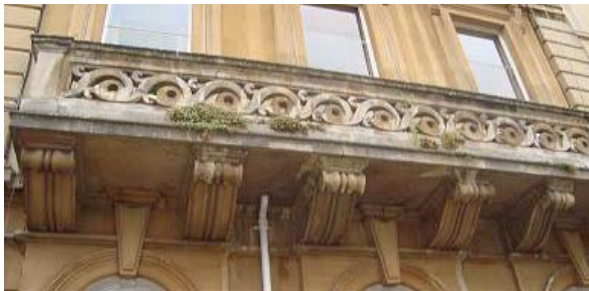
Figure 73: Stone balcony, Victoria Square

7.2.9 Clifton boasts a fine variety of decorative iron and stone balconies, which add greatly to the character of individual buildings and are significant in adding interest to the wider area. Earlier examples tend to be simpler of wrought iron on stone plinths; later Victorian ones become more elaborate in design, being of stone or decorative cast iron.

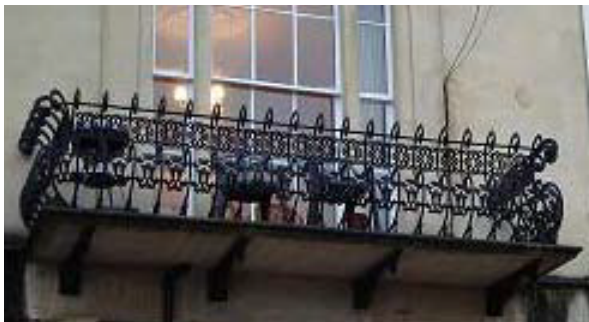
Figure 74: Basket balcony, St Paul's Road

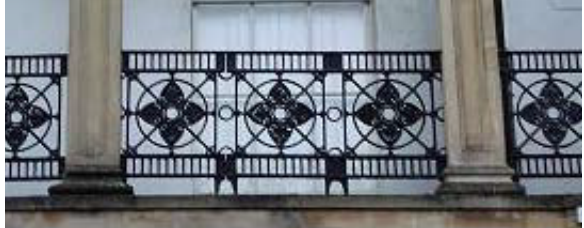
Figure 75: Balcony railing between pilasters, Buckingham Place

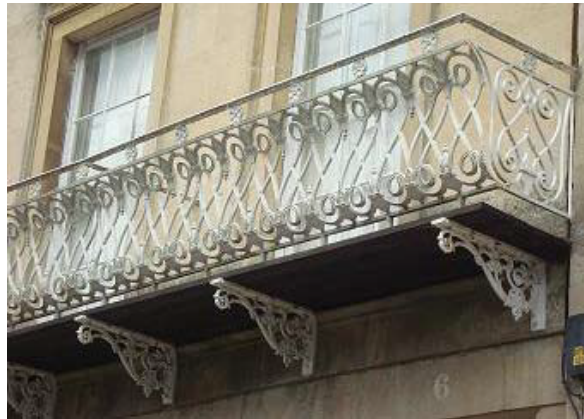
Figure 76: Stone balcony supported by decorative wrought iron brackets with figure of 8 railings, Saville Place

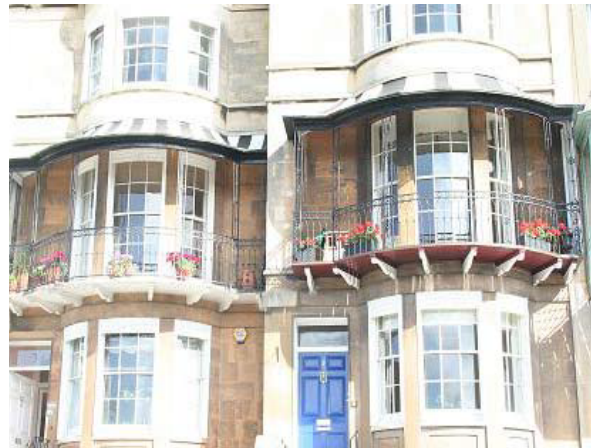
Figure 77: Bowed canopies, Sion Hill

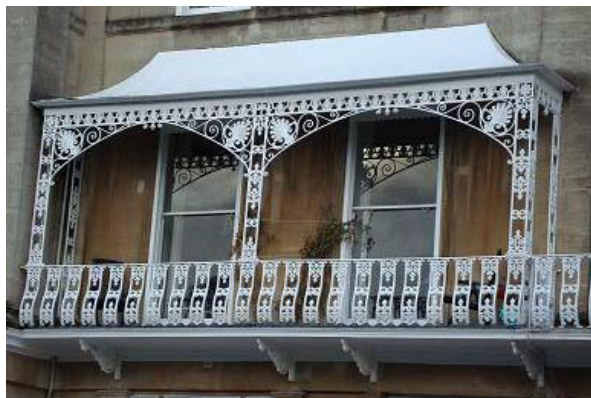
Figure 78: Canopied balcony with highly decorative support, Landsdown Place

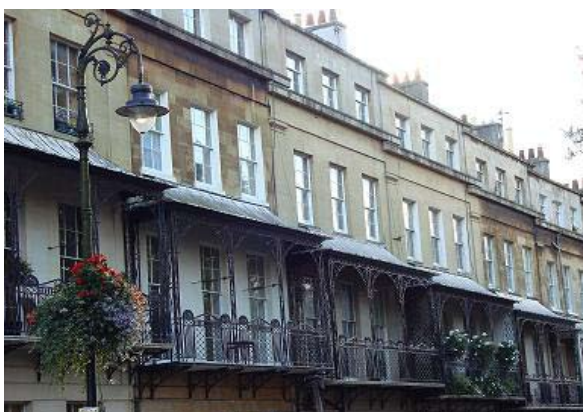
Figure 79: Group of canopied balconies that step with the terrace, Caledonia Place

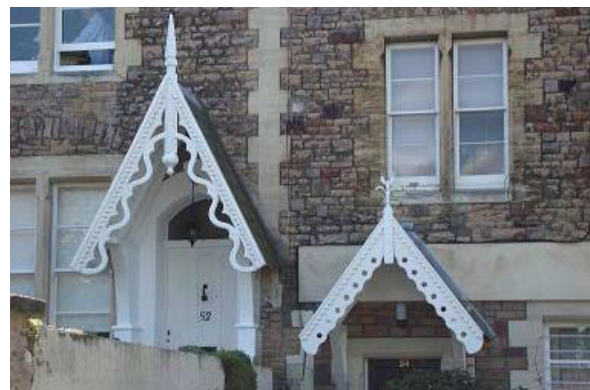
Figure 87: Decorative barge boards over porches or soffits adorn a number of late Victorian properties

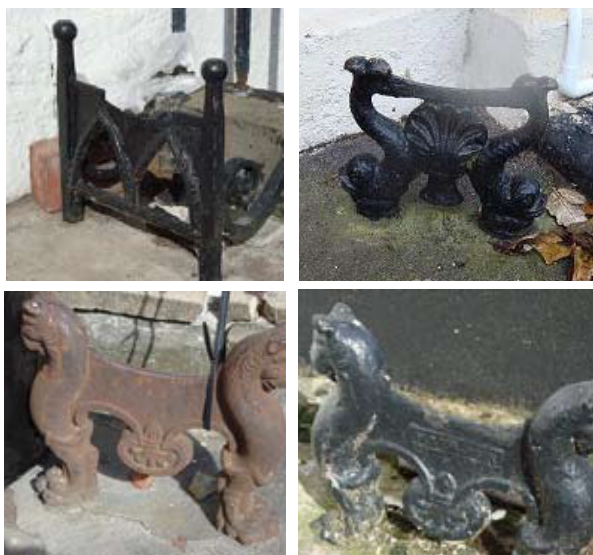
Figure 80-83: Various designs of cast iron footscrapers, many survive in the Clifton Spa terraces

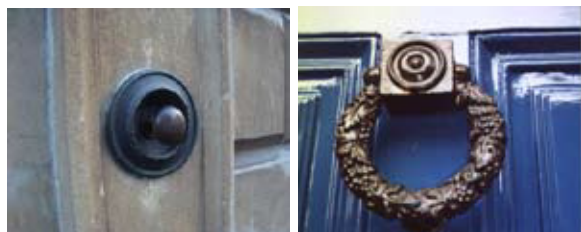
Figure 84-85: Original bell pull and traditional door knocker
