# Clifton & Hotwells

Character Appraisal & Management Proposals

June 2010

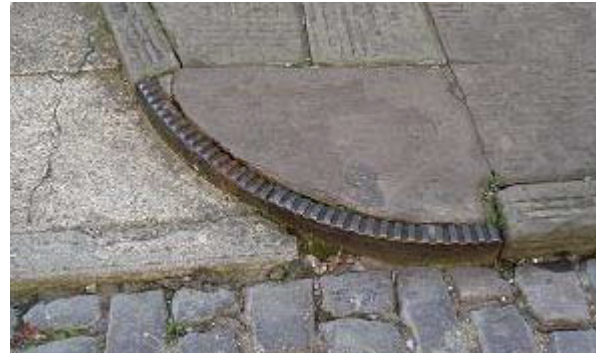
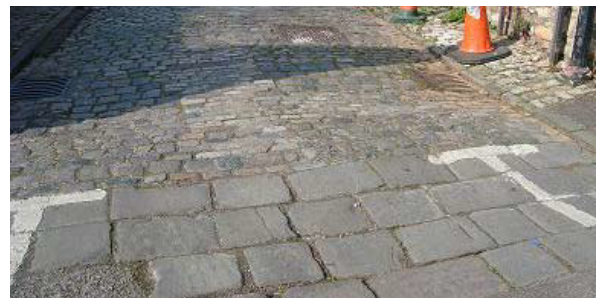
7.3.4 A particular townscape feature of Bristol is iron kerb edging, used to prevent damage to vulnerable Pennant corner stones. Only four streets in the Conservation Area retain their iron edges (3 Clifton Spa streets, and 1 in Hotwells). 80% -100% of the remaining pavements in the conservation area have Pennant kerbs, except in Hotwells where the number reduces to 50%. This is a feature and should be kept.

Figure 89 & 90: Traditional iron kerb edge; Pennant flag cross over to setted mews

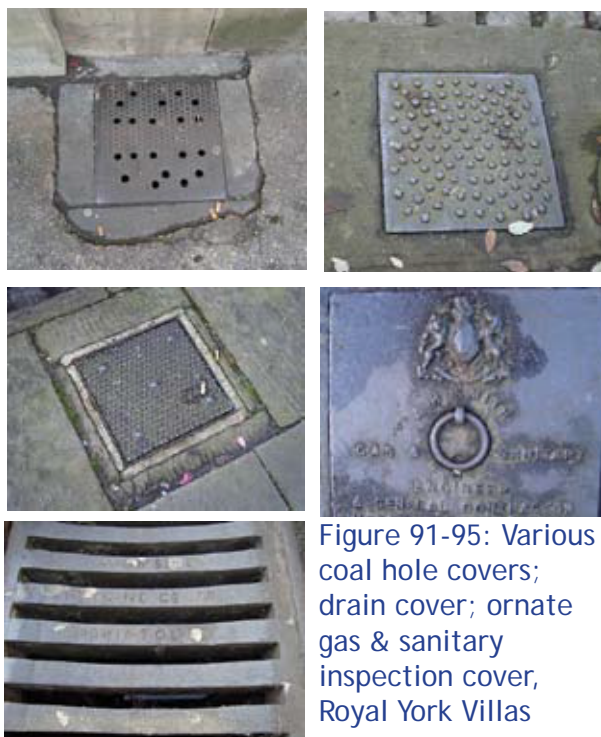
7.3.8 Although most drains are Bristol Water, some have Bristol founders marks such as this one by Avonside Engineers who made steam locomotives.

Figure 91-95: Various coal hole covers; drain cover; ornate gas & sanitary inspection cover, Royal York Villas

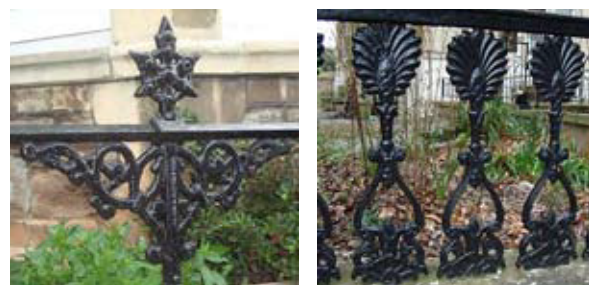
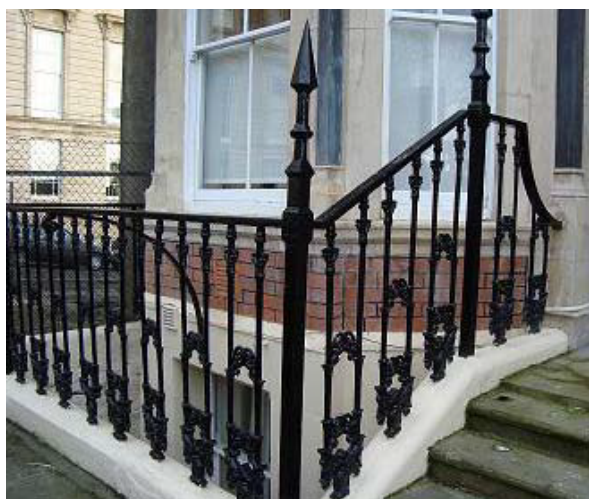
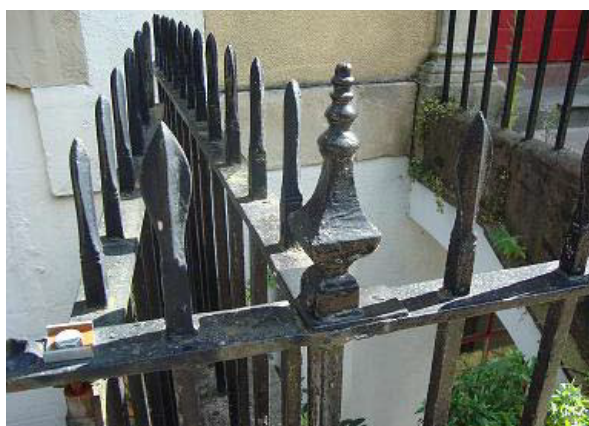
Figure 96-99: Various railing designs

7.3.13 When railings are repaired, the posts should be lead soldered and individually let into the stone coping, to prevent corrosion of the foot and the original quality of workmanship. Stone should be left unpainted or rendered.

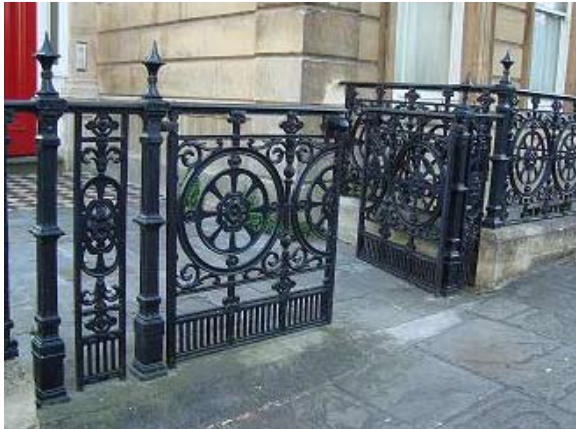
Figure 100: Elaborate gate, Victoria Square

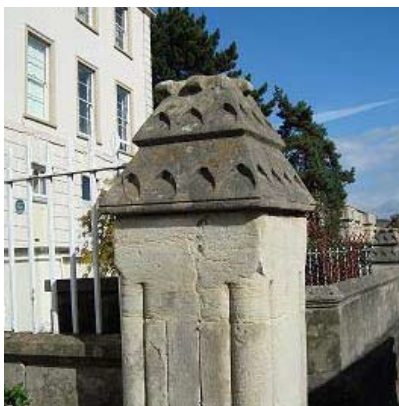
Figure 101: Stone gate post, Clifton Park

7.3.15 There are many designs of gate posts, both iron and imposing stone, both for driveways, paths to the front door, and down to the basement. Limestone posts can erode, particularly with frost damage, and require regular maintenance to avoid irreparable damage.

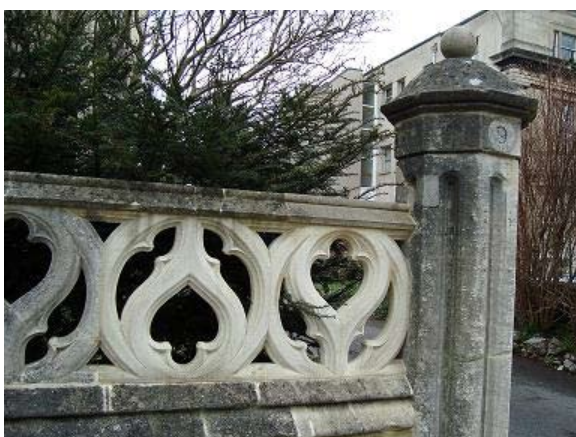
Figure 102: This stone balustrade on Clifton Park has been expertly repaired

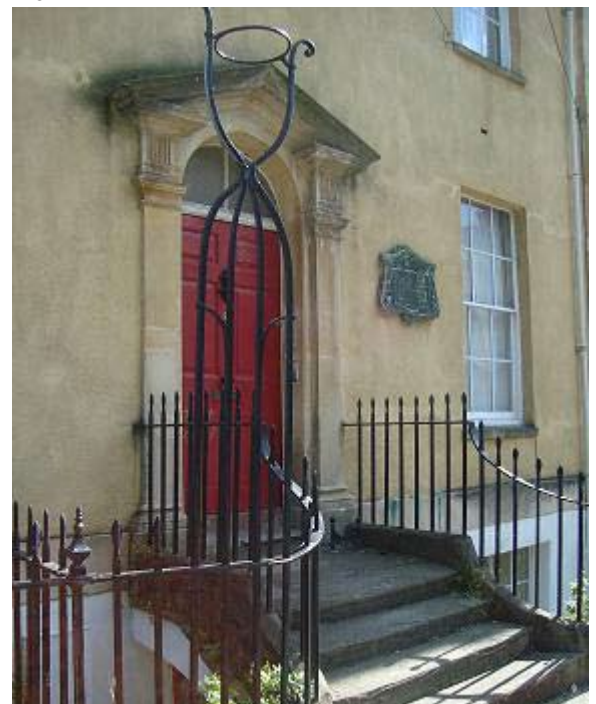
Figure 103: Original oil light fitting attached to wrought iron area railings

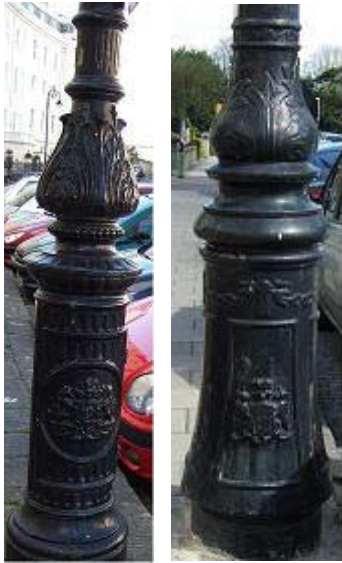
Figure 106-107: There is great variety between cast iron lamp standard bases

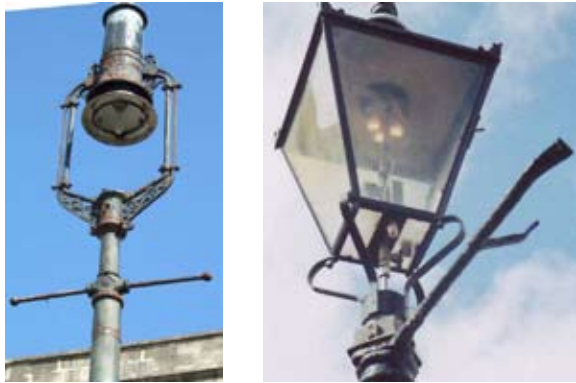
Figure 108 & 109: Unusual 'chin strap' lantern; traditional 'Windsor' lantern

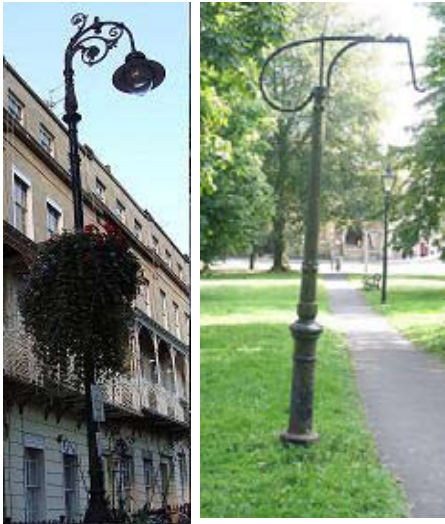
Figure 104-105: Tall arc lamppost, Caledonia Place; historic lamppost with no lantern

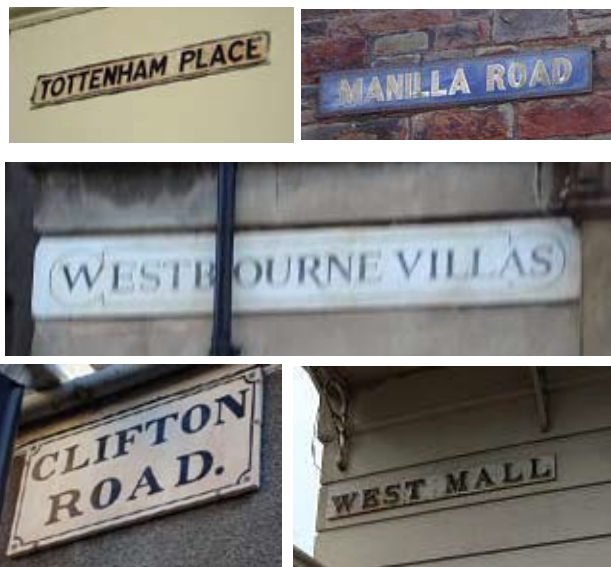
Figure 110-14: Various street signs in a variety of materials

7.3.25 There are many different street signs from the different periods. Old signs should be kept.

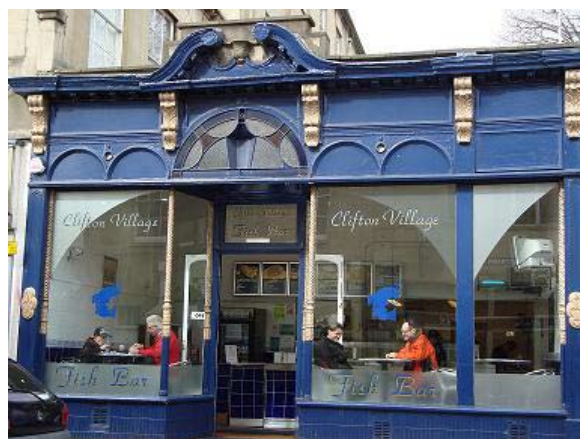
Figure 115: Elaborate timber shopfront, Princess Victoria Street

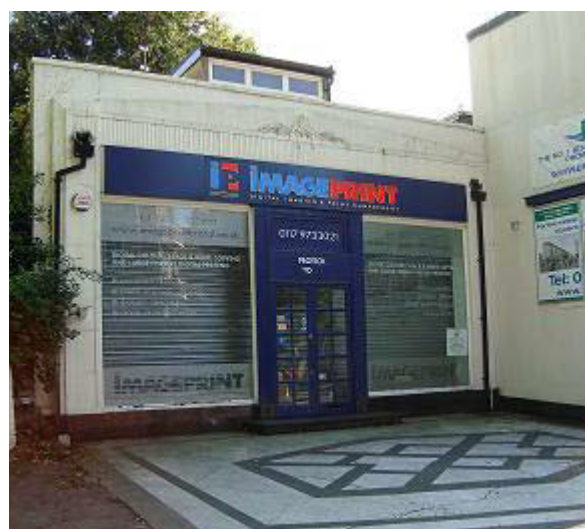
Figure 116: Early 20<sup>th</sup> century Art Deco surround with mosaic forecourt, Queens Road

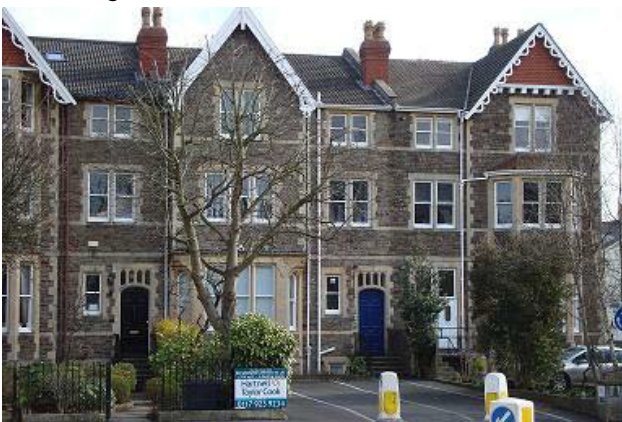
Figure 121: The garden on the right has lost the whole of its boundary wall and been surfaced for car parking. This impacts on the street and terrace as well as individual property and causes run-off during heavy rainfall leading to blocked drains and flooded roads

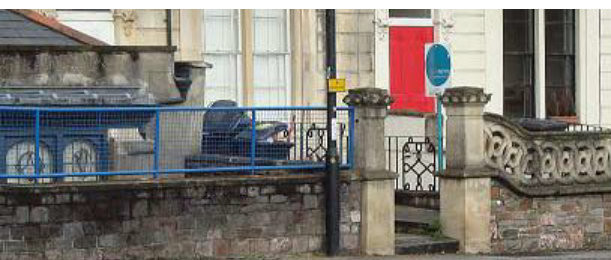
Figure 122: unsympathetic replacements railings detract from the stone balustrade opposite

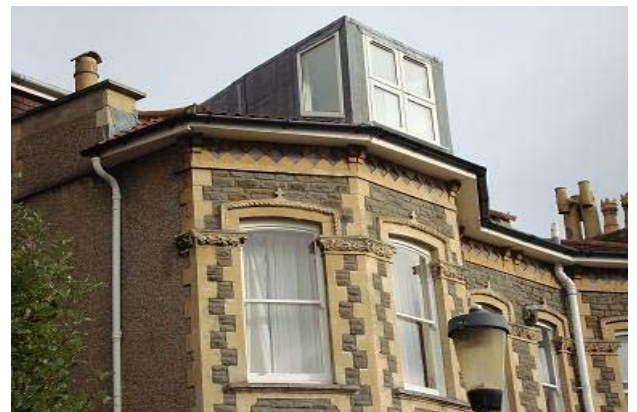
Figure 123: This style of dormer is out of scale and poorly detailed. It detracts from the building and the wider street

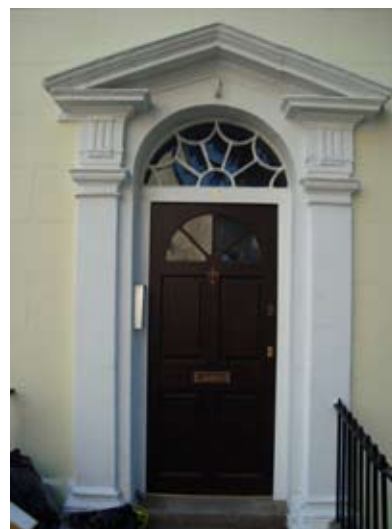
Figure 124: Modern door with integrated fanlight is inappropriate on a Grade II building with original fanlight

9.3 Where poor quality replacement doors and windows, especially in uPVC, or roof level extensions have been inserted these have had a significant and detrimental impact on the architectural integrity of individual buildings. Roof-level extensions are particularly detrimental, especially when they interrupt the consistency of a group.

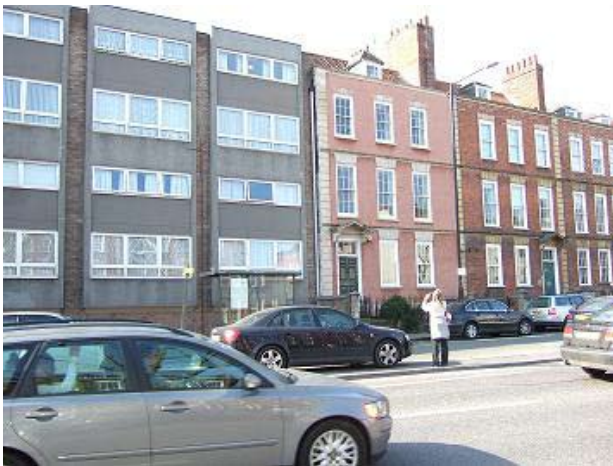
Figure 125: Dowry Parade, the material and fenestration pattern fails to respect that of the Grade II listed properties it adjoins and detracts from the quality of the group and the wider area

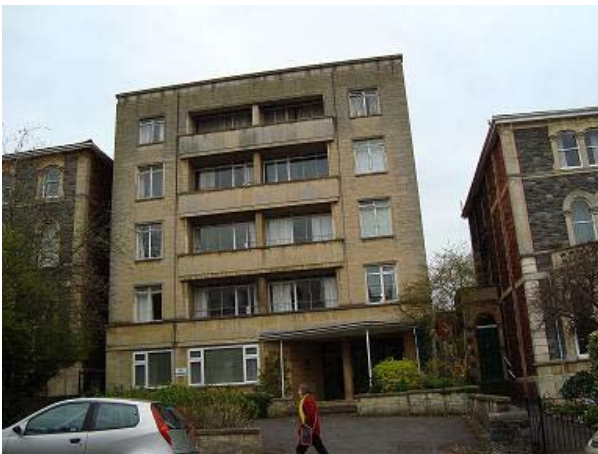
Figure 126: Pembroke Road flat block that is out of scale with the otherwise consistent building height and roof line of the street

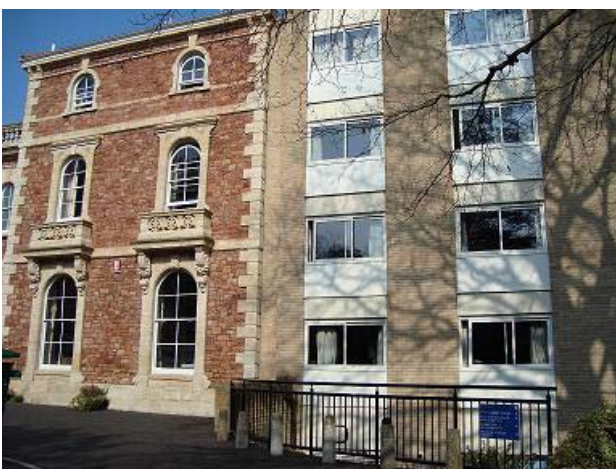
Figure 127: Wisemans, Worcester Road, is poorly detailed and the horizontal windows detract from the beautiful examples next door

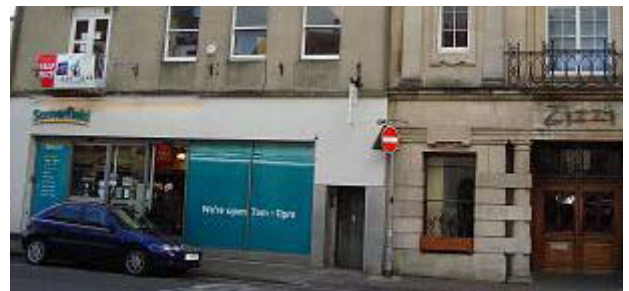
Figure 128: Somerfield shopfront, Princess Victoria Street - the lack of stallriser and powder coated aluminium frame give this shopfront a blank and hard face that detracts from the otherwise interesting range of quality shopfronts on Princess Victoria Street

9.6 Poor quality shopfronts and signage can have a dramatic effect on the quality of the street scene. This is particularly significant along Princess Victoria Street, Regent's Street and Hotwell Road.

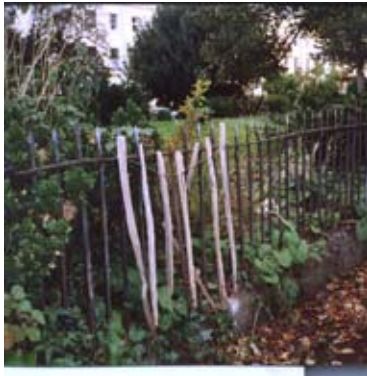
Figure 129: Wooden fence used to plug gap in the railings to a community garden

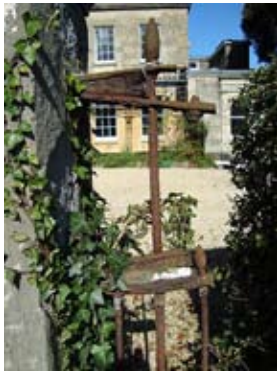
Figure 130-31: Examples of boundary railings that have fallen into a severe state of disrepair and are at risk of being lost through irreparable damage

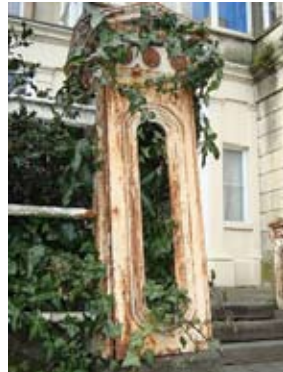
Figure 132: Steel gate, inappropriate for Grade II house and attracts graffiti

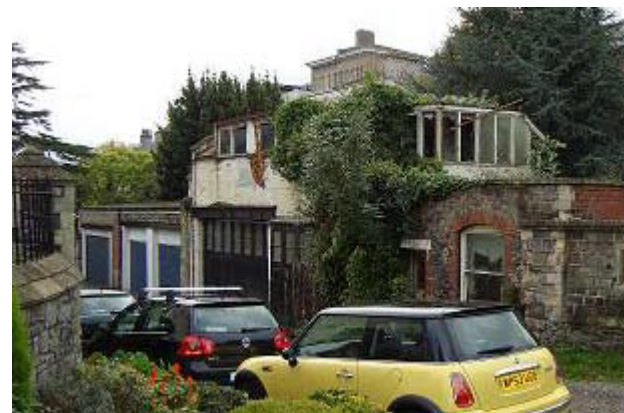
Figure 133: Traditional garage has been left to rot and overgrown with vines. The negative impact is on the character of this mews street which feels neglected and on the traditional garages that are worthy of retention and sympathetic restoration

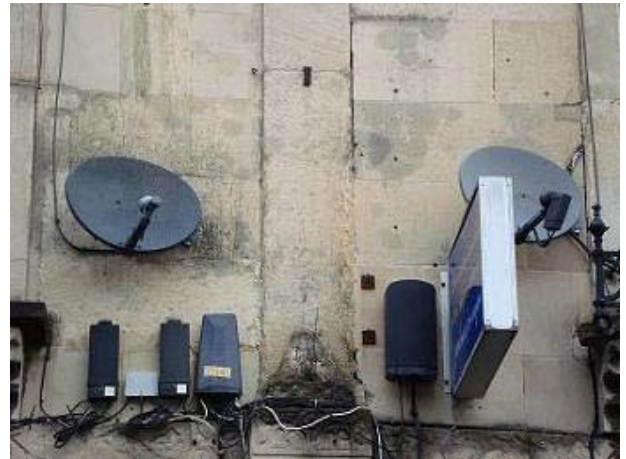
Figure 134: Satellite dishes on the sides of listed buildings are not acceptable. Unauthorised dishes can be enforced against and the owners required to remove them

9.8 Satellite dishes, telephone wires and poles, alarm boxes and other minor additions have a significant cumulative impact on the character of streets and terraces. Careful siting and choice of materials and colours can significantly reduce the impact of these elements. Redundant wires should be removed.

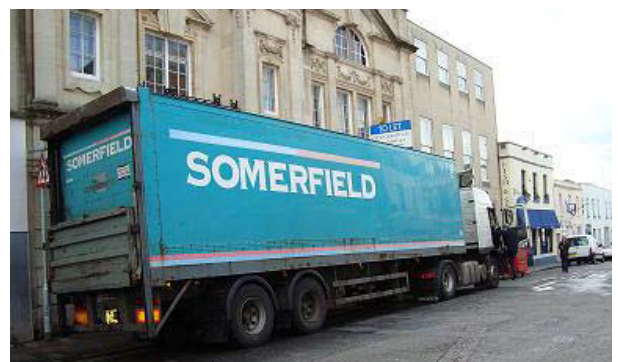
Figure 135: Large lorries down narrow streets cause damage to pavements

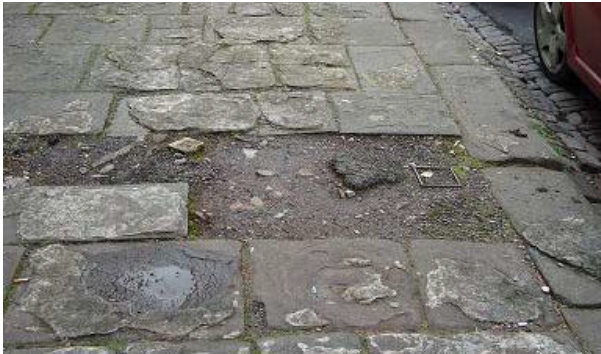
Figure 136: This pennant paving on a Grade II terrace is sorely neglected

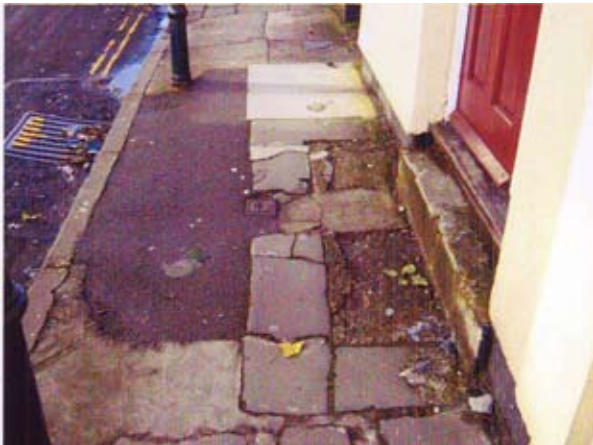
Figure 137: A dangerous, unsightly mix of pennant, tarmac and concrete on Princess Victoria Street

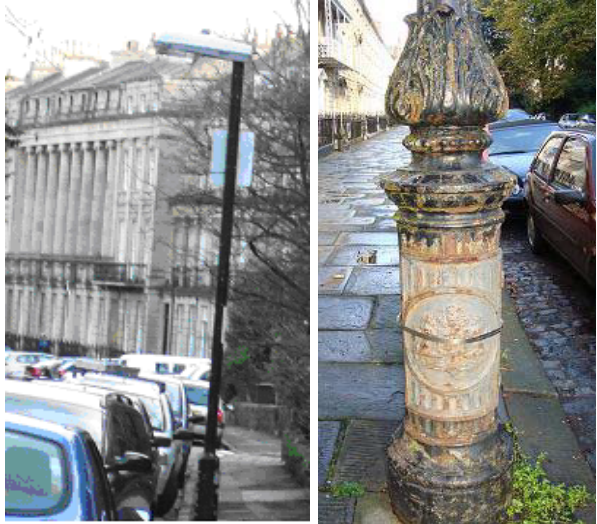
Figure 138-39: An unsympathetic modern replacement lamp standard adjacent to Grade II\* Vyvyan Terrace and Christchurch; Grade II lamp standard in poor state of repair

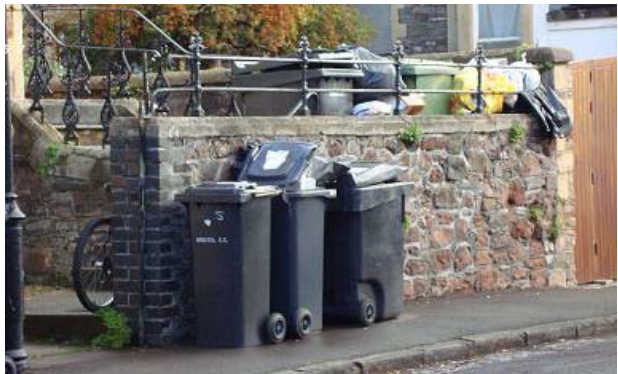
Figure 140: Wheelie bins cause an obstruction on the narrow pavement

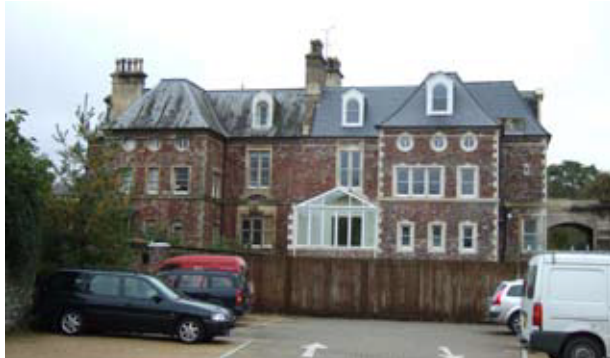
Figure 141: Unauthorised conservatory and dormer window to the rear of Grade II listed Sutton House, Clifton Down. Removed after a court case

9.14 Unauthorised structures or alterations have a significant detrimental impact on the quality of the local environment as well as individual buildings.
