6. Safe design, operation and maintenance of on-track plant and trolleys

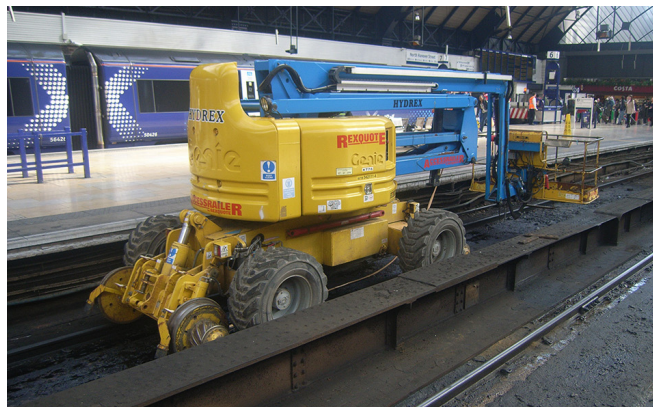
RRV after running away into Glasgow Queen Street station.

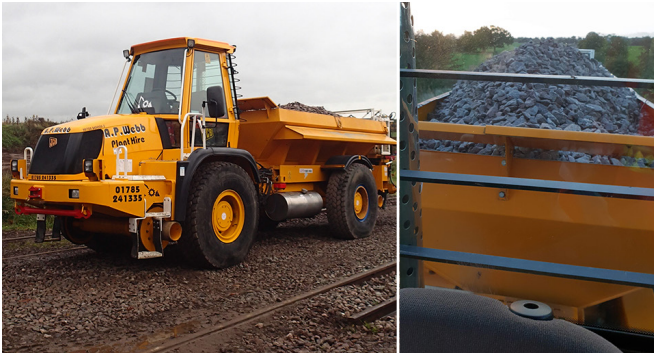
Ballast distributor RRV, and the view from the cab when running in reverse.

found that the driver of a ballast distributor, converted from a dumper truck, had a very restricted view of the line when driving in reverse, and did not see another, smaller, vehicle on the line before they collided with it.

Compliance with the restriction placed on the machine, that its movements should always be controlled by a person on the ground when it was being driven in reverse, would have meant that it could not travel at more than 3 mph. This would have had significant implications for the efficiency of the work and should have been considered when this machine was selected as being suitable for the planned work activity.
