1. Design and operation of user worked level crossings

Purpose of this summary

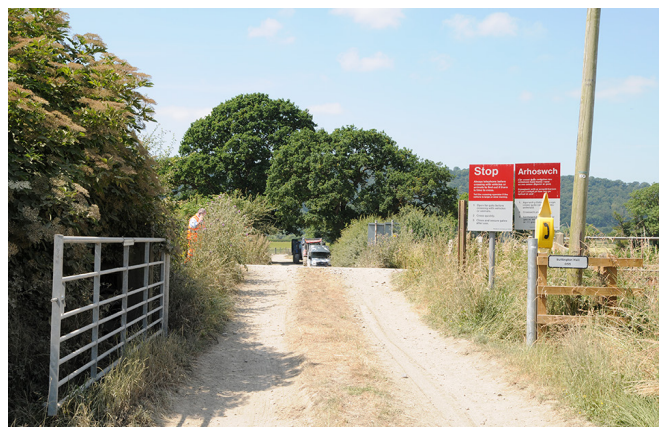
A user worked level crossing in Wales. Gates being left open is a regular problem at some crossings.

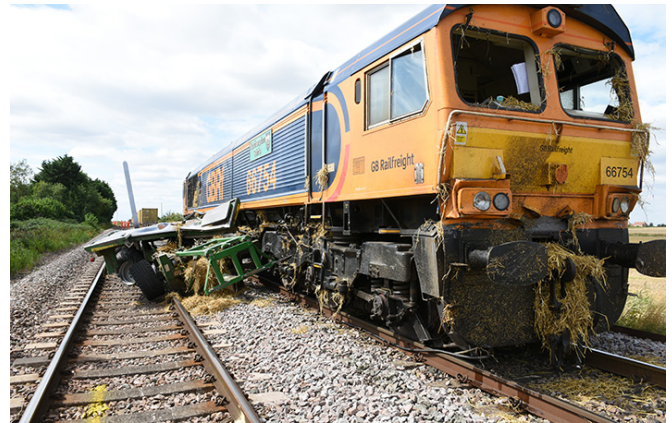
The aftermath of the collision at Kisby crossing in 2021.

The 2022 collision at a user worked crossing at Kisby in Cambridgeshire between a freight train and agricultural machinery ([report 12/2022](#)) took place on a private road and caused substantial damage as well as derailing the train involved. It occurred after an unfamiliar user did not contact the signaller for permission to cross, as was required for the safe operation of the crossing.

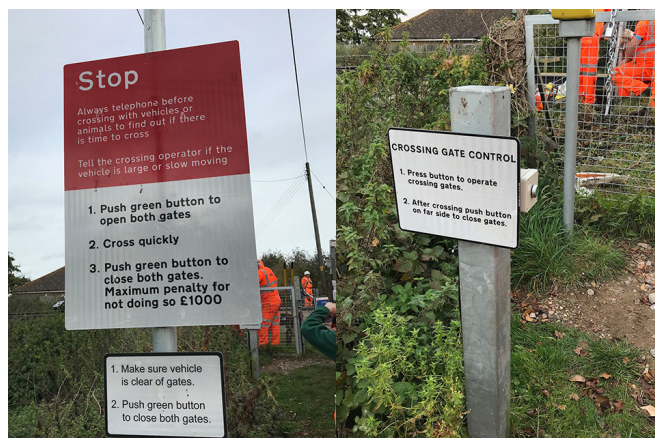
Signs at a user worked crossing.

In November 2023, the Private Crossings (Signs and Barriers) Regulations 2023 came into force, bringing into use new designs of warning signs and information boards for UWCs. These replaced the previous signs specified and described in earlier legislation which no longer reflected current thinking on how to convey information, and which could be confusing and hard to understand.

In addition to having a revised design, the new signs include provisions for use with the various novel technologies that have been introduced in recent years, such as power operated gates and barriers. These new regulations have been introduced by the Department for Transport (DfT), working with the industry and the Office of Rail and Road, as a result of RAIB recommendations that called for clear and effective signs to be used at these crossings ([report 13/2009](#) and [report 12/2018](#)). UWCs are now being fitted with these new signs, and it is expected that those on the mainline network will have been equipped with them by 2029.

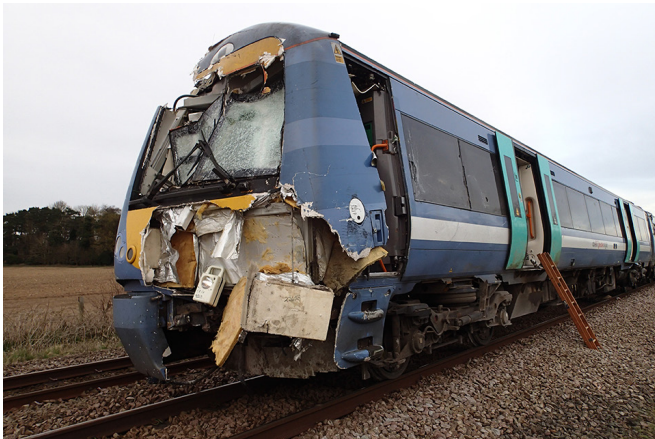
Damage to the train involved in the collision at Hockham Road in 2016.

In many cases, crossing users have to telephone a Network Rail signaller to find out whether it is safe to cross. This system places a high degree of reliance on the judgement of the signaller in deciding what to tell the user to do. The information available to the signaller about the position of approaching trains, on which their decision is based, may be limited by the signalling technology in use. The signaller may be supervising a large number of crossings, each with many users each day, and may not have the necessary local knowledge to appreciate the conditions at each one.

We have made recommendations on these issues recently following investigations at Hockham Road, Norfolk, ([report 04/2017](#)), Dock Lane, Melton, Suffolk ([report 08/2017](#)) and Bagillt ([report 11/2019](#)), calling for more use of technology to provide signallers with information on the position of trains, better training for signallers, clearer and more consistent instructions on decision-making, and for Network Rail to better manage factors such as workload and fatigue which may influence signallers' decisions. The importance of focusing management attention on this risk was demonstrated by an incident at Worlingham, Suffolk in 2020 ([safety digest 07/2020](#)).

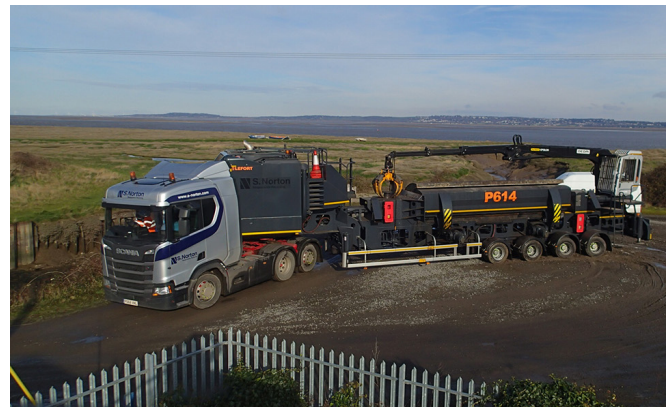
A large vehicle preparing to go over the user worked crossing at Bagillt.

Communication between the signaller and the user may not result in a clear understanding of the type of user and how long they need to cross safely. The signaller may have to rely heavily on the road user's assessment of the time they need to cross, when assessing what sort of protection is required. Following RAIB's investigation of the dangerous occurrence at Bagillt, Flintshire, in 2018, we have recommended improvements to the communications protocols used by signallers, and clarification of the method of operation when heavy or long road vehicles need to use crossings ([report 11/2019](#)).

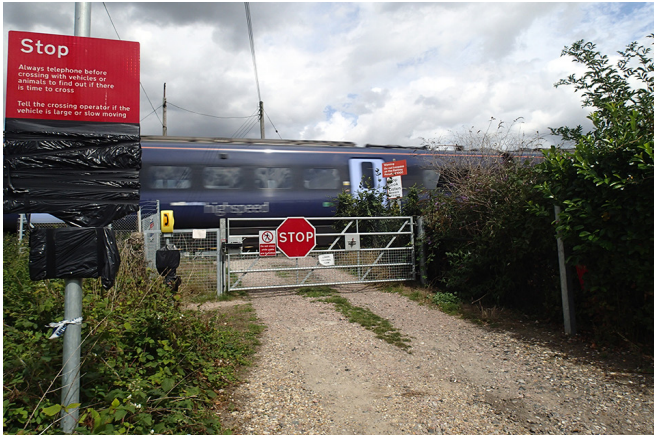
Frognal Farm crossing, after removal of the POGO system following the accident in 2017.

We found in two investigations into collisions (at Oakwood Farm, Yorkshire, in 2015 ([report 07/2016](#)) and Frognal Farm, Kent, in 2017 ([report 12/2018](#))) that potential issues with the design had not been sufficiently addressed, and users were likely to assume that if the gates opened in response to a press of the button, it was safe to cross.

RAIB recommended, in both those investigation reports, that Network Rail should review safety at all the crossings fitted with the system and ensure that it properly understands the hazards associated with this type of operating system before any further

crossings are converted. Network Rail has taken some POGO systems out of service, and has started a programme of modifications, including linking the operation of the gates to the indication on the stop lights, where these are fitted.
