## 3. Managing risk at the platform-train interface

### Purpose of this summary

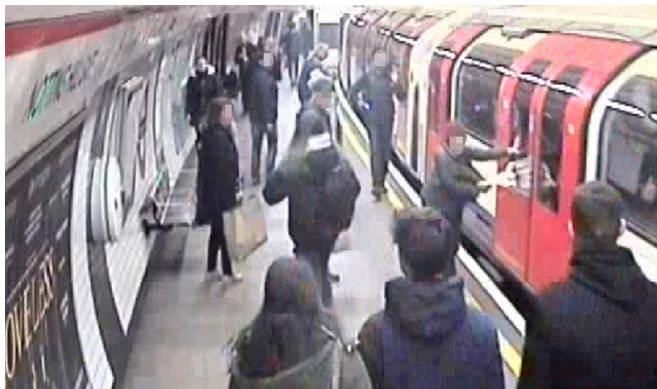
Passenger with bag trapped in train doors at Notting Hill Gate.

At Notting Hill Gate in 2018, a passenger's bag became trapped in the doors as she attempted to board the train. The trapped bag was not detected by the door control system. The passenger was unable to free herself from the bag, and was dragged along the platform and into the tunnel as the train departed, suffering serious injuries ([report 14/2018](#)).

We believe that more needs to be done to enhance the ability of door control systems to detect the presence of a trapped object.

anti-drag systems are already being used by some operators, and could be more widely adopted, particularly when new trains are being ordered and specified. We have recommended that these measures should be used on new London Underground trains, and trams.

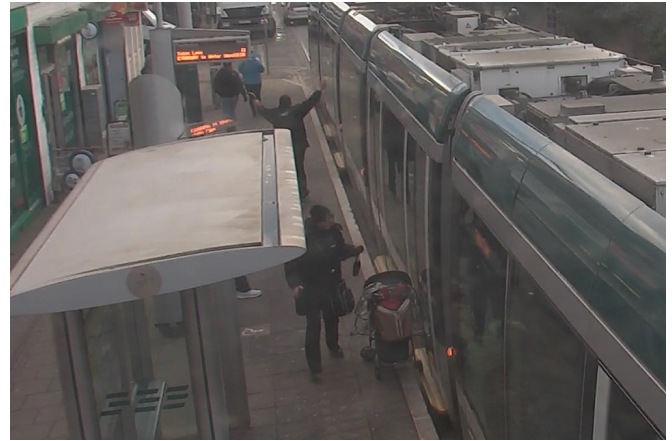
Pushchair trapped in tram doors at Radford Road, Nottingham in 2017.

At Radford Road, Nottingham, in 2017, a pushchair, fortunately unoccupied, became trapped in tram doors and was dragged all the way to the next stop ([report 15/2018](#)). We recommended that the tram operator should review all aspects of its arrangements for minimising the risk of this happening. We found that there was a lack of understanding of risk in this area, which may extend across the tram industry.

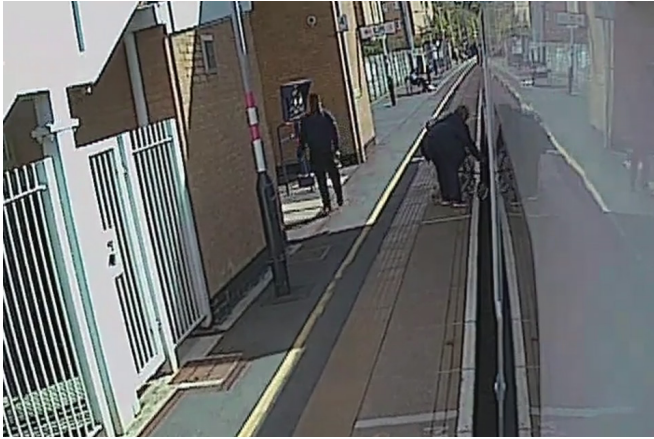
Passenger tries to free dog trapped in train doors at Elstree & Borehamwood.

At Elstree & Borehamwood in 2018 ([report 03/2019](#)), a passenger and her dog were boarding a train. The doors closed in front of the passenger and the dog's lead became trapped in the doors. The train departed, dragging the dog off the platform and leading to its death, while the passenger remained on the platform. The driver was in the habit of carrying out the final safety check in significantly less time than other drivers on the same route and did so on this occasion. Carrying out the check in a shortened time meant that even a slight loss of attention could have led to him missing the passenger and her dog in the CCTV image.

We have recommended measures to support train and tram drivers in maintaining attention and awareness, particularly when associated with automatic train operations (Notting Hill Gate), and research and development of technology to assist staff responsible for train dispatch to determine that passengers are clear of the train (Elstree & Borehamwood).

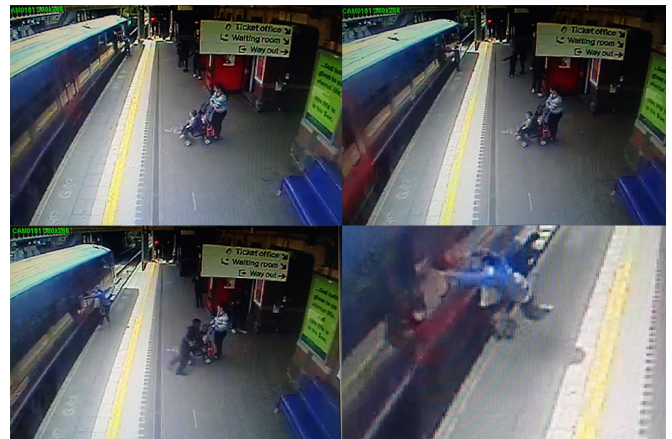
We saw another example of behaviour influenced by this belief at Hayes & Harlington in 2015, when a passenger placed her hand between the closing doors in the expectation that they would reopen and was subsequently dragged along the platform. In our report on this accident, we recommended research to better understand the way that passengers interact with rail vehicle/tram doors.

Passenger trapped in closing doors and dragged along the platform at Hayes & Harlington.

As a result of our Hayes & Harlington investigation ([report 12/2016](#)) we recommended that train and tram operating companies should introduce measures to address the risk of over-reliance on the door control system to detect trapped objects, and emphasise to their staff how the limitations of the detection systems reinforce the need for the final safety check by train dispatchers. We also called for measures to enhance the quality of the view of the platform-train interface, particularly in crowded conditions as a result of our Clapham South investigation ([report 04/2016](#)).

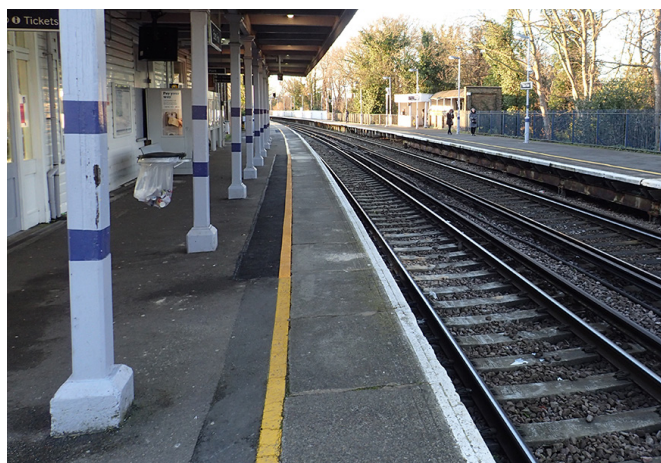
Platform with no tactile surface markings at Eden Park.

At Eden Park ([report 01/2021](#)), a visually and mobility impaired person fell from the edge of a platform into the path of an approaching train. The platform had no tactile surface markings which could have alerted the person to how close they were to the edge, and our investigation found that the railway industry's approach to the provision of tactile surfaces had been ineffective.

We have recommended that the railway industry and the Department for Transport review their approaches to the management of risk to vulnerable passengers on station platforms.
