## Construction Noise and Vibration Monthly Report – March 2024

### Buckinghamshire

# Non-Technical Summary

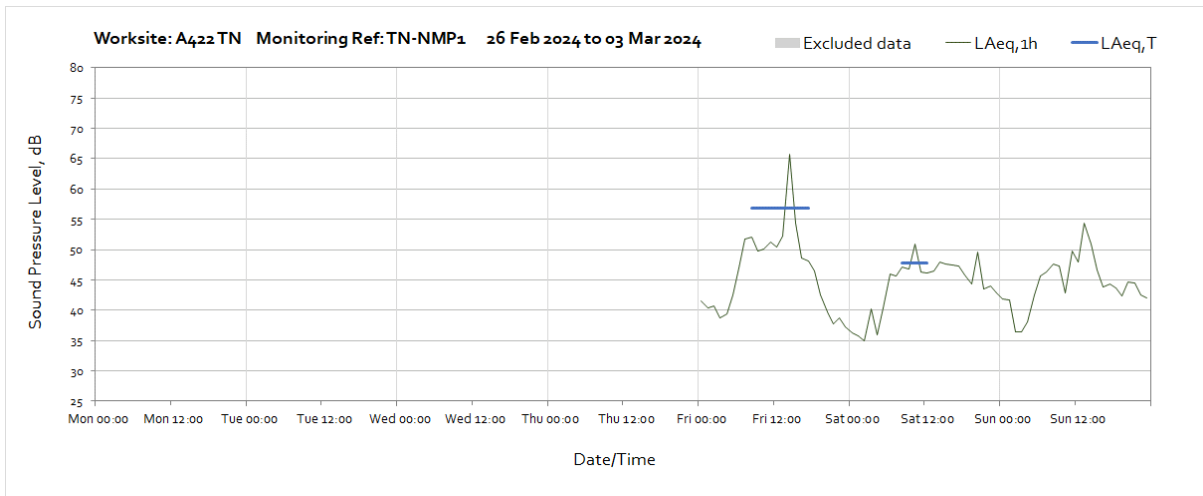
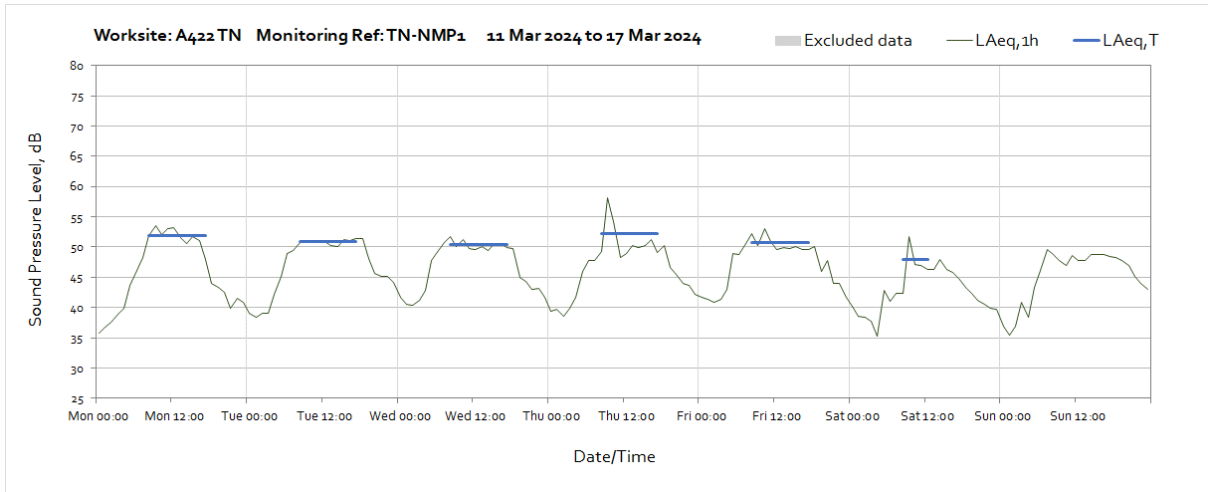
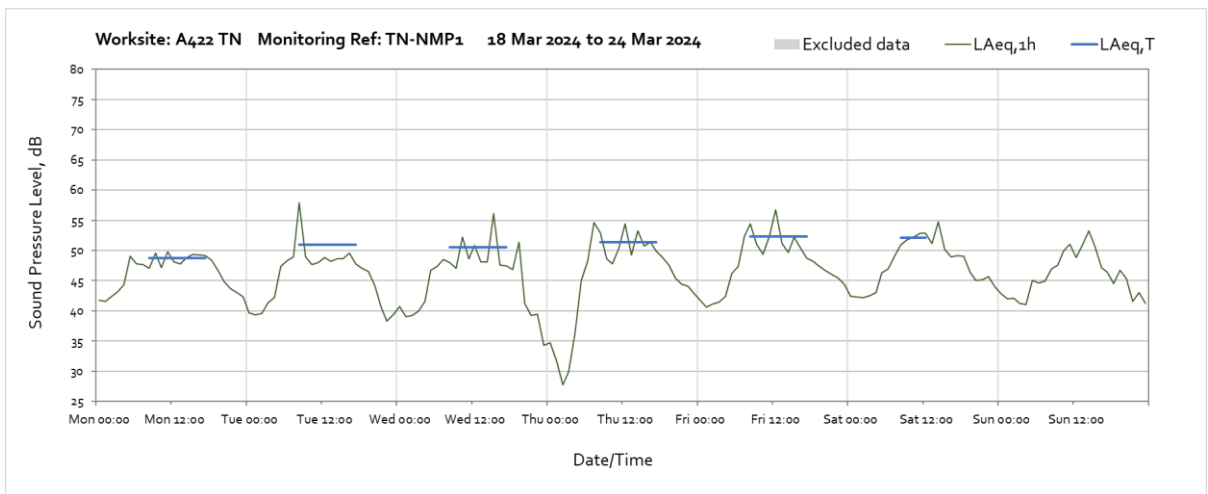
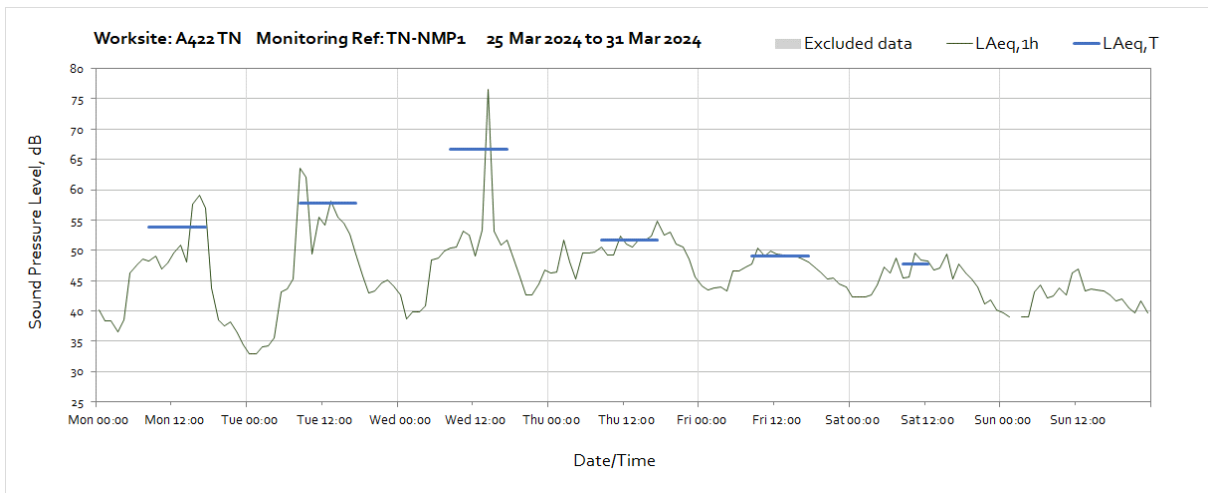
### Worksite: A422 TN – Monitoring Ref: TN-NMP1

The following graphs show the hourly measured ambient noise level  $L_{Aeq,1h}$  and, where relevant, the averaged noise level  $L_{Aeq,T}$  values, where the time period T is as specified in Table 1 of HS2 Information Paper E23. Periods where noise levels are adversely affected by weather or only measured for part of the period, which are not representative of HS2 construction works, have been greyed out and excluded from the calculation of the  $L_{Aeq,T}$  values in Table 3 of the main report.

Note: Missing data between 02:00 and 03:00 on Sunday 31<sup>st</sup> March is due to a monitor time adjustment at the start of British Summer Time.

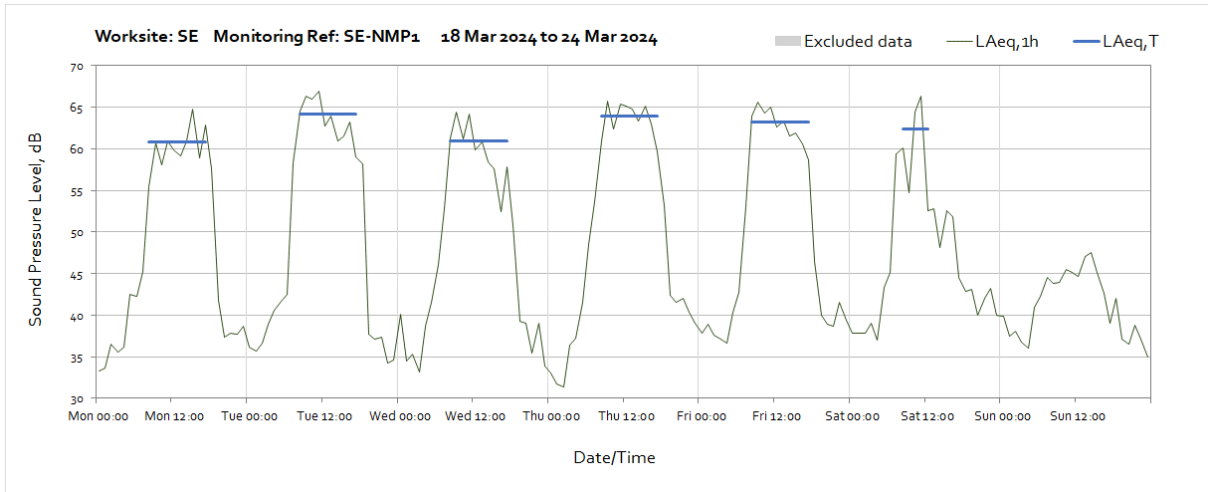
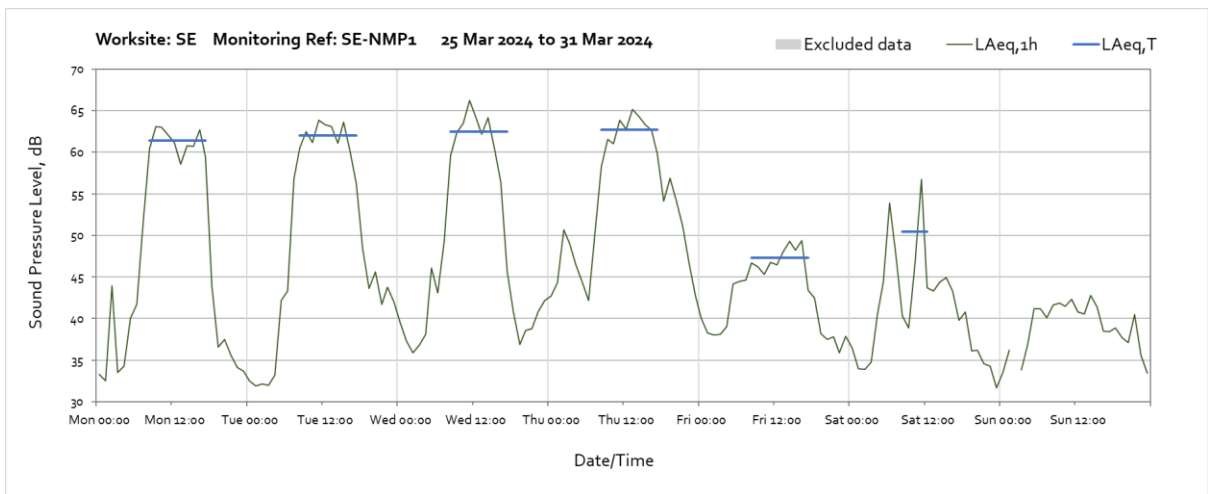
## Worksite: SE – Monitoring Ref: SE-NMP1

Note: Missing data between 02:00 and 03:00 on Sunday 31<sup>st</sup> March is due to a monitor time adjustment at the start of British Summer Time.

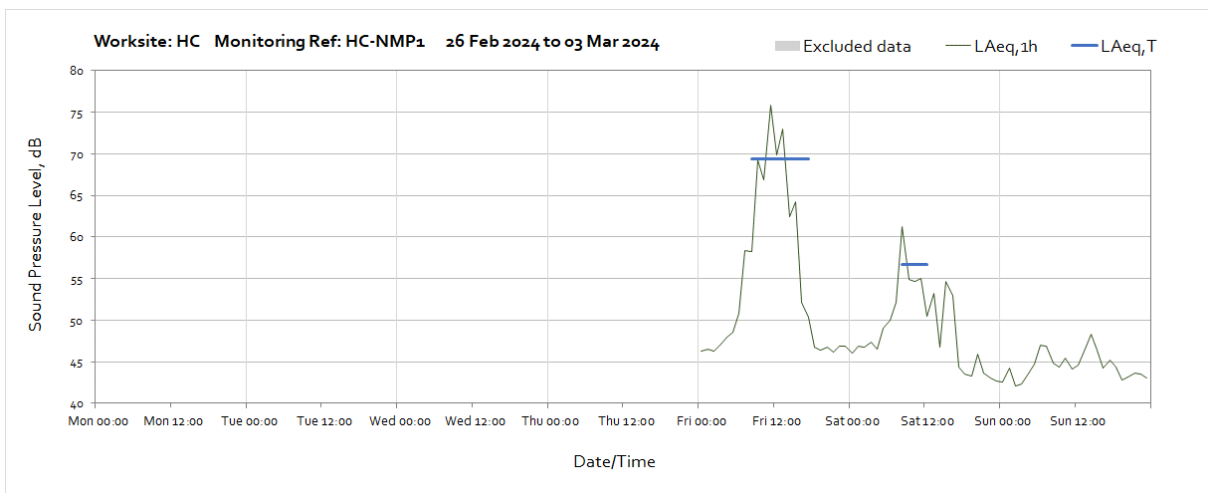
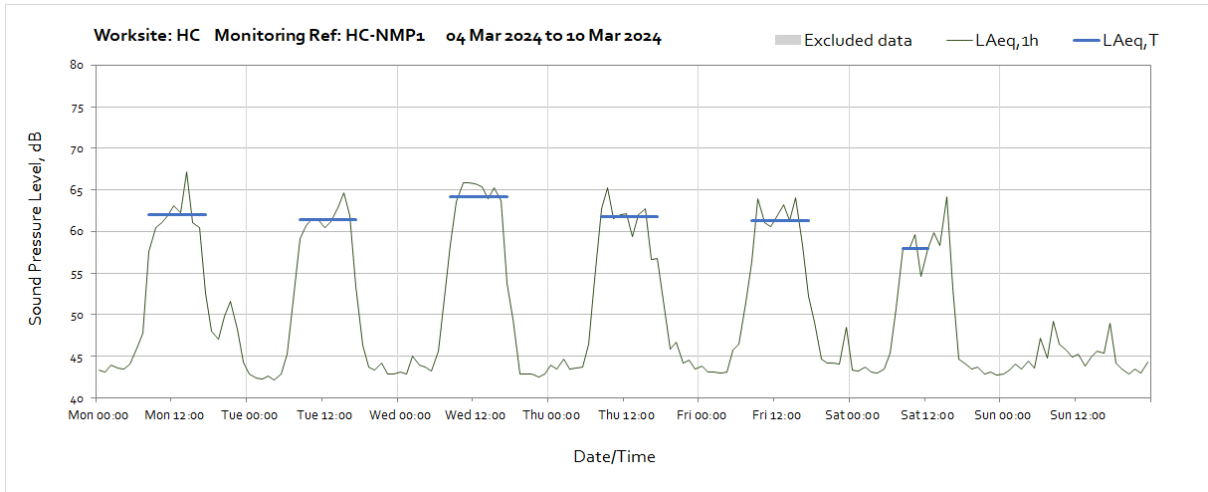
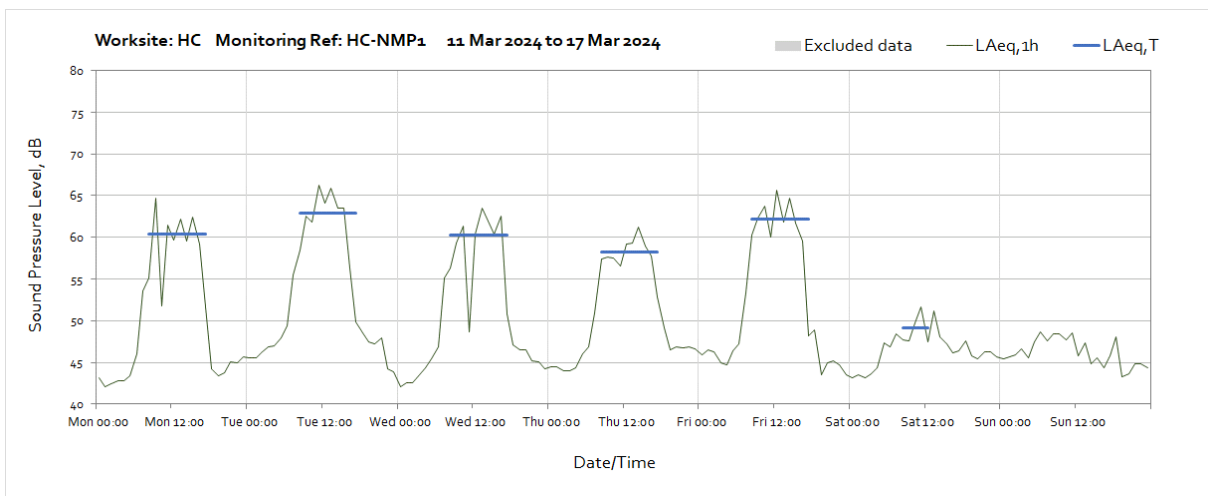
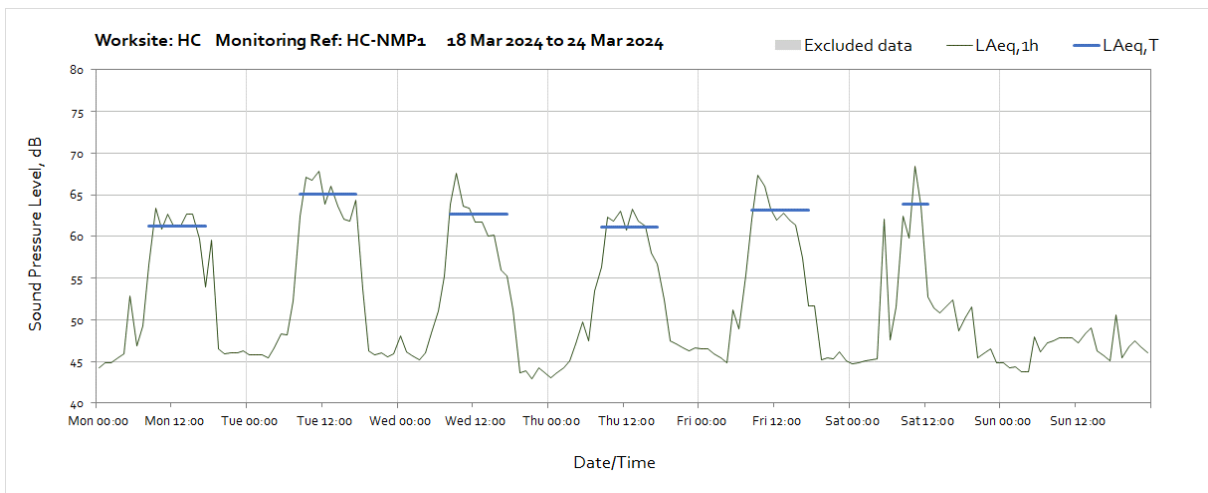
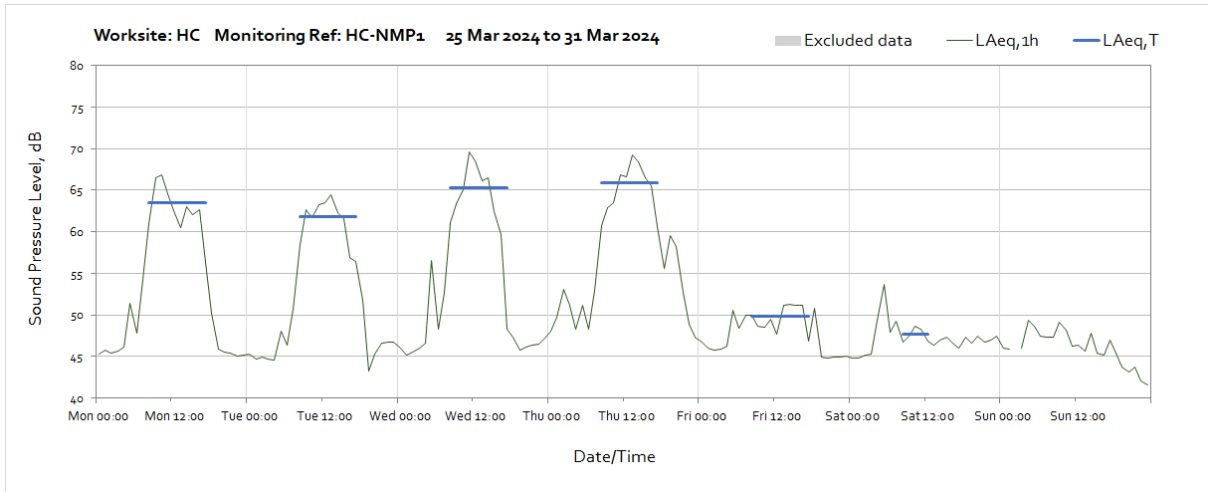
### Worksite: HC - Monitoring Ref: HC-NMP1

Note: Missing data between 02:00 and 03:00 on Sunday 31<sup>st</sup> March is due to a monitor time adjustment at the start of British Summer Time.

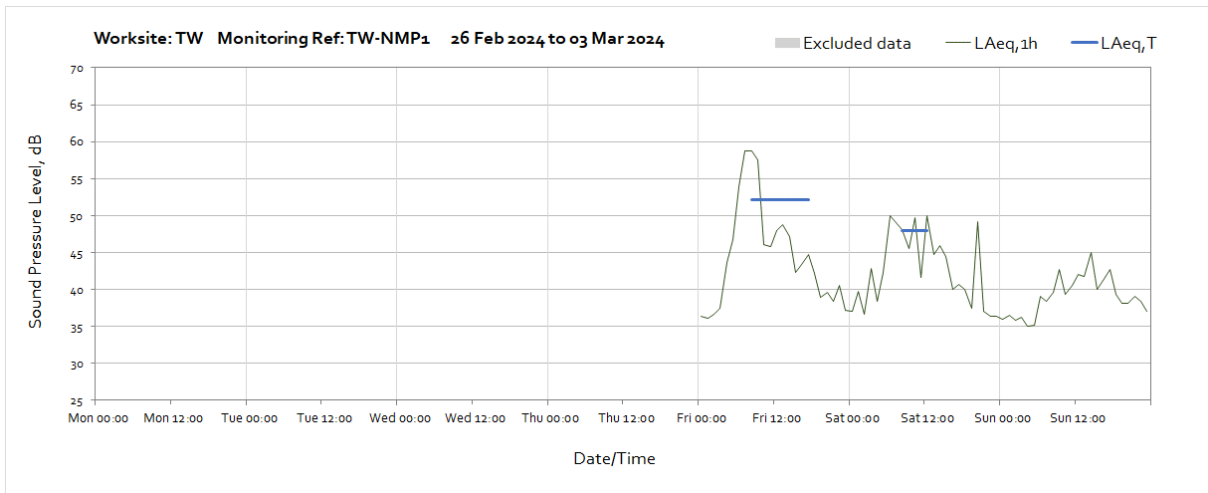
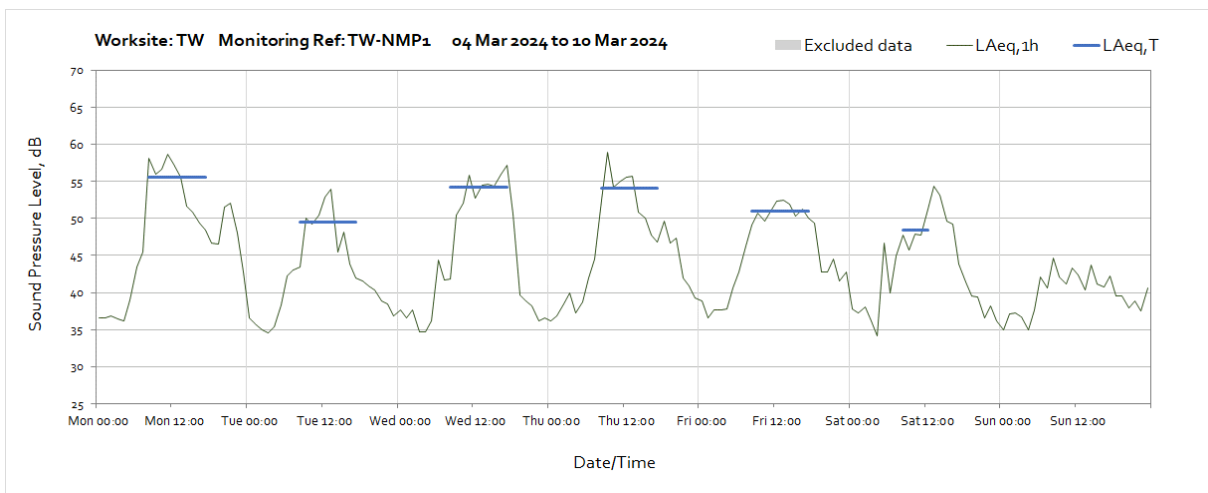
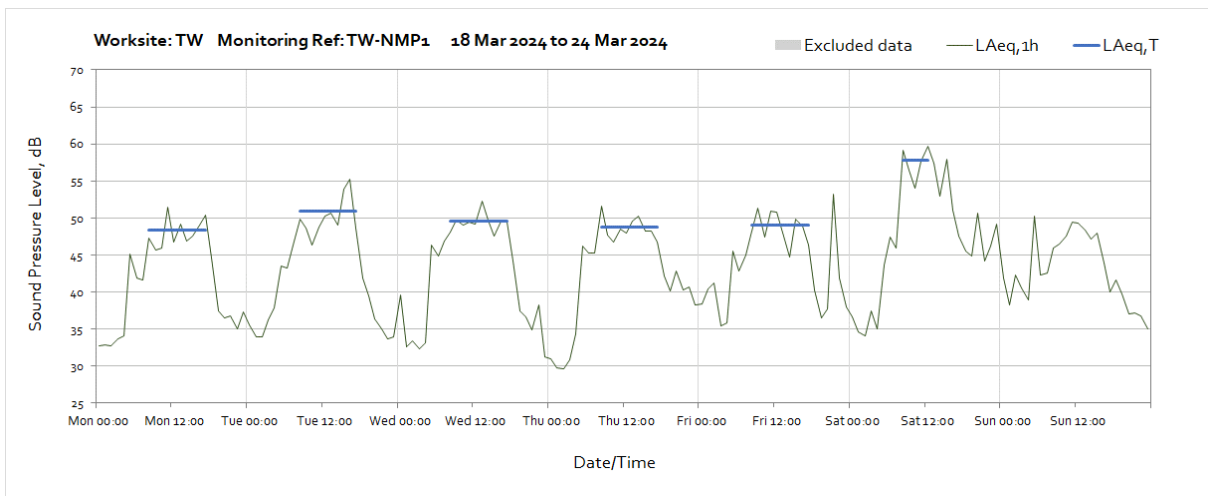
**Worksite: TW – Monitoring Ref: TW-NMP1**

Note: Missing data between 02:00 and 03:00 on Sunday 31<sup>st</sup> March is due to a monitor time adjustment at the start of British Summer Time.

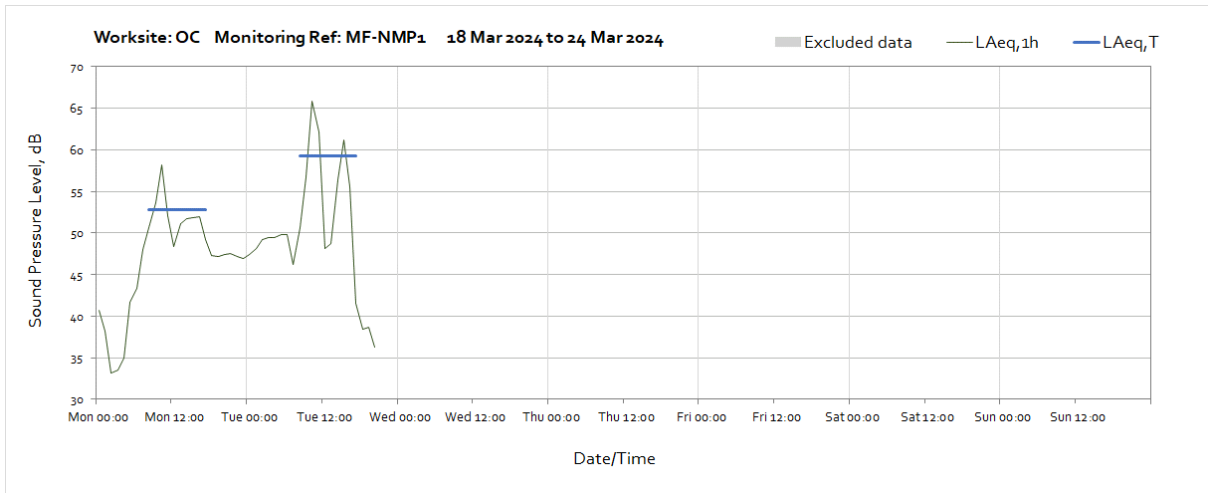
### Worksite: OC – Monitoring Ref: MF-NMP1

Note: Missing data from the start of the month until 13:00 on Tuesday 5<sup>th</sup> March was due to a faulty solar controller within the monitoring station.

Note: Missing data from 21:00 on Tuesday 19<sup>th</sup> March until month end was due to loss of power at the monitoring station caused by poor weather conditions preventing sufficient light reaching the solar panel.

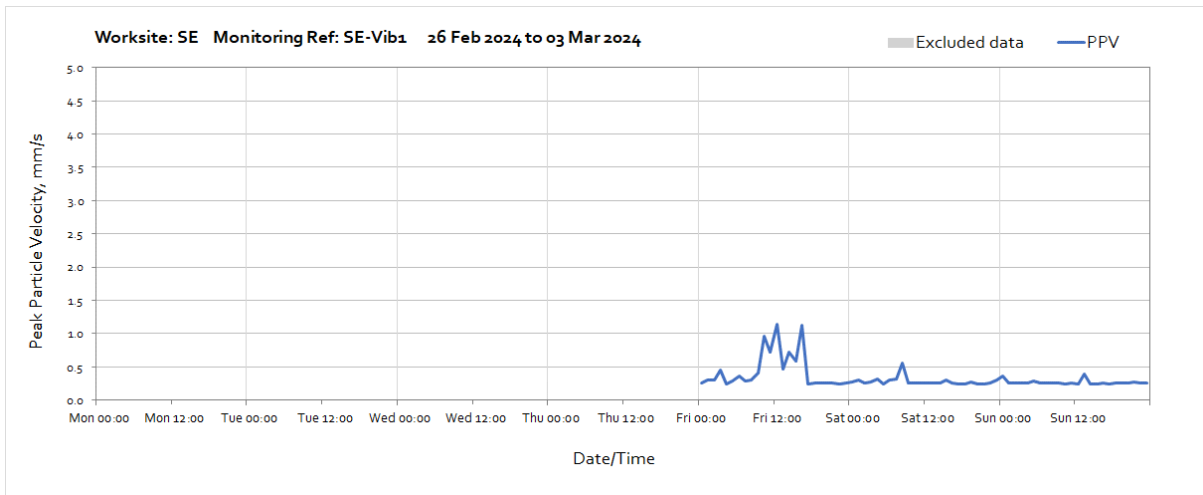
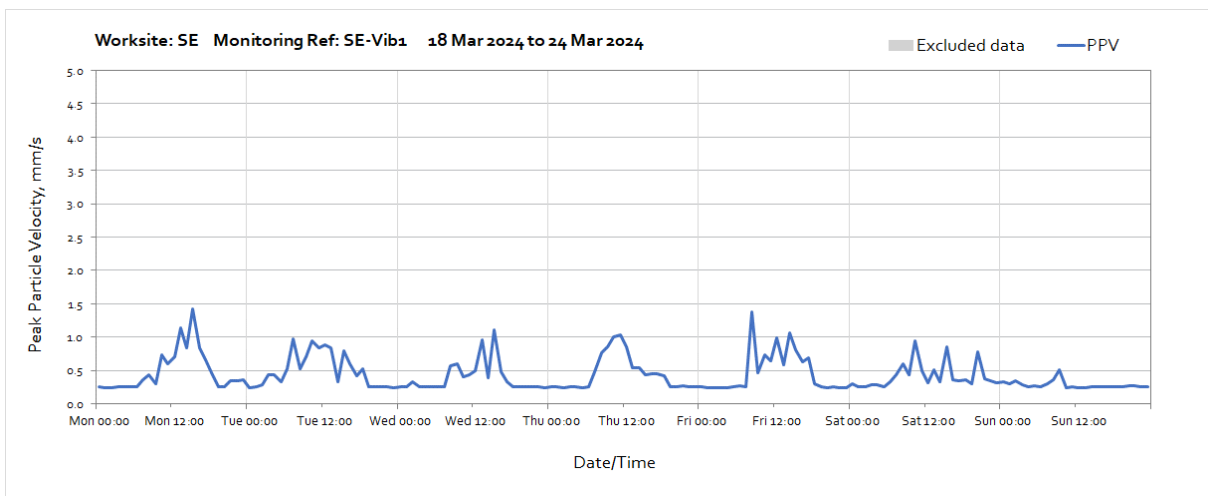
### Worksite: SE – Monitoring Ref: SE-Vib1

The following graphs show the hourly measured peak particle velocity PPV recorded during the monitoring period. The graphs show the highest PPV of the three orthogonal axes x, y and z. Periods where PPV values have been affected by local interference with the vibration monitor or only measured for part of the period, which are not representative of HS2 construction works, have been greyed out and excluded when calculating values in Table 4 of the main report.

Note: Missing data between 02:00 and 03:00 on Sunday 31<sup>st</sup> March is due to a monitor time adjustment at the start of British Summer Time.

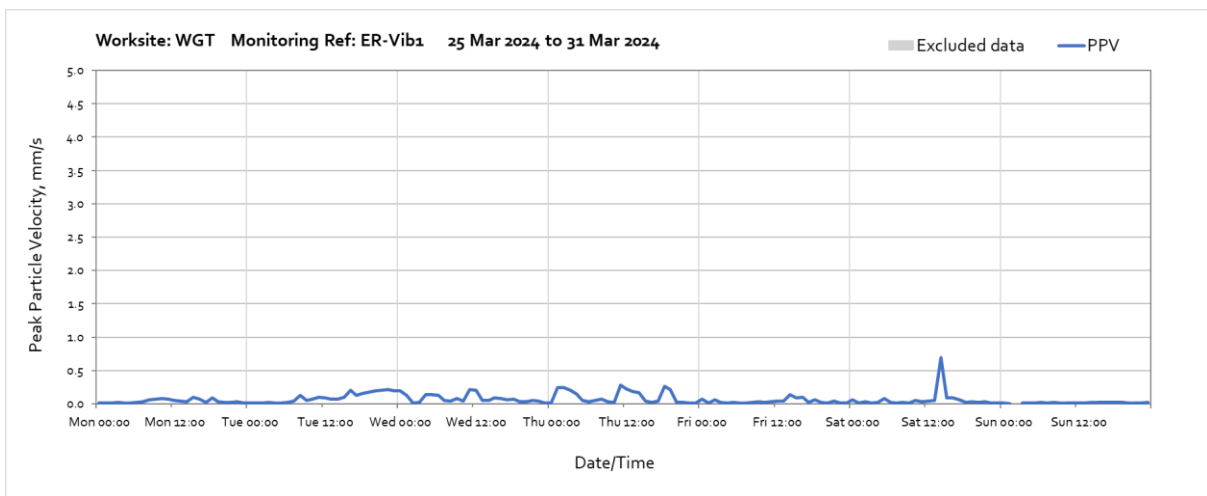
## Worksite: WGT – Monitoring Ref: ER-Vib1

Note: Missing data between 02:00 and 03:00 on Sunday 31<sup>st</sup> March is due to a monitor time adjustment at the start of British Summer Time.
