Construction Noise and Vibration Monthly Report – March 2024

London Borough of Ealing

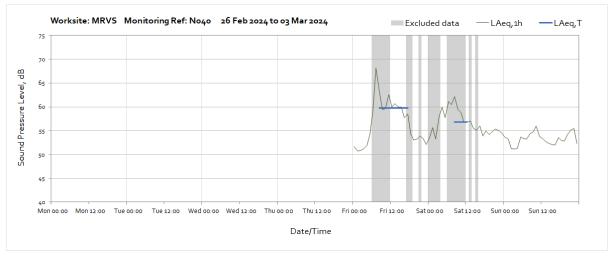
Worksite: MRVS - Monitoring Ref: N040

The following graphs show the hourly measured ambient noise level $L_{Aeq,1h}$ and, where relevant, the averaged noise level $L_{Aeq,T}$ values, where the time period T is as specified in Table 1 of HS2 Information Paper E23. Periods where noise levels are adversely affected by weather or only measured for part of the period, which are not representative of HS2 construction works, have been greyed out and excluded from the calculation of the $L_{Aeq,T}$ values in Table 3 of the main report.

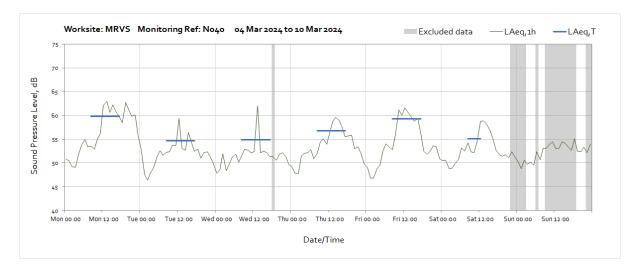
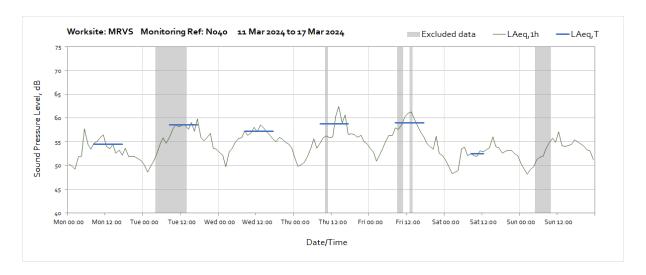
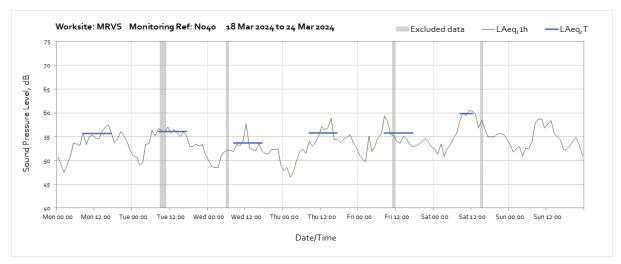
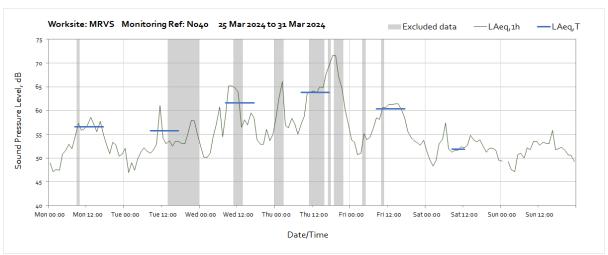
Note: Missing data between 01:00 and 02:00 on Sunday 31st March was due to a monitor time adjustment at the start of British Summer Time.

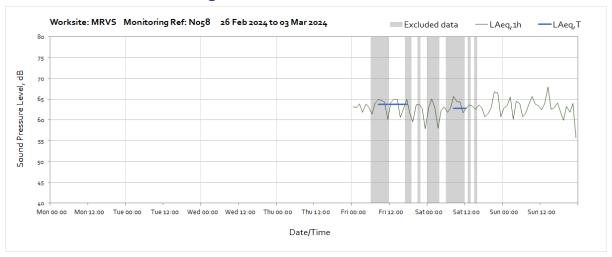
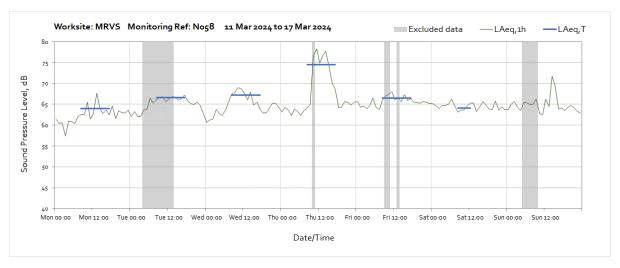
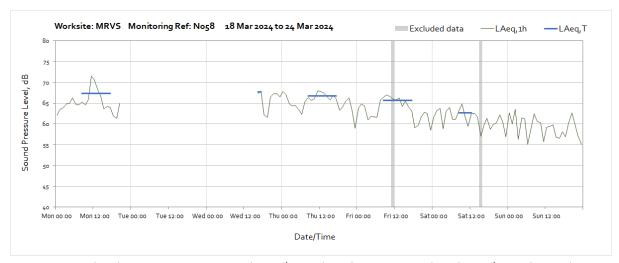
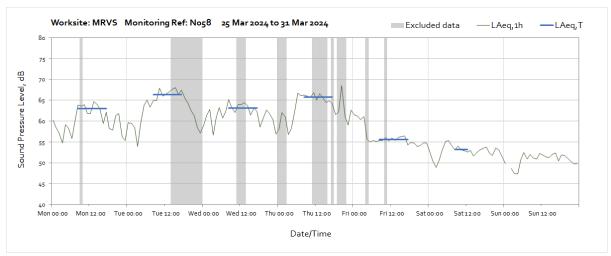
Worksite: MRVS - Monitoring Ref: N058

2.2.6 Two (2) SOAEL exceedances were recorded due to HS2 construction works during March 2024. The exceedance occurred at N058 during weekday and Sunday daytime periods.

Note: Missing data between 21:00 on Monday 18th March and 16:00 on Wednesday 20th March was due to loss of continuous site power at the monitoring station.

Note: Missing data between 01:00 and 02:00 on Sunday 31st March was due to a monitor time adjustment at the start of British Summer Time.

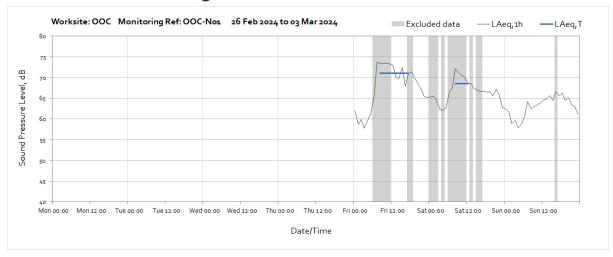
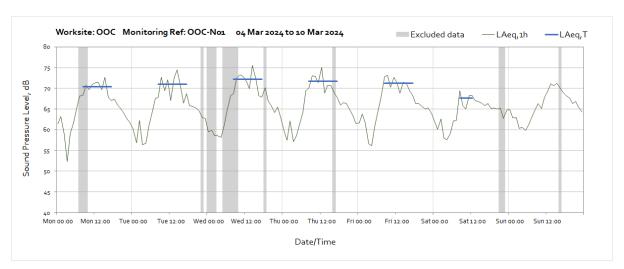
Worksite: OOC - Monitoring Ref: OOC-N01

Note: Missing data between 13:00 on Friday 22nd March and the end of the month was due to a communication error between the monitoring station and server which is currently under investigation.

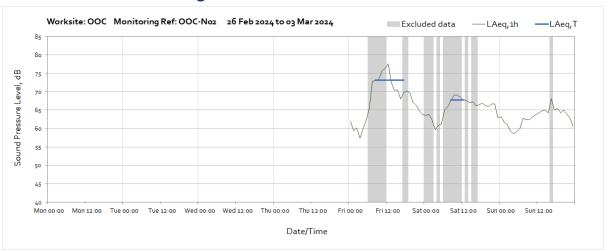
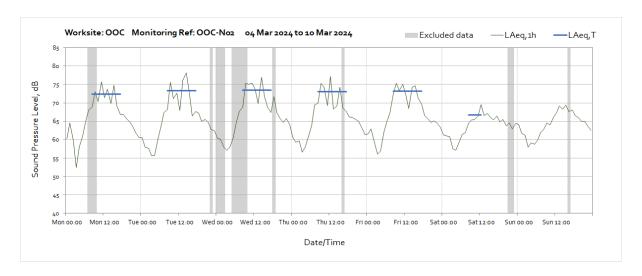
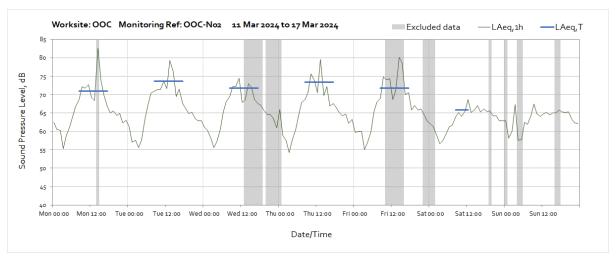
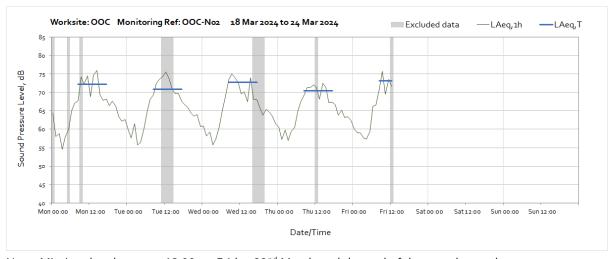
Worksite: OOC - Monitoring Ref: OOC-N02

Note: Missing data between 13:00 on Friday 22nd March and the end of the month was due to a communication error between the monitoring station and server which is currently under investigation.

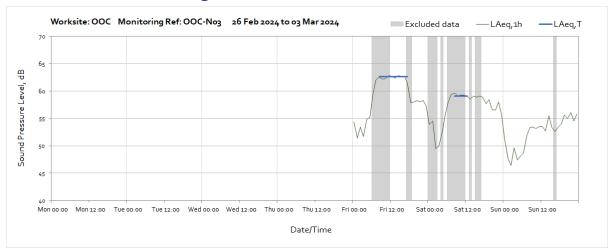
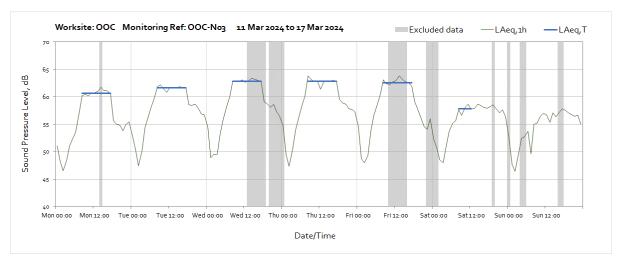
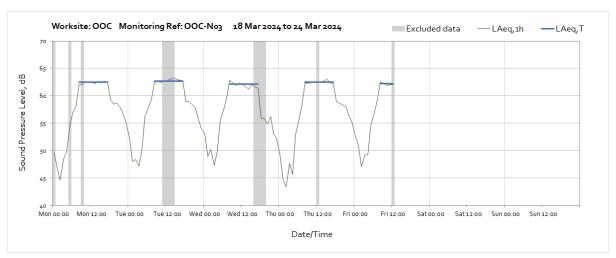
Worksite: OOC - Monitoring Ref: OOC-N03

Note: Missing data between 13:00 on Friday 22nd March and the end of the month was due to a communication error between the monitoring station and server which is currently under investigation.

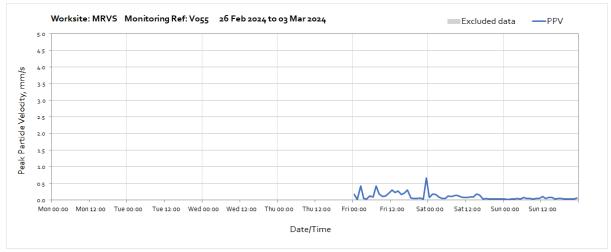
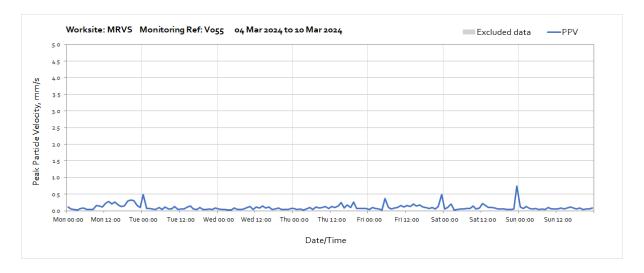
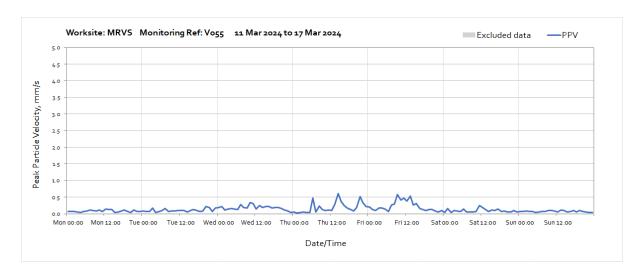
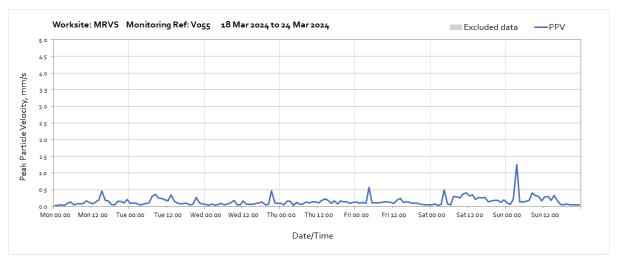
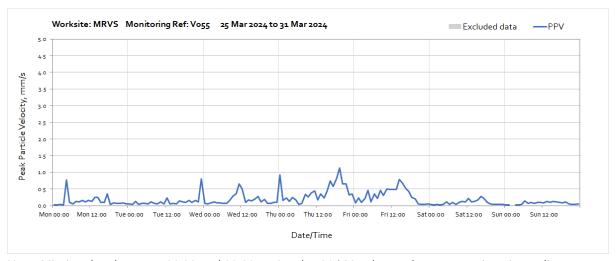
Worksite: MRVS - Monitoring Ref: V055

The following graphs show the hourly measured peak particle velocity PPV recorded during the monitoring period. The graphs show the highest PPV of the three orthogonal axis x, y and z. Periods where PPV values have been affected by local interference with the vibration monitor or only measured for part of the period, which are not representative of HS2 construction works, have been greyed out and excluded when calculating values in Table 4 of the main report.

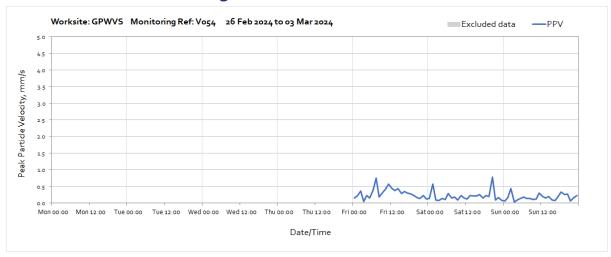
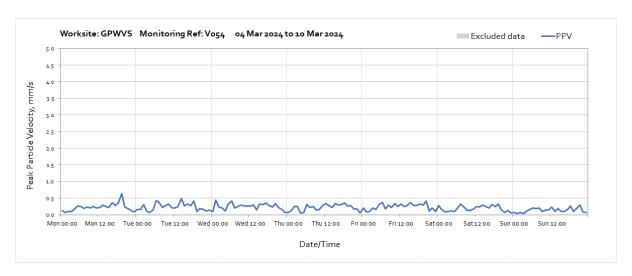
Worksite: GPWVS - Monitoring Ref: V054

Note: Missing data between 13:00 on Thursday 21^{st} March and 13:00 on Friday 22^{nd} March was due to depleted monitor battery.

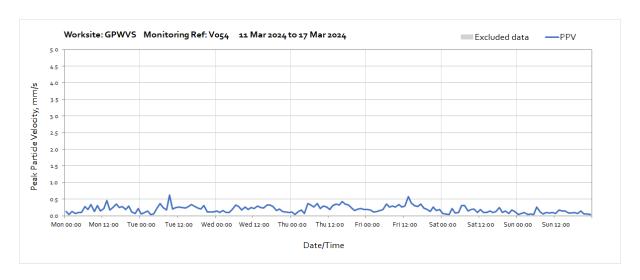
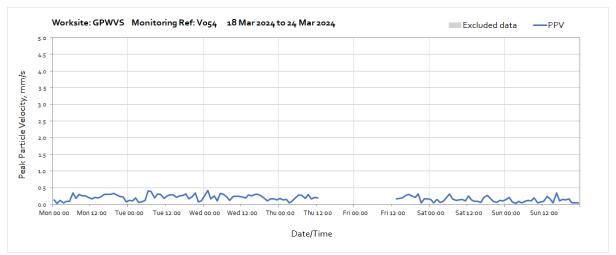
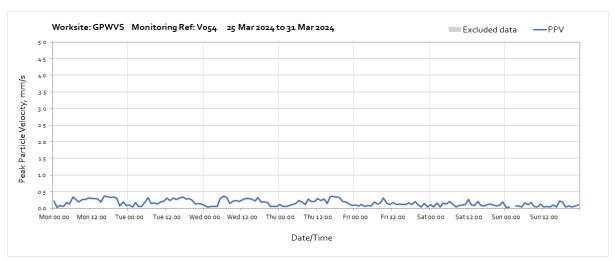
Note: Missing data between 01:00 and 02:00 on Sunday 31st March was due to a monitor time adjustment at the start of British Summer Time.

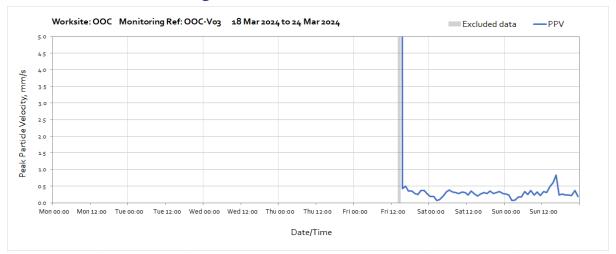
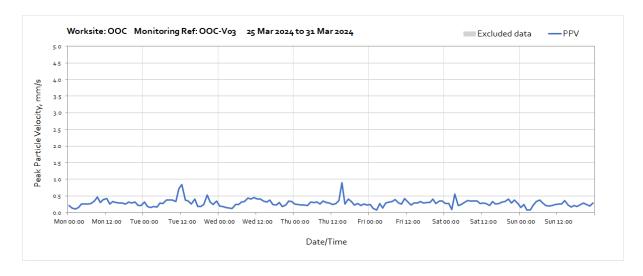
Worksite: OOC - Monitoring Ref: OOC-V03

Note: Missing data between 00:00 on Friday 1st March and 14:00 on Friday 22nd March was due to data logging error at the monitoring station which is currently under investigation.
