## **Construction Noise and Vibration Monthly Report – April 2024**

### London Borough of Camden

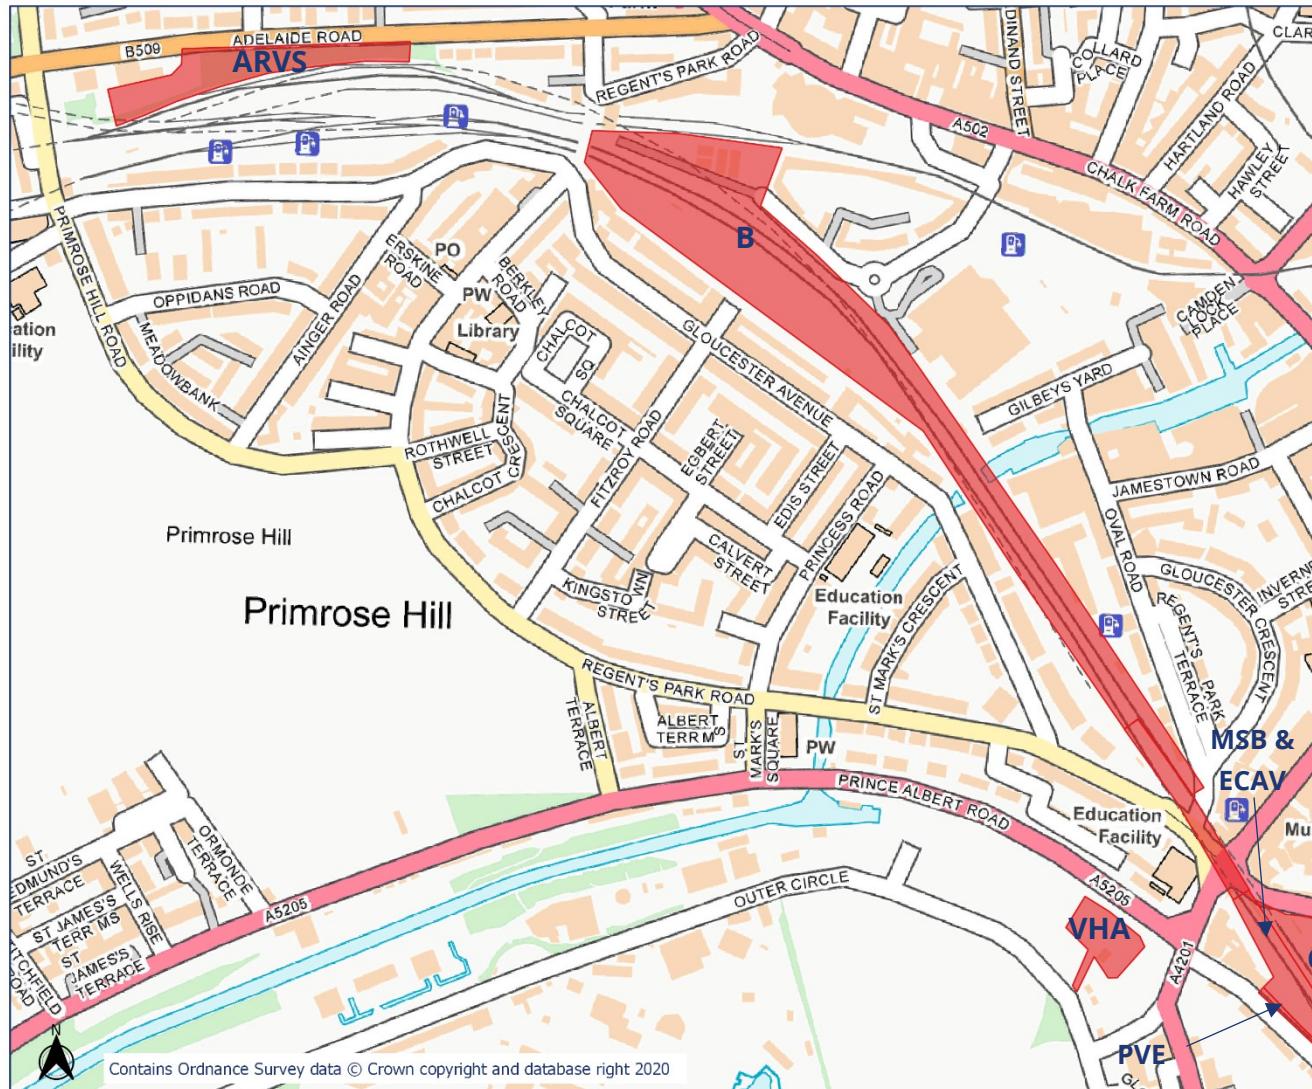
## Worksite Identification Plan - 1

- Vehicle Holding Area worksite ref.: VHA (see plan 1 in Appendix A), where work activities included:
  - Deliveries.
  - Site maintenance.
  - Surveys.
  - Haul road and drainage maintenance.

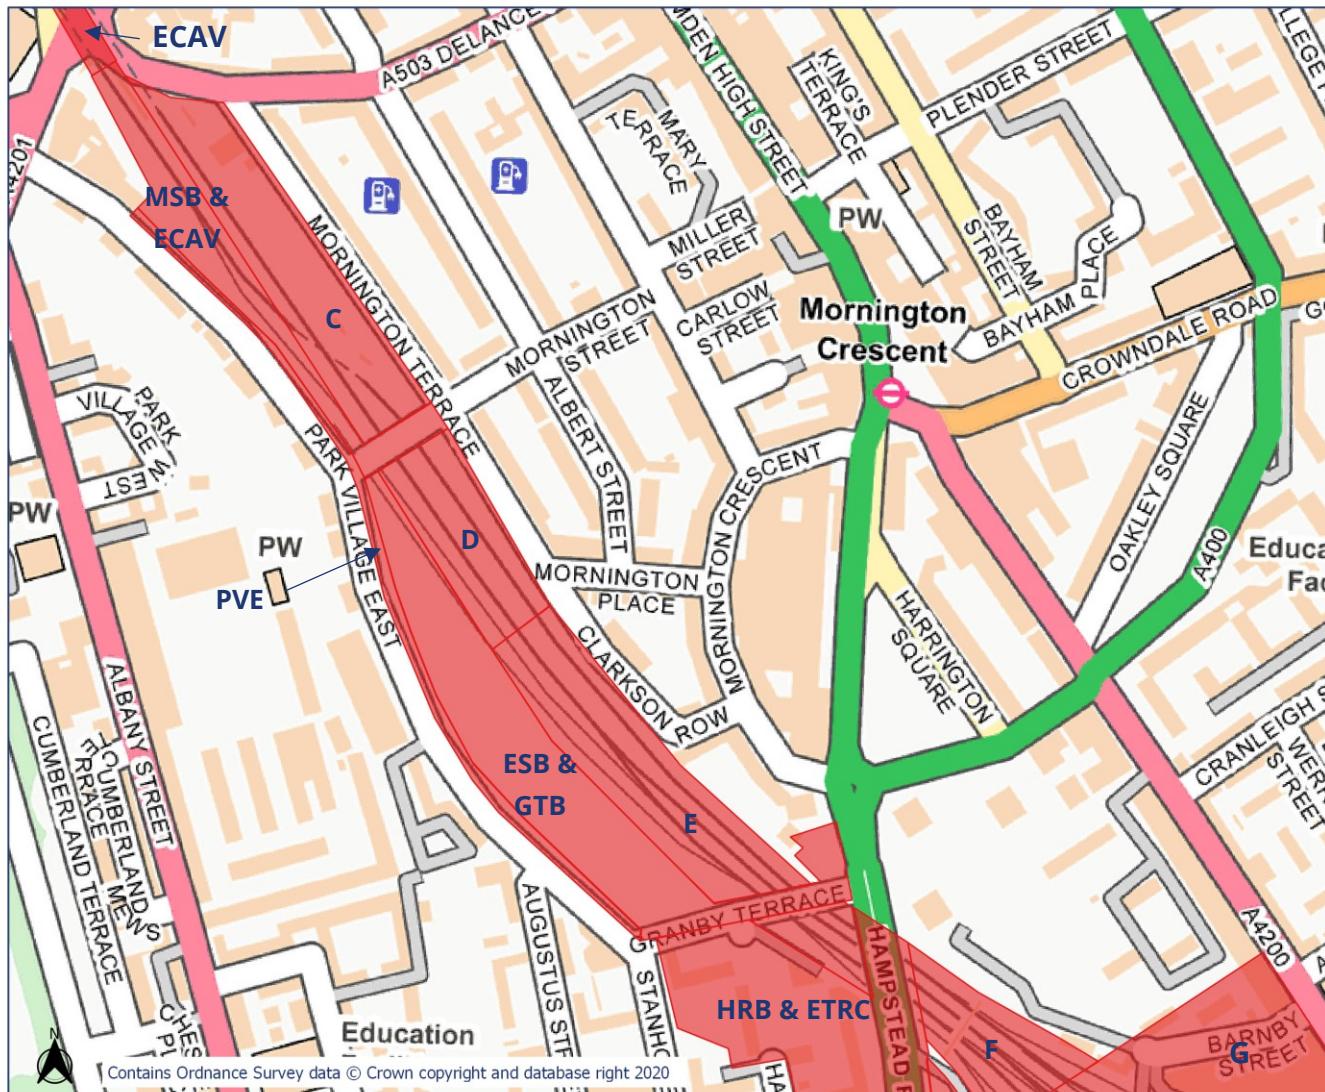
## Worksite Identification Plan - 2

- The Adelaide Road ventilation shaft ref.: ARVS, (see plan 2 in Appendix A), where work activities included:
  - Scaffold and walkway modification.
  - Checking of anchors.
  - Drainage works including main pipe, drainage channels, pump, and manhole installation.
  - Barrier installation.
  - Hardstanding completion.
  - Backfilling.
  - Instrumentation and monitoring installation.
  - Temporary edge protection removal.
  - Security grilles installation.
  - Site demobilisation.

- Mornington Street Bridge worksite ref.: MSB (see plan 2 in Appendix A), where no works were undertaken.
- Park Village East worksite ref.: PVE (see plan 2 in Appendix A), where work activities included:

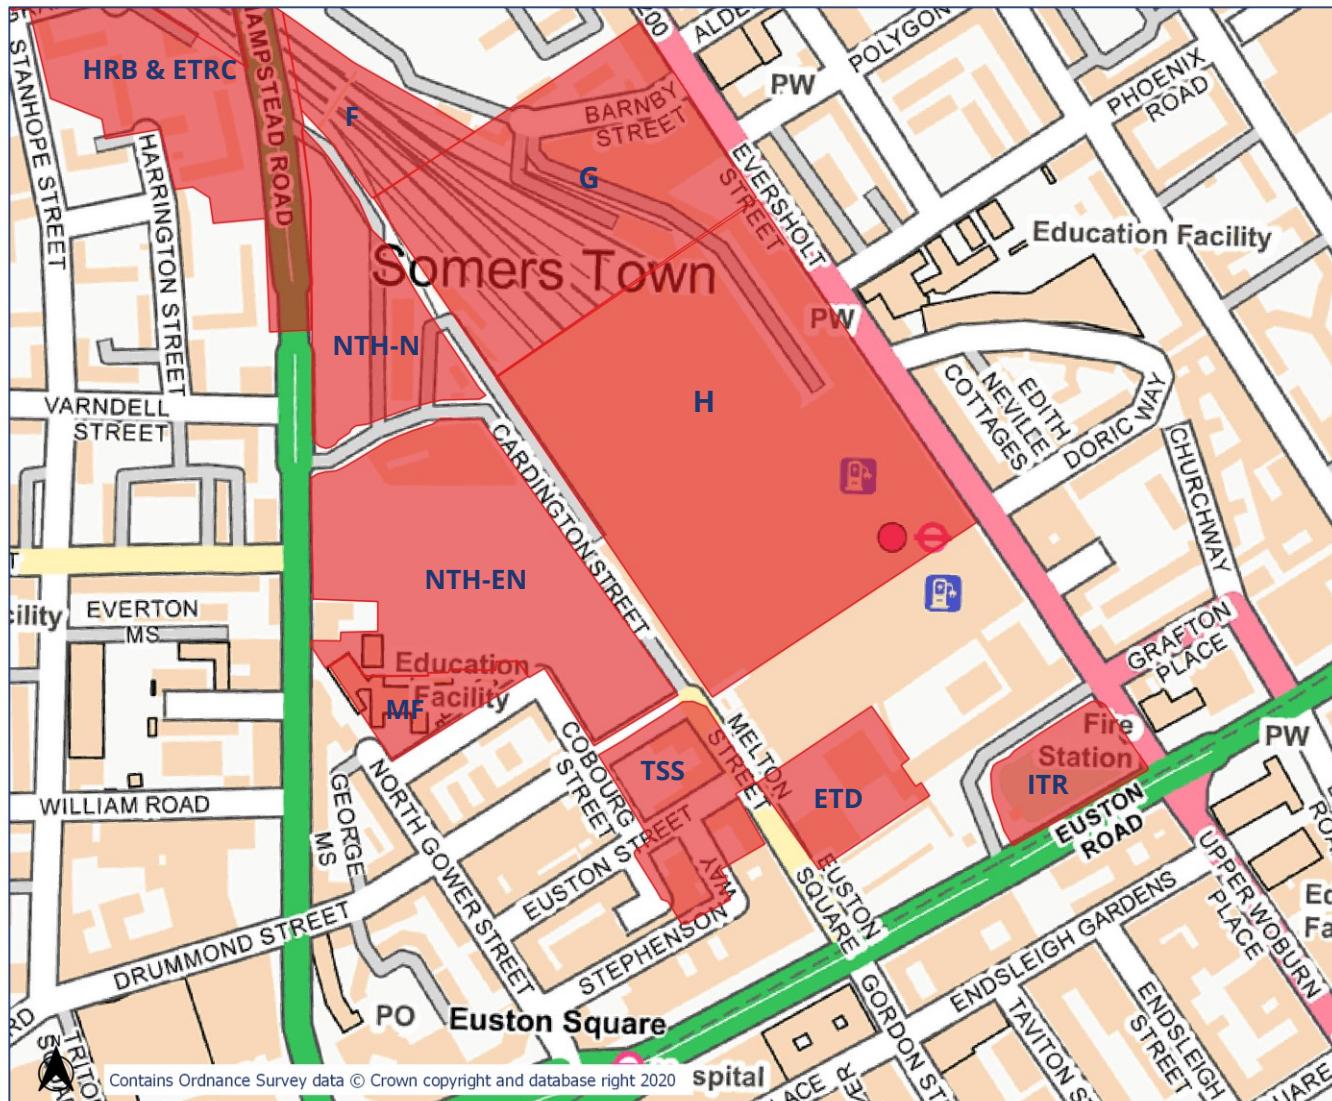
## **Worksite Identification Plan - 3**

- Utility works.
- Hampstead Road Bridge worksite ref.: HRB (see plan 3 in Appendix A), where work activities included:
  - Deliveries.
  - Site maintenance.

- Surveys.
  - Haul road and drainage maintenance.
  - Utility works.
  - Hoarding maintenance.
- Euston Cavern worksite ref.: ECAV (see plan 3 in Appendix A), where work activities included:

- On-Network worksites ref.: B, C, D, E, F, G and H (see plan 3 in Appendix A), where work activities included:
  - Monitoring and surveys, wall construction, backfilling, roof works, scaffold removal, formwork installation, concrete pouring, excavation works, ramp installation, steel fixing, drainage and ducting installation and material removals and deliveries. (Worksite E).

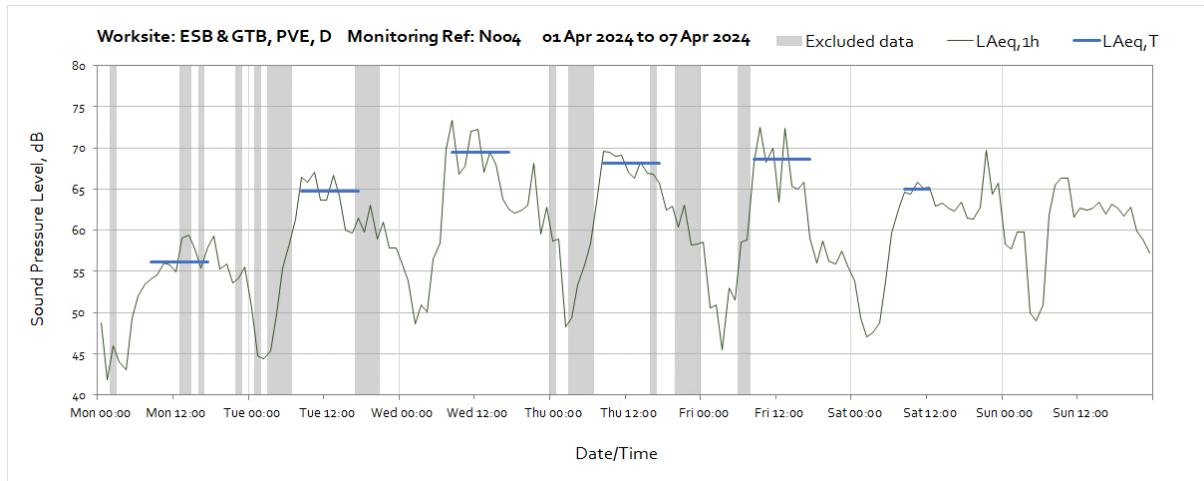
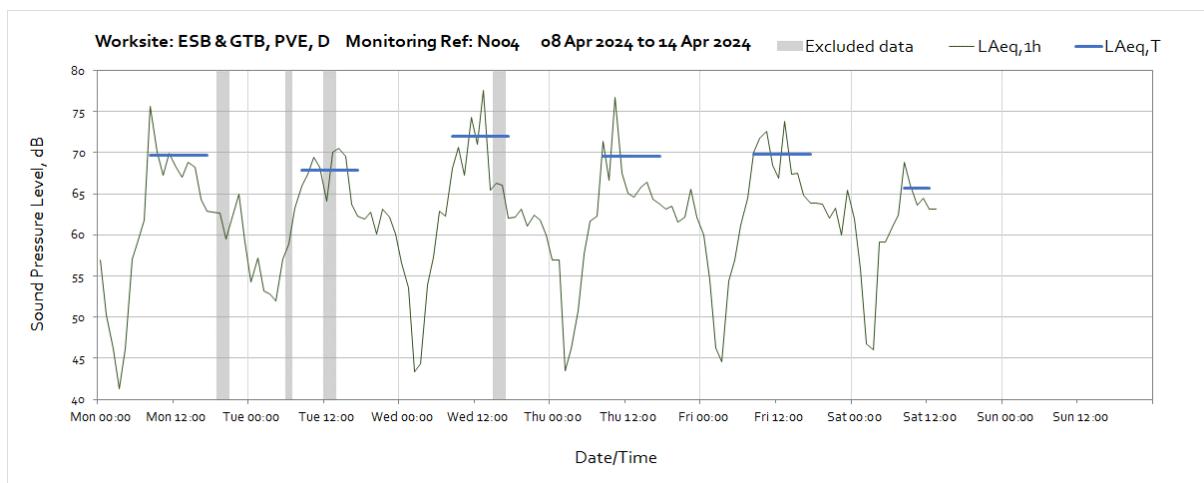
## Worksite: ESB & GTB, PVE, D – Monitoring Ref: N004

Note: Missing data from 14:00 on Saturday 13<sup>th</sup> April until the end of the month is due to loss of power to the lamppost which supplies power to the monitoring station.

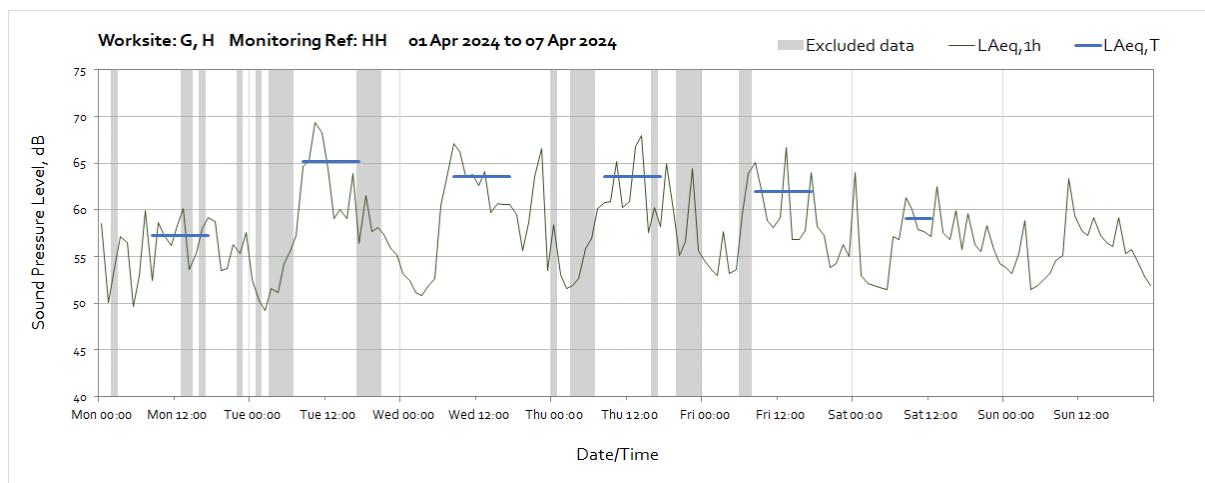
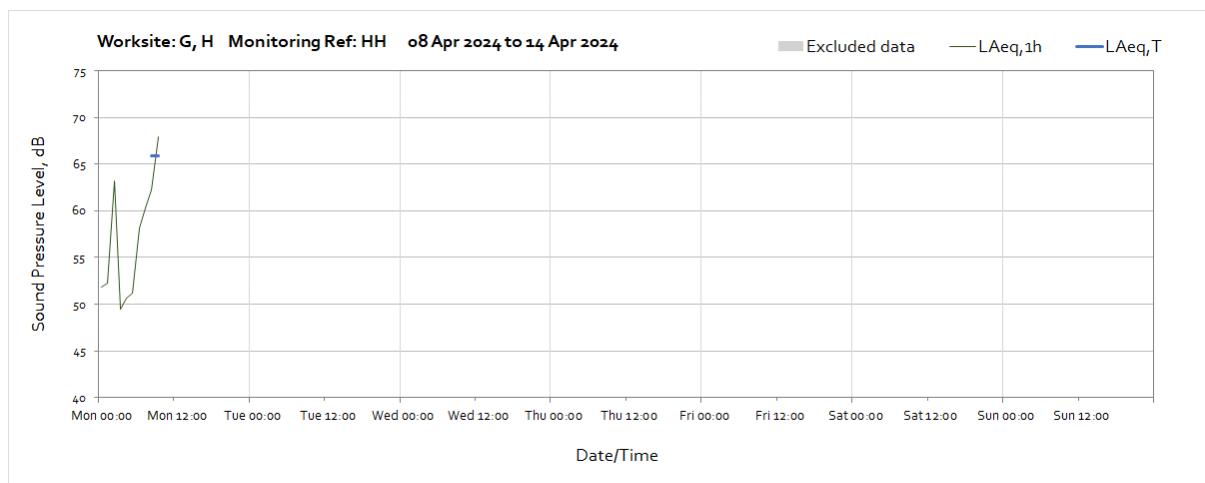
### Worksite: G, H - Monitoring Ref: HH

Note: Missing data from 09:00 on Monday 8<sup>th</sup> April until the end of the month is due to monitoring station being decommissioned.

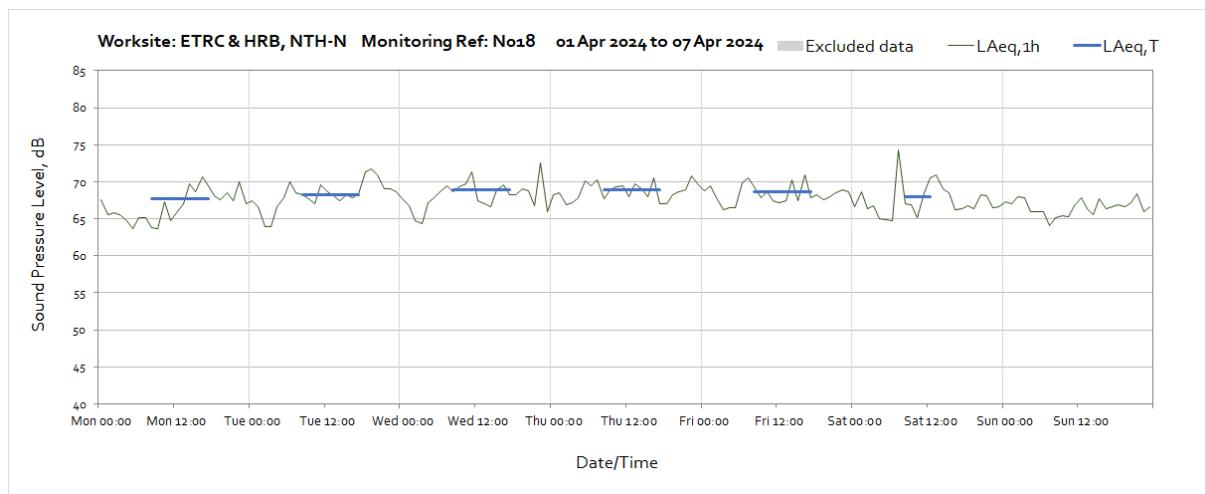
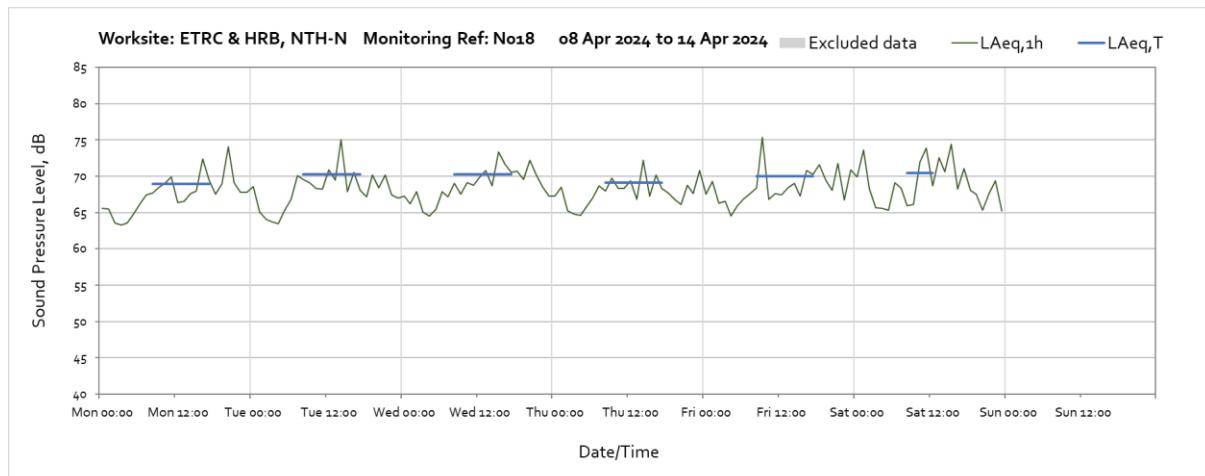
### Worksite: ETRC & HRB, NTH-N – Monitoring Ref: N018

Note: Missing data between 00:00 on Sunday 14<sup>th</sup> April and 07:00 on Monday 15<sup>th</sup> April is due to monitoring station system error.

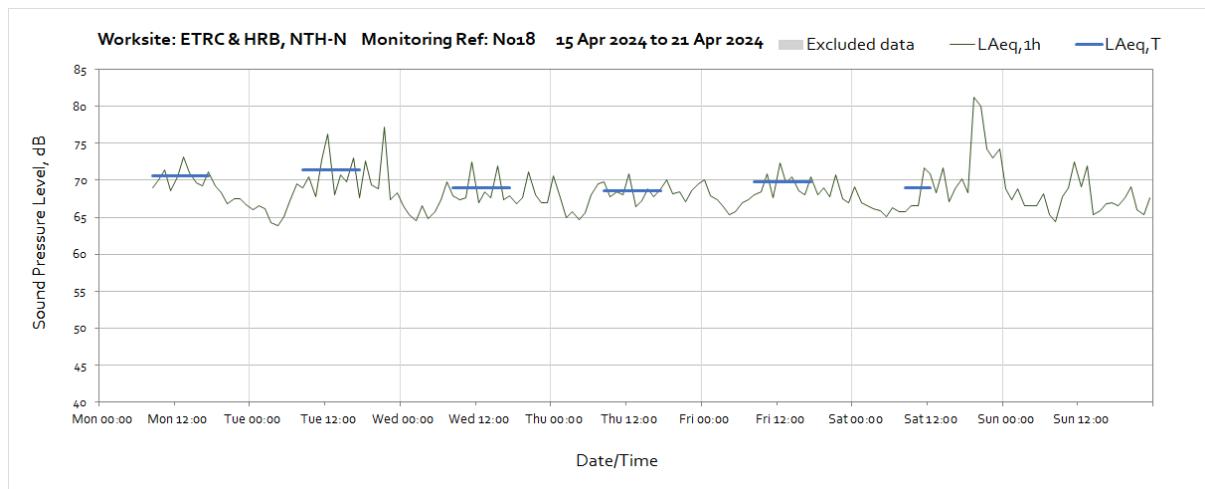
Note: Missing data between 00:00 on Sunday 14<sup>th</sup> April and 07:00 on Monday 15<sup>th</sup> April is due to monitoring station system error.

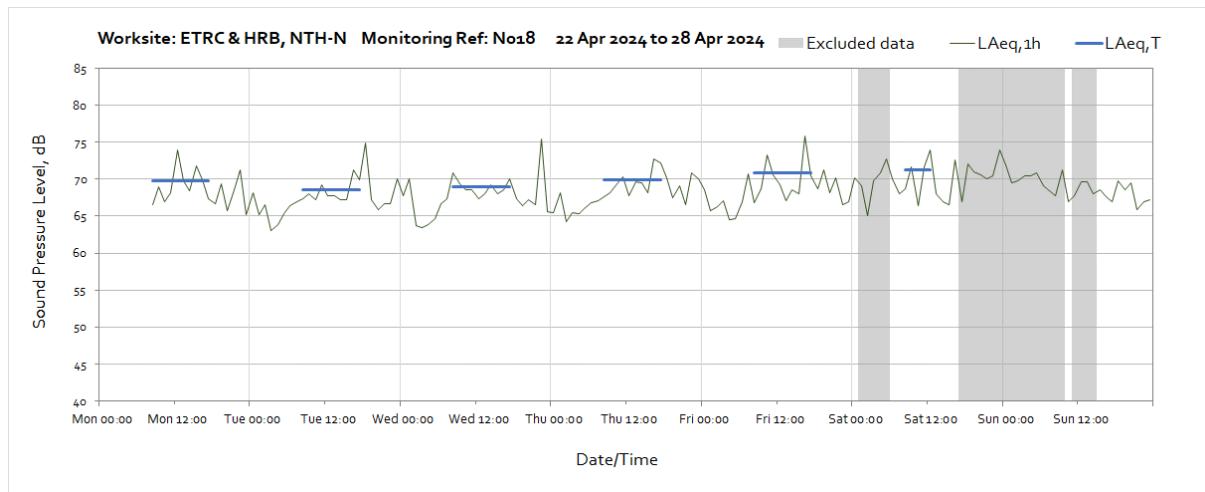
Note: Missing data between 00:00 and 08:00 on Monday 22<sup>nd</sup> April is due to monitoring station system error.

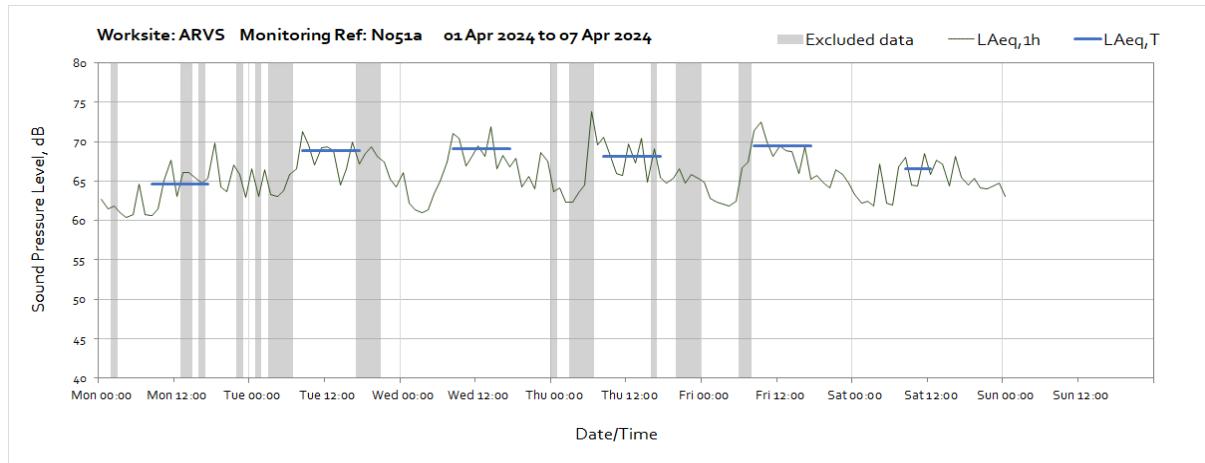
## Adelaide Road Ventilation Shaft (ARVS) – Monitoring Ref: N051a

Note: Missing data between 01:00 on Sunday 7<sup>th</sup> April and 12:00 on Monday 8<sup>th</sup> of April is due to a communication error between the monitoring station and the server.

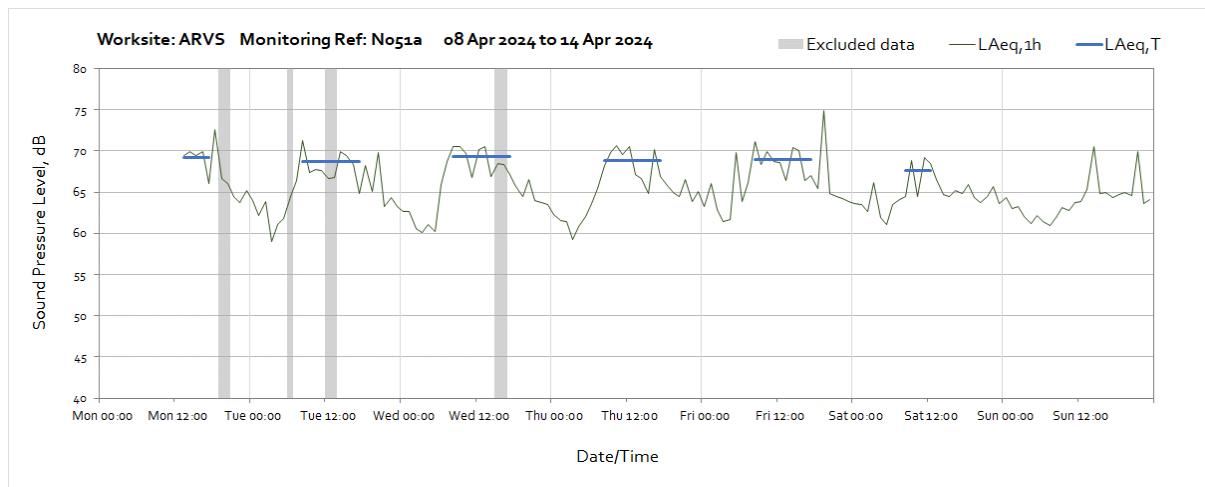
Note: Missing data between 01:00 on Sunday 7<sup>th</sup> April and 12:00 on Monday 8<sup>th</sup> of April is due to a communication error between the monitoring station and the server.
