April 2024

HS2

Air Quality and Dust Monitoring Monthly Report - April 2024 **Buckinghamshire** Council

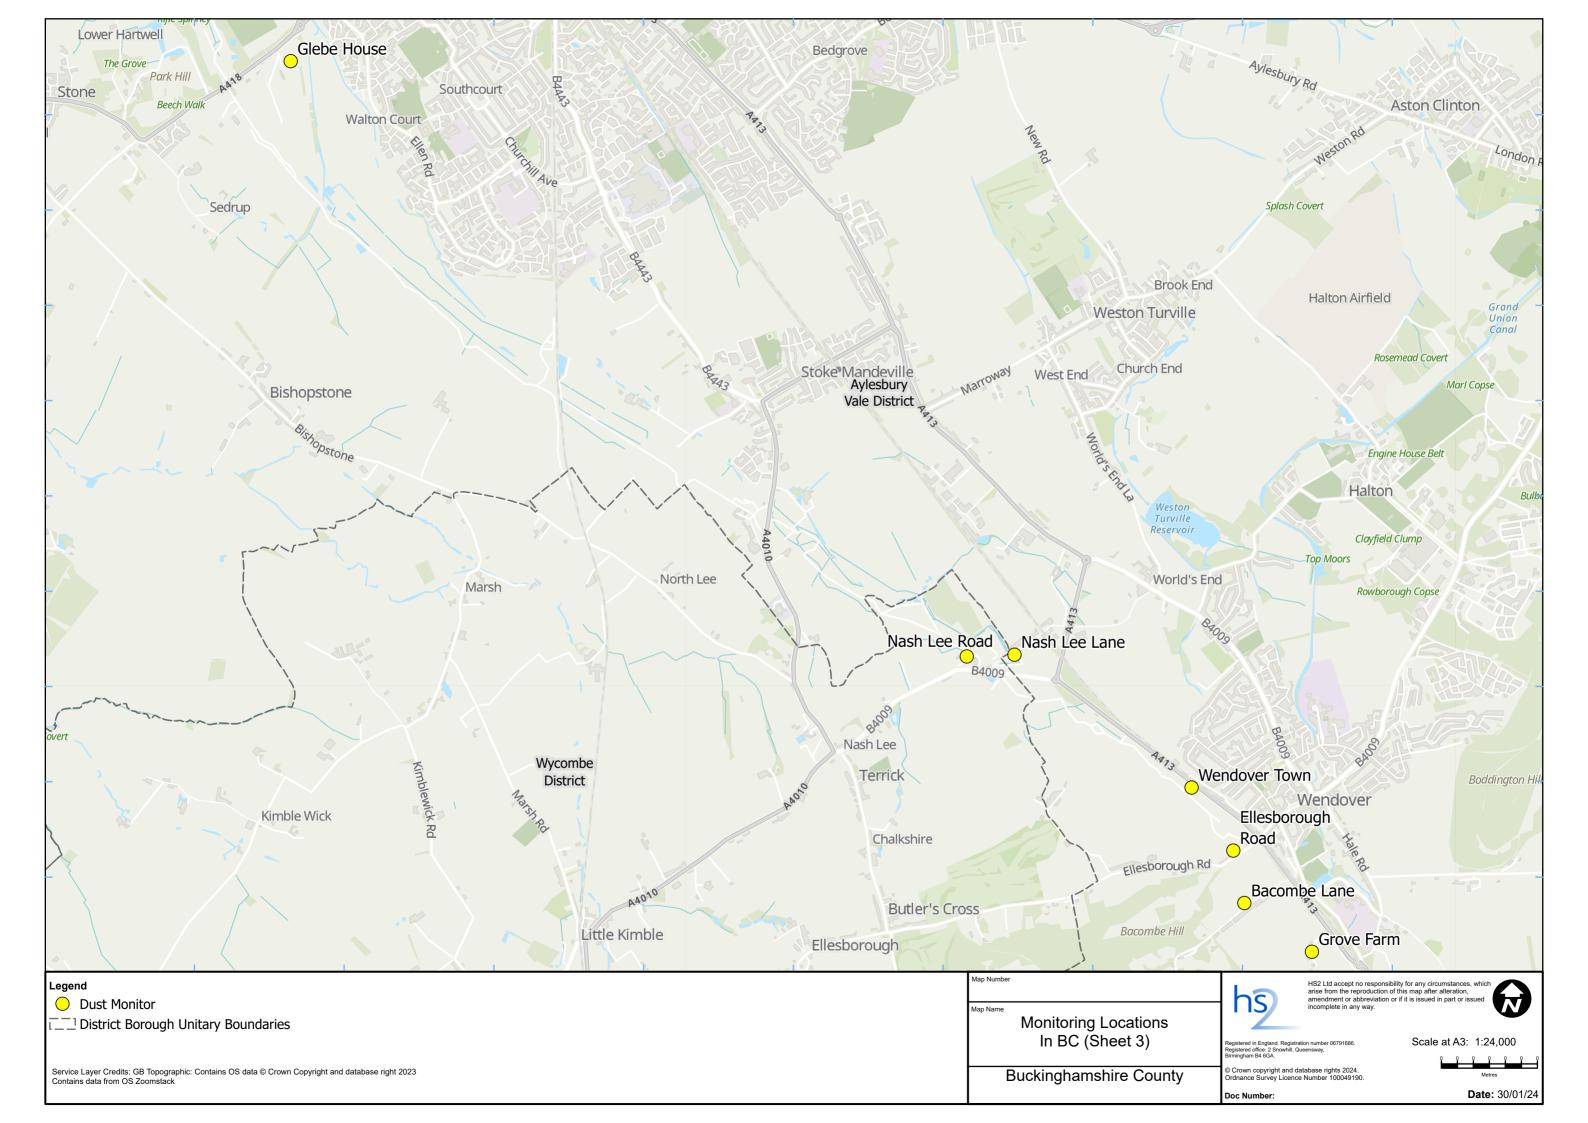
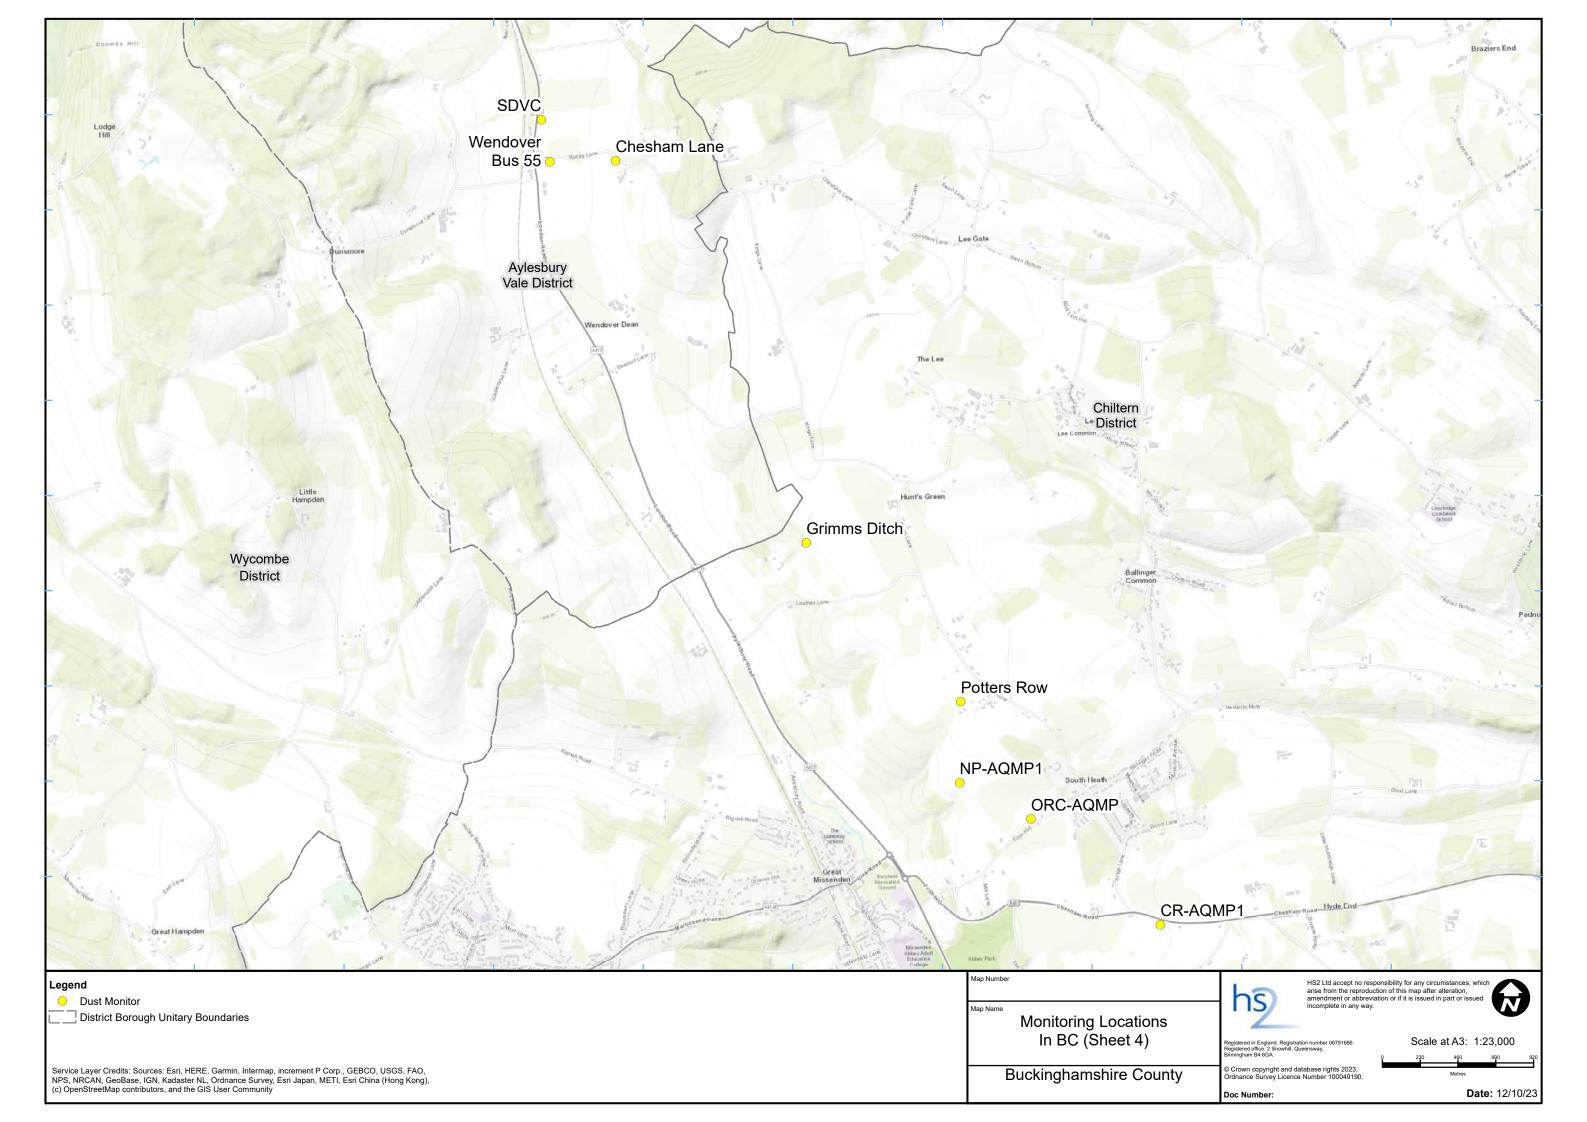
Figures 1-7: Worksite and Monitoring locations within BC

- 1.1.1 This Summary Report is published in fulfilment of commitments detailed in the High-Speed Rail (London-West Midlands) Environmental Minimum Requirements, Annex 1: Code of Construction Practice, for the nominated undertaker to present the results of dust monitoring undertaken in the Buckinghamshire Council (BC) during April 2024.
- 1.1.2 Figures 1-7 in Appendix A present the current worksites together with the dust monitoring locations.
- 1.1.3 This summary should be read in conjunction with the overview monitoring report available from www.gov.uk/government/collections/monitoring-the-environmental-effects-of-hs2, which highlights the applicable standards and guidance, as well as the air quality and dust monitoring methodologies to be implemented by nominated undertakers throughout construction.
- 1.1.4 The current worksites, as presented in Appendix A, Figures 1-7, include:

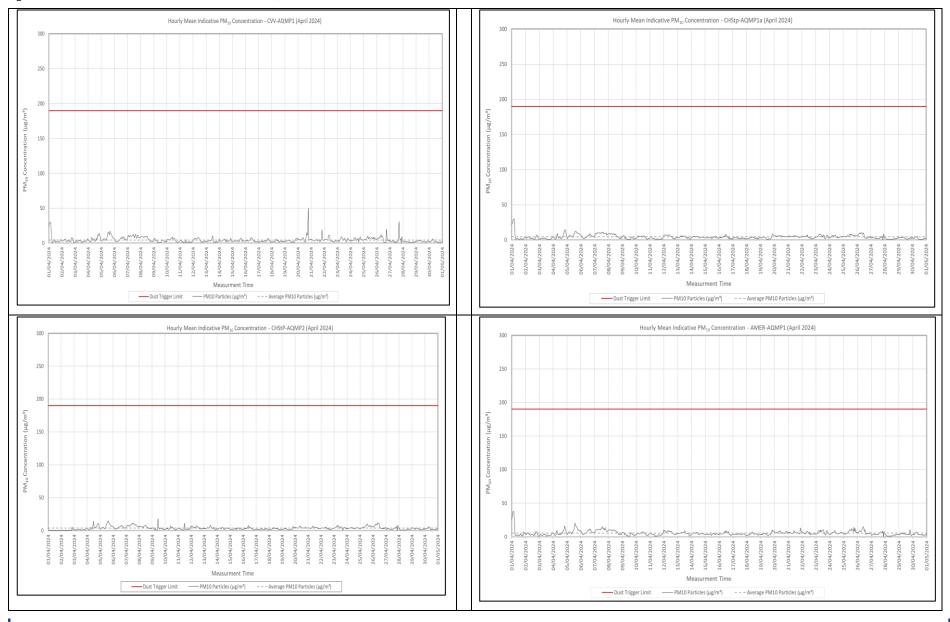
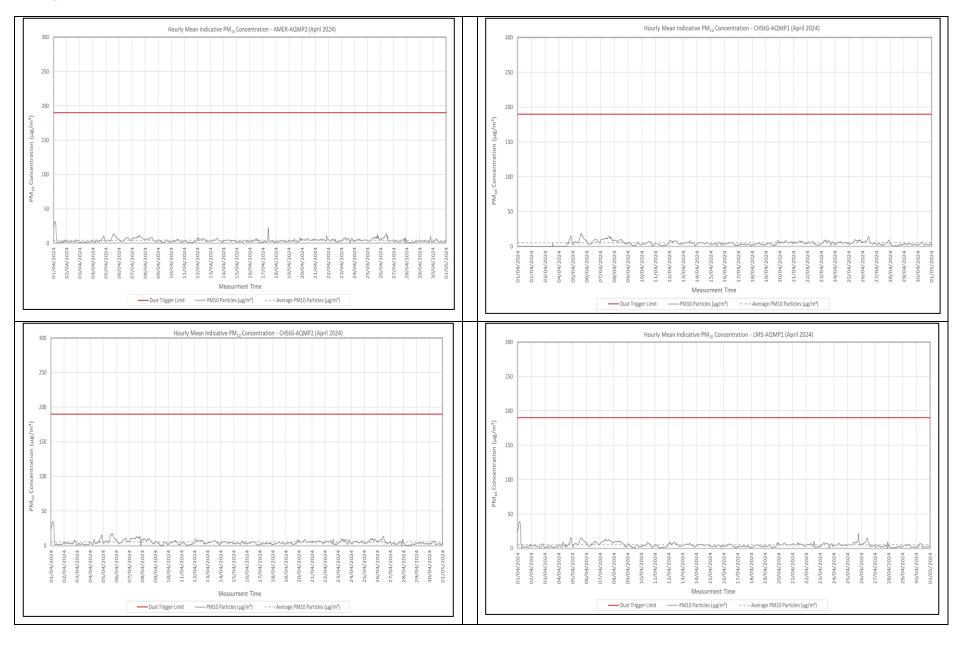
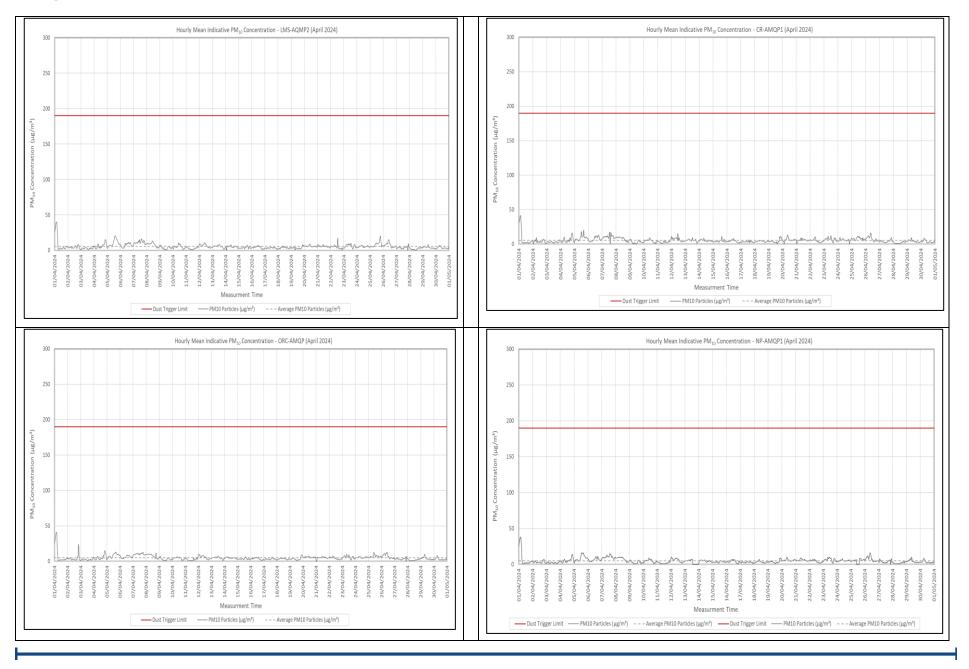
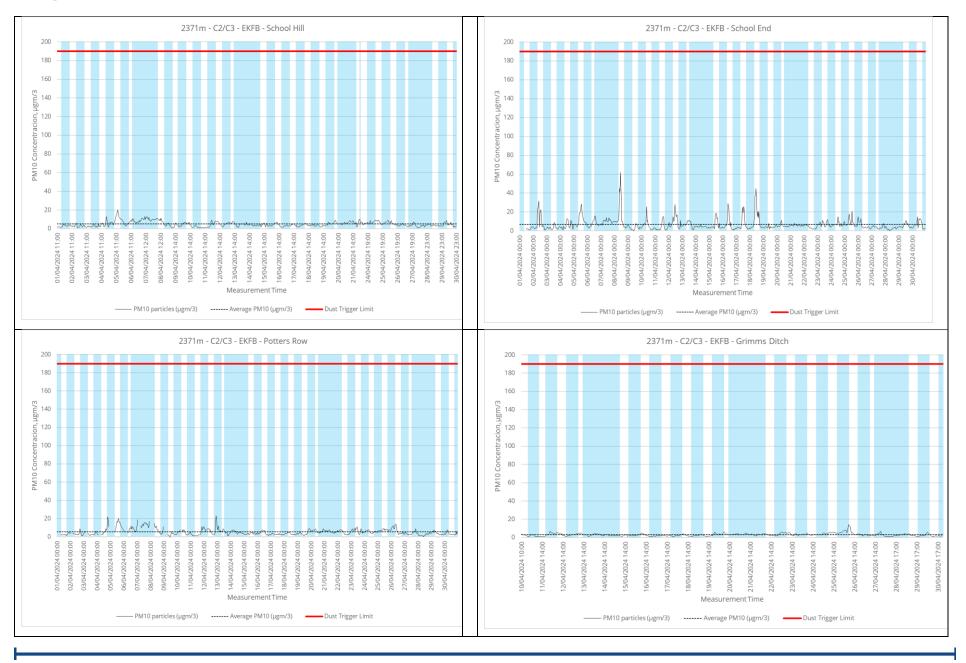
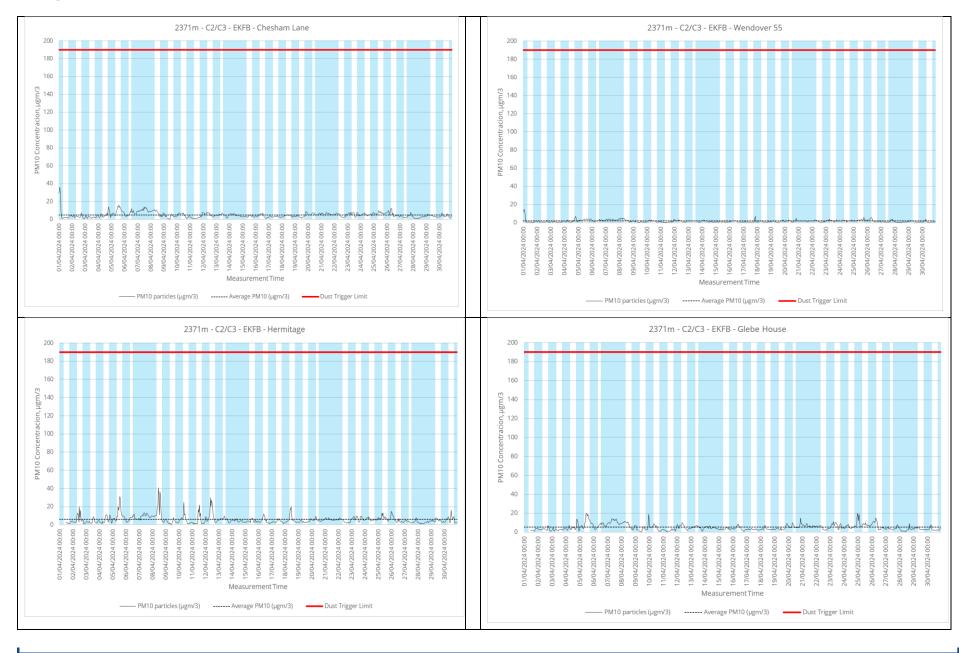
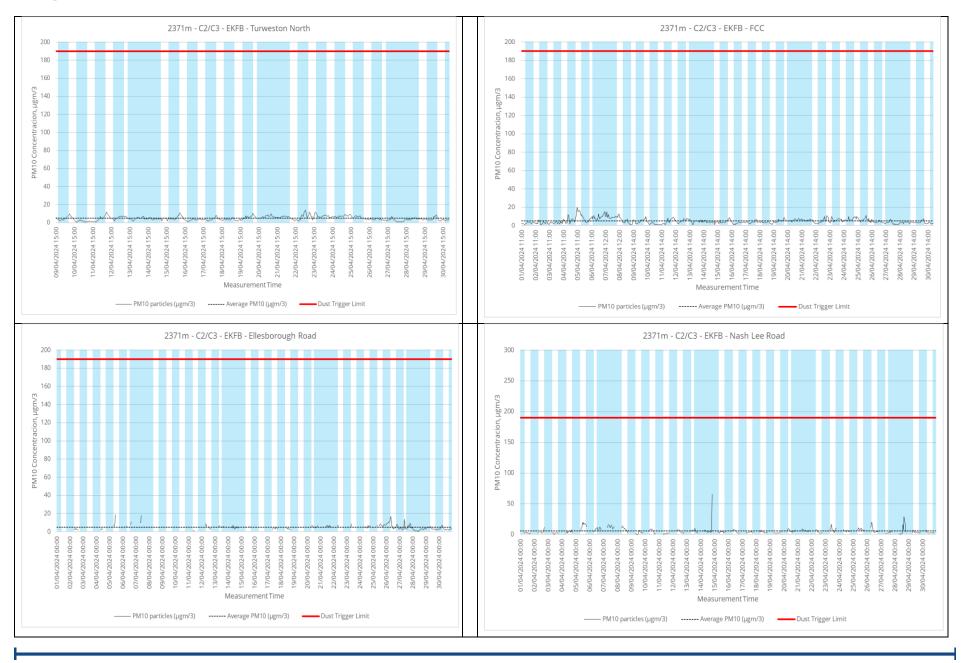
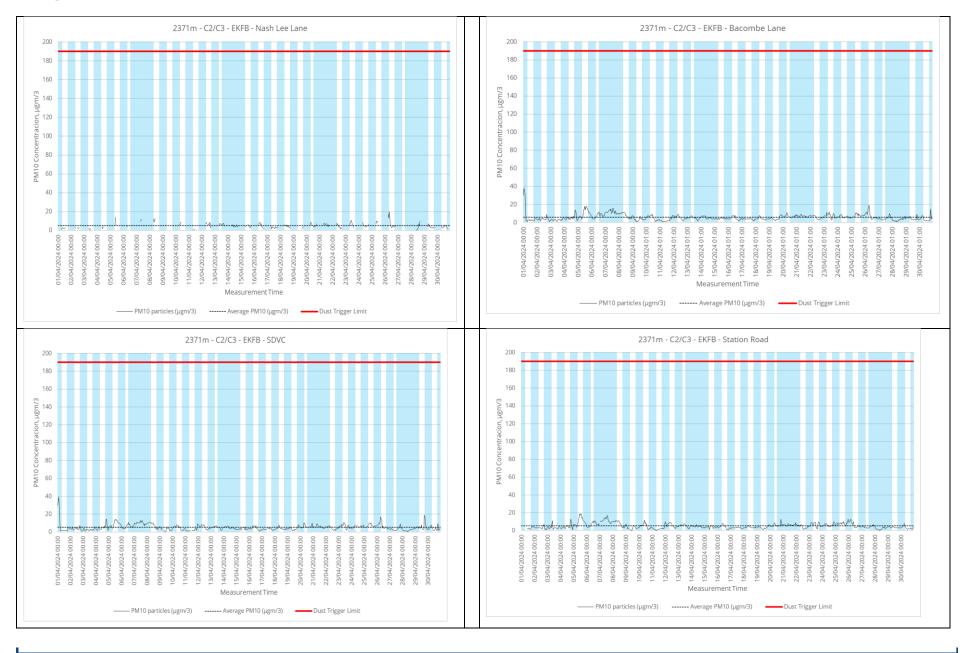
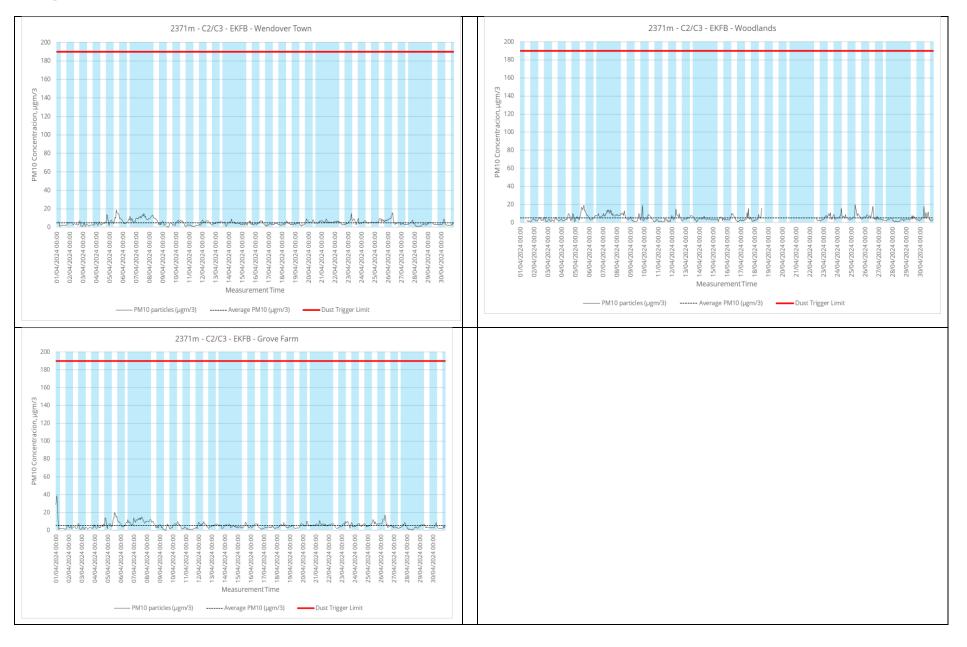
Figure 8: Continuous dust 1-hour mean indicative PM₁₀ concentration for all dust monitors

- 1.1.6 Dust monitoring locations and results are presented in Appendix B, Table 1, together with line charts of monthly data from each dust monitor presented in Figure 8. All continuous dust monitoring is undertaken using indicative monitors. Despite being Environment Agency (MCERTS) certified, indicative monitors carry a higher level of uncertainty than reference monitors, and therefore cannot be strictly compared with Air Quality Standards for human health and the environment. The purpose of the monitoring undertaken is to ensure the effectiveness of the on-site mitigation.

- 1.1.7 The trigger level for PM_{10} concentrations of 190 μ g/m³, measured as a 1-hour mean, in accordance with the updated guidance document 'Guidance on Monitoring in the Vicinity of Demolition and Construction Sites (December 2018)' has been applied.

- 1.1.8 No (0) dust trigger alerts were recorded during the monitoring period (April 2024).
- 1.1.9 Data capture was below 90% for multiple monitors due to the Grimms Ditch monitor having an internal hardware fault. Ellesborough Road monitor had a communication issue. Nash Lee Road and Nash Lee Lane was due to a lack of solar charge and battery faults. No data was recorded for Twyford due to a SD card error. The monitor was retrieved for repair on 17th April. Turweston North was reinstalled on 9th April 2024. CHStG-AQMP1 suffered an unknown failure on Mar 28th, and this was investigated on site on the 2nd of April, with data returning from 3rd April. Any sporadic loss of data can be attributed to technical issues and/or loss of power due to insufficient sunlight/wind for monitors using solar/wind power.
