Construction Noise and Vibration Monthly Report – May 2024

Buckinghamshire

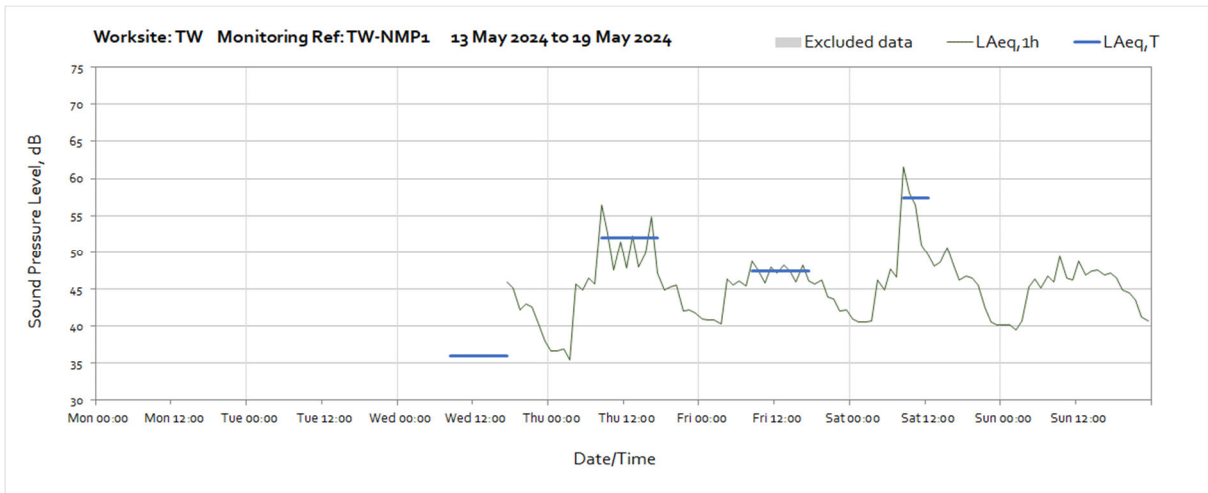
Worksite: TW – Monitoring Ref: TW-NMP1

Note: Missing data from the start of the month until 17:00 on Wednesday 15th May was due to a monitor storage error.

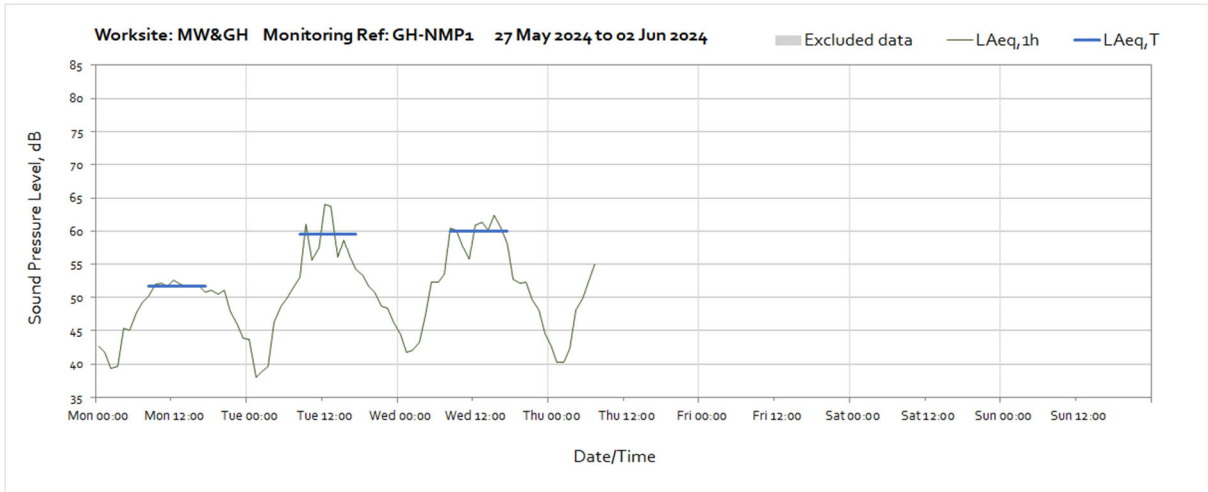
Worksite: MW&GH - Monitoring Ref: GH-NMP1

Note: Missing data from 08:00 on Thursday 30th May until month end was due to multiple aspects of the monitoring station being stolen.

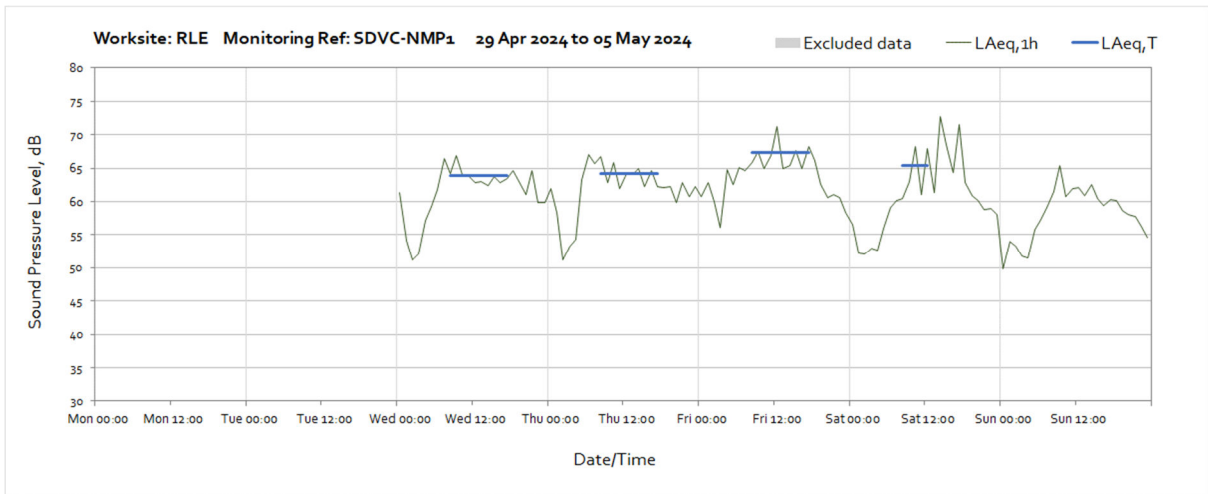
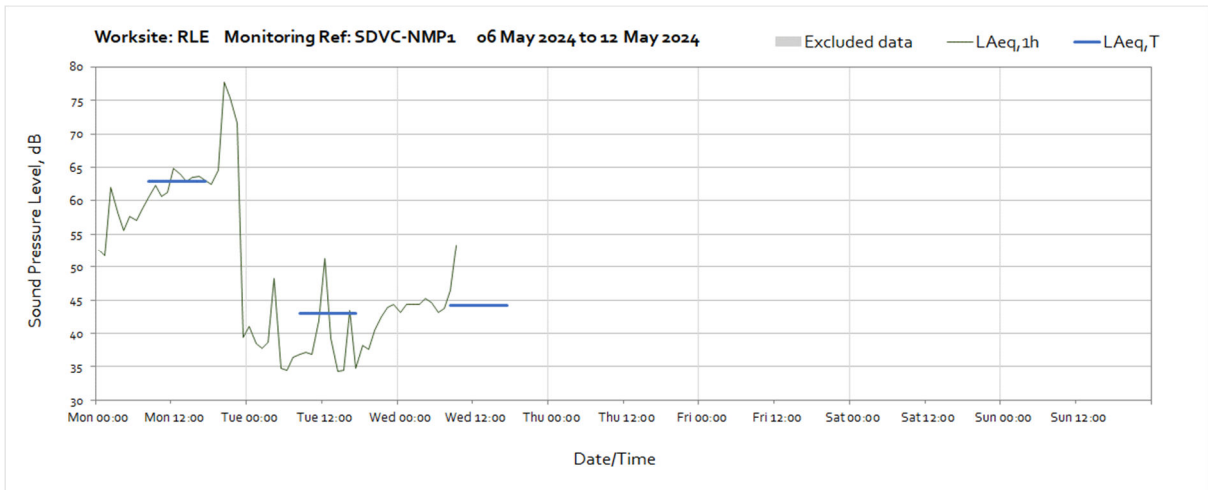
Worksite: RLE – Monitoring Ref: SDVC-NMP1

Note: Missing data from 10:00 on Wednesday 8th May until 12:00 on Friday 17th May was due to monitor retrieval for repair after a microphone fault during field calibration on Wednesday 8th May.

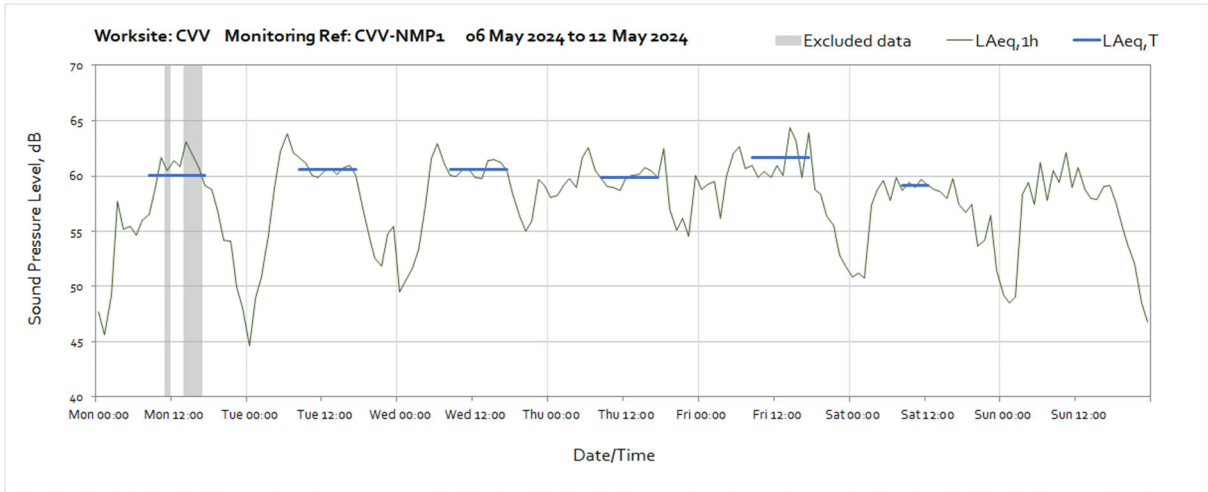
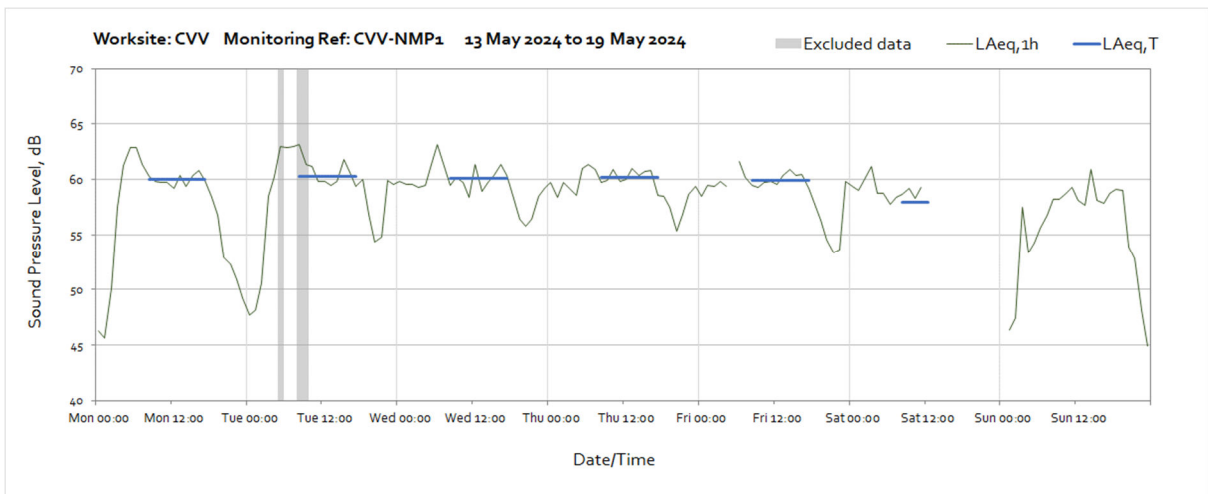
Worksite: CVV- Monitoring Ref: CVV-NMP1

Note: Missing data between 05:00 and 06:00 on Friday 17th May was due to an issue with data transfer. Missing data between 13:00 on Saturday 18th May until 02:00 on Sunday 19th May was due to a technical error within the monitoring station.
