Rail Accident Investigation Branch

# Rail Accident Report

## **Child fell from train on the Nene Valley Railway 16 February 2008**

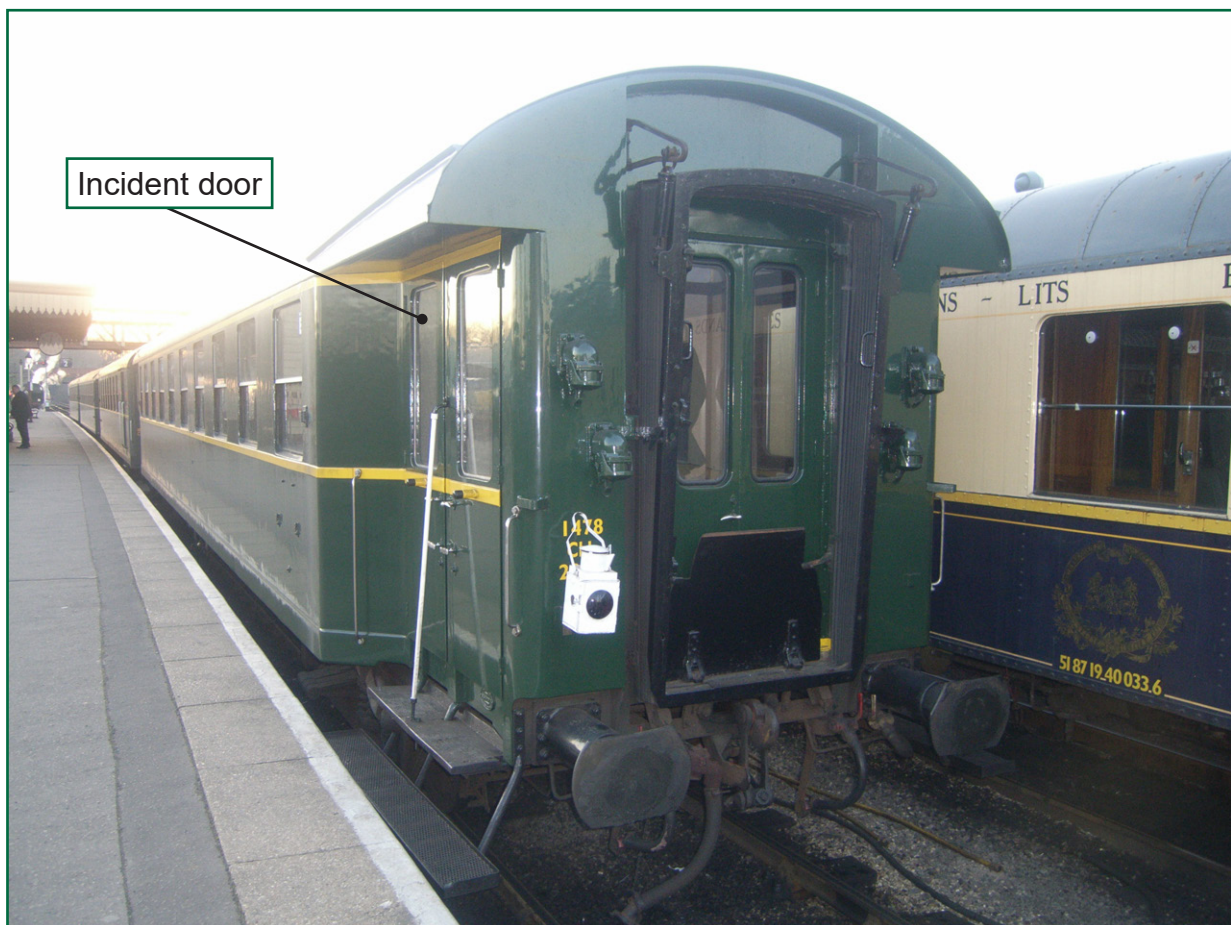
Figure 2: Leading right hand pair of doors on ex-DSB carriage 1478

- 7 The NVR is a heritage railway that operates the Peterborough (NVR) to Yarwell section of the former British Railways line between Peterborough and Northampton (Figure 1). Its headquarters is at Wansford. It operates steam and diesel hauled trains on its railway and, because the size of its bridges allows the use of larger trains than is normal in Britain, it is able to use continental rolling stock in a way that no other British railway can do.
- 8 The NVR owns, amongst its other rolling stock, five carriages formerly operated by Danske Statsbaner (DSB), the national railway in Denmark. They entered service on the NVR around 1978. The carriages have double doors (Figure 2) that give access from the platform to vestibules at each end.

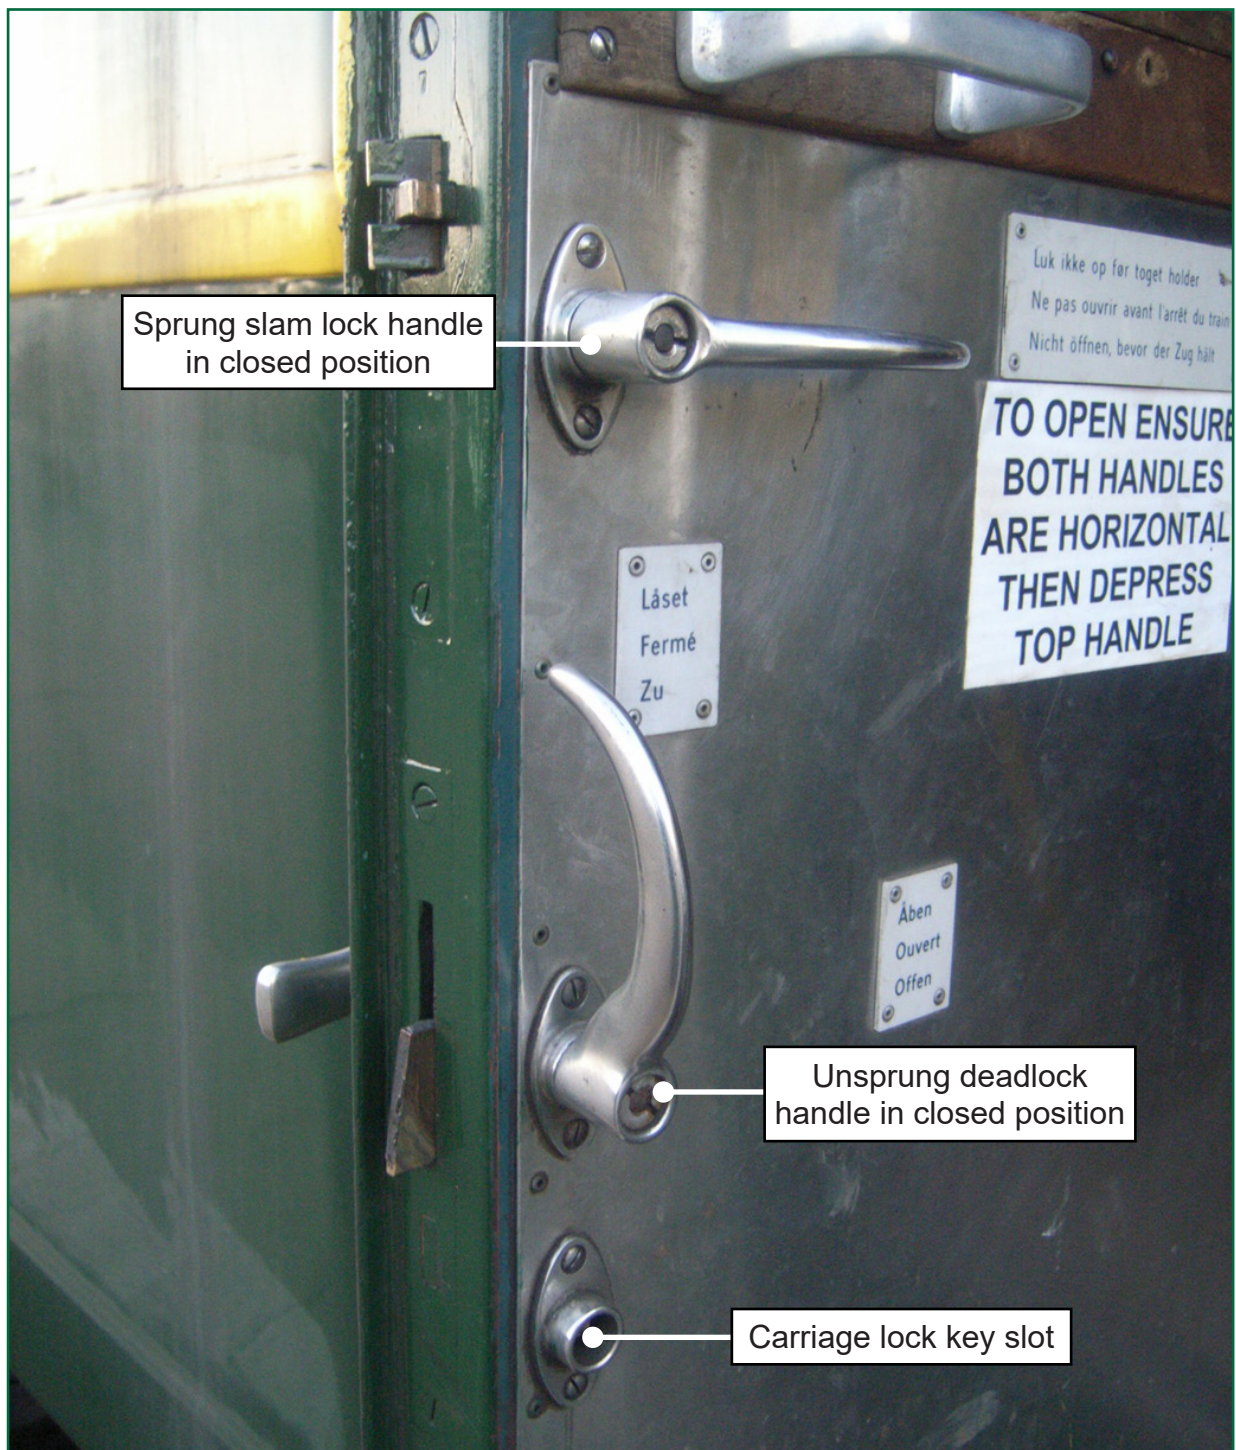
Figure 3: Incident door showing slam door and deadlock handles

- 9 Each external door is secured by two door locks and handles (Figure 3). The upper slam lock is sprung, and the handle inside the carriage is horizontal when the latch is engaged. The lower lock is not sprung, thus providing a deadlock, and the handle on the inside of the carriage should be vertical when the lock is engaged.
- 10 There are signs in Danish, French and German on the inside of the door stating that it should not be opened whilst the train is in motion; the only sign in English explains how the door handles should be worked to open the door.

- 20 The measurements showed that the incident door required a force of 32.1 N at the centre of the natural grip position (approximately 80 mm from the pivot) to open the door. The deadlock handle required a force of 34.1 N at the same position to unlock it.

- the deadlock handles have been turned through 90 degrees so that they are now horizontal and have to be lifted upwards to unlock;
- half the doors on each coach (the outer doors of each door pair) have been permanently locked out of use; and
- guards and travelling ticket inspectors have been briefed to be vigilant if young children are close to the handles of the external doors in the vestibule area.

1. NVR should investigate and urgently implement measures to reduce the risk of people being able to accidentally open the doors of their ex-DSB coaches, and any other carriages on the railway employing internal door handles. Their considerations should include, either singly or in combination :
  - modify the door handles to make them less easy to open accidentally (for example by making them stiffer to turn).
  - provide clear warning information to passengers, such as signs on the inside of the doors or safety announcements, in order to alert them and young children in their care, to keep away from the door handles while the train is in motion.

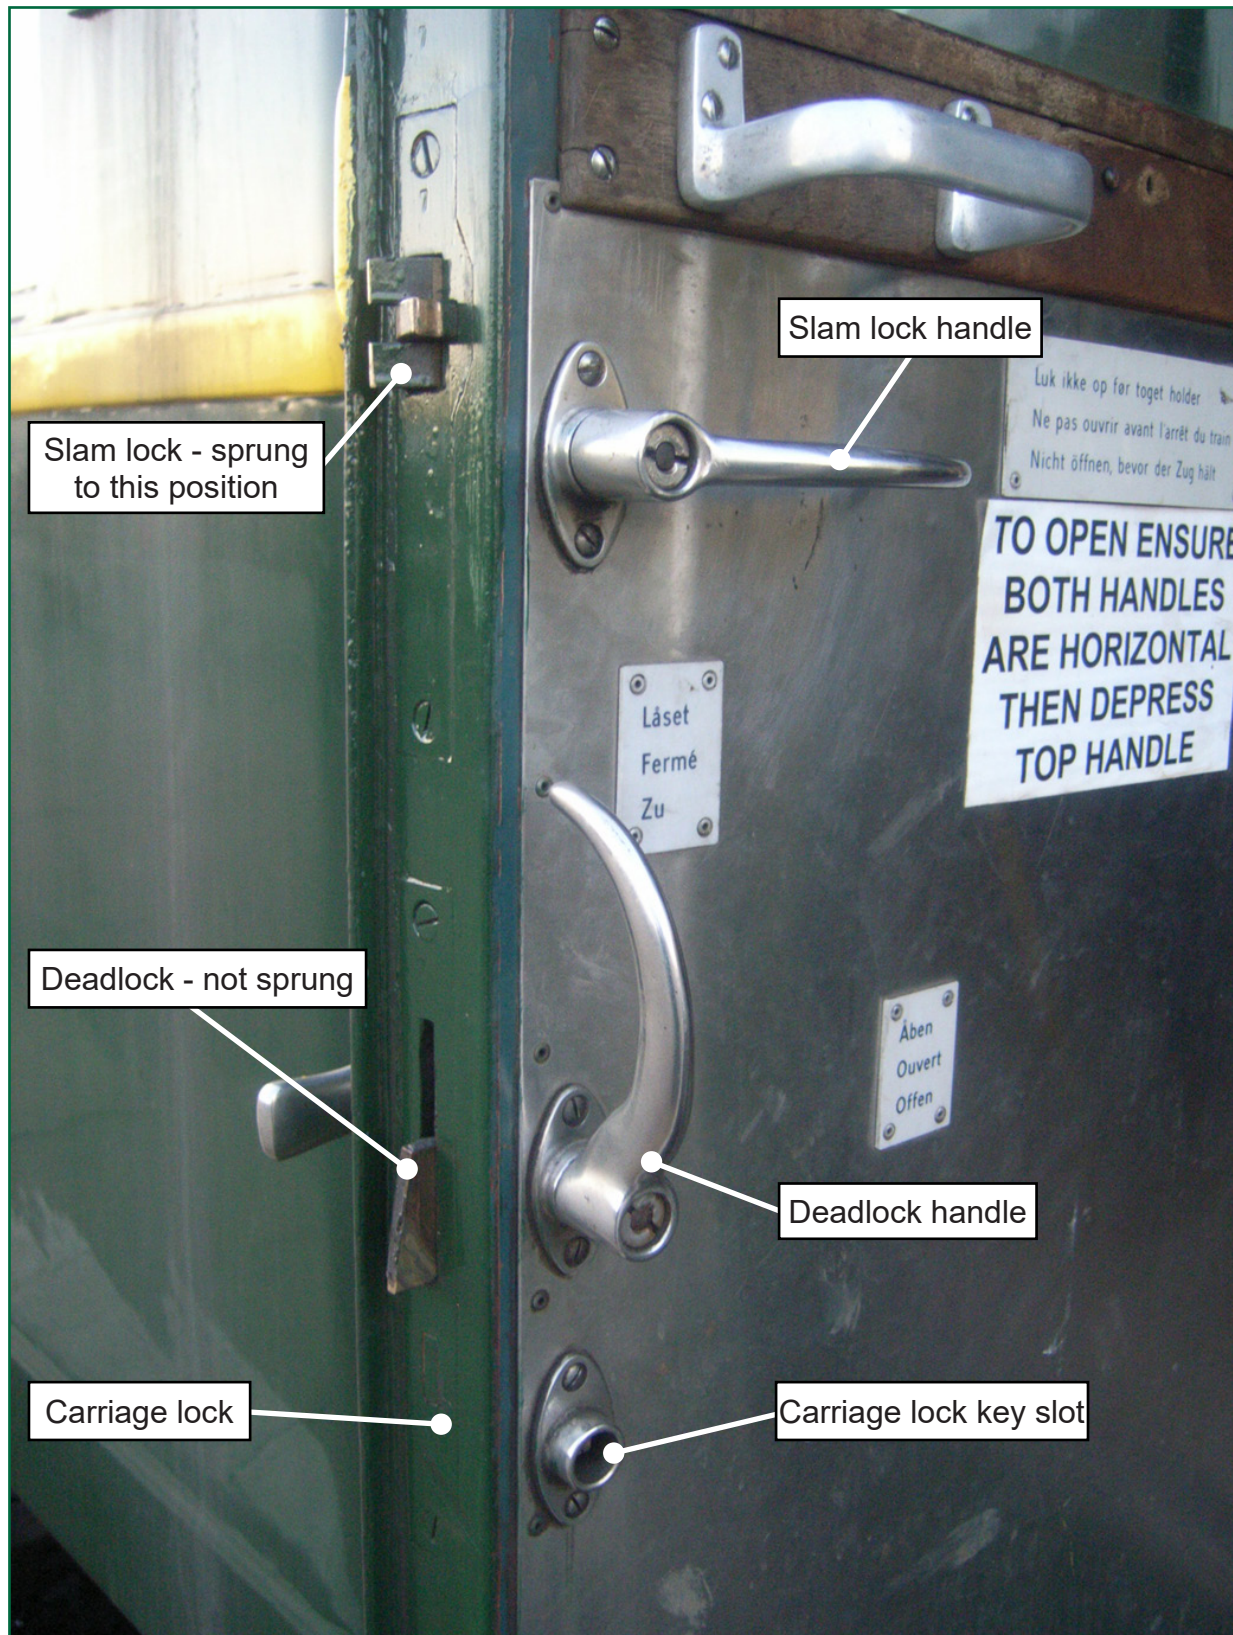
1. INCIDENT DESCRIPTION			
<b>LEAD / INSPECTOR</b>		<b>CONTACT TEL. No.</b>	
<b>INCIDENT REPORT NO</b>	0268	<b>DATE OF INCIDENT</b>	16/2/08
<b>INCIDENT NAME</b>	Wansford, Nene Valley Railway		
<b>TYPE OF INCIDENT</b>	Child fell from train travelling at approx 20 mph		
<b>INCIDENT DESCRIPTION</b>	A vestibule door on former Danske Statsbaner (Danish Railways) carriage 1478 came open whilst the train was running from Wansford to Peterborough, allowing a young child to fall onto the railway track.		
<b>SUPPORTING REFERENCES</b>	See attached photograph for details of the door handle arrangements

2. URGENT SAFETY ADVICE	
<b>USA DATE:</b>	18/02/08
<b>TITLE:</b>	Door locking arrangement on former Danske Statsbaner carriages
<b>SYSTEM / EQUIPMENT:</b>	Nene Valley Railway
<b>SAFETY ISSUE DESCRIPTION:</b>	The former Danske Statsbaner carriages used on the NVR have vestibule doors with two interior handles, a lower one to deadlock the door and an upper one to open the slam lock. The lower lock is not sprung; the upper lock is.
<b>CIRCUMSTANCES:</b>	Initial RAIB tests indicate that only a small force is necessary to open both interior door handles—estimated at about 2 kilos applied at the end of the door handles. If the lower lock is moved to the open position and the upper lock is then turned the door is free to open, allowing egress from the train. The forces to turn the handles are such that they can be applied by a small child.
<b>CONSEQUENCES:</b>	Risk of fall from train.
<b>REASONS FOR ISSUE:</b>	The Nene Valley Railway should investigate and urgently implement one or more measures to reduce the risk of people being able to open the doors of carriage 1478, and any other carriages on the railway employing the same door lock arrangement.  This advice is also sent to the Heritage Railway Association in case any other railway has a similar arrangement, and to the European Rail Agency, in case the door arrangement is still in use in Denmark, or on heritage railways in Europe.
