# Air Quality and Dust Monitoring Monthly Report – June 2024 Warwick District Council

A report prepared by EWCs and MWCCs on behalf of HS<sub>2</sub> Ltd.

# **Monthly Summary**

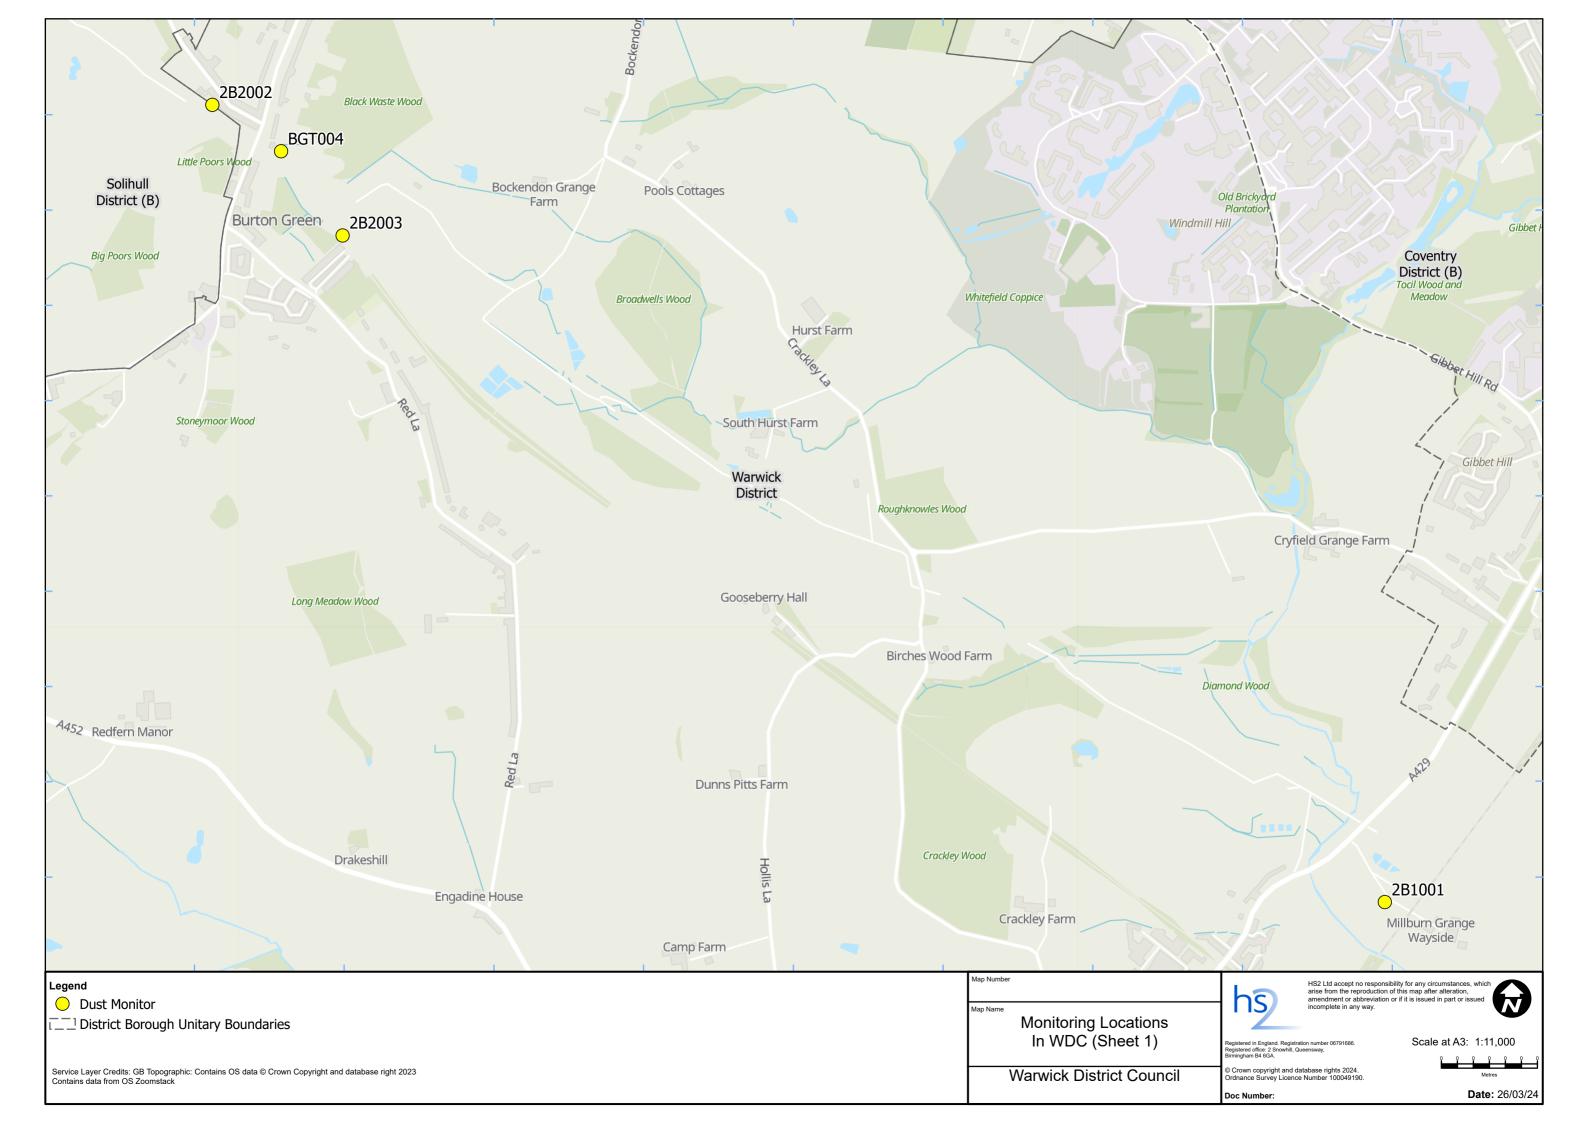
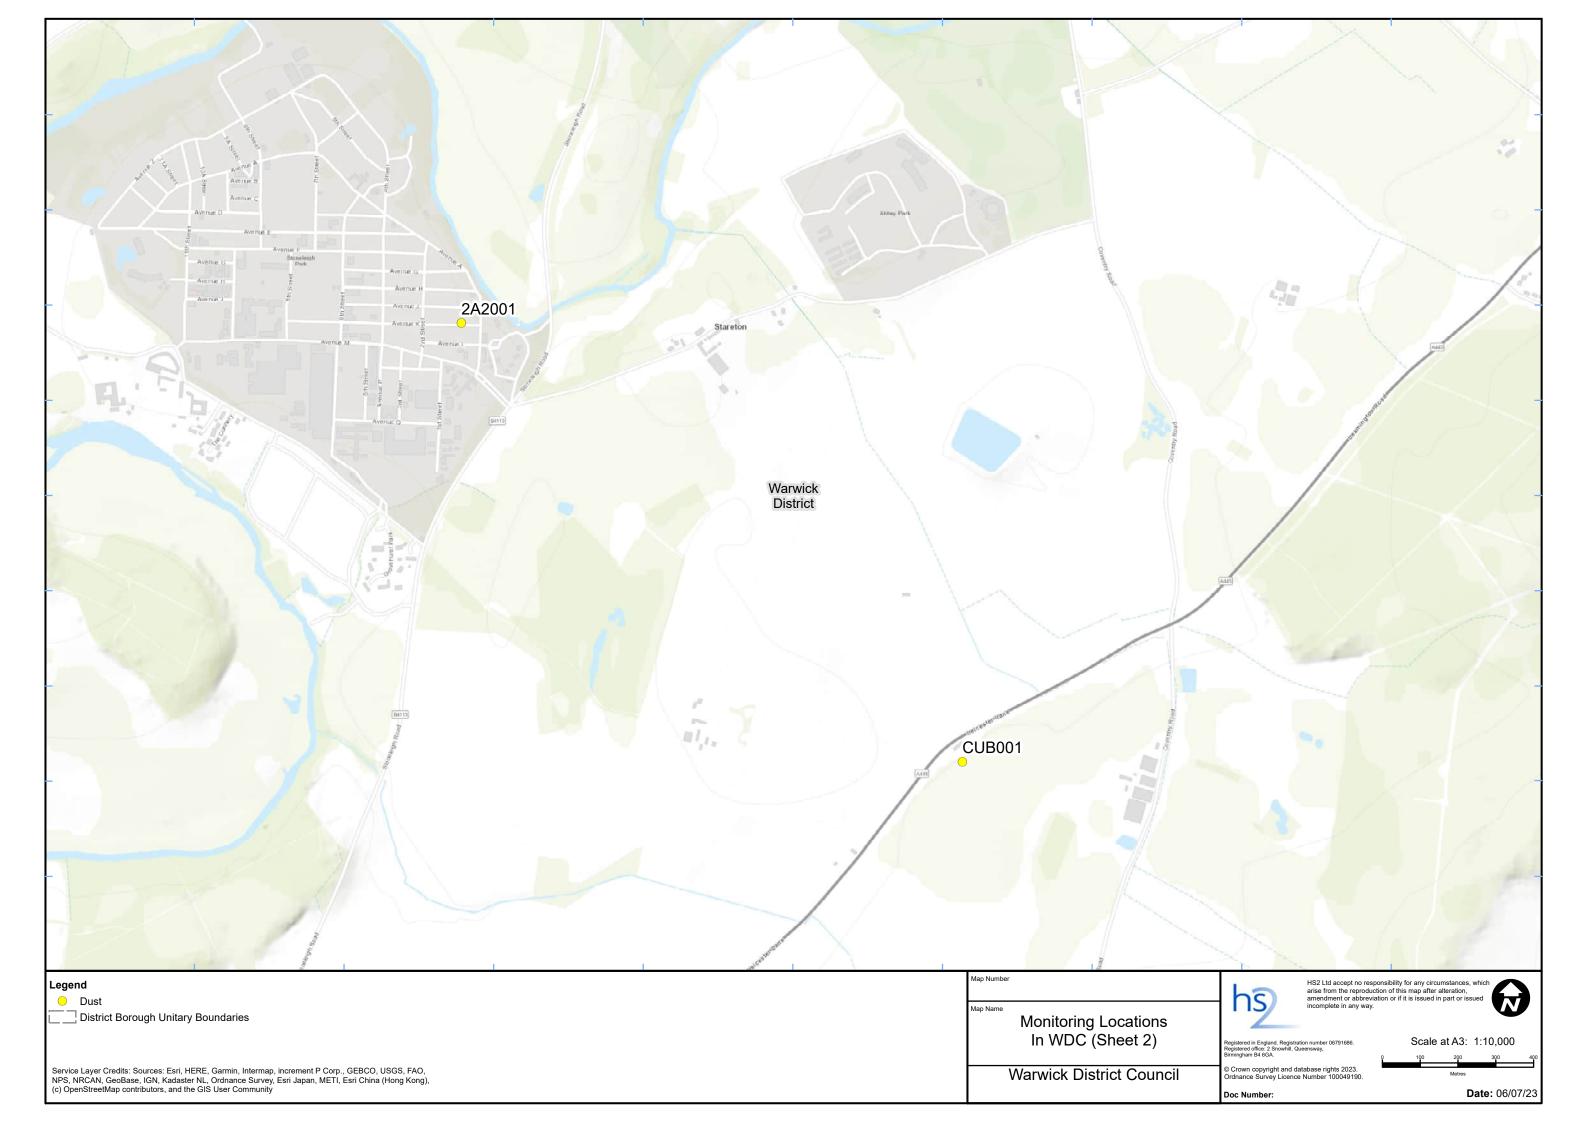
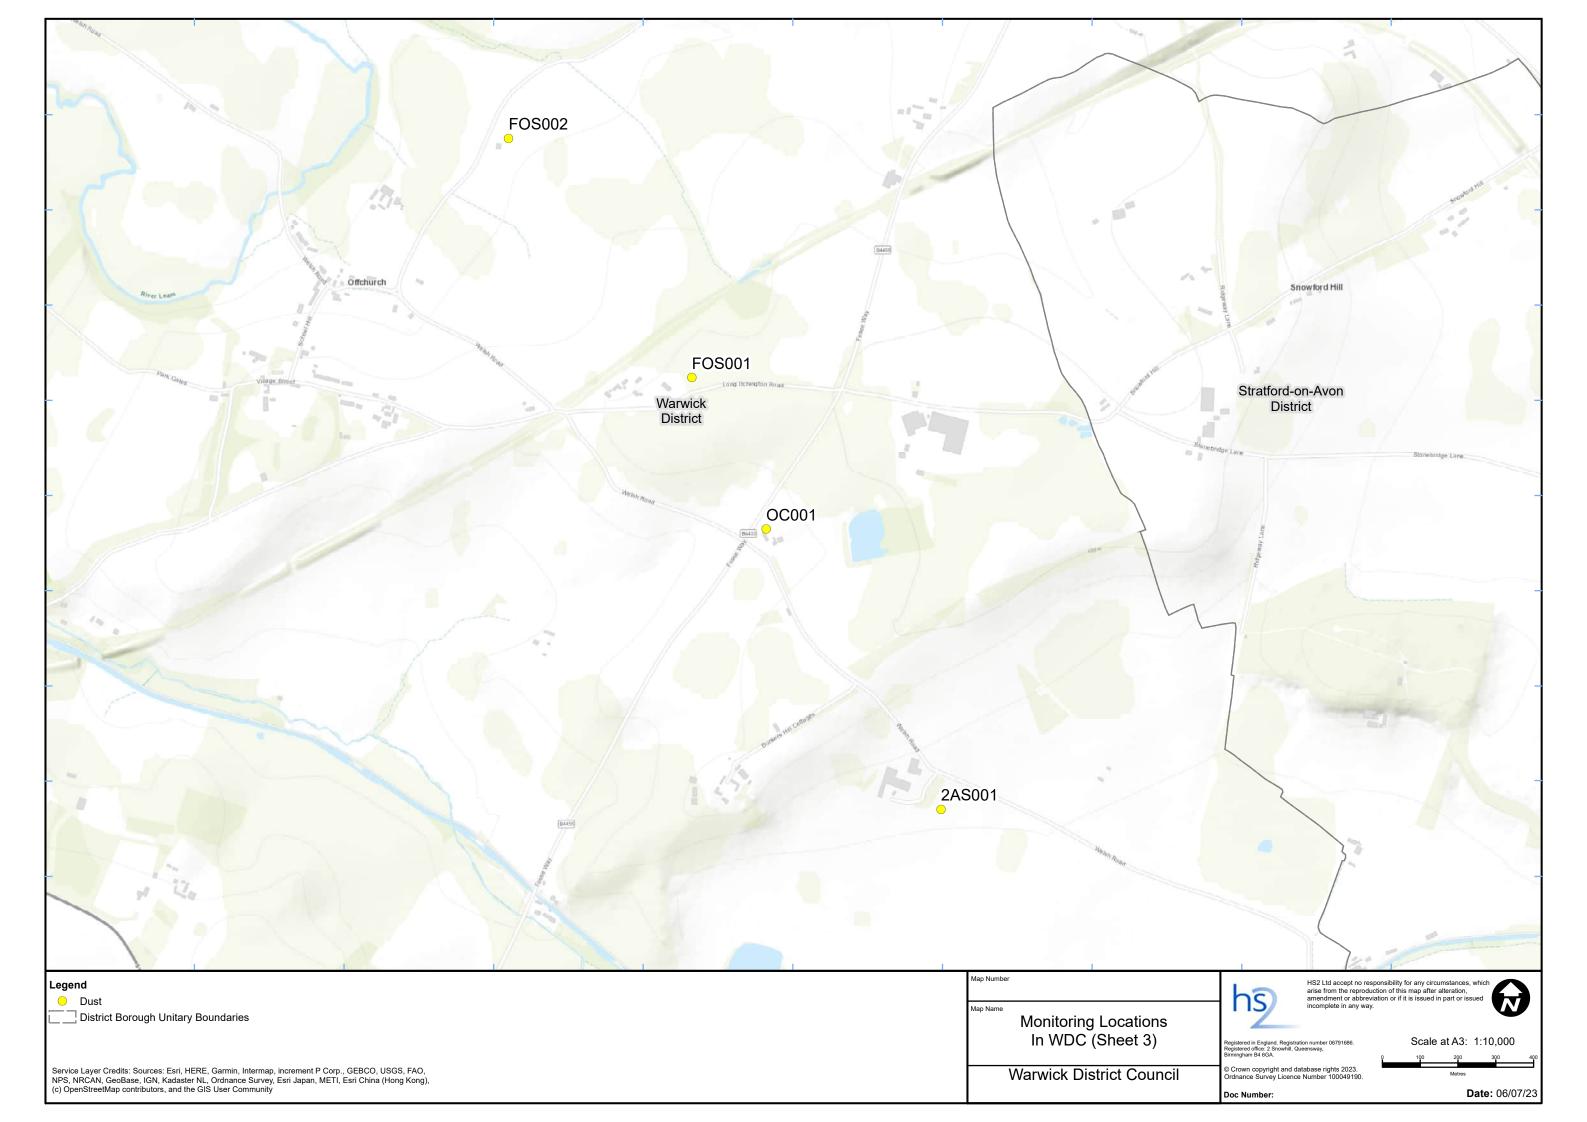
Figures 1-3: Worksites and Monitoring Locations within WDC

- 1.1.2 Figures 1 to Figure 3 in Appendix A present the current worksites together with the dust monitoring locations.
- 1.1.3 This summary should be read in conjunction with the overview monitoring report monthly available from <u>www.gov.uk/government/collections/monitoring-the-</u> <u>environmental-effects-of-hs2</u>, which highlights: the applicable standards and guidance, as well as the air quality and dust monitoring methodologies to be implemented by nominated undertakers throughout construction.

- 1.1.4 The current worksites, as presented in Appendix A, Figures 1 to 3, include:

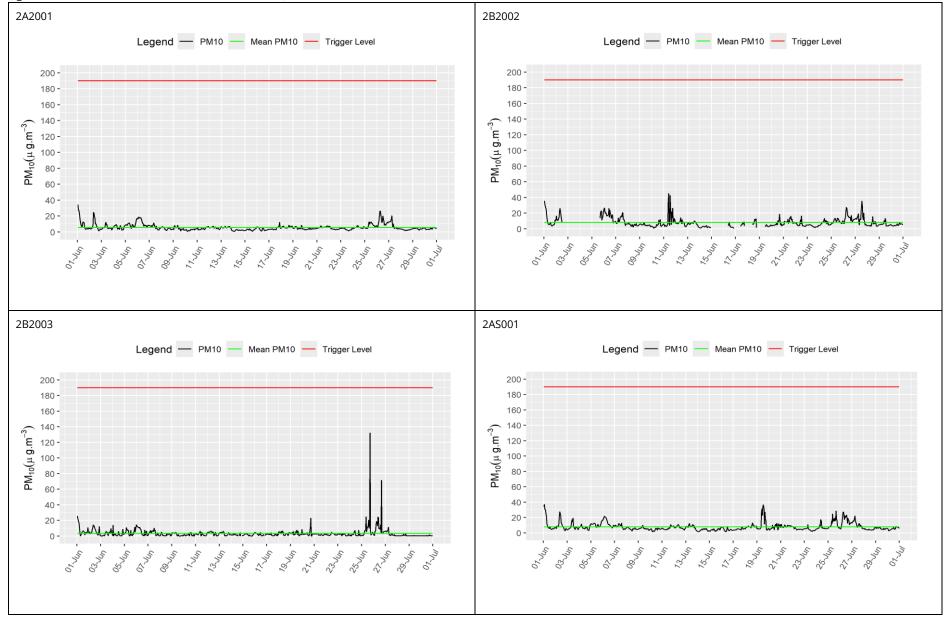
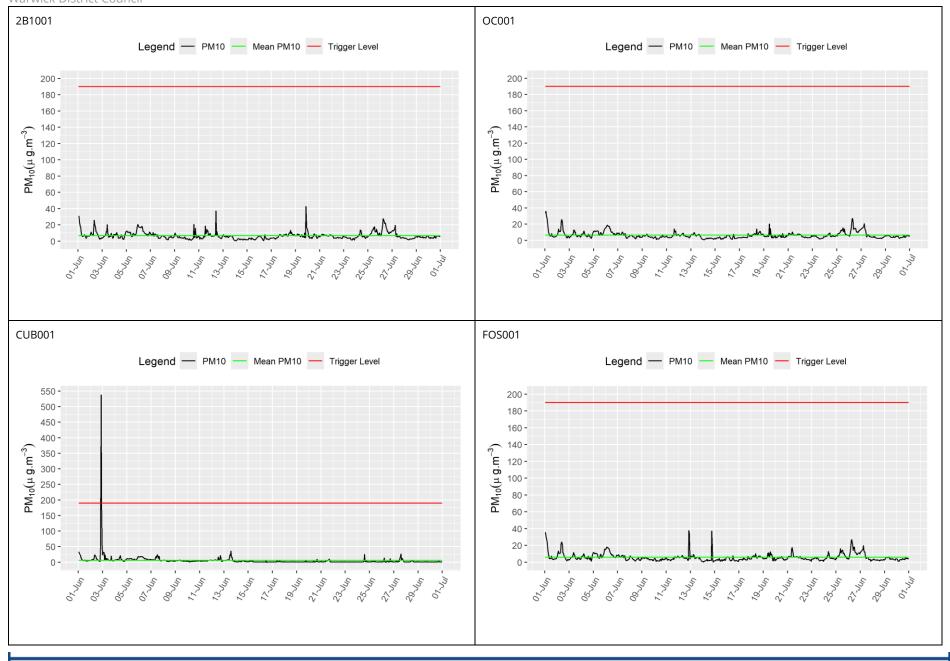
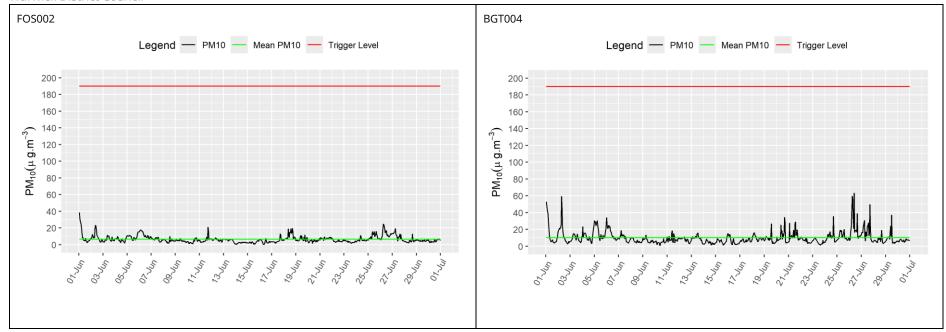
Figure 4: Construction dust 1-hour mean indicative PM<sub>10</sub> concentration for all dust monitors

- Trench sheet installation.
- Excavation of sheet piling works.
- De-vegetation works in the area.
- 1.1.5 Ten (10) dust monitors are installed around these worksites, where works are underway. These sites returned a low to medium dust risk rating.
- 1.1.6 Dust monitoring locations and results are presented in Appendix B, Table 1, together with line charts of monthly data from each dust monitor, presented in Figure 4. All continuous dust monitoring is undertaken using indicative monitors. Despite being Environment

- 1.1.7 The trigger level for PM<sub>10</sub> concentrations of 190 μg/m<sup>3</sup>, over a 1-hour period, in accordance with the updated guidance document '*Guidance on Monitoring in the Vicinity of Demolition and Construction Sites (October 2018)*' has been applied.
- 1.1.8 Details of the trigger alert investigations and remediations are presented in Appendix B, Table 2.
- 1.1.9 Data capture was below 90% for the 2B2002 monitor due to an issue with the monitor which was resolved by the monitor being swapped out on 11<sup>th</sup> June 2024, followed by a field calibration and battery refresh on 19<sup>th</sup> June 2024.
- 1.1.10 There were no (0) complaints received during the reporting period (June 2024).

| Monitoring Site ID | Period of trigger alert &<br>Concentration recorded | Investigation | Outcomes / Resolution / Remedial measures<br>implemented |
|---|--|---|--|
| CUB001 | 02/06/2024:<br>20:01 - 21:00; 537.8 μg m <sup>-3</sup> | This exceedance occurred outside of current BBV<br>construction hours, so the exceedance is unlikely to be<br>associated with HS2 construction works. | N/A |
