Construction Noise and Vibration Monthly Report – June 2024

London Borough of Camden

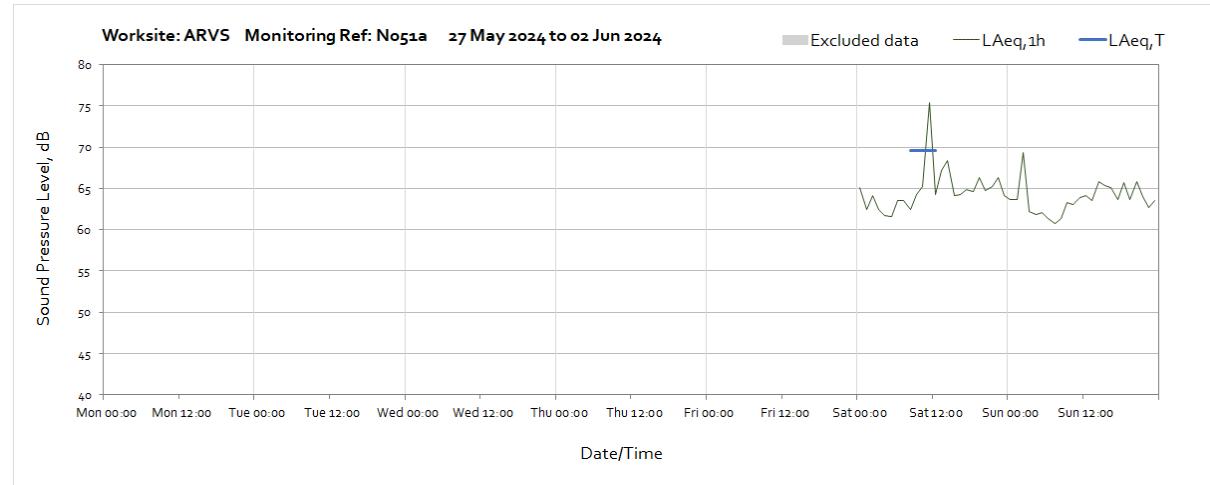
Adelaide Road Ventilation Shaft (ARVS) – Monitoring Ref: N051a

Note: Missing data between 01:00 on Sunday 09th of June 2024 and 08:00 on Wednesday 19th of June 2024 is due to memory card failure within the monitoring station.
