# Phase I Desk Study and Preliminary Risk Assessment

*Land East of Ugley Village Hall, Ugley*

*Prepared by Pelham Structures  
August 2024*

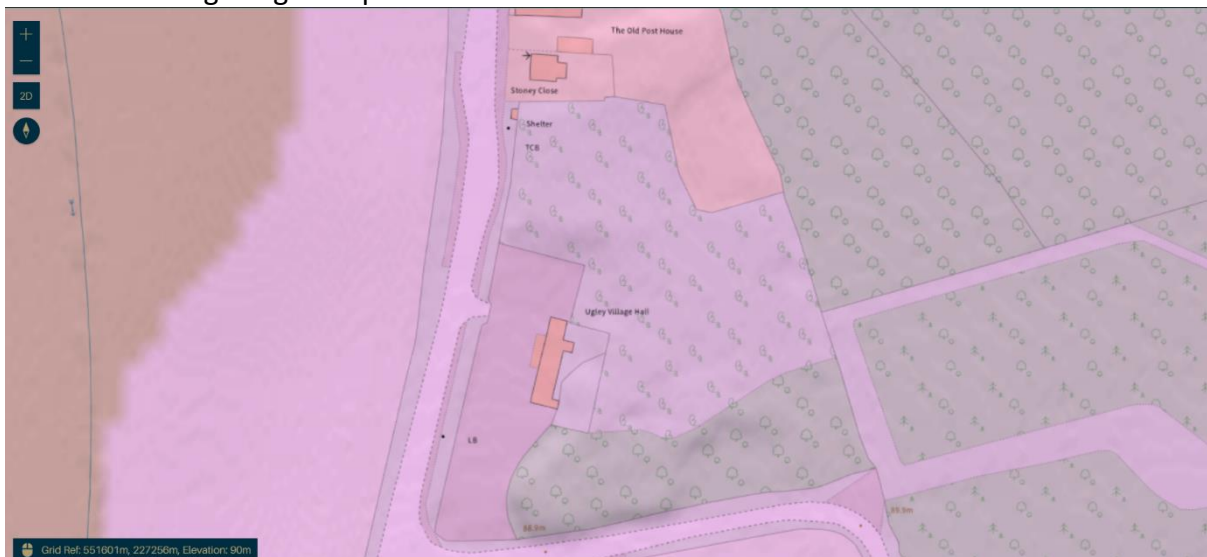
- 4.2.4. The entire application site is located on the Glaciofluvial Gravel, e.g., deposited by torrents of water from above a retreating glacier and from pressurized water from below the glacier.

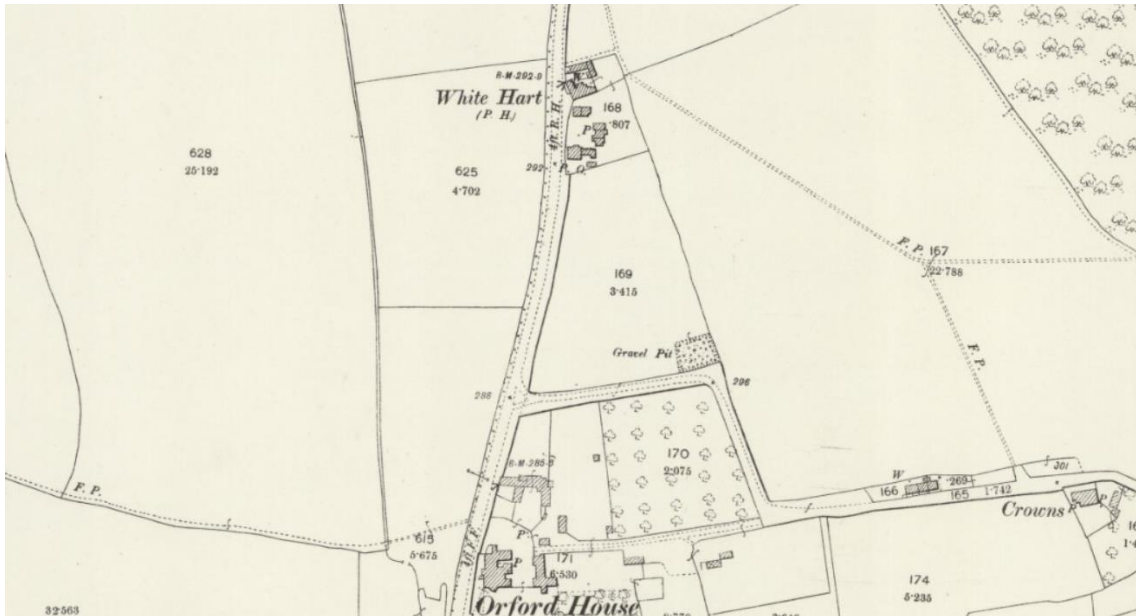
1897 the gravel extraction had just commenced in the southeast corner.

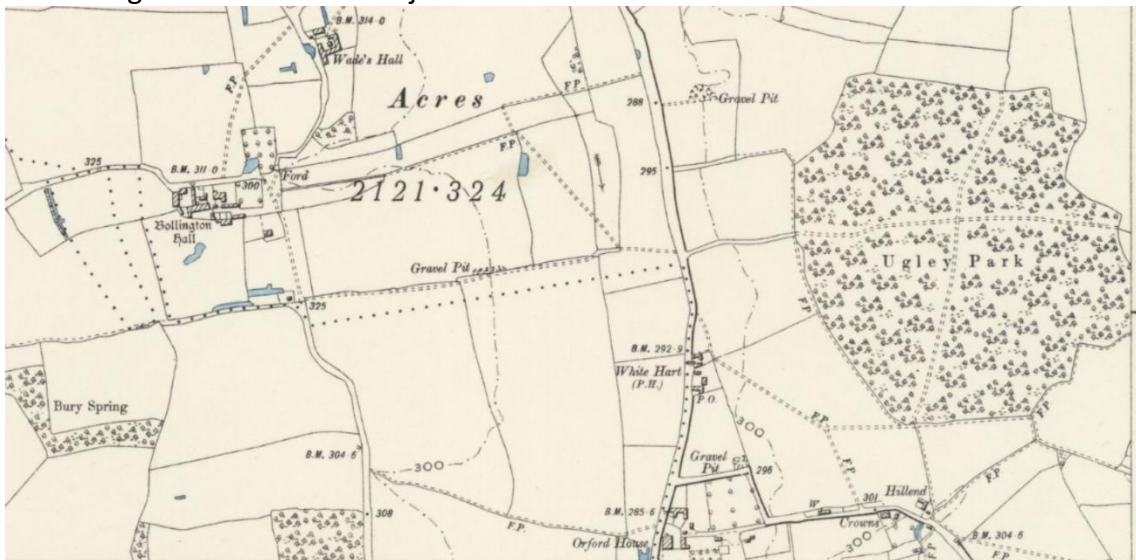
1898 ponds shown in blue. There appear to be no ponds shown either within the application red line or in the northeast quarter beyond Ugley Park.

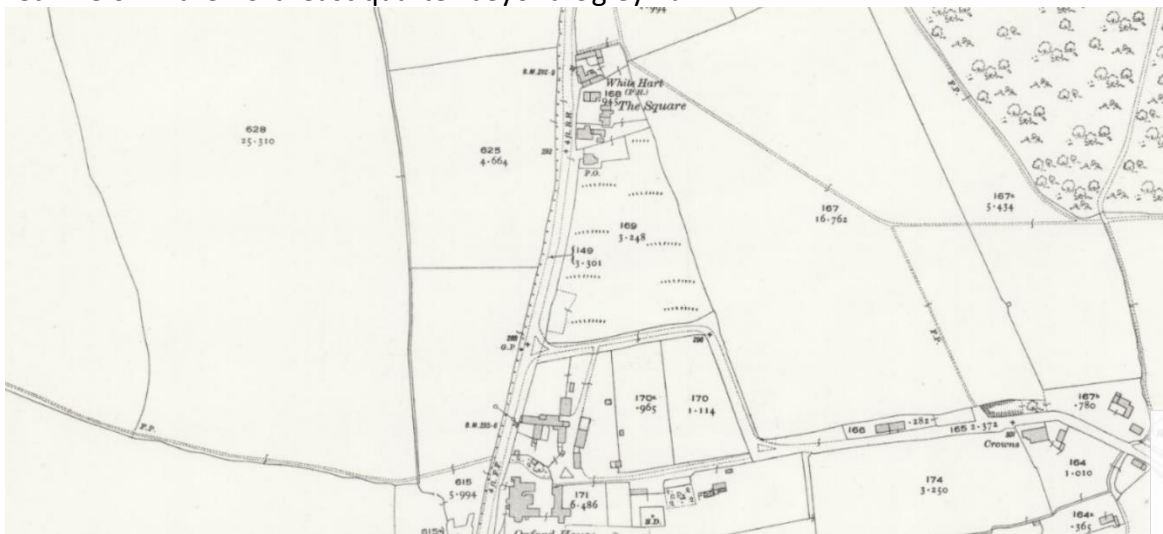
1921 the whole site appears to be 'Rough Pasture' One tentatively concludes that all the main gravel extraction took place between 1898 and 1921 or earlier? The Ordnance Survey is sometimes slow to add features like the Village Hall that was donated to the village in 1920.

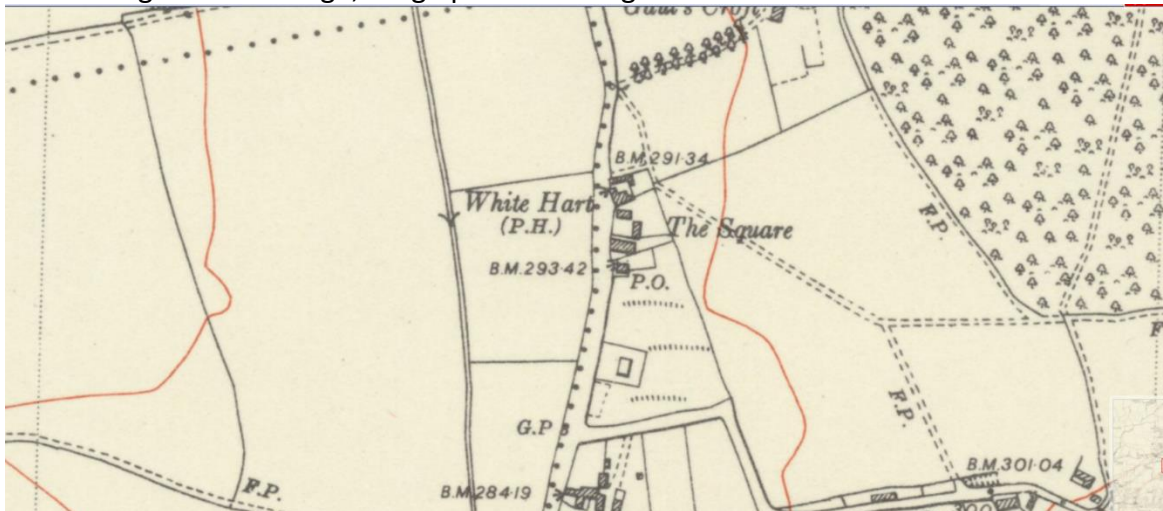
1951 Village Hall rebuilt late 1940s? after bomb damage during WW2.

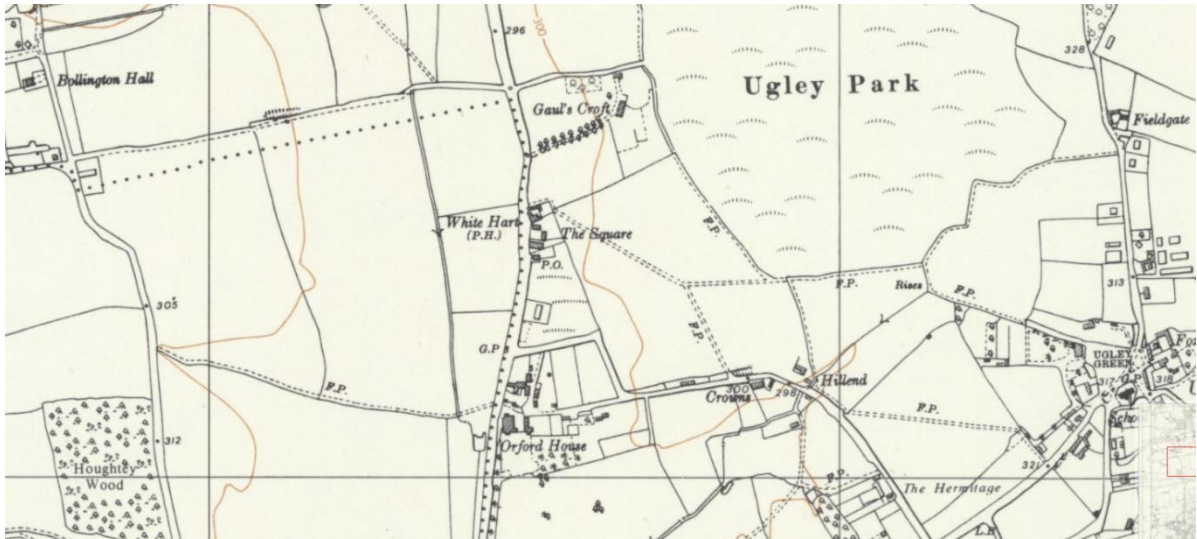
1960 Remains as rough pasture. Village Hall appears to have been extended.

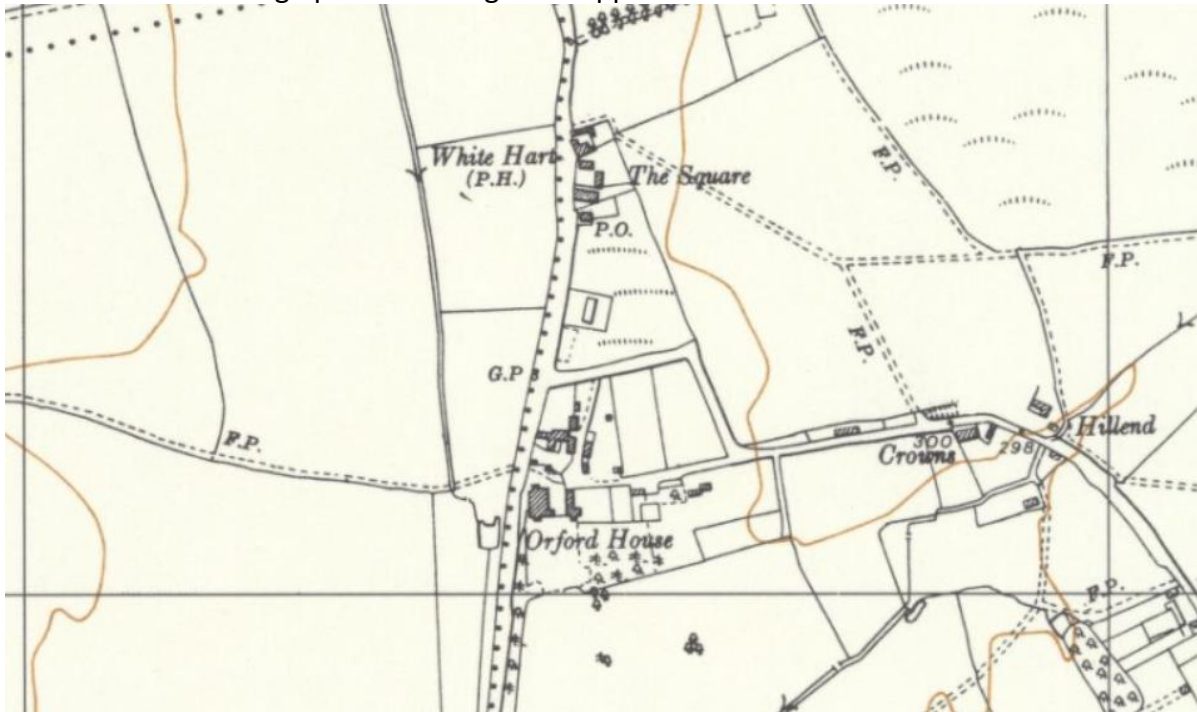
1966 No significant change from 1960

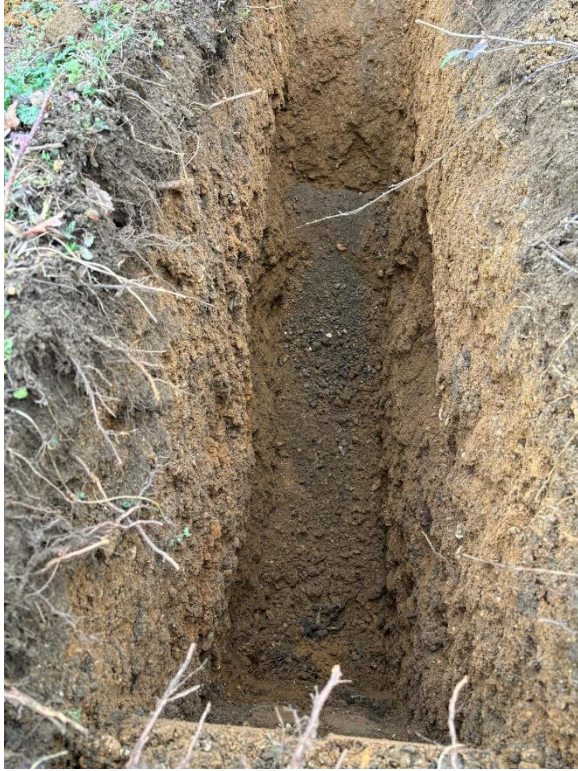
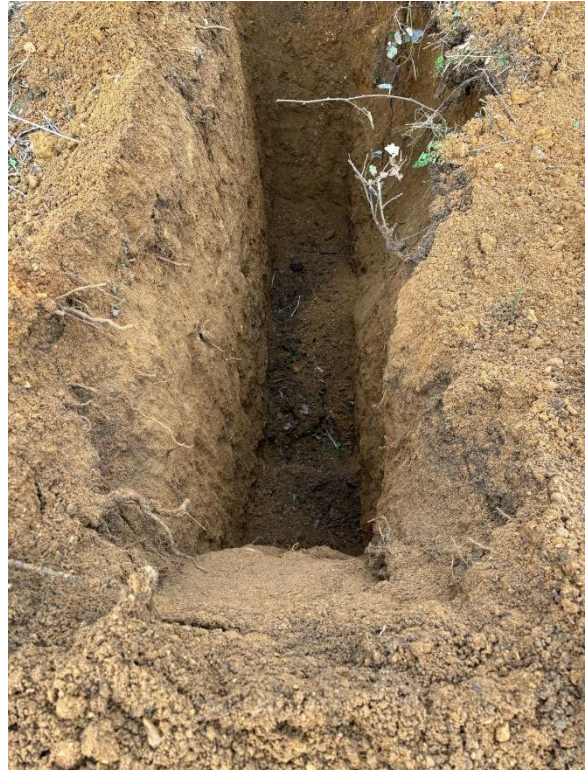
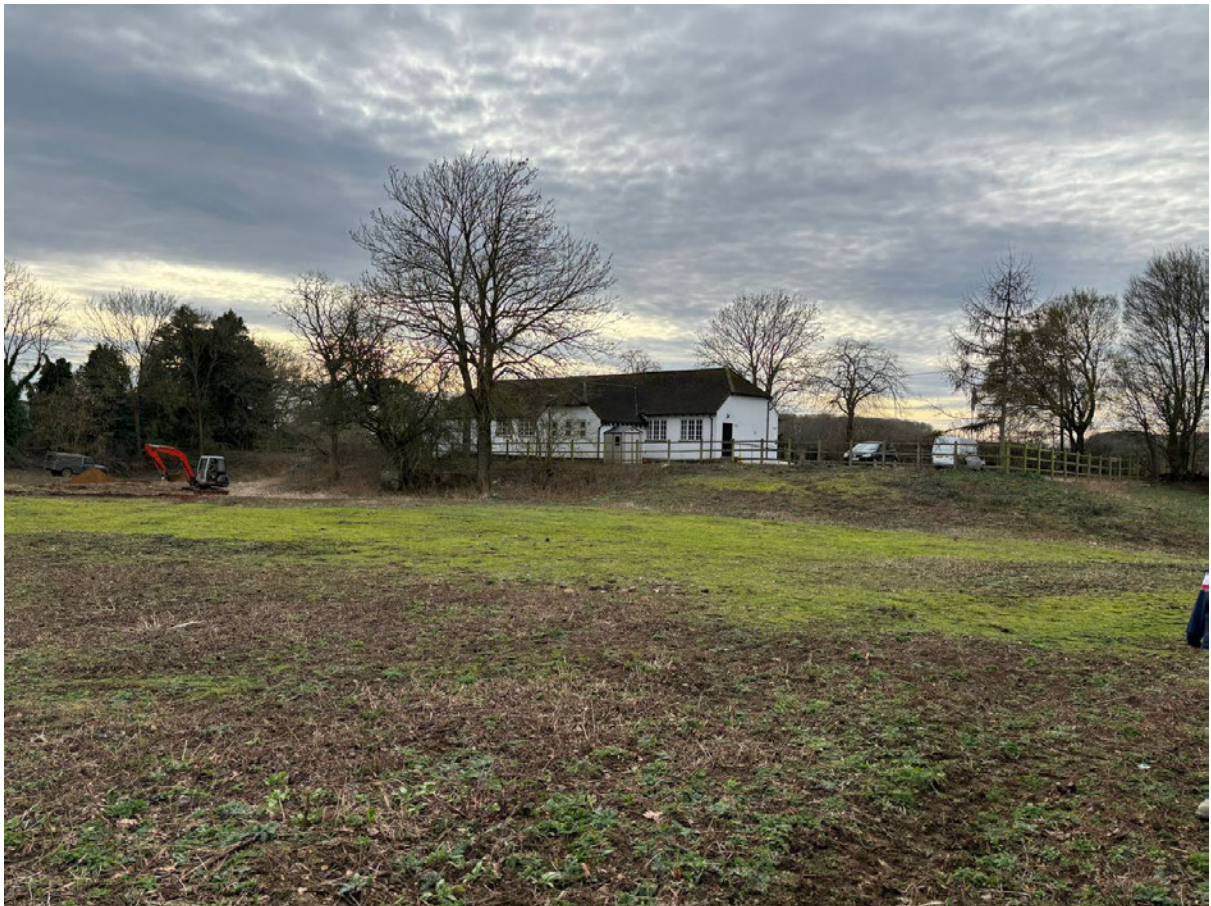
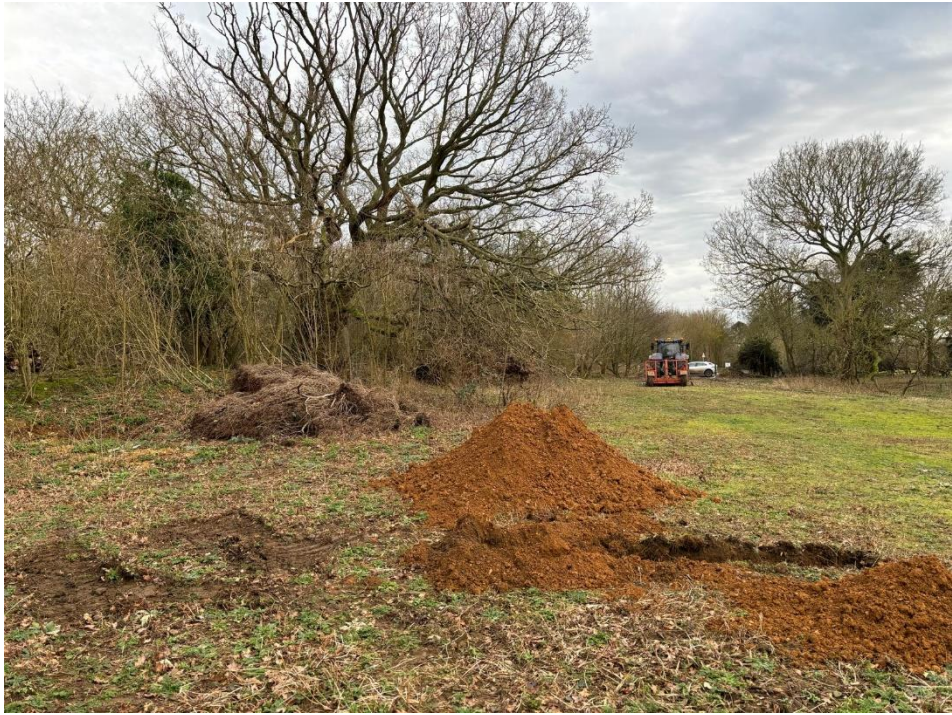
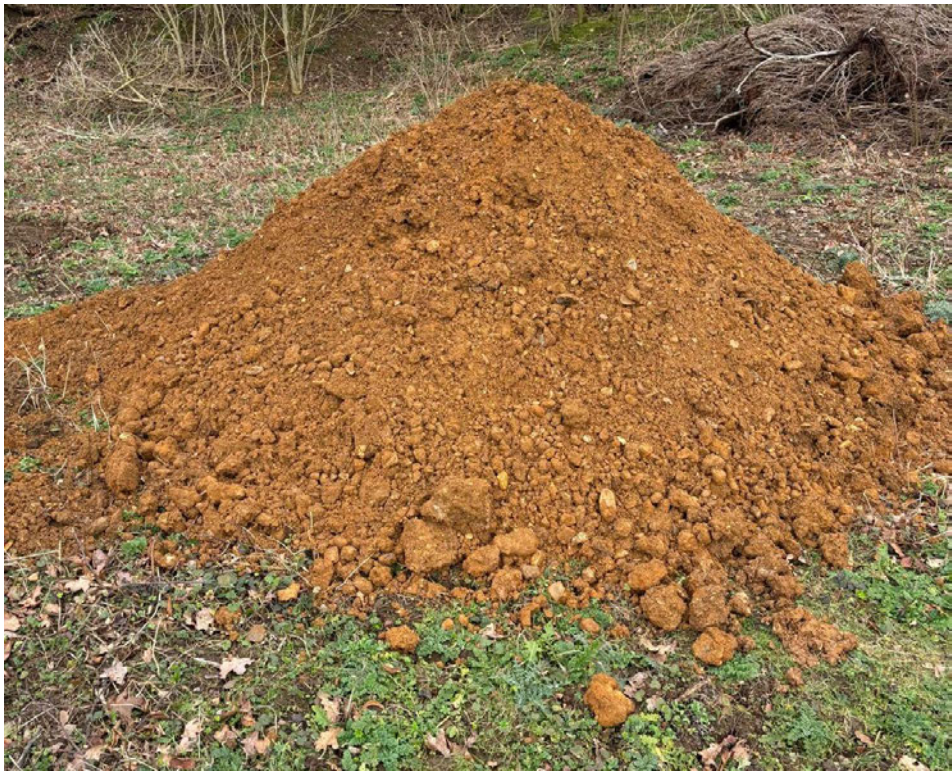
*Appendix B: Pictures of trail pits 15<sup>th</sup> Feb 2024*

In addition to the desk top study trial pits were undertaken 15<sup>th</sup> February 2024, these showed further seems of gravel but no sign of contamination. The photos of these pits is provided at appendix B. this show the soil conditions to be largely sand/ gravel.

- 5.1. The trial pits show that the ground conditions are sandy gravel and therefore are considered to be limited risk associated with the ground conditions.
