Air Quality and Dust Monitoring Monthly Report - July 2024
Birmingham City Council

A report prepared by EWCs and MWCCs on behalf of HS2 Ltd.

- 1.1.1 This Summary Report is published in fulfilment of commitments detailed in the High Speed Rail (London-West Midlands) Environmental Minimum Requirements, Annex 1: Code of Construction Practice, for the nominated undertaker to present the results of dust monitoring undertaken within Birmingham City Council (BCC) during July 2024.

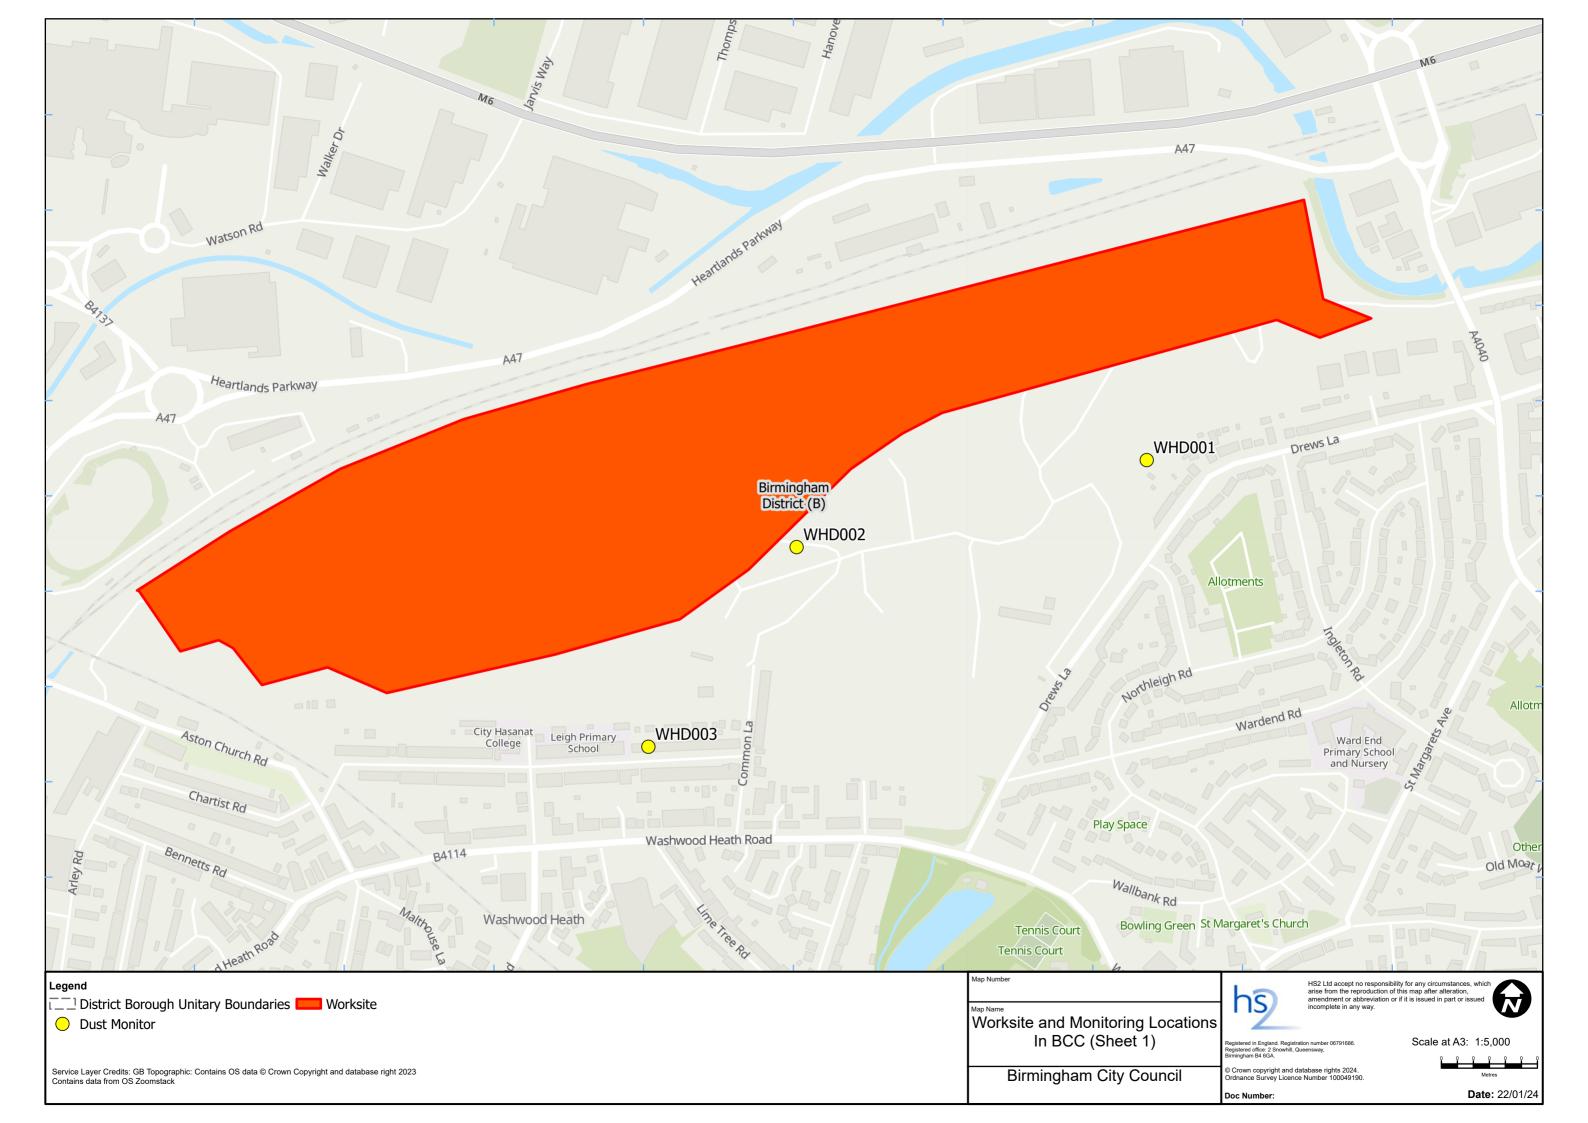
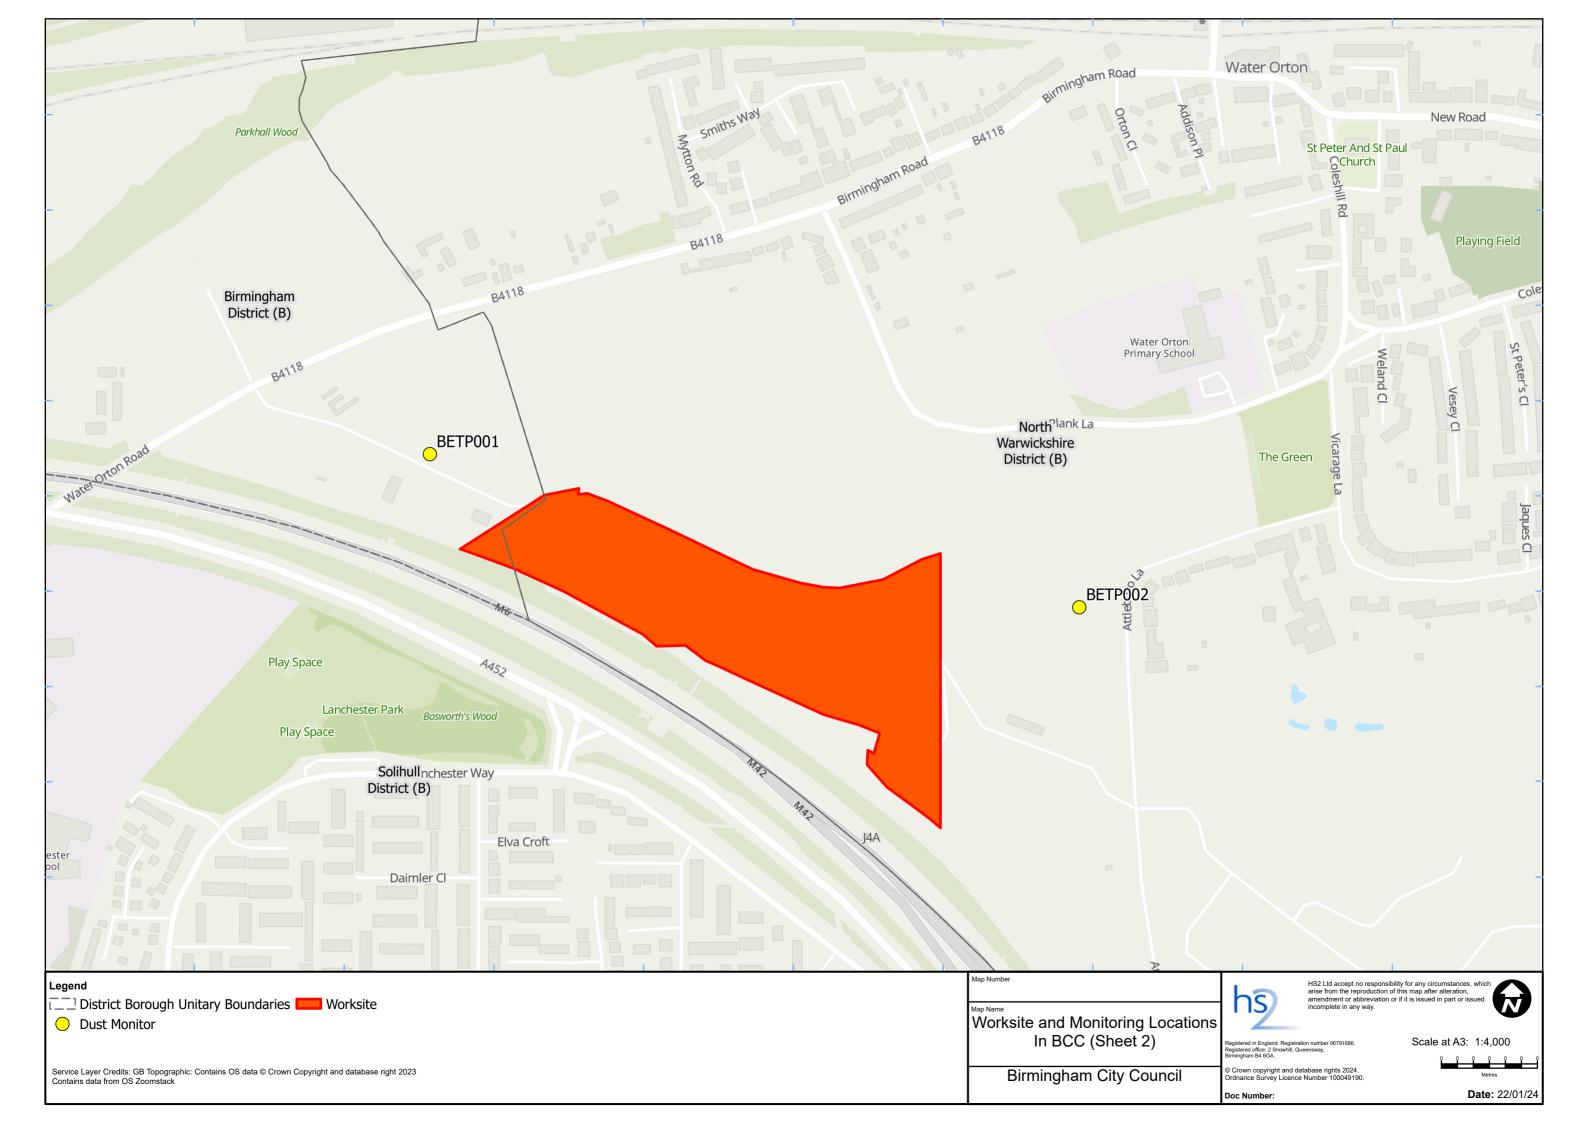
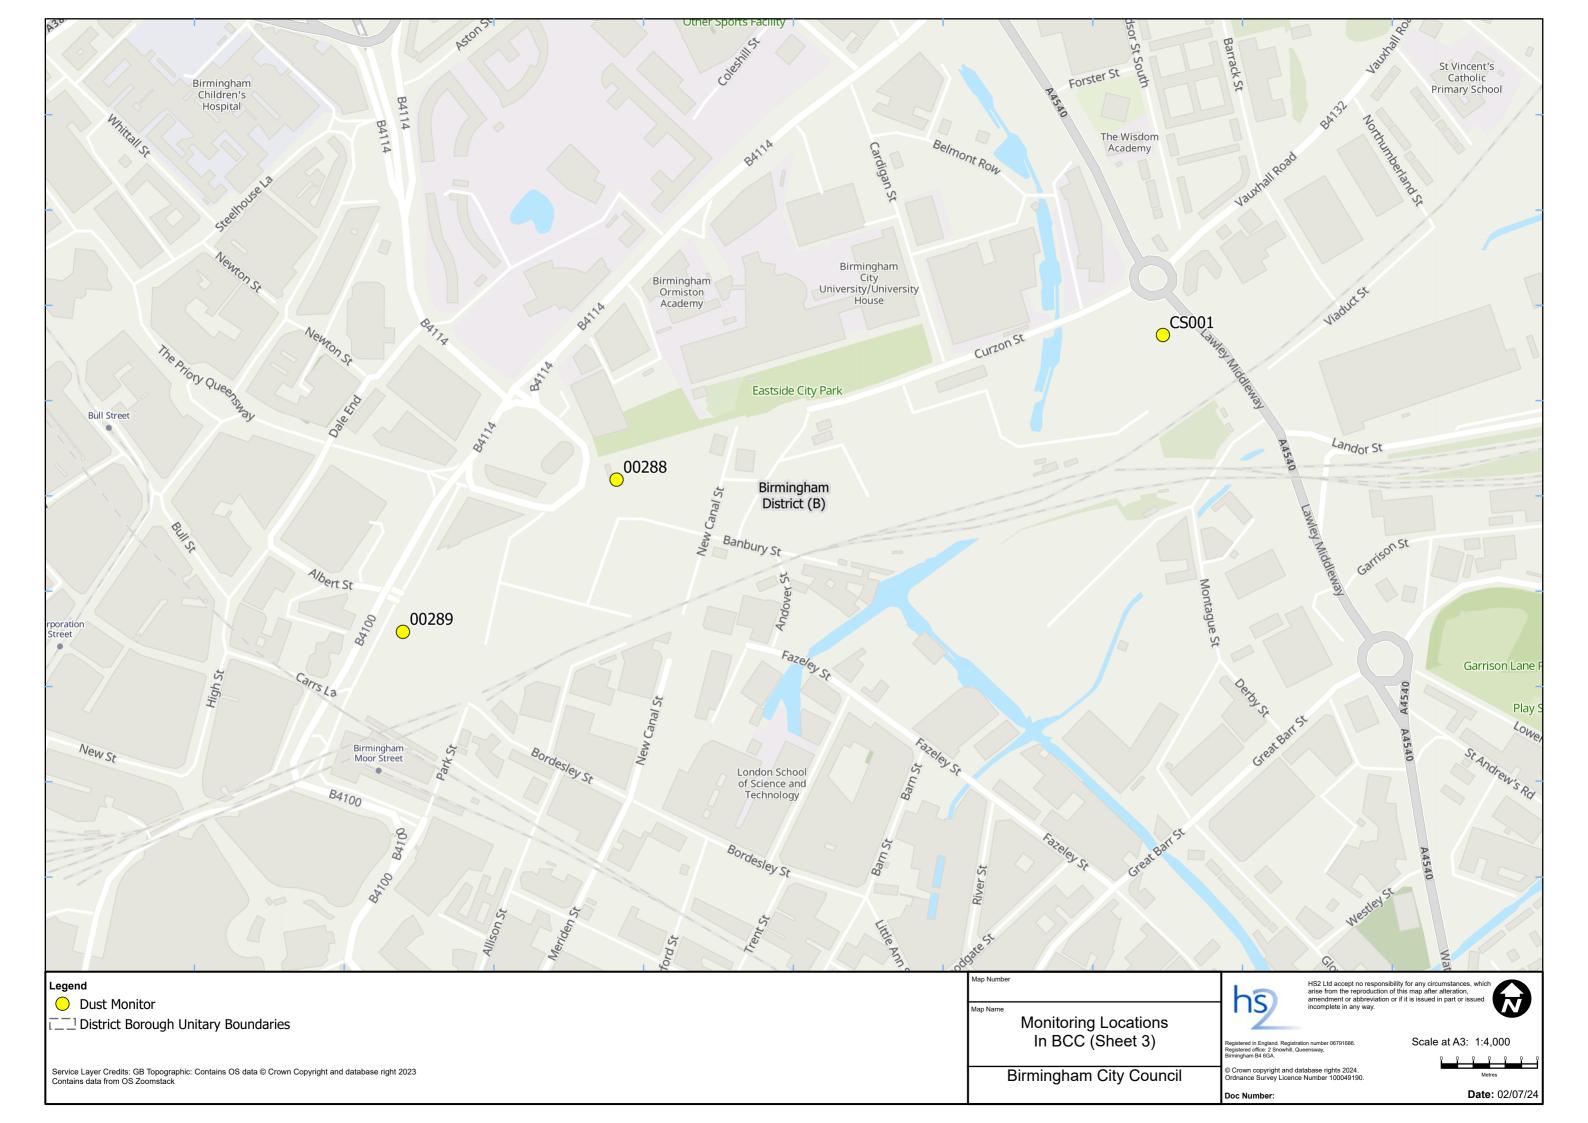
Figures 1 - 3: Worksites and Monitoring Locations within BCC

- 1.1.2 Figure 1 to Figure 3 in Appendix A present the current worksites together with the dust monitoring locations.
- 1.1.3 This summary should be read in conjunction with the overview monitoring report monthly available from <a href="www.gov.uk/government/collections/monitoring-the-environmental-effects-of-hs2">www.gov.uk/government/collections/monitoring-the-environmental-effects-of-hs2</a>, which highlights: the applicable standards and guidance, as well as the air quality and dust monitoring methodologies to be implemented by nominated undertakers throughout construction.

- 1.1.4 The current worksites, as presented in Appendix A, Figure 1 to Figure 3, include:

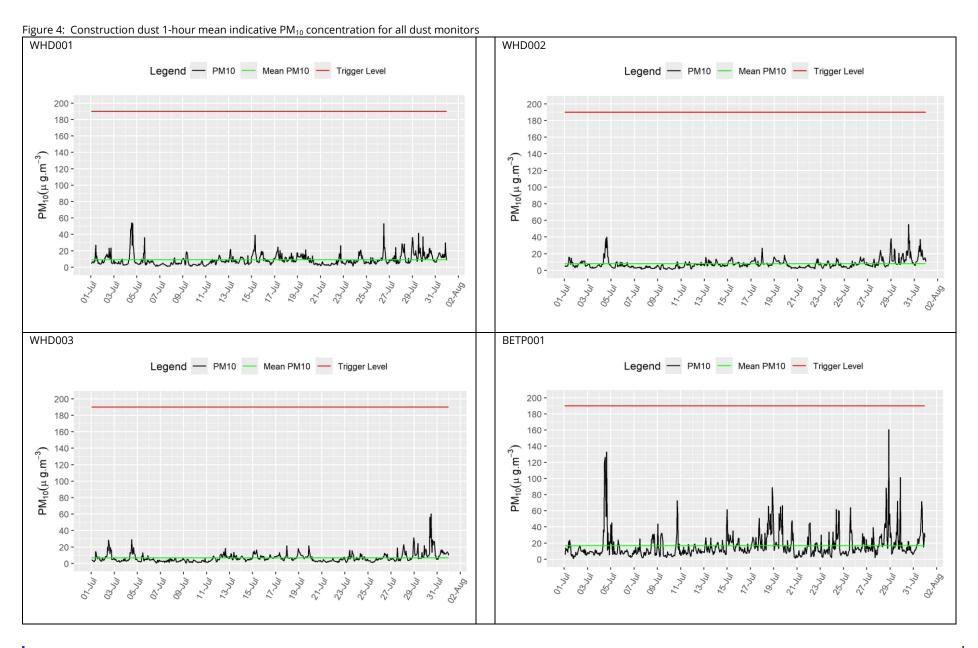
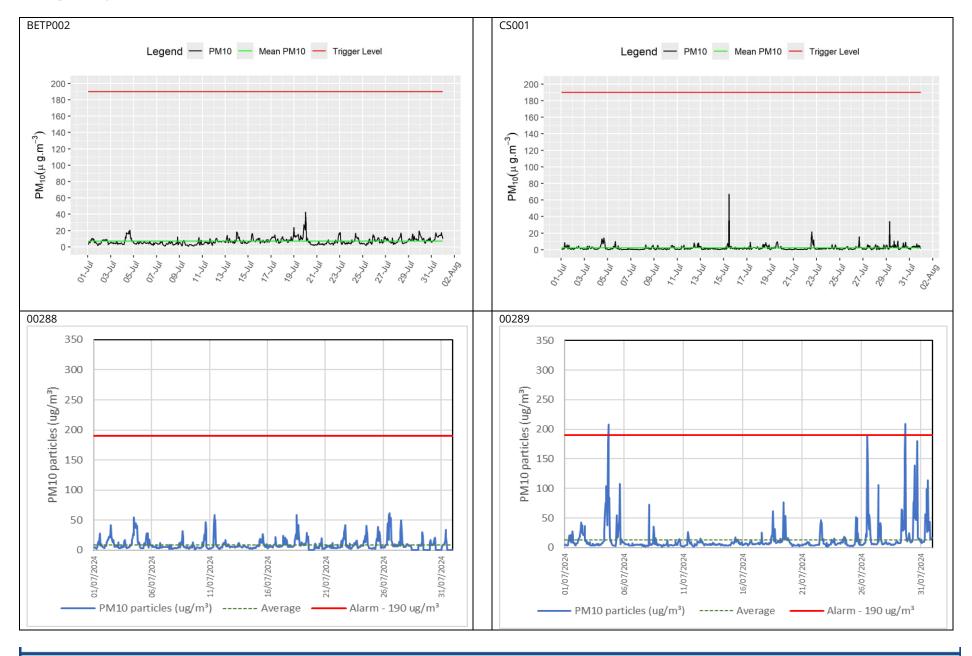
- 1.1.6 Dust monitoring locations and results are presented in Appendix B, Table 2, together with line charts of monthly data from each dust monitor, presented in Figure 4. All continuous dust monitoring is undertaken using indicative monitors. Despite being Environment Agency (MCERTS) certified, indicative monitors carry a higher level of uncertainty than reference monitors, and therefore cannot be strictly compared with Air Quality Standards for human health and the environment. The purpose of the monitoring undertaken is to ensure the effectiveness of the on-site mitigation.

- 1.1.7 The trigger level for PM<sub>10</sub> concentrations of 190 μg/m³, over a 1-hour period, in accordance with the updated guidance document 'Guidance on Monitoring in the Vicinity of Demolition and Construction Sites (October 2018)' has been applied.

Monitoring Site ID	Period of trigger alert & Concentration recorded	Investigation	Outcomes / Resolution / Remedial measures implemented
00289	04/07/2024: 16:01 – 17:00; 207.9 μg/m³ 29/07/2024: 16:01 – 17:00; 209.6 μg/m³	At the time of the trigger no significant dust visitable on site, and dust management controls were in operations (Dust cannons and bowsers on haul roads).	Controls already in place to manage dust on site during warm / dry weather.
