## Construction Noise and Vibration Monthly Report – July 2024

London Borough of Camden

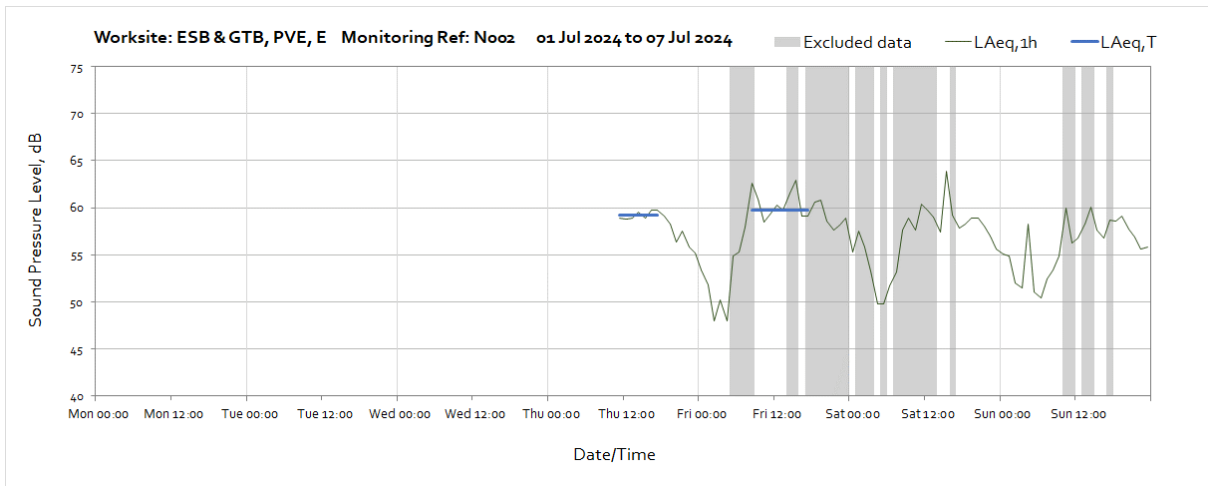
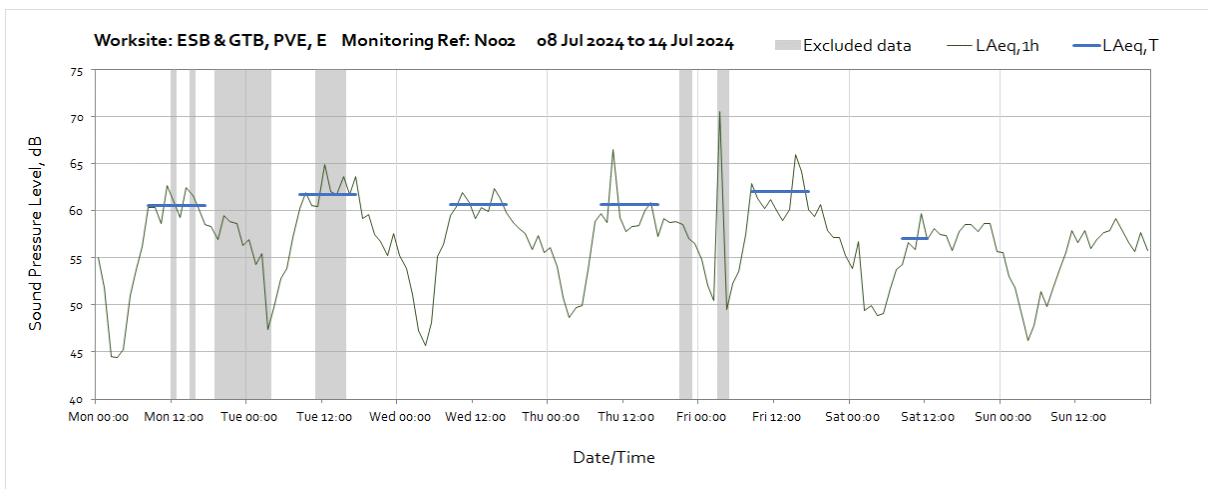
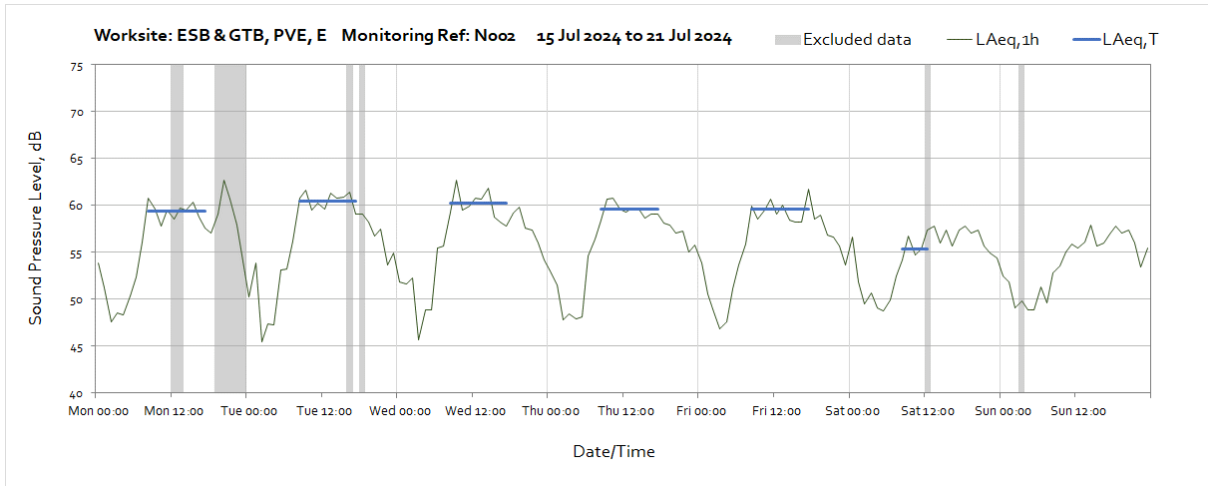
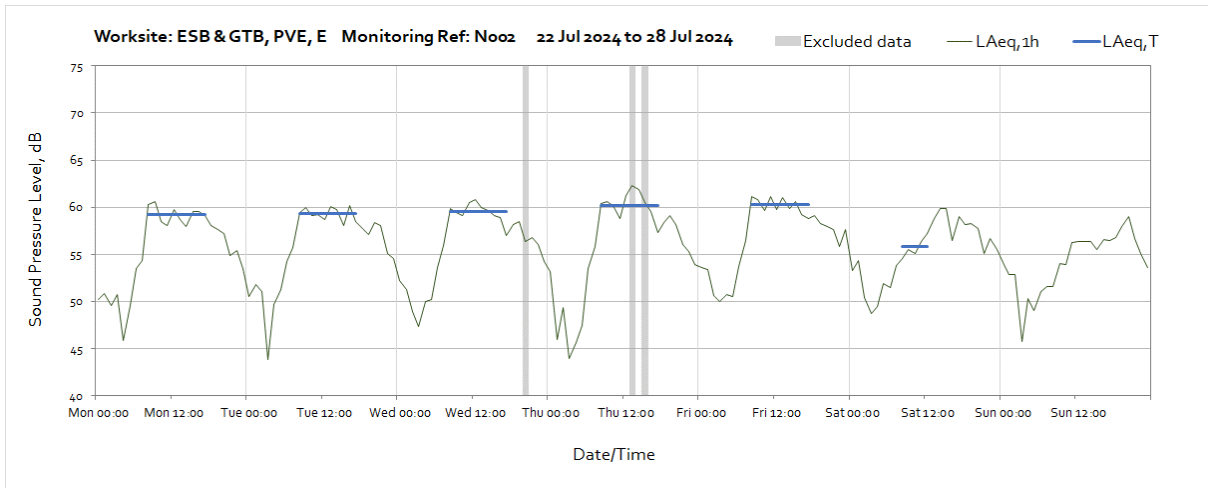
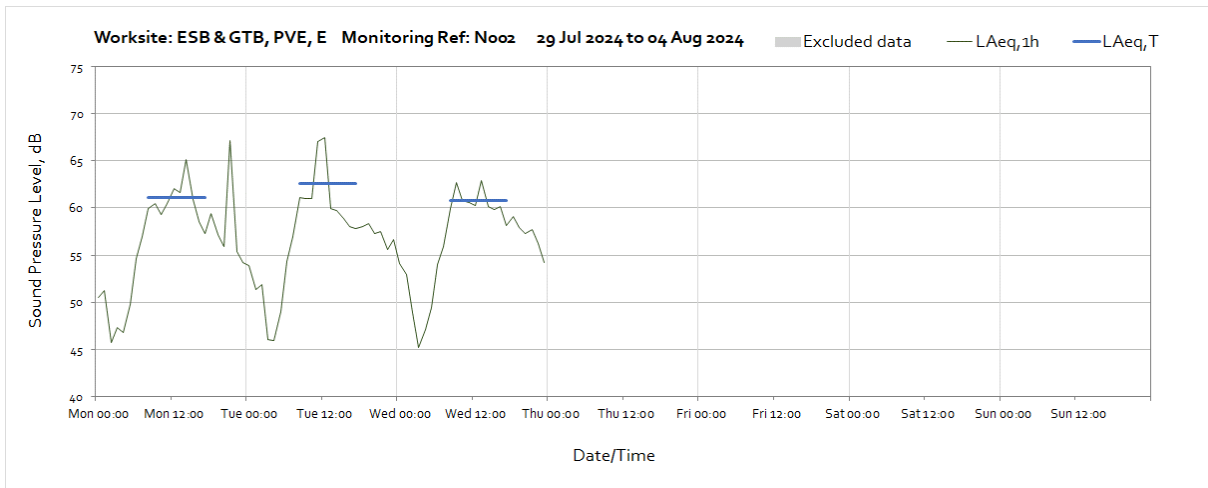
**Worksite: ESB & GTB, PVE, E - Monitoring Ref: N002**

Note: Missing data between the start of the month and 10:00 on Thursday 04<sup>th</sup> July was due to a fault at the monitoring station.

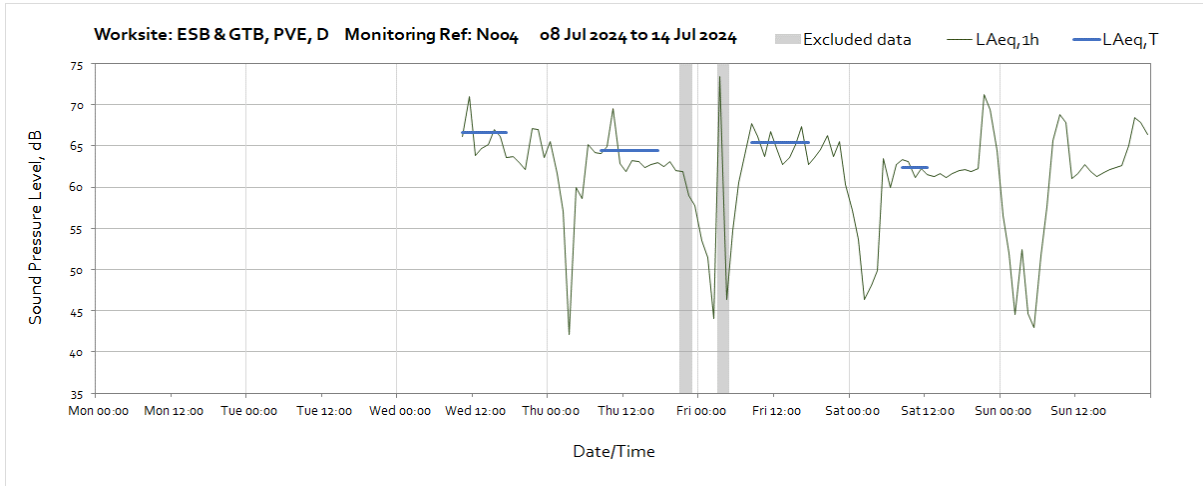
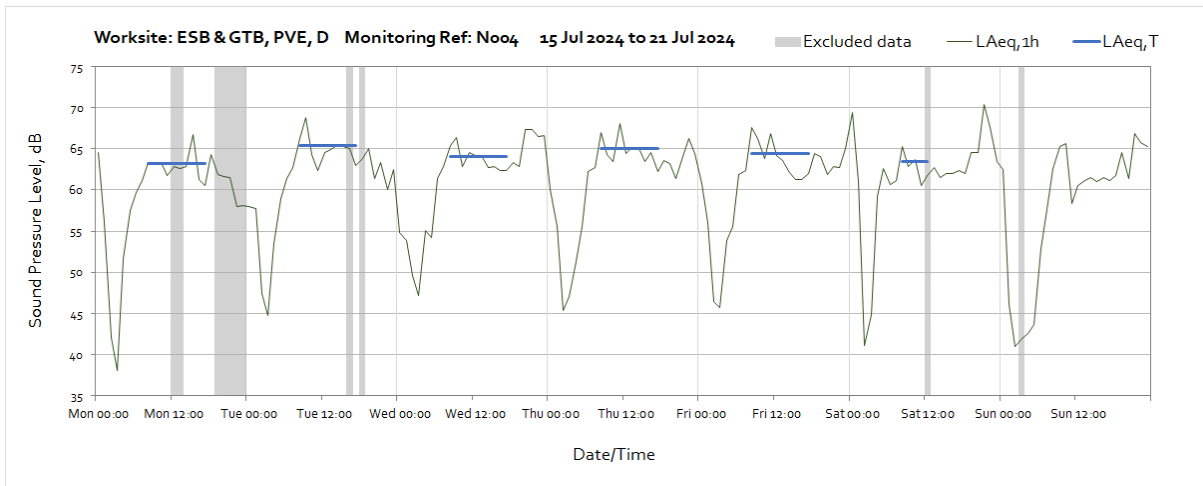
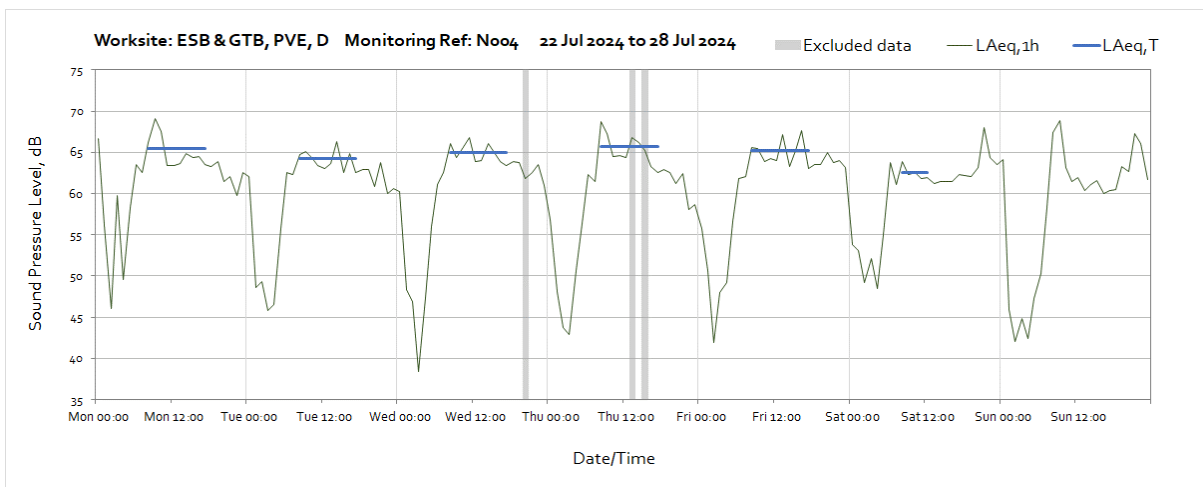
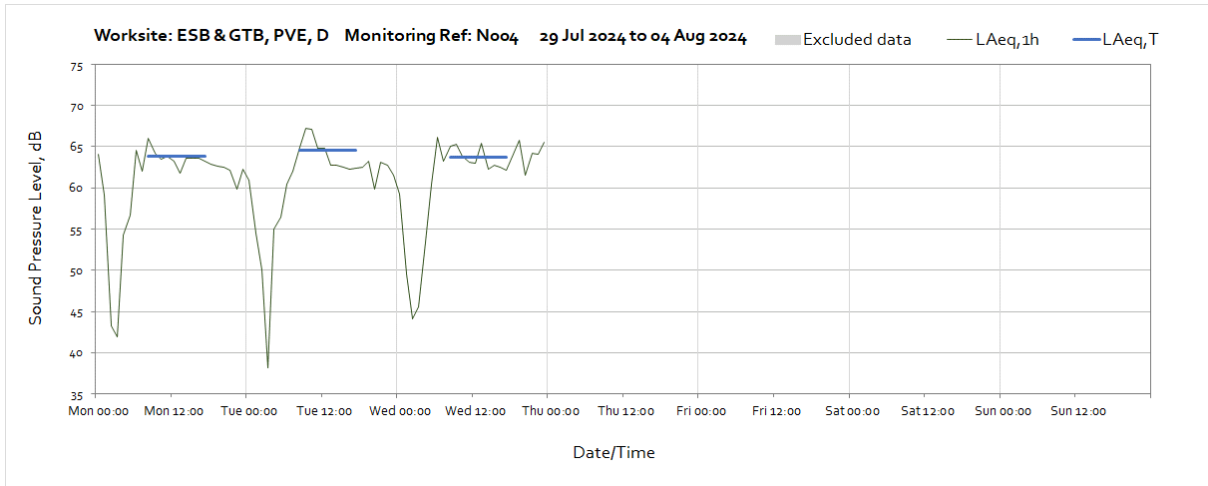
## Worksite: ESB & GTB, PVE, D – Monitoring Ref: N004

Note: Missing data between the start of the month and 09:00 on Wednesday 10<sup>th</sup> July was due to loss of power at the monitoring station.

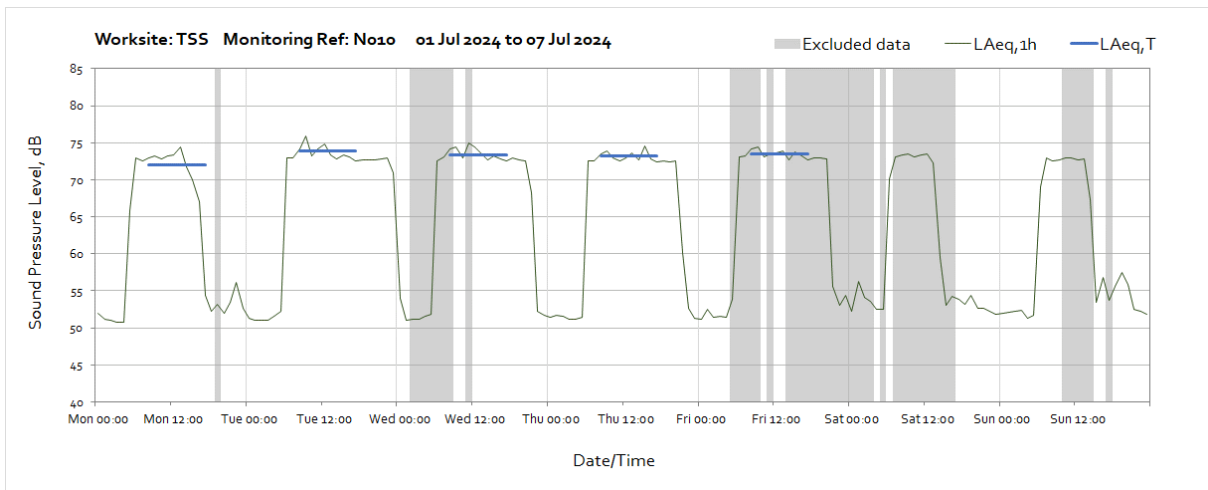
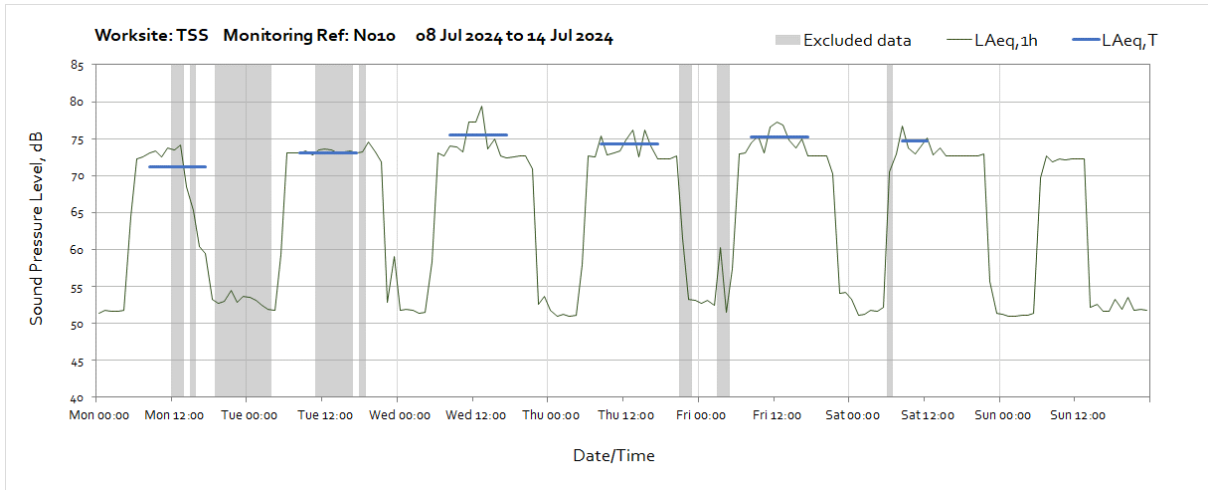
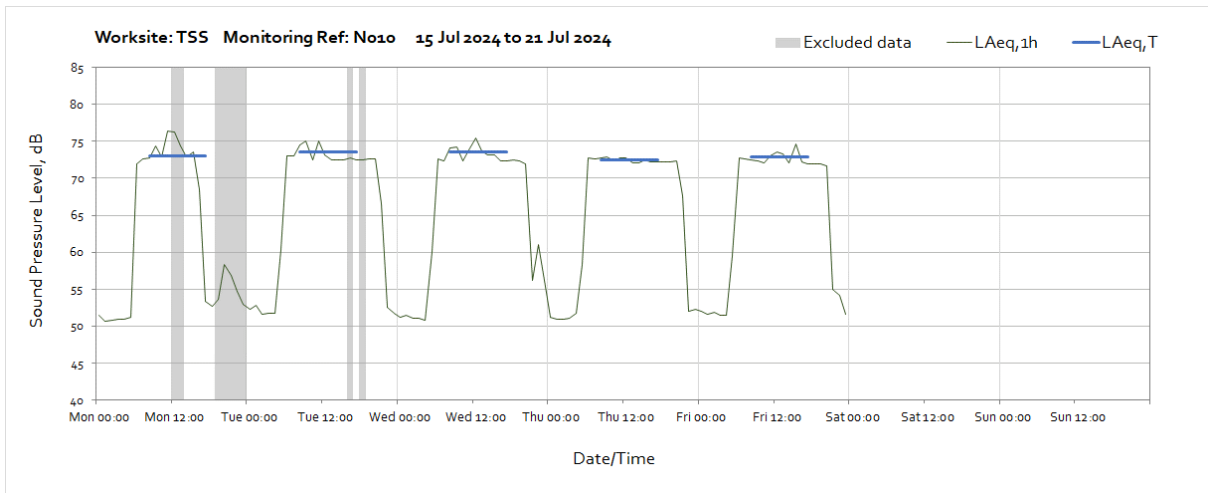
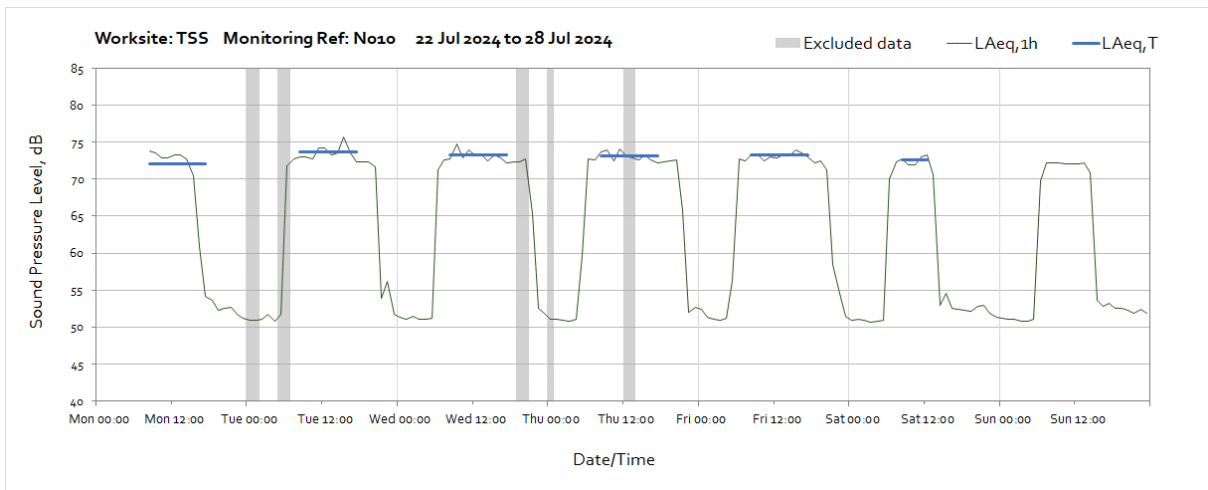
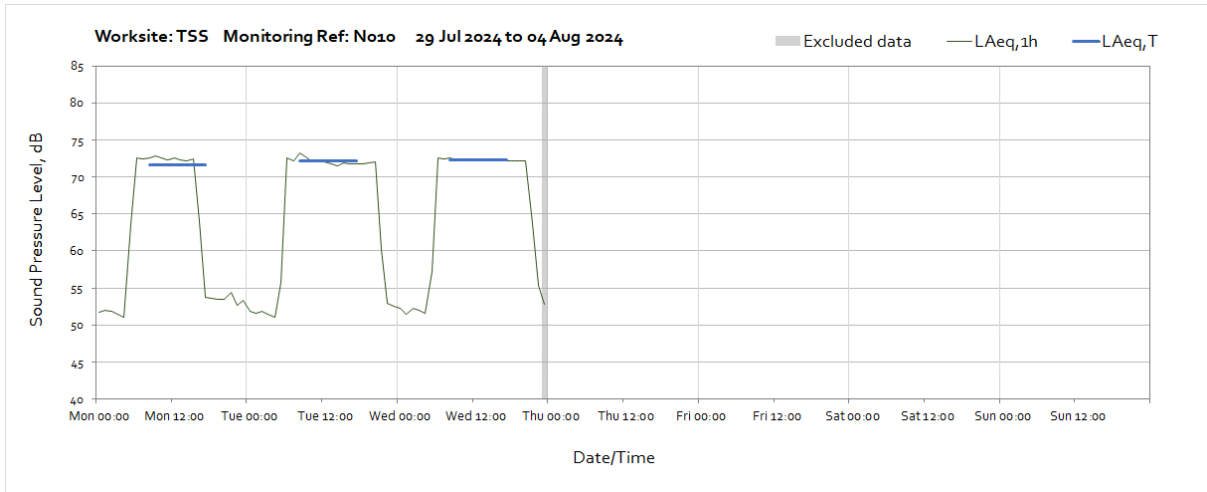
**Worksite: TSS - Monitoring Ref: N010**

Note: Missing data between 00:00 on Saturday 20<sup>th</sup> July and 07:00 on Monday 22<sup>nd</sup> July was due to a memory card error at the monitoring station.

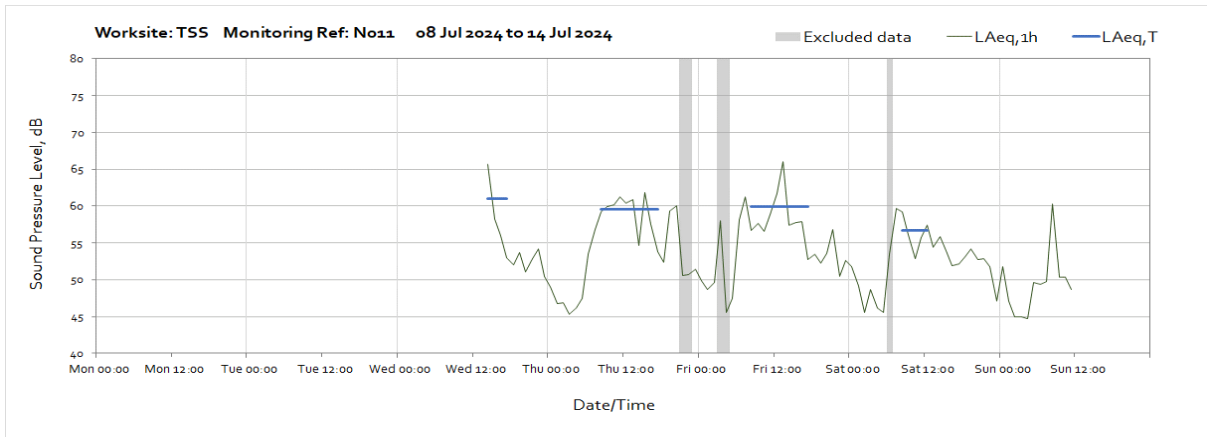
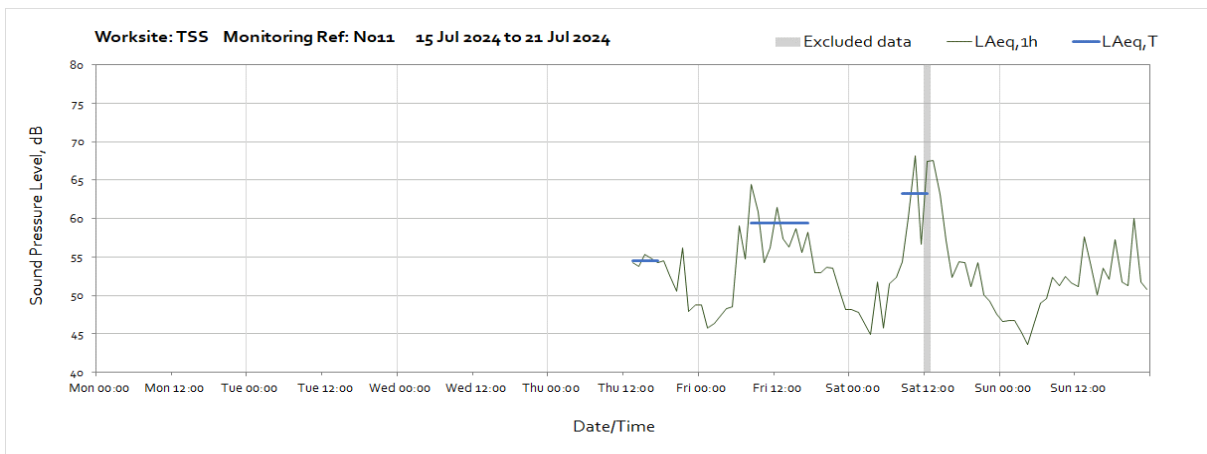
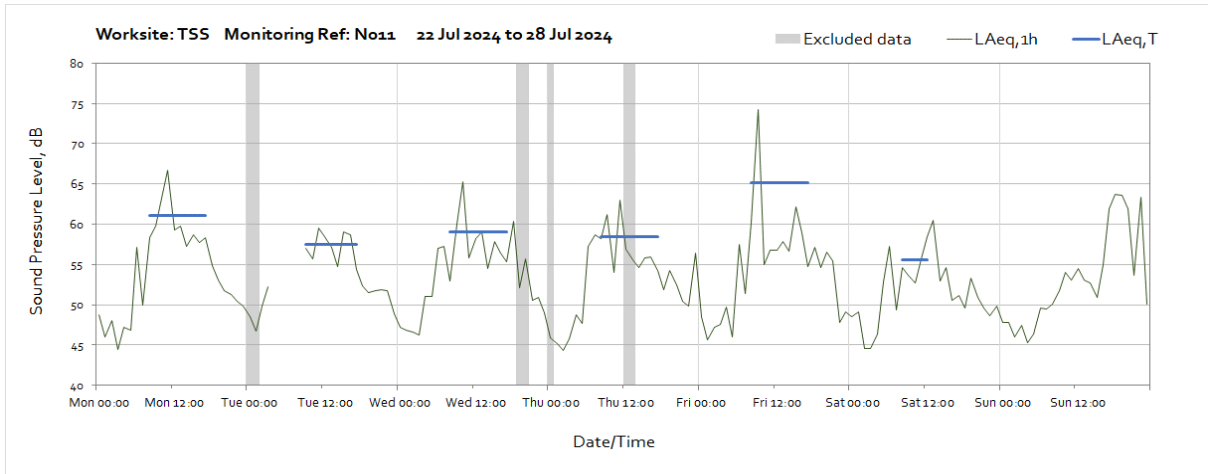
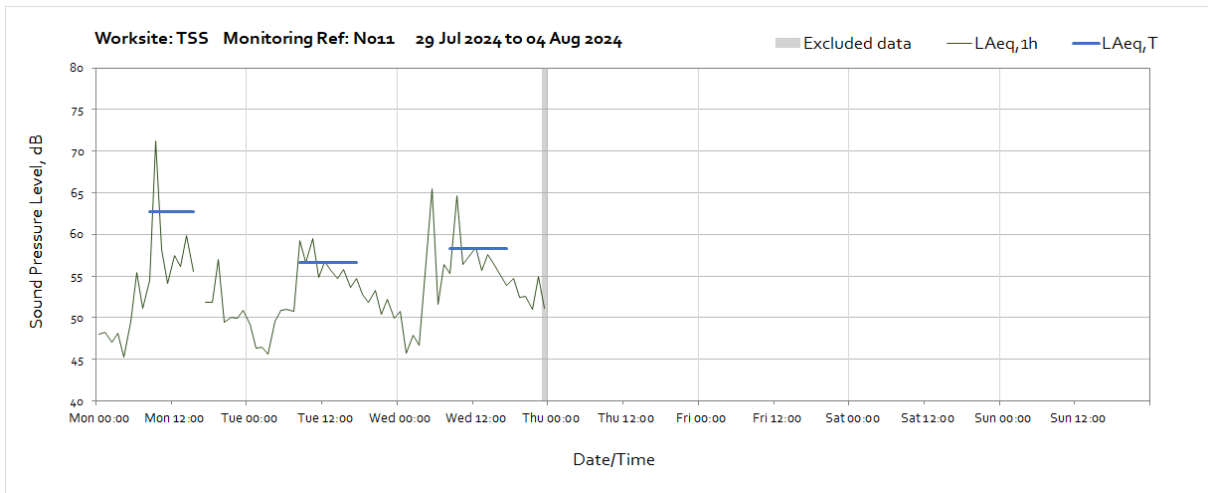
### Worksite: TSS – Monitoring Ref: N011

Note: Missing data between the start of the month and 13:00 on Wednesday 10<sup>th</sup> July was due to a system error at the monitoring station.

Note: Missing data between 12:00 on Sunday 14<sup>th</sup> July and 12:00 on Thursday 18<sup>th</sup> July was due to a loss of power at the monitoring station.

Note: Missing data between 04:00 and 08:00 on Tuesday 23<sup>rd</sup> of July was due to a monitoring station system reboot.

Note: Missing data between 15:00 and 17:00 on Monday 29<sup>th</sup> of July was due to a monitoring station system reboot.

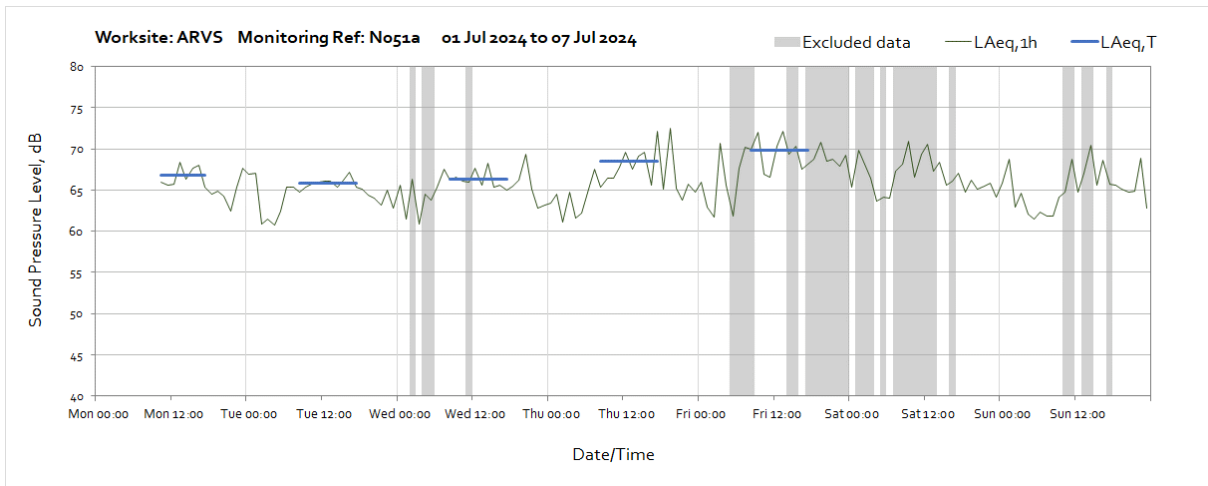
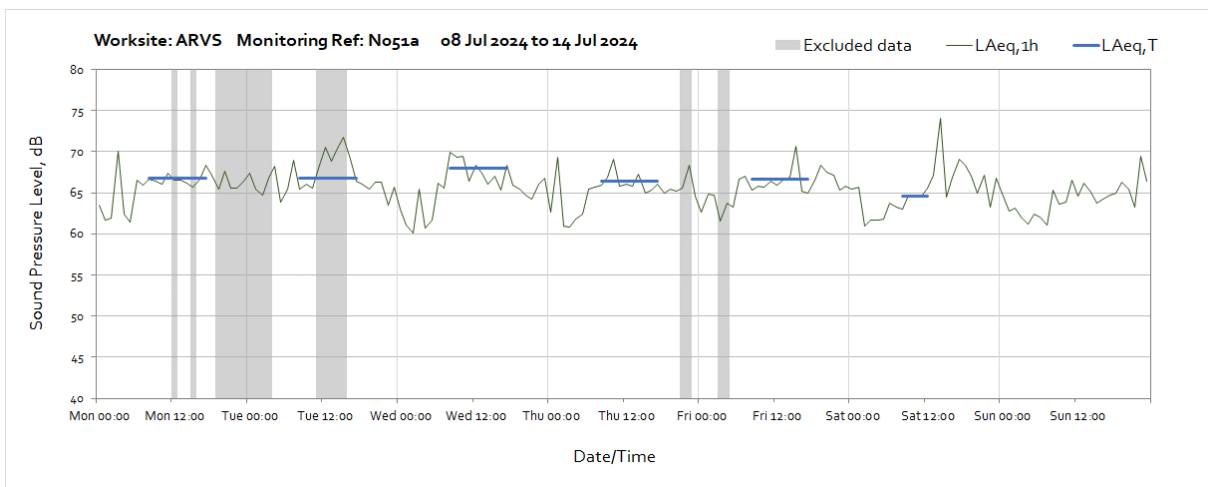
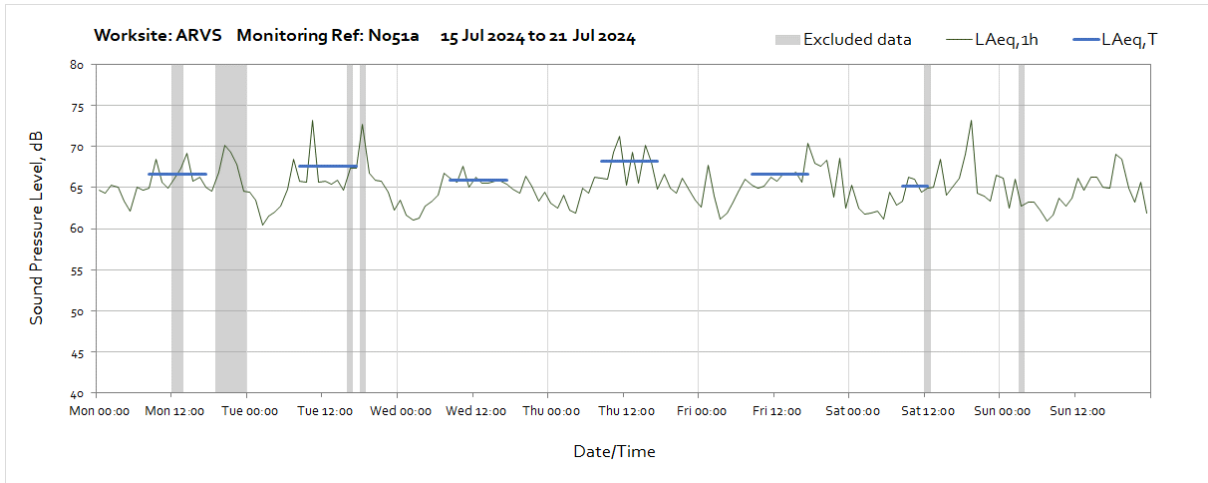
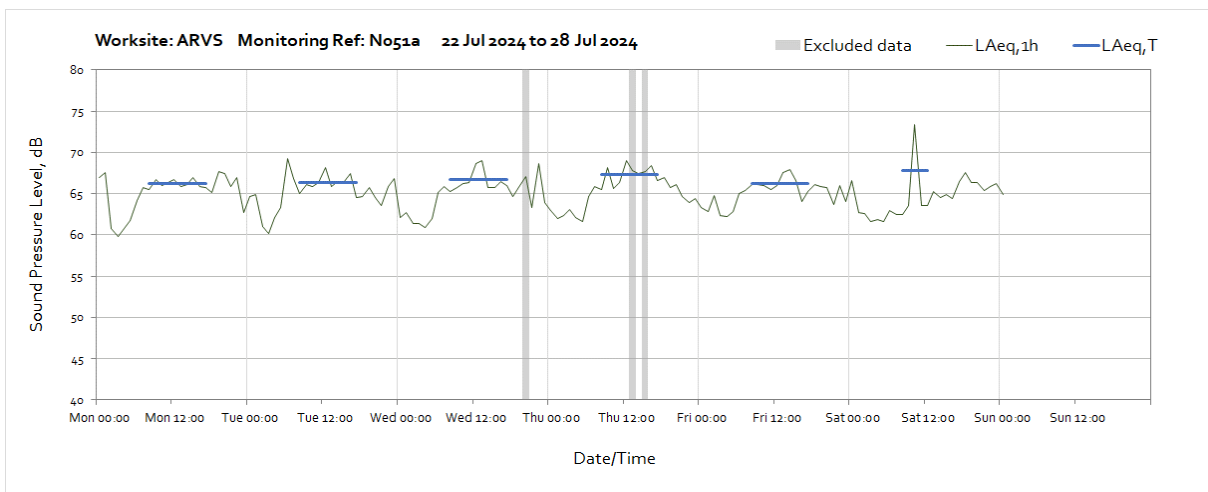
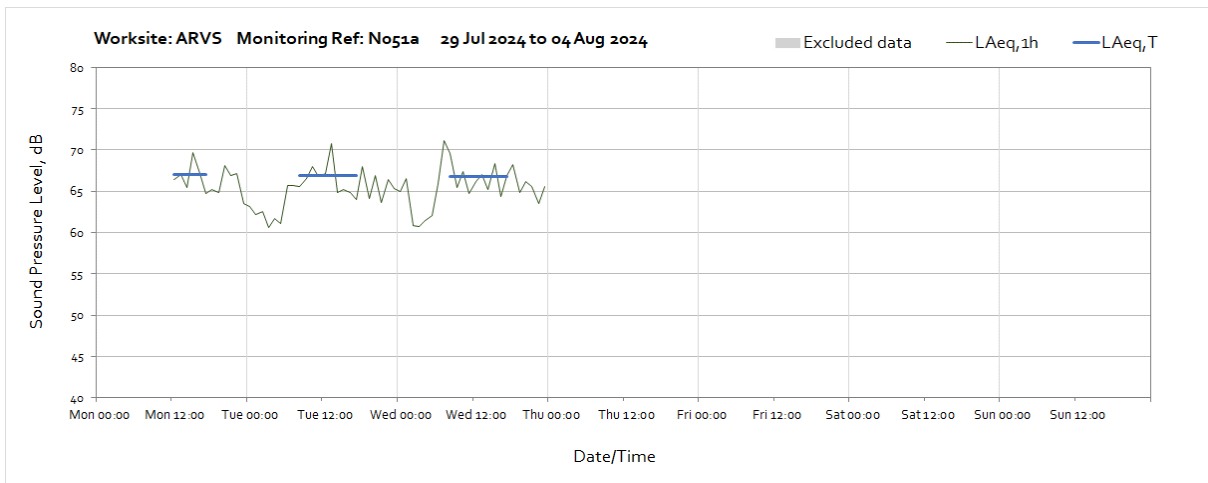
### Adelaide Road Ventilation Shaft (ARVS) – Monitoring Ref: N051a

Note: Missing data between the start of the month and 09:00 on Monday 01<sup>st</sup> July was due to a fault at the monitoring station.

Note: Missing data between 01:00 on Sunday 28<sup>th</sup> July and 11:00 on Monday 29<sup>th</sup> July was due to a monitoring station automatic restart.

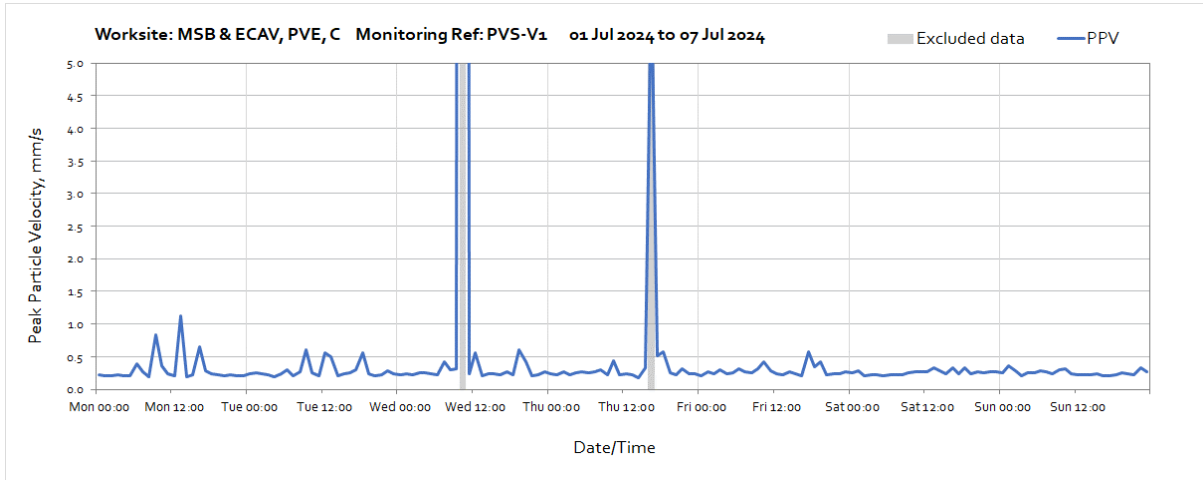
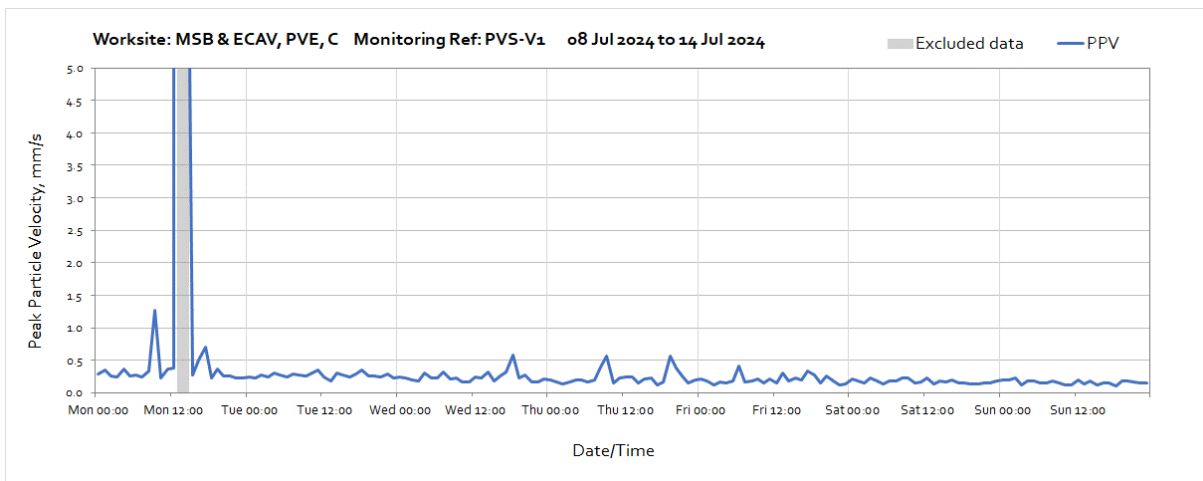
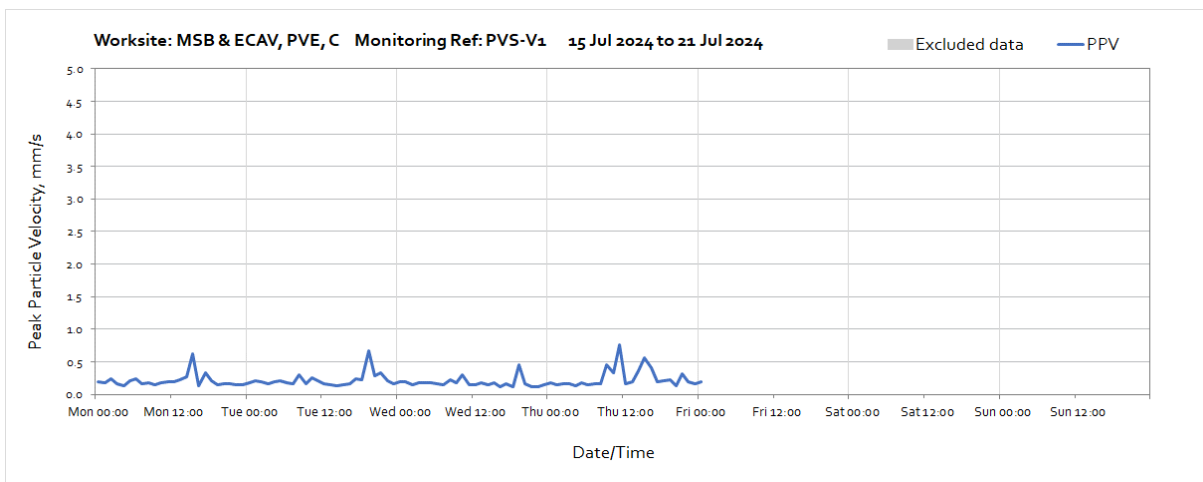
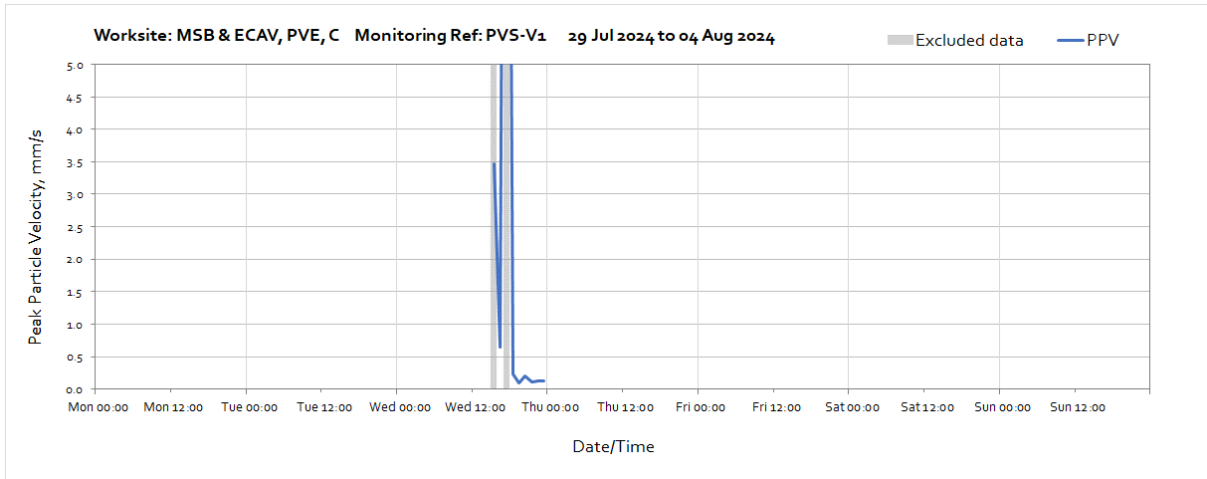
## Worksite: MSB & ECAV, PVE, C - Monitoring Ref: PVS-V1

Note: Missing data between 01:00 on Friday 19<sup>th</sup> July and 14:00 on Wednesday 31<sup>st</sup> July was due to a fault at the monitoring station.
