Construction Noise and Vibration Monthly Report – August 2024

Buckinghamshire

This Noise and Vibration Monitoring Report fulfils HS2 Limited's commitment detailed in the Environmental Minimum Requirements (EMRs), Annex 1, Code of Construction Practice, to present the results of noise monitoring carried out within Buckinghamshire (BS) during the month of August 2024.

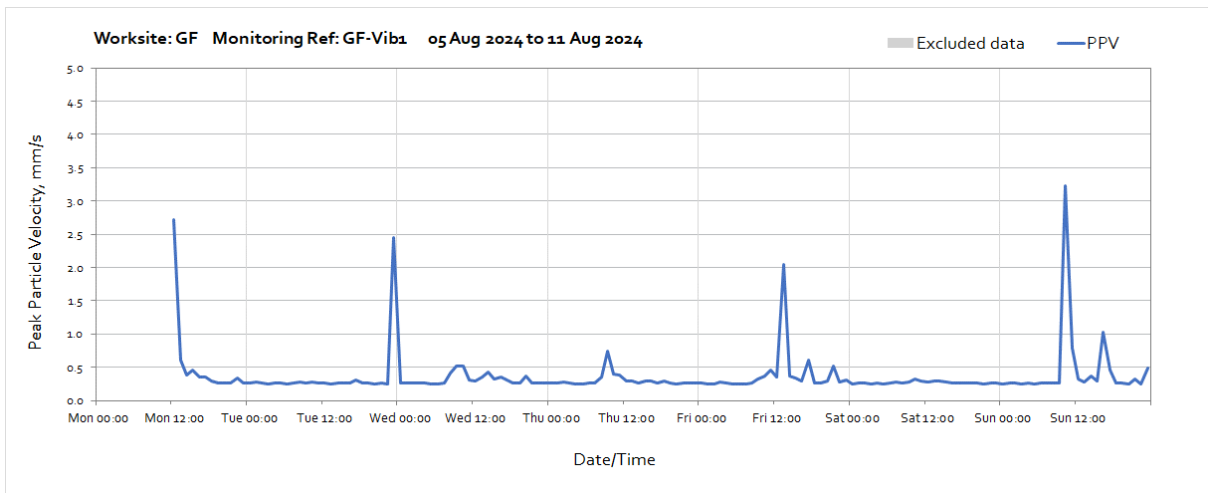
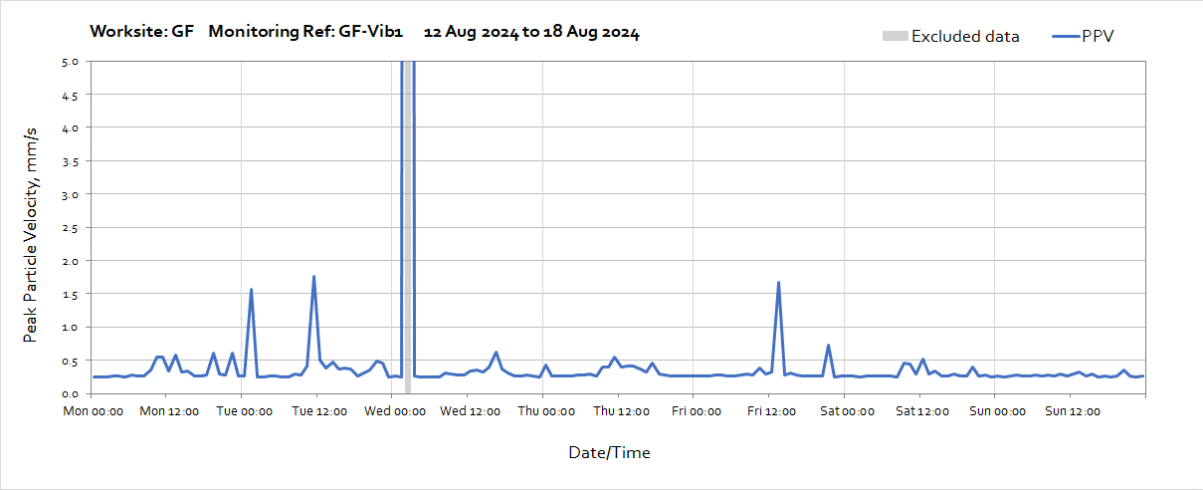
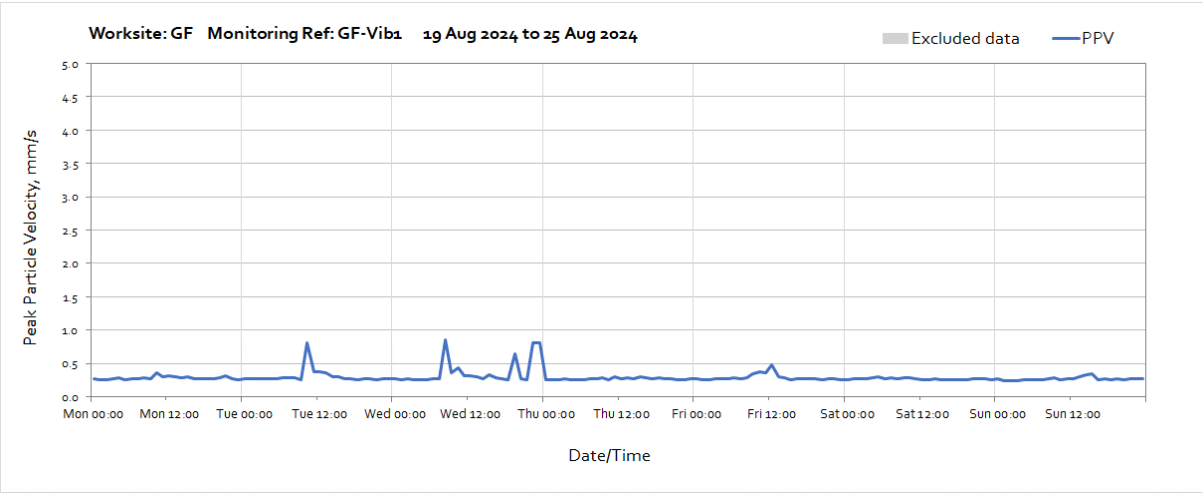
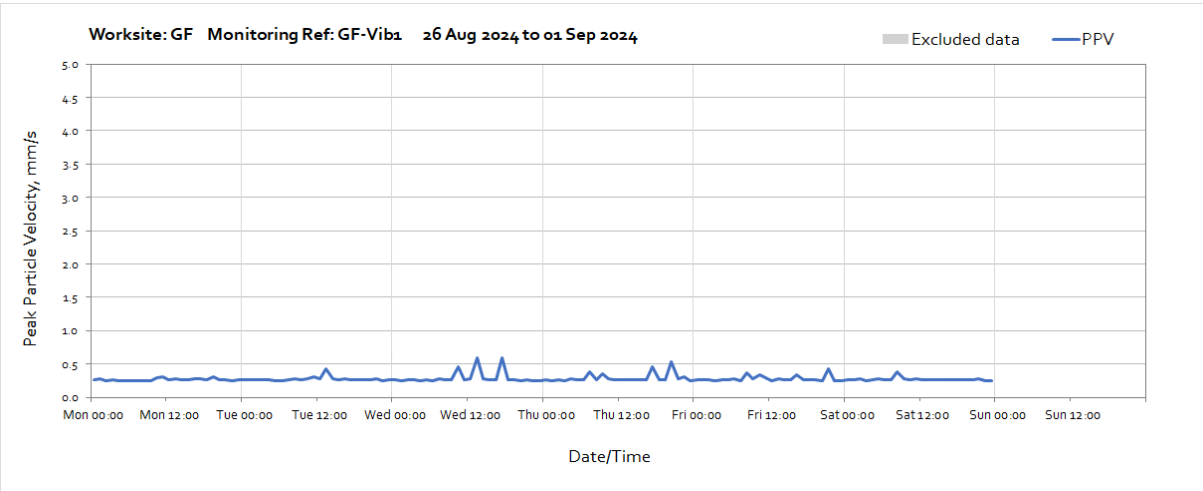
Worksite: GF – Monitoring Ref: GF-Vib1

Note: Monitor was re-installed after repair 12:00 on Monday 5th August.
