Construction Noise and Vibration Monthly Report – August 2024

London Borough of Camden

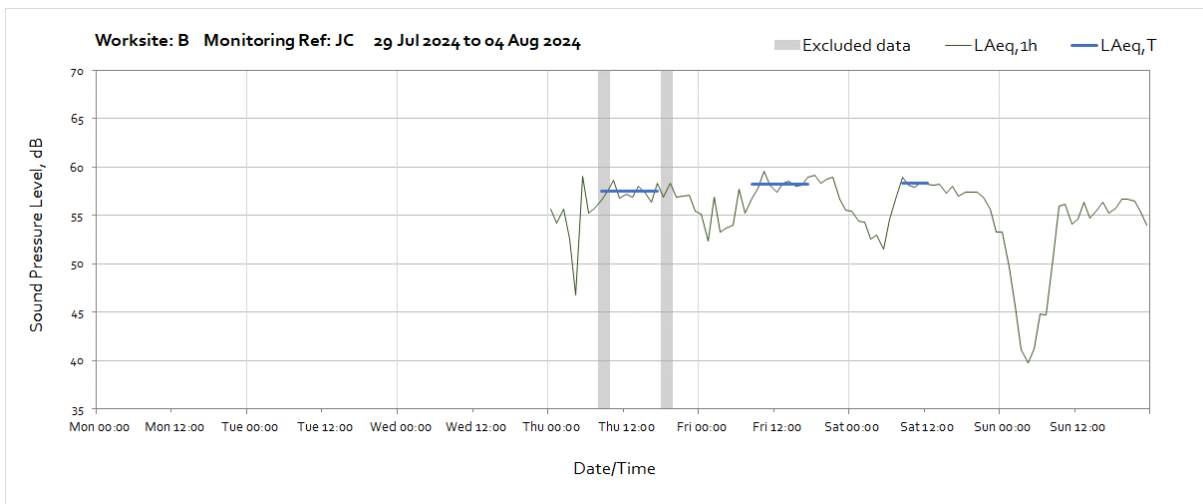
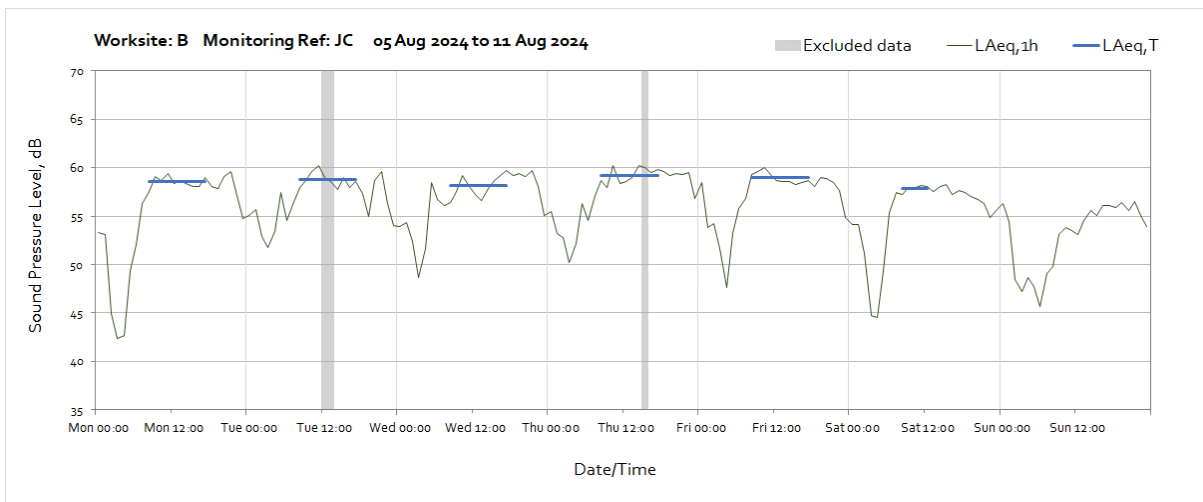
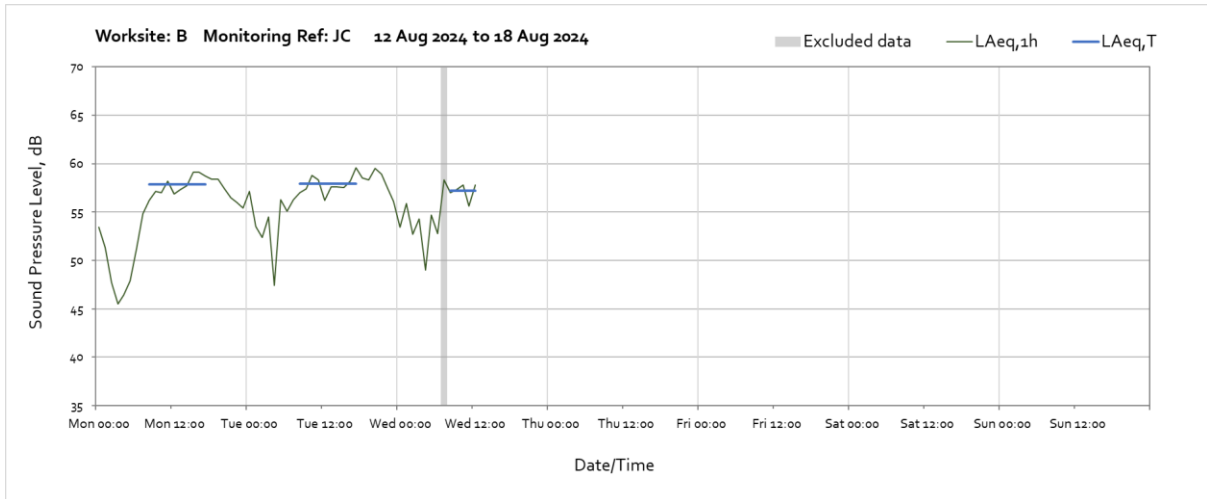
Worksite: B – Monitoring Ref: JC

The following graphs show the hourly measured ambient noise level $L_{Aeq,1h}$ and, where relevant, the averaged noise level $L_{Aeq,T}$ values, where the time period T is as specified in Table 1 of HS2 Information Paper E23. Periods where noise levels are adversely affected by weather or only measured for part of the period, which are not representative of HS2 construction works, have been greyed out and excluded from the calculation of the $L_{Aeq,T}$ values in in Table 3 of the main report.

Note: Noise monitor was removed from site on Wednesday 14th August due to the completion of works on site.

- 1.2.2 Noise monitor ref. JC at worksite ref. B was removed from site on Wednesday 14th August due to the completion of works on site.
- 1.2.3 Maps showing the position of noise and vibration monitoring installations are presented in Appendix B.

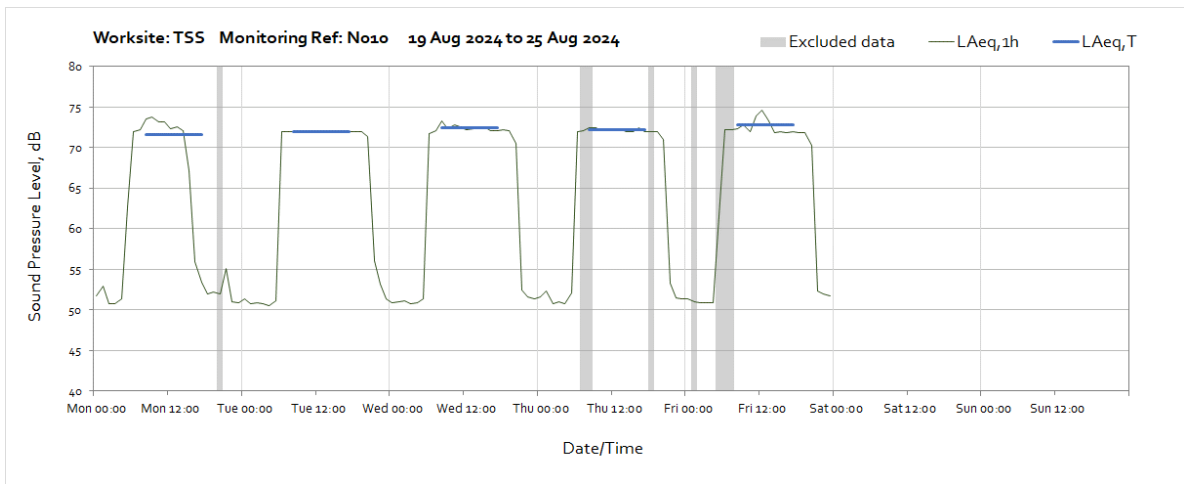
Worksite: TSS – Monitoring Ref: N010

Note: Missing data from 00:00 on Saturday 24th until 08:00 on Monday 26th August was due to the monitoring station running out of data storage capacity.
