Department for
Energy Security
& Net Zero

LEEDS BECKETT UNIVERSITY
LEEDS SUSTAINABILITY
INSTITUTE

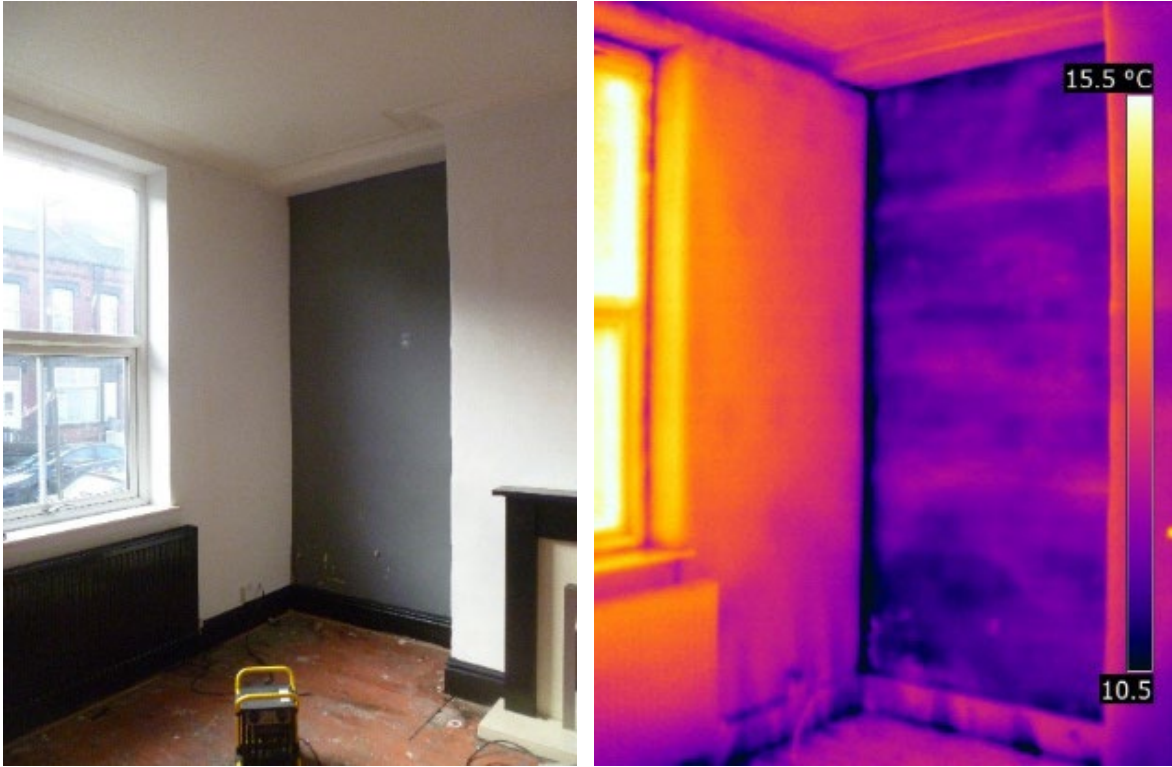
Figure 3-1 Base case infiltration through the suspended timber ground floor at wall junction and behind the existing IWI during depressurisation

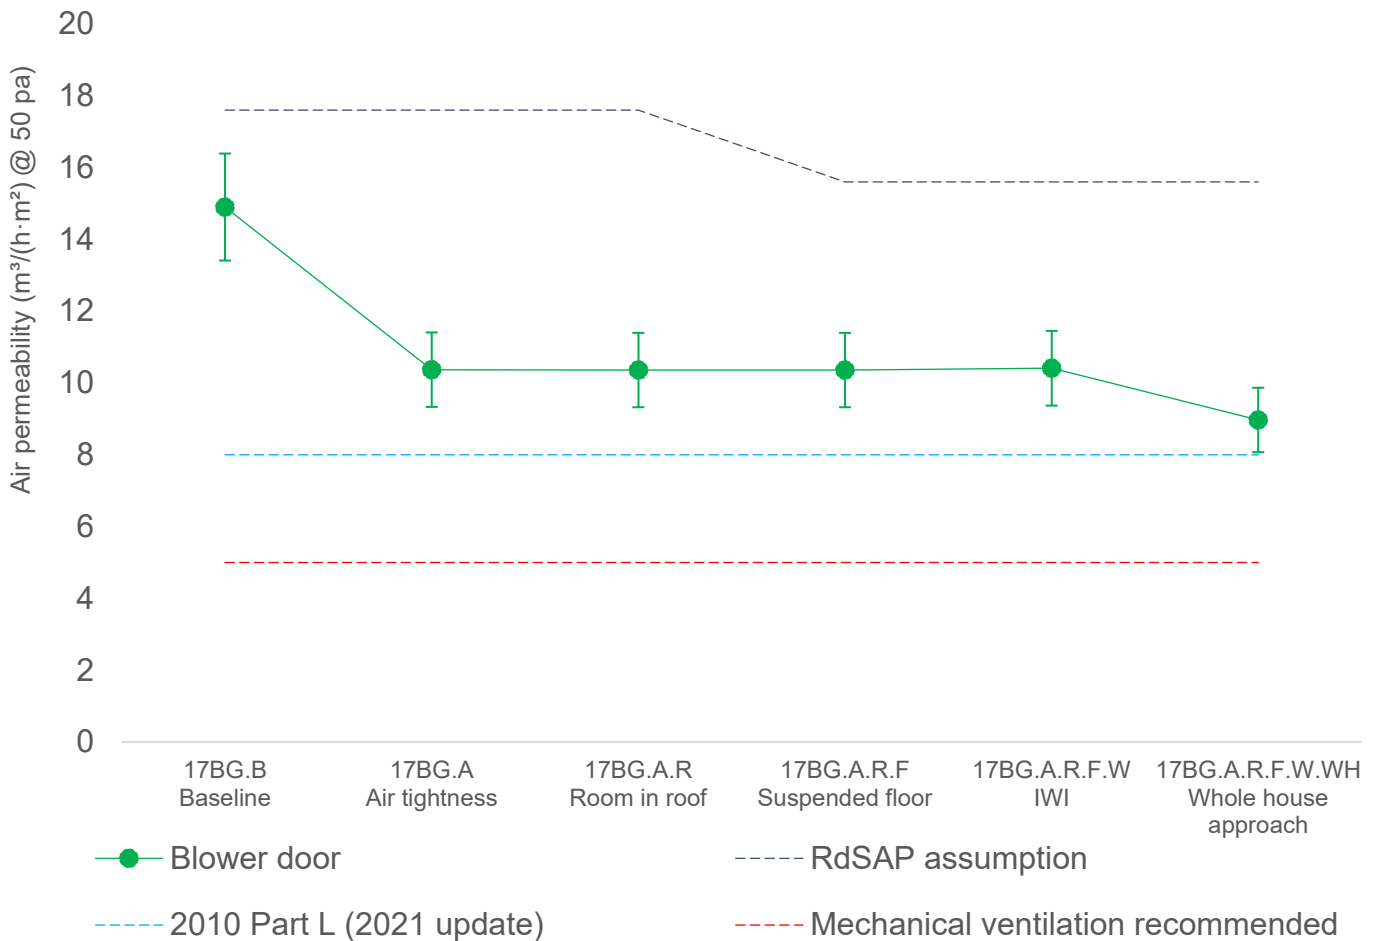
Figure 3-4 Airtightness improvements made at each retrofit stage

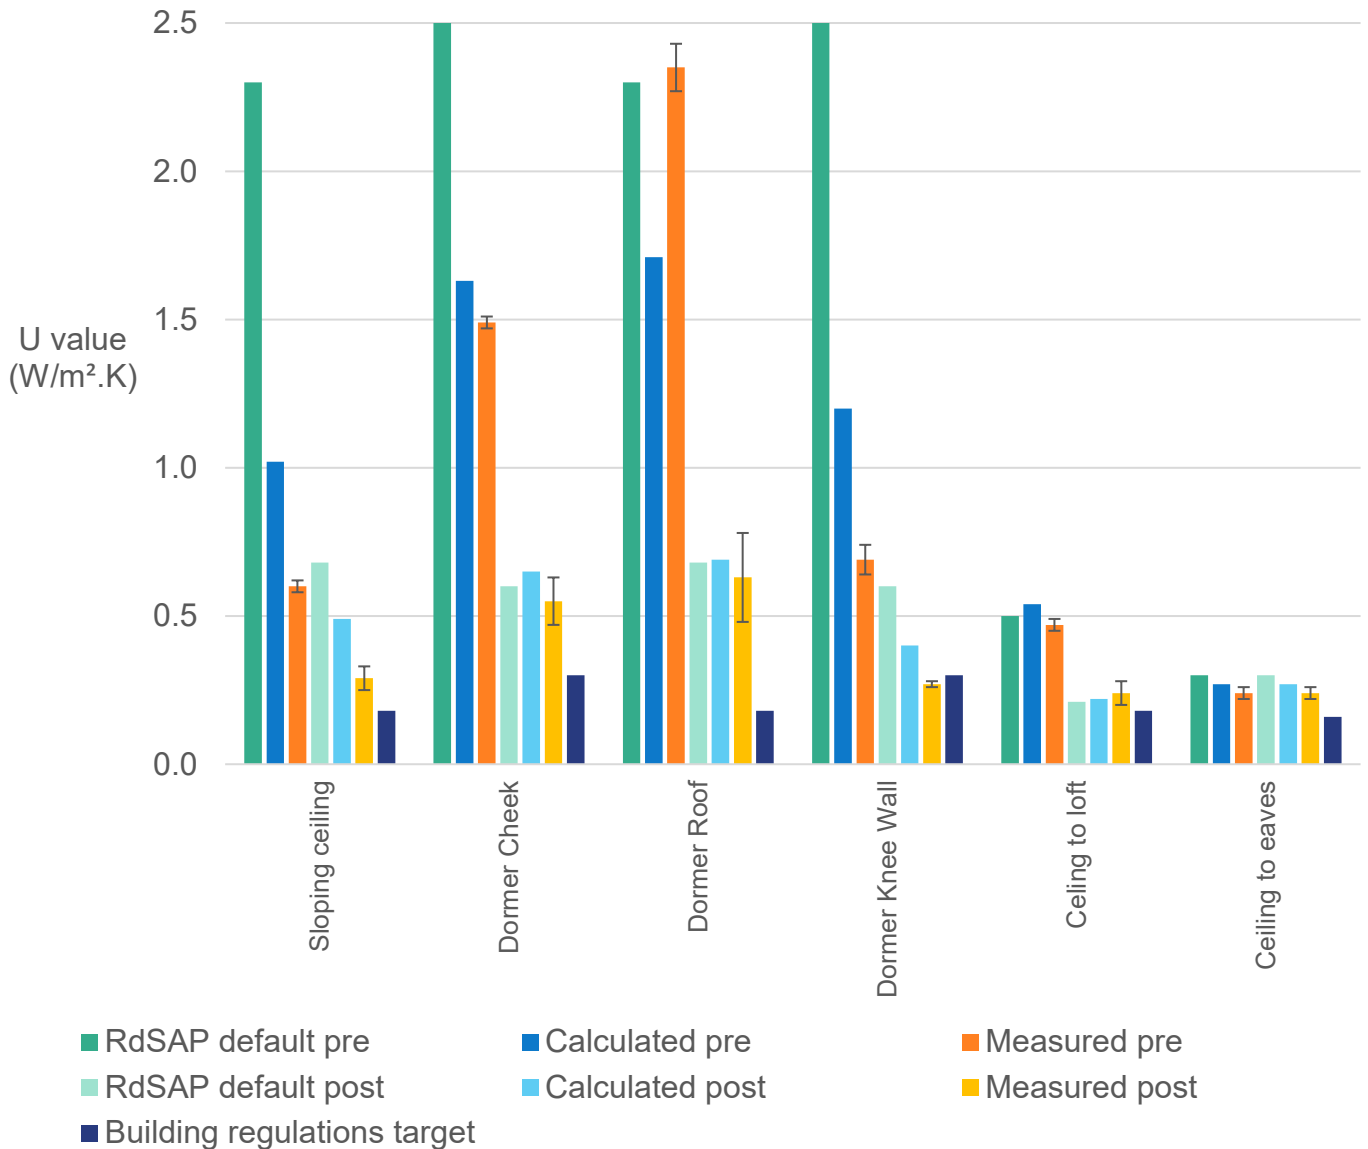
Figure 3-9 Pre- and post-retrofit room-in-roof U-values

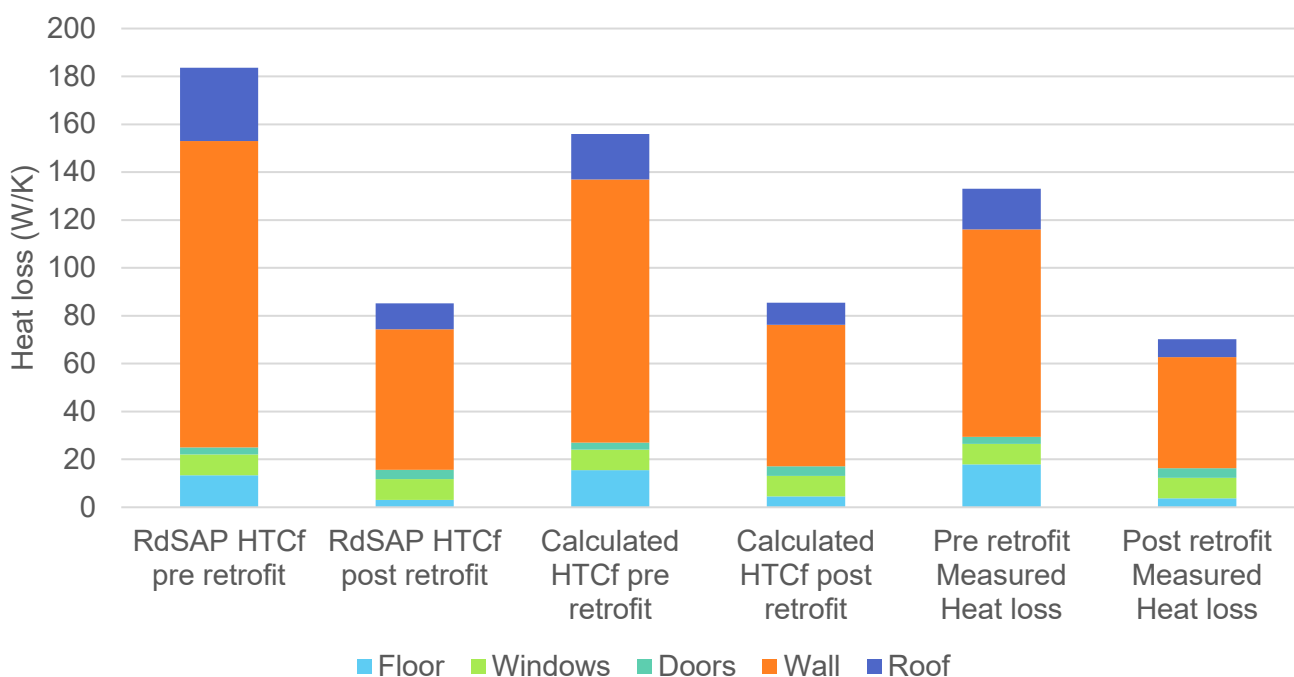
Figure 3-10 Heat transfer coefficient of fabric elements (HTC_f) pre- and post-retrofit, as recorded by heat flux density measurements

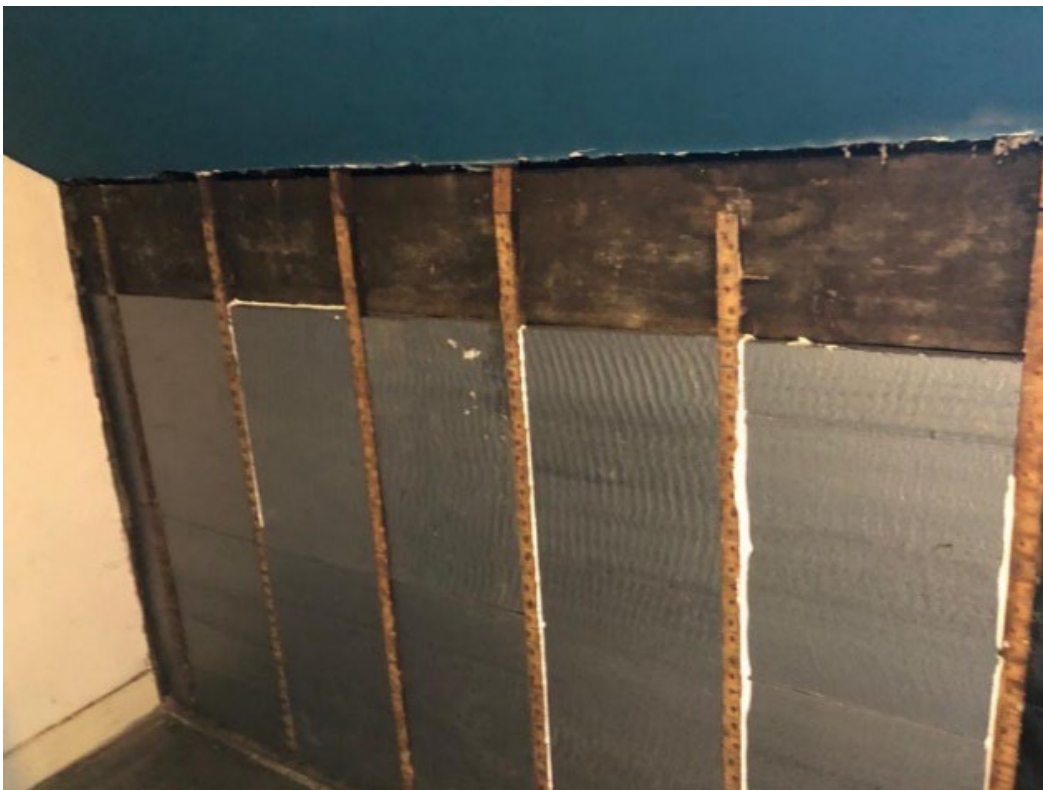
Figure 3-12 Knee wall insulation mid-retrofit (17BG.A.R)

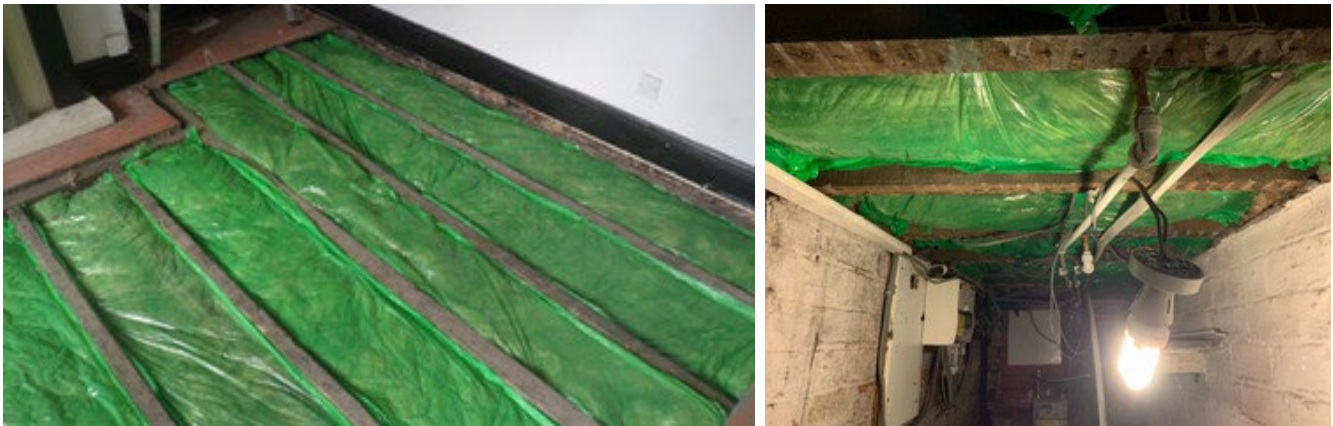
Figure 3-15 Suspended timber ground floor insulation mid-retrofit (17BG.A.R.F)

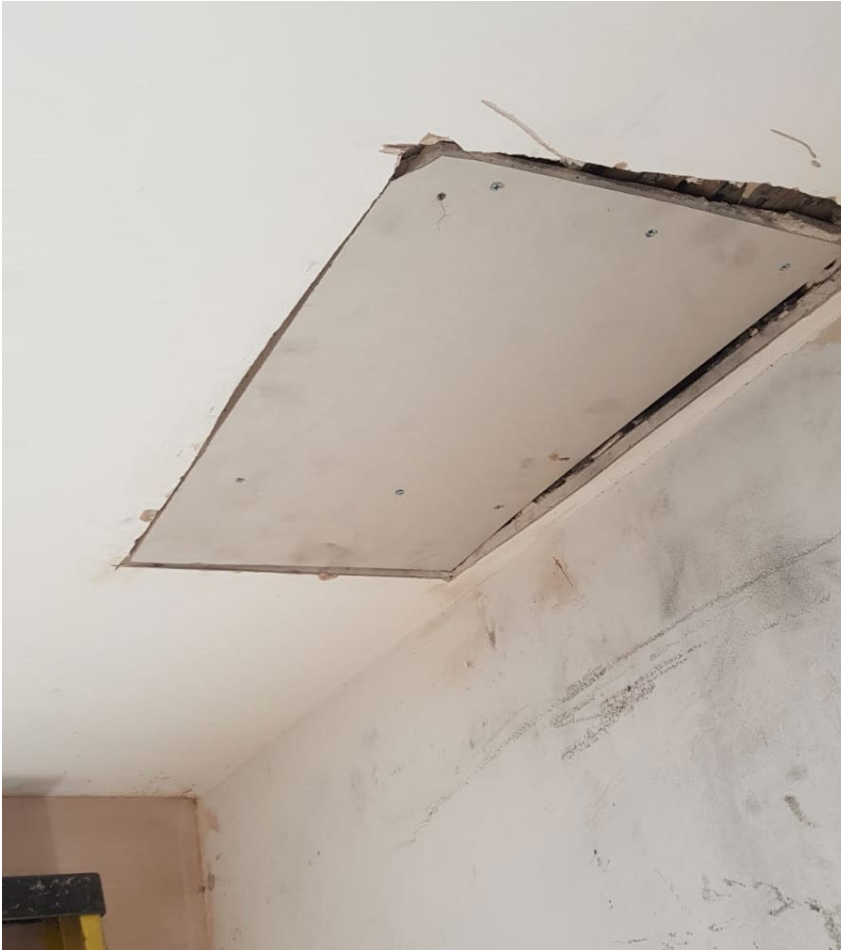
Figure 3-18 Ceiling removal to access loft to install insulation and replacement mid-installation (17BG.A.R.F.W.WH)

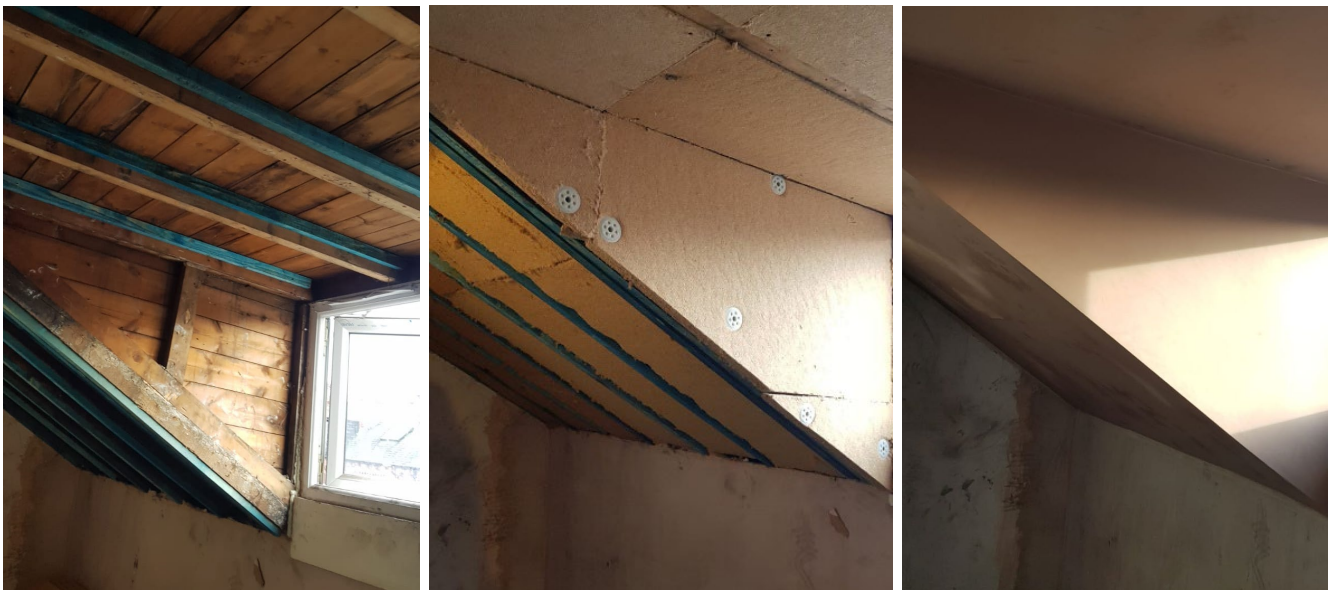
Figure 3-19 Dormer roof, cheeks and sloping ceiling insulation retrofit stages (17BG.A.R.F.W.WH)

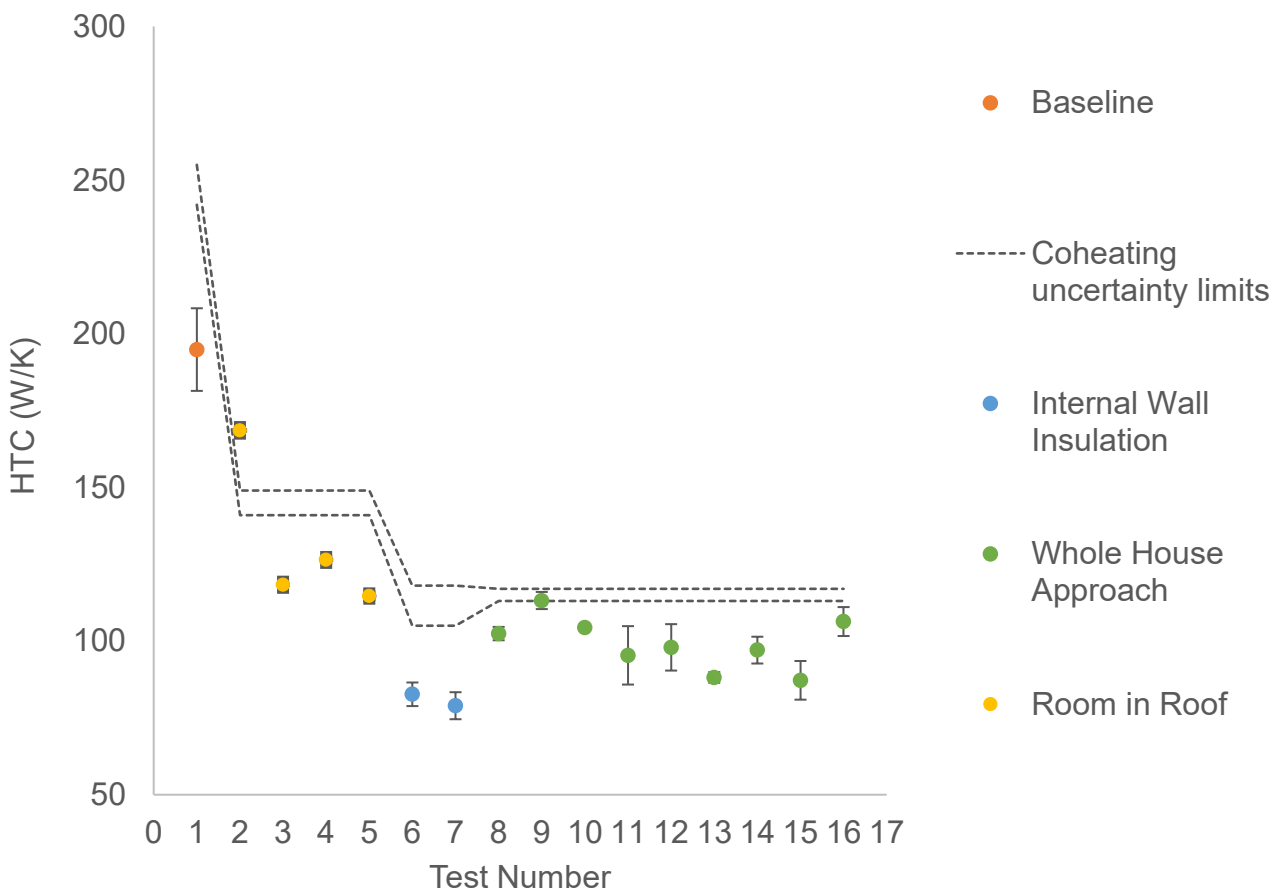
Figure 3-21 Predicted HTC via QUB test

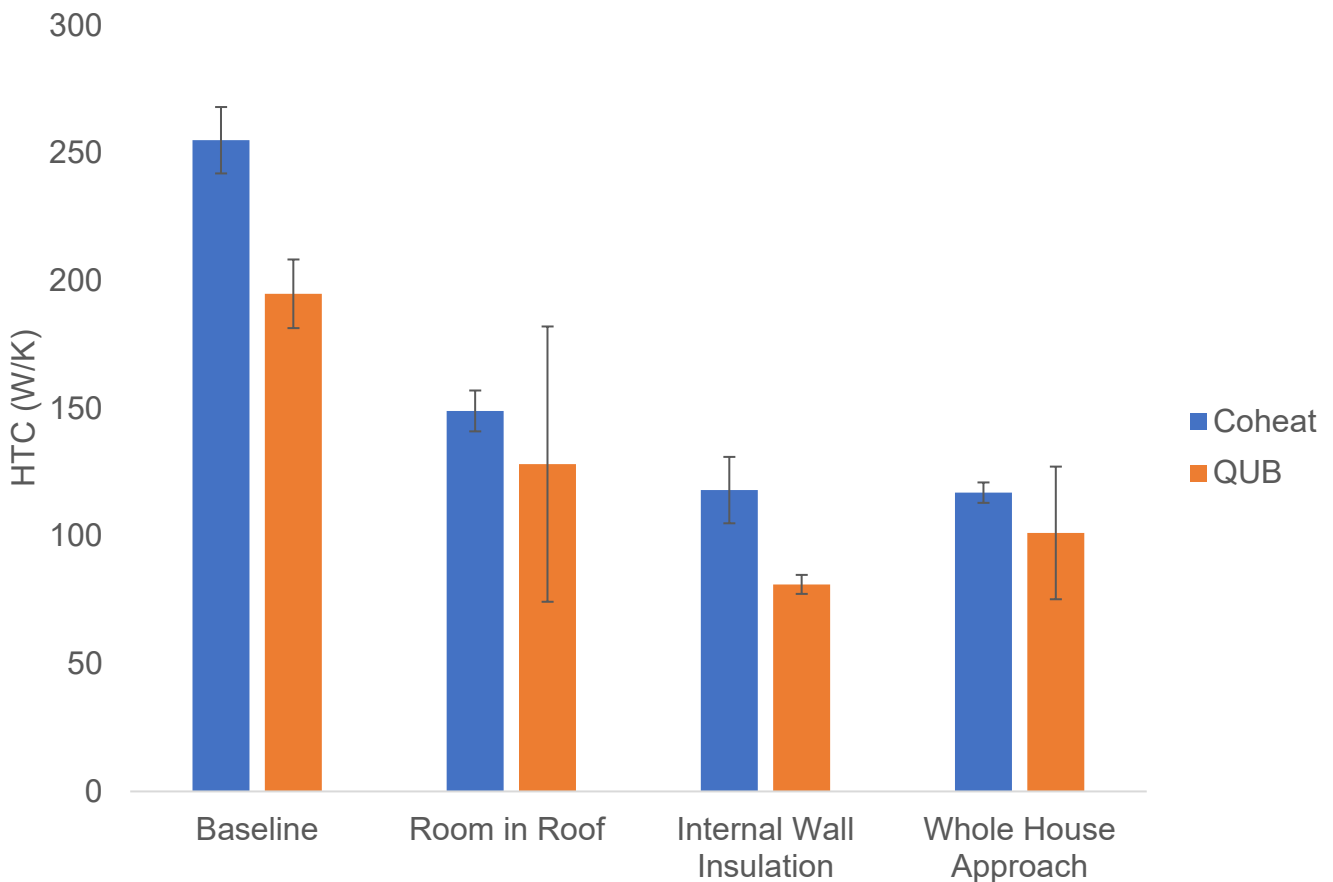
Figure 3-22 Average QUB vs coheating HTC measurements

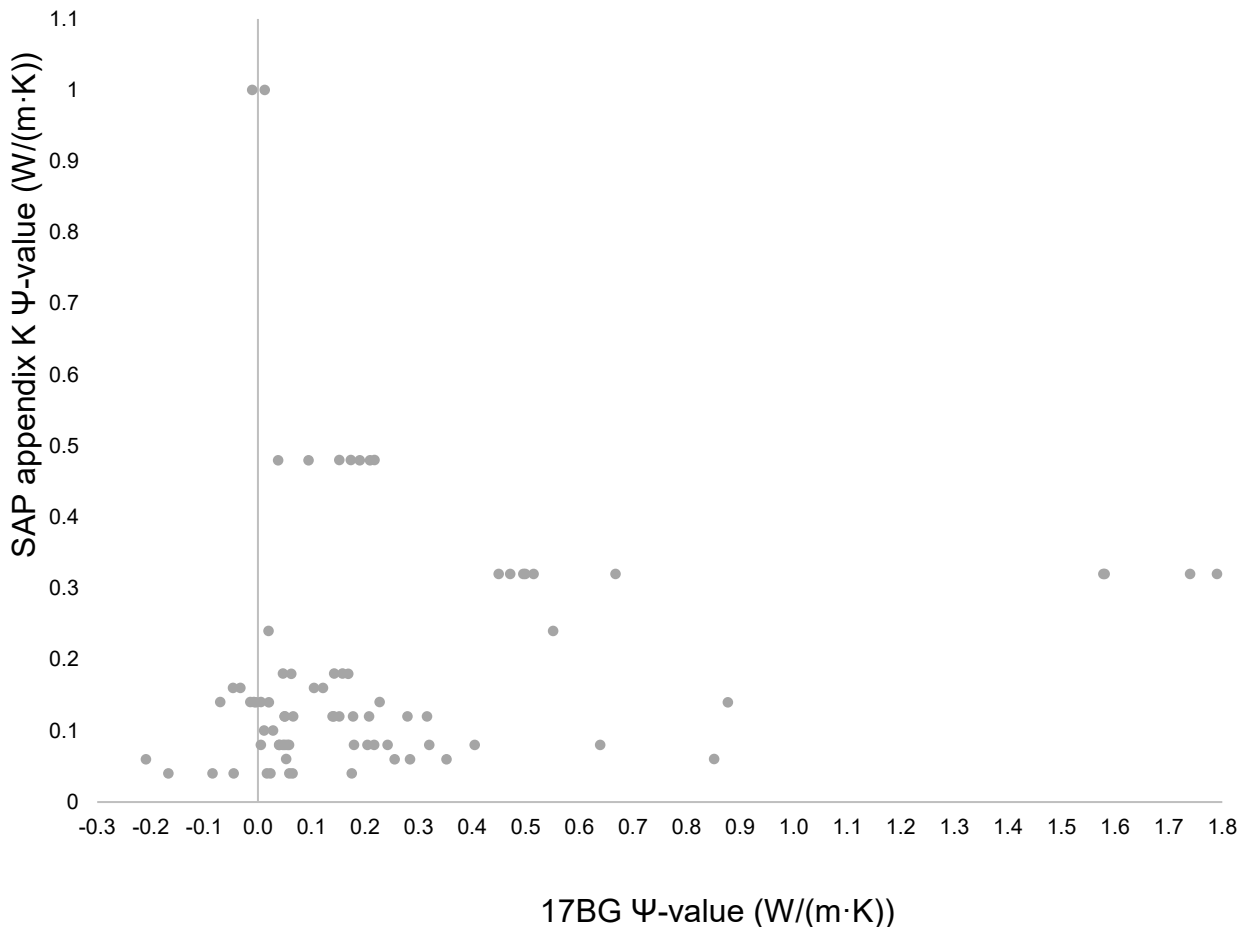
Figure 3-24: Comparison of RdSAP and 17BG Ψ -value

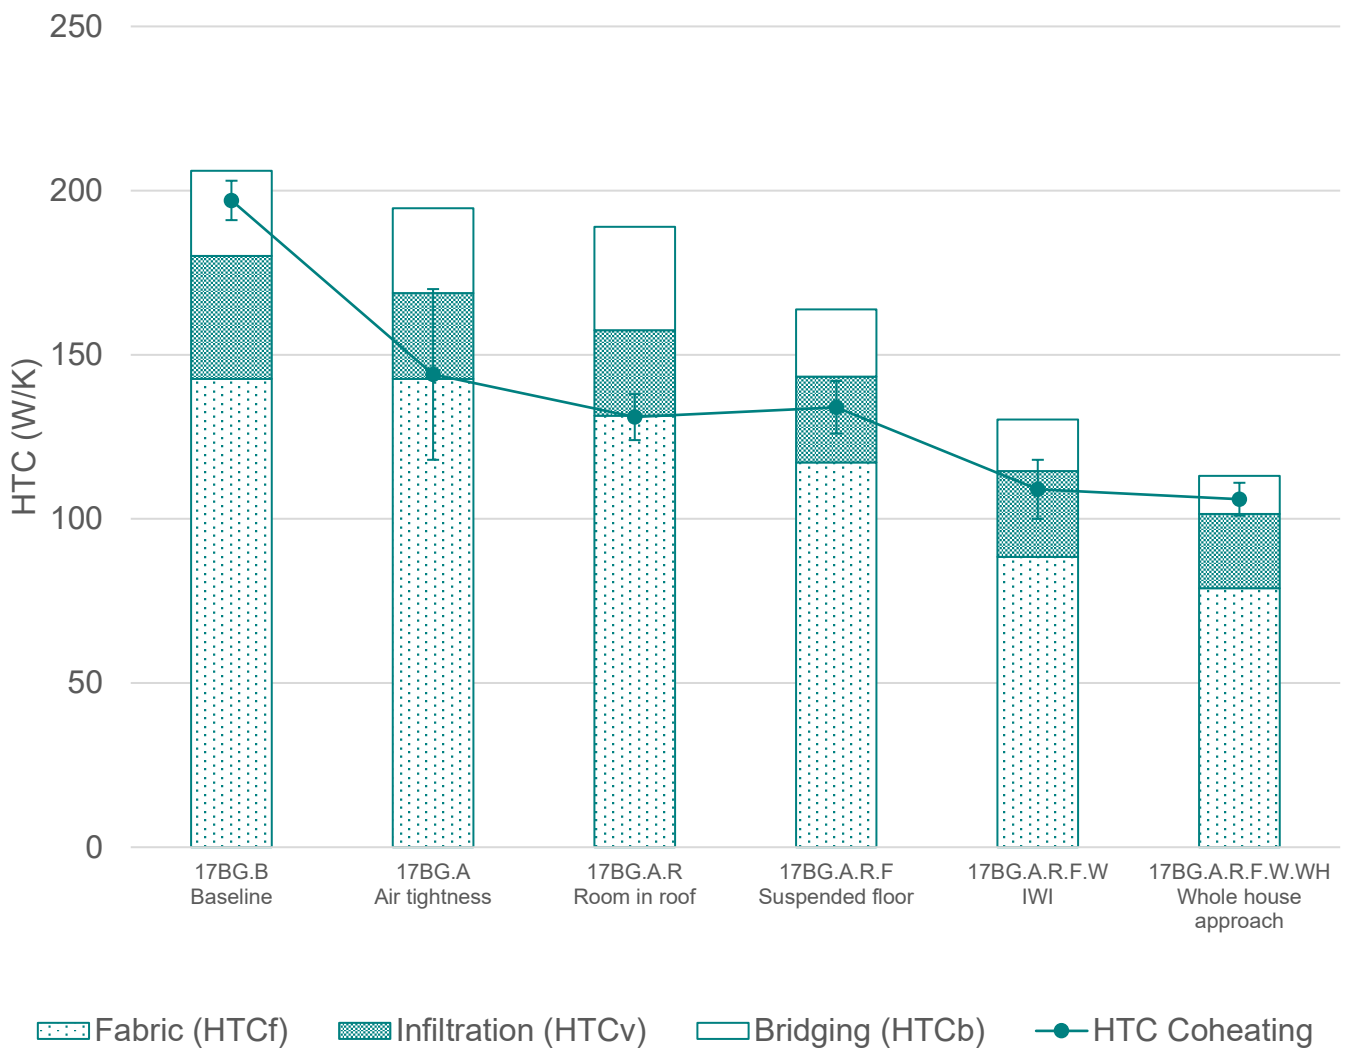
Figure 3-26 Aggregated vs. disaggregated measured HTC

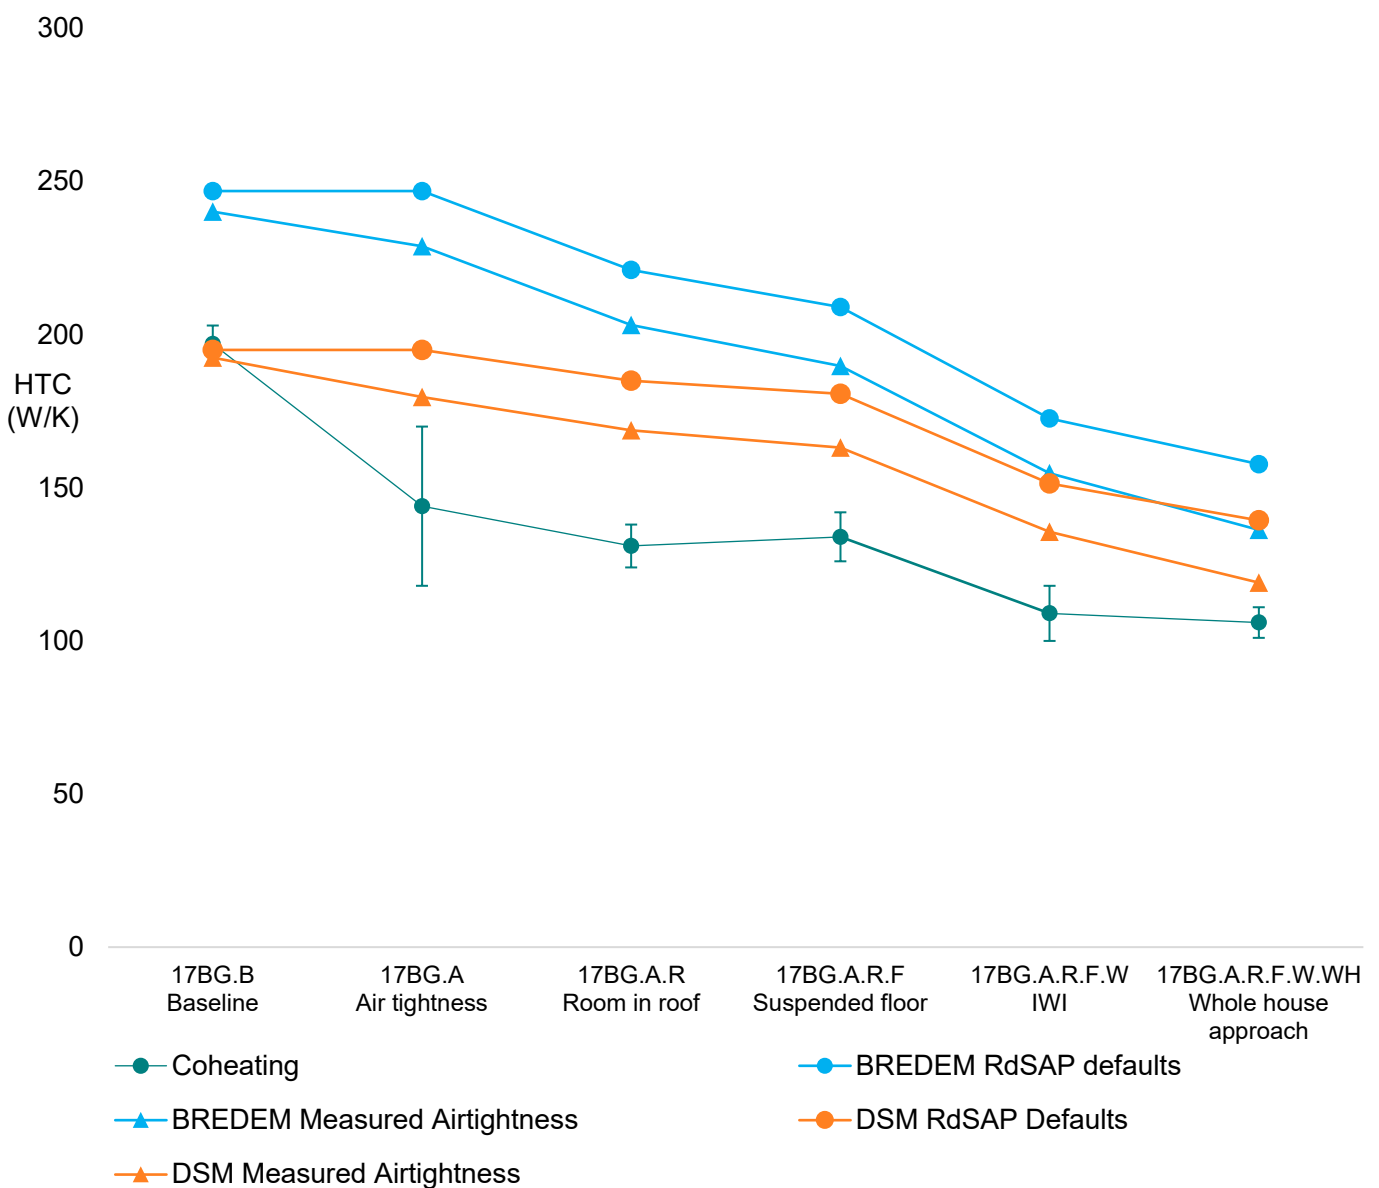
Figure 3-28 Measured vs modelled HTC calibration step 2: measured infiltration

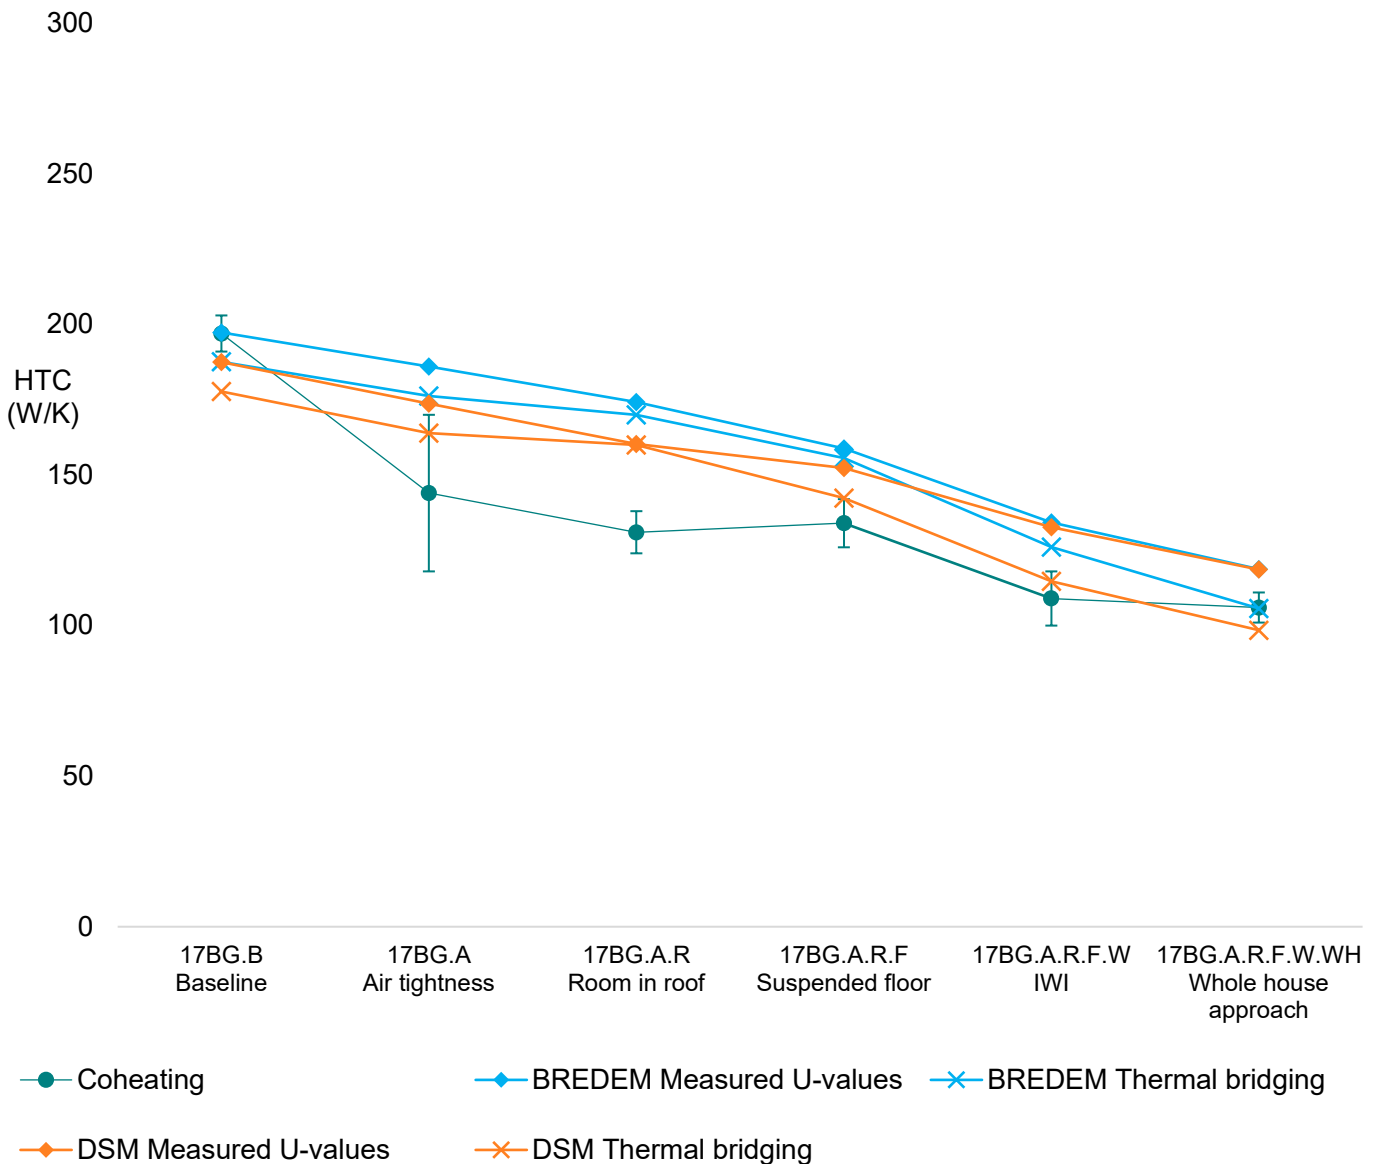
Figure 3-31 Measured vs modelled HTC calibration step 5: calculated thermal bridging

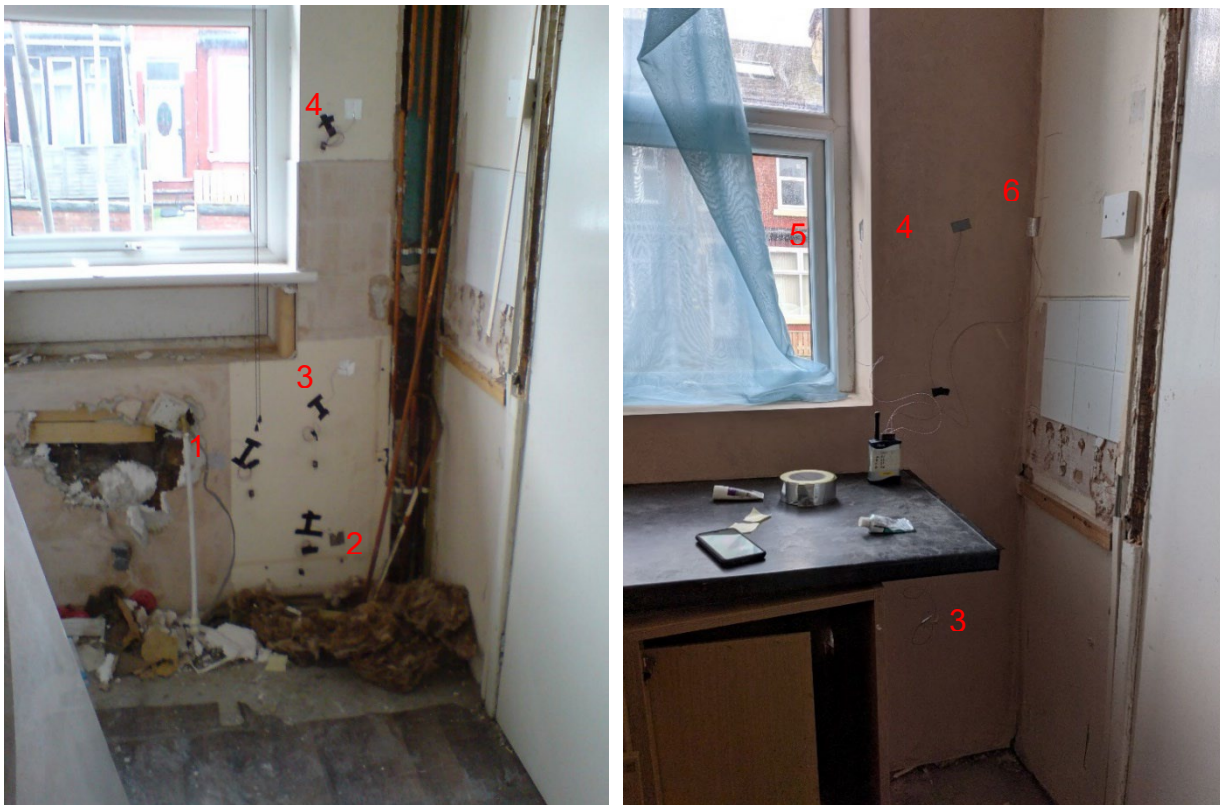
Figure 3-42 Kitchen thermocouple sensor locations: Left 17BG.W; Right 17BG.WH

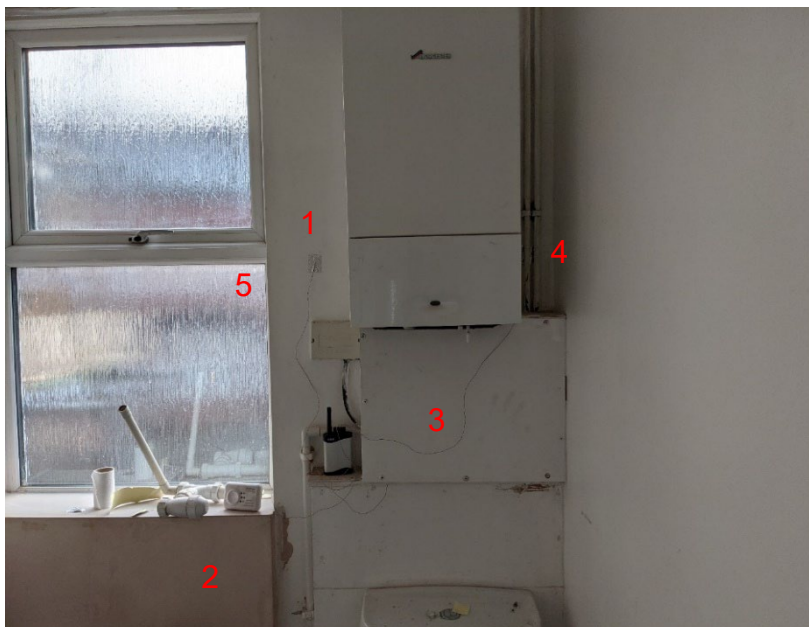
**Figure 3-44 Bathroom thermocouple locations (17BG.W)**

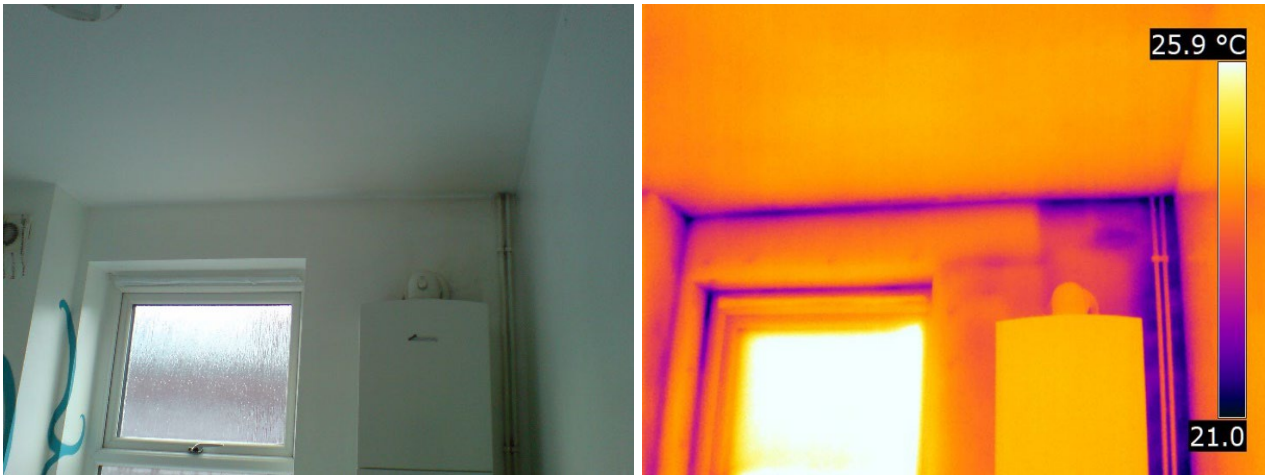
Figure 3-45 Existing TIWI installed to the left of the boiler (warmer), uninsulated wall above and to the right of the boiler (colder)

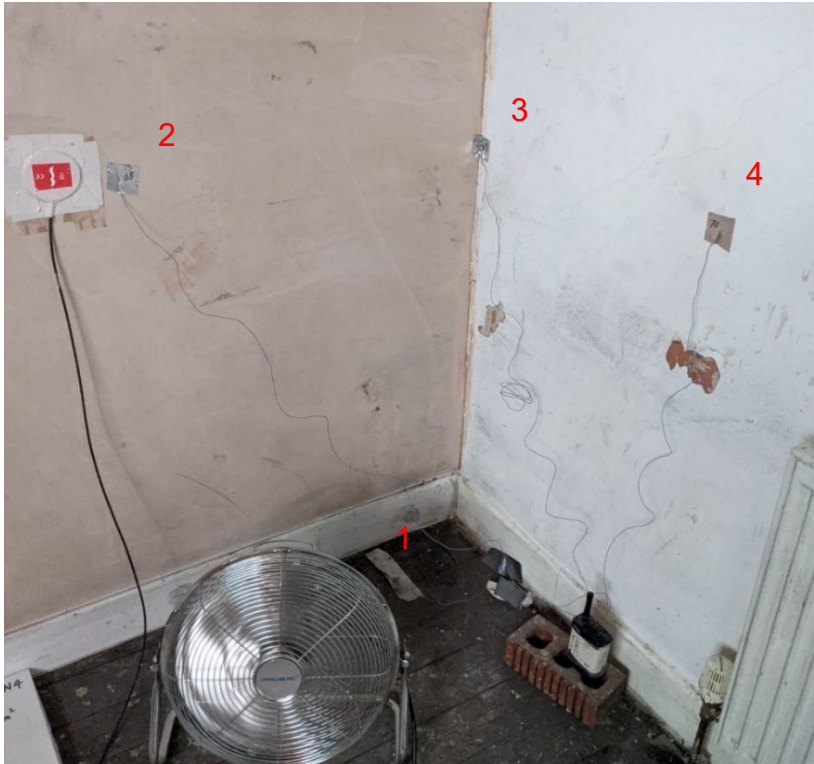
Figure 3-48 Room-in-roof thermocouple locations (17BG.W)
