DEEP Report 2.04

Case Study 01BA

Case Study 01BA is a two bed 1910 end-terrace in which a whole house retrofit was undertaken. The whole house retrofit was undertaken in stages, reflecting a piecemeal approach to retrofit, with stages comprising of loft insulation, new double glazing and composite doors, ground floor insulation, and external wall insulation (EWI). The performance of each individual retrofit stage was assessed for airtightness, thermal performance, and moisture risk. This case study also provided the opportunity to investigate a traditional retrofit journey that a home may make over several decades, and understand how piecemeal retrofit affects whole house performance. It also explores the impact of installing suspended ground floor insulation when only half the ground floor was of a suspended construction.

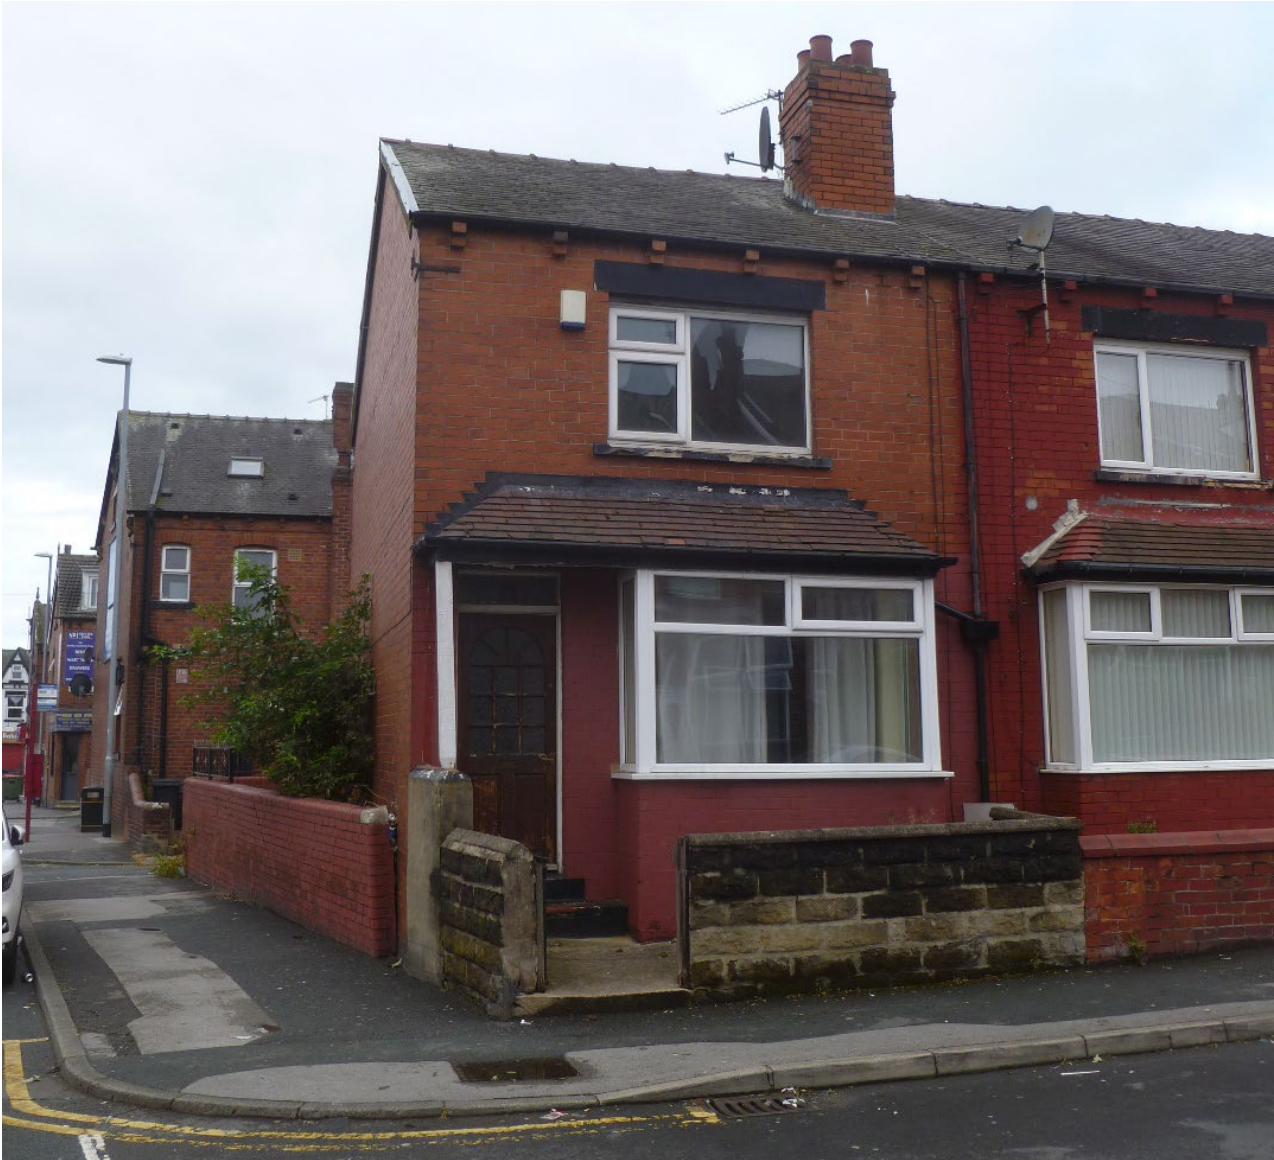
Figure 1-1 Case study house

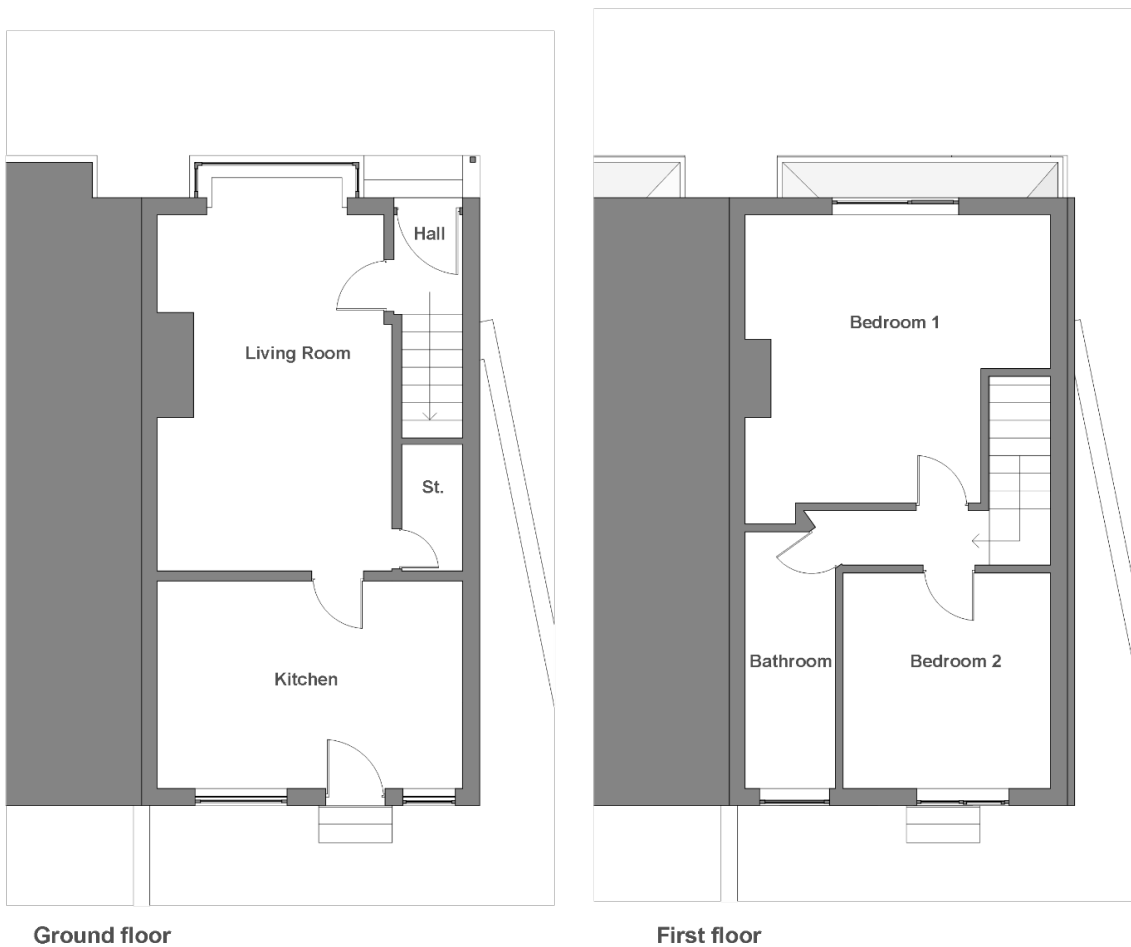
Figure 1-3 House plans

Floor plans, elevations and sections can be seen in Figure 1-2 and Figure 1-3 respectively.

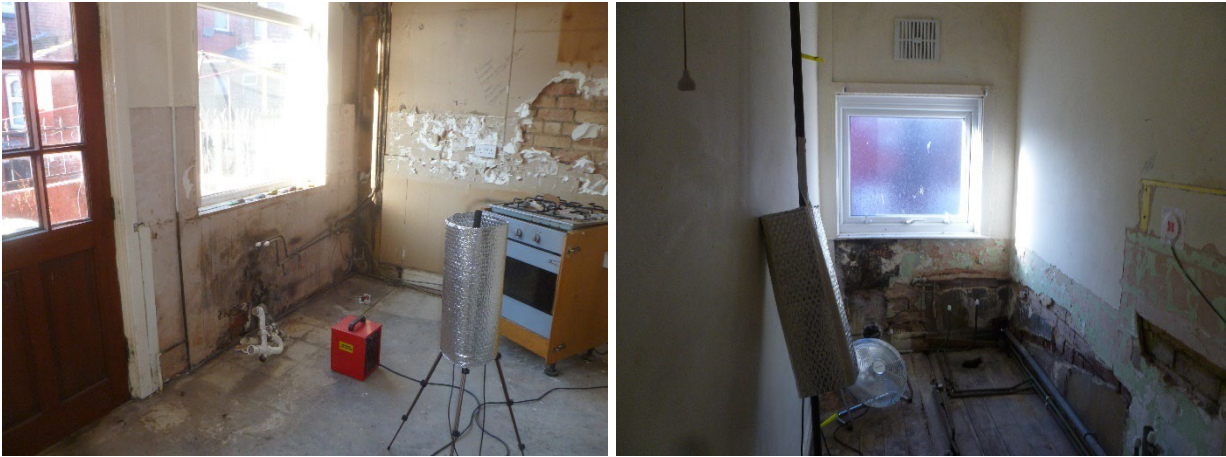
Figure 1-5 Kitchen and bathroom with fittings removed prior to testing

All kitchen and bathroom fittings had been removed by the landlord prior to handing over to the research team for testing. While direct penetrations to outside were temporarily sealed throughout the retrofit process some unfinished detailing was visible, that would be covered over if the house was in a habitable state, and areas of unplastered brickwork remained where fittings had been removed from the walls (Figure 1-5).

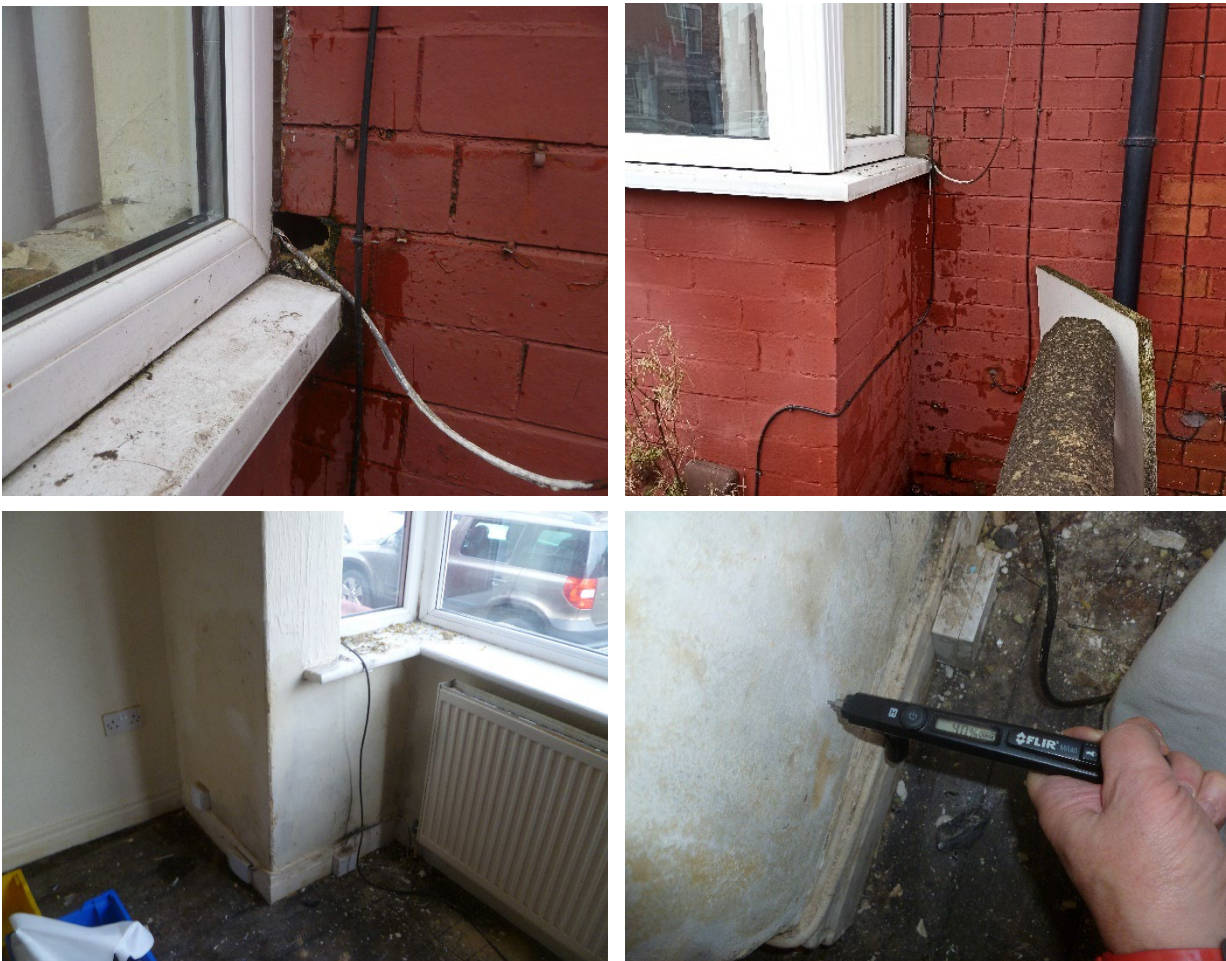
Figure 1-5 Evidence of damp in baseline case study

There were no obvious defects in the building elements, apart from a hole in the external wall close to bay window where a section of brickwork was missing. Consequently, part of the inner bay wall and adjacent front-facing external wall in the living room were visibly damp, as shown in Figure 1-6. %WME readings as high as 40 % were observed near the base of the bay wall compared to <5 % on the dry party wall. The section of missing brickwork was sealed, and the fabric dried out prior to any testing taking place.

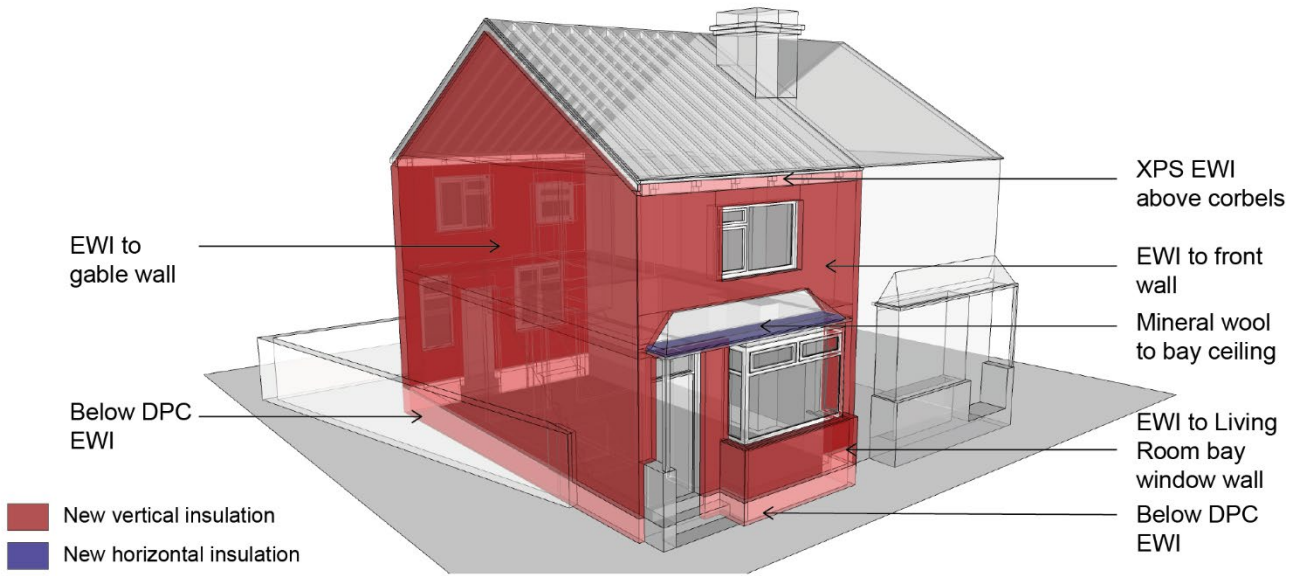
Figure 1-10 Stage 1: Installation of new EWI to front, gable and rear walls, which includes XPS to the corbels and below DPC, plus mineral wool insulation to bay window roof (01BA.R.G.F.W) – front and rear views respectively

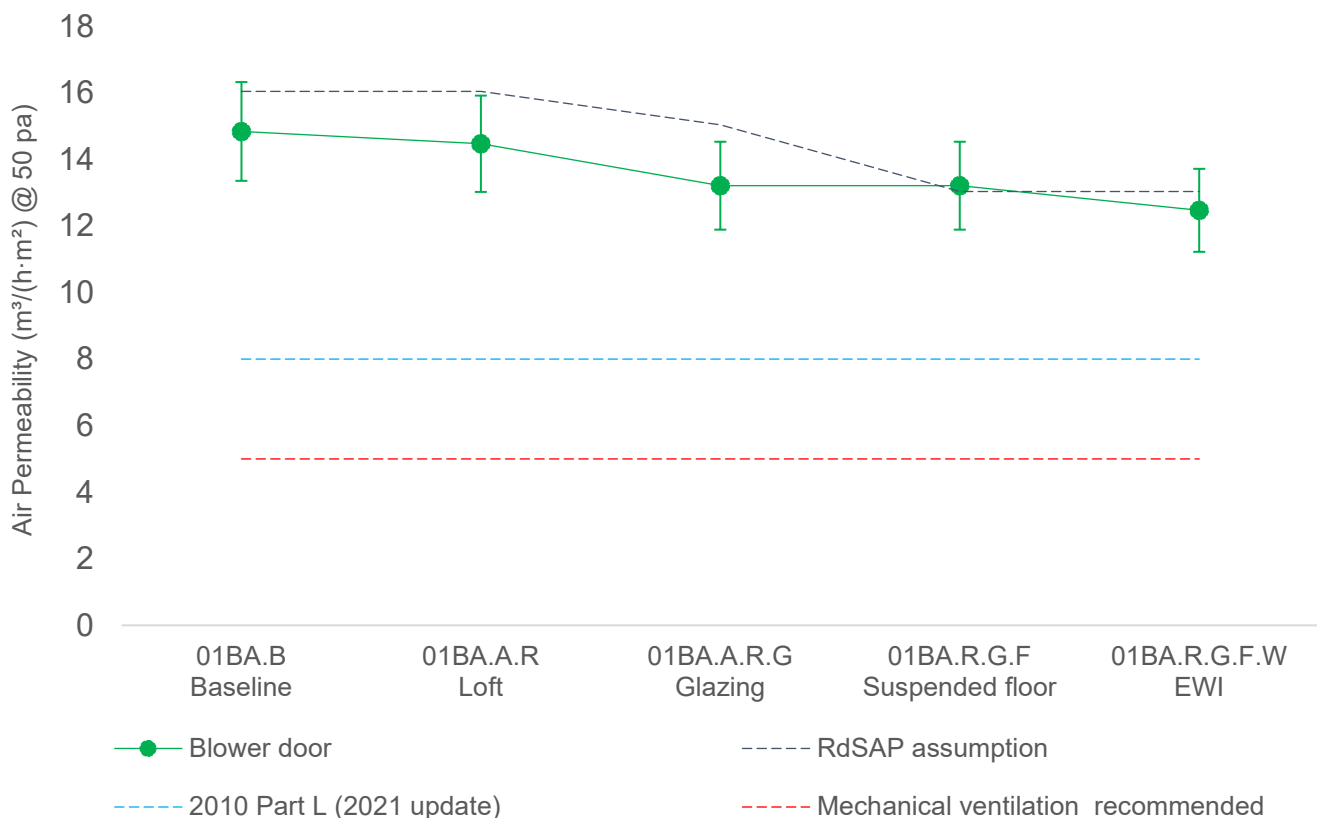
Figure 3-1 Airtightness improvements made at each retrofit stage.

The base case status of the house had relatively large amounts of air leakage; its infiltration rate was found to be around 15 m³/(h·m²) @ 50Pa. For context, the average UK air permeability value for existing homes is estimated to be approximately 11.5 m³/(h·m²) @ 50Pa [4] and the limiting value permitted under Building Regulations for new build homes is now 8 m³/(h·m²) @ 50Pa [5]. It is important to note that the air permeability rate is not the same as ventilation for fresh air, for which there was purpose provided ventilation. This was via trickle vents on windows, an electrical intermittent extraction fan located in the kitchen, and a wall vent in the bathroom (all of which were retained throughout the retrofit). The results of these tests are illustrated in Figure 3-1.

Overall, the infiltration rate in the house was reduced slightly by undertaking the various retrofits from ~ 15 to $13 \text{ m}^3/(\text{h}\cdot\text{m}^2)$ @ 50Pa, though there remained significant room for further improvement. It is also interesting to note that this case study home had similar levels of airtightness to those predicted in RdSAP, though they are often outside the uncertainty bounds of the test.

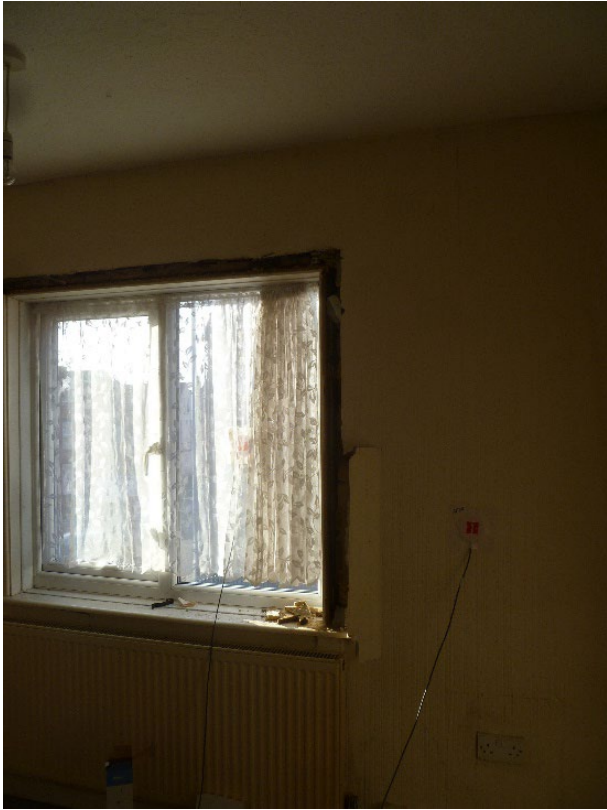
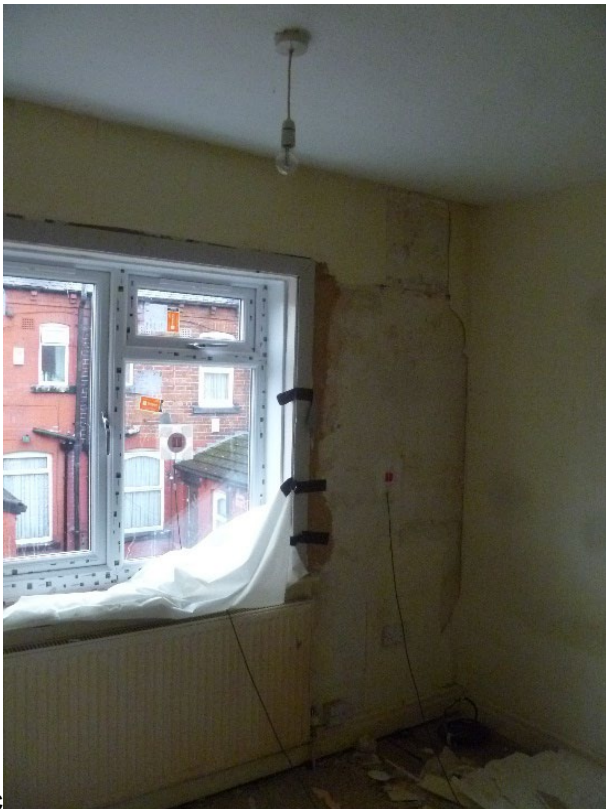
Figure 3-3 Air leakage around the bedroom 2 window frame with the original (top) and replacement (bottom) windows

In addition, when the new external windows and doors were installed, the openings around these elements were repaired so that the new frames were better sealed in the external walls, Figure 3-3, although new air paths existed through the new trickle vents.

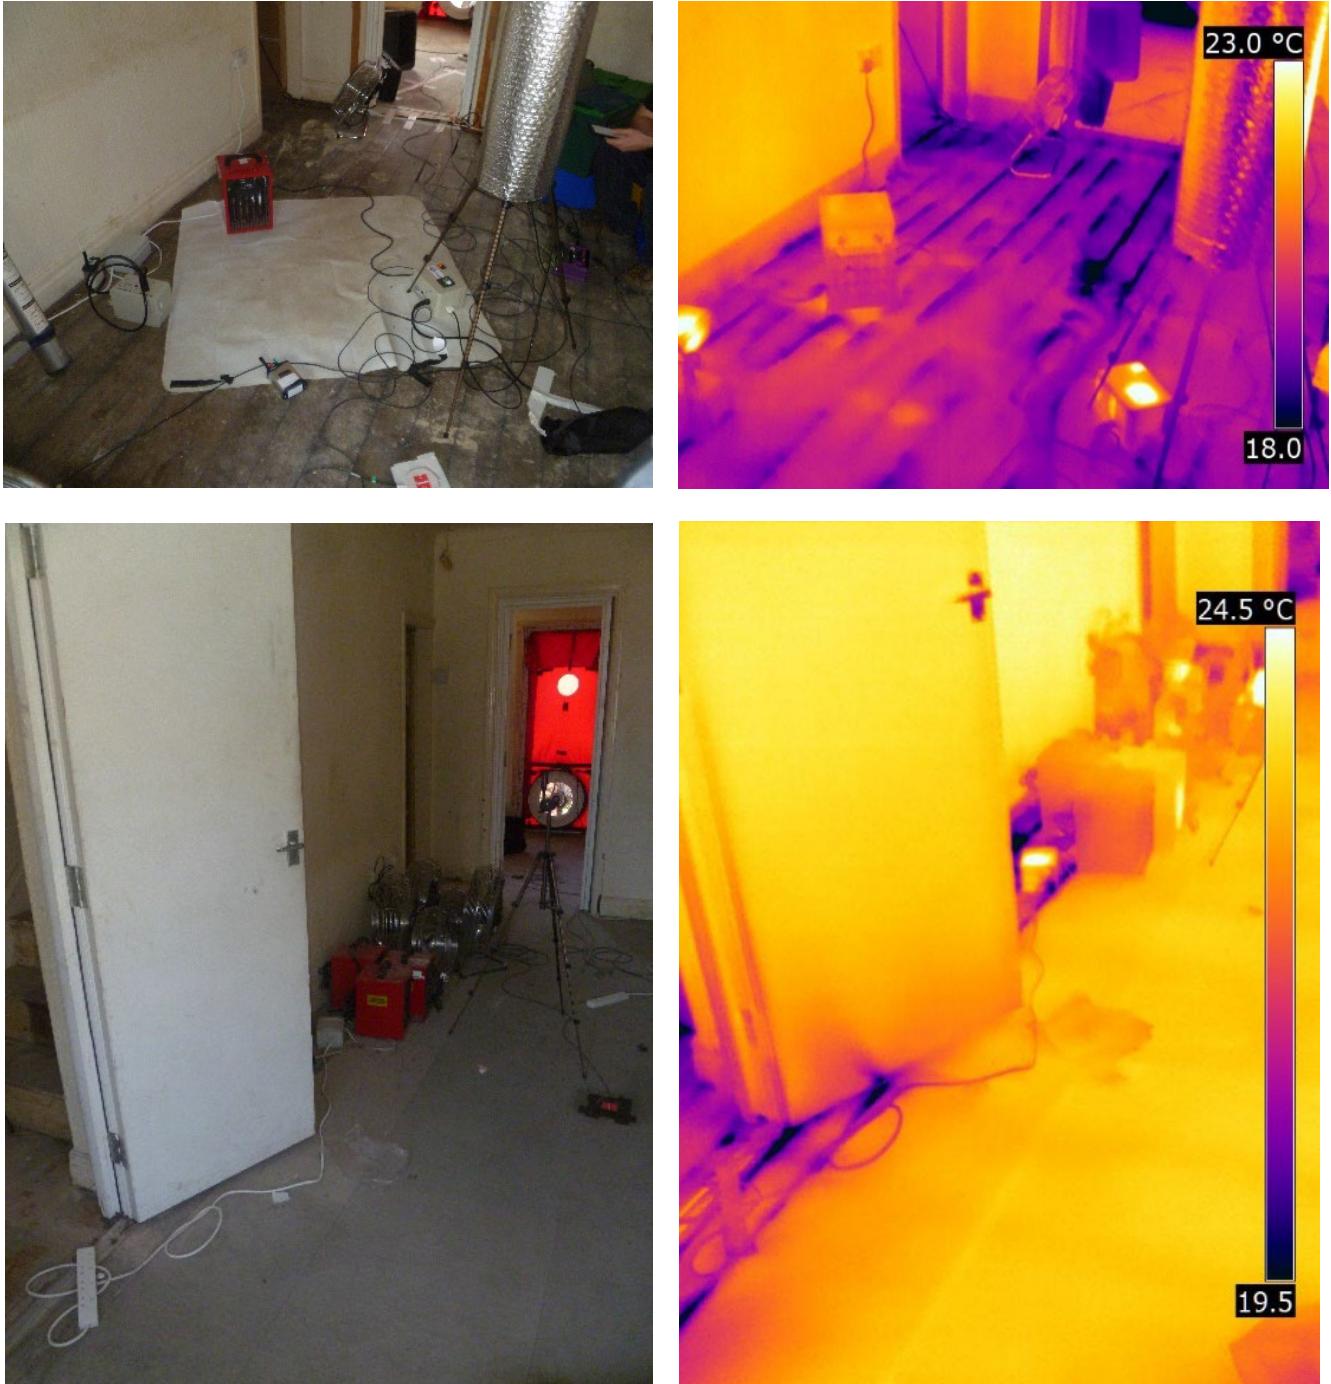
Figure 3-2 Air leakage through the suspended ground floor was reduced with the replacement floor covering

Treatment of the suspended timber ground floor involved installing under-floor insulation with a vapour permeable membrane and replacing old floorboards with new flooring panels in the living room. This significantly reduced air leakage through the main expanse of the living room floor (Figure 3-4). Air leakage from the suspended floor void remained around the room perimeter and at smaller areas, such as the hall and understairs cupboard, where the existing floorboards remained.

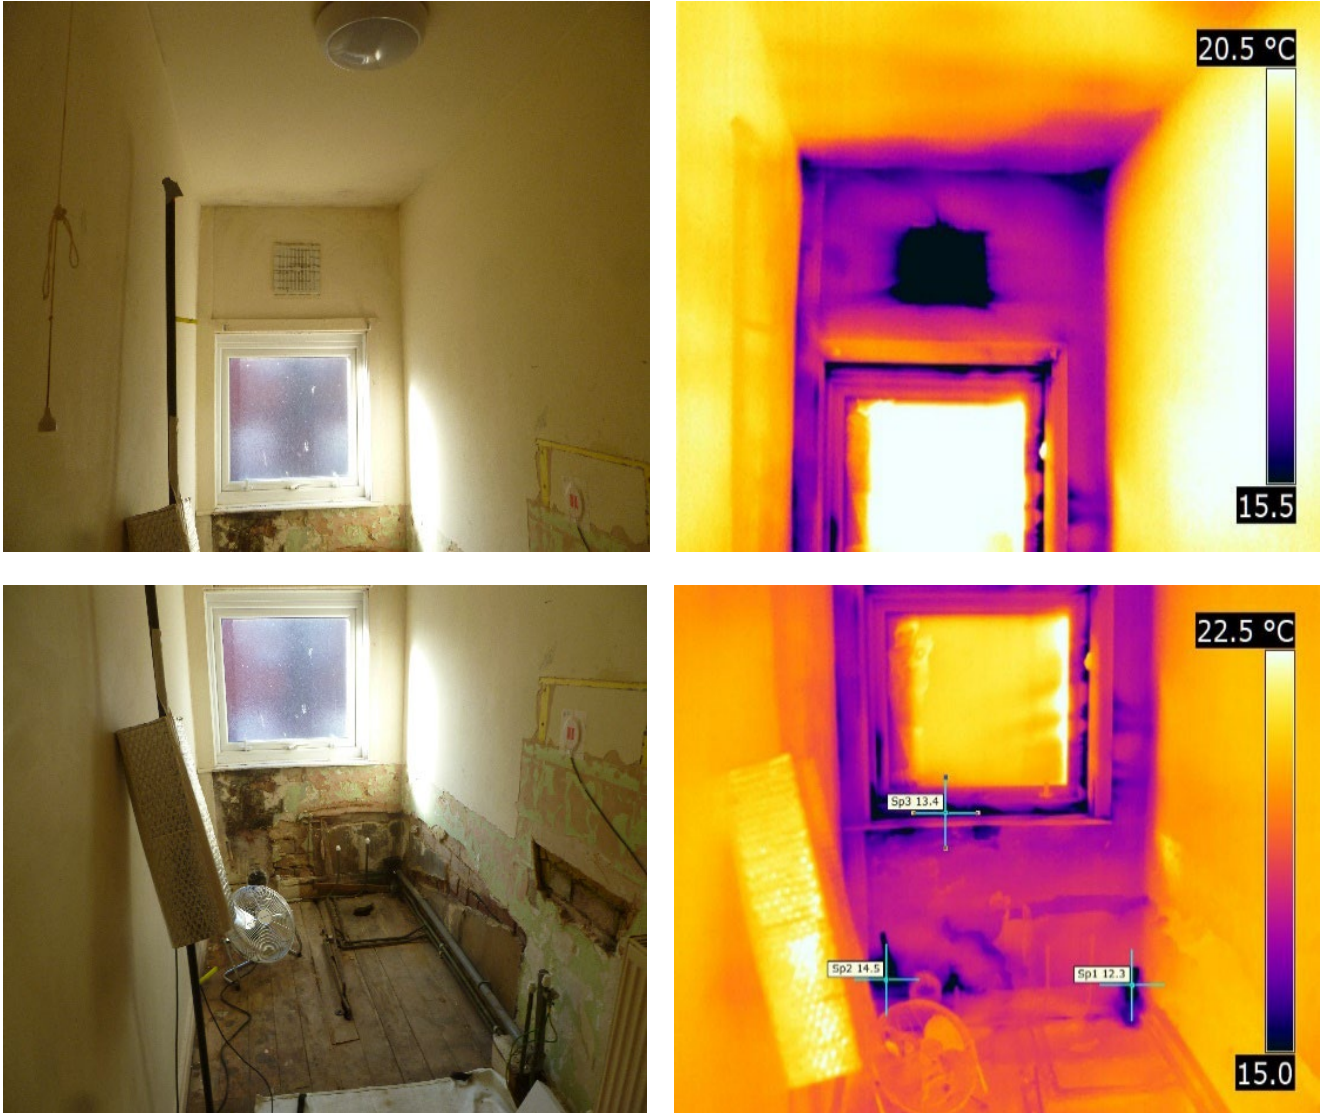
Figure 3-6 Air leakage around bathroom service penetrations at Stage 1 (01BA.B)

In the bathroom, the waste and soil pipes and other service penetrations were sealed with tape, but gaps remained around the penetrations, most of which would normally be obscured by boxing and the bath panel (Figure 3-6). As in the kitchen, there were areas of exposed brickwork where plaster had been dislodged when the fittings were removed; air movement into the exposed brickwork could be detected but it was slight compared to the other leakage paths identified.

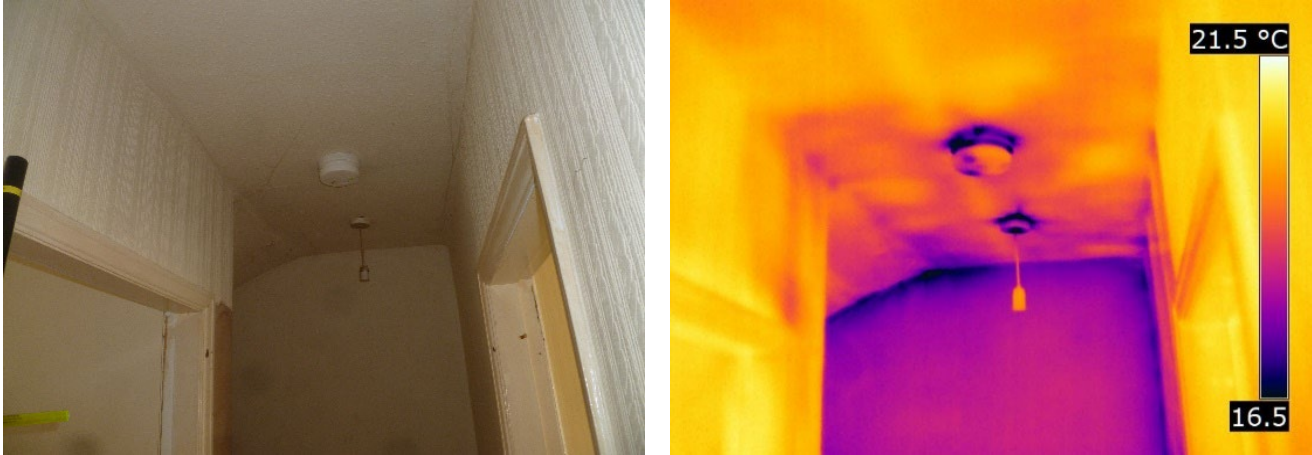
Figure 3-4 Air leakage around electrical penetrations in the landing

A number of less significant air leakage pathways remained throughout the retrofit process. No specific airtightness measures were undertaken to address service penetrations during the course of the retrofits. Air leakage was detected throughout around the boiler flue, electrical penetrations through the top floor ceiling (Figure 3-7) and to the consumer unit in the cupboard beneath the stairs.

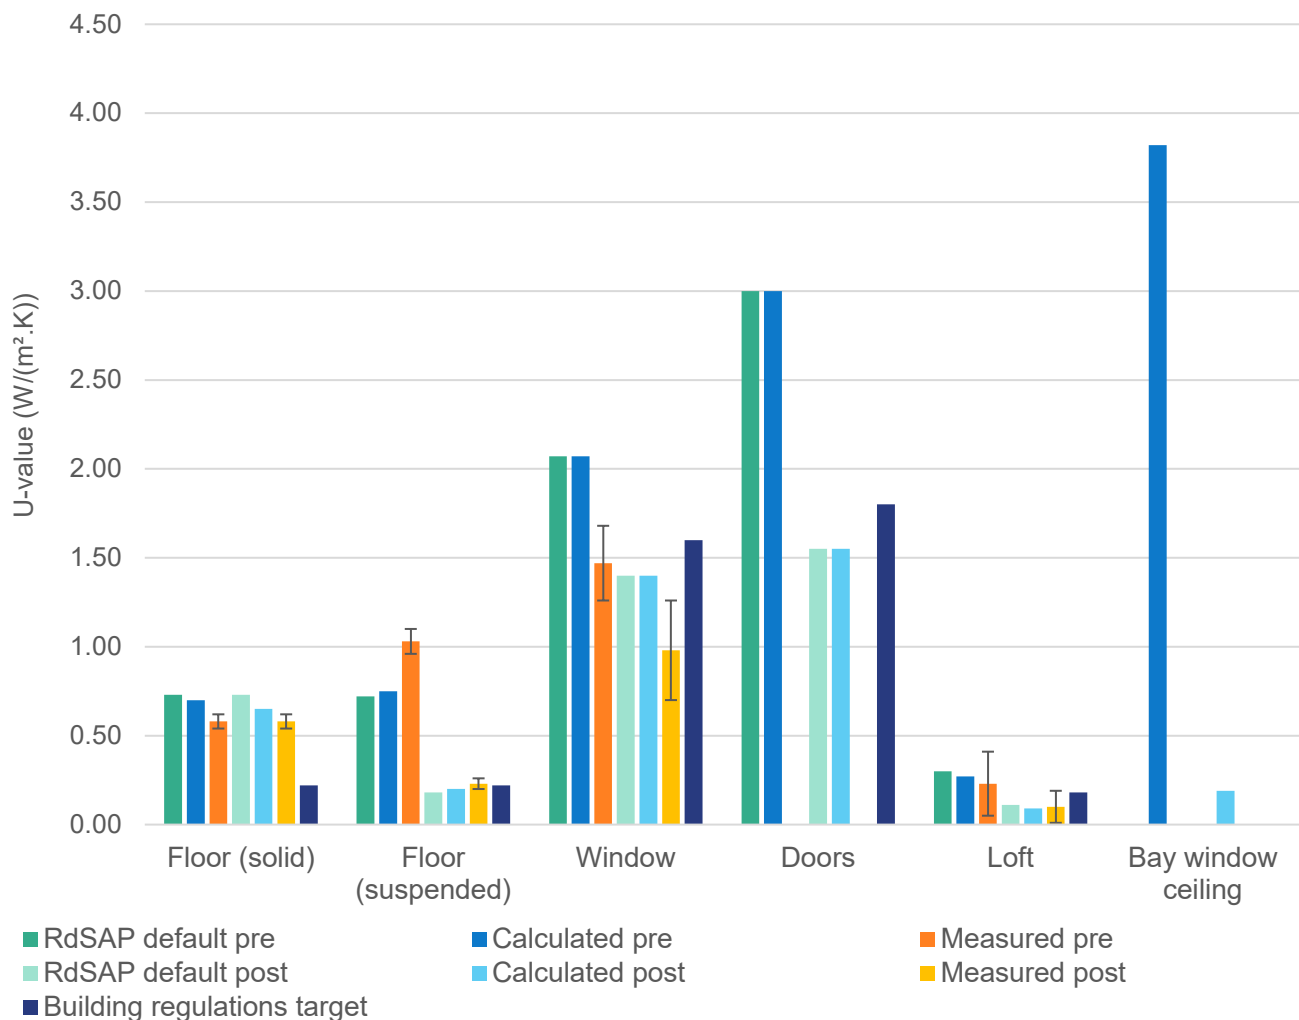
Figure 3-10 Pre- and post- U-values (excluding walls) ($W/(m^2 \cdot K)$)

Large improvements were also observed in centre pane window U-value (33 ± 35) %. Both the pre- and post-retrofit U-values were measured to be substantially lower than the defaults and calculated values. Though the measured window U-value is only a centre pane value so does not include the thermal properties of the frame. Additionally, the uncertainty measured is relatively high, as there was only one HFP installed on a window, and glazing is more susceptible than opaque construction materials to variations in external conditions.

The loft insulation also substantially reduced the ceiling U-values by (57 ± 20) %, even though these elements had already previously been retrofitted. This indicates that there may be some benefit in replacing loft insulation that is observed to be disturbed or topping up loft insulation that is less than 150 mm deep.

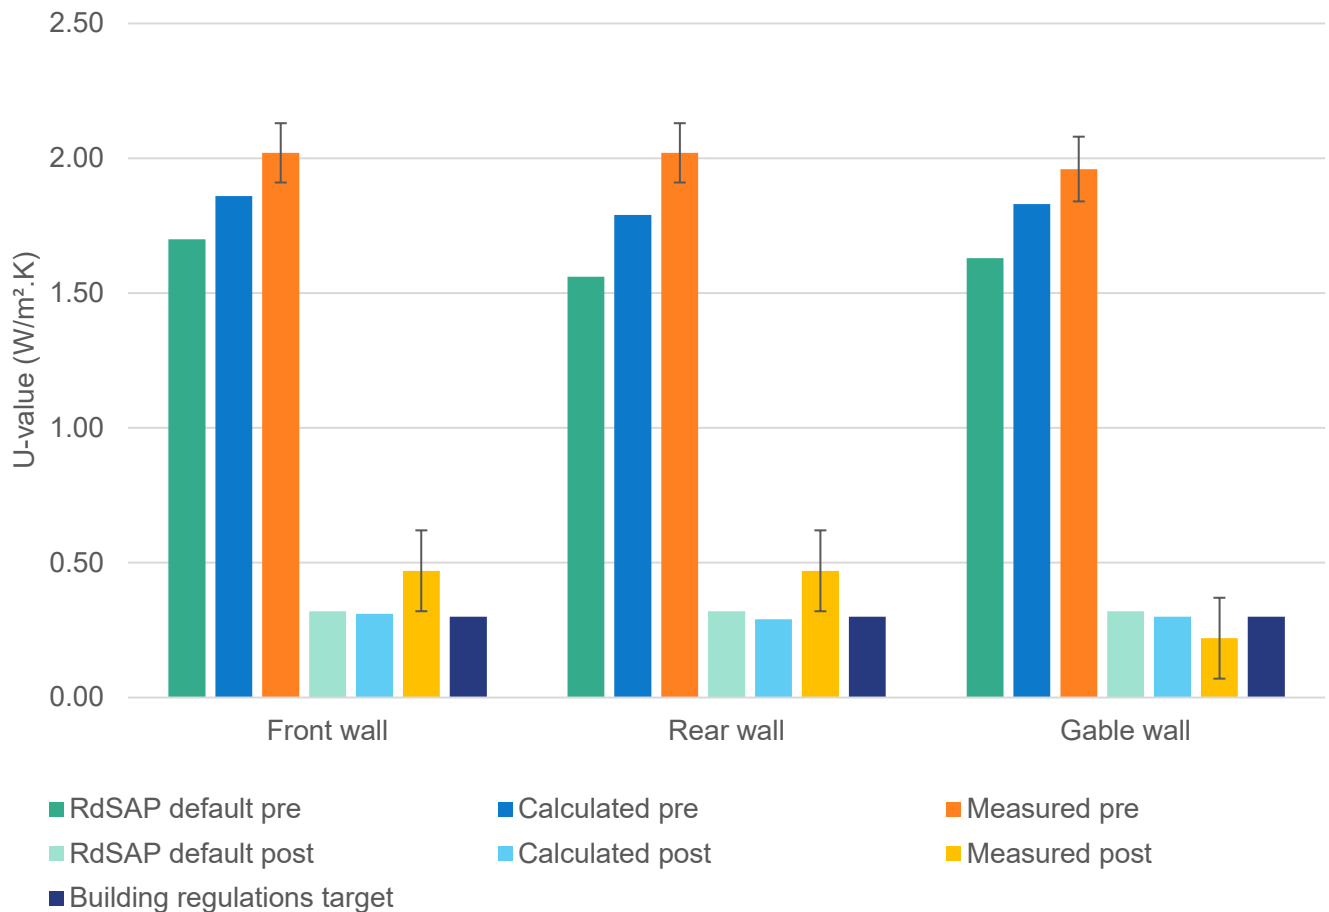
Figure 3-11 Wall pre- and post- U-values (W/(m²·K))

Figure 3-11 shows the U-values of the external solid walls, pre- and post-retrofit. The addition of the EWI onto the external walls provided a large improvement of between (77 ± 13) % and (89 ± 13) %.

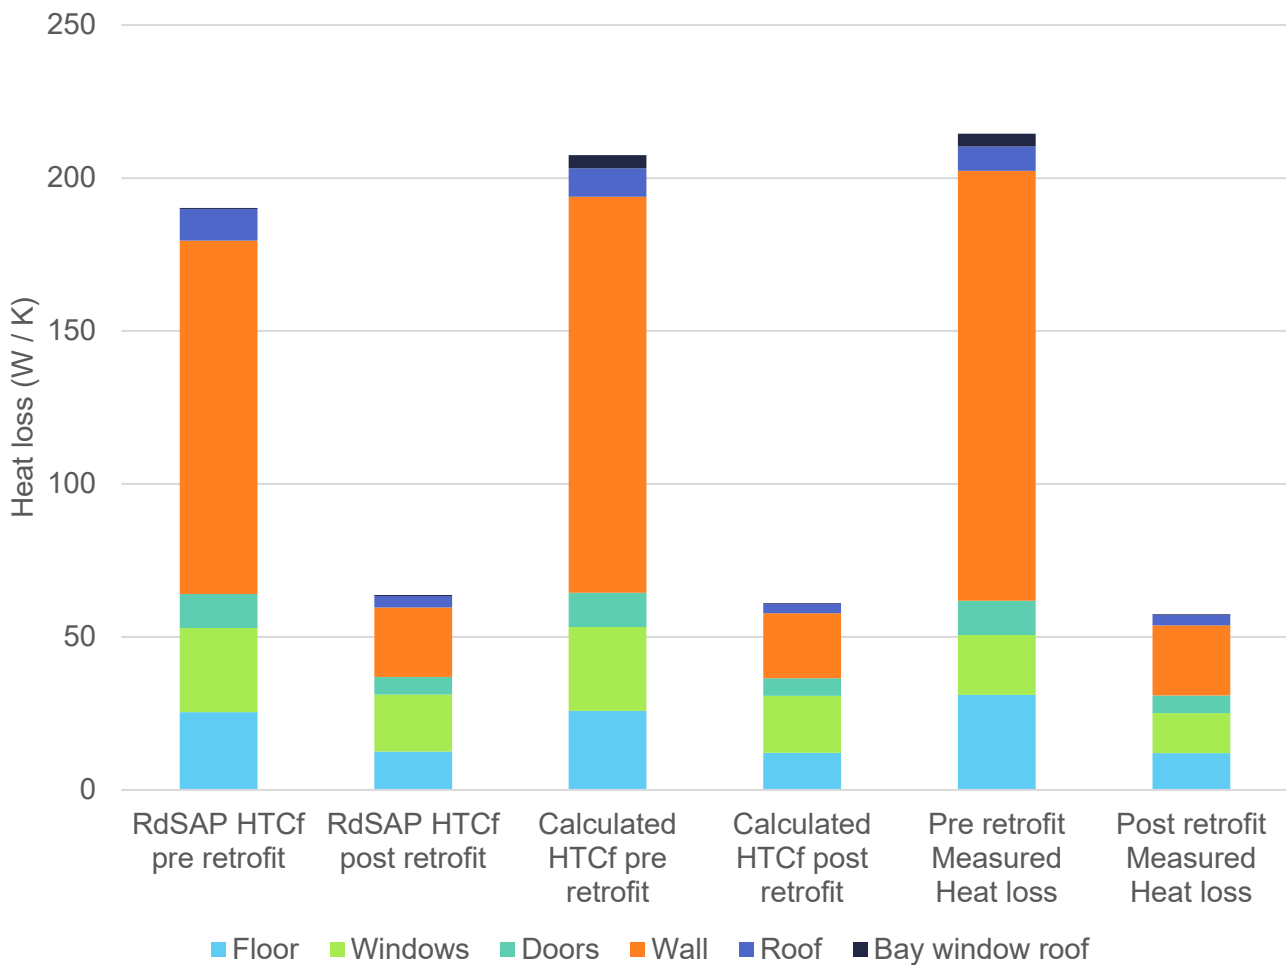
Figure 3-7 Measured heat loss of fabric elements pre- and post-retrofit

The most dramatic reduction was observed in the external wall heat losses, which were expected to reduce by around 84 %. The reduction achieved is so impactful since the home has a large gable wall, and therefore, a large heat loss area for this element from which savings could be made, coupled with a large reduction in wall U-values of between 79 % and 84 %. Installing EWI on end-terrace homes, therefore, may provide one of the most profound strategies for heat loss reductions for retrofit policy. The findings suggest that increasing the proportion of solid wall insulation installations taking place, could increase the impact of retrofits taking place in the UK housing stock.

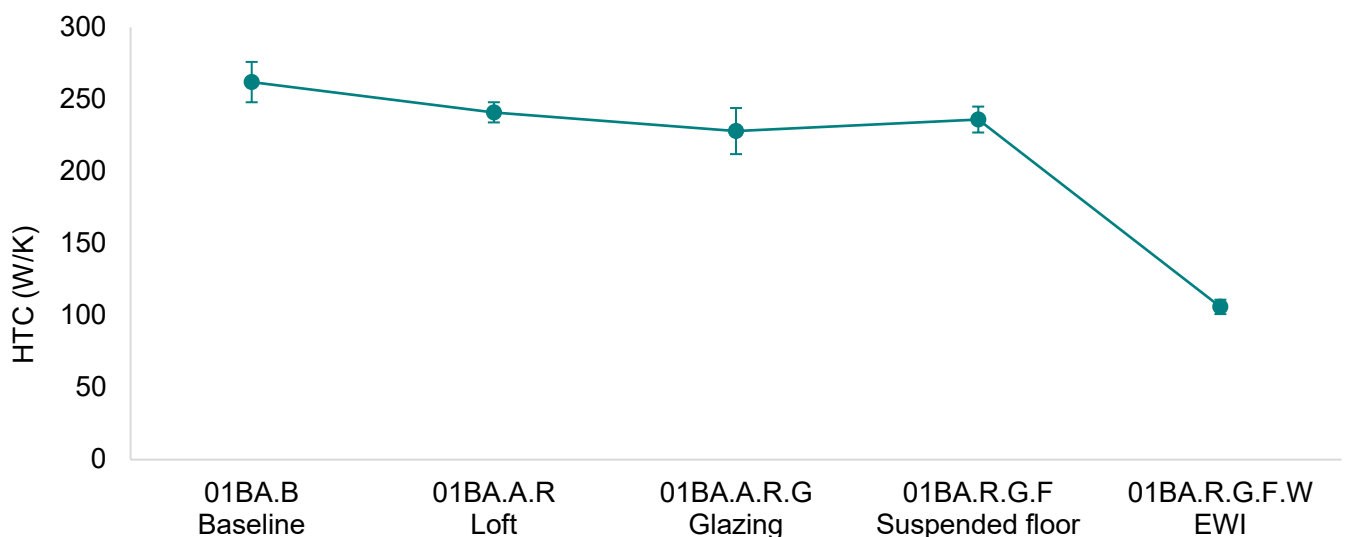
Figure 3-13 Coheating HTC at each retrofit stage

As can be seen in Figure 3-13, the uncertainty values of the coheating test were generally lower than the previously estimated uncertainty of 8 % to 10 % for the test.

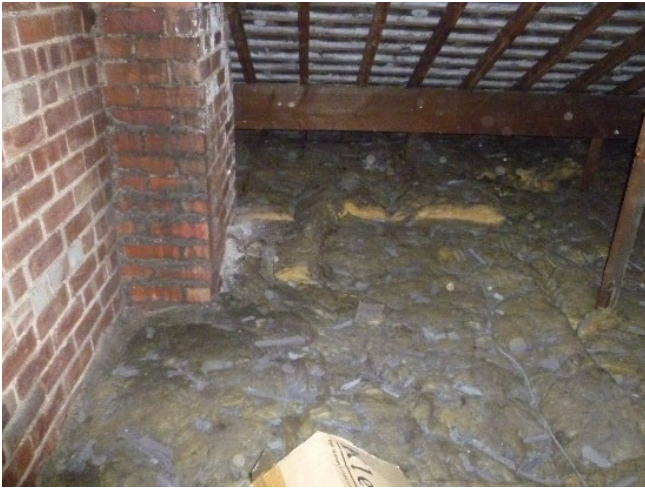
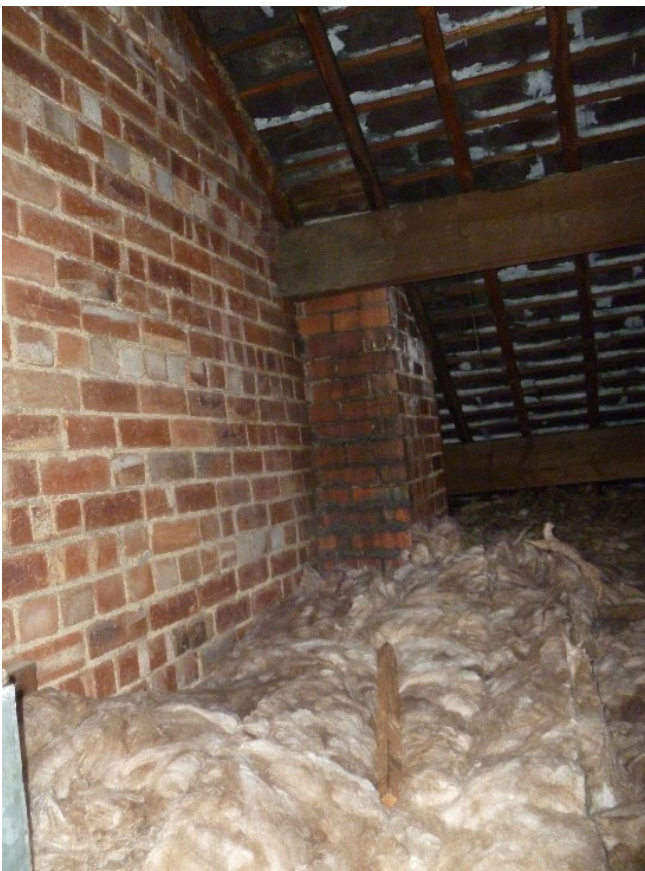
Figure 3-15 Comparison of original loft insulation (top) and new (bottom) showing bypassing and bridging at the chimney breast and the intersection between the party wall and the first-floor ceiling.

Whilst direct heat losses into the loft through the horizontal ceiling were clearly reduced, other heat loss mechanisms existed and are harder to quantify. Figure 3-15 illustrates one of these additional mechanisms. In this example, air inside the chimney bypasses the insulation layer located at the ceiling level both before and after the loft retrofit, although the additional depth of the retrofitted insulation lengthens the thermal bridge at the base of the chimney stack and along the party wall. The images also illustrate a thermal bypass at the intersection between the party wall and the first floor ceiling. Ventilation of unused chimneys is recommended to avoid moisture and condensation issues; for heat loss reduction the preferred solution would be to remove the chimneys and chimney breasts entirely, an option often not undertaken (and not considered here) due to the associated costs and level of disruption.

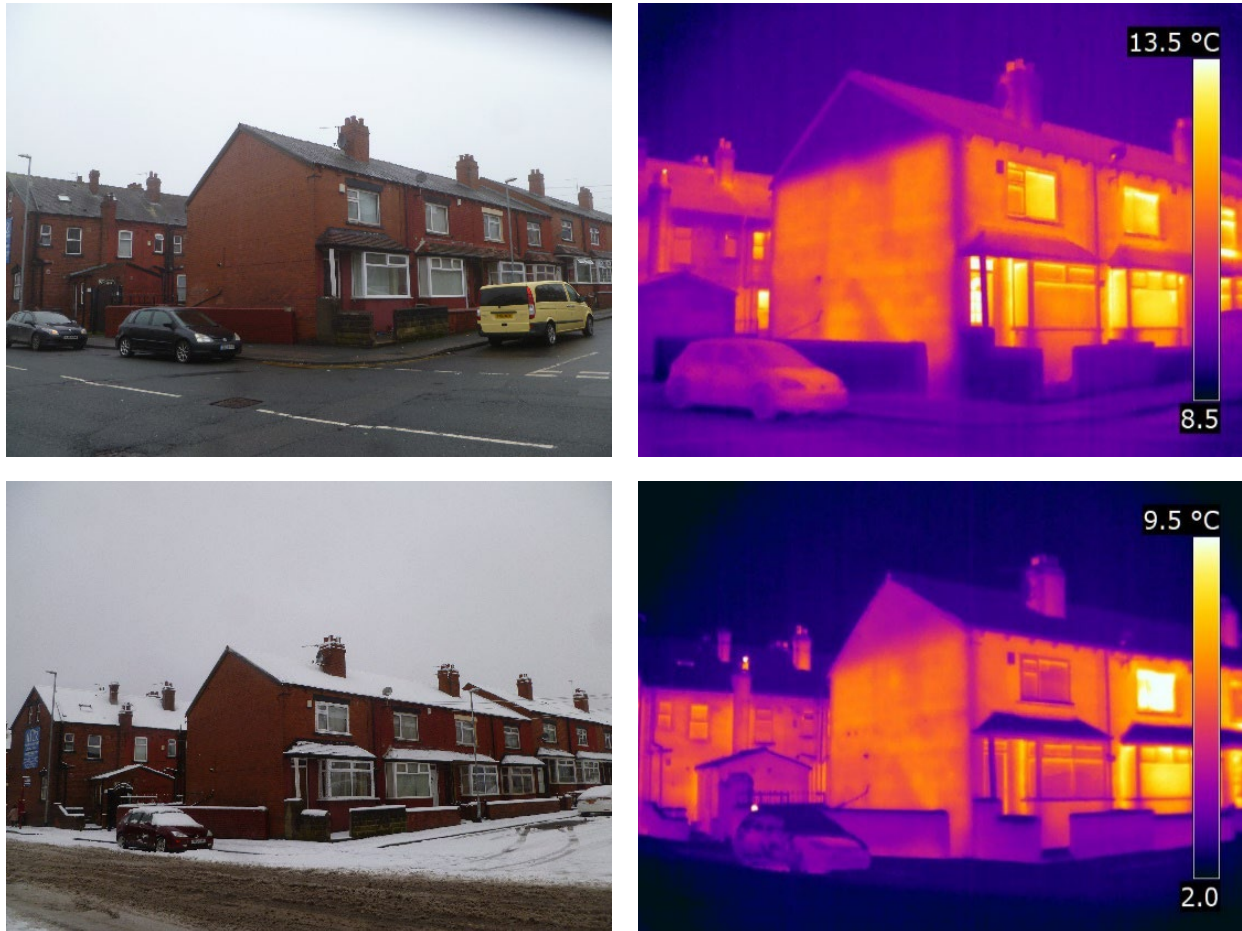
Figure 3-16 Comparison of old windows and doors (top) and replacements (bottom) on the front façade during coheating phases

The original uPVC double glazed windows were over a decade old and incorporated only very small openable areas, which may have implications for achieving adequate summertime cooling. The original doors were timber and in relatively poor condition. The next retrofit was therefore to upgrade these fenestrations, with new A rated double glazed windows and composite doors as shown in Figure 3-16.

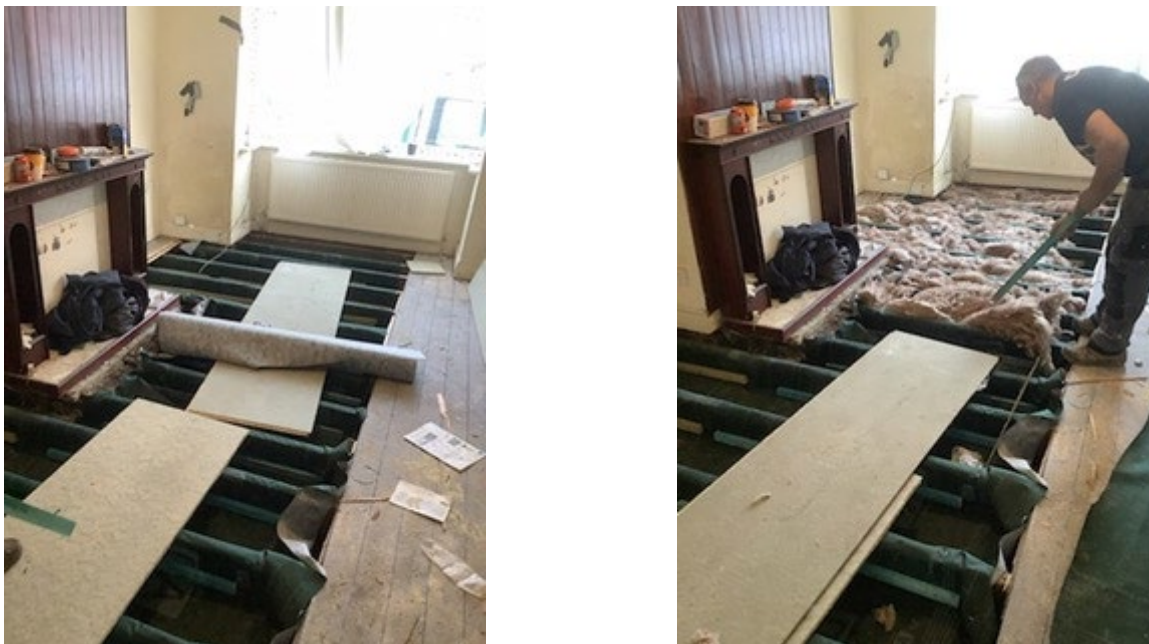
Figure 3-17 The airtight membrane was laid over and between floor joists in the living room (left hand side) and before the mineral wool insulation added (right hand side)

It is noteworthy that this retrofit did not result in a measurable reduction in the airtightness of the home. An air barrier membrane was specified as part of the suspended timber ground floor retrofit (Figure 3-17); however, it appears this was only partially successful. A reduction was observed through the living room floor, but not the hall and understairs cupboard. This suggests that a partial under floor membrane is not particularly effective since it changed the air leakage pathways and leakage points, rather than minimising air leakage overall. Reducing infiltration through the ground floor has been noted as being an important component of the ability of ground floor retrofits to reduce heat losses. More research into air leakage through suspended timber ground floors and how this can be minimised during retrofits is needed.

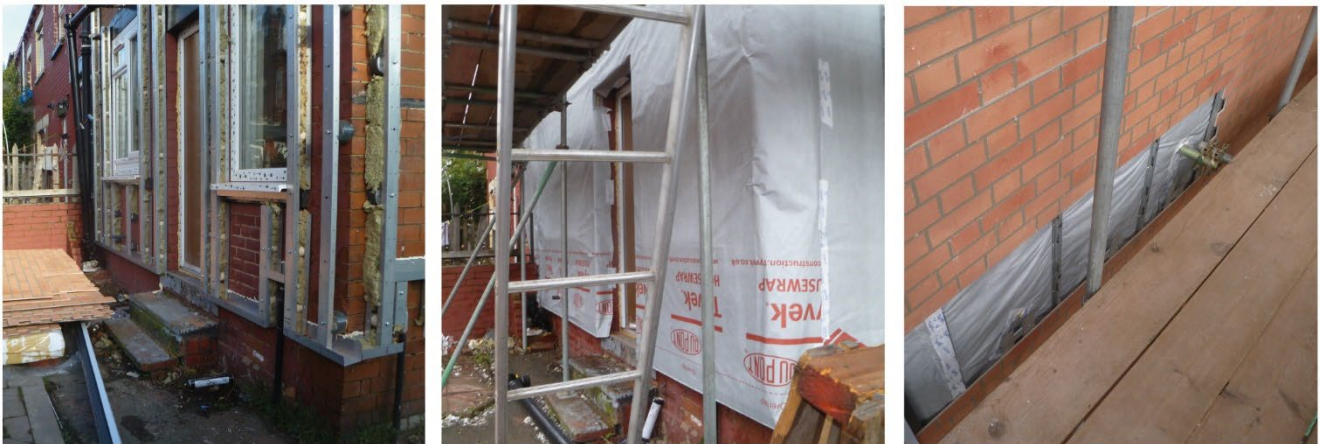
Figure 3-18 The EWI installation process. The steel section frame was put up (left hand side), then covered with a membrane and injected with insulation (middle). Finally, the pre-made rainscreen panels were added (right hand side).

The major retrofit success associated with this case study home was the EWI shown in Figure 3-18, which achieved a substantial reduction in overall HTC of (130 ± 10) W/K (55 ± 5 %). The main reasons for this large reduction can be attributed to the fact that the home was an end-terrace with a very large gable wall, meaning there was a large area of external wall that was insulated as part of the retrofit, accounting for almost 45 % of the entire dwelling heat loss area.

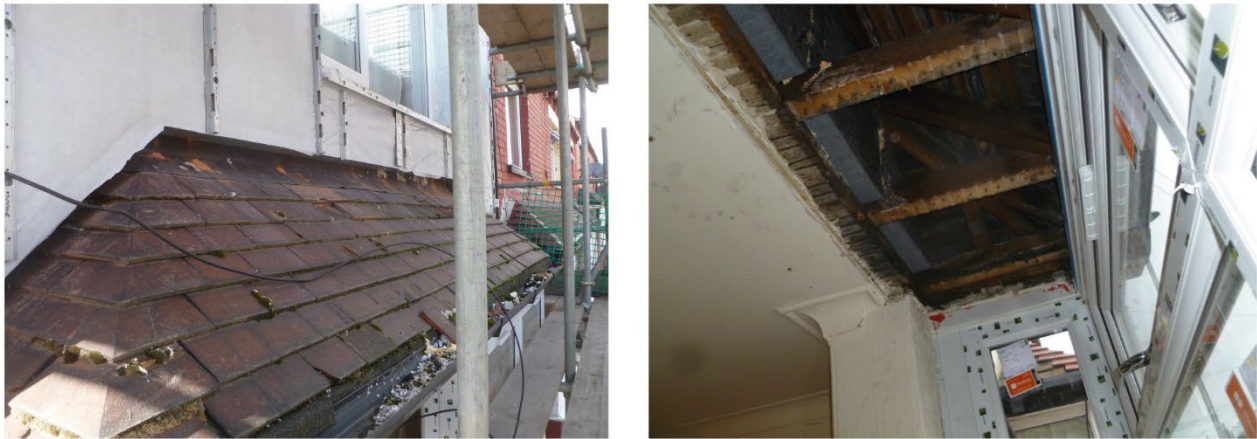
Figure 3-19 The bay window roof before rainscreen panels were added (left hand side) and internally, prior to insulation being installed (right hand side).

However, as this element only represents a relatively small heat loss area, it is likely to have had only a small contribution to the whole house HTC reduction measured. More significantly, the bay roof retrofit will have reduced the risk of the occurrence of surface condensation on the ceiling, which is discussed further in Section 3.5.
