DEEP Report 2.04

Case Study 01BA

Case Study 01BA is a two bed 1910 end-terrace in which a whole house retrofit was undertaken. The whole house retrofit was undertaken in stages, reflecting a piecemeal approach to retrofit, with stages comprising of loft insulation, new double glazing and composite doors, ground floor insulation, and external wall insulation (EWI). The performance of each individual retrofit stage was assessed for airtightness, thermal performance, and moisture risk. This case study also provided the opportunity to investigate a traditional retrofit journey that a home may make over several decades, and understand how piecemeal retrofit affects whole house performance. It also explores the impact of installing suspended ground floor insulation when only half the ground floor was of a suspended construction.

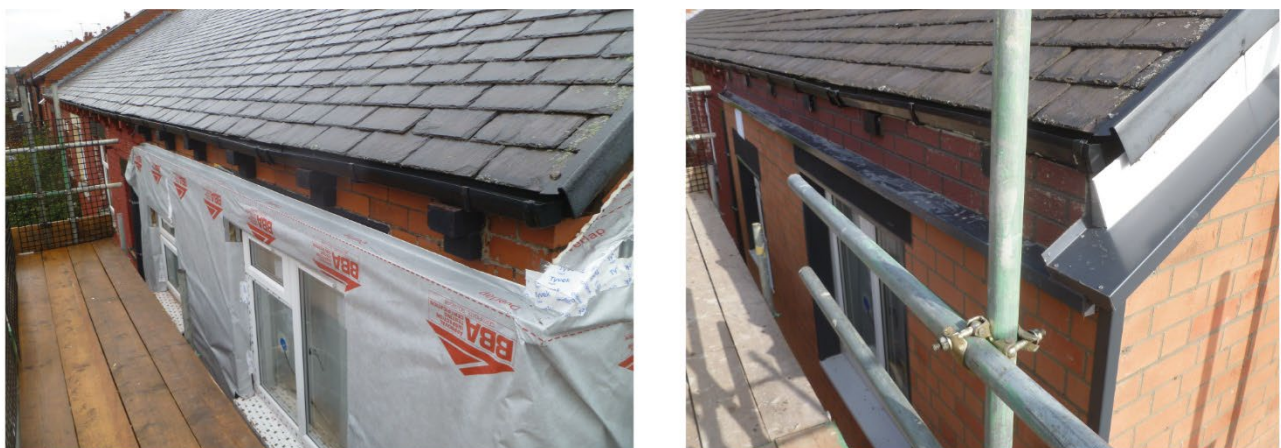
Figure 3-20 EWI was installed up to the underside of the corbels, where an insulated render based EWI system was used to accommodate the brickwork feature.

There were several other interesting features of note, particularly those areas of the dwelling that were insulated with an 75 mm XPS foam, below the DPC and the corbels at the eaves (Figure 3-20), since the same system that was used for the rest of the house could not be used to insulate these areas.

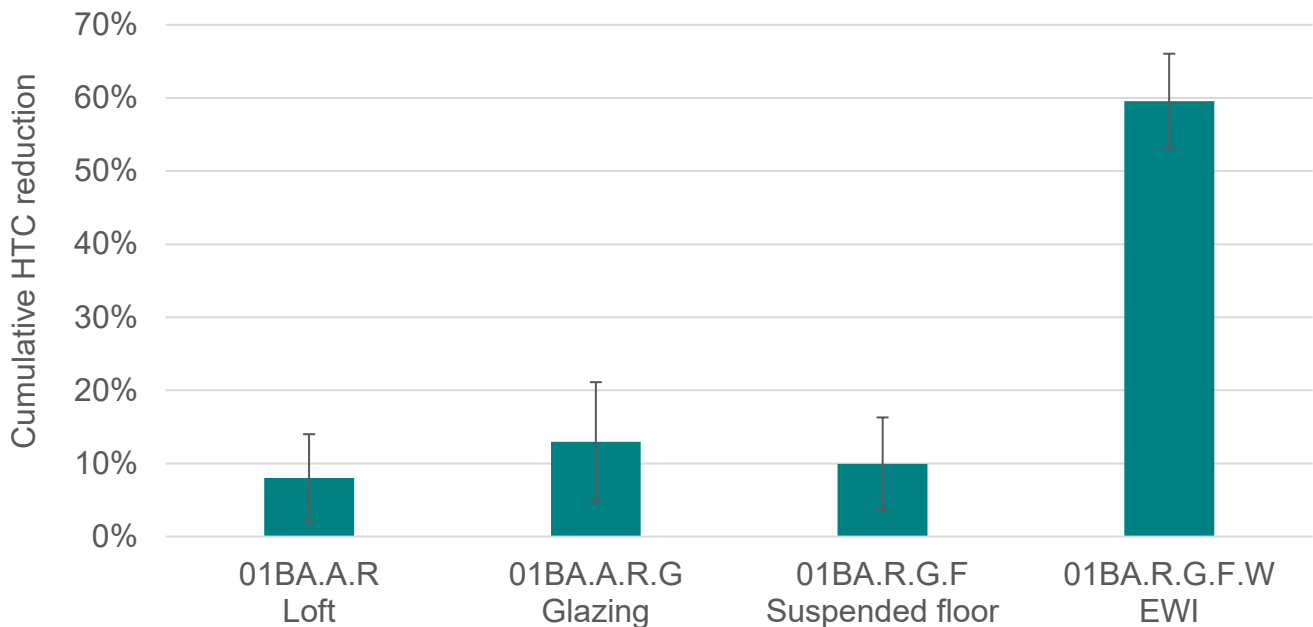
Figure 3-21 Cumulative HTC savings from each retrofit stage

The cumulative HTC reductions as measured by the coheating tests are shown in Figure 3-21. This illustrates the scale of savings made, and that almost all the retrofit savings were achieved by the EWI retrofit. The uncertainty in the test makes it difficult to have certainty on the specific benefits of each of the other specific retrofits.

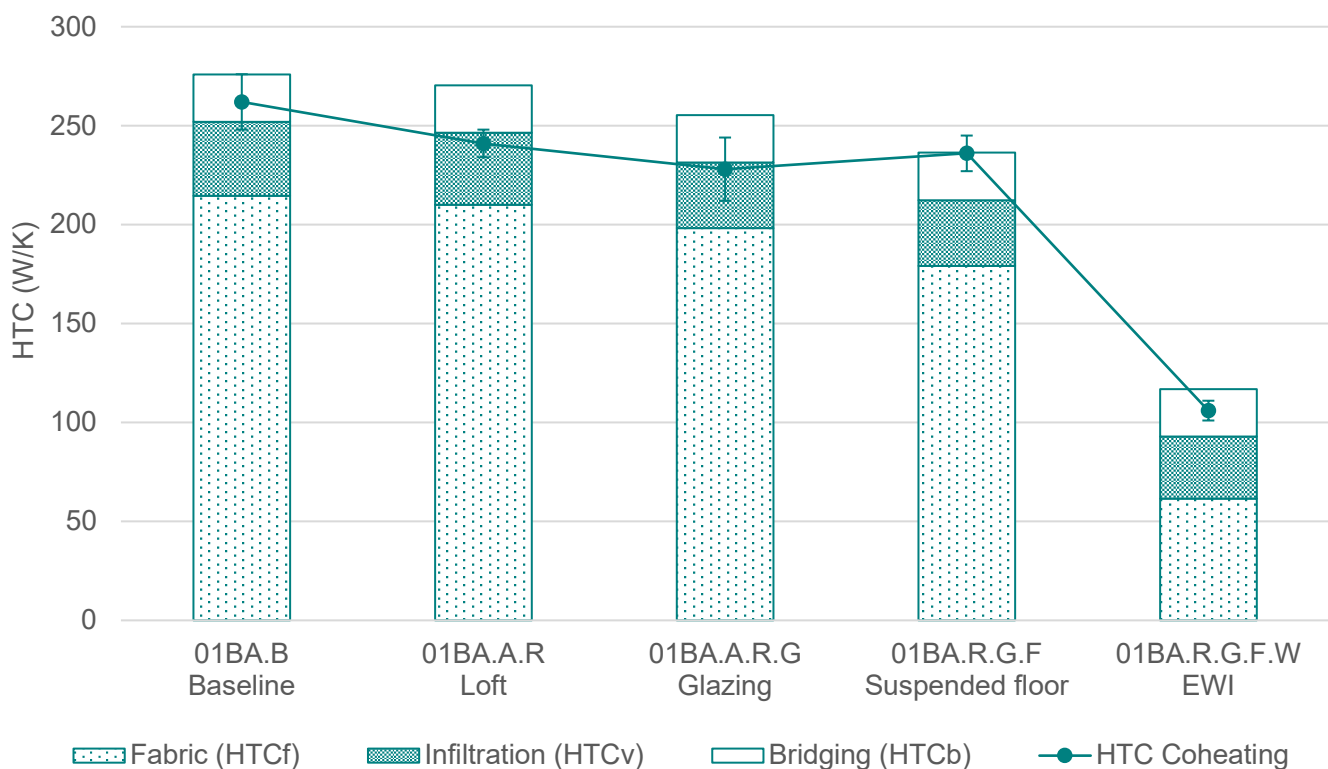
Figure 3-22 Calculated vs measured HTC

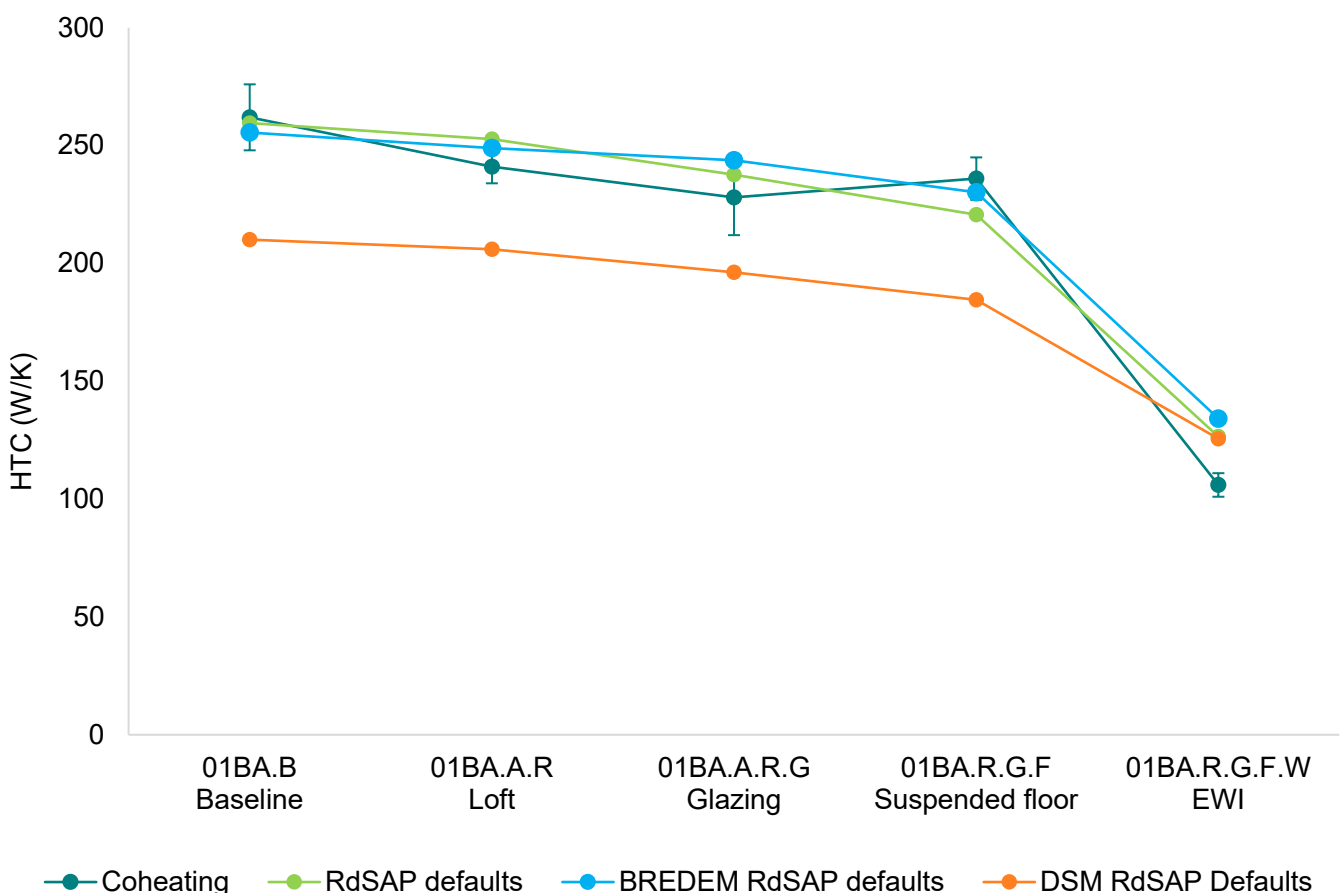
Figure 3-23 Measured vs modelled HTC calibration step 1: default data

- Although the DSM had a much lower starting base case than the other models, once all of the retrofits were undertaken, the results from all of the models converged, such that was significantly less difference in the total HTC between all the models.

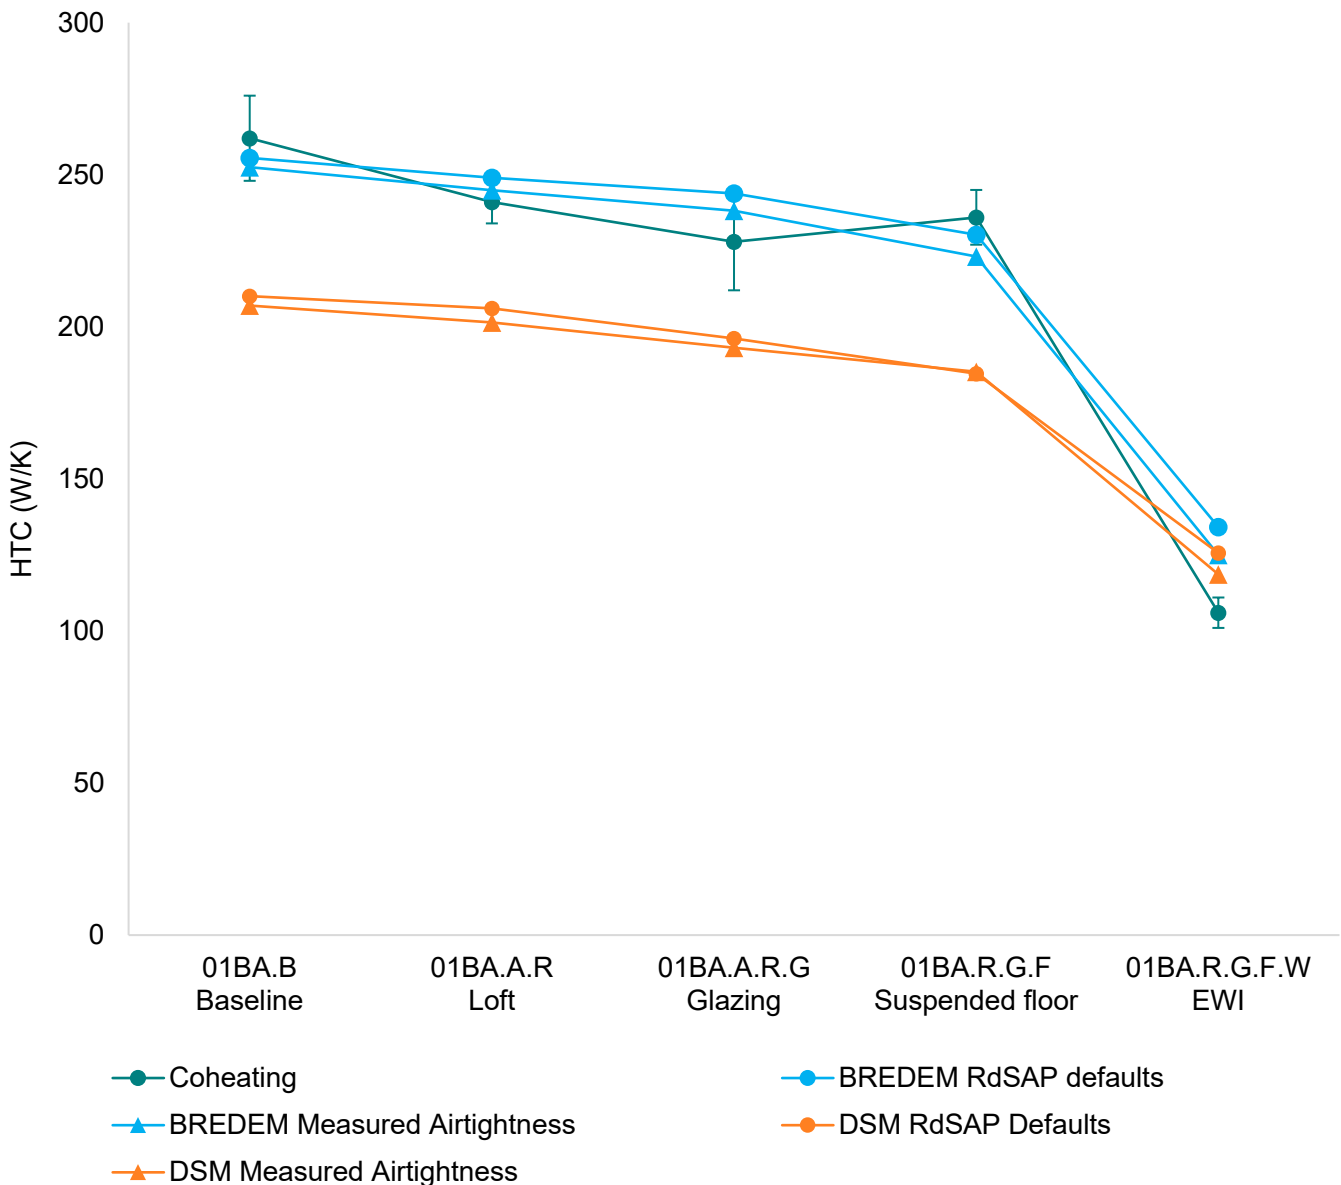
Figure 3-24 Measured vs modelled HTC calibration step 2: measured infiltration

- RdSAP is not included in this step as infiltration cannot be altered in the software.
- A relatively small reduction in HTC is observed in this stage since the default infiltration rate of the house was relatively similar to that which was measured.
- This reduction brings the steady-state predictions for the loft, glazing, and EWI retrofit stages more in line with the measured values. However, all the other stages, including the base case, and all the DSM predictions move marginally further away because they were already lower than the coheating measurements.

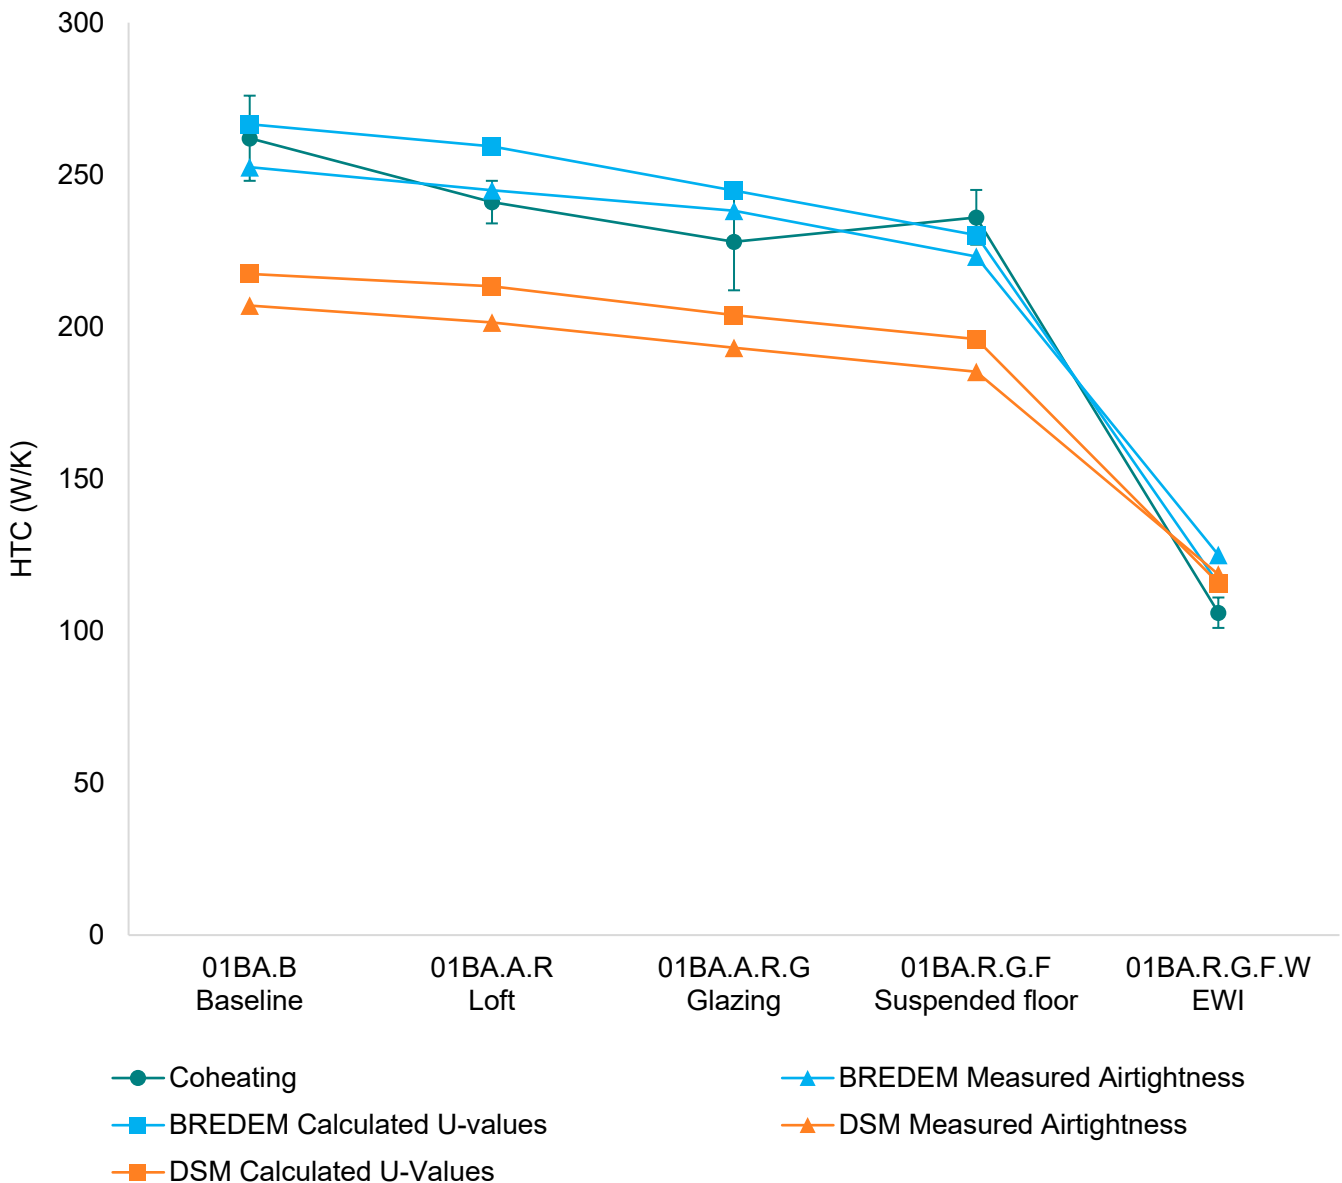
Figure 3-25 Measured vs modelled HTC calibration step 3: calculated U-values

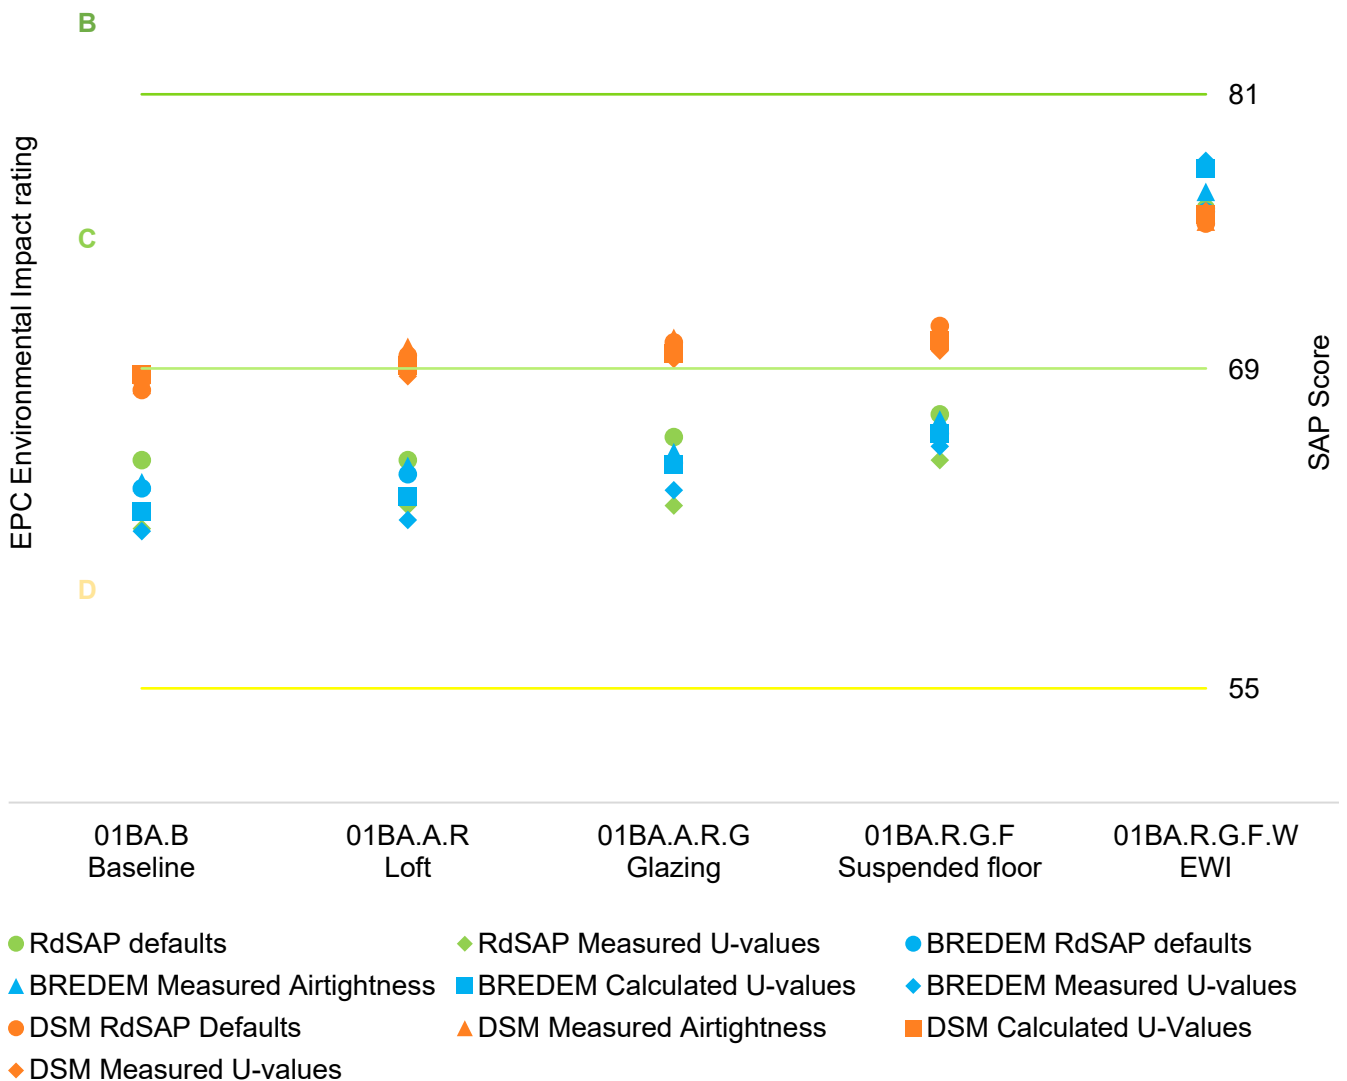
Figure 3-27 Predicted impact of retrofits on EPC band

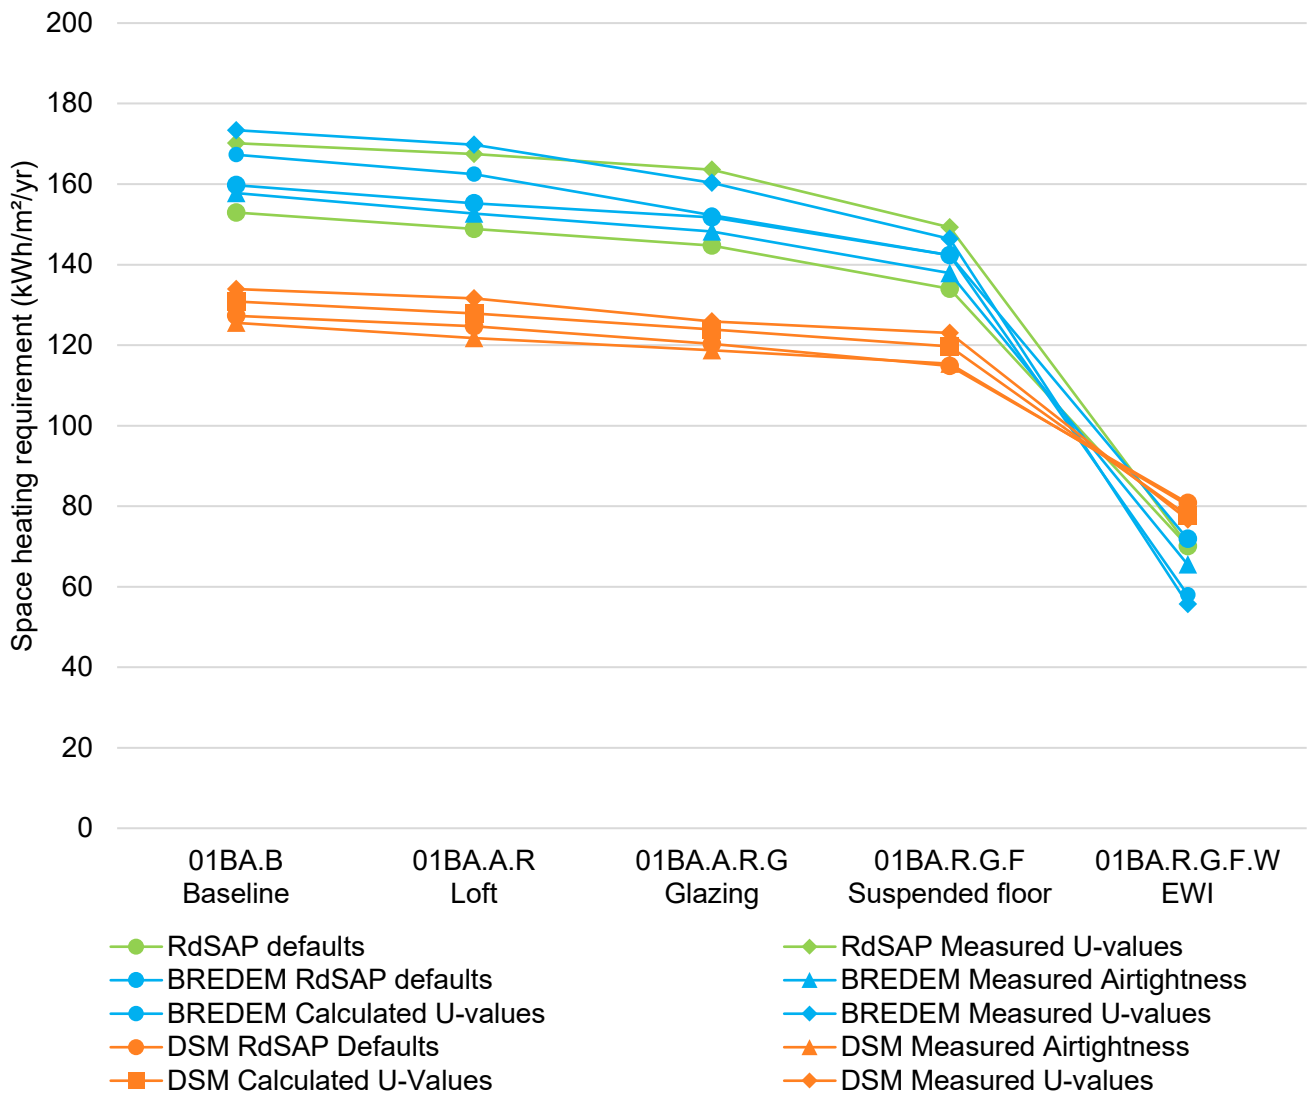
Figure 3-28 Predicted cumulative reduction in annual space heating demand

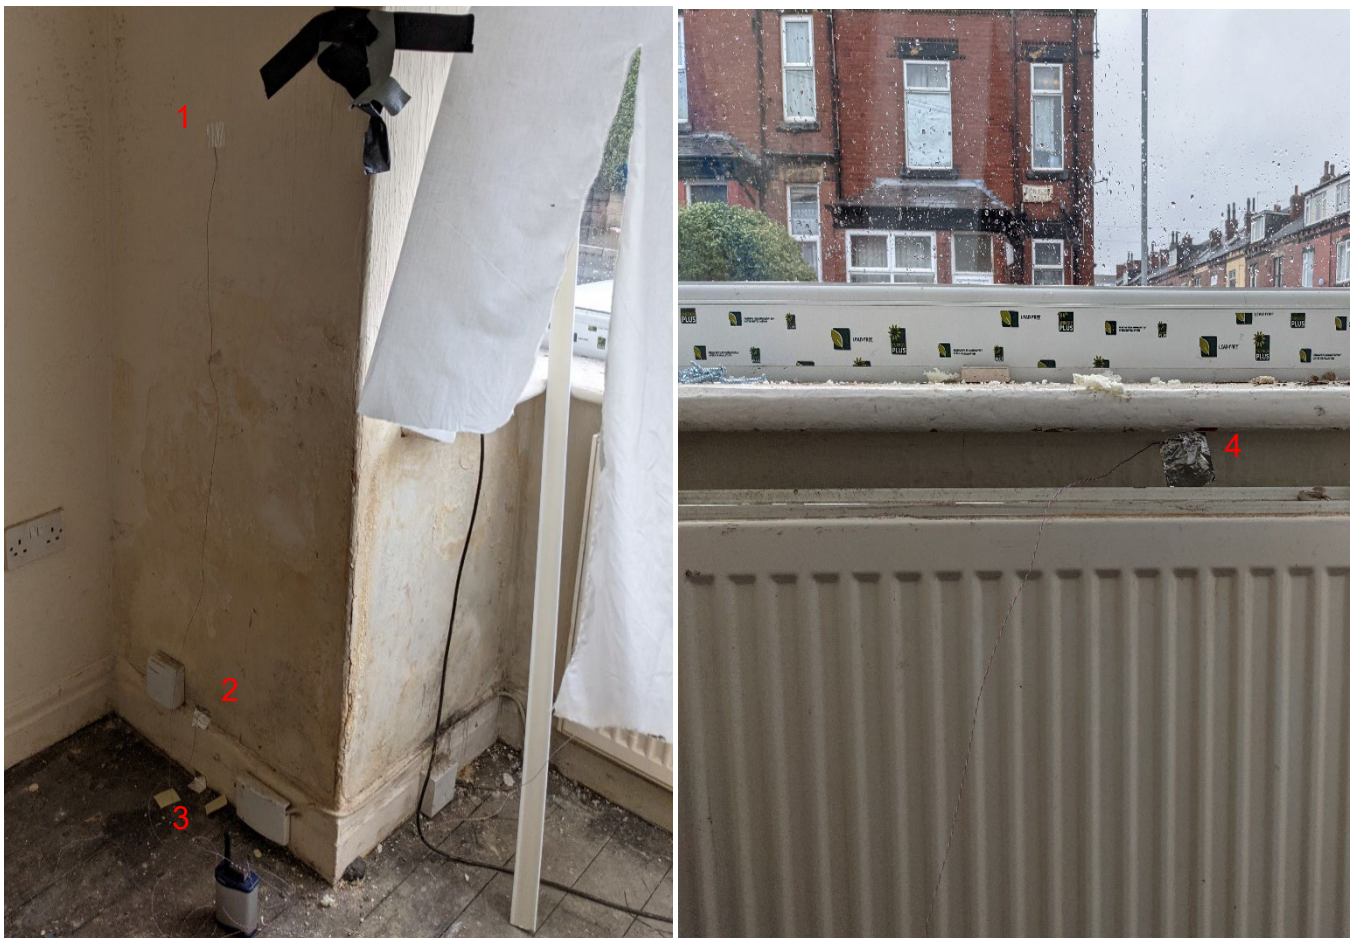
Figure 3-34 Position of thermocouple sensors in living room. Left: sensors on external wall. Right: sensor below window sill.

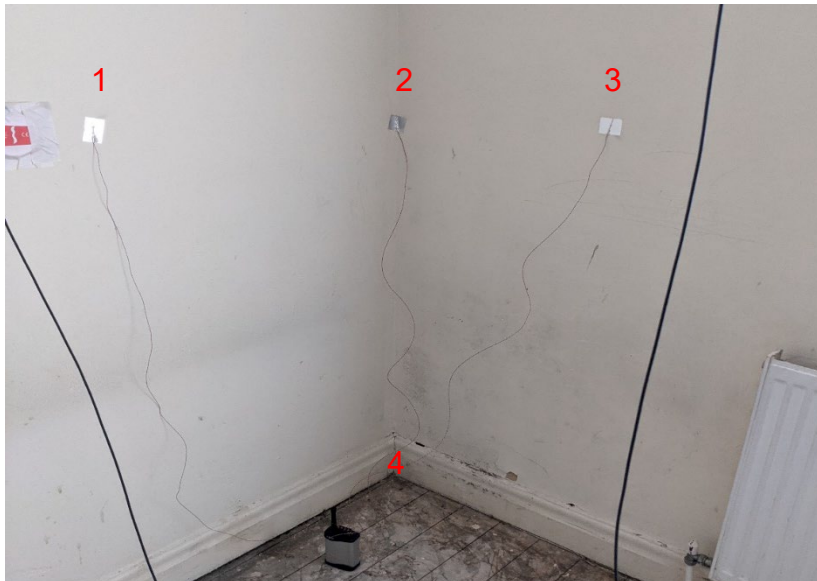
Figure 3-35 Bedroom 1 - front wall to party wall junction, surface temperature sensors.

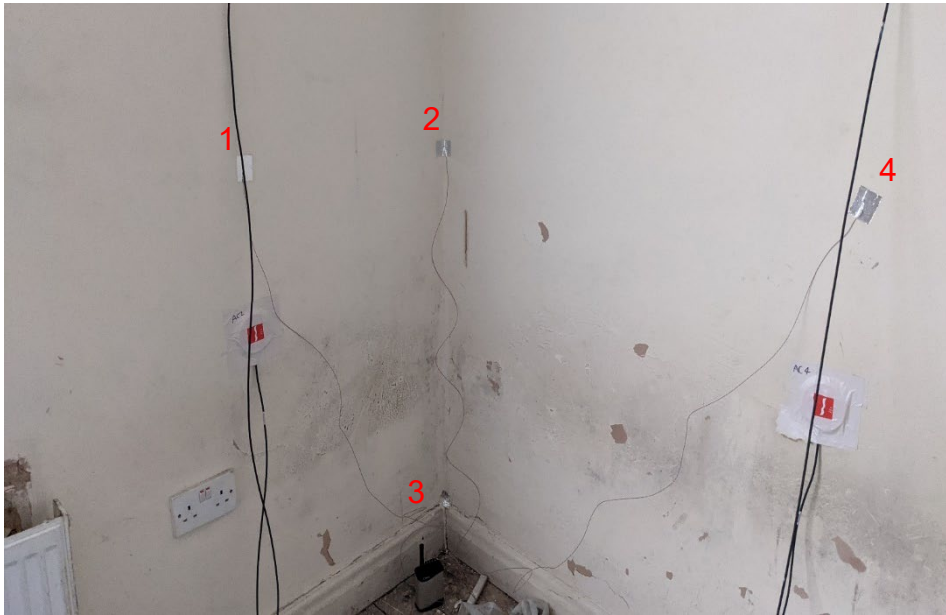
Figure 3-36 Bedroom 1 - external corner junction surface temperature sensors

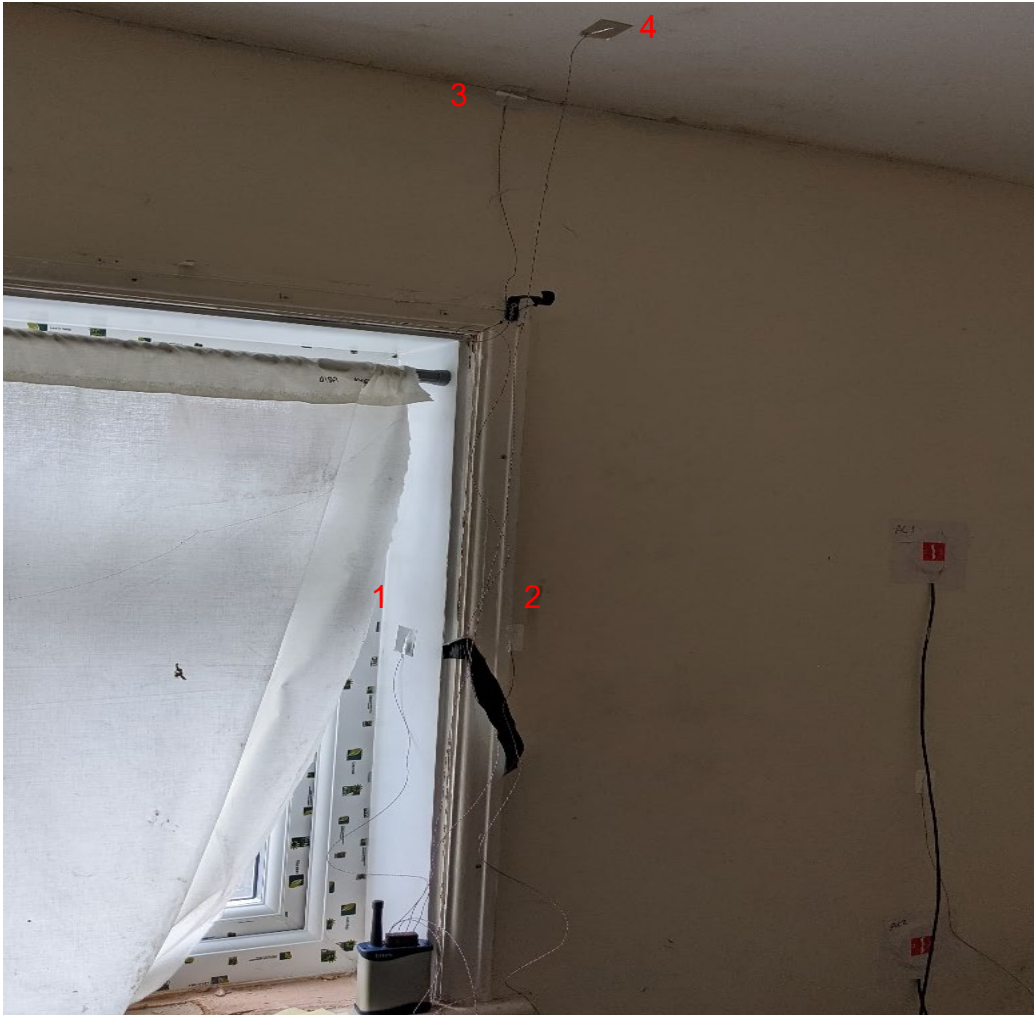
Figure 3-37 Bedroom 1 window and ceiling surface temperature sensor locations.
