DEEP Report 2.09

Case Study 27BG

October 2024

Case study 27BG is a two-bed 1890 solid walled dwelling with a room-in-roof. It is a back-to-back style terrace home resulting in a very large area of party wall. Two comparable suspended timber ground floor retrofits were undertaken. In the first, XPS boards were installed between the timber joists. This was then removed and replaced with mineral wool of equivalent performance. The case study provided the opportunity to evaluate retrofits in house types with large areas of party walls, explore the risks and performance of suspended floor retrofits in this type of house and compare two common ground floor retrofit approaches.

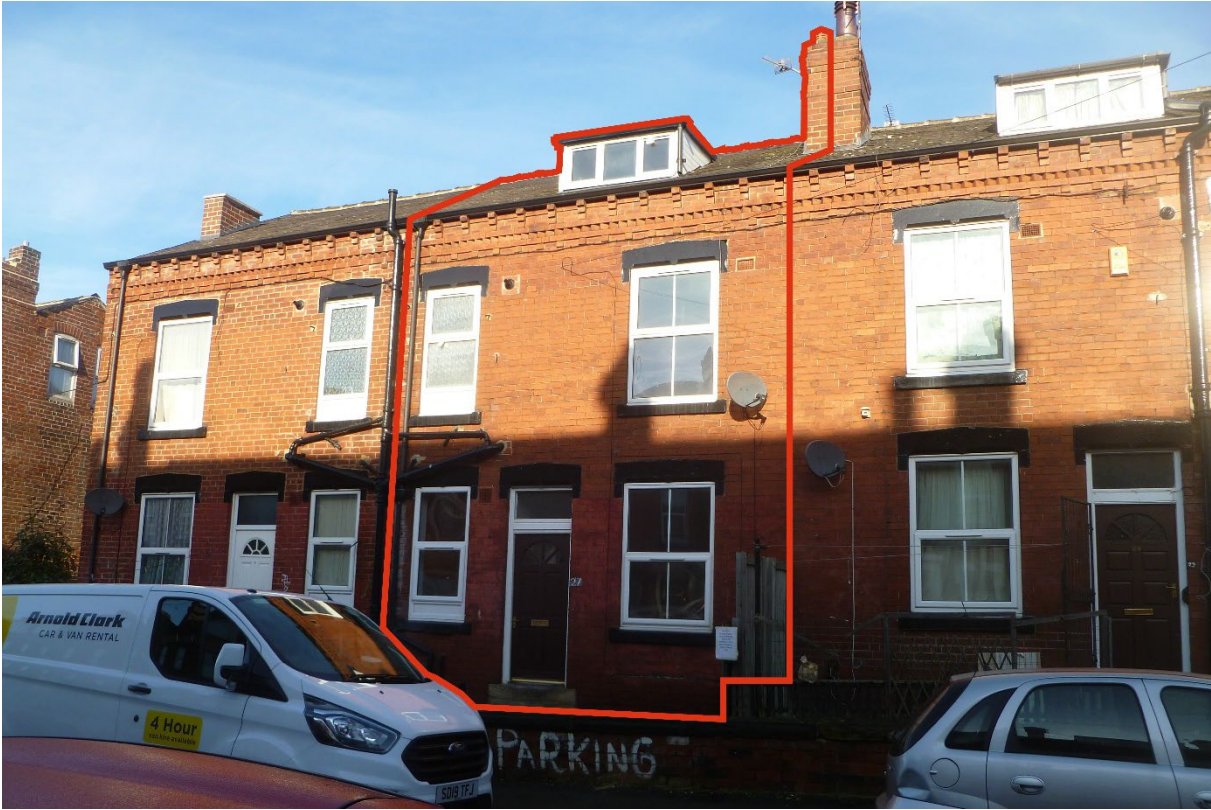
27BG, shown in Figure 1-1, is a two-bedroom property in Leeds, West Yorkshire, built around 1890. It is a mid-terrace back-to-back (i.e., neighbours to the sides and rear), made of solid nine-inch brick, so it has only one external wall (front). It also has a chimney stack, a room-in-roof, a half-basement and a suspended timber ground floor. Entry is directly into the Living Room, with the Kitchen also on the ground floor. Stairs up to the middle floor (comprising Bedroom 1 and Bathroom) are at the rear of the Living Room. Stairs down to the basement, which spans part of the ground floor, are accessed through the Kitchen. Bedroom 2 is in the roof. While the Living Room and Bedroom 1 have chimney breasts, they are both sealed.

Figure 1-1 Case study house

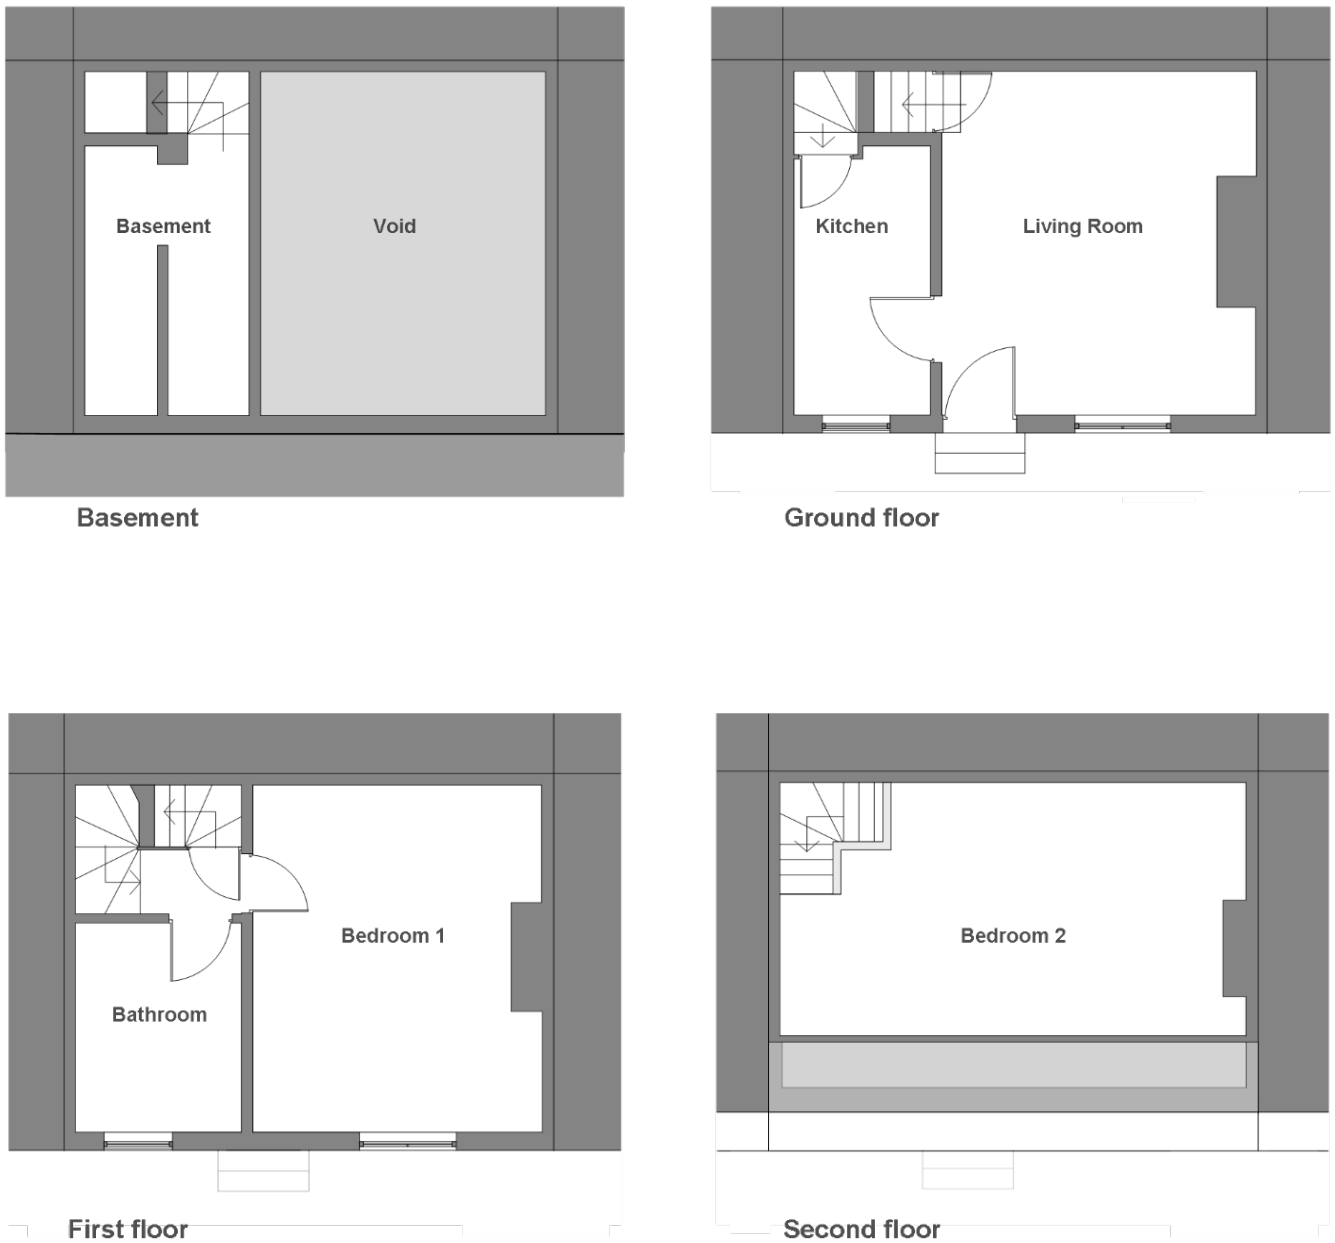
Figure 1-3 House floor plans

The floor plans, elevation and sections for the dwelling are given in Figure 1-3 and Figure 1-4.

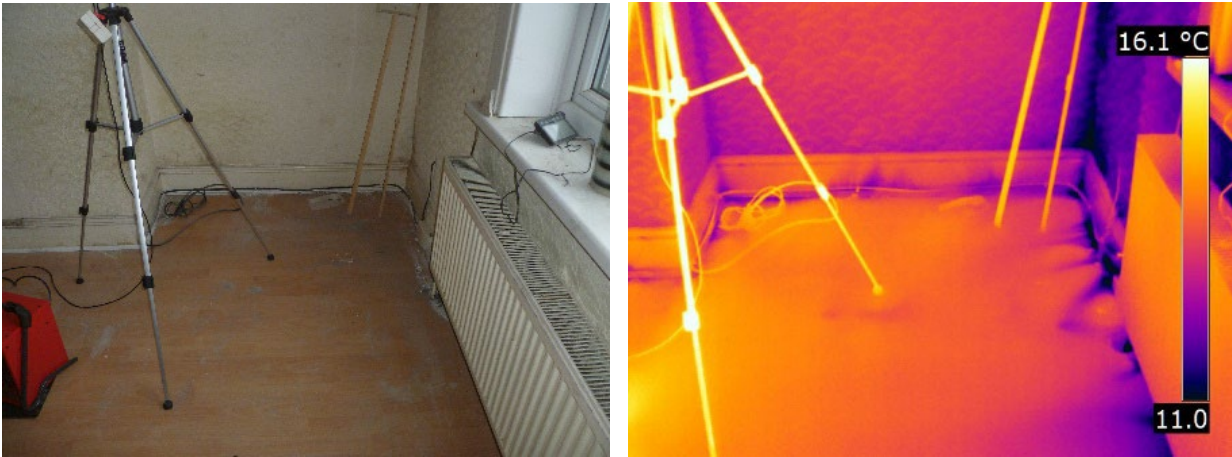
The major air leakage routes in 27BG were mainly through the suspended timber ground floor, at the perimeter of the intermediate floors, via penetrations in the building fabric around services, at the window sills and at the basement door, as shown in Figure 3-1 to Figure 3-5.

The unsealed penetrations and window sills created direct air exchange with the outside. The suspended timber ground floor was unsealed and so the infiltration here illustrates air exchange with the basement.

Figure 3-2 Base case infiltration around the ground floor perimeter during depressurisation

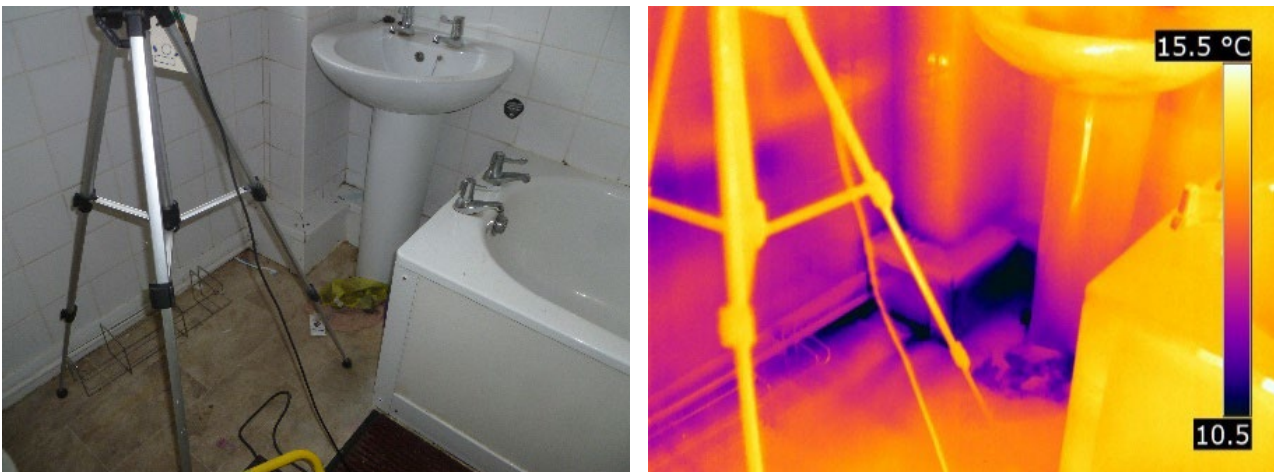
Figure 3-4 Base case infiltration around boxed-in services during depressurisation

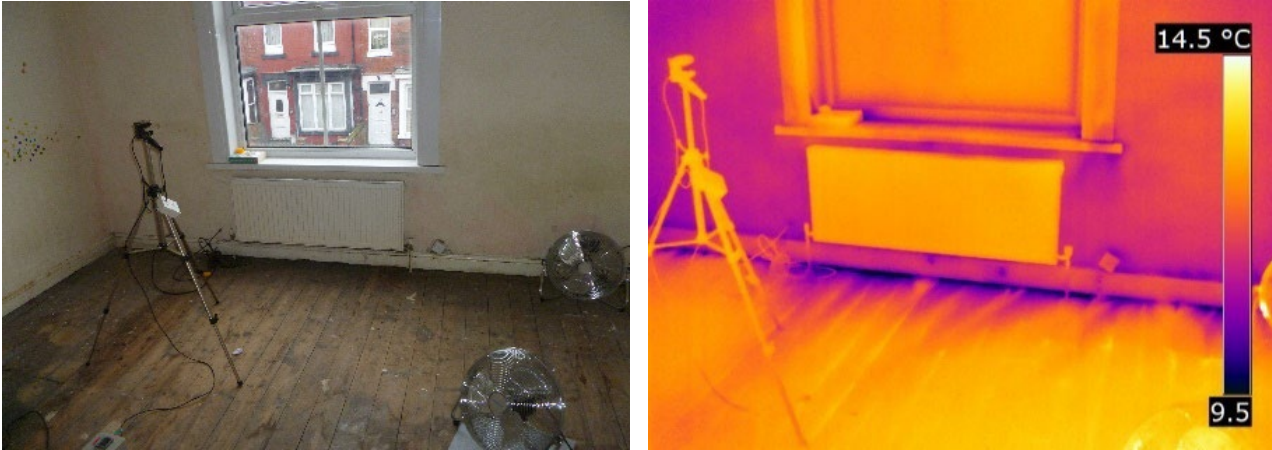
Infiltration via the intermediate floor void was observed to be close to external temperatures under depressurisation, which is suggestive of air exchange between the floor void and mini cavities in the external walls or with services routes that enter the intermediate floor.

Figure 3-5 Base case infiltration around the perimeter of the intermediate floor during depressurisation

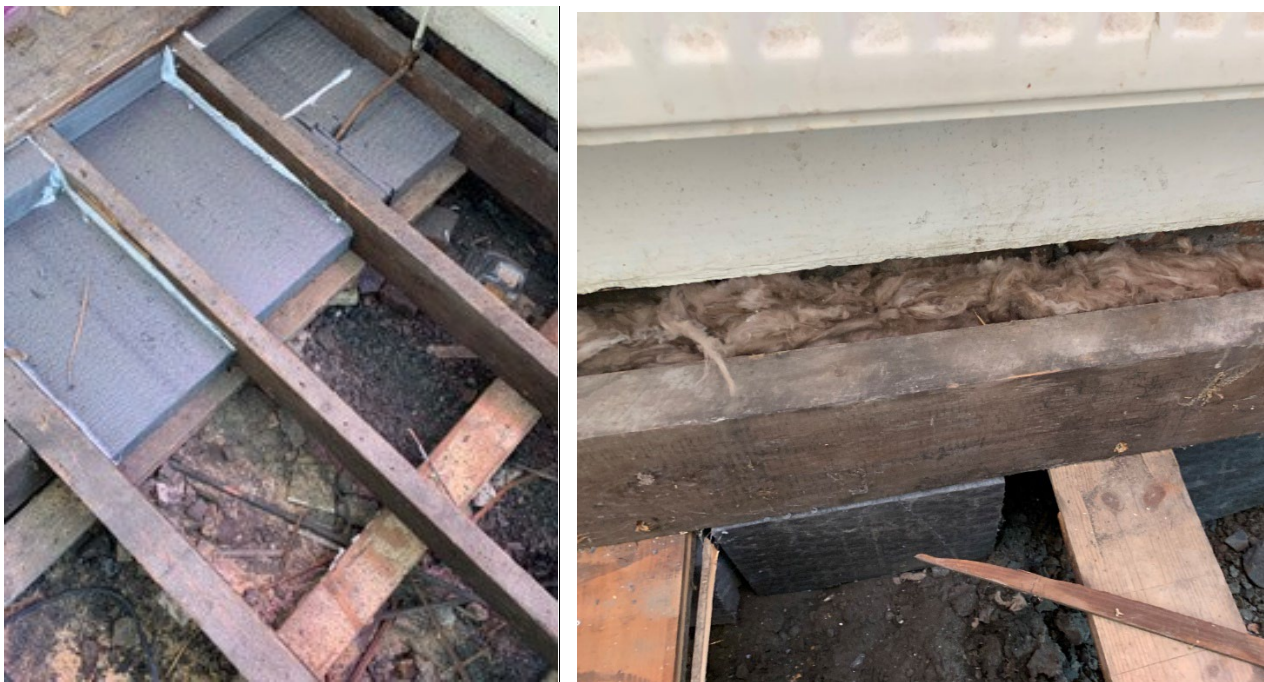
The XPS was installed between the floor joists and sealed using expandable foam. Since the joist was too close to the wall, it was not possible to fit XPS at the perimeter so mineral wool was installed here to maintain the insulation layer, as shown in Figure 3-6. Figure 3-7 shows the encapsulated mineral wool installation between the floor joists.

Figure 3-6 XPS installed between joists (left) mineral wool at floor perimeter (right)

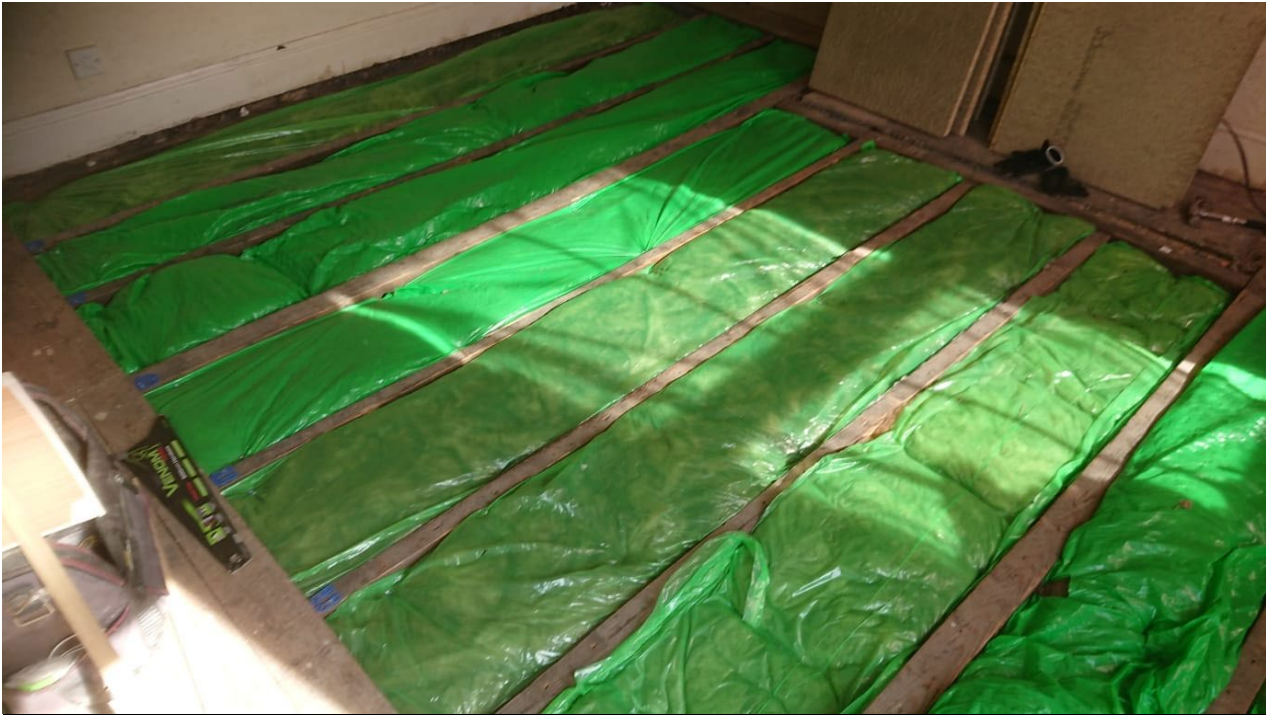
Figure 3-7 Mineral wool installed between joists

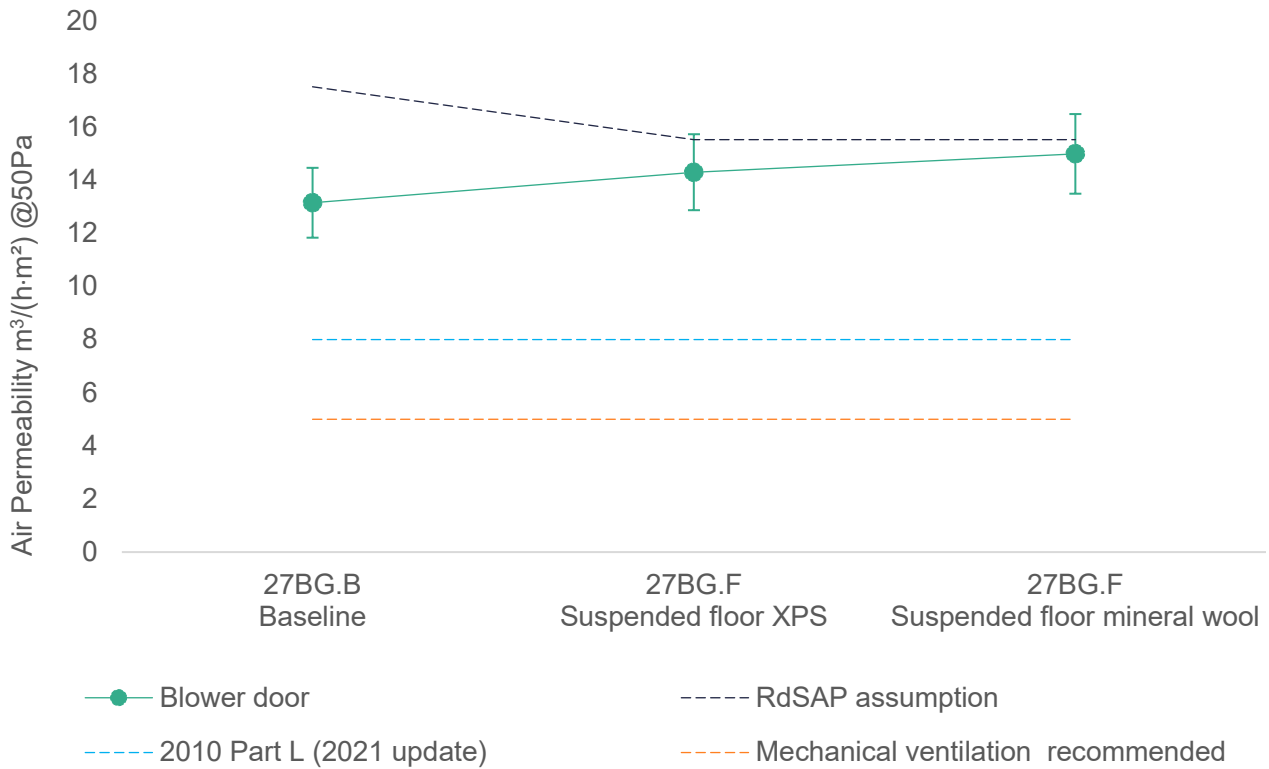
The results of the blower door tests are shown in Figure 3-8 and the airtightness of the house is well above the maximum allowable for new build homes in all retrofit states. In the baseline state, the RdSAP substantially over-predicted the air leakage taking place in the home, though the prediction was similar in the retrofitted state. Thus, using predicted infiltration to estimate ventilation heat losses in RdSAP can cause inaccuracies in EPC models.

Figure 3-8 Airtightness at each retrofit stage

Following the ground floor retrofits, the infiltration rate increased slightly with the mean air permeability rising from 13 to 14 $\text{m}^3/(\text{h}\cdot\text{m}^2)$ @ 50Pa for the XPS ground floor retrofit and 15 $\text{m}^3/(\text{h}\cdot\text{m}^2)$ @ 50Pa for the mineral wool floor retrofit. The removal of the laminate floor covering in the living room and linoleum in the kitchen prior to the ground floor retrofits would have contributed to this increase. The floor coverings were not replaced for the post-retrofit air tests. However, the scale of change in airtightness is still in line with the uncertainty of the test.

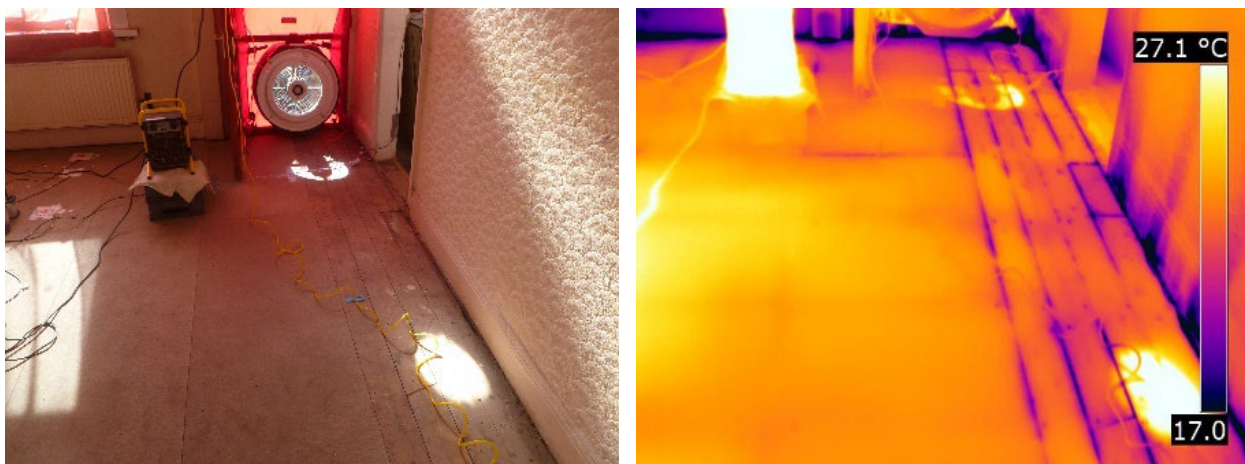
As mentioned, thermography undertaken during depressurisation confirmed that the air leakage around the ground floor perimeter persisted after the ground floor retrofits, as shown in Figure 3-9. An air barrier membrane was specified to accompany the ground floor retrofits, though it appears it was either omitted or installed unsuccessfully.

This finding suggests that, if floors are insulated without air barrier membranes, savings may not be maximised, as ground floor air leakage may not be addressed by insulation and new floor coverings alone.

Figure 3-9 Infiltration around the perimeter of the suspended timber ground floor after XPS retrofit during depressurisation

The infiltration for the base case home was initially lower than the 17.5 $\text{m}^3/(\text{h}\cdot\text{m}^2)$ @ 50Pa for the house predicted in RdSAP. The RdSAP model predicted that the air leakage would reduce following the floor insulation, which was not observed in the case study. Although infiltration through the floorboards was reduced post-retrofit, due to the installation of new tongue and groove flooring sheets, as shown in Figure 3-9, air leakage pathways around the floor perimeter persisted.

Infiltration was observed around the perimeter of the ground floor post-retrofit using thermography during depressurisation, indicating that the specified air barrier membrane was either not installed or not effective.

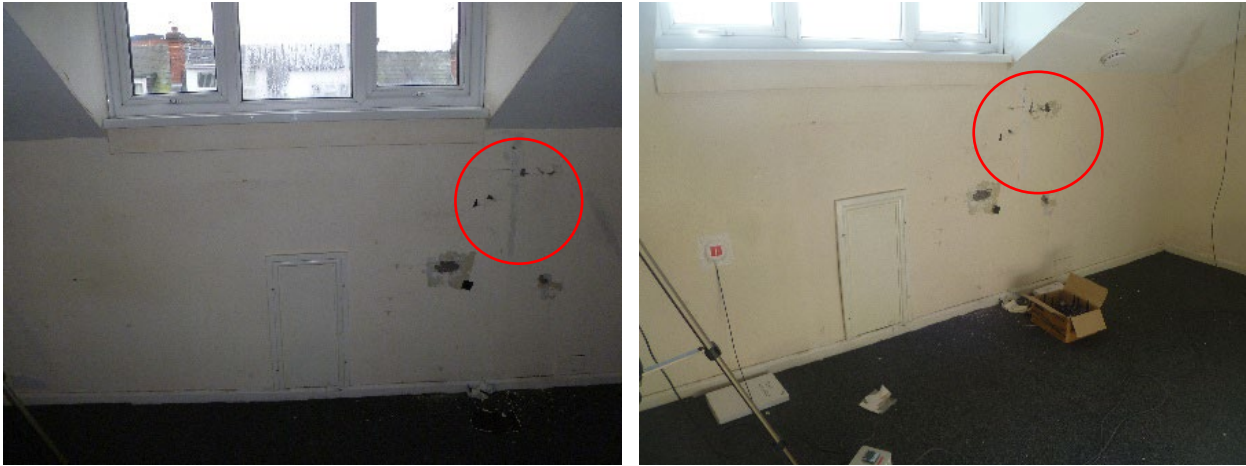
Additionally, cracked plasterwork was observed in the room-in-roof knee wall which deteriorated over the course of the test, and may have marginally increased infiltration. This may have implications for the savings measured by the coheating tests as well as the suitability of the blower door test method where there is already damage to the building fabric.

Figure 3-10 Deteriorating fabric causing worsening infiltration between first test (left) and final test (right)

The blower door results and observations suggest there may have been a progressive worsening of the airtightness of the home with deterioration of other building elements, though the difference is within the uncertainty of the test. This increase may be linked to a new air leakage pathway being detected as the study proceeded, as shown in Figure 3-10.

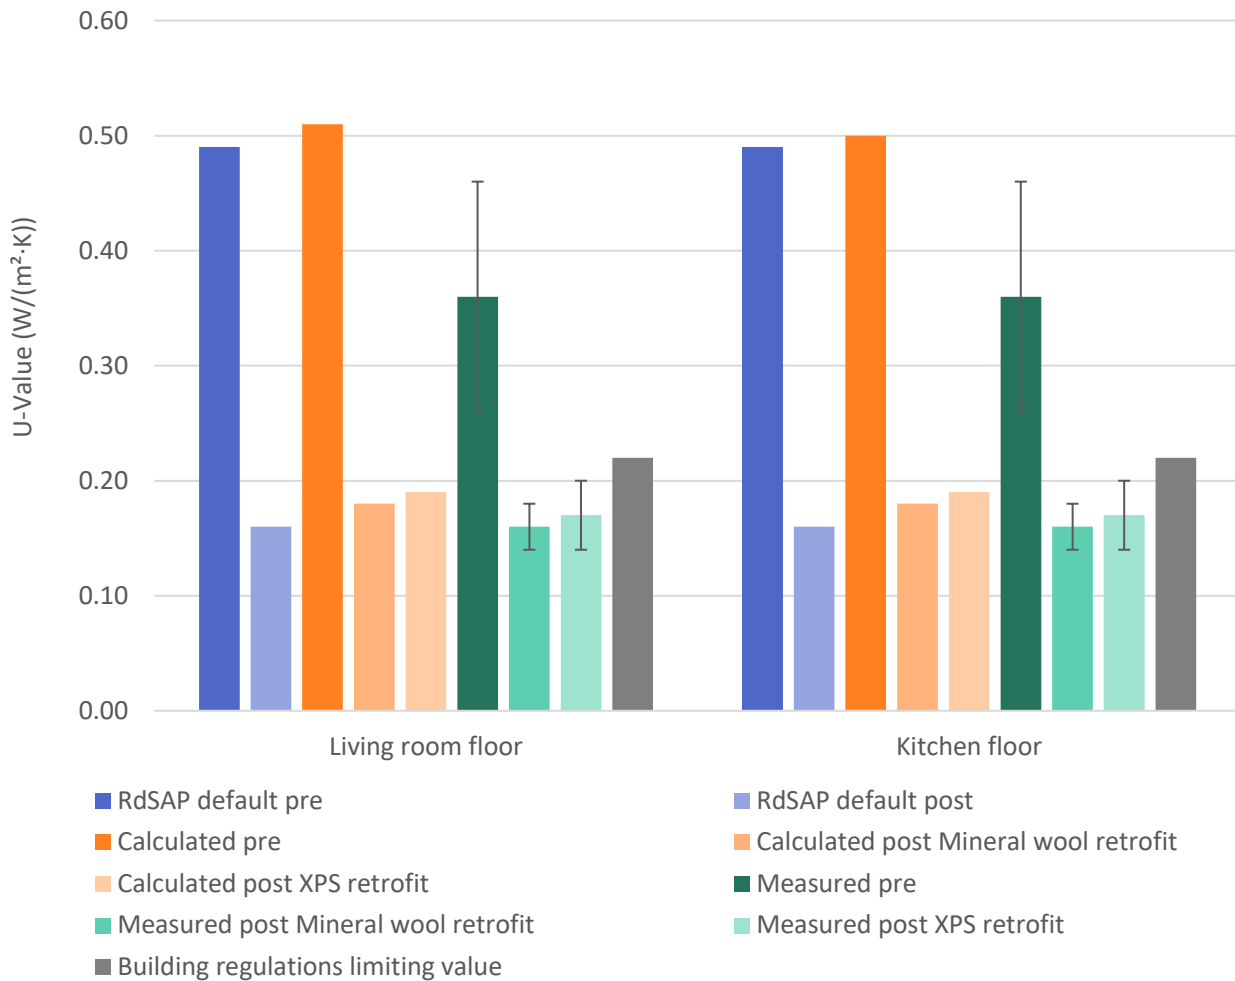
A summary of the before and after ground floor U-values for 27BG is presented in Figure 3-11. This compares the default U-values used in RdSAP based on Appendix S [8], the calculated U-values derived from the BRE calculator, and the values estimated from in-situ heat flux density measurements. As shown, the RdSAP defaults and BRE calculator predict roughly the same U-values. The in-situ measured value was actually lower, which means the potential to make improvements may be less in this house than predicted by an EPC assessment. Post-retrofit the RdSAP default, BRE calculator and measured U-value were all similar.

Figure 3-11 Pre- and post-floor retrofit U-values

A 53 % and 56 % reduction in floor U-value was achieved by the XPS and mineral wool retrofits, respectively, meaning both performed equally and successfully reduced the U-value to below the limiting value required in Part L1B of the Building Regulations. Because the calculated and default U-values were higher, this saving appears less than predicted. The pre- and post-retrofit U-values and the percentage improvements in U-values achieved by the floor retrofits are listed in Table 3-1 and Table 3-2, respectively.

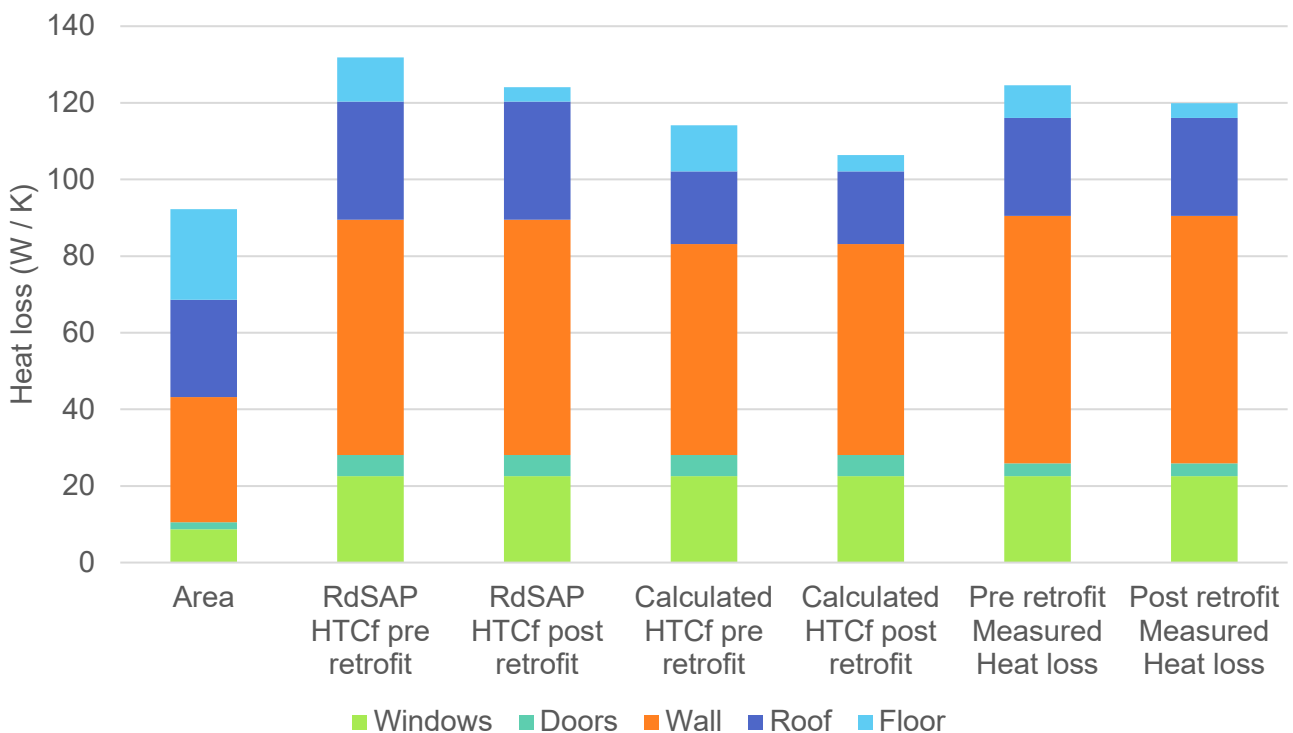
- The heat loss through the ground floor drops from 9 W/K (7 %) pre-retrofit to 4 W/K (3 %) post-retrofit.
- External walls are the most significant element responsible for around 50 % of HTC_f pre- and post-retrofit.
- HTC_f is highest when RdSAP defaults are used pre- and post-retrofit.

Figure 3-12 Heat loss of fabric elements pre- and post-retrofit, as recorded by heat flux density measurements

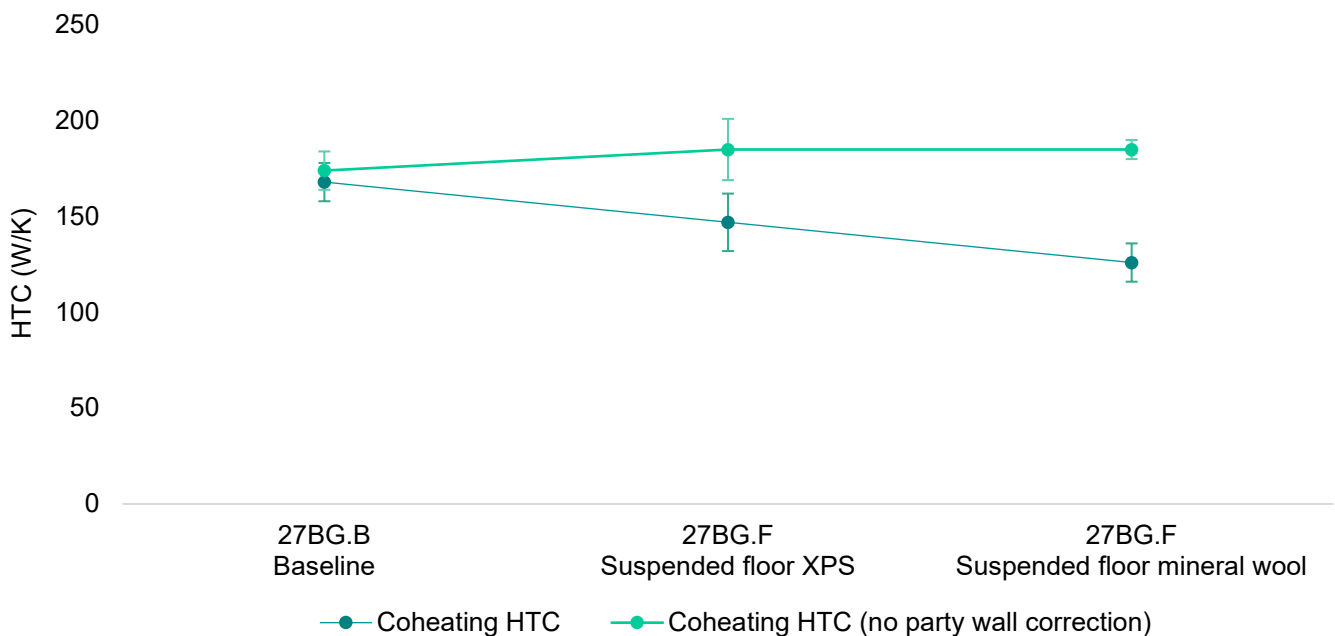
Since PW heat loss was not known for each stage, the analysis must assume it to be constant across the three tests. However, as internal temperatures were not recorded in adjacent dwellings this cannot be known with any certainty. If the adjacent homes had different internal temperatures between the tests, there may have been different amounts of heat loss through the party wall in each test which will go unaccounted for. This approach makes the relative changes between the retrofit stages more comparable, though the absolute HTC may not be accurate, i.e., not accounting for PW heat loss means the coheating HTC can be regarded as an overestimate since PW heat losses are expected to be relatively large for this home. The measured HTC for the base case and retrofitted house is shown in Figure 3-1.

Figure 3-13 HTC with and without PW correction for the baseline and alternative suspended timber floor retrofits

The changes in HTC attributable to the retrofits are described in Table 3-3. As shown, no detectable reduction compared to the base case was achieved by either insulation retrofit. Note that although the HTC value increased as a result of the floor insulation, the uncertainty in these numbers means that the difference is well within the margin of error and therefore cannot be considered significant.

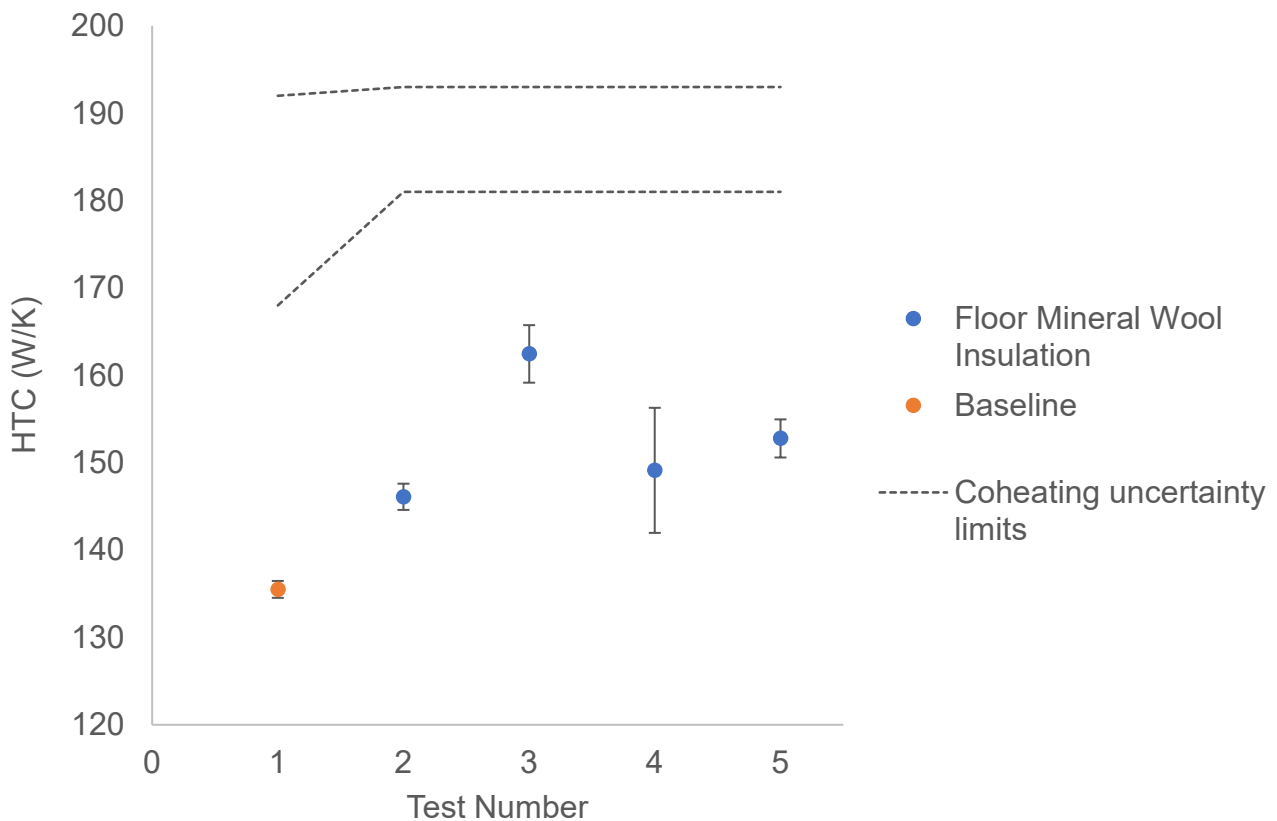
Of the 12 tests, 6 were excluded based on the test α value (a ratio of power input, temperature difference and the HTC of the property) being outside the recommended limit. This is a result of the QUB tests taking place immediately after coheating and the internal temperature subsequently changing between tests. In addition, a further test was excluded due to sensor failure during the test. This resulted in compliant tests being recorded for only two retrofit stages, the baseline and the suspended ground floor mineral wool insulation. The tests were completed in February 2020 (baseline) and November 2020 (ground floor mineral wool insulation). Despite the house being mid terraced with two PWs, no PW adjustment was applied to the QUB measurements. The results of the remaining 5 tests are shown in Figure 3-14, compared against the upper and lower uncertainty limits of the measured coheating tests (no party wall correction).

Figure 3-14 Predicted HTC via QUB test (no PW correction)

All the QUB measurements are lower than the uncertainty boundary of the coheating measurements.

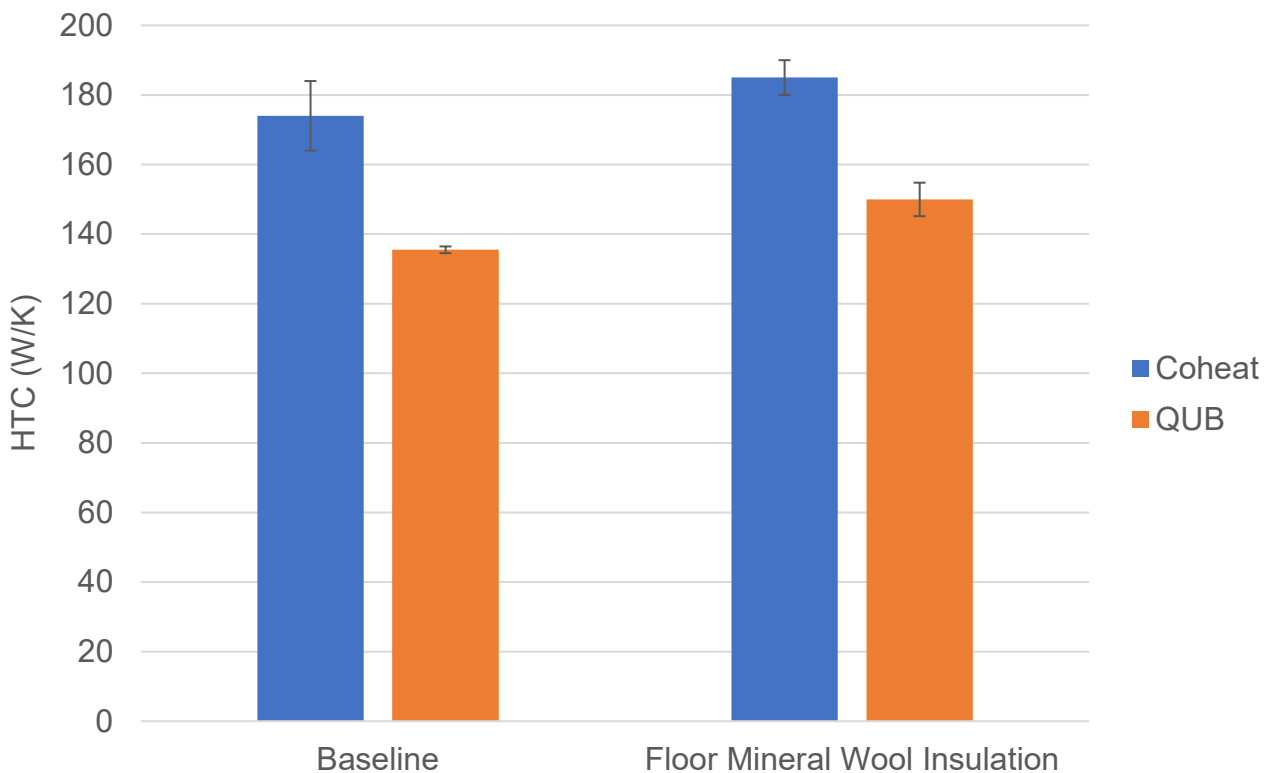
The weighted average of the stages where QUB tests were completed are shown in Figure 3-15. No PW correction was applied to these measurements.

Figure 3-15 Average QUB vs. coheating HTC measurements (no PW correction)

As with the individual tests, the QUB average values are less than the corresponding HTC measured through coheating, by 22 % and 19 %, respectively, for the baseline and mineral wool retrofit stages. Possible reasons could be differing heat flow patterns through elements that do not face the external environment, such as party walls and basements. As mentioned, heat flux of the party wall was not recorded during the QUB tests so corrections for these cannot be applied.

The increase in HTC measured through QUB following the retrofit measures mirrored that seen in the coheating measurements with possible causes being the basement temperature, PW heat flows which were not measured and an increase in air permeability between the two stages. The increase in HTC between the two QUB measurements was 11 %, which was 4 % in the coheating measurements.

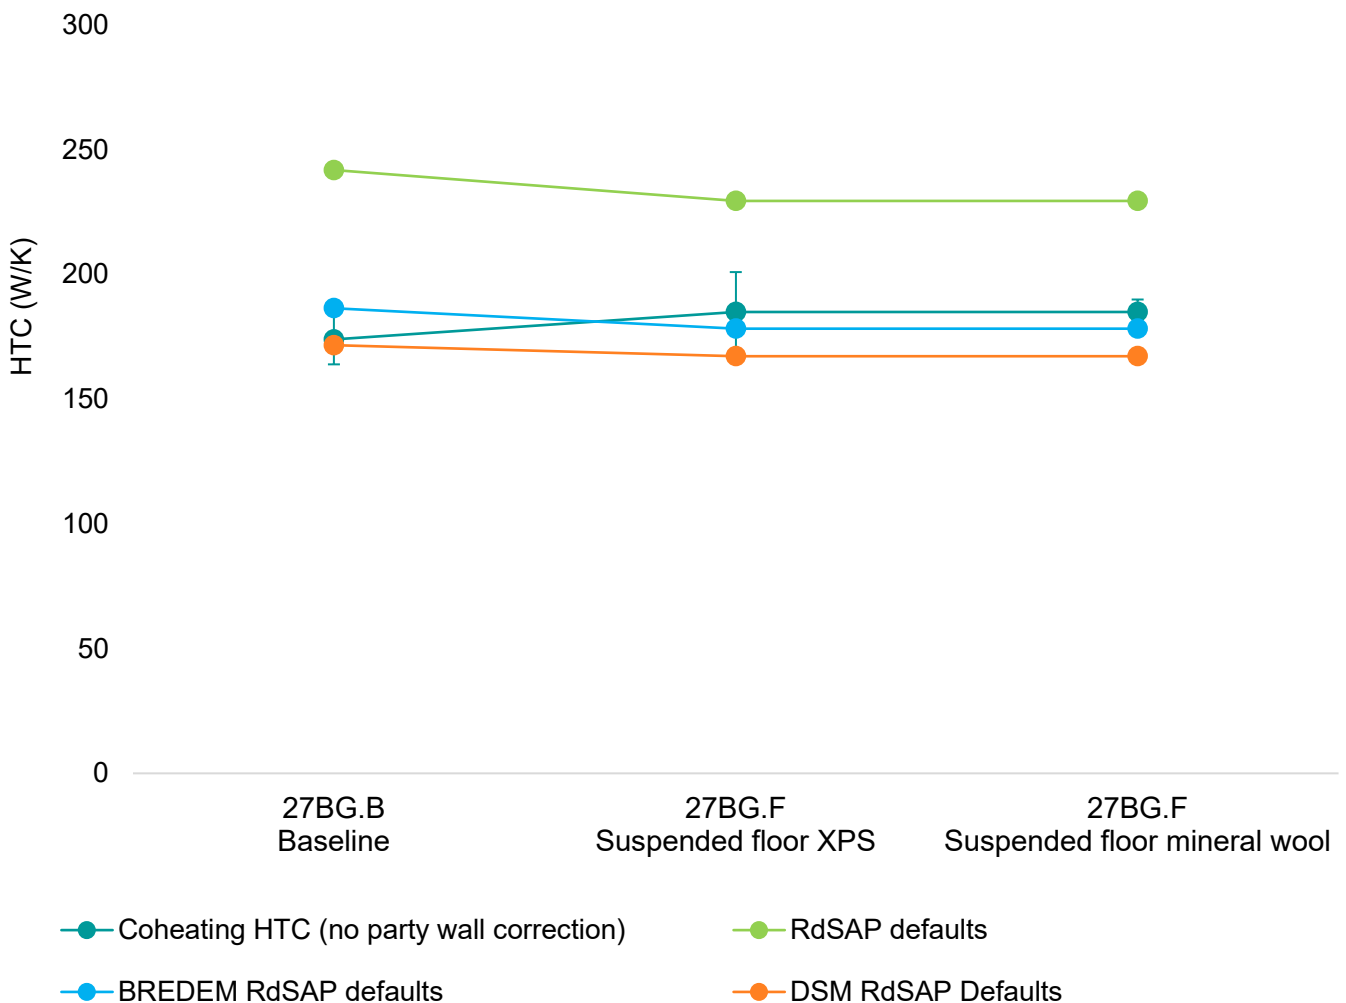
The measured HTC values for each retrofit stage are plotted against the HTC values predicted by the uncalibrated models using default RdSAP input data for infiltration and U-values in Figure 3-17, which shows:

- The RdSAP estimated HTC is substantially higher than the BREDEM estimate. When specific dimensions are used for the roof elements, the HTC reduces substantially as reflected by the BREDEM HTC predictions. Further investigation reveals this is caused by the simplified assumptions RdSAP makes about the room-in-roof geometry and U-values.

- The modelled predictions for both retrofit scenarios are identical, since the RdSAP defaults do not differentiate between insulation products, and only allow a maximum of 150 mm insulation to be input.

Figure 3-17 HTC Calibration step 1: RdSAP defaults

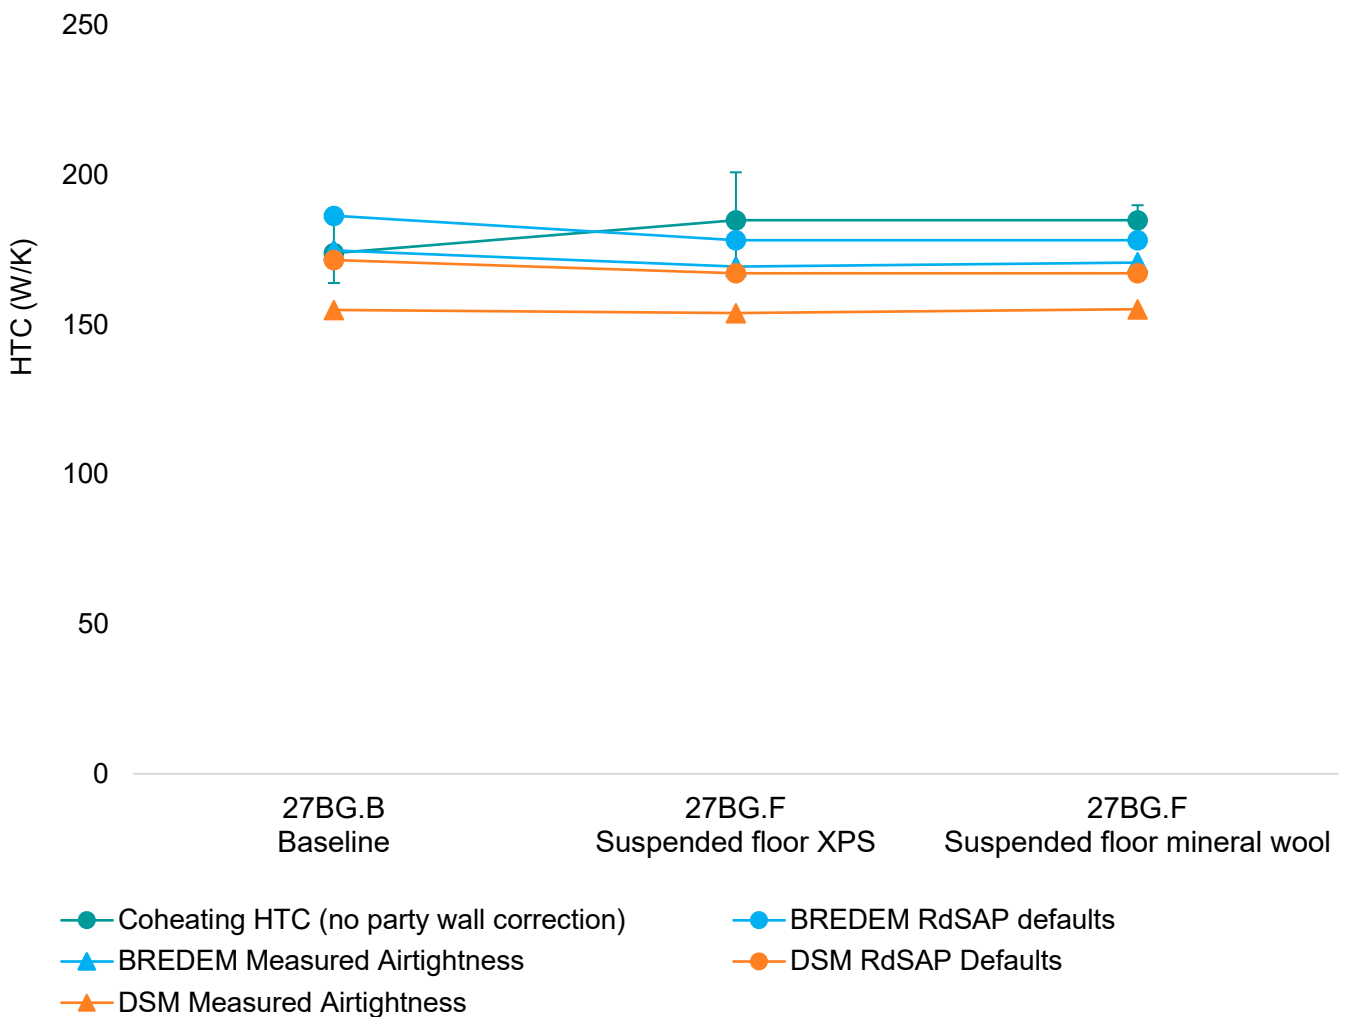
Figure 3-18 illustrates the impact of including the actual infiltration rates measured in the house on the DSM and BREDEM estimates of HTC. The U-values in the models are still assumed to be the RdSAP defaults.

- Including the measured airtightness results in the model substantially reduced the predicted HTC. This was expected as the measured airtightness was lower than the RdSAP defaults assumed.
- The additional infiltration rate that was measured in the mineral wool retrofit, compared to the XPS retrofit, is captured as a slight increase in the predicted HTCs.
- RdSAP does not allow infiltration rates to be altered, so is not included in this phase.

Figure 3-18 HTC Calibration step 2: Measured infiltration

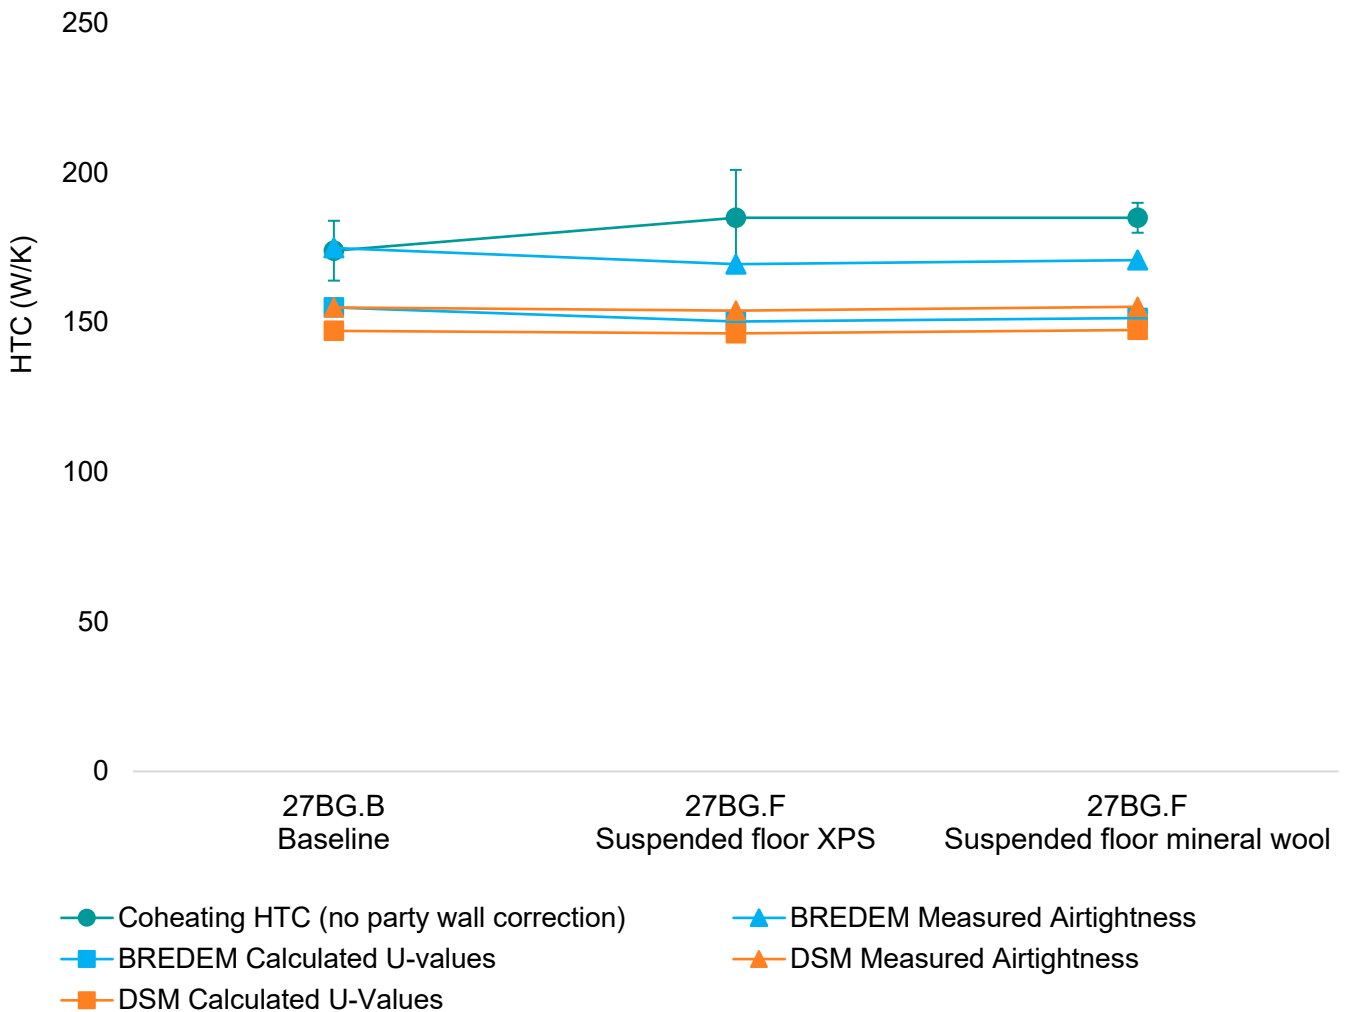
Figure 3-19 shows the impact of including the calculated U-values for the fabric elements in the BREDEM and DSM models to add to the measured infiltration rates.

- Adding in the calculated U-values resulted in a further reduction in the predicted HTC, since the calculated U-values in the room-in-roof were substantially better than those predicted in RdSAP, though the calculated wall U-values were marginally worse than the defaults.
- The predicted HTCs were substantially below the measured coheating HTC, which may be expected, since the coheating HTC shown did not account for party wall heat losses so may be overestimated.
- The reductions from the retrofit predicted by the models with calculated U-values and measured infiltration were marginally smaller than predicted using defaults.
- The steady-state and dynamic models' HTC predictions were similar when using the same default airtightness and calculated U-value assumptions for the house.
- RdSAP does not allow calculated U-values to be input and so is not included in this calibration stage.

Figure 3-19 HTC Calibration step 3: Calculated U-values

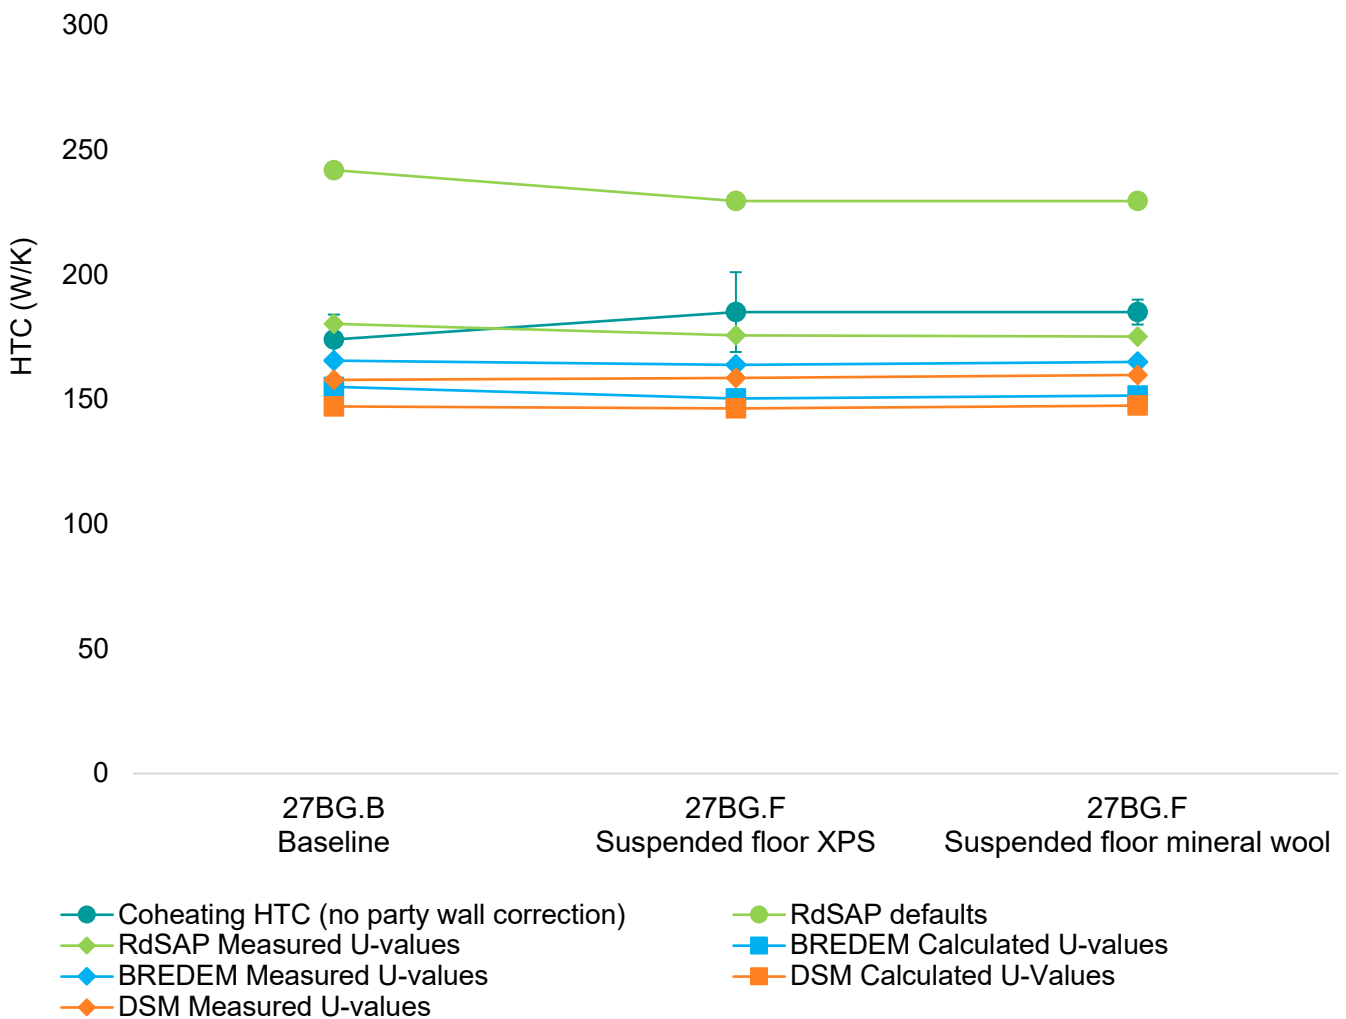
- The RdSAP predictions are still slightly higher than the BREDEM prediction since there are discrepancies in the way the surface areas and floor U-values are calculated and because the RdSAP model still assumes the default (higher) infiltration rate.

Figure 3-20 HTC Calibration step 4: Measured U-values
