DEEP Report 2.09

Case Study 27BG

October 2024

Case study 27BG is a two-bed 1890 solid walled dwelling with a room-in-roof. It is a back-to-back style terrace home resulting in a very large area of party wall. Two comparable suspended timber ground floor retrofits were undertaken. In the first, XPS boards were installed between the timber joists. This was then removed and replaced with mineral wool of equivalent performance. The case study provided the opportunity to evaluate retrofits in house types with large areas of party walls, explore the risks and performance of suspended floor retrofits in this type of house and compare two common ground floor retrofit approaches.

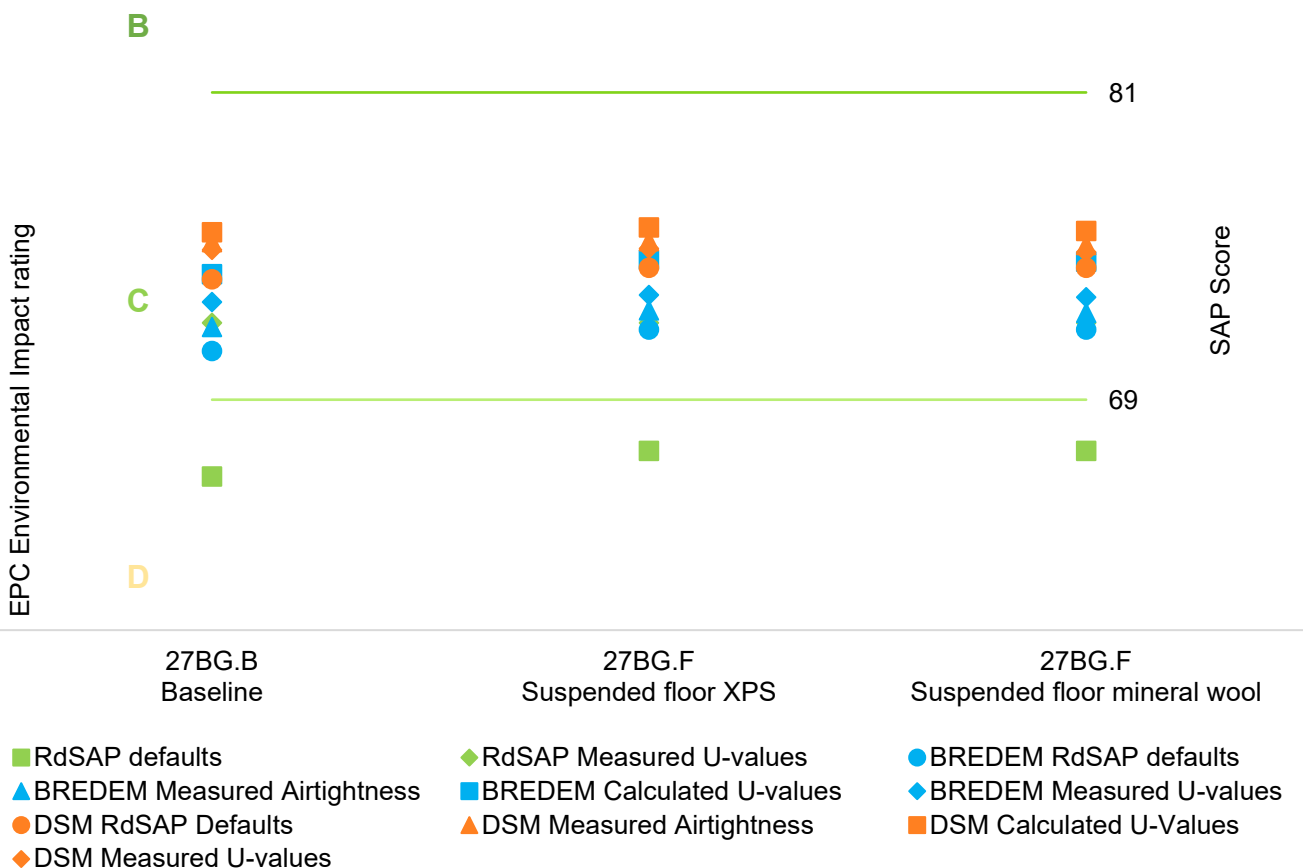
- Other than the RdSAP default case, updating the default data with measured and calculated data did not affect the home’s EPC band.
- 27BG was a similar building type to DEEP case study home 17BG, which was an end-terrace on the same street. Since 17BG had an external gable wall, it had higher heat loss, and was therefore deemed to be band E pre-retrofit. This means that households in inefficient homes which have large areas of party elements (flats and back-to-back homes) have higher EPC bands than their end-terrace counterparts, which could make them ineligible for retrofit funding. This may prove problematic for neighbourhood scale retrofit schemes.

Figure 3-2121 Predicted impact of retrofits on EPC band

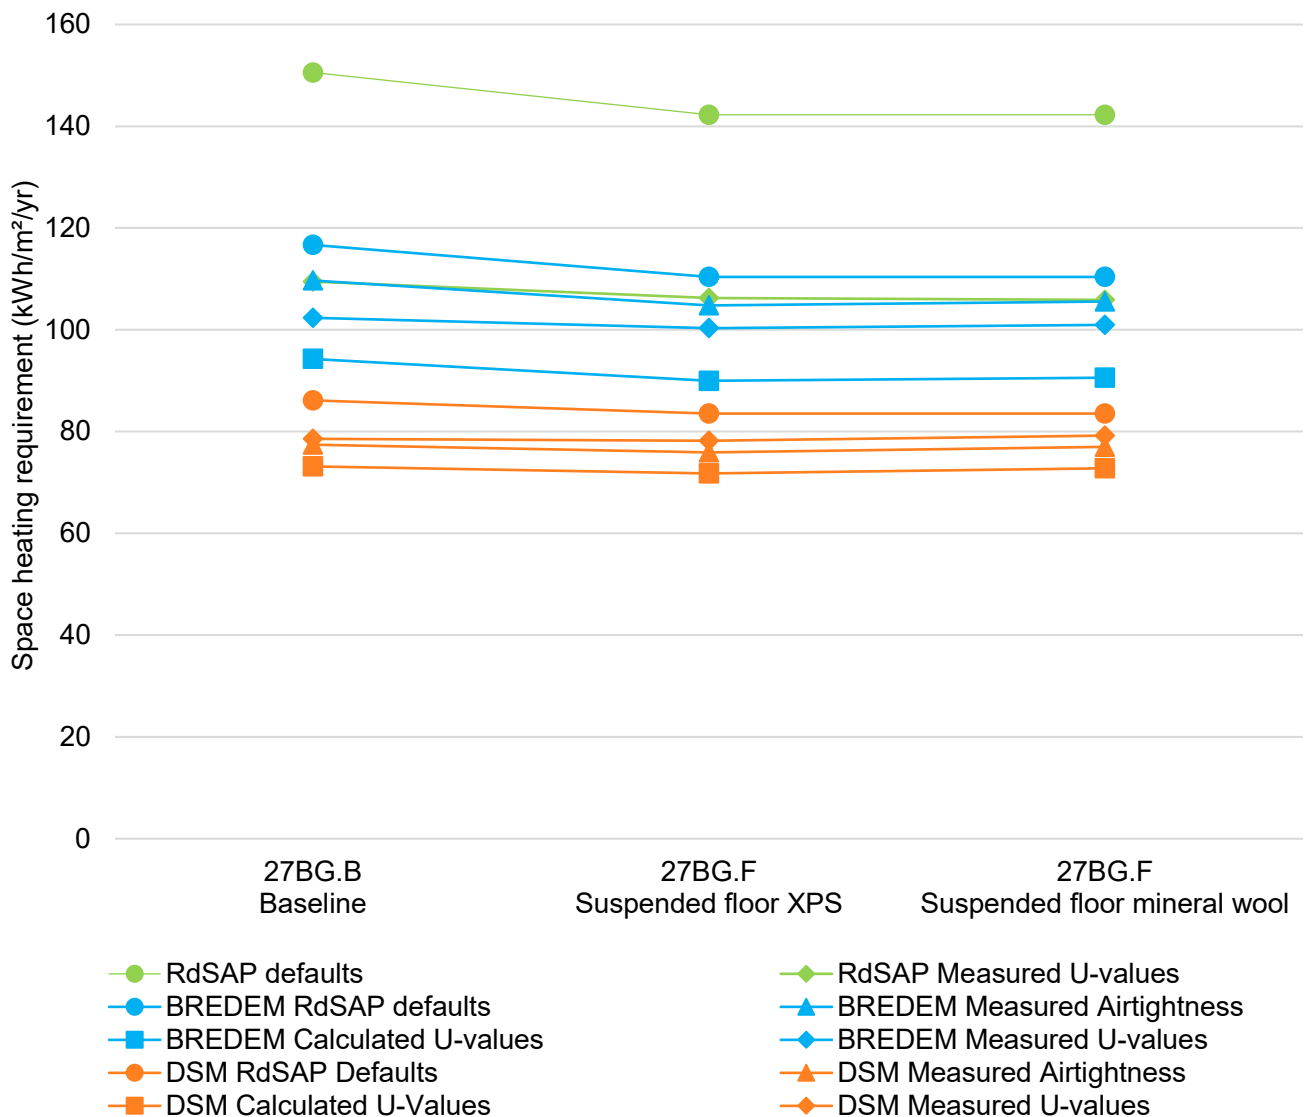
- Space heating demand is predicted to reduce to between -1 % (i.e., an increase in heating demand since the increase in infiltration post-retrofit seems to offset any savings achieved by the floor insulation) and 6 % following the ground floor retrofits, depending on which model and assumptions are used.
- DSM predicts lower space heating demand than RdSAP and BREDEM regardless of which inputs are used due to the way internal gains are calculated.
- RdSAP defaults substantially overestimate the heat loss from the room-in-roof.
- The SHDF 90 kWh/m² target is only met with the DSM model, not in any steady-state model, despite the dwelling achieving an EPC band C in BREDEM.

Figure 3-2222 Predicted reduction in annual space heating demand

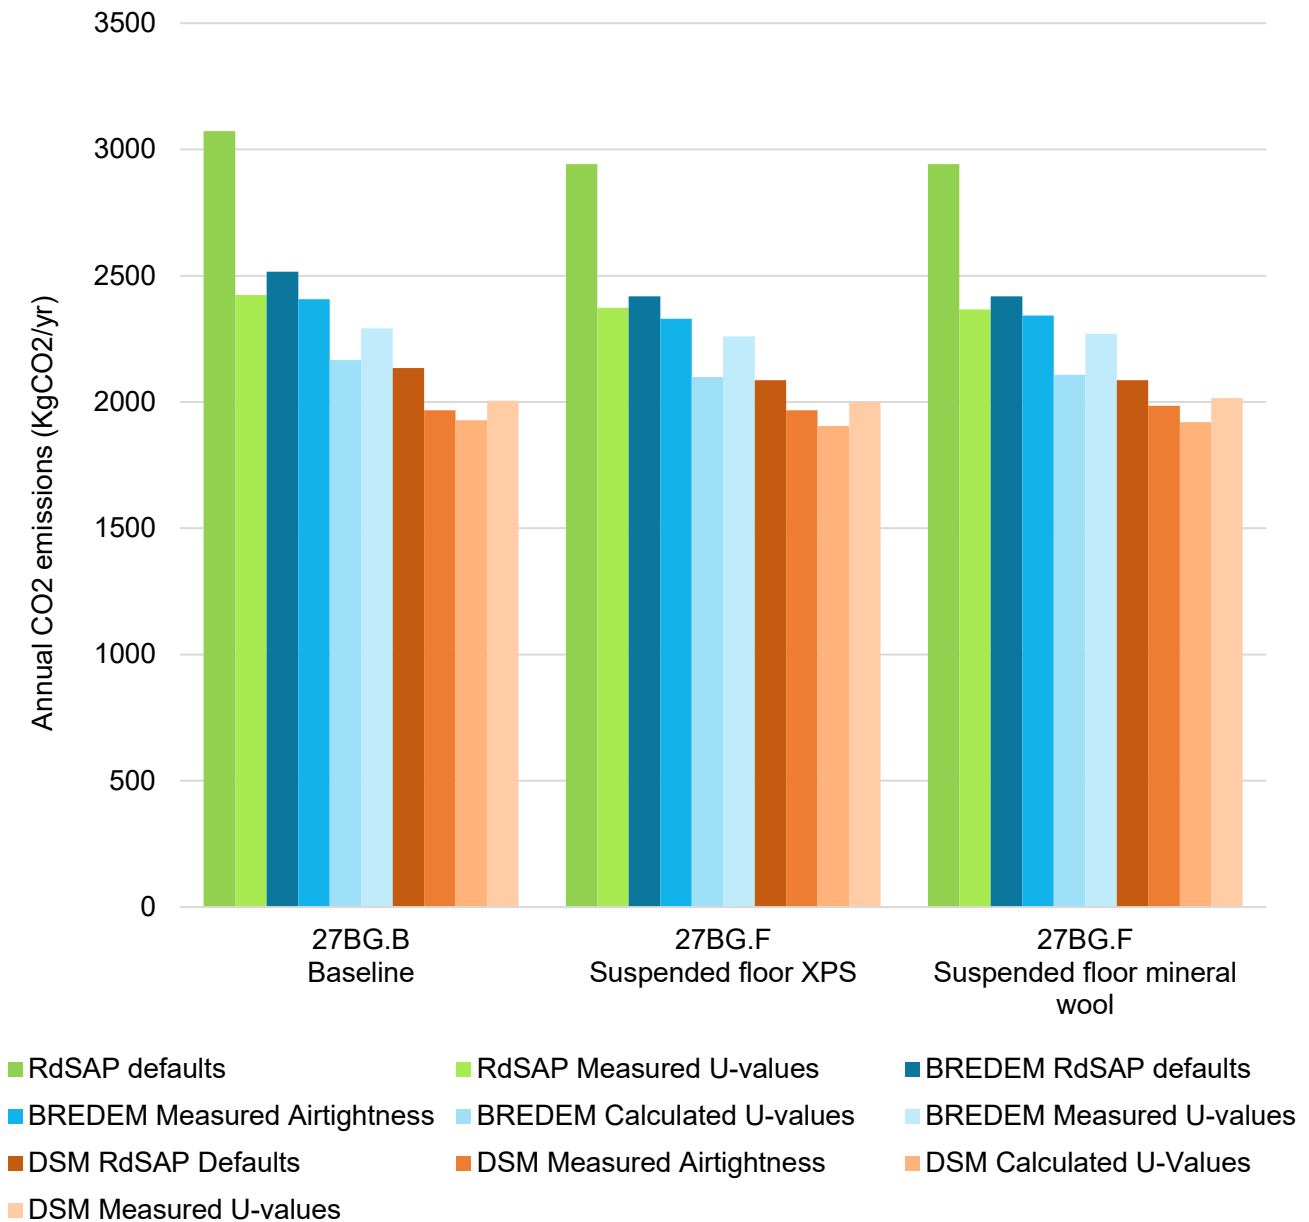
- Using the RdSAP age band defaults results in more predicted CO₂ emissions, since it underestimates the baseline energy efficiency of the house.
- DSM generally predicts much lower CO₂ emissions than RdSAP and BREDEM, since it assumes lower annual overall fuel consumption.
- The ground floor retrofits result in no meaningful reduction in CO₂ regardless of which model and assumptions are used, ranging between -1 % (due to a small increase in infiltration) and 4 %.

Figure 3-2323 Annual CO₂ emissions pre- and post-retrofit

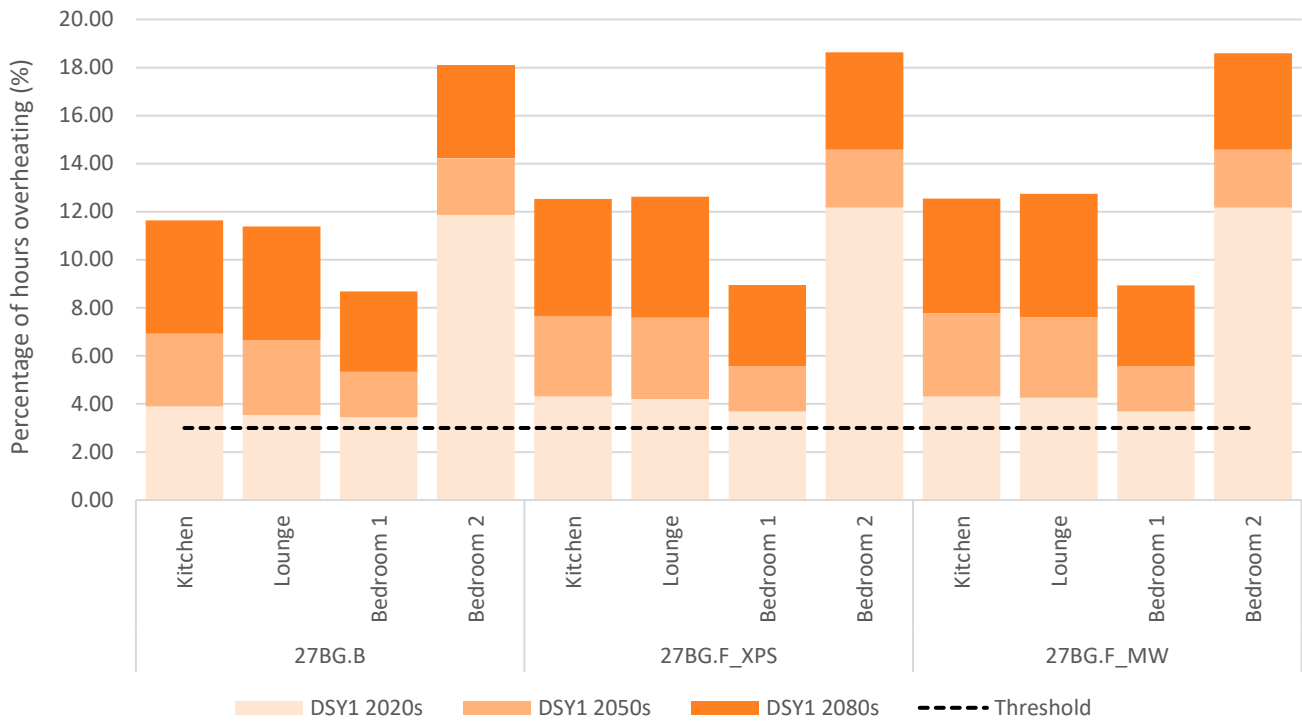
Figure 3-2424 Modelled overheating under TM59 Criteria A

The results for TM59 Criteria A in Figure 3-24 show the percentage of hours when $\Delta T \geq 1$ K, with a threshold of 3 % of occupied hours. Although the ground floor retrofits increased the extent of overheating marginally, it is the lack of any cross ventilation and small opening areas that leads to extensive overheating, even in the baseline case.

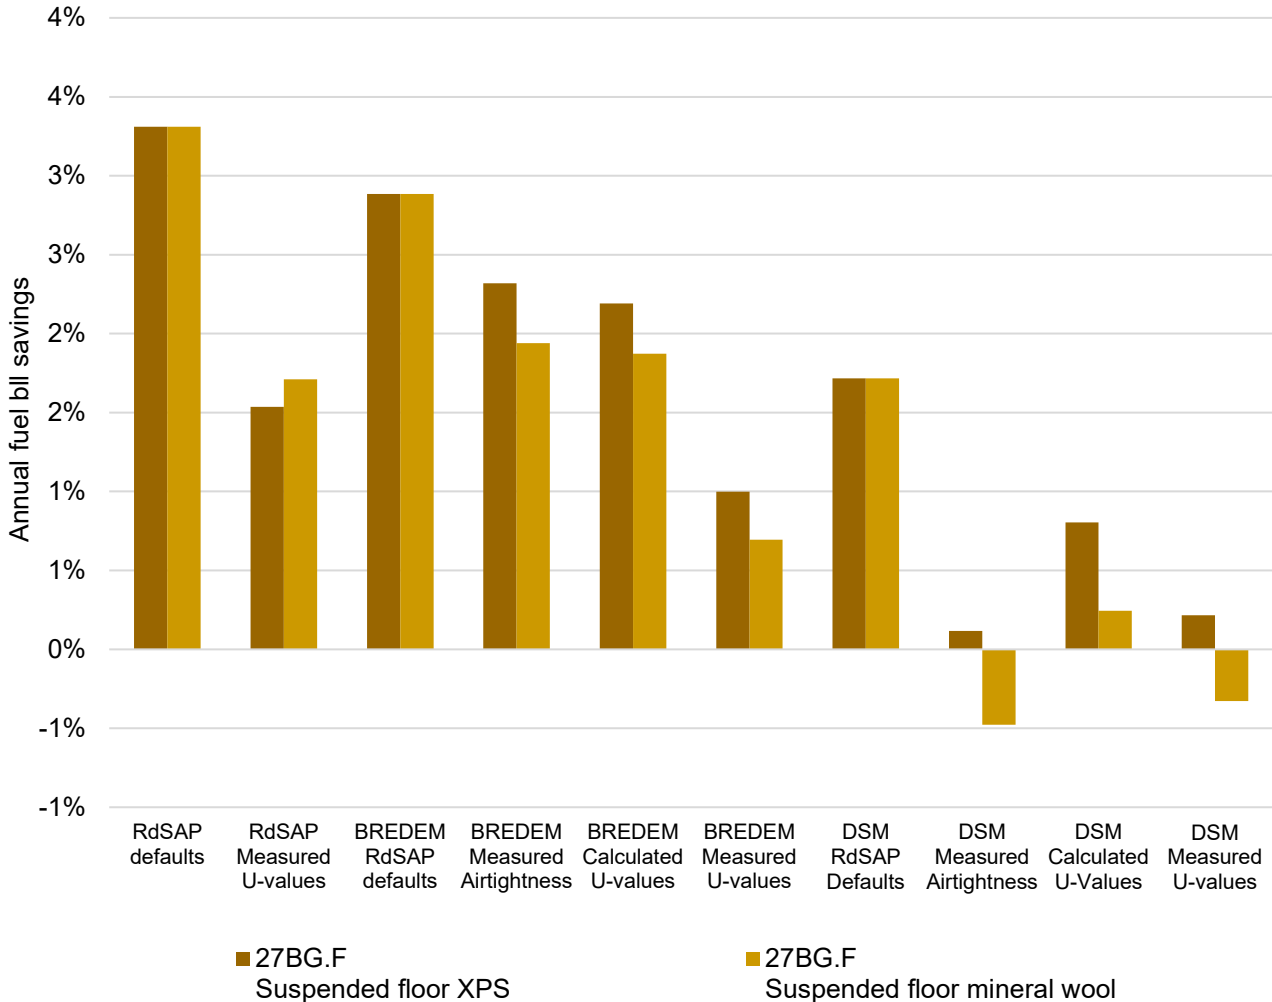
The impact of the retrofits on household dual fuel bills is shown in Figure 3-26, using the SAP fuel prices of 3p per kWh gas and 13p per kWh electricity. These values do not reflect current fuel prices and are shown only as an illustration.

Figure 3-26 Predicted fuel bills

The analysis shows that both insulation types achieve a similar impact on fuel bills. In the worst case, marginally reducing space heating demand by between 1 % (shown as negative savings), where the increase in infiltration offsets the reductions in floor heat losses, and just over 3 %, when using default U-values, though the measured values reveal that savings up to 2 % may be more realistic. The major benefit of floor insulation may therefore be improved surface floor temperatures, which can improve thermal comfort rather than achieving fuel bill savings.
