DEEP Report 2.11

# Case Study 07LT & 09LT

October 2024

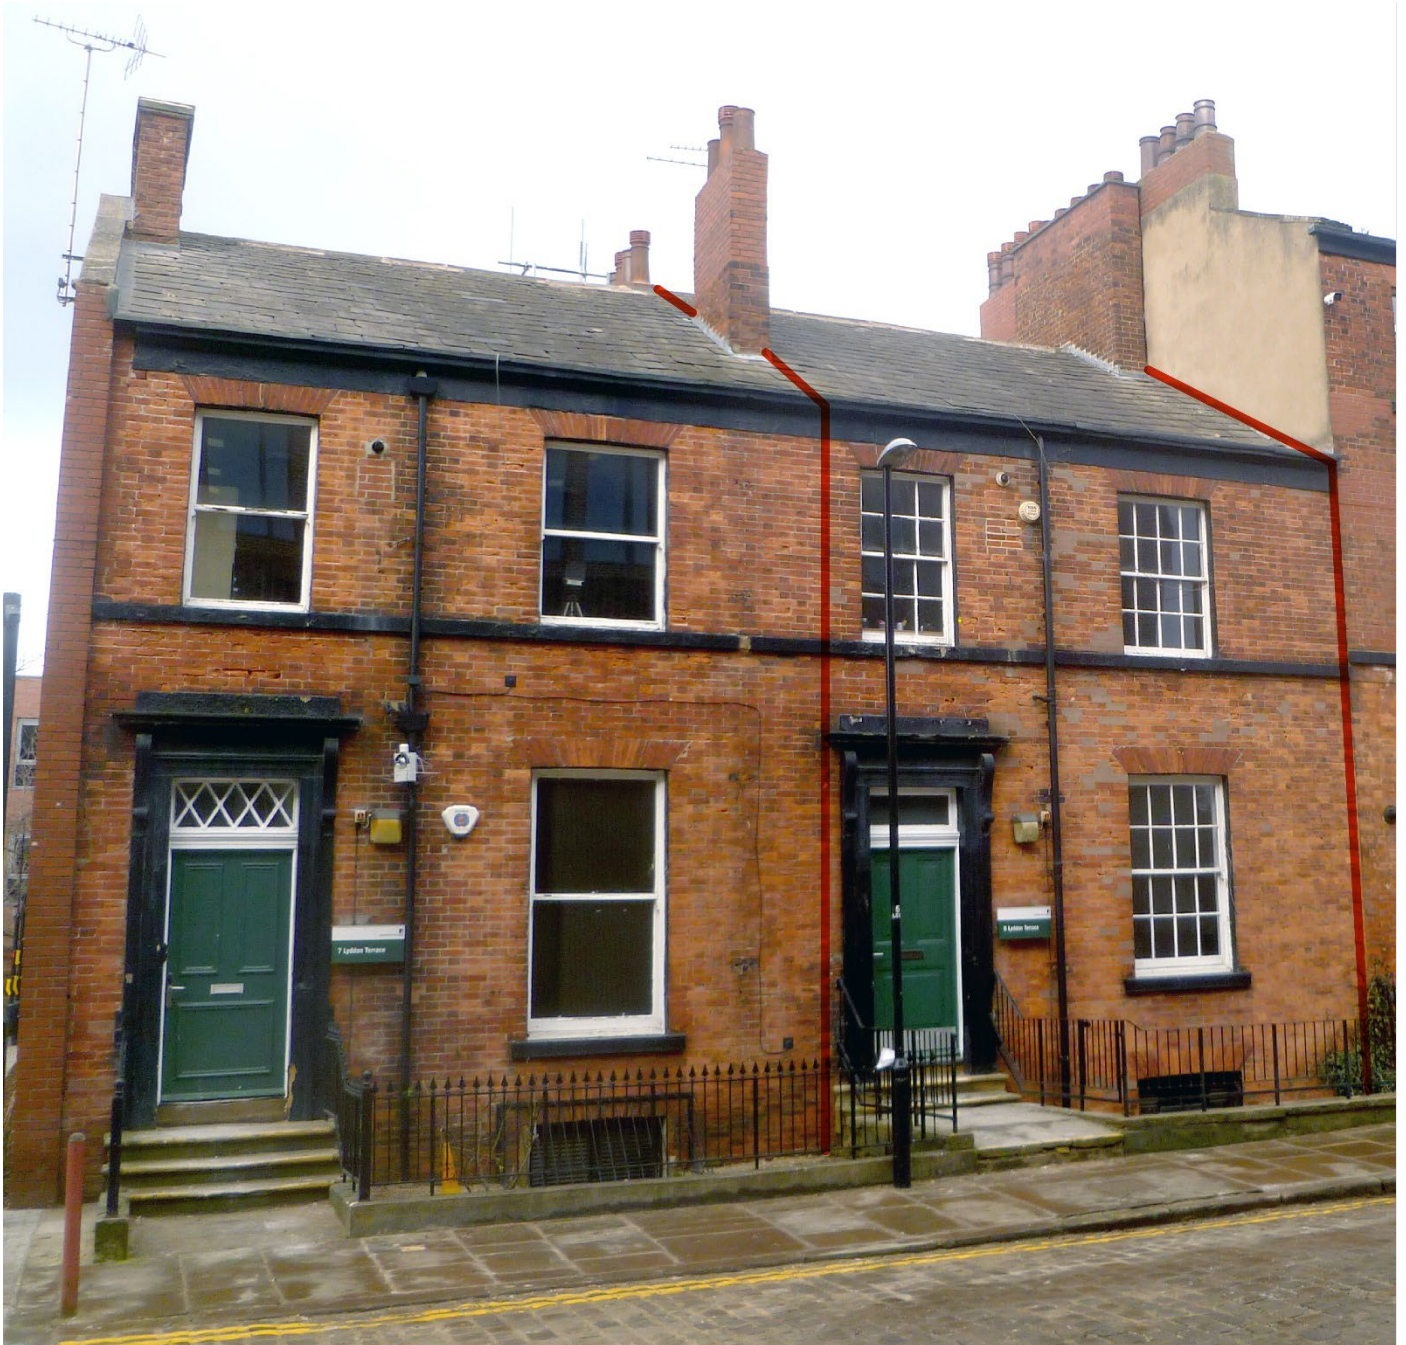
Figure 1-1 Case study houses (07LT on the left and 09LT on the right)

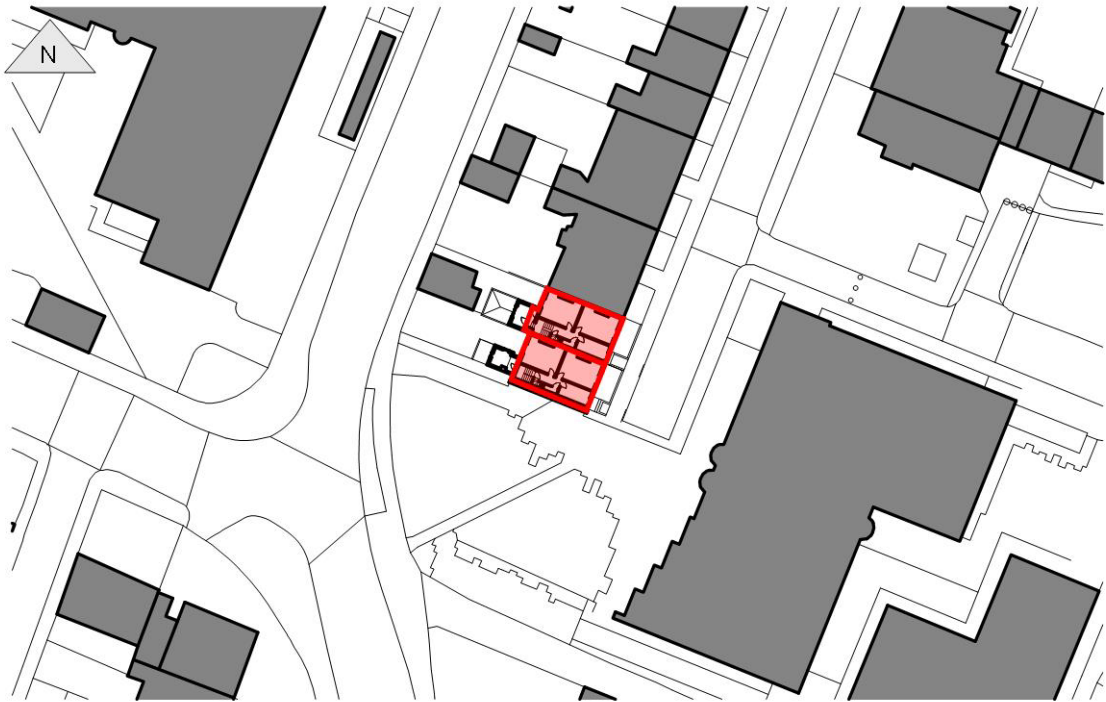
**Figure 1-2 Case study houses site location plan**

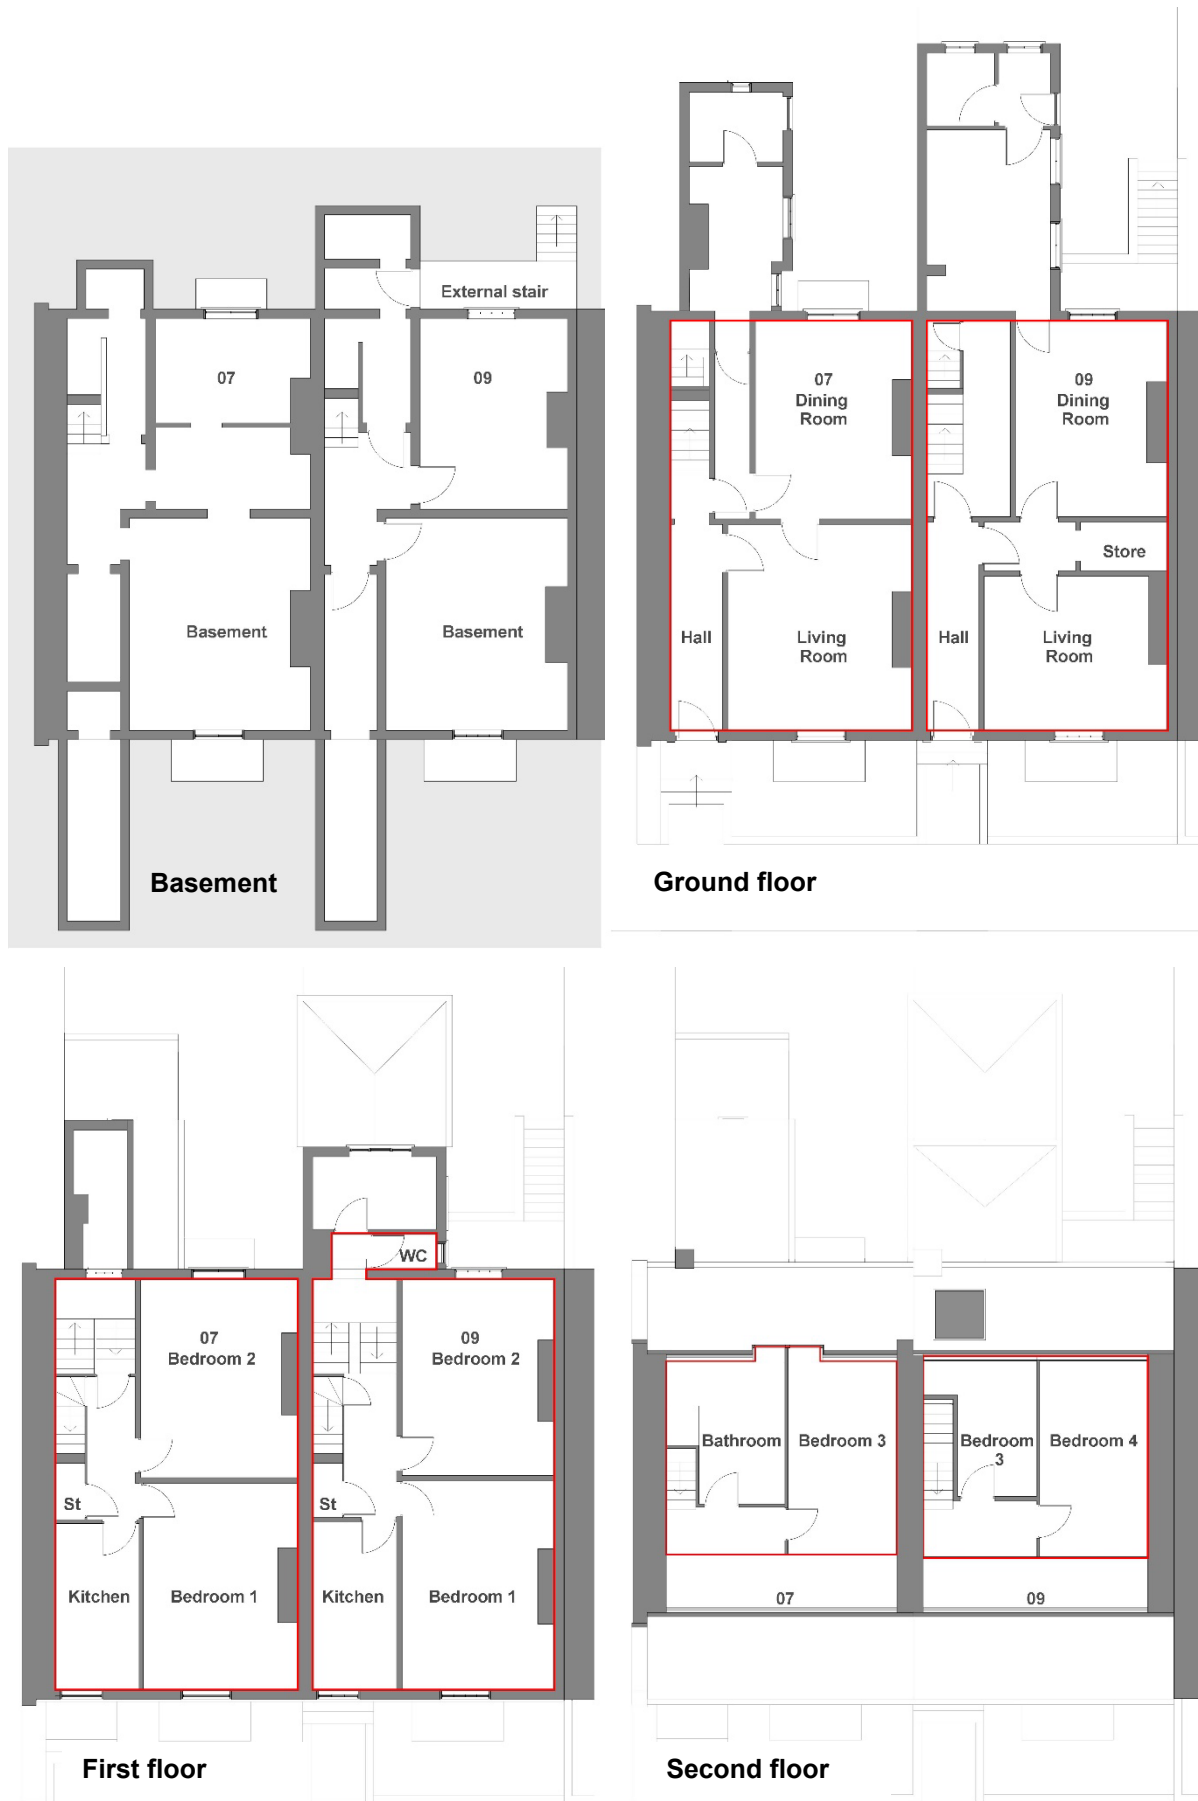
Figure 1-3 House floor plans

Floor plans, elevations and sections are shown in Figure 1-3, Figure 1-4 and Figure 1-5, respectively.

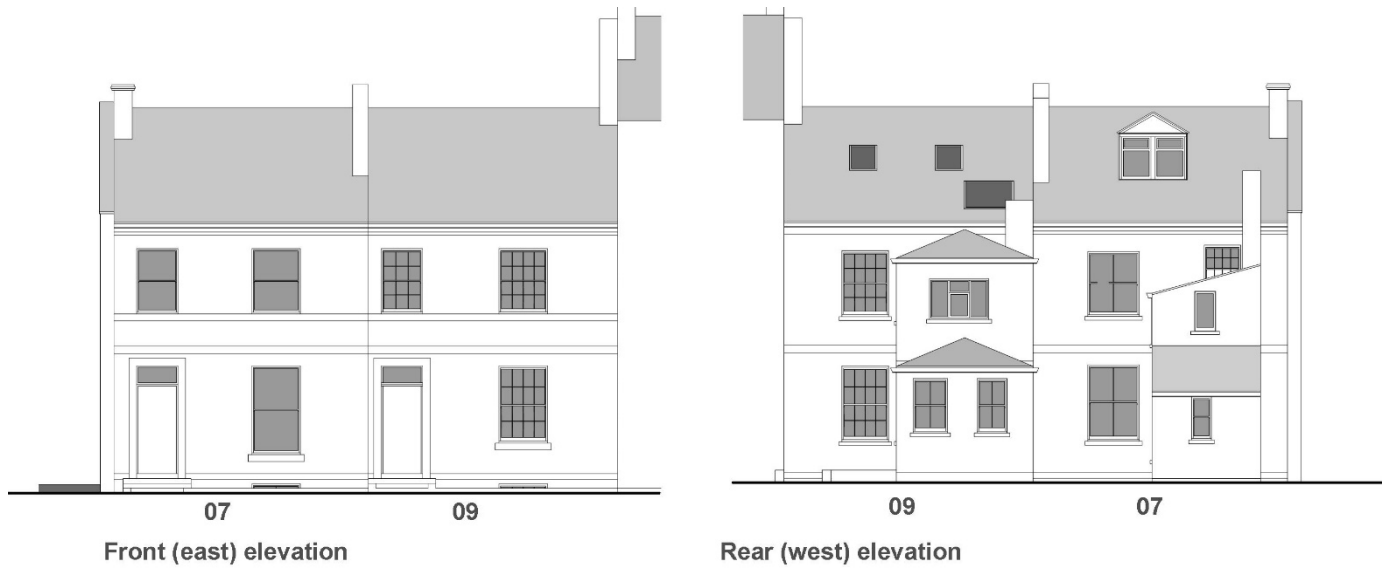
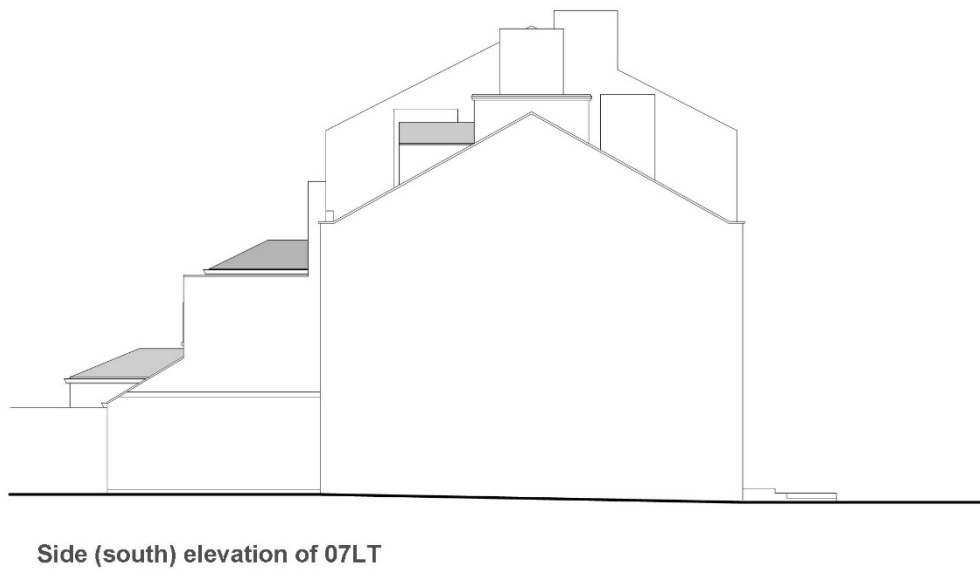
Figure 1-4 Front, side and rear elevations plus a sectional elevation of 07LT

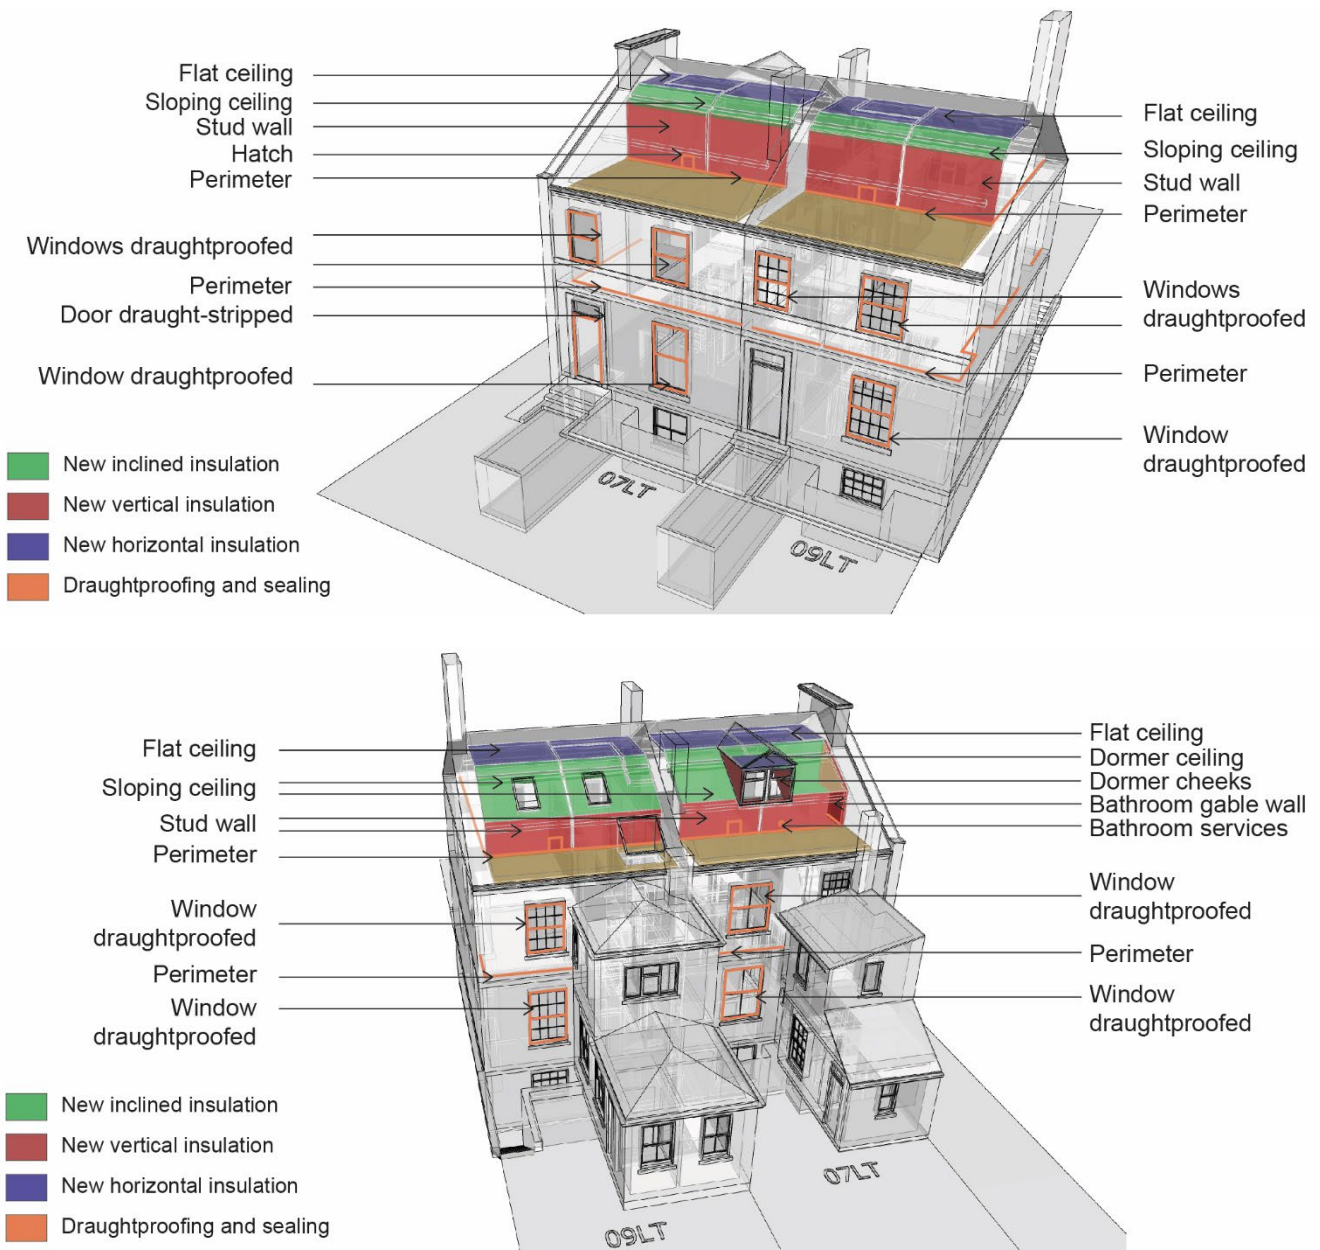
**Figure 1-7 Stage 2: Insulation and draughtproofing added – front and rear (07LT.R.A and 09LT.R.A)**

The sequence of the staged whole house retrofit approach is shown and illustrated in Figure 1-6 and Figure 1-7. Building performance evaluation (BPE) tests, whole house energy modelling and elemental thermal simulations were conducted at each retrofit stage to quantify changes in energy performance and the potential for condensation risk. The specific methodologies for these are described in the DEEP Methods 2.01 Report.

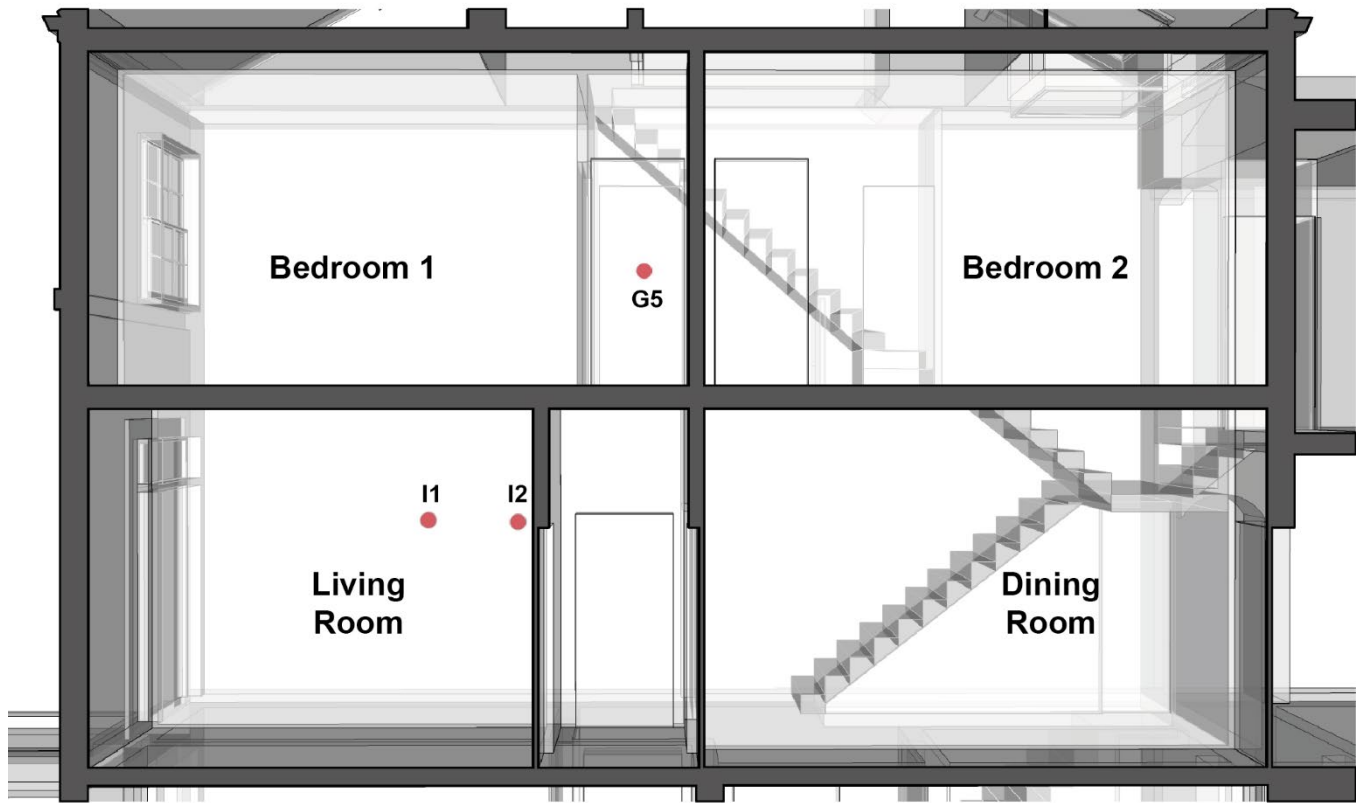
Figure 2-3 Heat flux plate locations for 09LT at ground and first floor level

36 Hukseflux HFP01 heat flux plates (HFPs) were installed on various elements in 07LT, and 41 were installed in 09LT. These were used to measure the U-values of fabric elements, quantify improvements in U-values achieved by the fabric upgrades and quantify party wall heat loss experienced during the coheating test. The HFP locations are listed in Table 2-2 and, for context, visualised in Figure 2-1 and Figure 2-2. Thermography was undertaken to identify the most representative HFP location for each fabric element and, where possible, multiple locations for each element were measured.

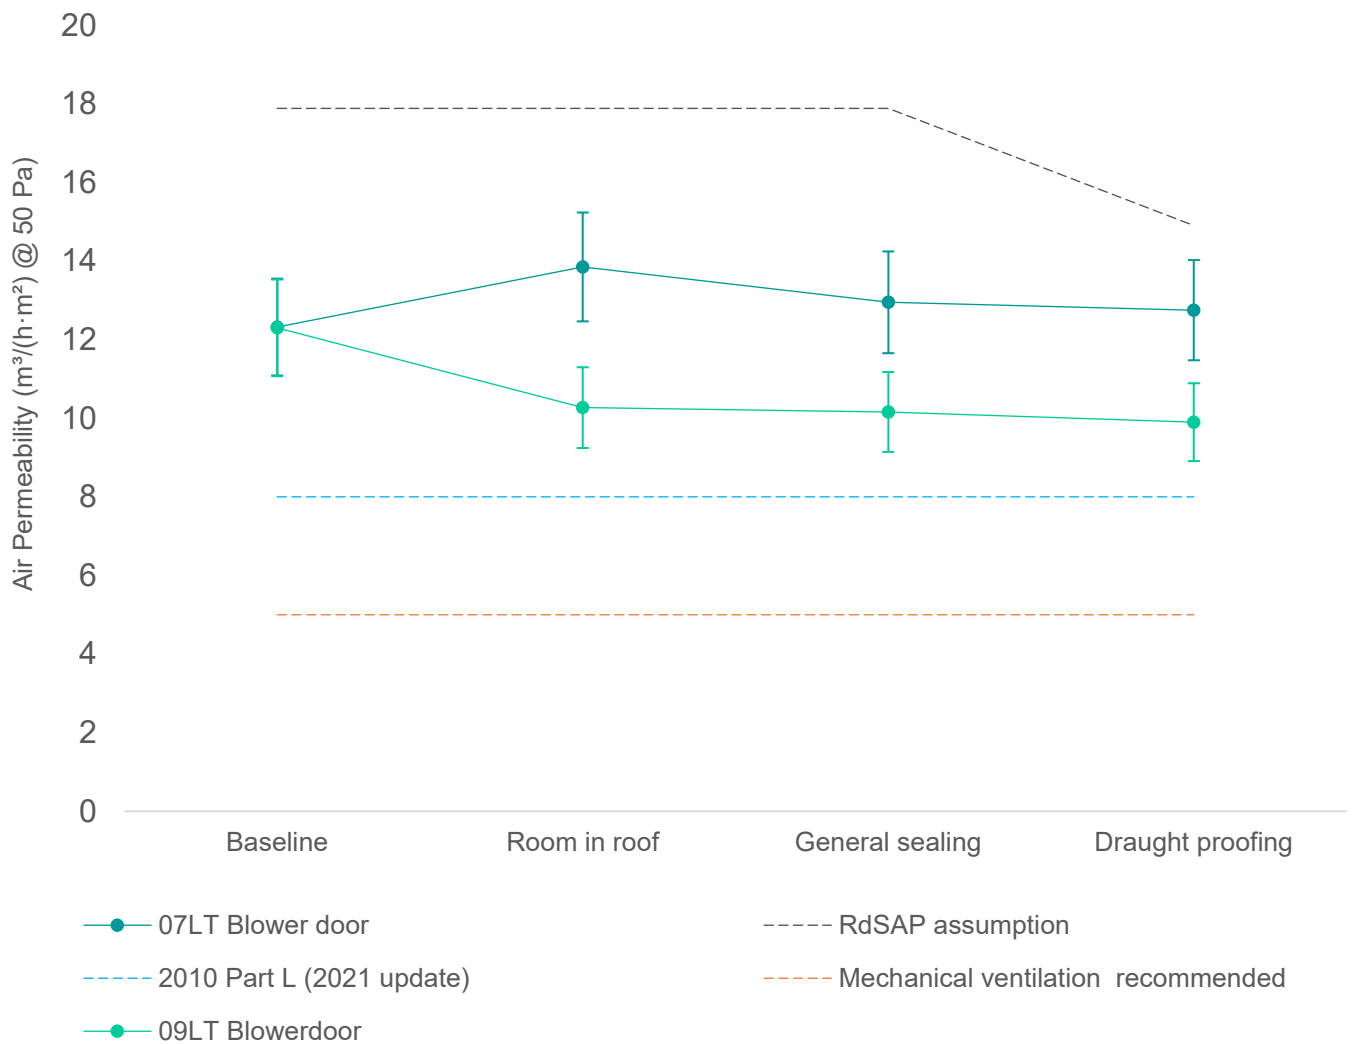
As shown in Figure 3-1, in their original condition both test houses displayed levels of air permeability fairly typical for houses of this age and construction. 07LT had a mean air permeability of  $12.32 \text{ m}^3/(\text{h}\cdot\text{m}^2) @ 50\text{Pa}$ , and 09LT had  $12.30 \text{ m}^3/(\text{h}\cdot\text{m}^2) @ 50\text{Pa}$ . With the volumes of the houses being  $>450 \text{ m}^3$ , this suggests that there was a considerable amount of uncontrolled air movement through the properties, well above the limiting value for new build homes, though less than assumed in the RdSAP EPC model.

**Figure 3-1 Airtightness of case studies**

Pulse tests were undertaken at various stages, at the same visits as blower door tests. However, for most of the test period the large volumes and low levels of airtightness proved beyond the capabilities of the Pulse system with just one 40 litre receiver and a single 60 litre expansion tank, as 3 x 40 litre air receivers/tanks are required for such properties<sup>7</sup>. Uploading the failed Pulse test outputs to the BTS Pulse portal for reprocessing resulted in valid test results with warnings about test conditions. TM 23 AP<sub>50</sub> conversions of the updated test results are shown alongside blower door results in Figure 3-1.

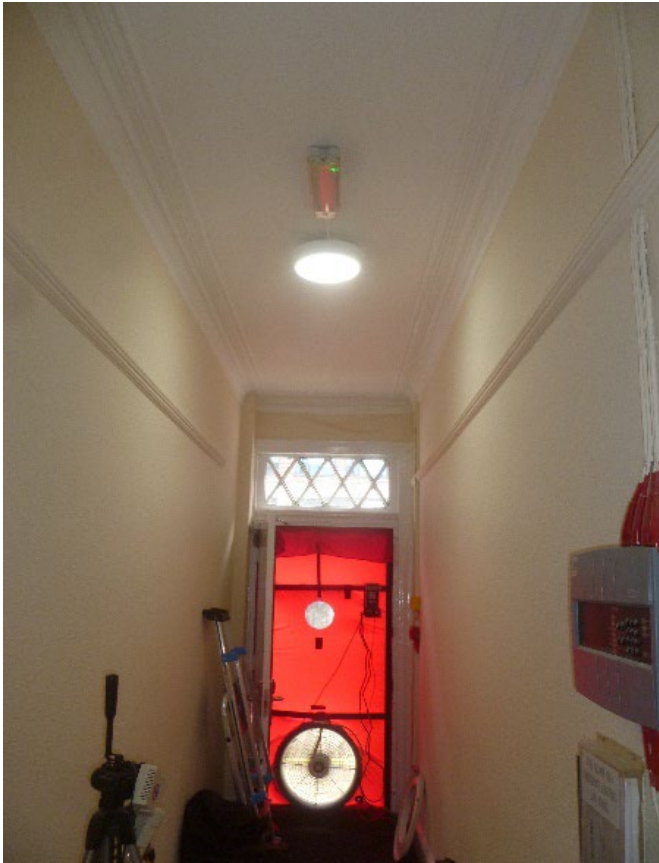
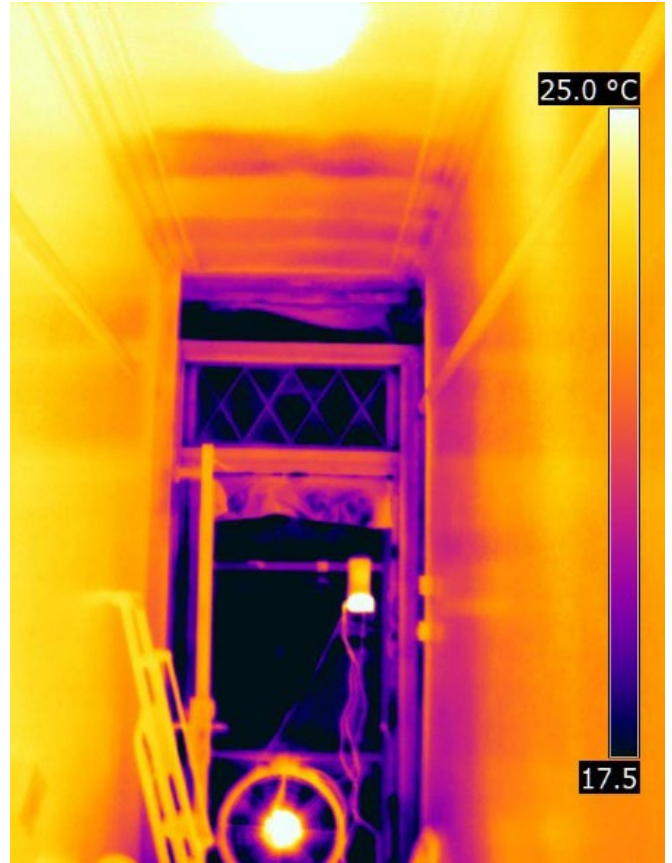
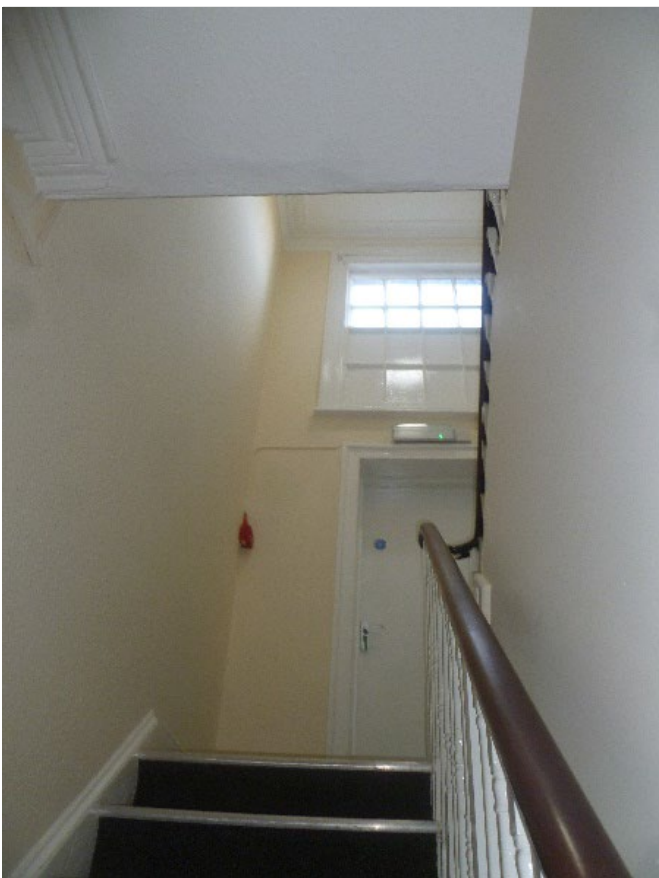
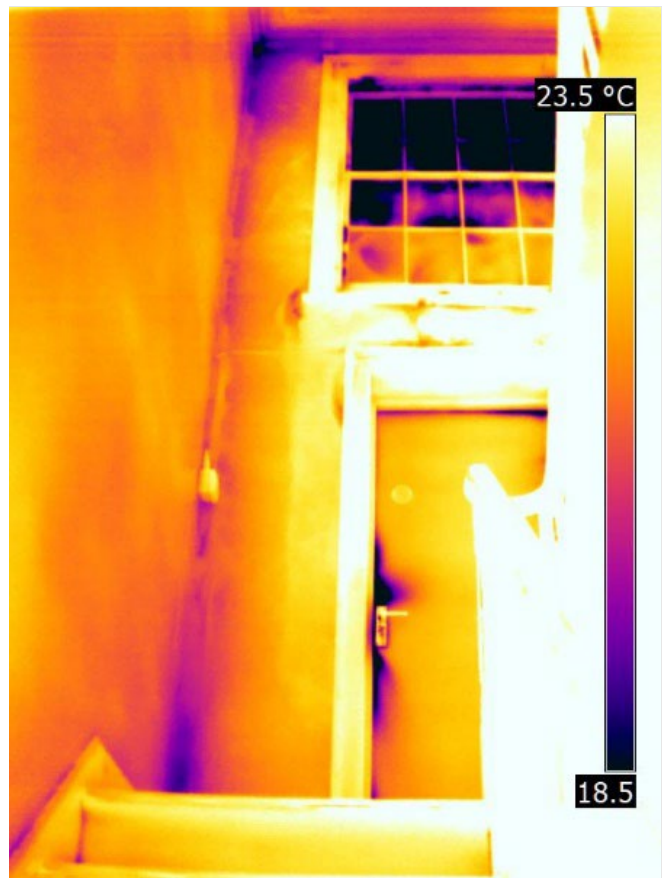
Leakage at the front doors was not included in the blower door tests as the fans were positioned here for the tests, but even when closed daylight was visible between the doors and frames. The rear annexes were closed off for the pressure tests, but both these doors and the cellar doors were only internal doors. Even though they provided the boundary of the airtightness barrier for the tests, they were not designed to be as airtight as external doors. The windows also performed poorly, particularly the single glazed sash windows throughout the ground and first floors of both houses.

**Figure 3-2 Air leakage at the front door of 07LT (moving into the floor void above) and around the first floor door to the rear annex and window above**

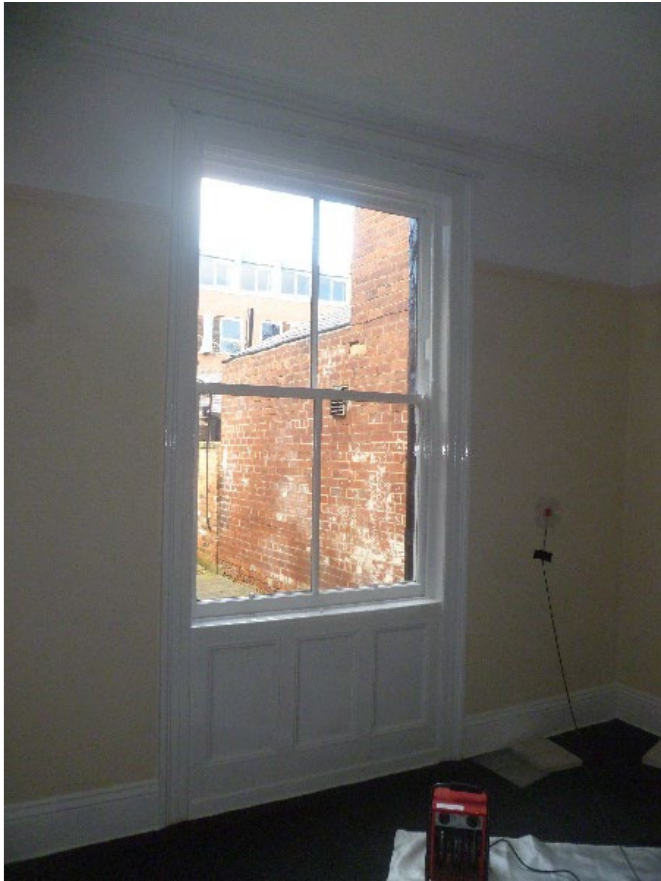
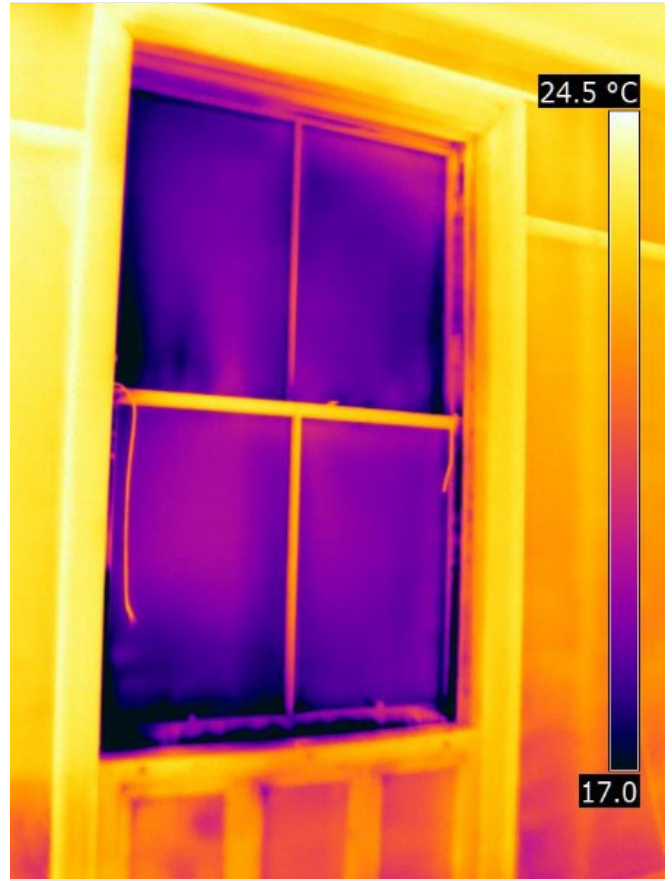
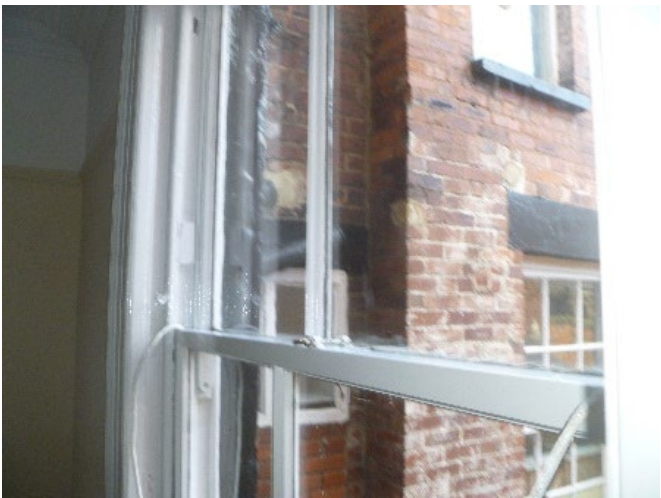
Air leakage was detected around the frames of all windows and doors, with severe air leakage commonplace around the sashes and particularly between the sash meeting rails. Some fireplaces had been blocked up and fitted with vents, and these performed reasonably well. However, the remaining open fireplaces and those which had just been boarded over allowed considerable amounts of airflow through and around them. The hatches to the eaves voids and lofts were not draught-stripped and all allowed air movement around them.

**Figure 3-3 Significant air leakage at the single glazed sash windows around, and at the meeting rails between the sashes**

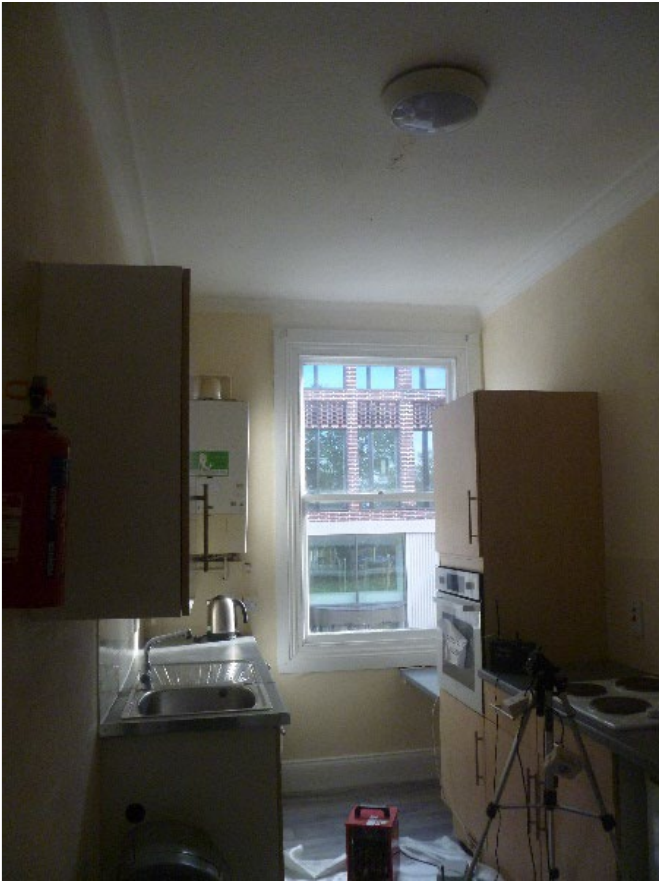
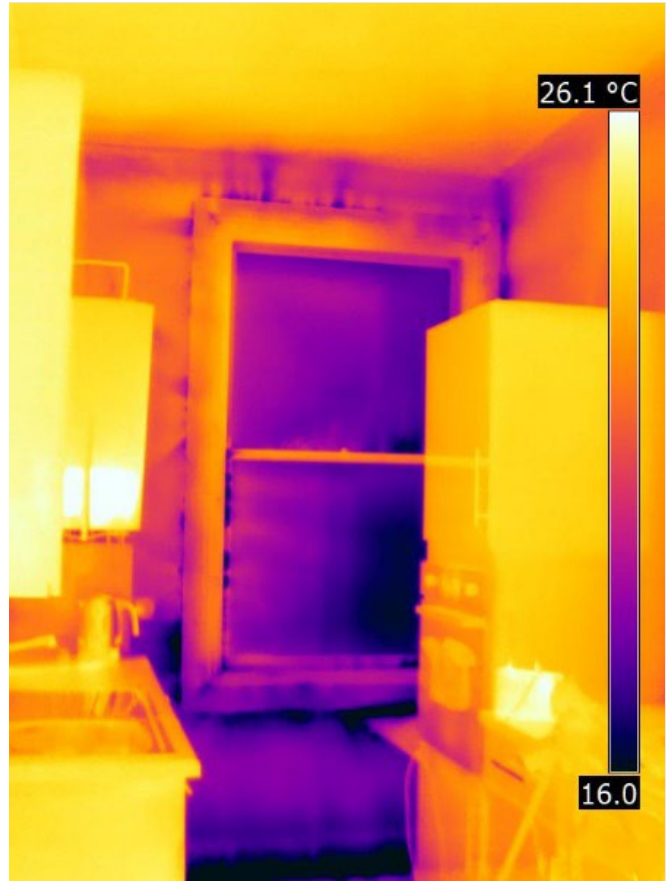
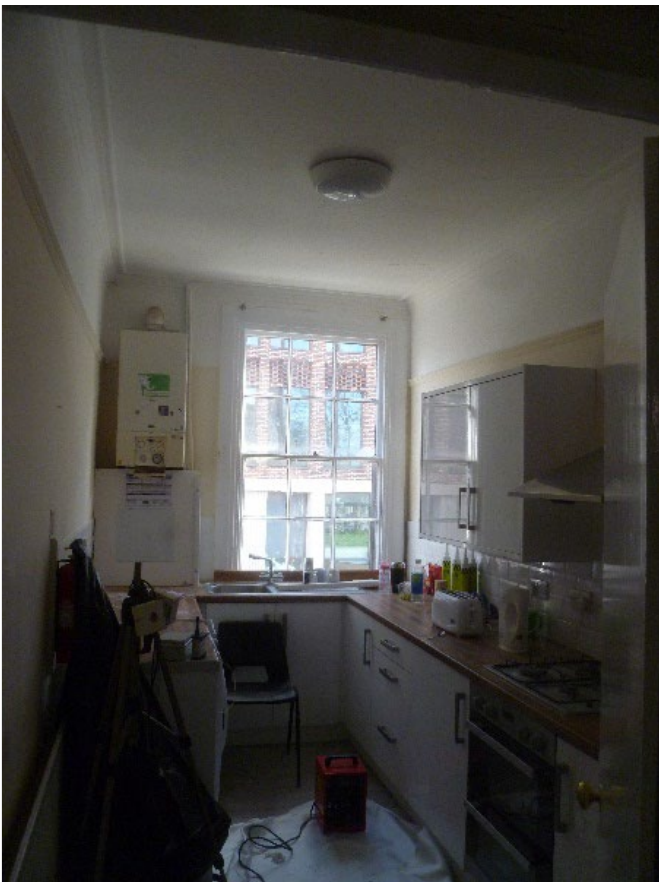
Figure 3-4 Significant air leakage around the kitchen windows in 07LT (top) and 09LT (bottom)

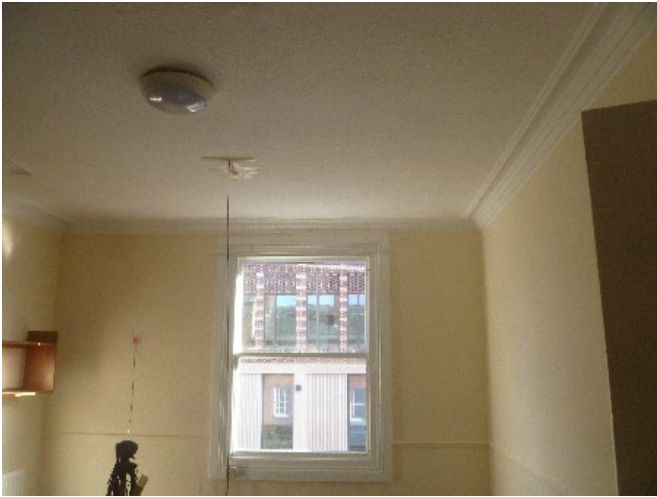
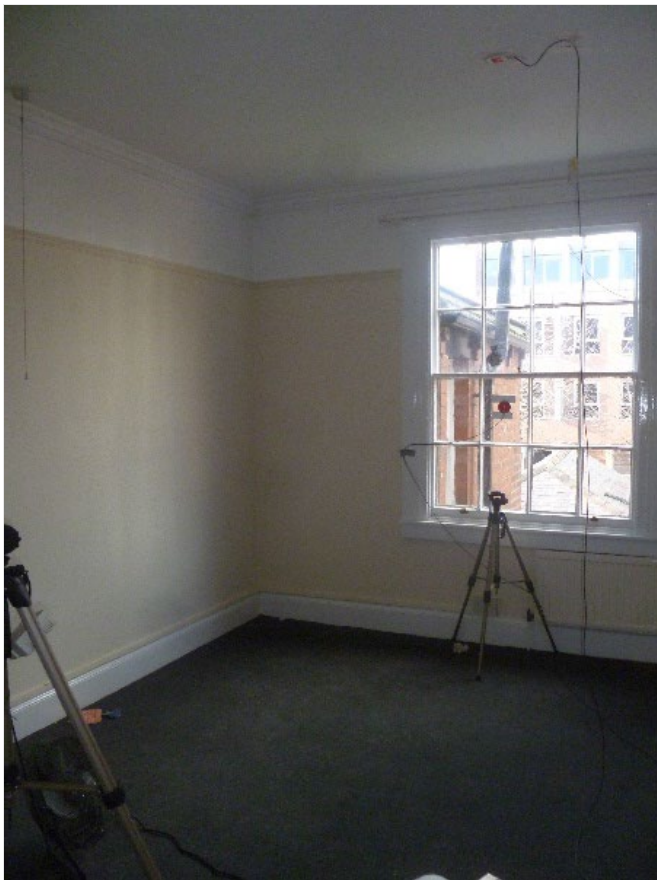
Figure 3-5 Significant air leakage around the window frames in 07LT Bedroom 1 (top) and 09LT Bedroom 2 (bottom)

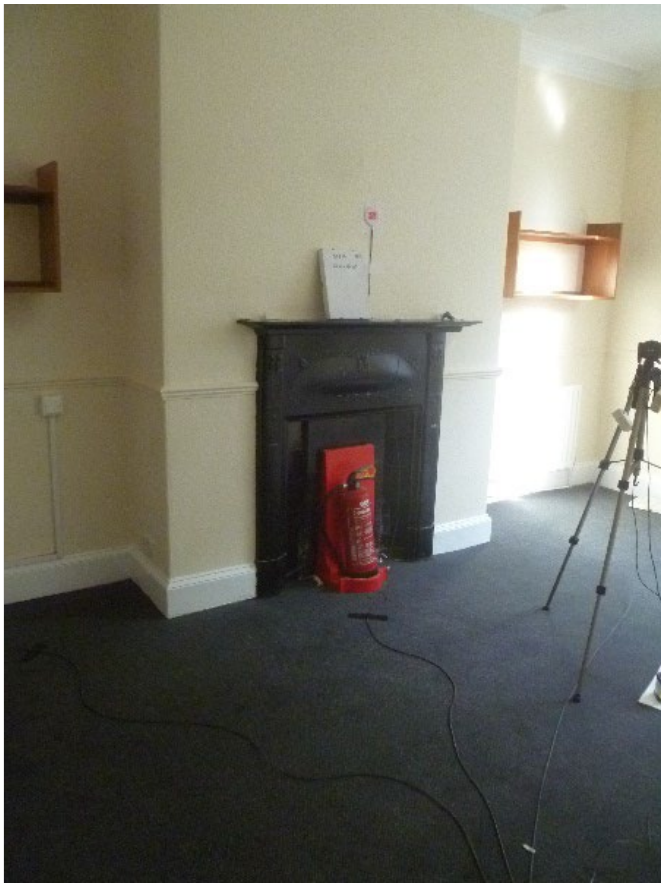
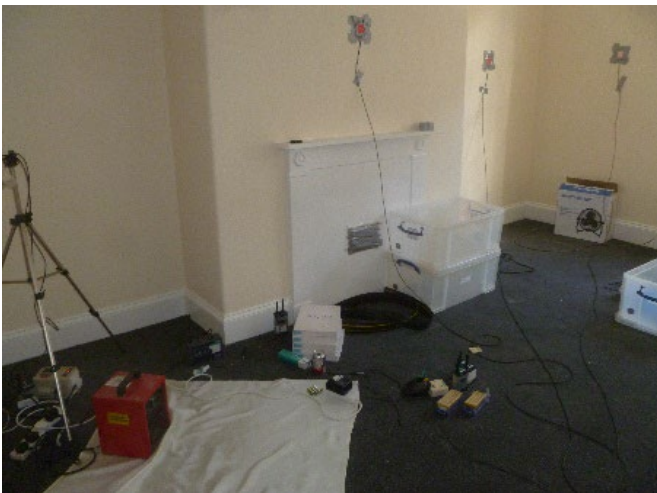
**Figure 3-6 Contrasting airtight performance of the fireplaces in Bedroom 1 of 07LT (open) and Bedroom 1 of 09LT (sealed and vented)**

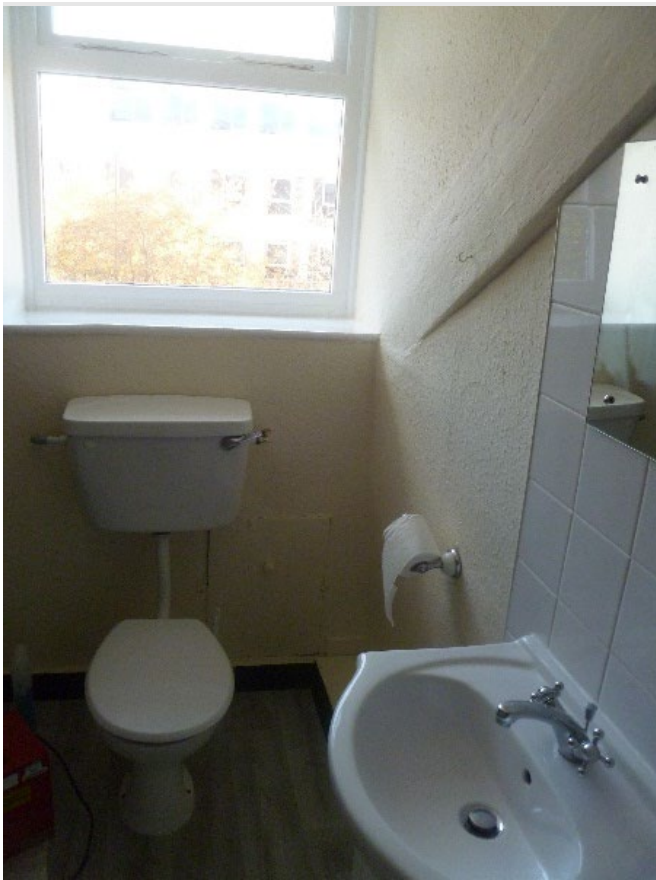
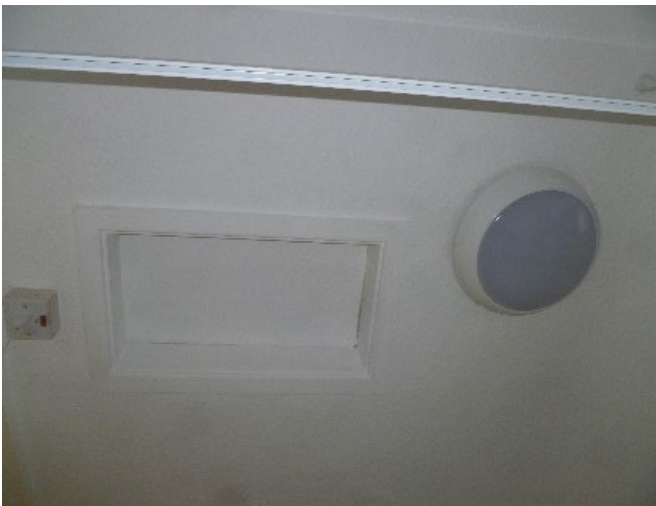
**Figure 3-7 Air leakage around all loft and eaves void access hatches**

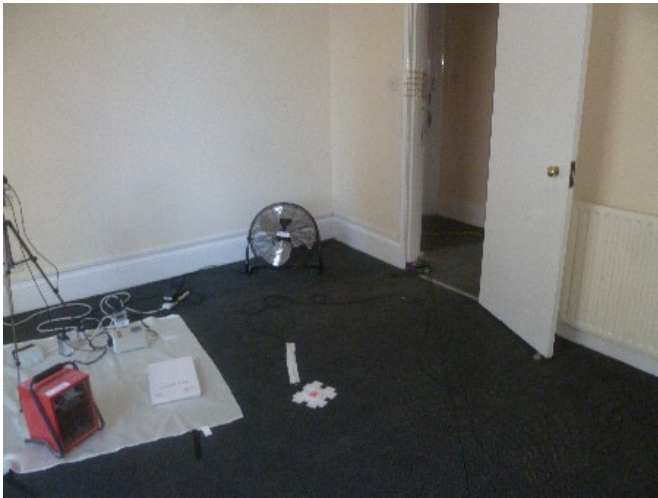
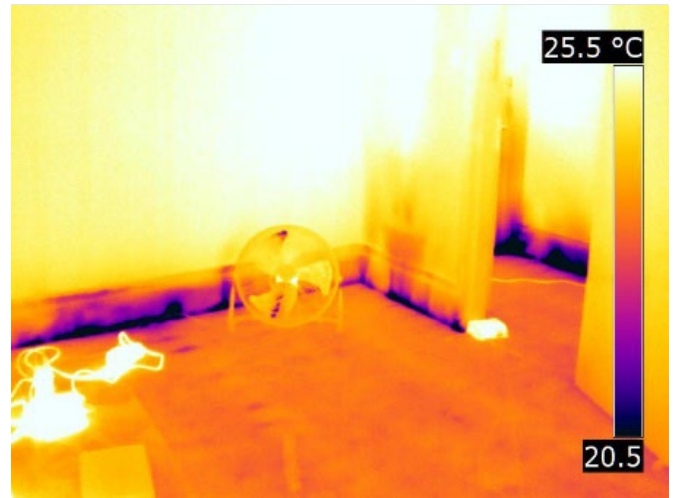
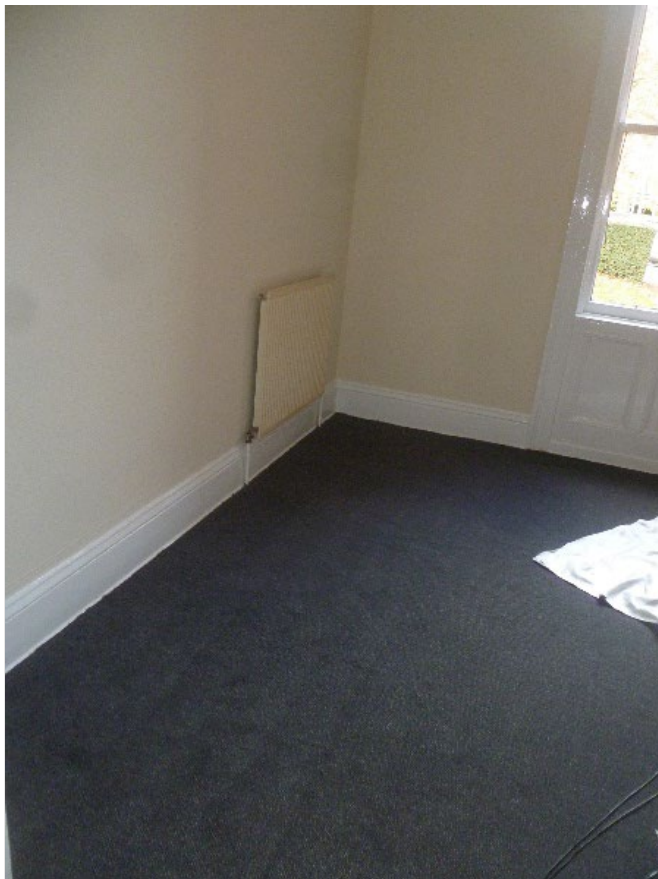
Under depressurisation, cooler air was observed being drawn up from the cellars through and around the ground floor in both properties. This was observed around all ground floor room perimeters and in some areas through gaps between the floorboards (Figure 3-8).

**Figure 3-8 Air leakage at the ground floor room perimeters in 09LT (top) and 07LT (bottom) with cold spots on the carpet where air was drawn up from the cellar through gaps between the floorboards**

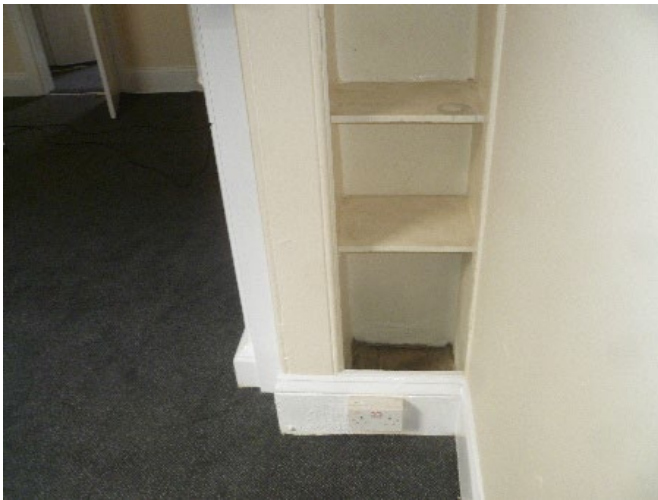
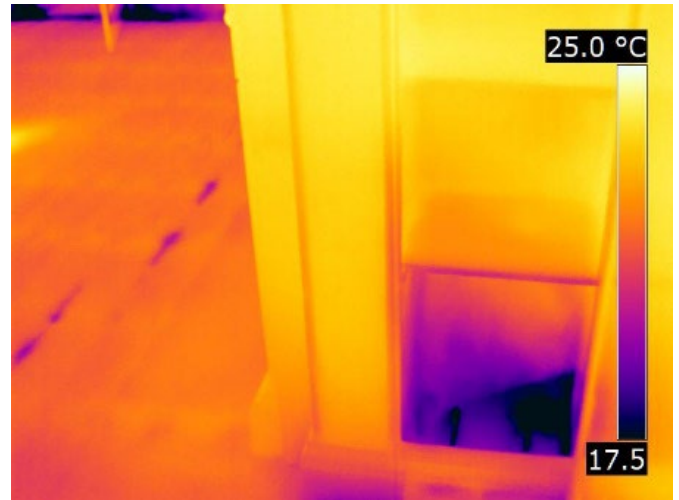
The emerging air was noticeably cooler at the junctions of the ground floor with the front and rear external walls. Figure 3-9 illustrates this, with air emerging at the floor perimeter as cold as the air entering around the window and air coming through areas of uncarpeted floor, suggesting an equally short and direct leakage path.

**Figure 3-9 Emerging air at the ground floor, coolest at the room perimeter junctions with the external walls and areas of uncarpeted floor**
