DEEP Report 2.11

# Case Study 07LT & 09LT

October 2024

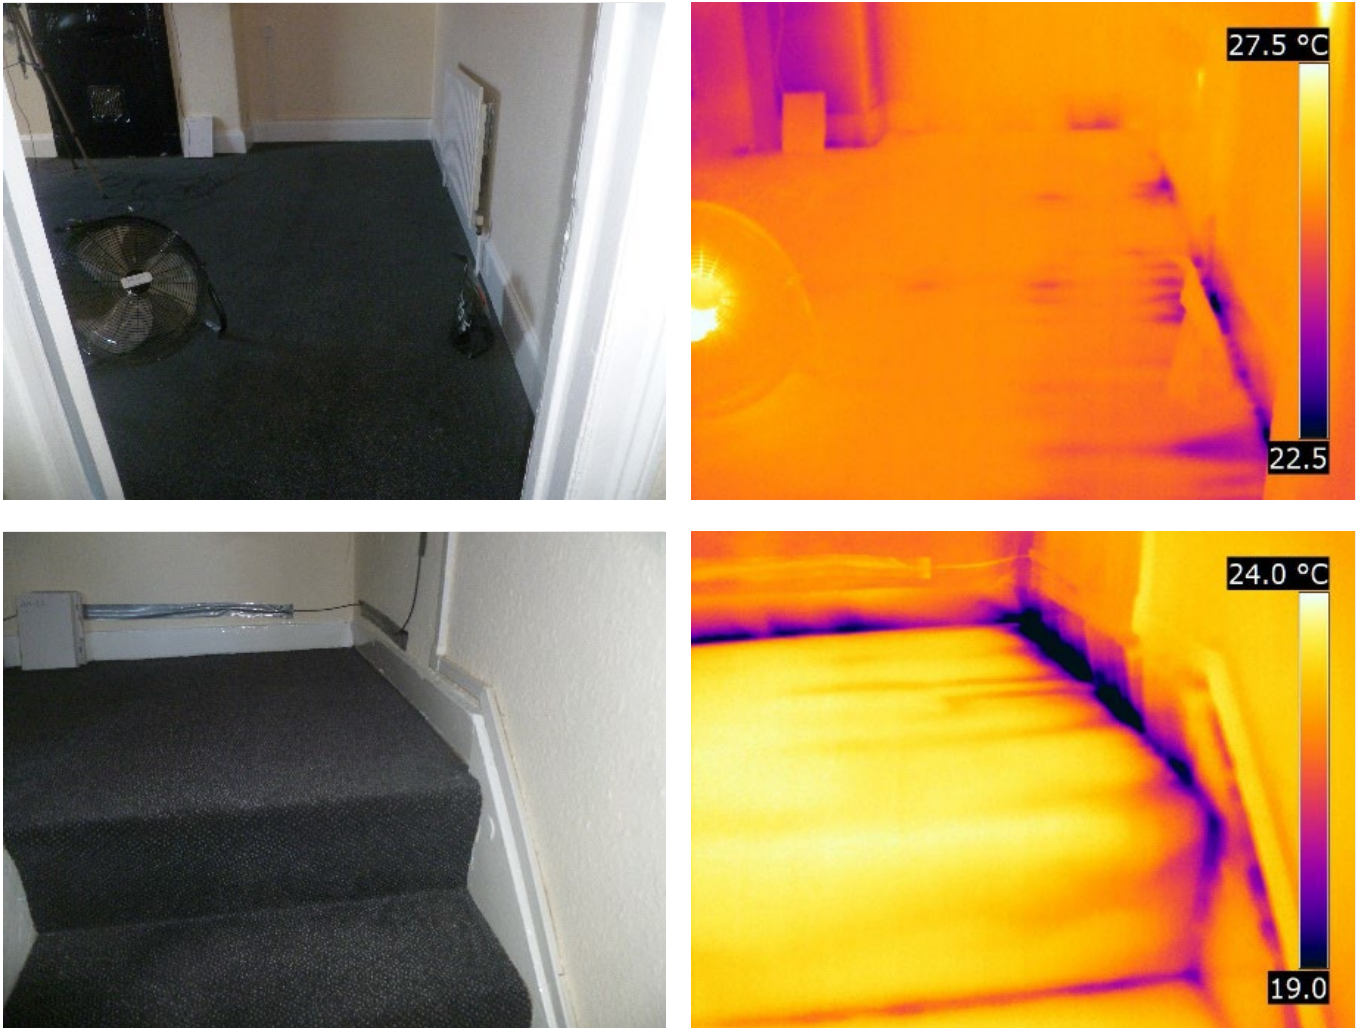
Many additional, less-direct air leakage pathways were detected around both houses, where the air emerging under depressurisation was some distance from the point of entry into the habitable space through the external envelope. Figure 3-10 shows air emerging around the perimeters of both the first and second intermediate floors in 07LT under depressurisation. It cannot be deduced from these where the emerging air was entering the house, but with no nearby openings or penetrations the air must have been travelling through interconnected voids within the dwelling.

**Figure 3-10 Infiltration around intermediate floor and stair perimeters**

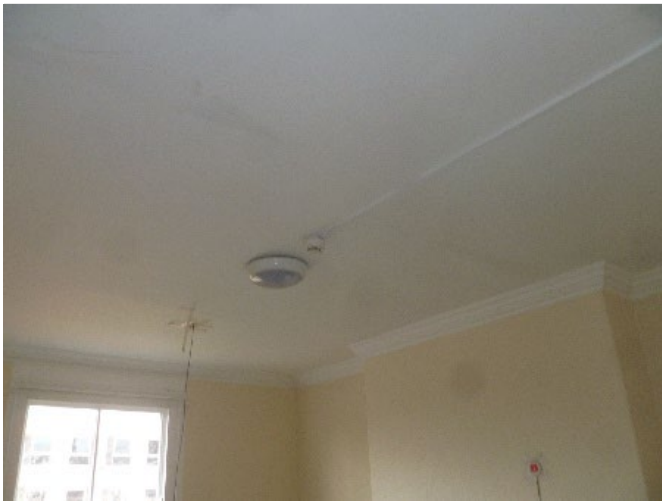
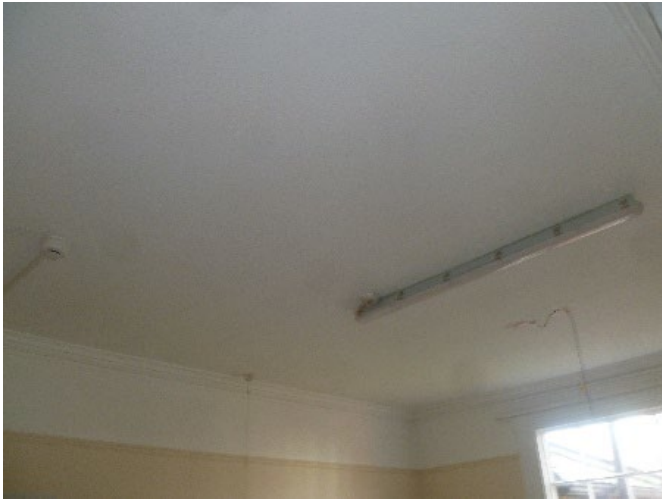
Figure 3-11 shows the ceiling of the first floor Bedroom 2 in 07LT, where cold air can be seen circulating in the eaves void directly above but not in the area of ceiling directly below the bathroom.

**Figure 3-11 Signs of air movement in the ceilings beneath the eaves voids in 07LT (top) and 09LT (bottom)**

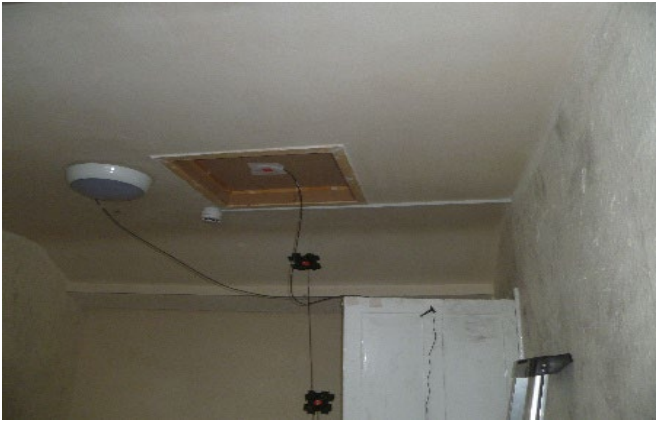
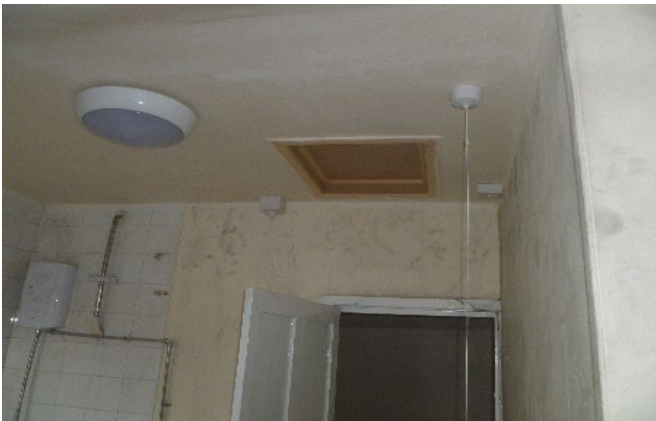
**Figure 3-13** The new loft hatches, not yet draught-stripped, in 07LT at the time of the post room-in-roof retrofit pressure test

The increase in air leakage in 07LT following the room-in-roof retrofit was partly due to some deterioration in temporary sealing made elsewhere in the property (Figure 3-12), but also delays due to additional repair work in the roof meant that testing had to be conducted before the room-in-roof retrofit had been fully completed with some final finishing work still to be done. Time pressure on the testing regime resulted in the pressurisation testing of 07LT being undertaken when the thermal barrier had been completed but not all final finishing, such as fastening and draught-stripping the loft and eaves void access hatches (Figure 3-13 and Figure 3-14).

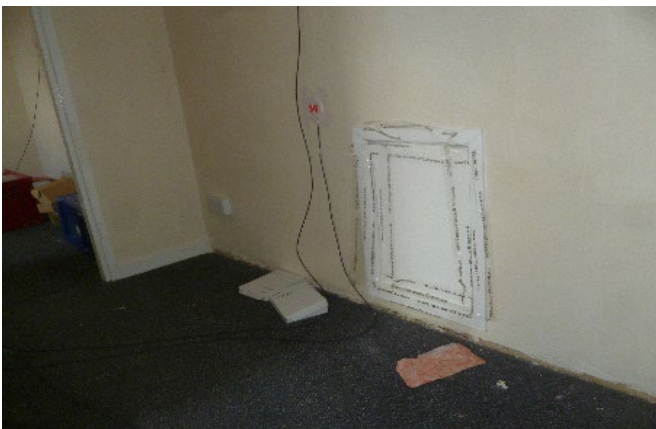
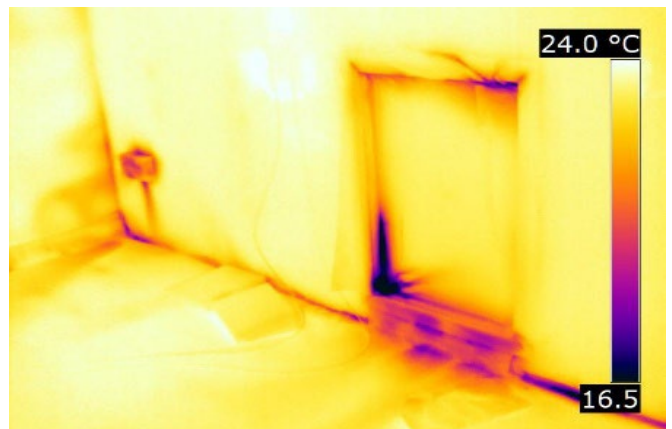
**Figure 3-14** The new eaves void access hatches in 07LT, not yet fastened and draught-stripped, at the time of the post room-in-roof retrofit pressure test

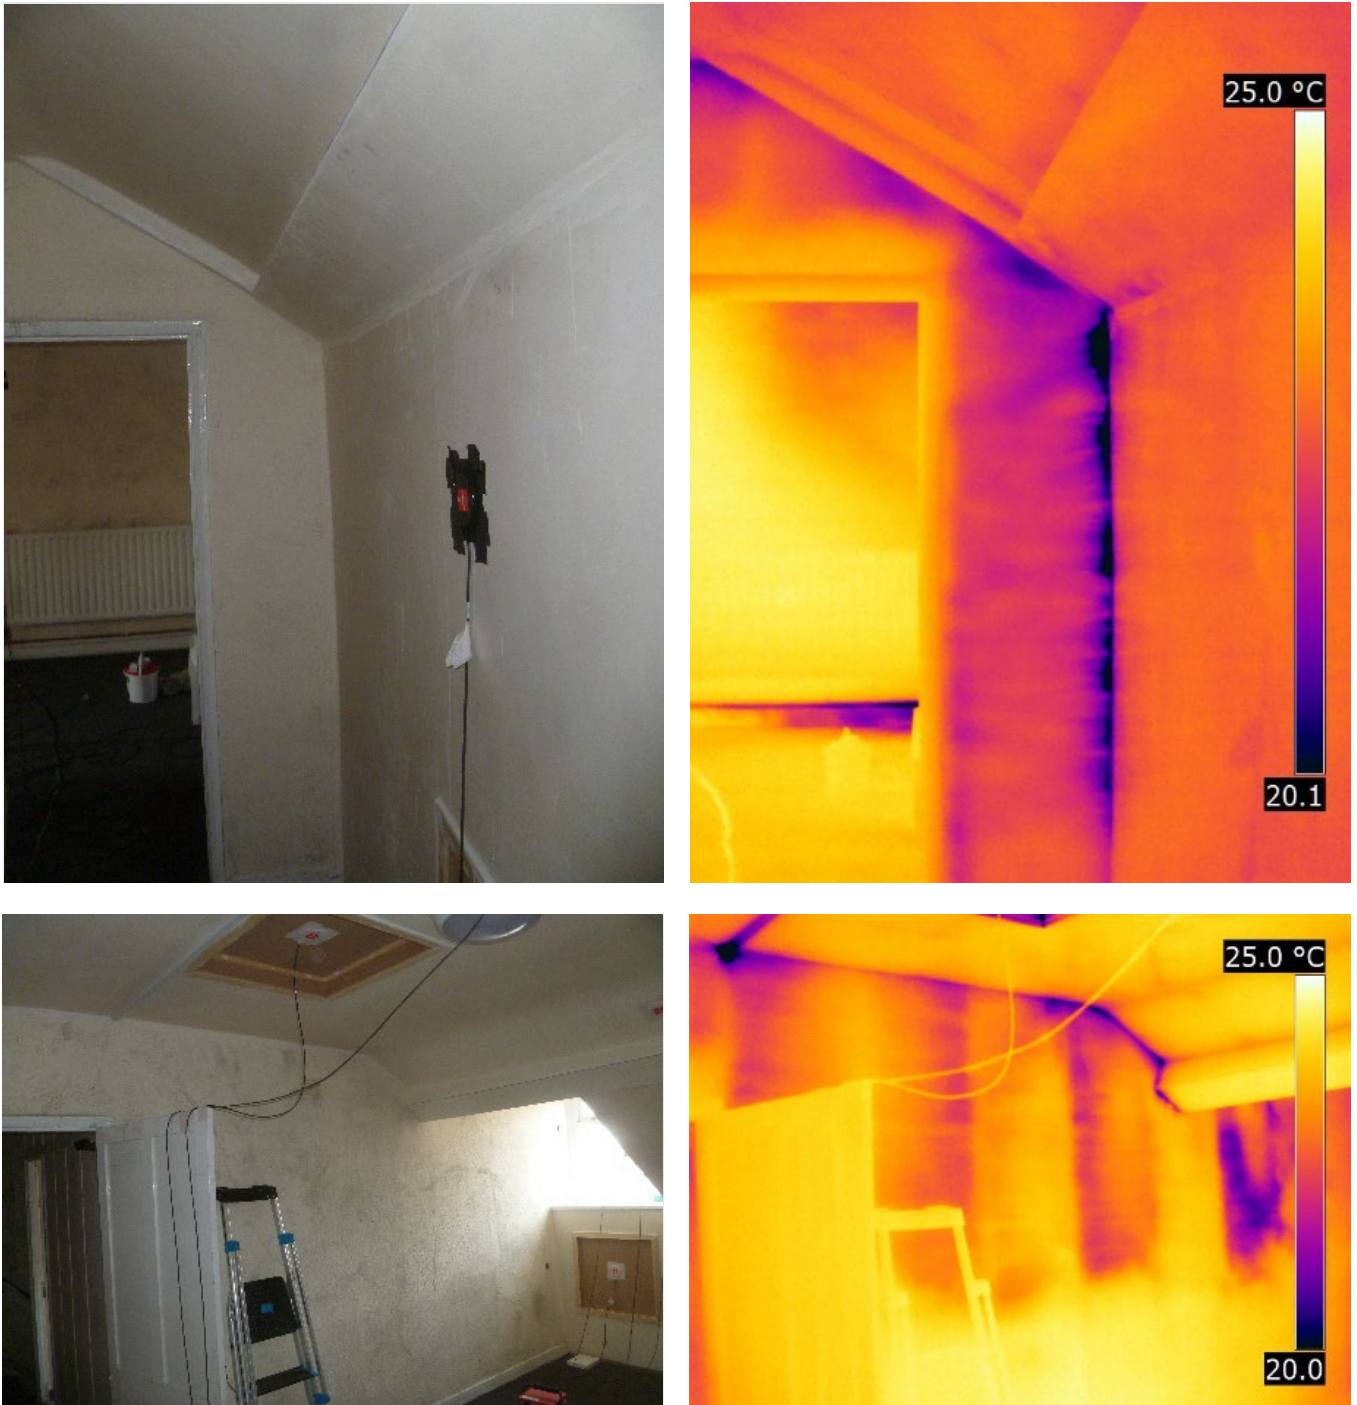
Following both room-in-roof retrofits, additional indirect air leakage into the existing internal partition wall voids which had not been previously detected was revealed. Figure 3-15 and Figure 3-16 show cold air being drawn from the roof and eaves voids under depressurisation into the second floor partition wall voids in each home. This was made obvious by the increased temperature differential between the living space and loft/eaves voids. What remains unclear is how much the improved thermal performance of the refurbished roofs contributed to the increased temperature differential and how much was due to cooler external temperatures at the times of the tests. The post-retrofit tests were undertaken with external temperatures just above 5 °C, whereas the pre-retrofit tests were conducted with external temperatures approaching 10 °C.

**Figure 3-15 Indirect air leakage into the second floor partition wall voids in 07LT**

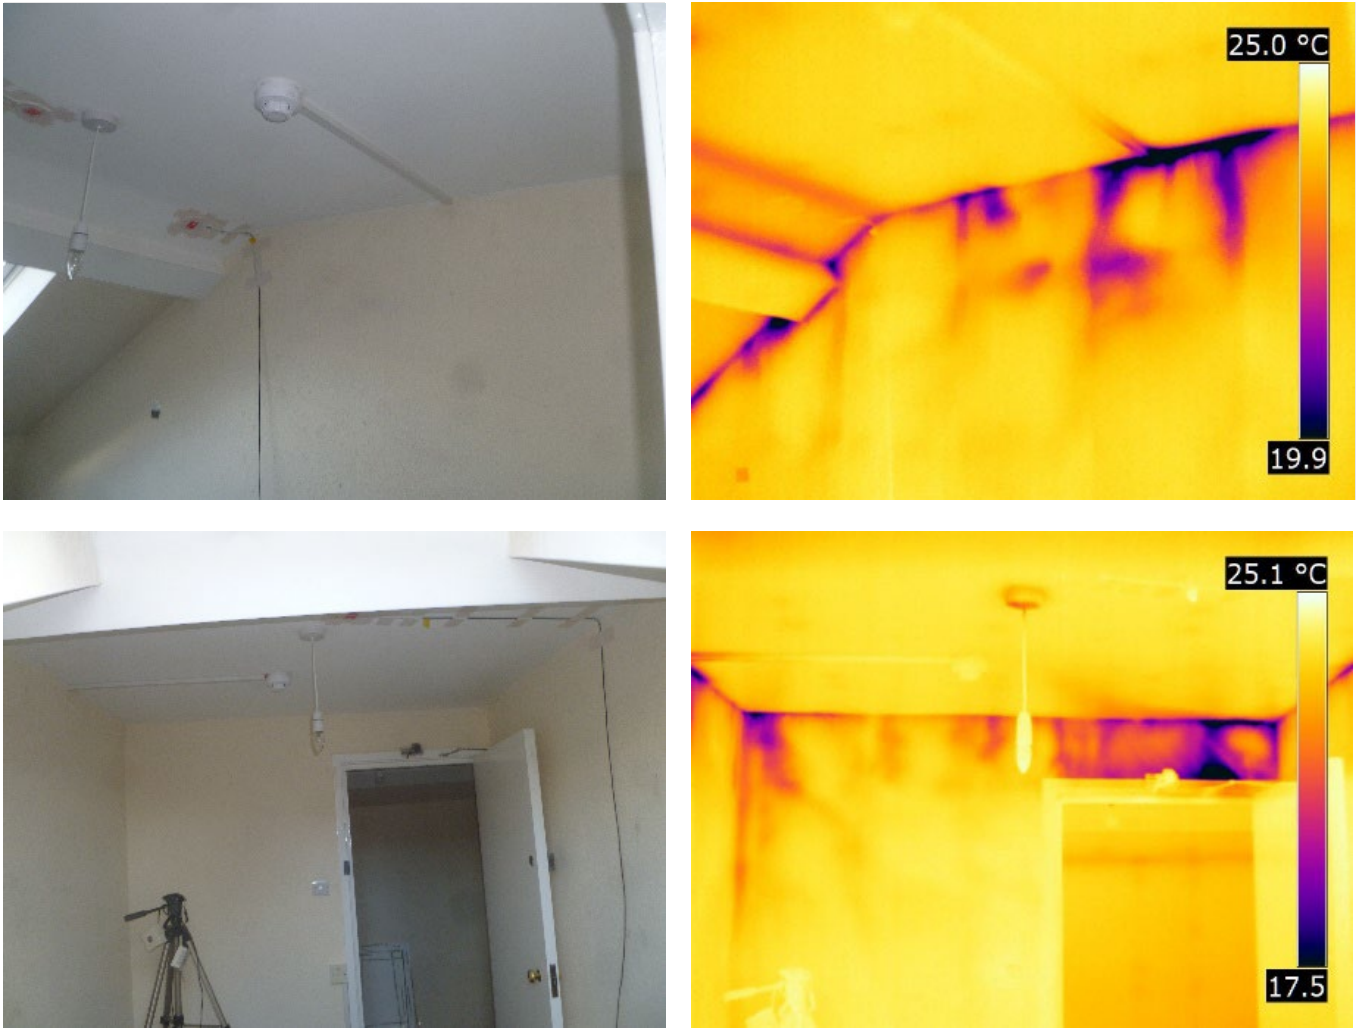
**Figure 3-16 Indirect air leakage into the second floor partition wall voids in 09LT**

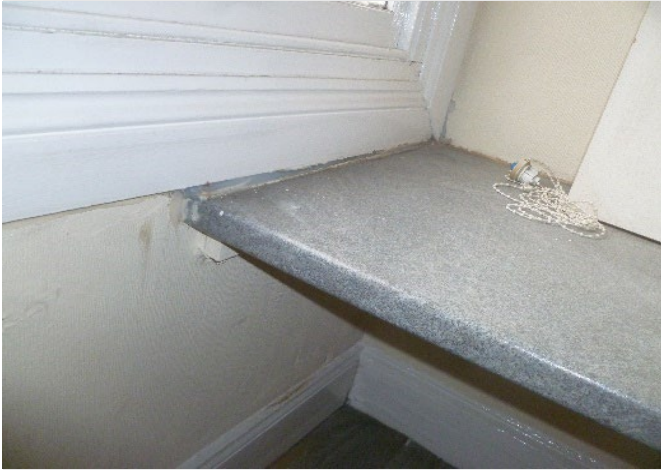
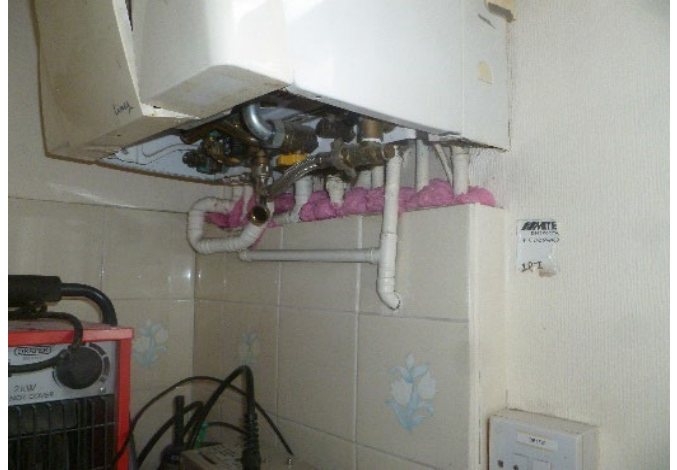
These airtightness measures appeared to address mainly direct infiltration by sealing visible and easily accessible gaps around penetrations, openings and floor perimeters with expanding foam and mastic, without tackling the more complex indirect air leakage through interconnected voids throughout the homes. Figure 3-17 and Figure 3-18 illustrate the types of measures undertaken.

**Figure 3-17 Additional sealing in the kitchen of 07LT**

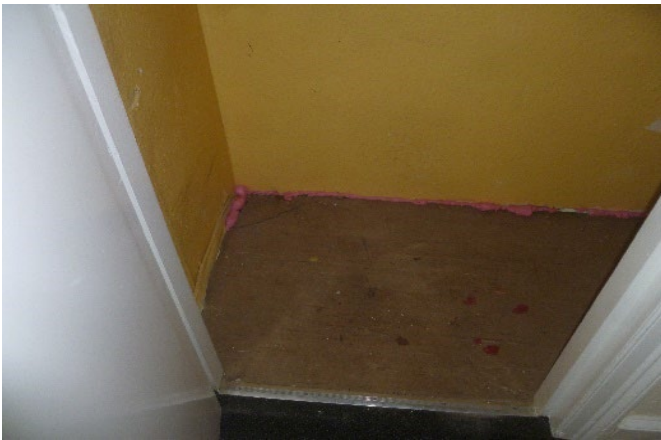
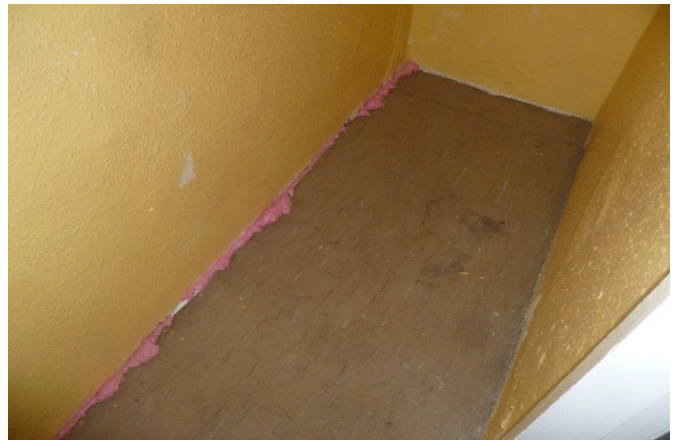
**Figure 3-18 Additional sealing around room perimeters on both intermediate floors in 09LT**

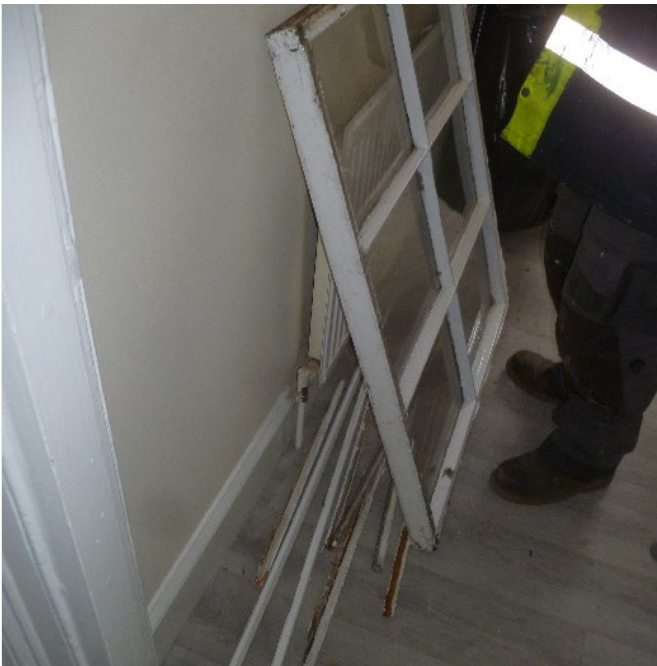
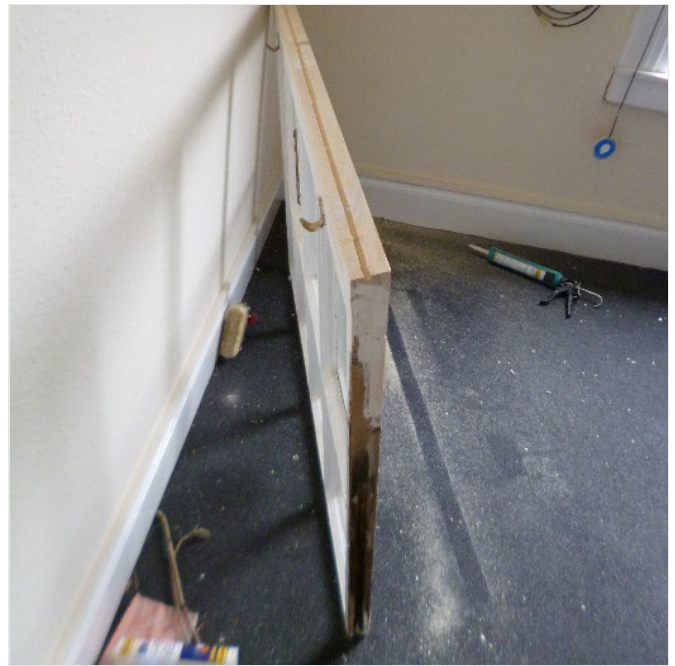
In 07LT, the window refurbishment included repairing damaged sash rails, replacing beading around each of the upper and lower sashes, replacing damaged or missing locks and backplates, and the addition of draught-stripping brushes around the lower sashes and between the sash meeting rails (Figure 3-19 and Figure 3-20). A small reduction in mean air permeability was seen under both dwelling depressurisation (0.23  $\text{m}^3/(\text{h}\cdot\text{m}^2)$  @ 50Pa) and pressurisation (0.17  $\text{m}^3/(\text{h}\cdot\text{m}^2)$  @ 50Pa).

**Figure 3-19 Individual sashes and beading removed, sashes repaired and beading replaced**

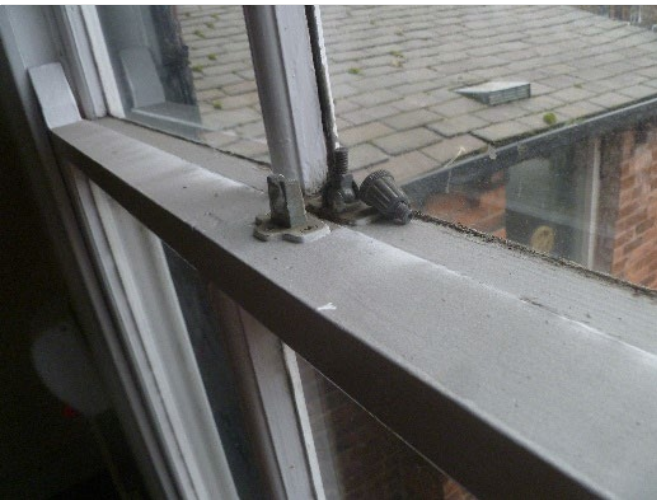
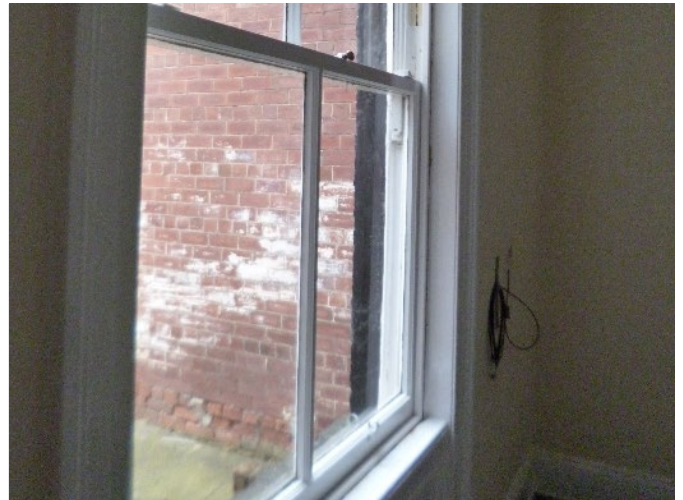
**Figure 3-20 Damaged window locks replaced and new beading fitted in 07LT**

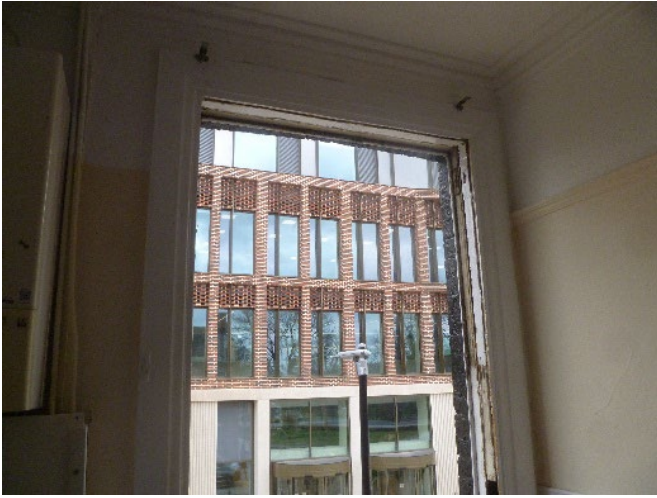
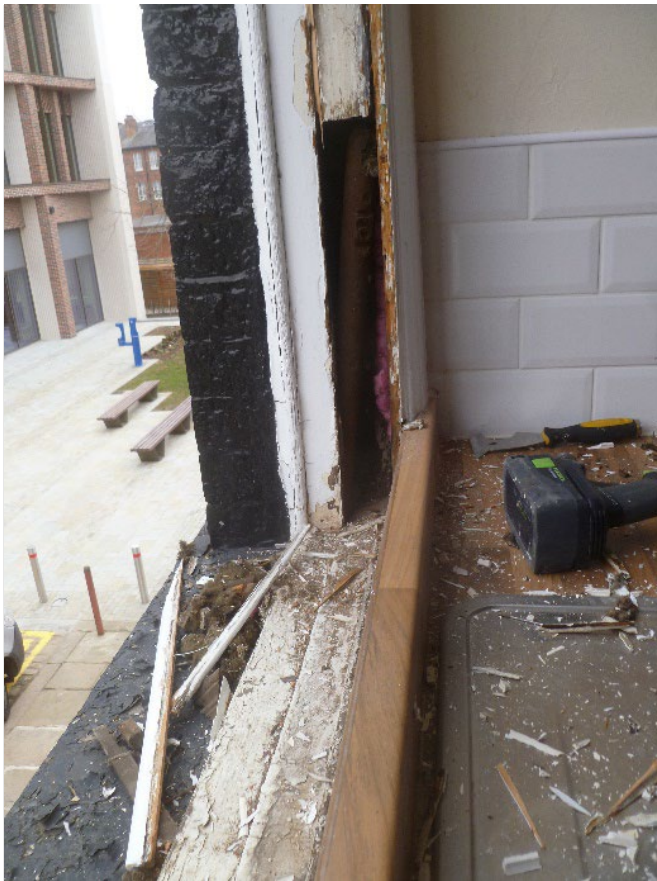
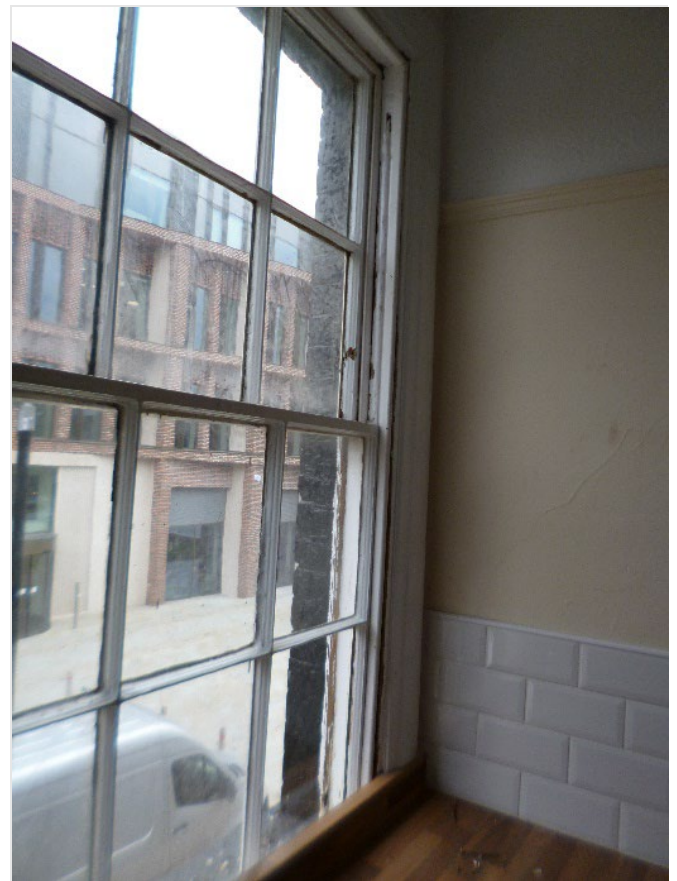
In 09LT, not only were the same measures undertaken as 07LT, but the sash weights, cords and pulleys were overhauled to make the windows fully operable (Figure 3-21).

**Figure 3-21 Kitchen window in 09LT removed and mechanism repaired**

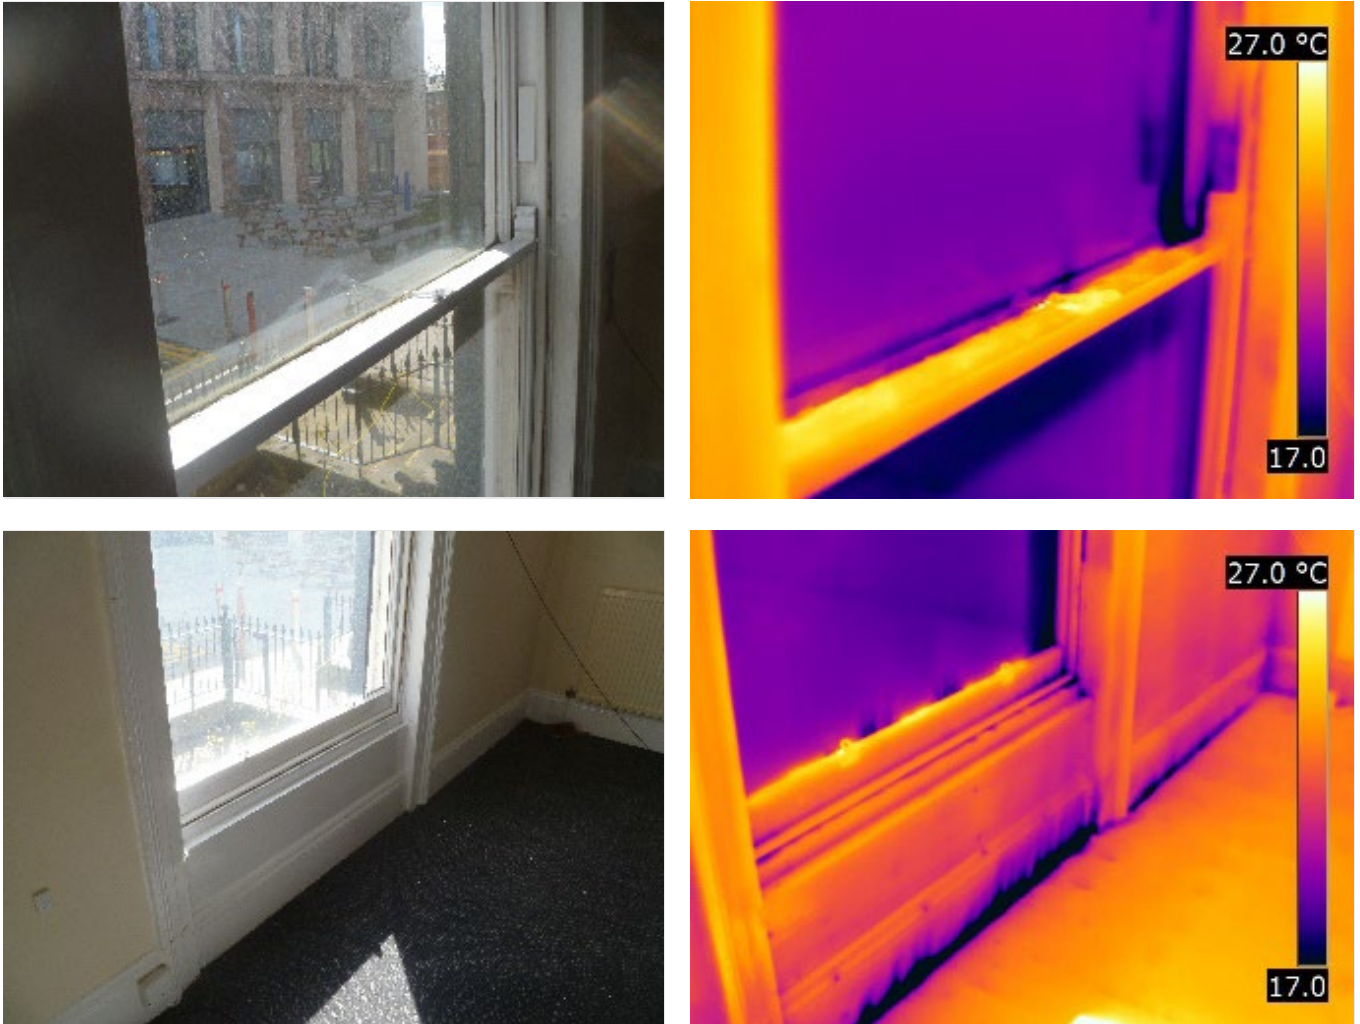
The reduction in mean air permeability was due to a decrease in the result under pressurisation ( $0.62 \text{ m}^3/(\text{h}\cdot\text{m}^2) @ 50 \text{ Pa}$ ), with only a negligible change under depressurisation. Leakage detection under depressurisation showed that the brushes installed at the meeting rails reduced air leakage between the sashes but failed to prevent significant air leakage at either end of the meeting rails (Figure 3-22). The new beading was, however, reasonably effective at reducing airflow around the lower sashes.

**Figure 3-22 Front room in 07LT showing reduced air leakage at meeting rails and lower sash**

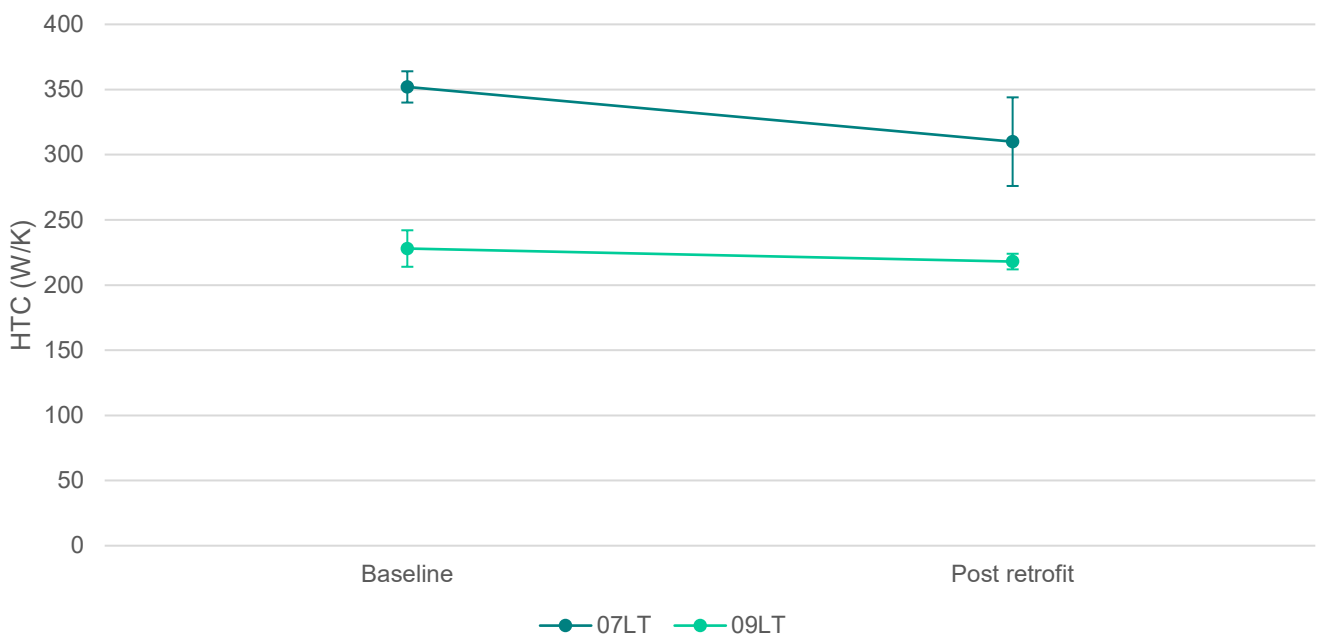
The savings in 07LT are statistically significant whereas the savings measured in 09LT are within the uncertainty of the test. Since only marginal reductions in infiltration were measured in 07LT and no airtightness improvements were achieved in 09LT, the savings can predominantly be attributed to the room-in-roof insulation.

**Figure 3-27 Coheating HTC**

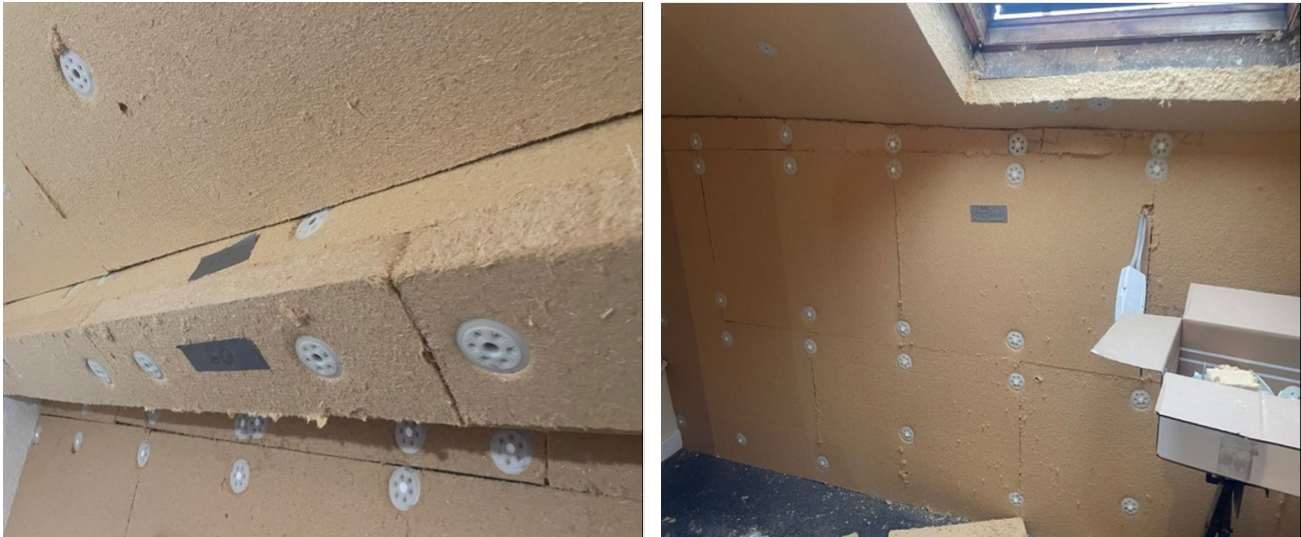
The retrofit involved the removal of existing knee walls and ceilings. To take the additional weight of the wood fibre boards, additional bracing support was needed which added unanticipated costs and time to the programme. The wood fibre board was mechanically fixed to existing gable walls and timbers, and care was taken to continue the insulation layer around the purlins, as shown in Figure 3-28.

**Figure 3-28 Wood fibre board installation**

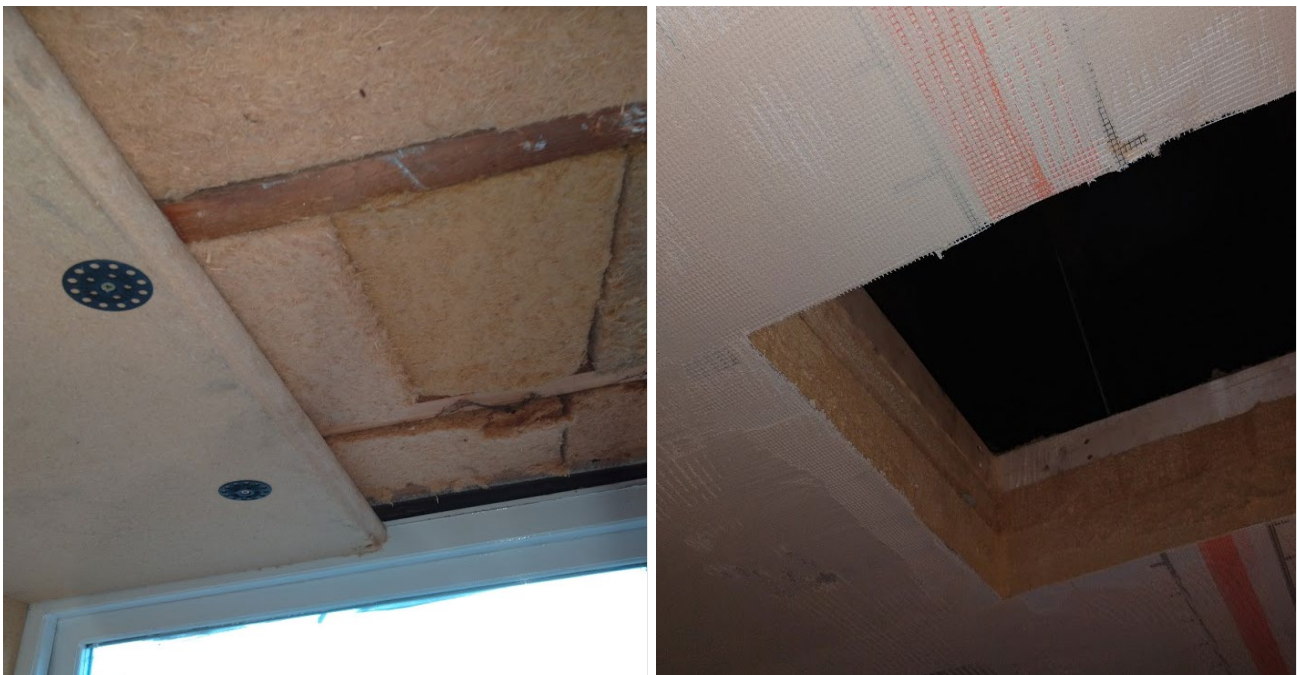
The installation of the wood fibre board necessarily reduced the head height available in the room-in-roof. As shown in in Figure 3-29, the increase in additional insulation on the ceiling did not cause any overlap on the window frames, which could have caused additional design challenges. However, the extra fabric thickness did mean that standard access hatches could not be installed, and bespoke joinery work was needed.

**Figure 3-29 Reduction in ceiling height caused by the addition of wood fibre insulation**

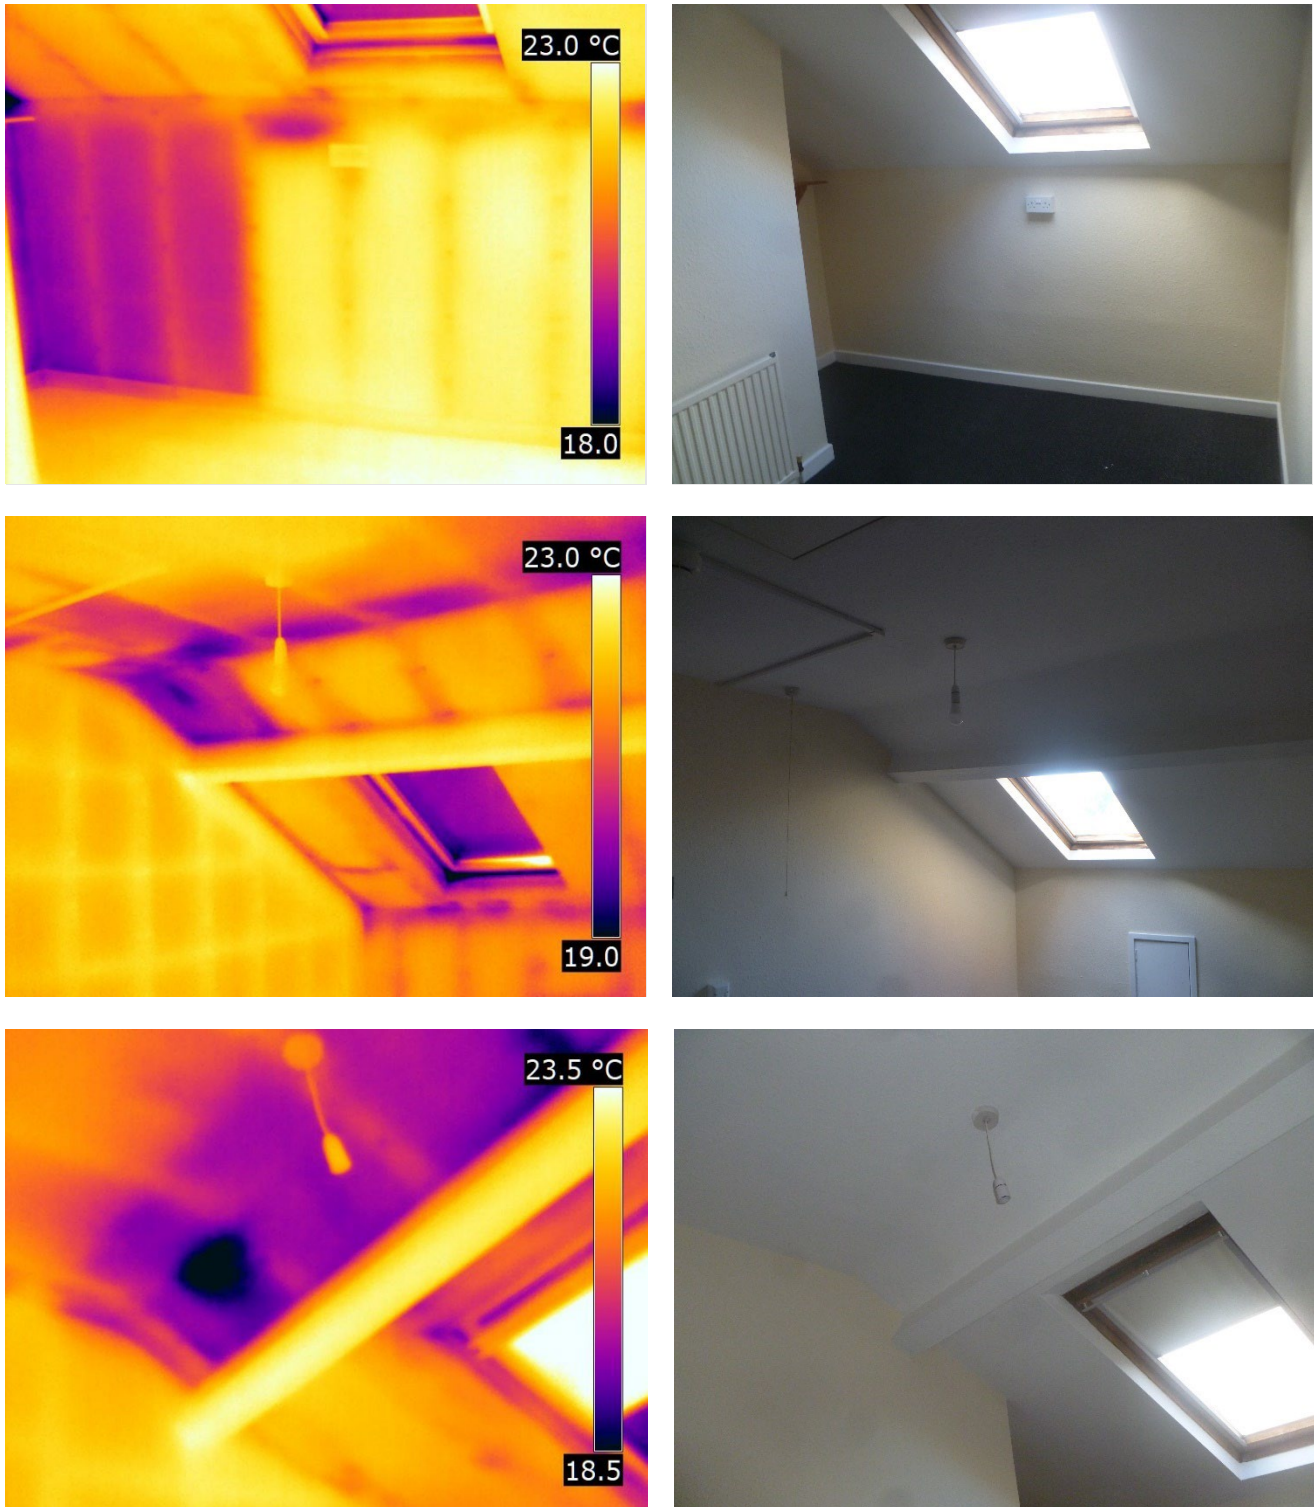
In addition to the retrofit achieving heat loss savings, the fabric achieved more consistent and higher surface temperatures. Room-in-roof geometry is complex, often leading to discontinuities in insulation layers, as found in these homes prior to the retrofit (Figure 3-30). These areas can cause cold spots which may be at elevated risk of surface condensation.

**Figure 3-30 Discontinuities around complex geometries in room-in-roof pre-retrofit causing cold bridging resolved post-retrofit**

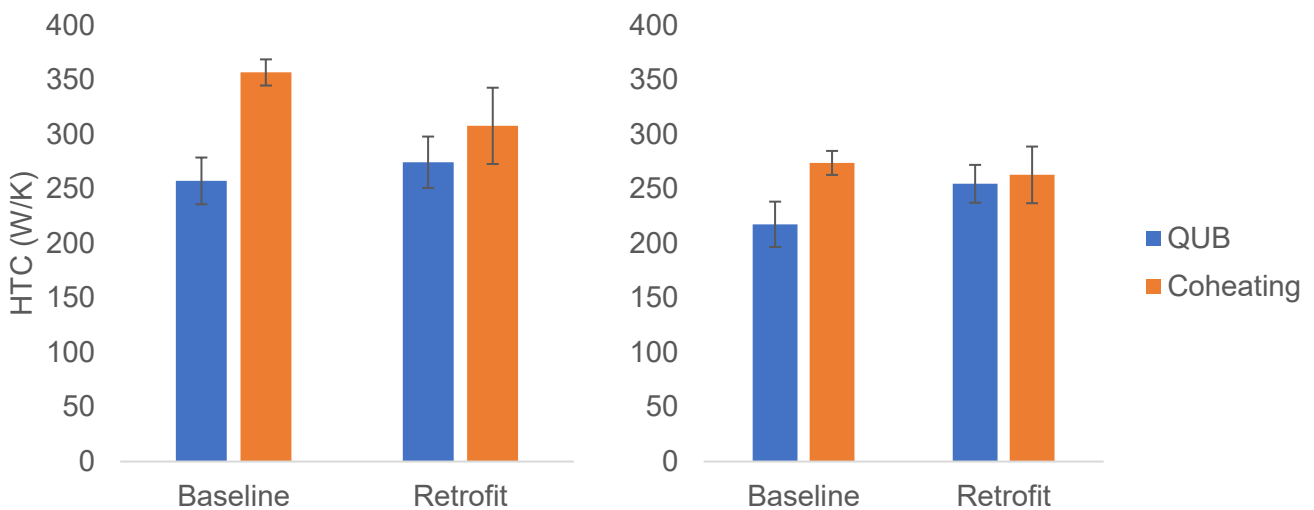
The overall uncertainty weighted average QUB measurements are compared against coheating in Figure 3-33. When evaluating the uncertainty weighted average for the QUB measurements, the agreement between the two techniques improved with the completion of the retrofit works. The relative difference for the baseline and retrofit stages improved from 28 % to 11 % for 07LT, and 21 % to 3 % for 09LT.

**Figure 3-33 Average QUB HTC measurement vs. coheating measurement for 07LT (left) and 09LT (right)**

The patterns observed in the results are reflective of existing research which shows better agreement between QUB and coheating tests in higher performing (lower heat loss) buildings [5, 6]. However, as the retrofit works led to only modest reductions in overall heat loss no significant improvement in the QUB measurements was detected.

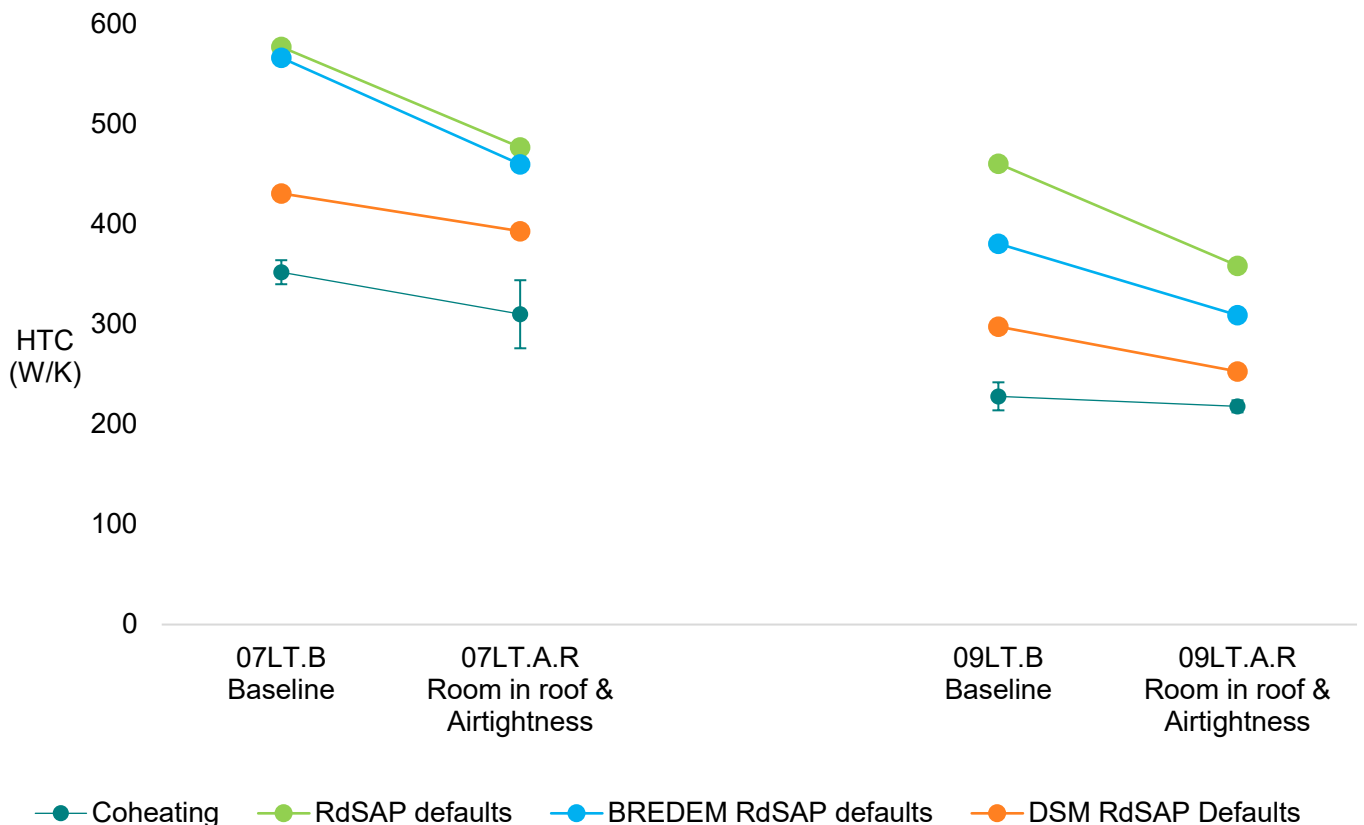
- All the models predict significantly higher HTC and HTC reductions than the coheating tests, since the RdSAP default U-values for rooms-in-roof are substantially higher than usually measured.
- The RdSAP default input room-in-roof simplified assumptions mean that EPCs predict the highest HTC savings of 17 % and 22 % for 07LT and 09LT, respectively, whereas the coheating test measured only  $(12 \pm 10)$  % and  $(4 \pm 7)$  % reductions.
- Additionally, the room-in-roof simplification in EPCs does not consider there to be party walls in the room-in-roof, meaning that RdSAP has higher HTC predictions than BREDEM (where the actual geometry is used) especially in 09LT, which is a mid-terrace.
- Consistent with other DEEP case studies, the DSM model predicts much lower HTC values than the steady-state models.

Figure 3-34 Measured vs. modelled HTC calibration step 1: Default data

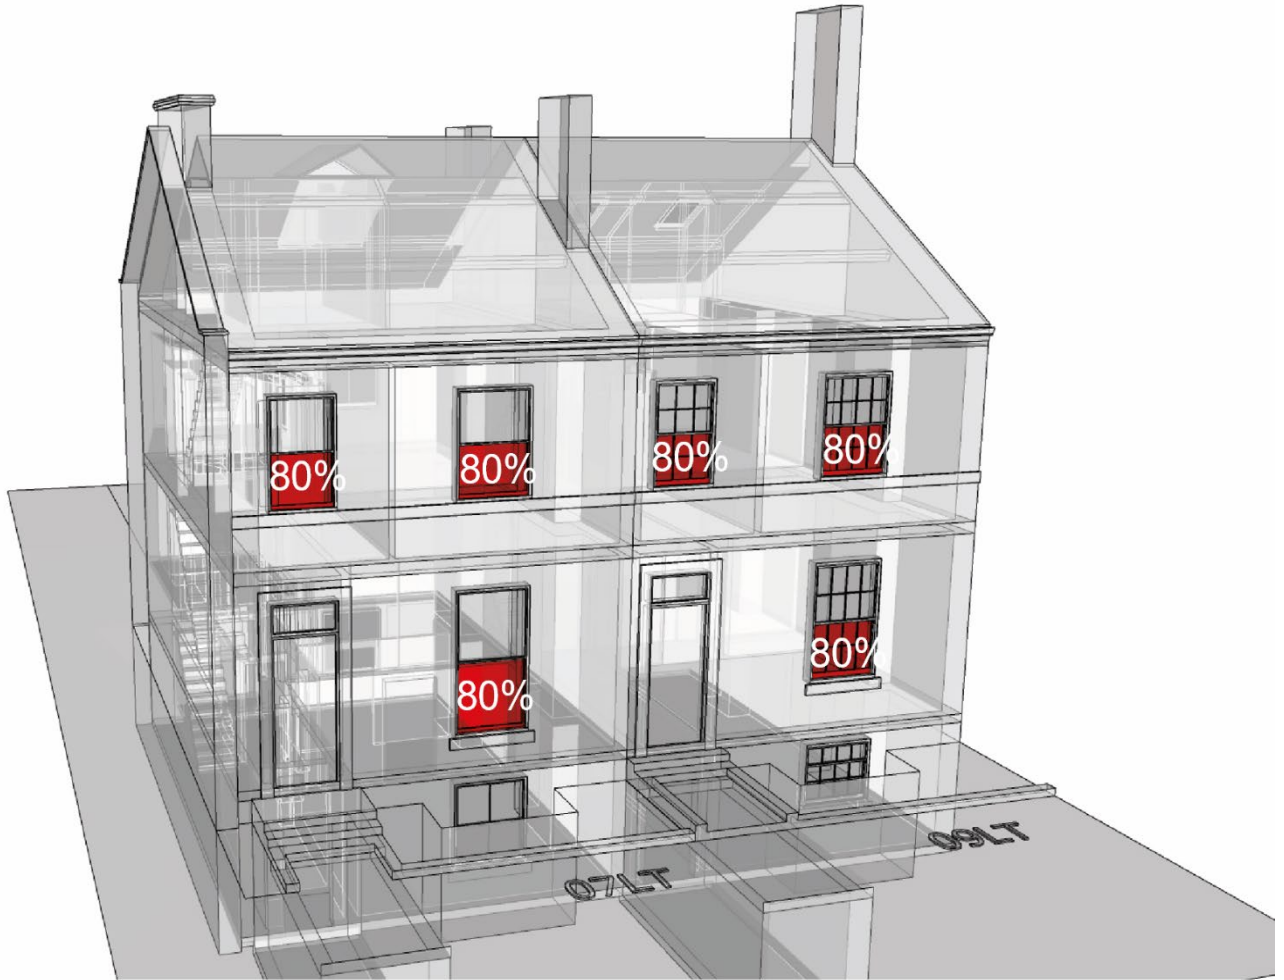
There is very little difference between the window opening areas in both houses, and between pre- and post-retrofit stages. The main differences are at the rear and in the room-in-roof areas. The two dwellings have differently shaped extensions at the rear, which means 07LT has an additional window opening on the first-floor landing. There are opening skylights in the room-in-roof bedrooms in 09LT, whereas 07LT has a small dormer construction at the rear of the room-in-roof, although the openable areas of the windows in both properties are very similar overall.

Figure 3-41 Percentage of opening area for openable windows

Overheating assessment was carried out at each stage of the retrofit. Following the TM59 guidance, the initial assessment was completed using the CIBSE Design Summer Year 1 (DSY1) file for a 2020s high emission scenario at the 50<sup>th</sup> percentile, for Leeds in this instance. There are three DSY files available for the 14 UK regional locations, which use actual weather data that simulate various heatwave intensities. DSY1 represents a moderately warm summer; DSY2 represents a short, intense warm spell; and DSY3 represents a longer, less intense warm spell [13]. Assessment was also carried out for future weather scenarios, using the DSY1 files for the 2050s and 2080s high emission scenarios at the 50<sup>th</sup> percentile. As with all naturally ventilated homes, it is the percentage of openable area of the windows that has the strongest influence on overheating risk, and these are illustrated in Figure 3-41.
