DEEP Report 2.12

Case Study 19BA

Case study 19BA is a four bed 1900 mid-terrace in which airtightness and room-in-roof retrofits were undertaken. The airtightness retrofit consisted of general sealing of air leakage paths, without significant deconstruction of the building fabric. The room-in-roof retrofit consisted of new insulation to the ceilings of the loft and eaves voids, new insulation to the sloped ceilings and insulation to the knee walls and dormer external wall. The performance of each retrofit was assessed for airtightness and thermal performance.

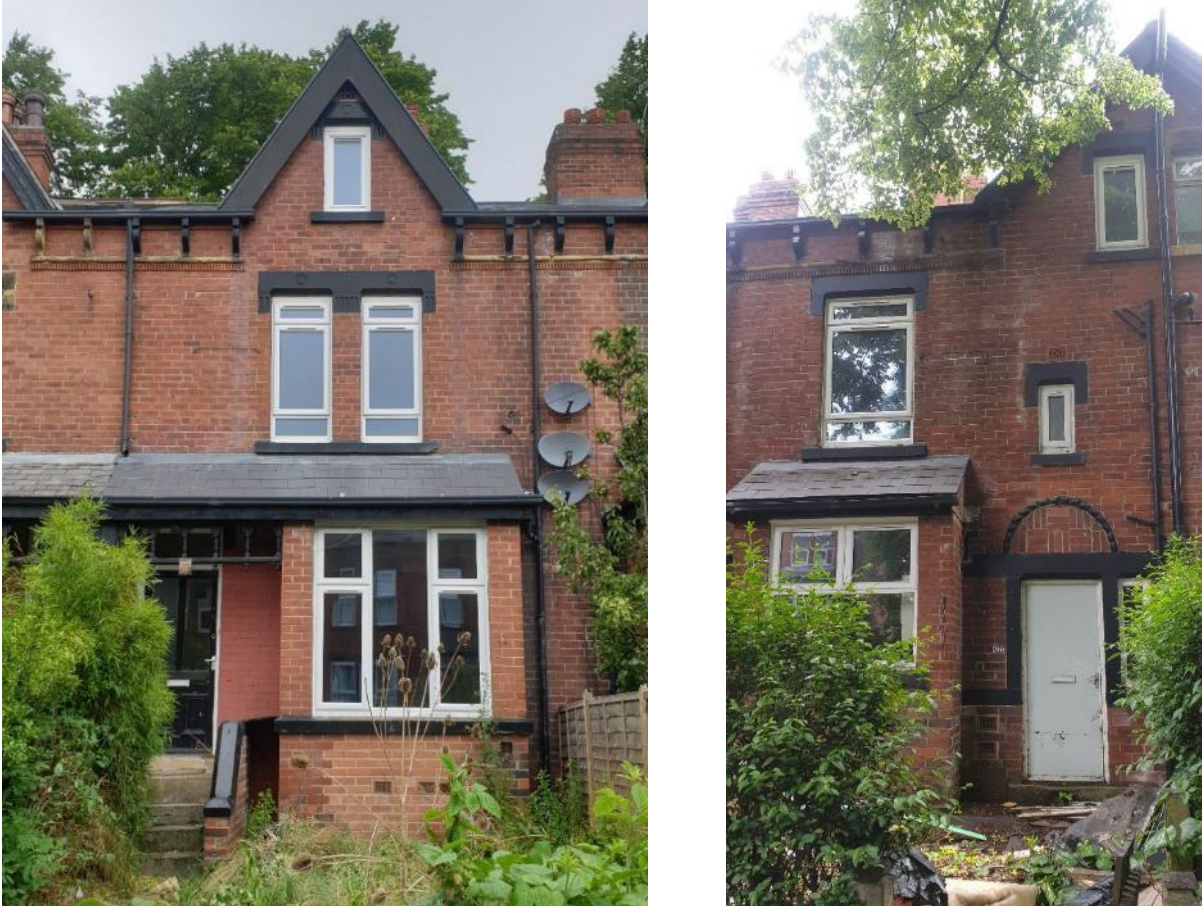
Figure 1-1 Case study house – front elevation (LHS), rear elevation (RHS)

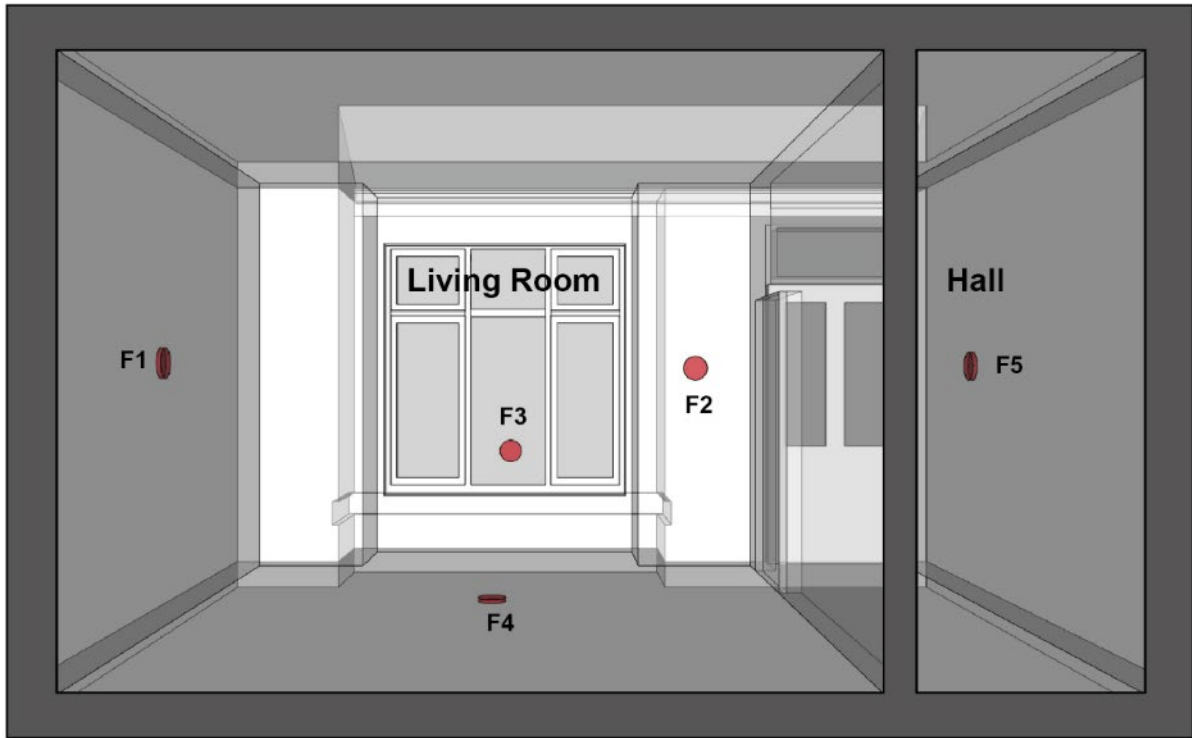
Figure 2-1 Ground floor HFP locations

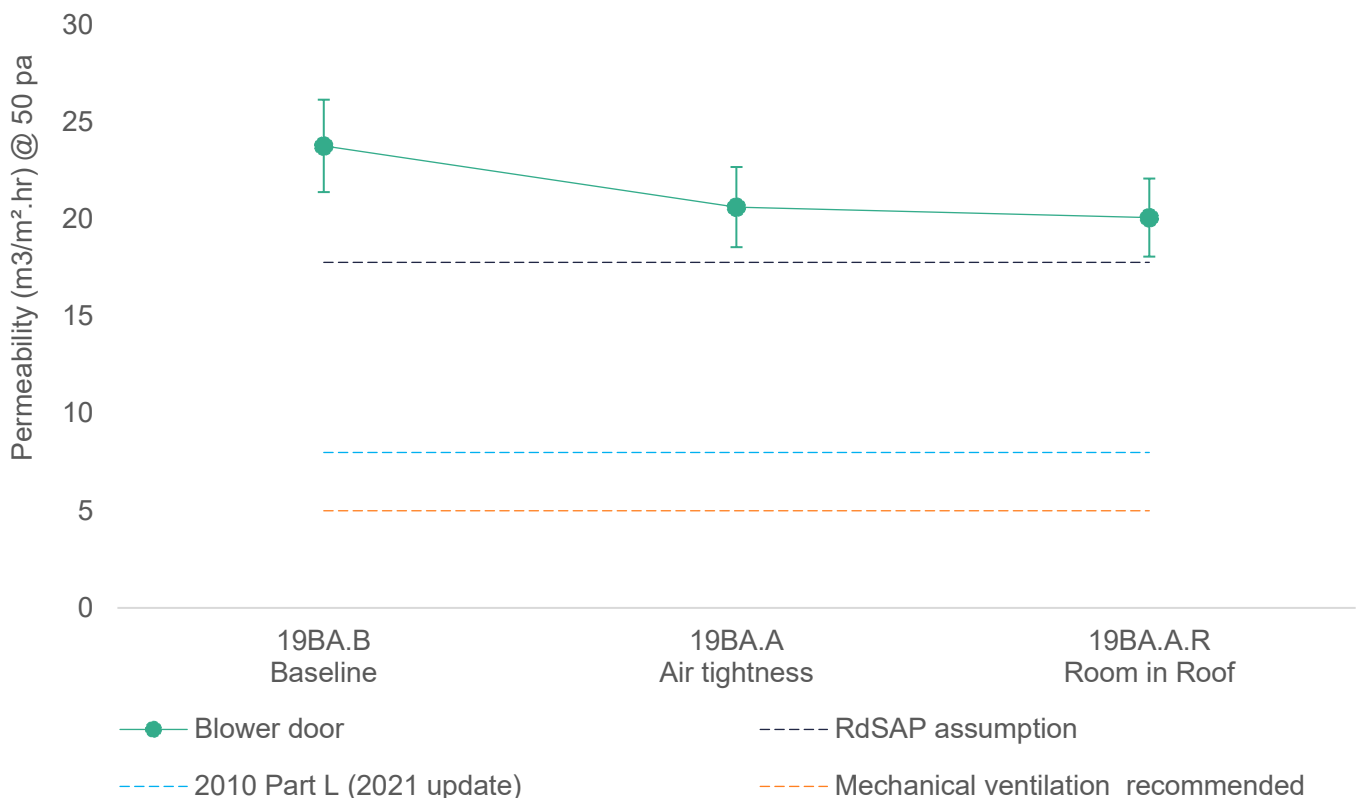
Figure 3-1 Airtightness improvements made at each retrofit stage

19BA is a large dwelling with many complex, interconnected air leakage pathways. This means the home had very high levels of infiltration, 23.8 m³/(h·m²) @ 50Pa, as shown in Figure 3-1, which is around three times the limiting value allowed for new build homes in England and Wales. The non-destructive airtightness improvements were only partially successful, and reduced infiltration to 20.6 m³/(h·m²) @ 50Pa, however this still represents a large amount of air leakage. The room-in-roof retrofit did not achieve any meaningful improvements with the final infiltration of the home assessed as 20.1 m³/(h·m²) @ 50Pa.

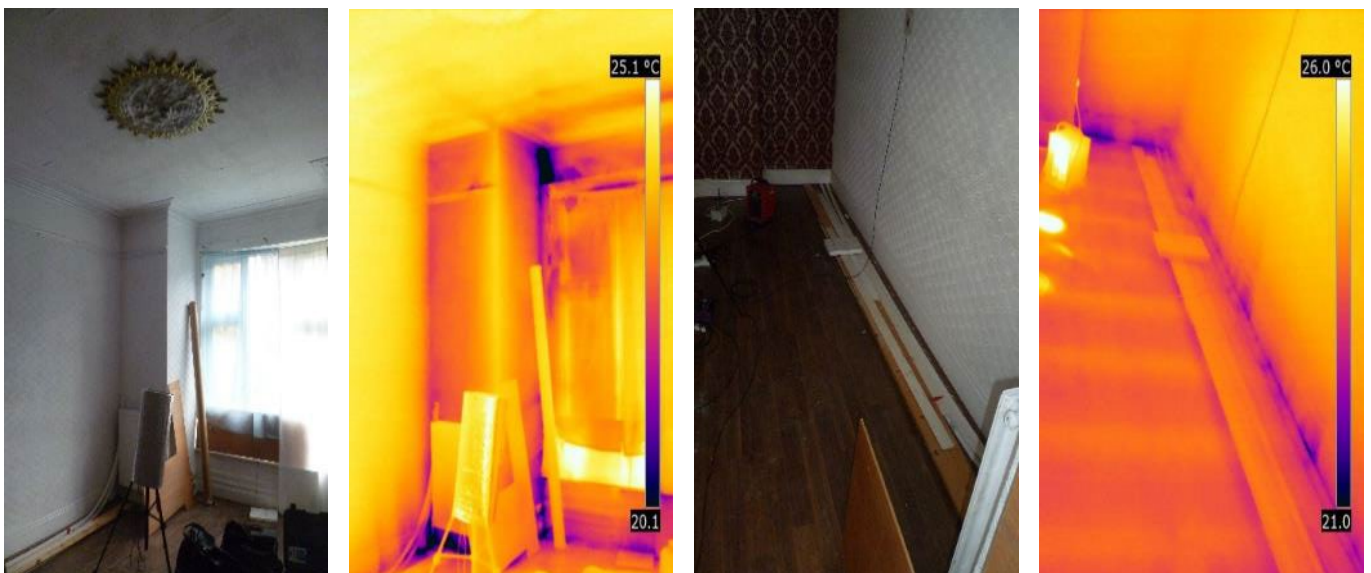
Figure 3-2 Air leakage in the living room around the bay window and ground floor perimeter

Figure 3-2 shows infiltration in the living room at the bay and at floor junctions with the party and internal wall.

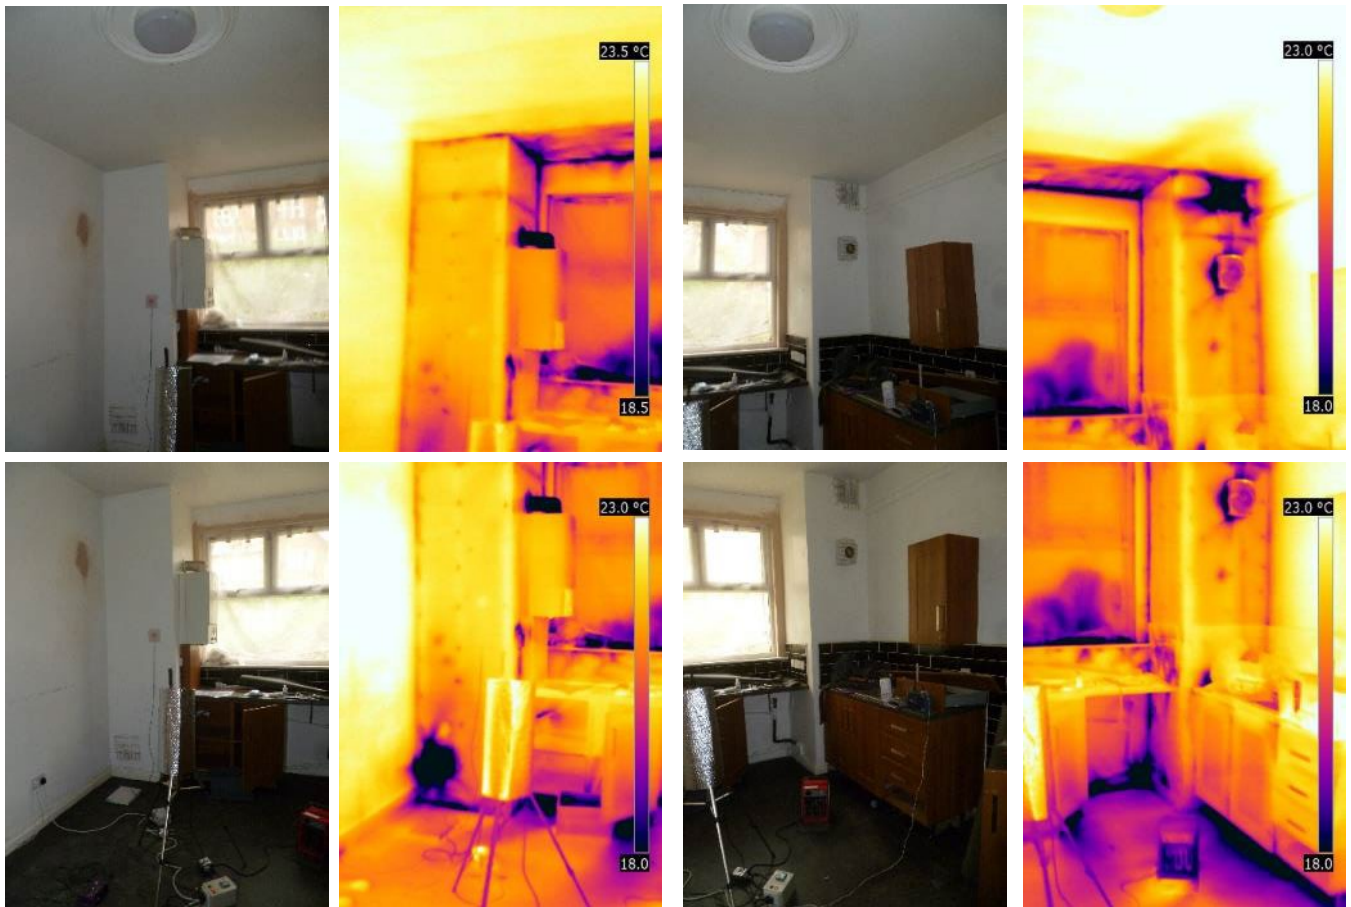
Figure 3-3 Service penetrations in the kitchen bay

Figure 3-3 shows severe infiltration in the kitchen, as well as direct infiltration at the window and external wall junctions. Indirect air exchange at the two boxed-in voids either side of the bay and the bay roof can also be observed. In the halls both direct air leakage through external wall openings and infiltration drawn up from the cellar were observed, as shown in Figure 3-4.

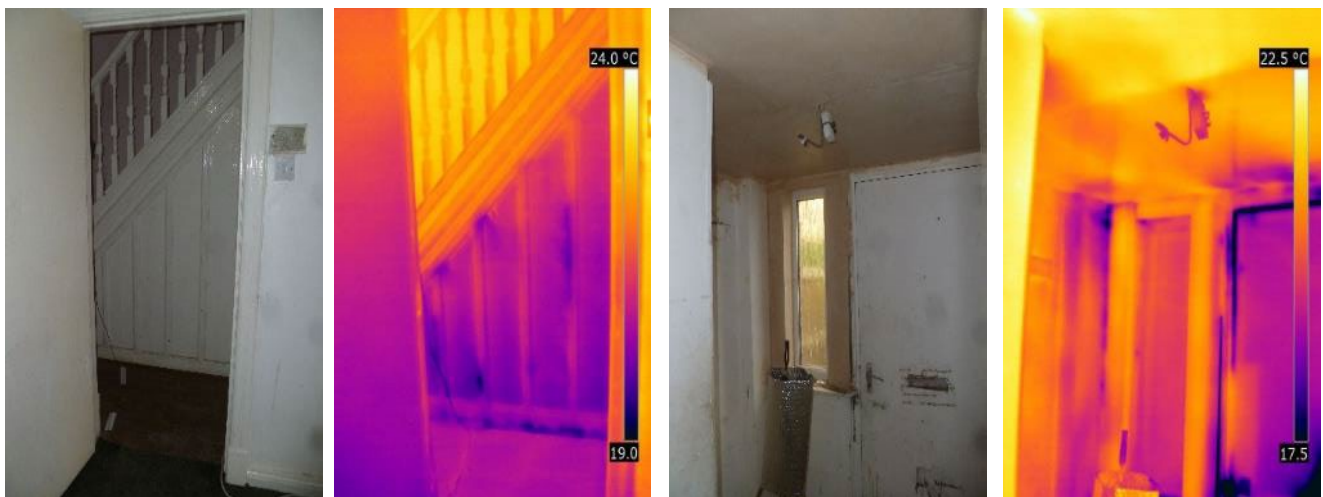
Figure 3-4 Air entering the front and rear halls from the cellar and directly from outside

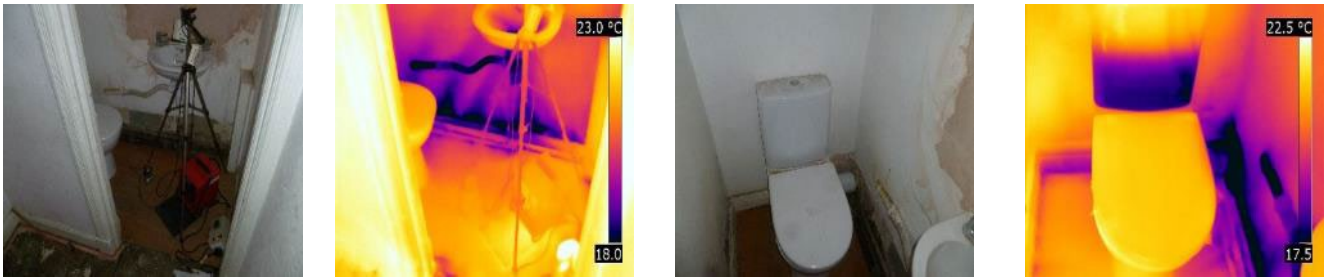
Figure 3-5 Infiltration at the first floor WC

3-6 and Figure 3-7 show direct air leakage at penetrations, openings and junctions, with cooler air being drawn into the habitable space directly from outside.

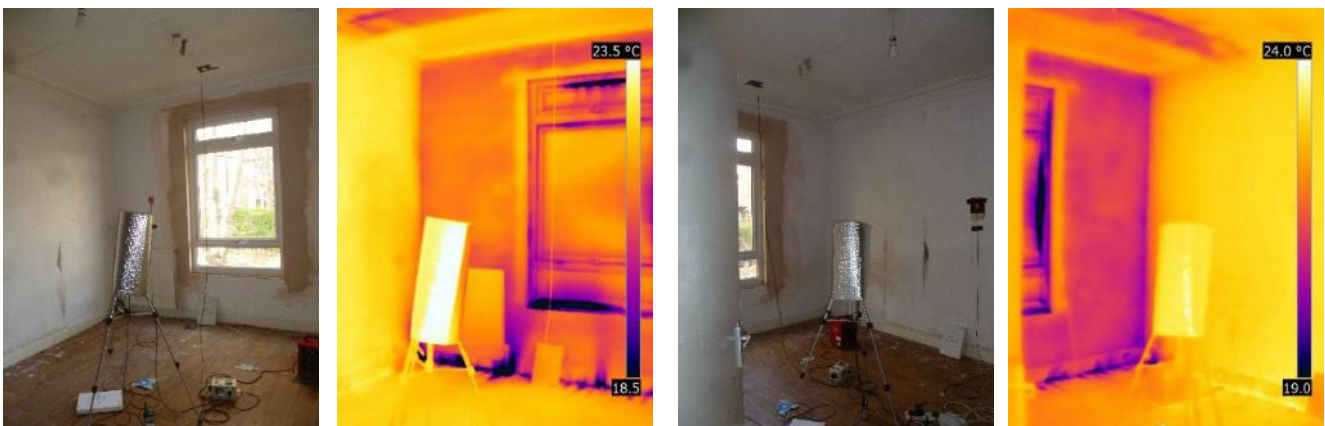
Figure 3-7 Direct air leakage in the front bedroom at the floor junction with the external wall and at the window

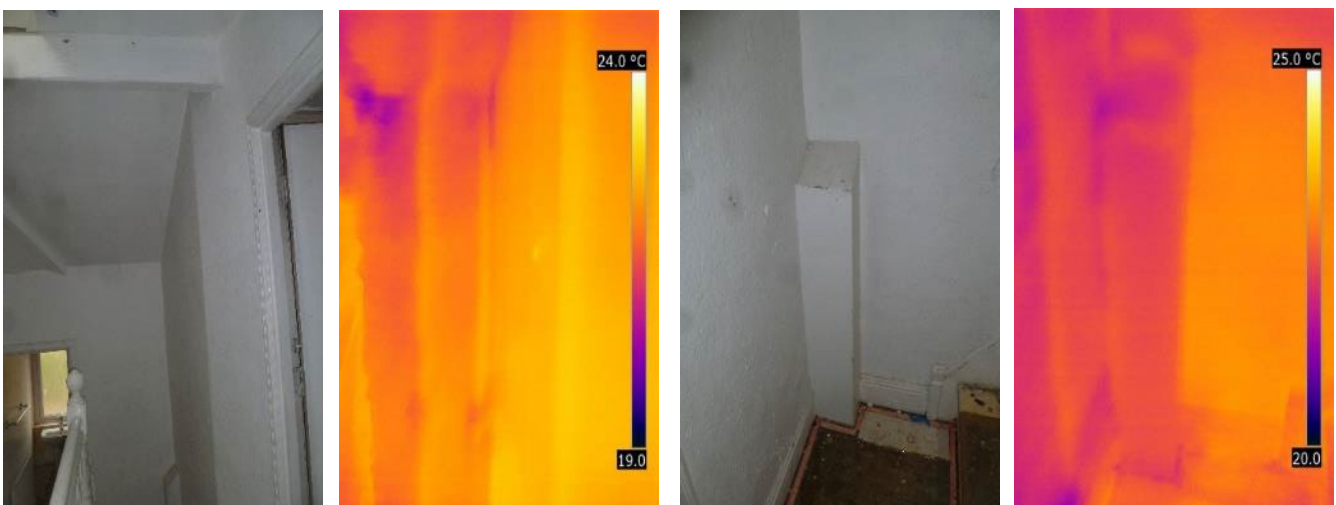
Figure 3-9 The second floor landing with cooler air being drawn through partition wall voids

Figure 3-9 shows air movement within the partition wall voids on the landing. As these voids appeared to be linked to the intermediate floor, the roof void, the loft space and the eaves void, it is not possible to know exactly where this air entered the house or the links between the internal spaces.

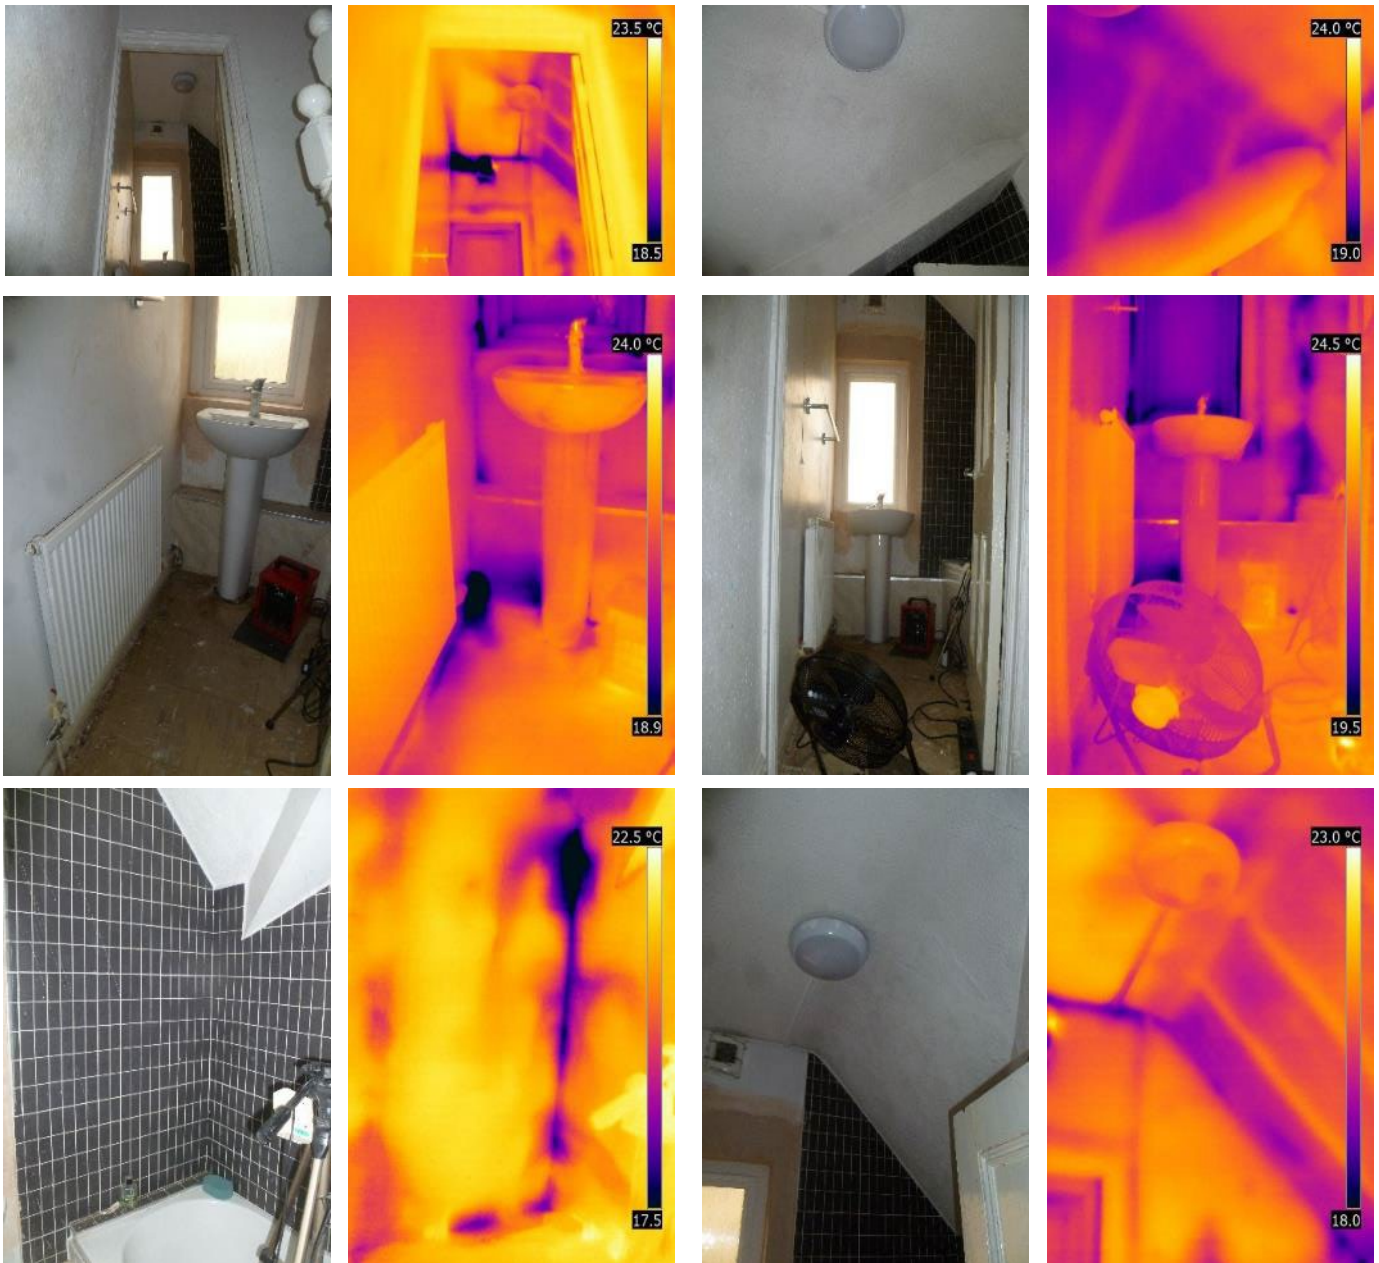
Figure 3-10 The second floor bathroom showing both direct and indirect air leakage

Figure 3-10 displays the many and varied air leakage paths in the second floor bathroom, with direct air leakage around plumbing penetrations, the central light fixing, the extract vent and external wall junctions, and other complex air movement within the connected wall and ceiling voids.

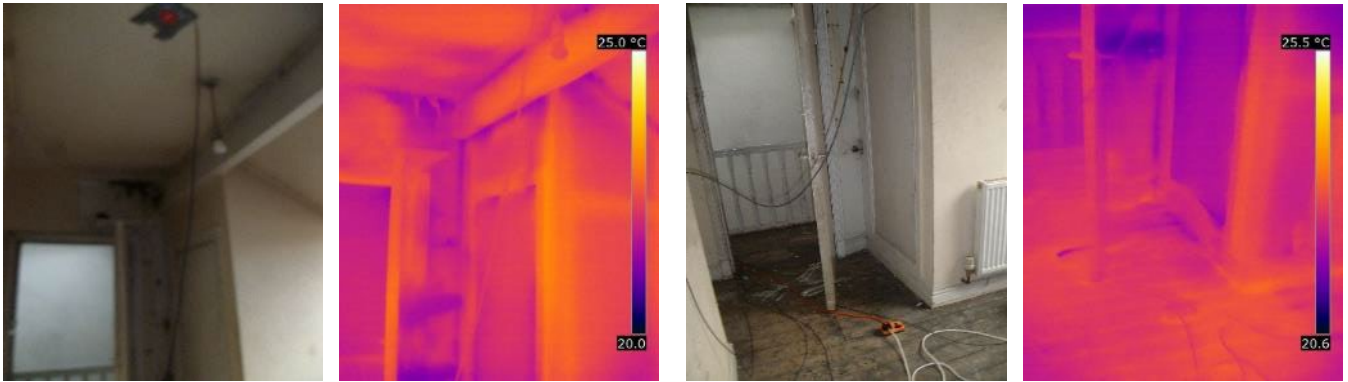
Figure 3-11 Air movement within the partition walls at the cylinder cupboard

Figure 3-11 shows the cylinder cupboard which backs onto the bathroom providing some links to other voids. Figure 3-12, Figure 3-13 and Figure 3-14 show leakage paths in the front and rear bedrooms. Although the eaves voids in each room have different geometries, they suffer from similar issues, with access hatches and junctions not being airtight and allowing the voids to connect to create complex air movement pathways. The implication of multiple air leakage pathways is that significant destructive work would be required to achieve a single continuous air barrier.

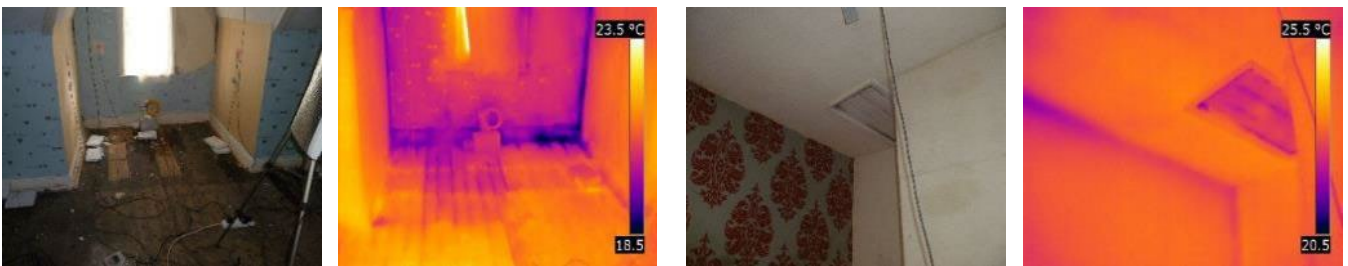
Figure 3-13 Direct air leakage in the front bedroom at the external wall junction with the floor and around the loft hatch

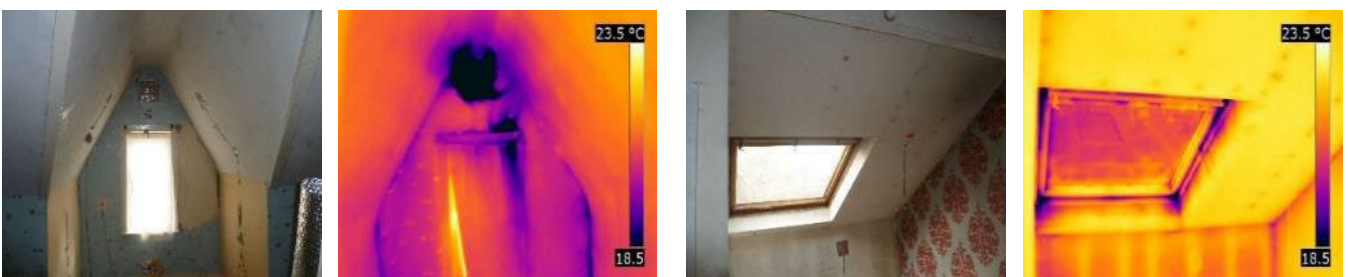
Figure 3-14 Air leakage at the windows in the front and rear bedrooms, and around the vent above the front bedroom window

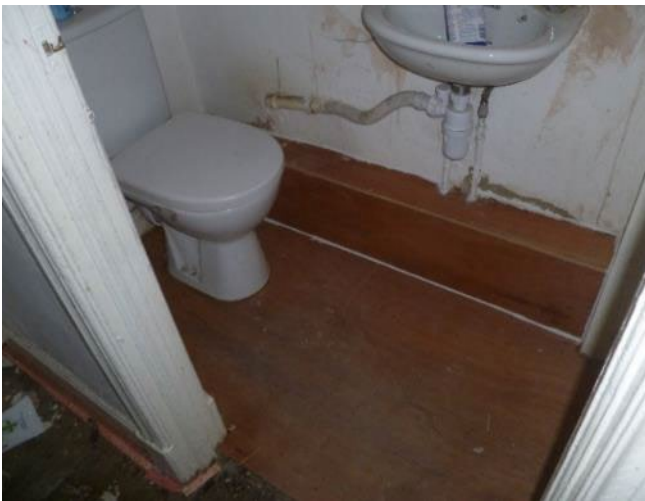
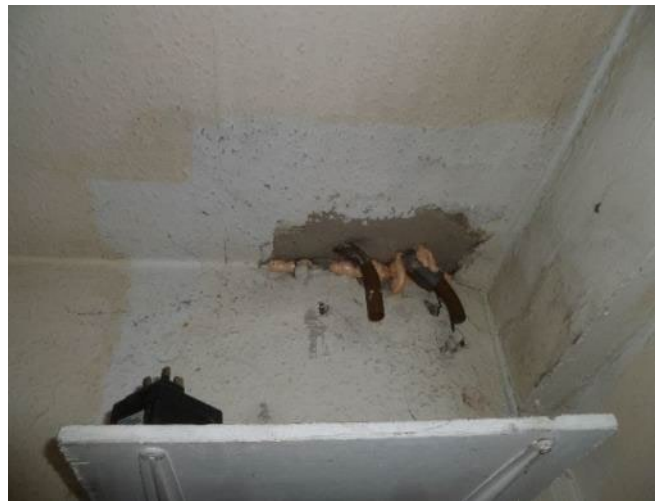
Figure 3-15 Mastic and foam fillers addressing the gaps identified in the airtightness tests

Airtightness measures were undertaken in 19BA to understand what improvements could be achieved without destructive work. The points of air leakage identified in the pre-retrofit blower door tests were addressed using standard products and techniques available to the general public. Thus, only easily accessible leakage paths were addressed. Mastic sealants and foam fillers were applied to gaps in the internal envelope identified by thermographic leakage detection under dwelling depressurisation. Draught-stripping was installed at the external and cellar doors, and mastic was applied at the floor perimeters. This approach initially reduced mean air permeability from 23.8 to 18.8 m³/(h·m²) @ 50Pa. Figure 3-15, Figure 3-16 and Figure 3-17 show some of the interventions undertaken.

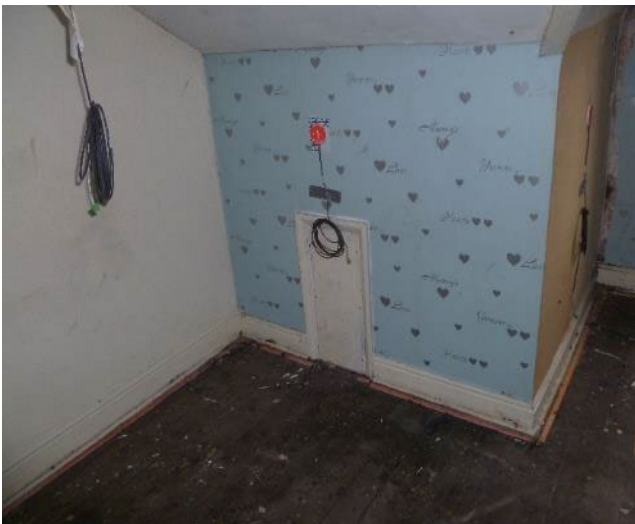
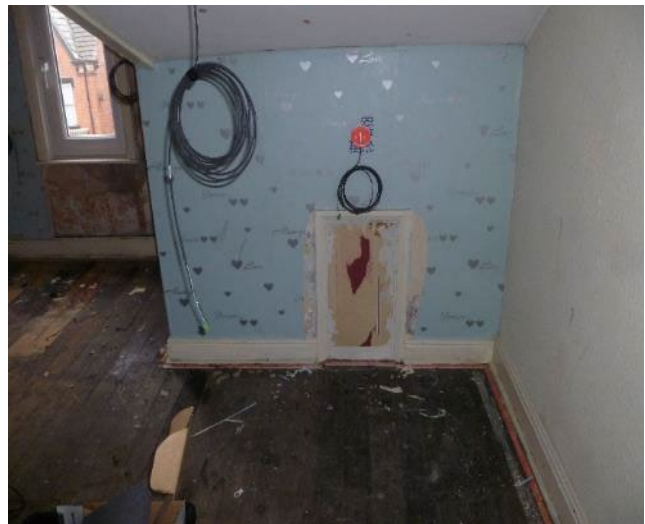
Figure 3-16 Sealed access hatches to the eaves voids

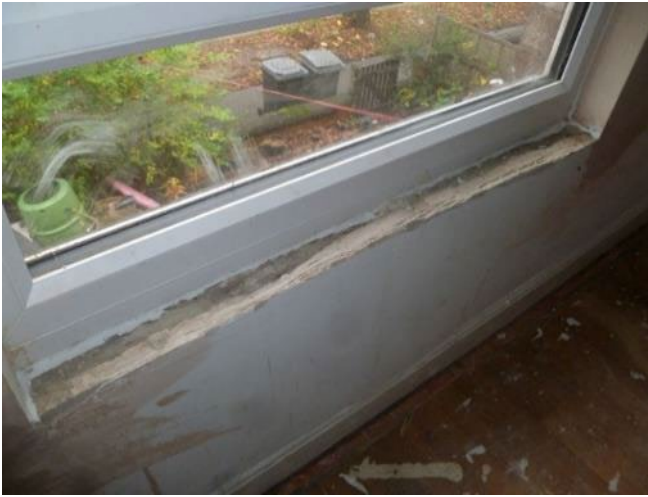
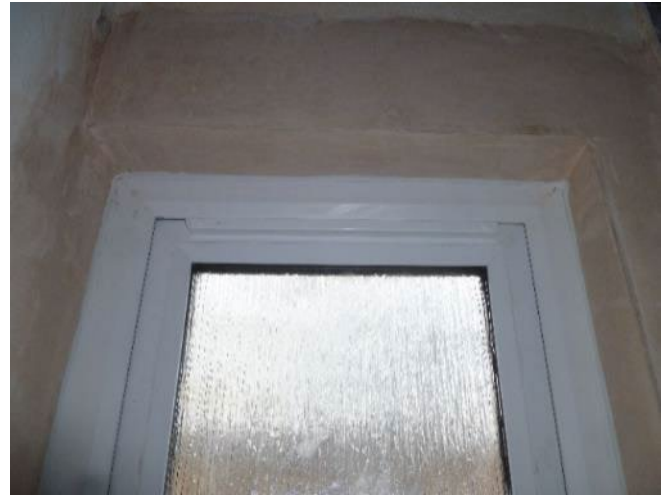
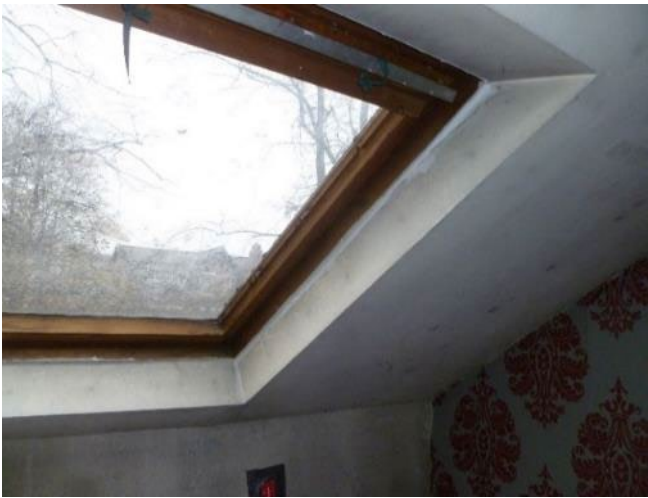
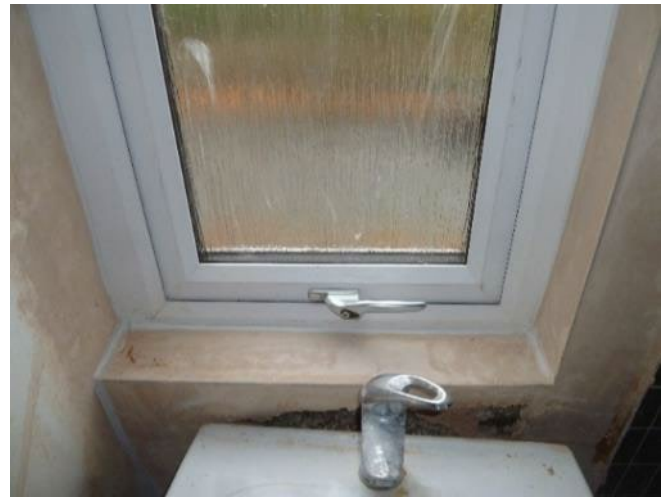
Figure 3-17 Mastic sealant applied around window frames

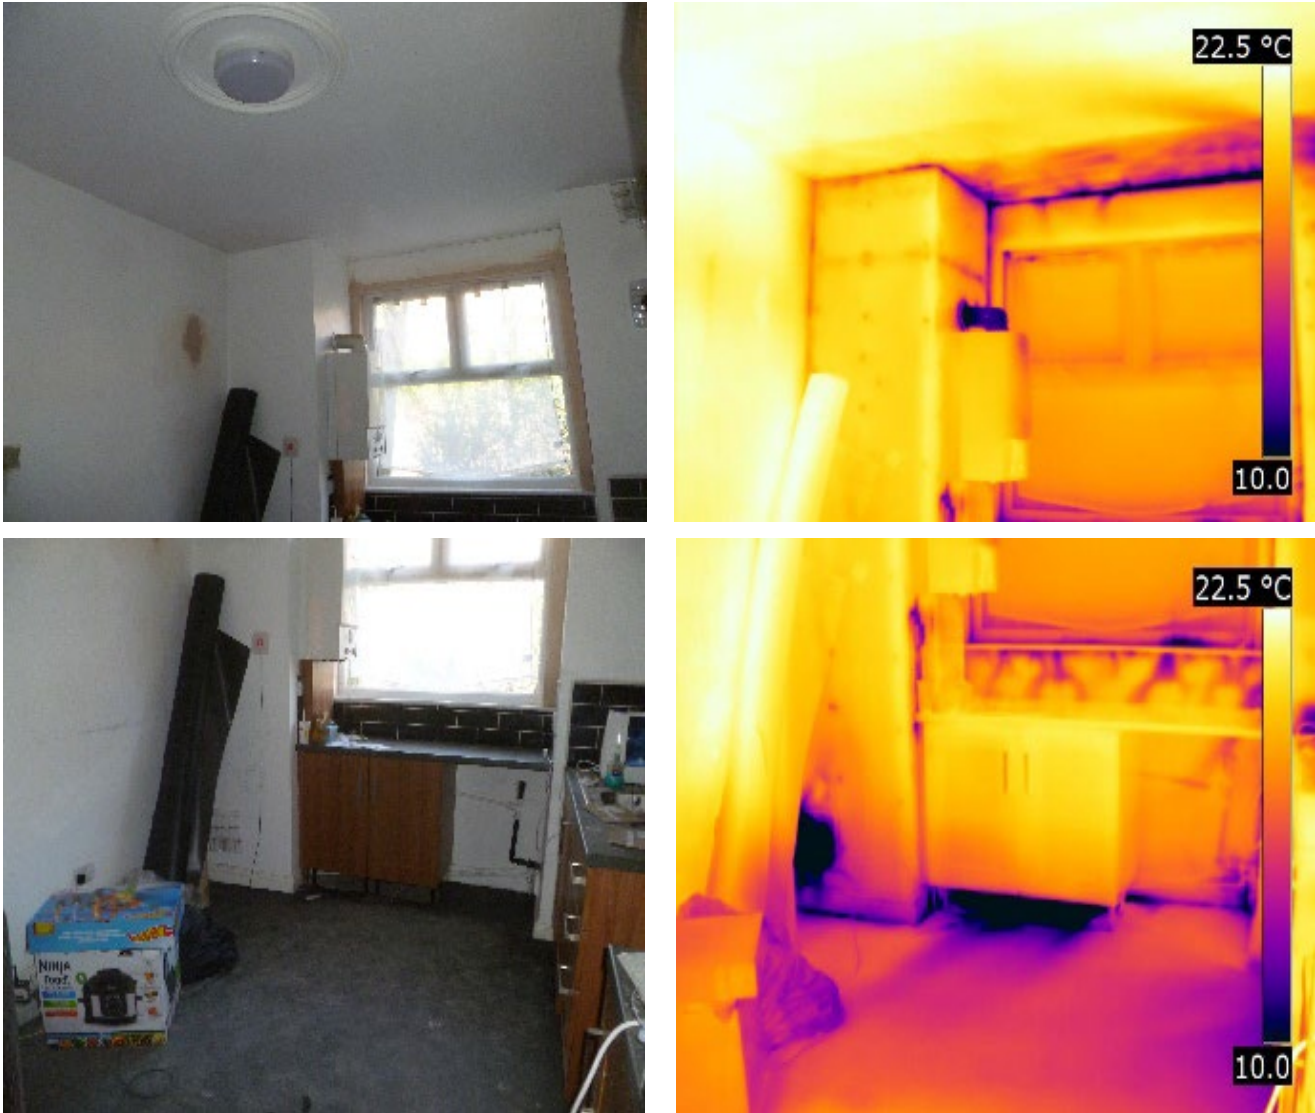
Figure 3-18 Thermographic detection of leakage at the kitchen bay

On the ground floor, air leakage up from the cellar appeared to be the main problem, with many of the direct air leakage paths from outside through the external walls at least partially addressed. Figure 3-18 shows an improvement in airtightness around the kitchen window and service penetrations, but now the air movement from underneath the kitchen units (not previously identified as a severe leakage path) appeared to have increased, at least proportionally.

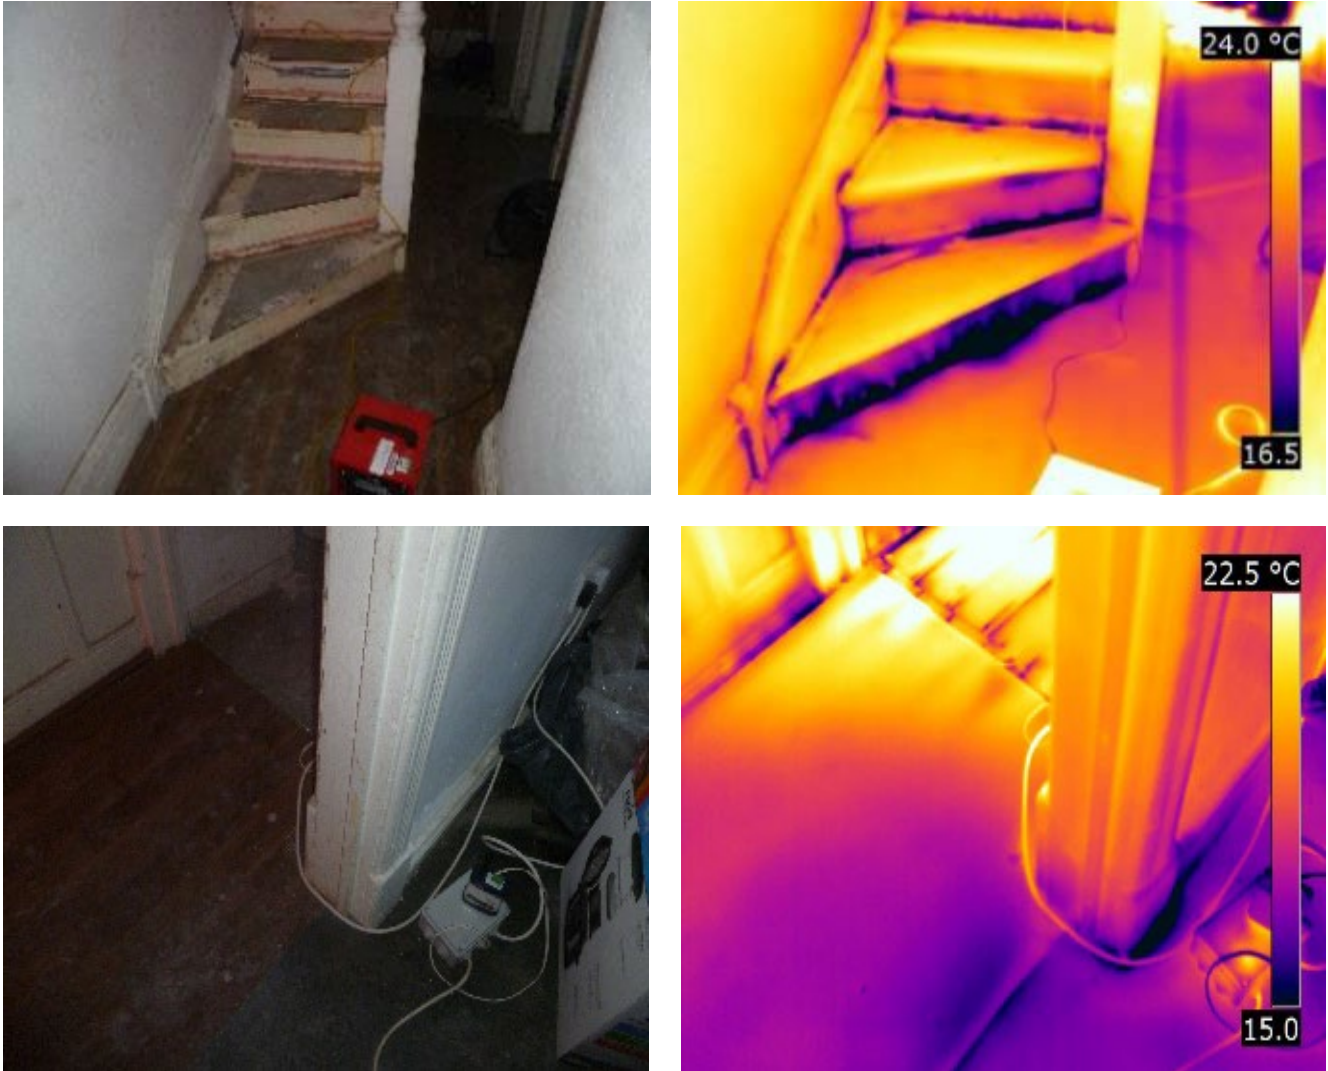
Figure 3-19 Air movement up from the cellar near the centre of the house

As most exposed floor-wall junctions on the ground floor were sealed, areas that had not been treated became more obvious leakage paths, as illustrated in Figure 3-19, such as the base of the staircase and internal room junctions.

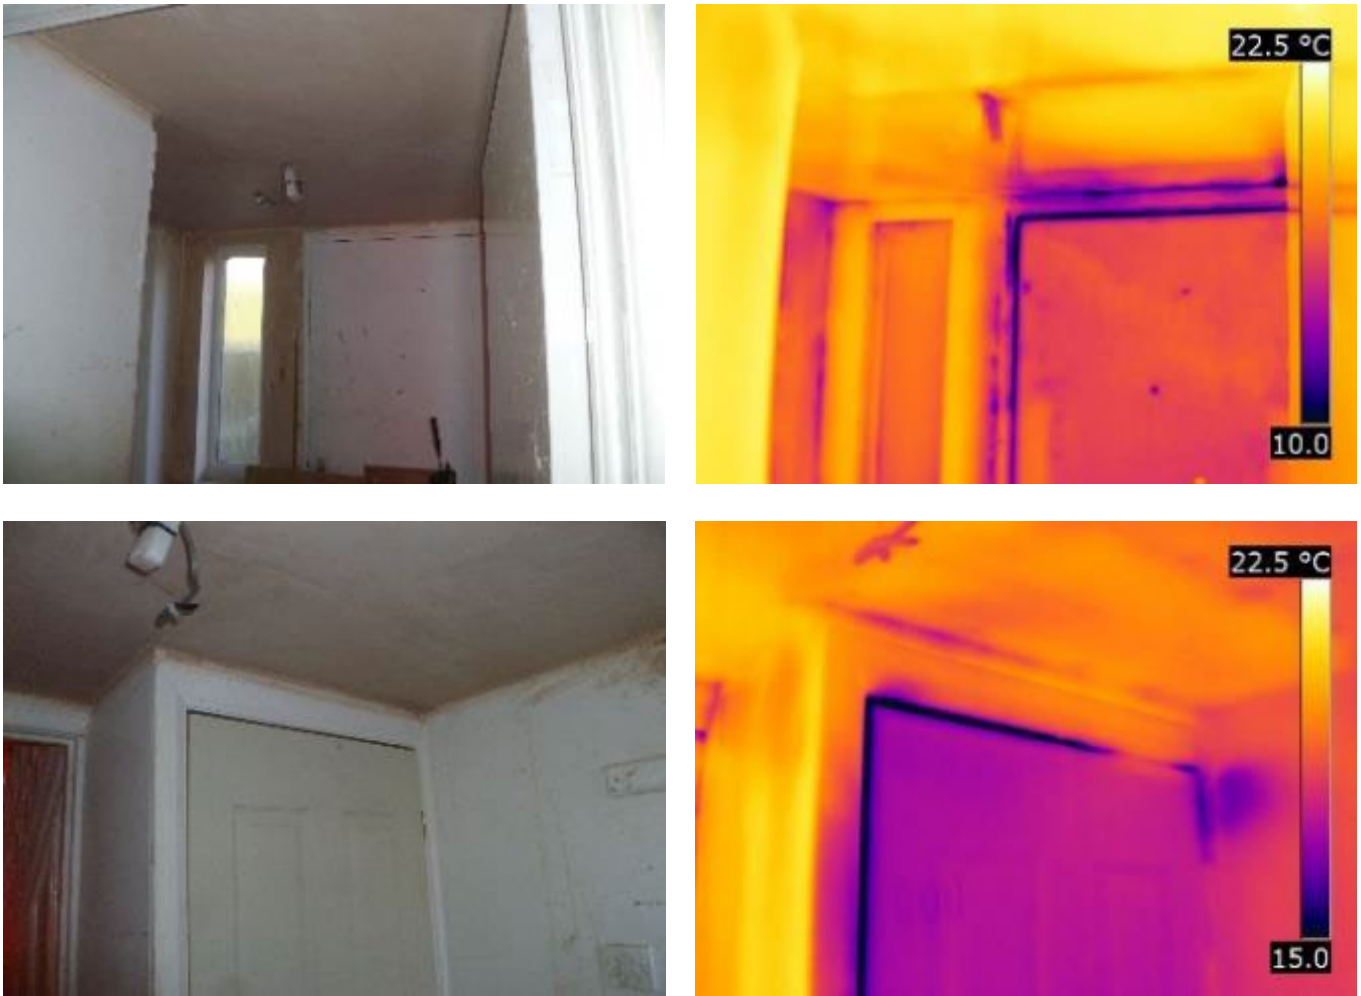
Figure 3-20 The rear (top) and cellar (bottom) doors showing air leakage

The external doors and cellar door had been improved, but there was still infiltration detected around them (Figure 3-20). The rear and cellar doors still allowed air leakage.

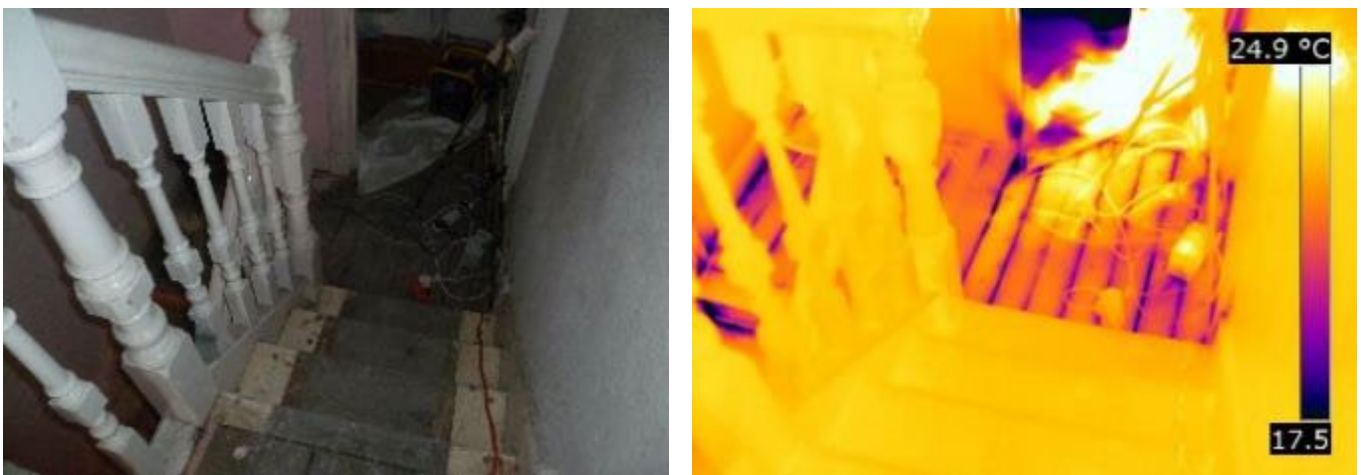
Figure 3-21 Air movement through intermediate floors in the centre of the dwelling

Figure 3-21 shows air movement through the intermediate floors detected around the centre of the dwelling. The emerging air was significantly cooler than the internal ambient temperature even though it was some distance from where it must have entered the building.

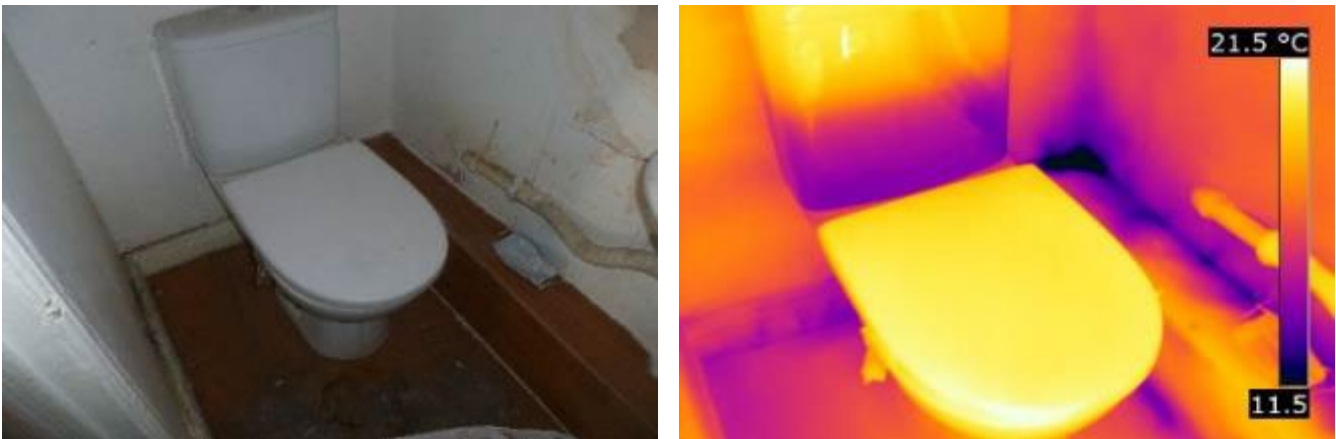
Figure 3-22 Un-adhered mastic sealant on the new boxing in the WC

Some unaddressed air leakage paths still remained, and some of the less significant pathways identified previously appeared to have become more severe as other leakage routes were removed. Mastic applied to fresh plywood boxing in the WC had already begun to fail (Figure 3-22), although subsequent decoration and caulking may well re-seal these.

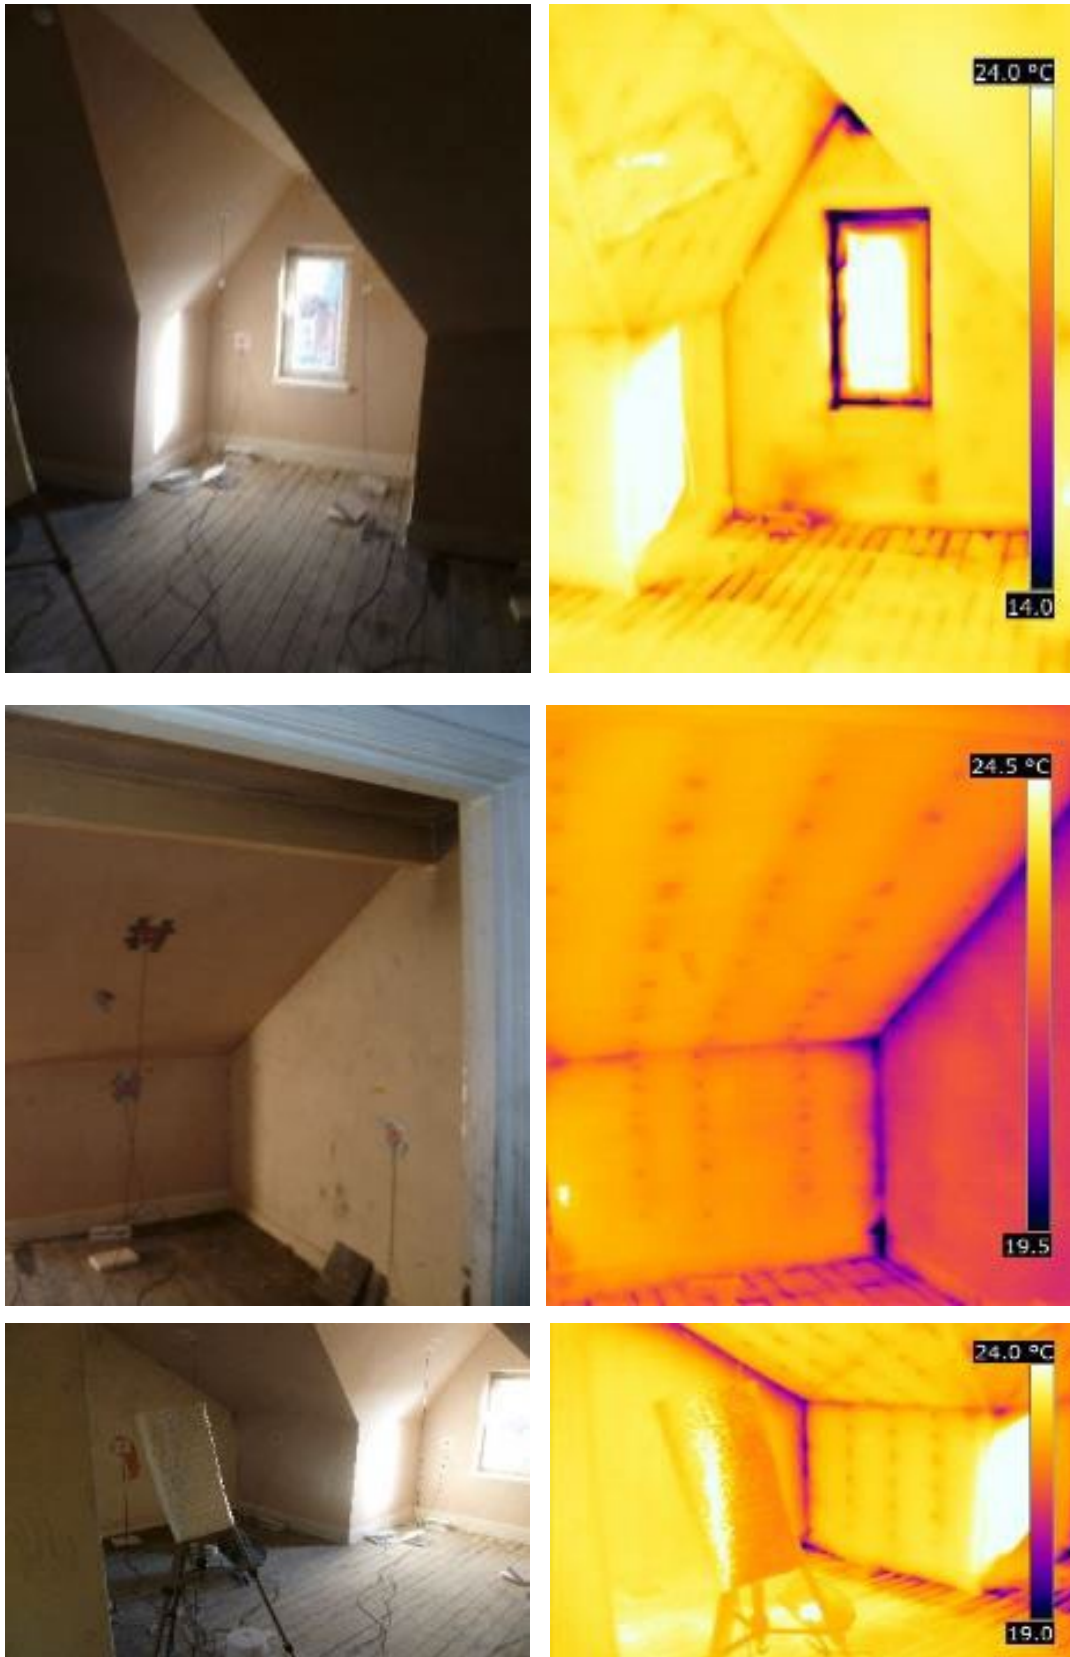
Figure 3-25 Air leakage through cracks in plaster and failed mastic seals at interfaces between elements in Bedroom 3 under depressurisation immediately following coheating

Figure 3-25 shows the same phenomenon in Bedroom 3, with air leakage through shrinkage cracks at junctions, which again might be reduced with subsequent decoration and caulking.

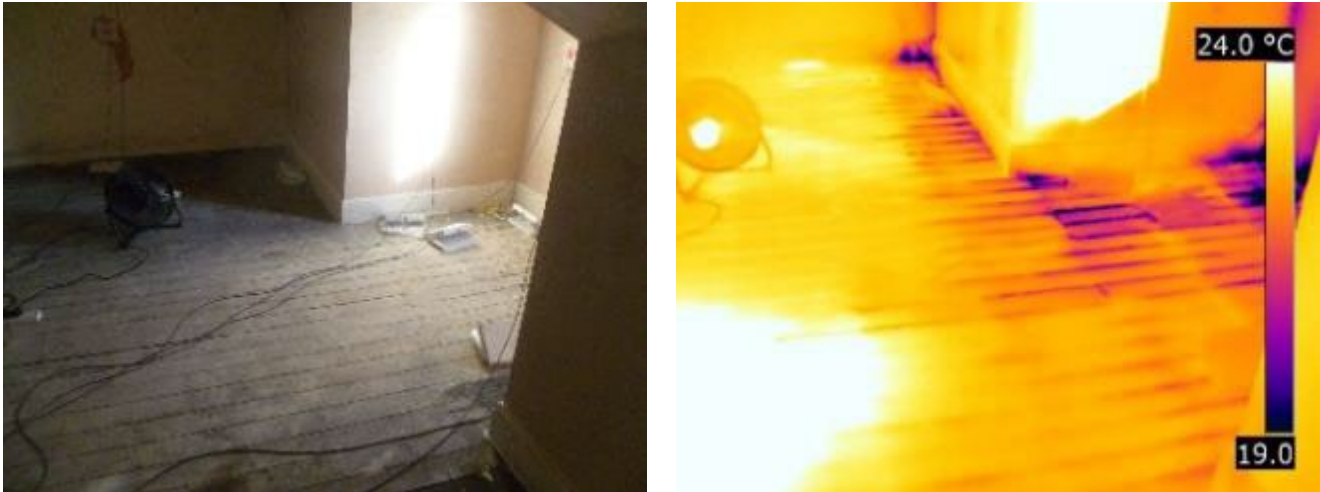
Figure 3-26 Air leakage under the floor from a boxed-in airing cupboard

The same was observed at all the interfaces in all the rooms in the roof which, cumulatively, significantly undermined the airtightness improvement that would have otherwise been assumed to have been made. There were also some air leakage pathways that were not completely removed despite the creation of new internal wall surfaces and plastering of all the room-in-roof walls and ceilings. For instance, Figure 3-26 shows indirect air leakage emerging through holes in the internal partition wall between Bedroom 4 and the landing, which was part of the old airing cupboard where fixings had been removed, but which had not yet been decorated.
