DEEP Report 2.12

Case Study 19BA

Case study 19BA is a four bed 1900 mid-terrace in which airtightness and room-in-roof retrofits were undertaken. The airtightness retrofit consisted of general sealing of air leakage paths, without significant deconstruction of the building fabric. The room-in-roof retrofit consisted of new insulation to the ceilings of the loft and eaves voids, new insulation to the sloped ceilings and insulation to the knee walls and dormer external wall. The performance of each retrofit was assessed for airtightness and thermal performance.

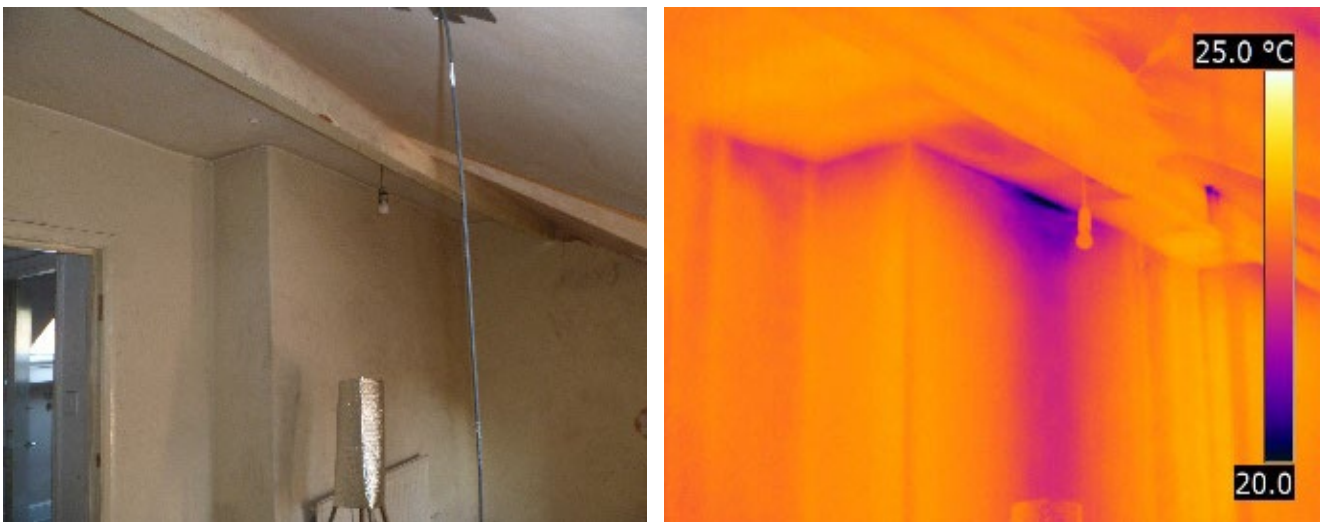
Figure 3-27 Indirect air leakage through the floor in Bedroom 1 being drawn down the chimney breast

Figure 3-27 shows air from the loft being drawn down the chimney breast creating a potential air leakage pathway.

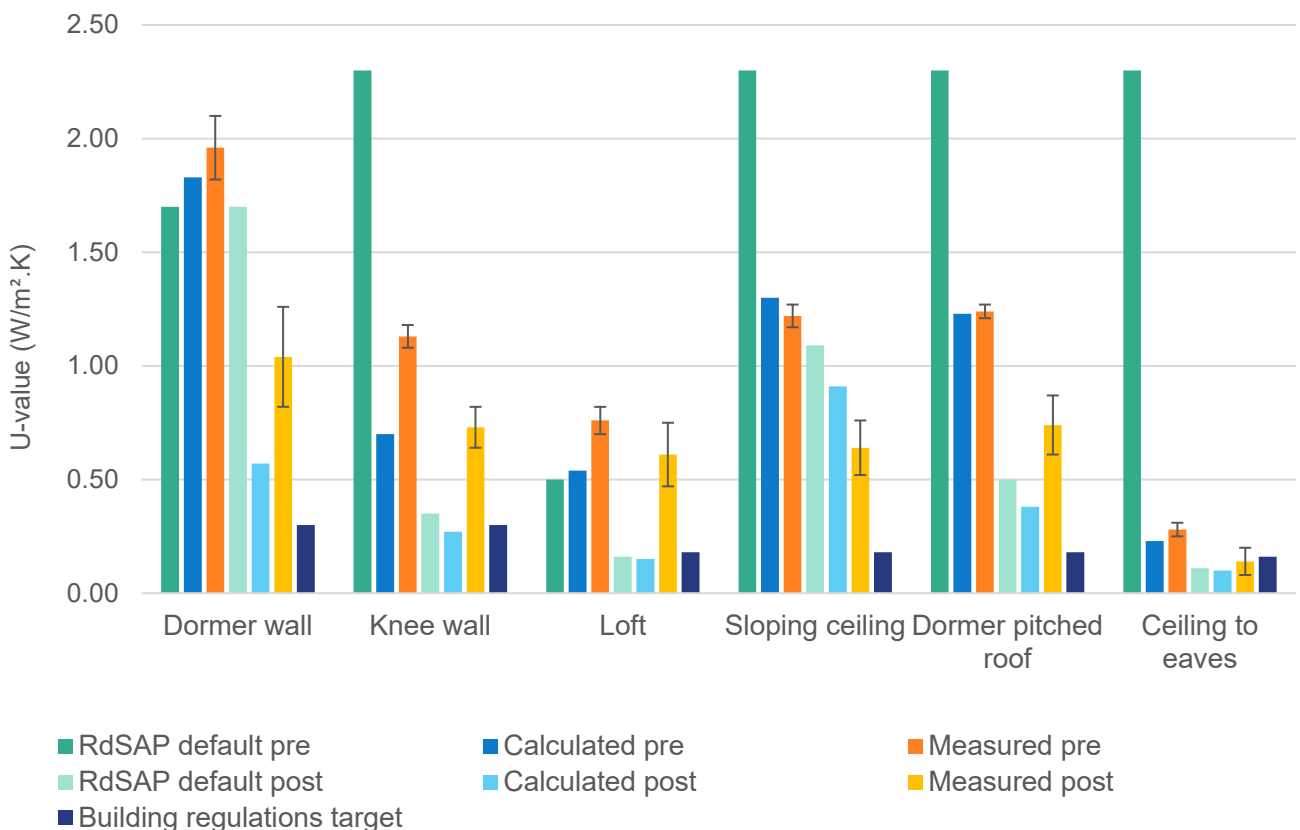
Figure 3-29 Pre- and post-retrofit fabric U-values for room-in-roof (W/(m²·K))

The measured U-values were, however, more in line with the calculated U-values based on the site observations of the in-situ fabric, with the notable exception of the knee wall and loft which showed a substantial performance gap. The cause of this is not known, though it may be due to thermal bypass or inconsistency in the insulation at the point of measurement.

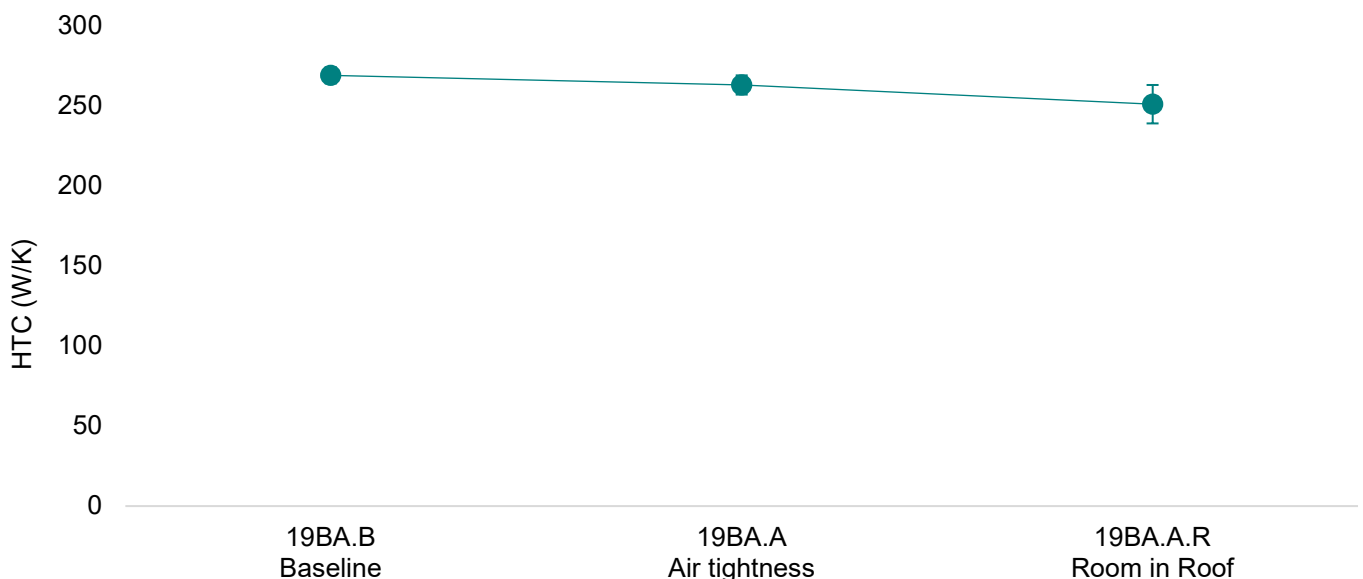
Figure 3-32 Coheating HTC at each retrofit stage

The results are visualised in Figure 3-32, again showing the small change achieved by the retrofits relative to the whole house heat loss. This has implications for the significance of leaving solid walls uninsulated in the context of domestic energy efficiency policy.

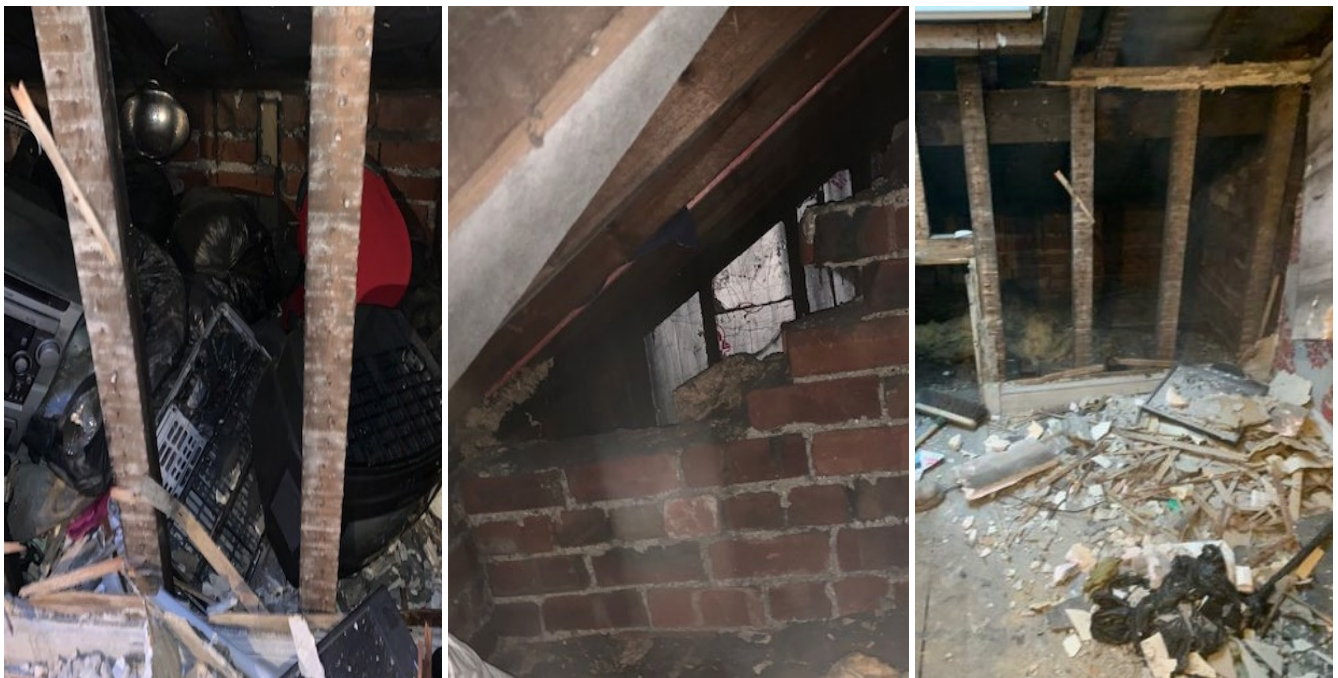
Figure 3-33 Debris behind knee walls (left), missing party wall brickwork between dwellings in eaves (middle) and substantial waste generated by the removal of existing surfaces (right)

Furthermore, the case study shows how a room-in-roof retrofit can reduce plane element heat losses. However, it also highlights practical issues that arose as part of the installation process. As shown in Figure 3-33, there were substantial amounts of debris and repairs were needed which added significant time delays and costs to the project, as well as the disruption that removing the existing fabric surfaces caused. All these issues have real world implications for room-in-roof retrofits being installed at scale.

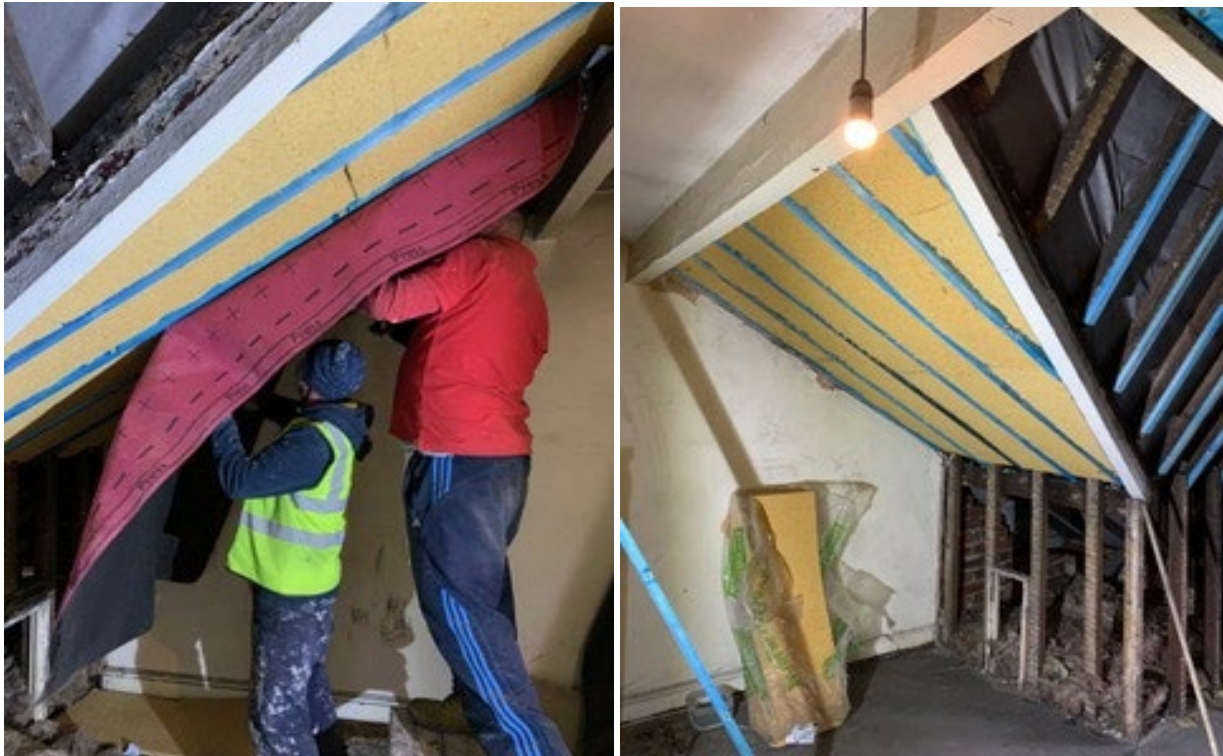
Figure 3-34 Installation of new breathable moisture membrane and additions to roof timbers (blue) to accommodate the extra thickness of the insulation

Thus, the retrofit provided confidence that the roof timbers were in good condition and the roof system was weathertight and not at risk of leaks. These benefits of the retrofit were not measurable via the building performance testing undertaken for this case study. However, they are important considerations for homeowners and landlords who may choose to undertake room-in-roof retrofits.

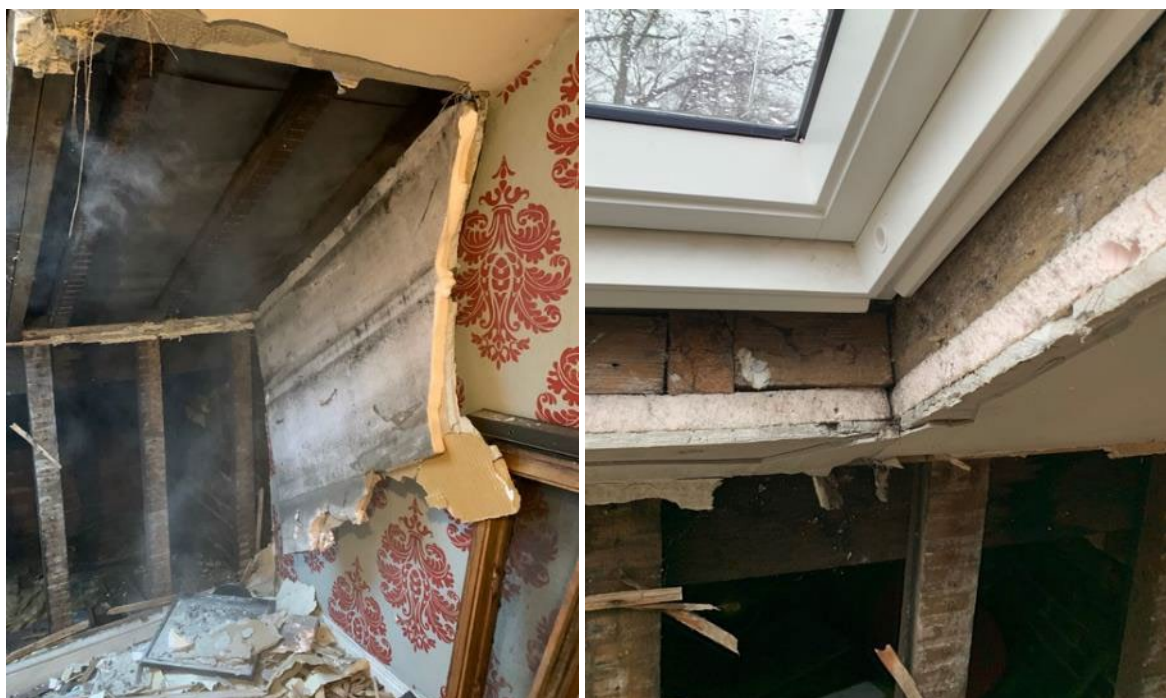
Figure 3-35 Existing insulation found installed in the room-in-roof sloping ceiling

The coheating test suggests that the room-in-roof retrofit itself did not significantly lower the home's HTC, achieving only a (12 ± 13) W/K or (5 ± 5) % reduction. One reason for this is that when the original room-in-roof ceiling was removed it was found that the sloping ceiling already had some phenolic foam insulation, as shown in Figure 3-35. This means the relative improvement for this element was lower than it would have been if the previous retrofit had not taken place.

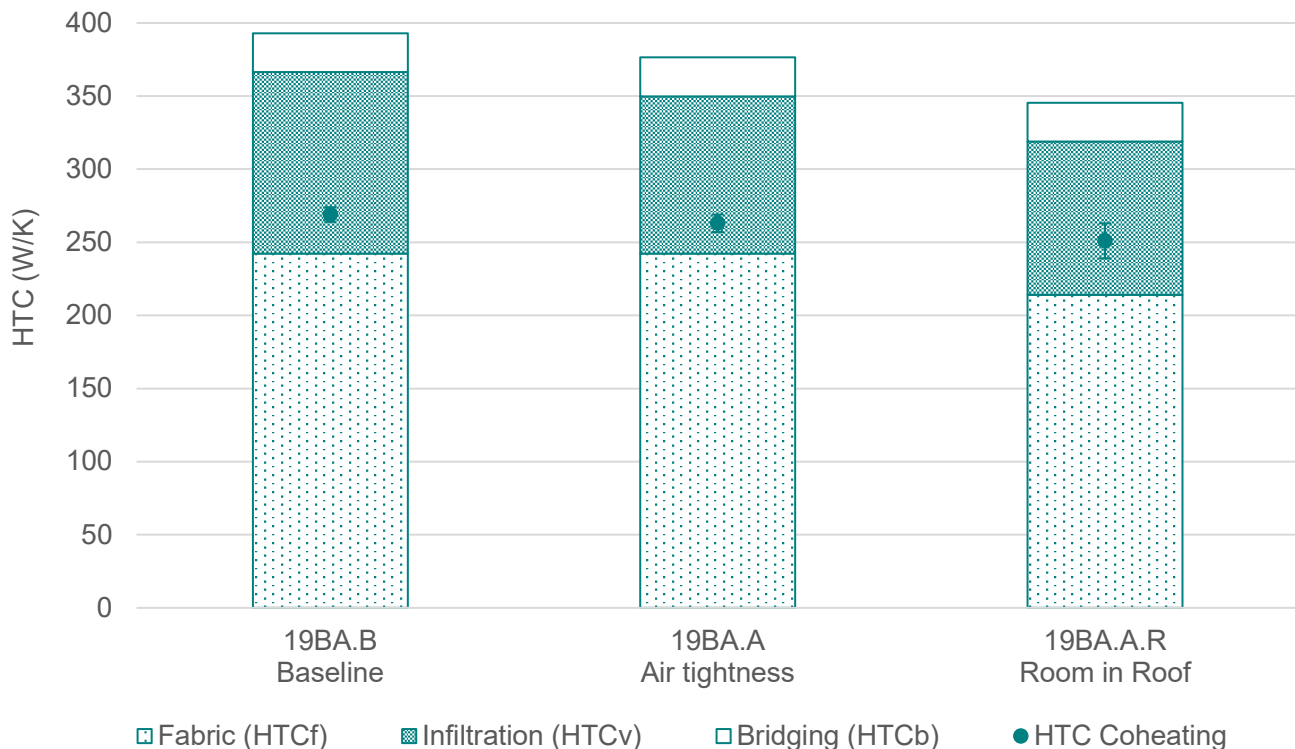
Figure 3-36 Aggregated vs. disaggregated measured HTC

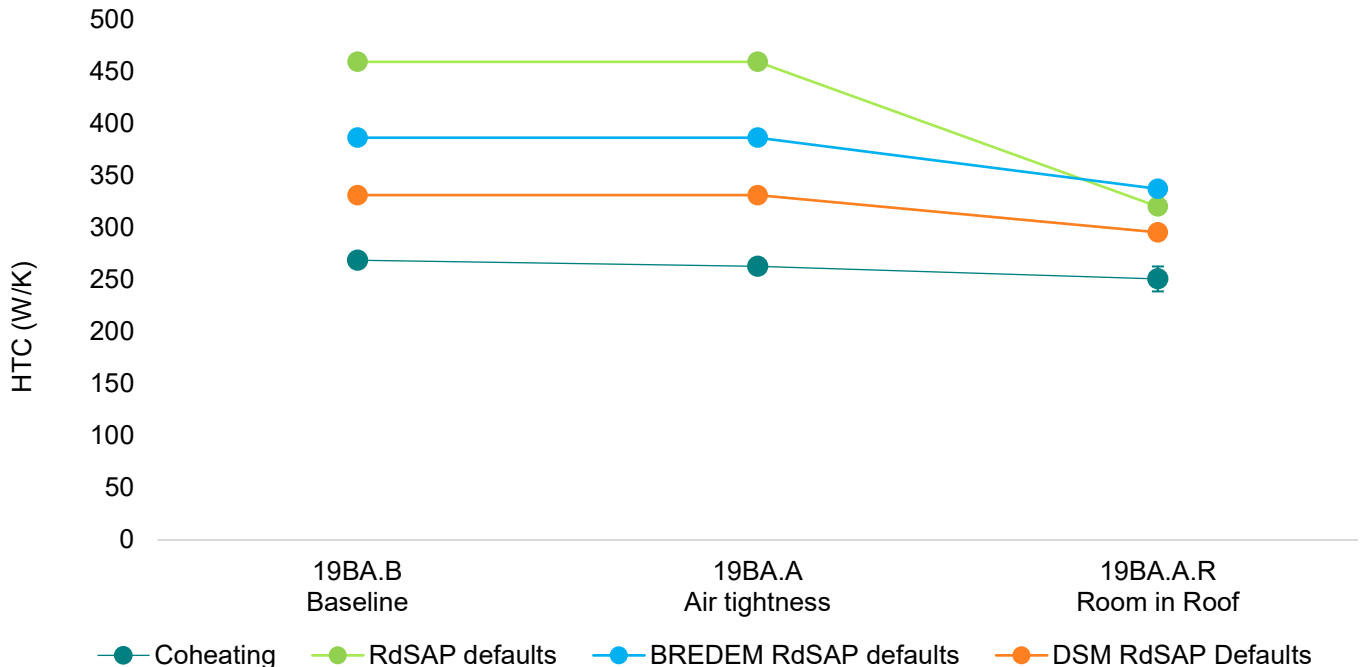
Figure 3-37 Measured vs. modelled HTC calibration step 1: Default input data

- BREDEM and DSM predict only a modest reduction in HTC (13 % and 11 %, respectively) resulting from the room-in-roof retrofit, since they use age band U-values for the room-in-roof elements.

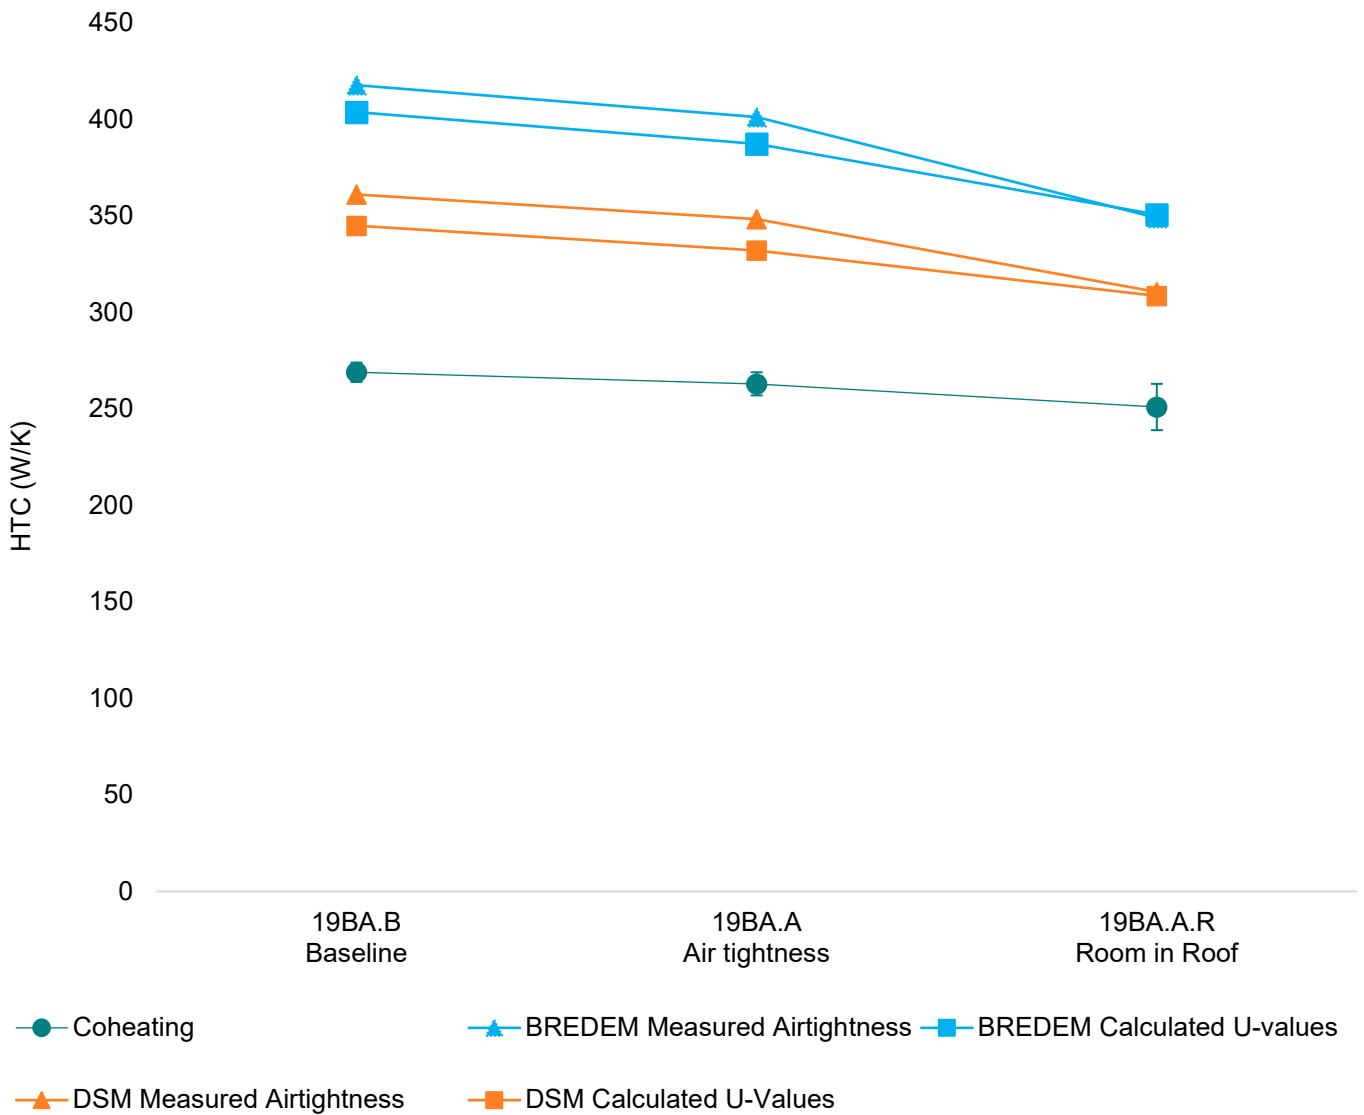
Figure 3-39 HTC Measured vs. modelled HTC Calibration step 3: Calculated U-values

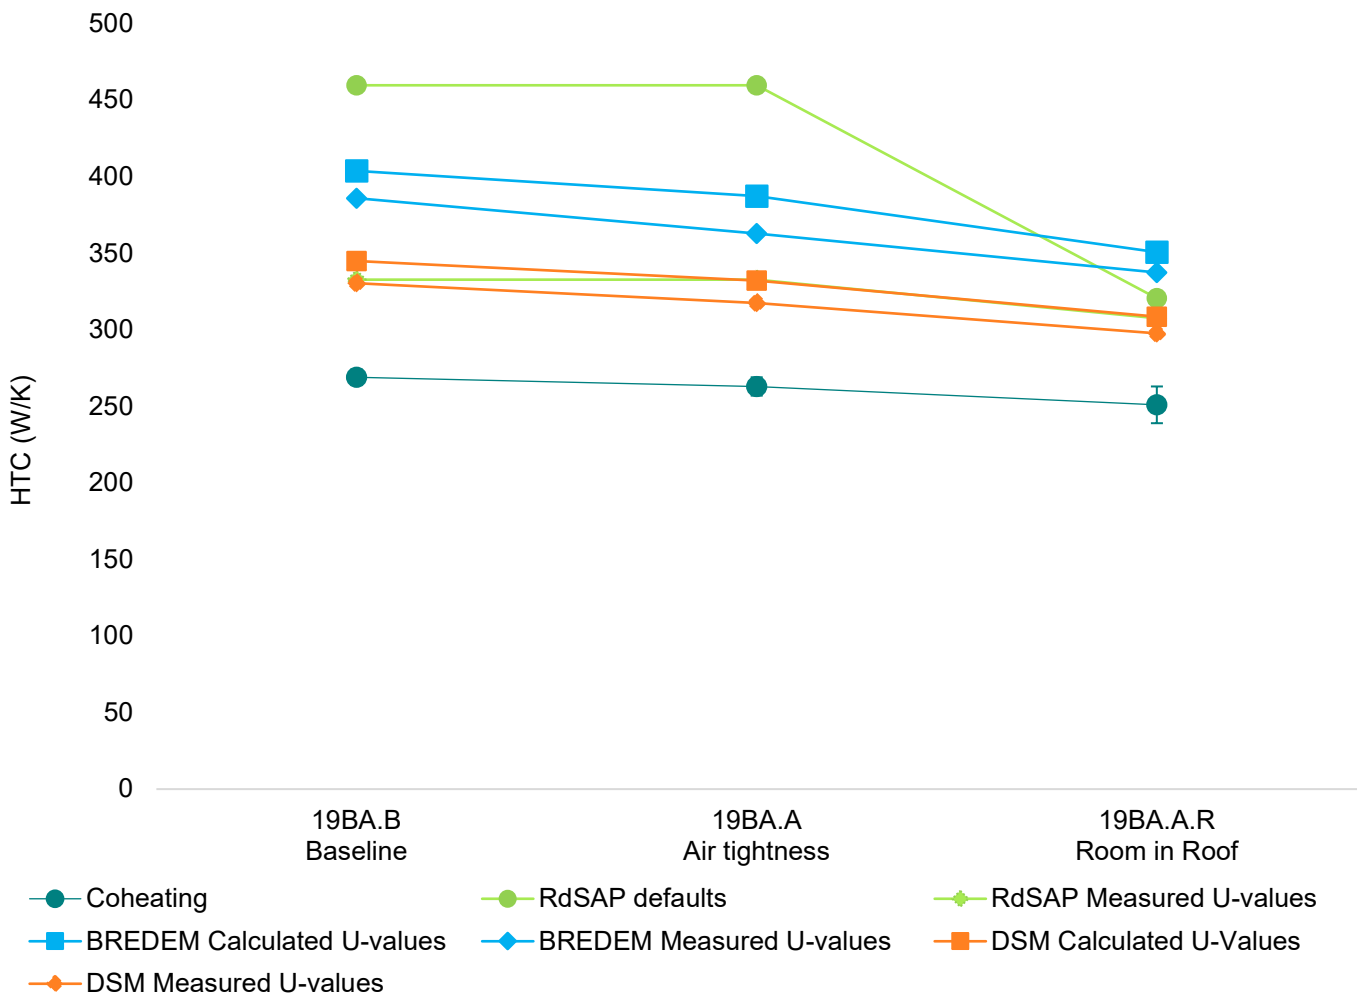
Figure 3-40 HTC Measured vs. modelled HTC calibration step 4: Measured U-values

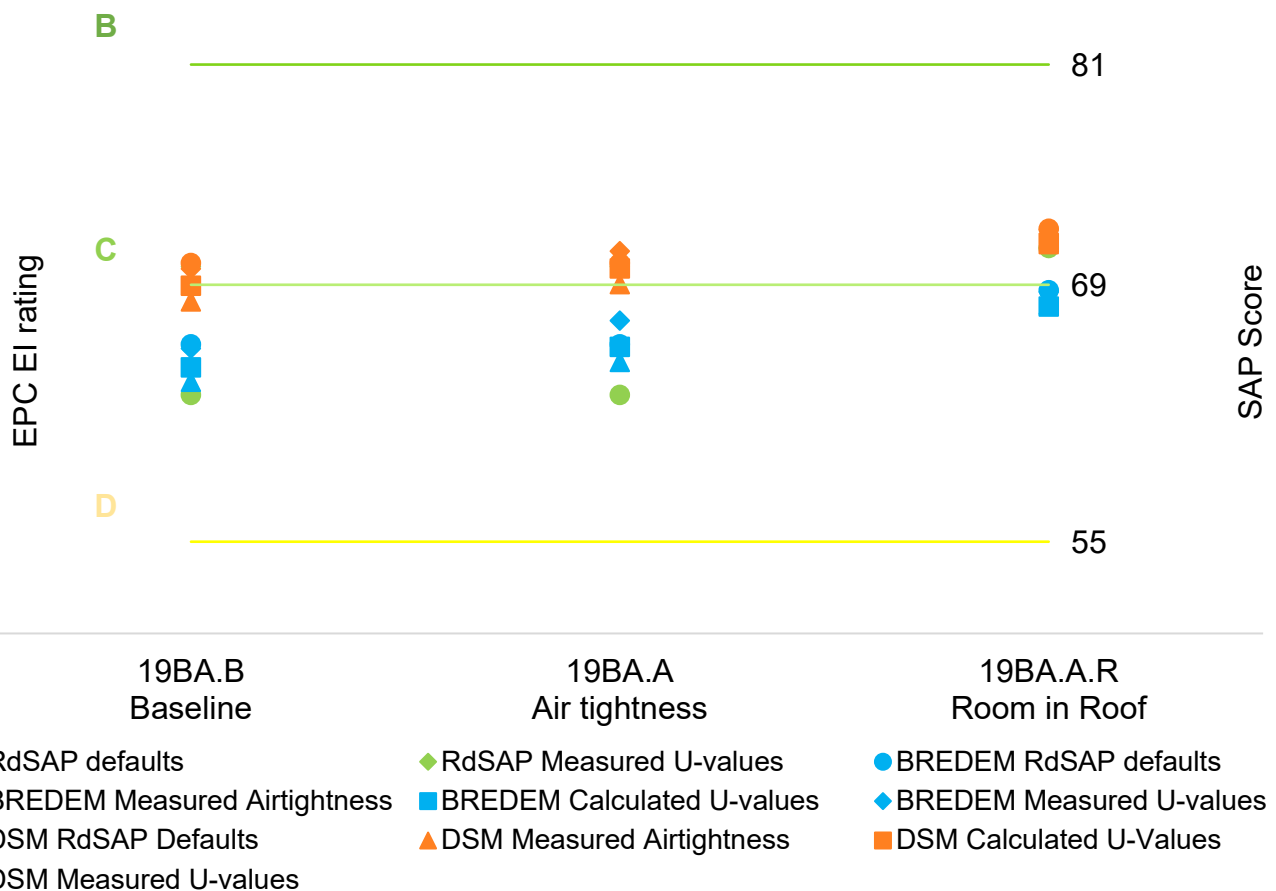
Figure 3-41 Impact of retrofit on EPC band

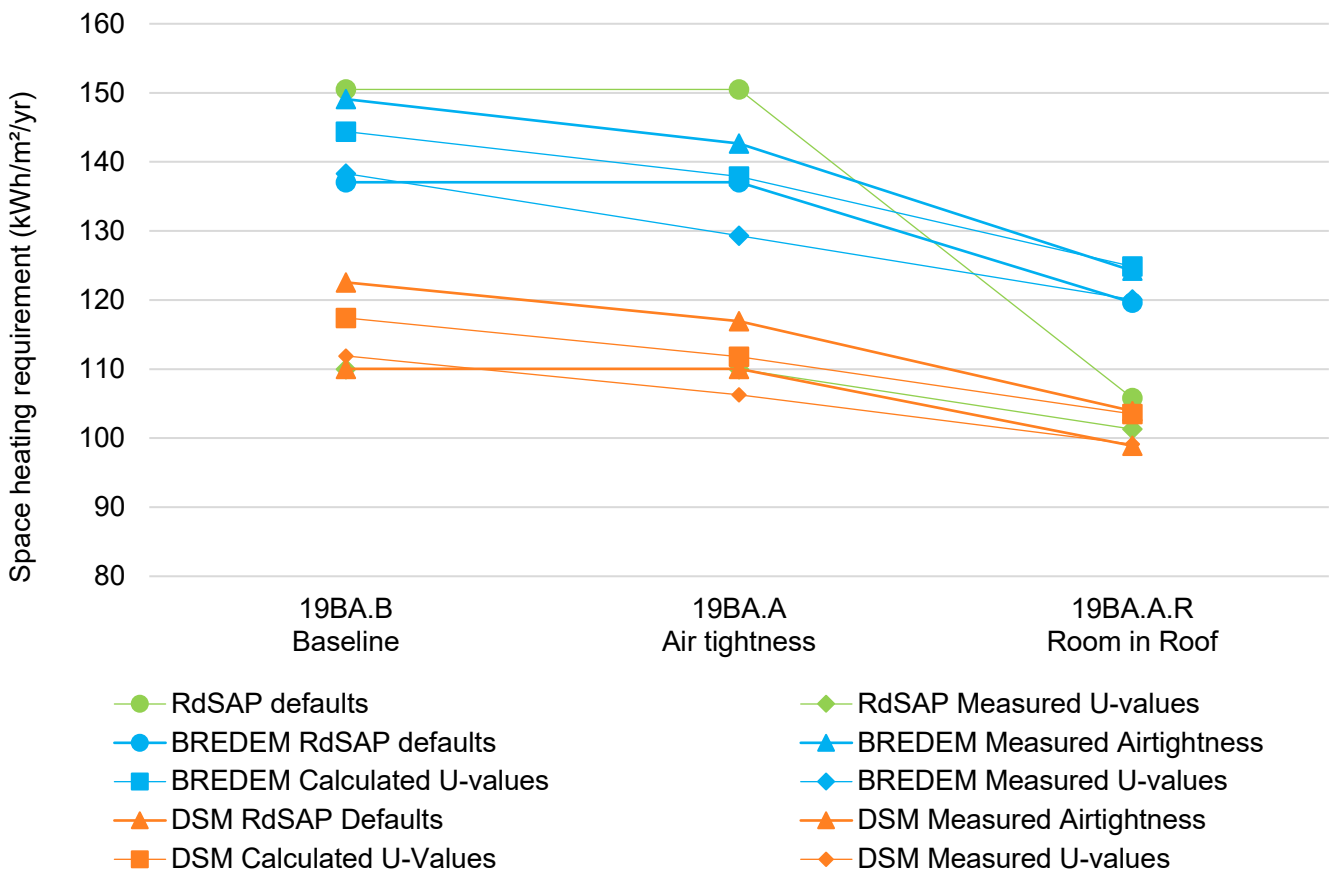
Figure 3-42 Predicted cumulative reduction in annual space heating demand

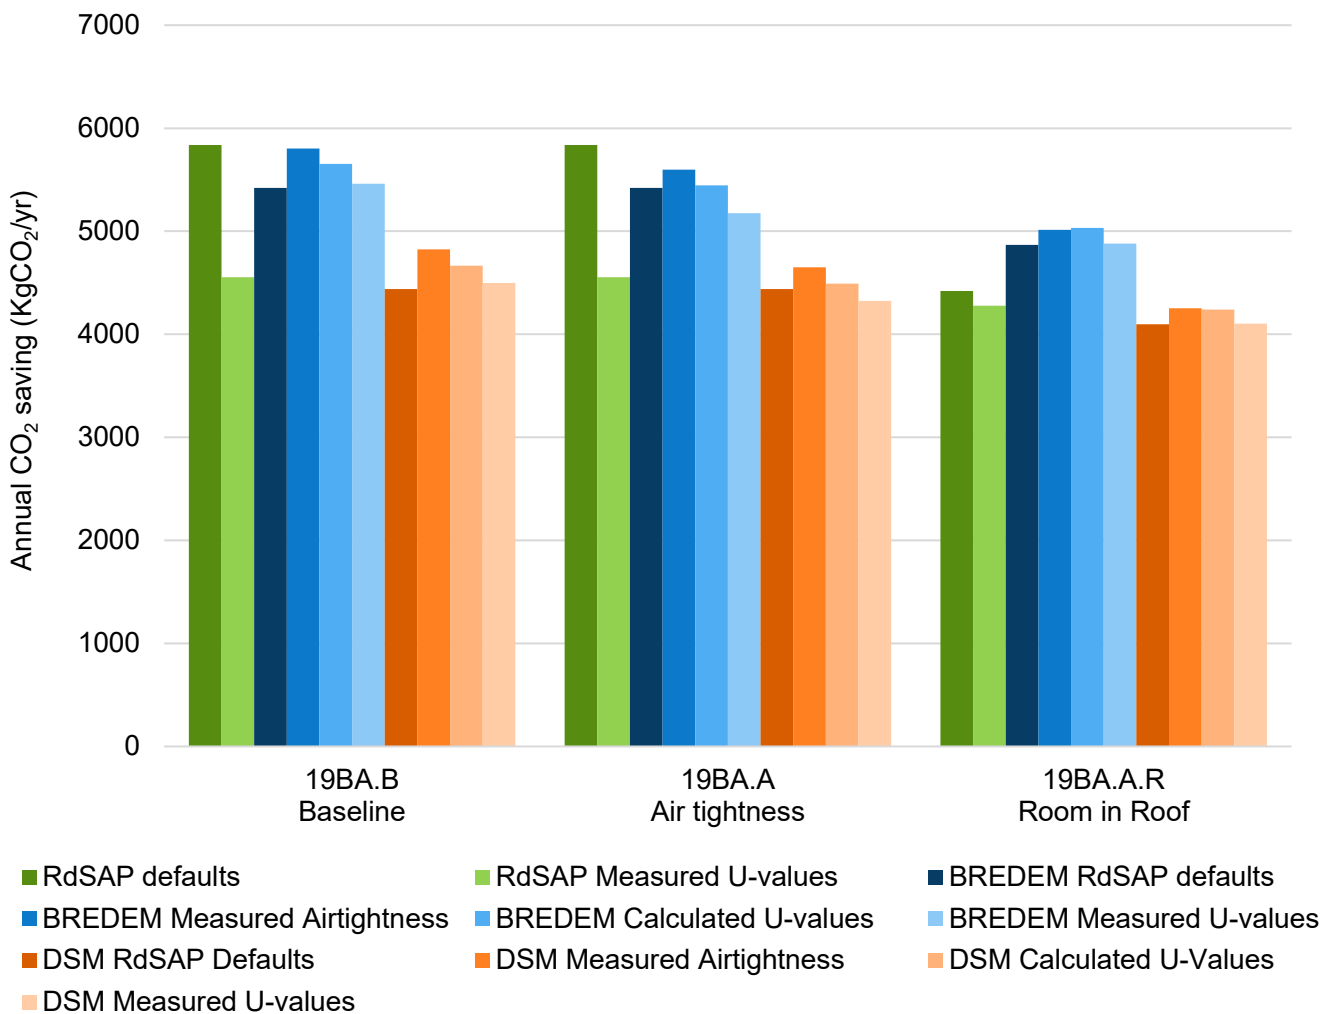
Figure 3-43 Annual CO₂ emissions following each individual retrofit

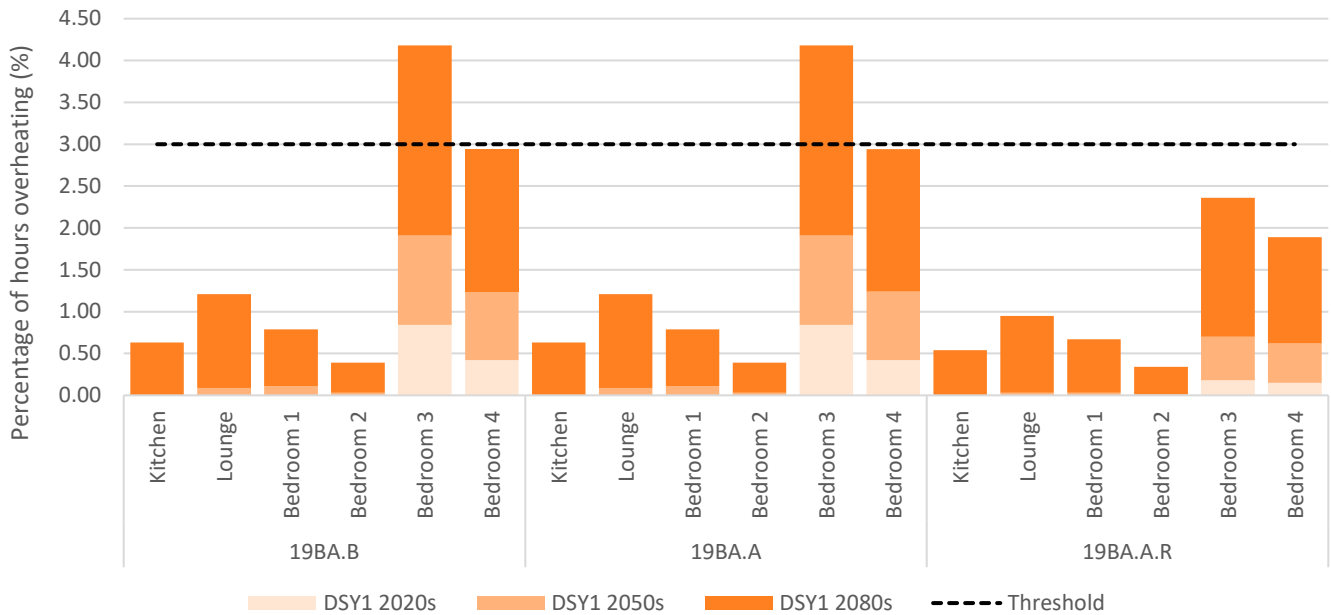
Figure 3-45 Modelled overheating under TM59 Criteria A
