# Arboricultural Impact Assessment and Tree Protection Plan

## Cotham School CCTV

**Cotham School**

16<sup>th</sup> October 2024

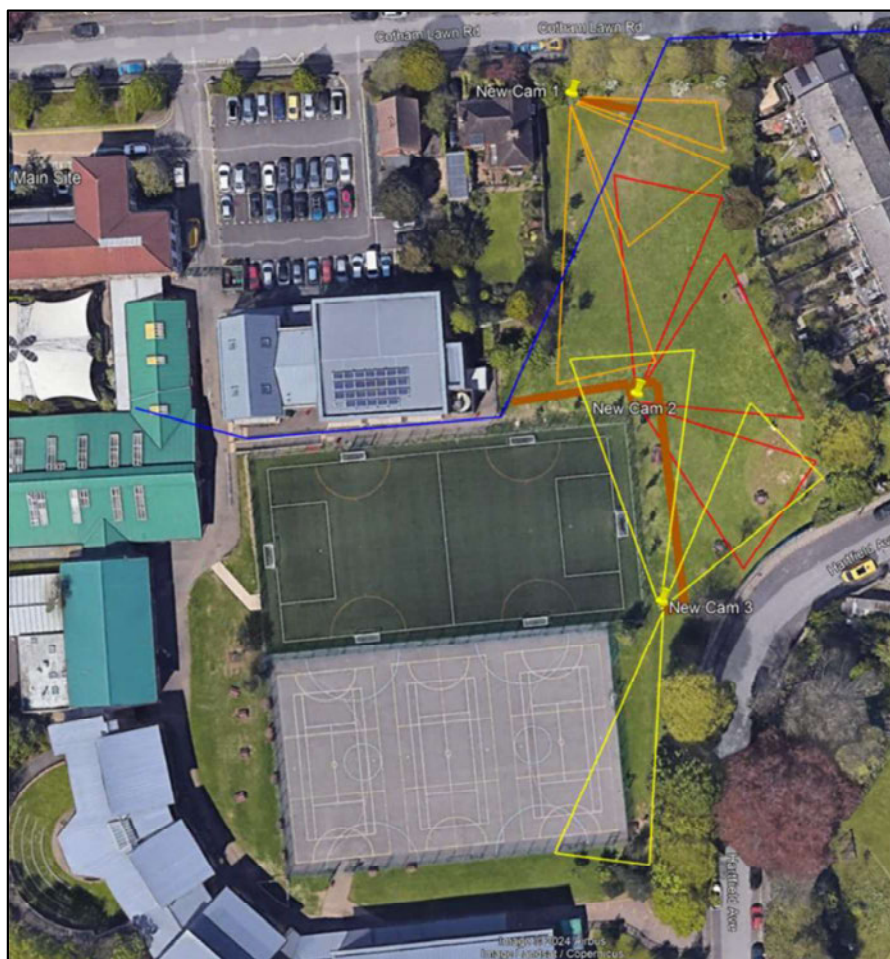
**Figure 1: The existing duct route is indicated in blue and the proposed new cable routes are indicated in brown.**

1.1.3 The visibility splays of each camera are shown on Figure 1 in yellow. These views will not be obscured by the trees.

3.2.1 Each of the poles will be constructed on a concrete base that is 1.1m x 1.1m in size and dug into the ground. These foundations are all outside of the root protection areas of adjacent trees.

3.2.2 The power cables required by the cameras will be installed within ducting that is mole-ploughed into the ground. The route of the new ducting has been selected to avoid tree root protection areas.

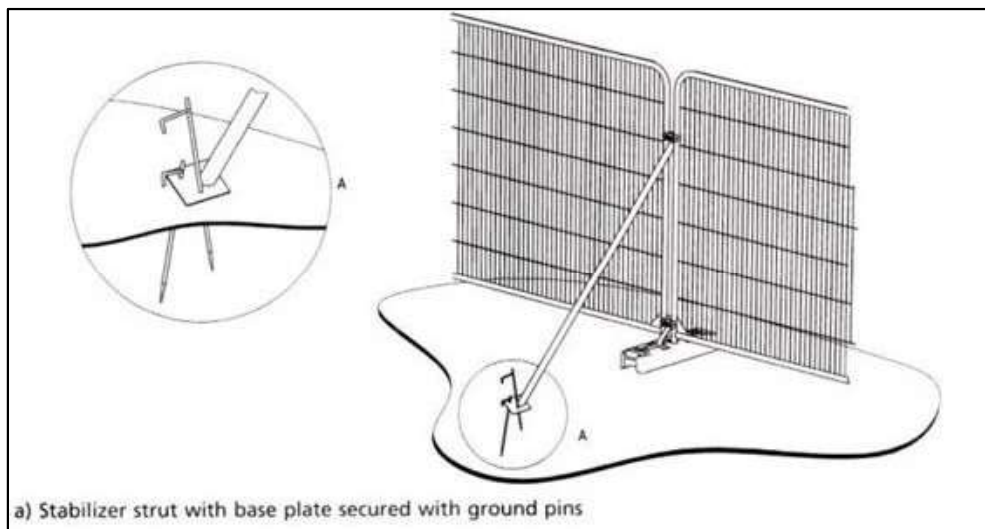
Figure 3a of BS5837:2012.

Fencing (or other forms of barrier) must be fit for the purpose of excluding construction activity and appropriate to the degree and proximity of work taking place around the retained trees. In most cases fencing should consist of a scaffold framework comprising a vertical and horizontal framework, well braced to resist impacts, with vertical tubes spaced at a maximum interval of 3m (as detailed in in Figure 2 of BS5837). That would be appropriate, but for this project I expect that the most practical fencing to use would be Heras fencing that has been fixed in place (as detailed in figure 3a of BS5837). Therefore, it is proposed that Heras fencing is used, and that the feet are pinned, or the panels braced, to prevent contractors from being able to easily move the feet and alter the fence alignment during construction. Heras produce support braces that can be used to stabilise fence panels.

Once the barriers have been erected the areas of land within the construction exclusion zone should be regarded as sacrosanct, and should not be removed or altered without prior consultation with the project arboriculturist and, where necessary, approval from the local planning authority. All-weather notices should be attached to the fencing with words such as: 'Construction Exclusion Zone - No Access'. Throughout the construction period attention should be paid to ensure that barriers remain rigid and complete.

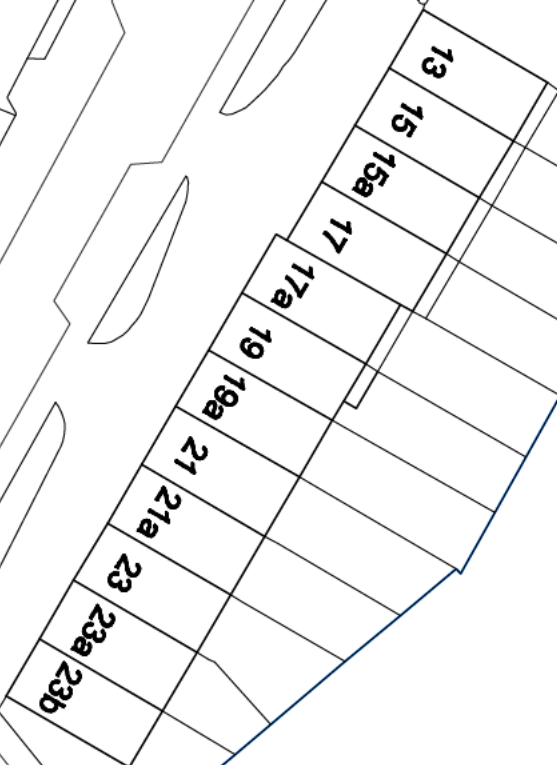
**Drawing Number:**  
TPP-1

2.3.1 The Tree Protection Plan (TPP-1) shows the locations of the trees and where fencing and ground protection will be installed in order to protect them during construction. This plan is provided at the rear of the report.

**Drawing Title:**  
Tree Protection Plan

3.4.1 Temporary fencing and/or barriers must be used during construction to protect retained trees situated near works areas. The locations of such fencing/barriers is indicated on Tree Protection Plan at the rear of the report (TPP-1). For effective tree protection, protective fencing must be installed before any heavy plant machinery is used on the site and must remain in place until completion of construction works (unless under arboricultural supervision). The fenced off areas will be designated as 'construction exclusion zones'.

The location of the tree protection fencing that will be required is shown on the tree protection plan, (this is provided at the rear of this document). **For effective tree protection it is crucial that the protective fencing is installed before any heavy plant machinery is used on the site.** The tree protection fencing must remain in place until the construction works have been completed (unless under arboricultural supervision). The fenced off areas will be construction exclusion zones.
